Cotton Dyeing & Finishing Mills Ltd. - Central Store shed.

Amtoli, Habirbari, Seed Store Bazar, Valuka, Mymenshingh
(24.3150,90.3840)

17th January 2022

Central Store shed. (Shed-6): Single storied prefabricated steel shed.

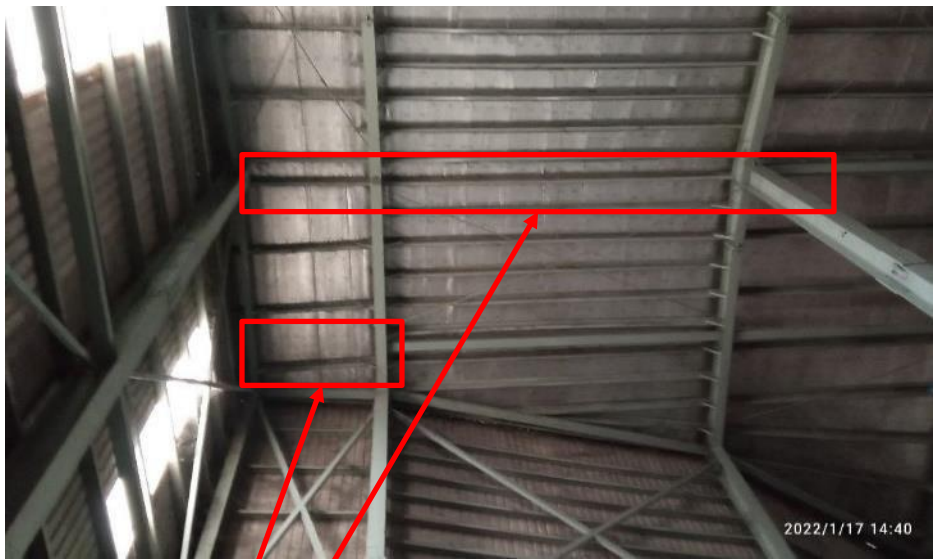
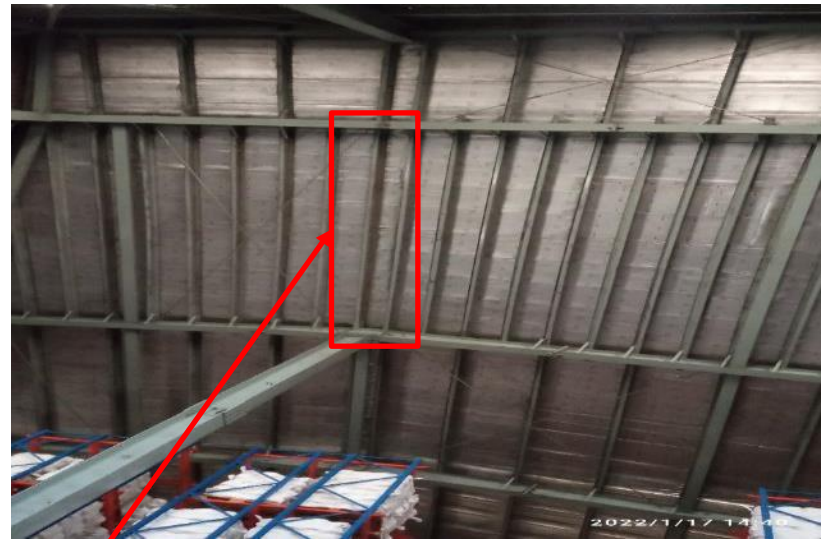
Missing lateral load transfer media (compression strut) on roof.

Missing compression strut on roof

The building engineer is required to update compression strut location in structural drawing & check the stability of the structure.

Item No.	Observation	Recommended Action Plan	Recommended Timeline
01	Missing lateral load transfer media (compression strut) on roof.	As a part of Engineering Assessment (EA), the building engineer is required to update compression strut location in structural drawing & check the stability of the structure and suggest necessary remedial actions.	6-weeks
02	Missing lateral load transfer media (compression strut) on roof.	Carry out remedial works as the EA.	6-weeks
03	Soil bearing capacity consideration in DEA report & foundation adequacy check.	Building engineer required to consider geotechnical investigation report close vicinity of the structure, determine actual soil bearing capacity and check the foundation adequacy accordingly.	6-months
04	Soil bearing capacity consideration in DEA report & foundation adequacy check.	Implement any remedial works from the design report.	6-months

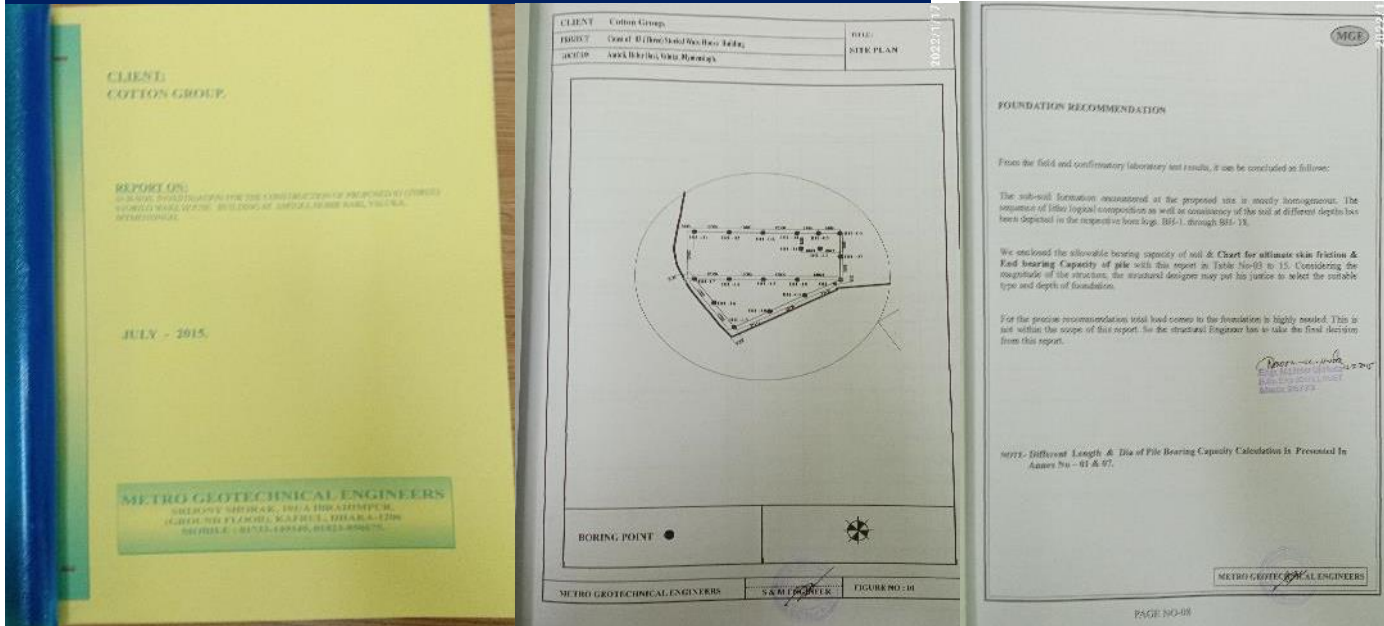
Geotechnical investigation report attached in the design report not matched with the available geotechnical investigation report. Consider geotechnical investigation report which was done close vicinity to the structure (Provided report during inspection), determine actual soil bearing capacity and check the foundation adequacy accordingly.

Soil test report used in DEA report

Soil test report provided during inspection

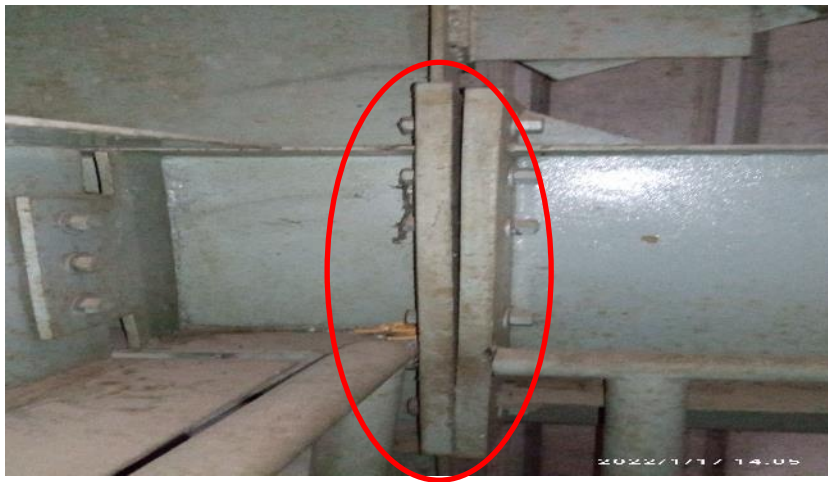
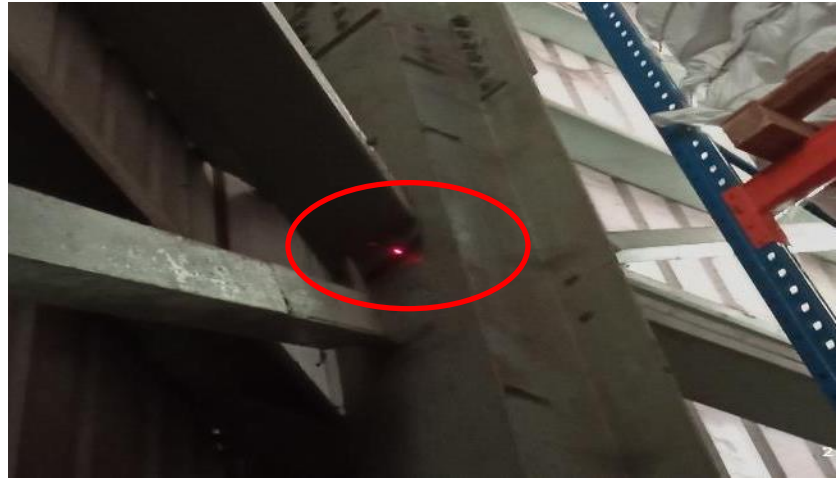
Connection gap in joints

Loose bolts and connection gaps in several locations were observed. The building is required check the structure to identify the loose bolts & connection gaps and take action to tighten up the loose bolts & fill up the connection gaps properly.

Item No.	Observation	Recommended Action Plan	Recommended Timeline
05	Significant gaps in connection & loose bolts.	The building is required check the structure to identify the loose bolts & connection gaps and take action to tighten up the loose bolts & fill up the connection gaps properly.	6-weeks
06	Discrepancies in as-built drawings & lack of details.	Building engineer to survey the structure and prepare accurate as-built structural drawings.	6-weeks
07	Sign of rust in steel members.	Apply rust proof coating to the steel members.	6-months

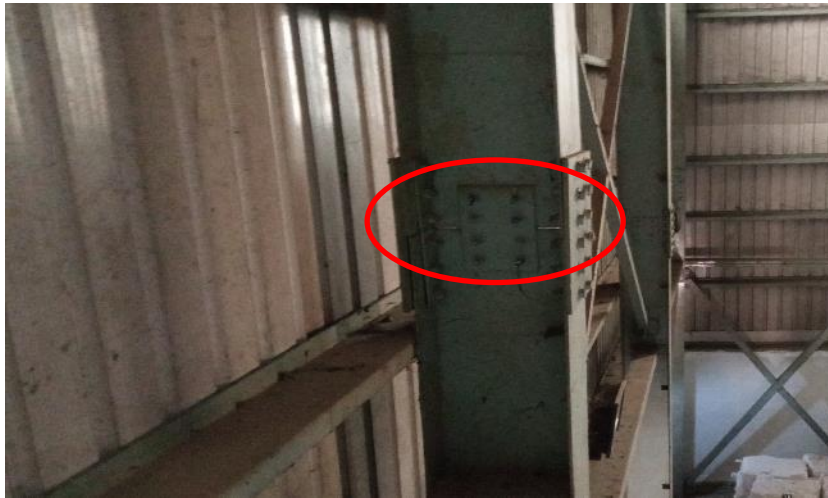
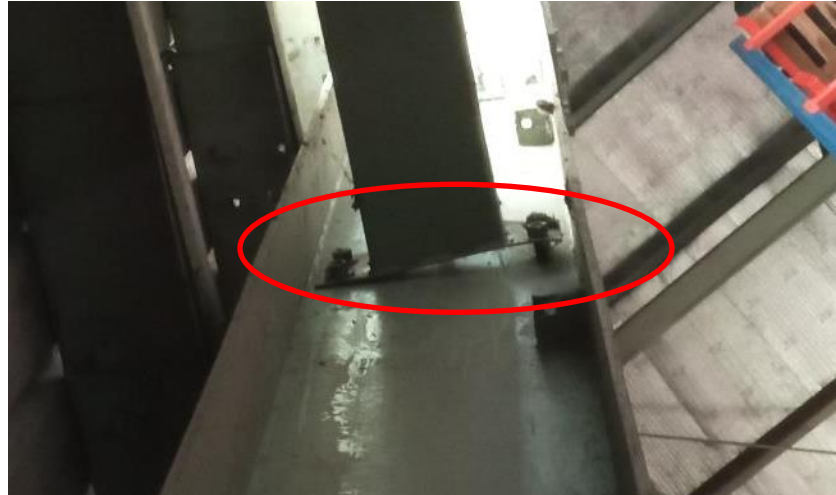
Loose bolts

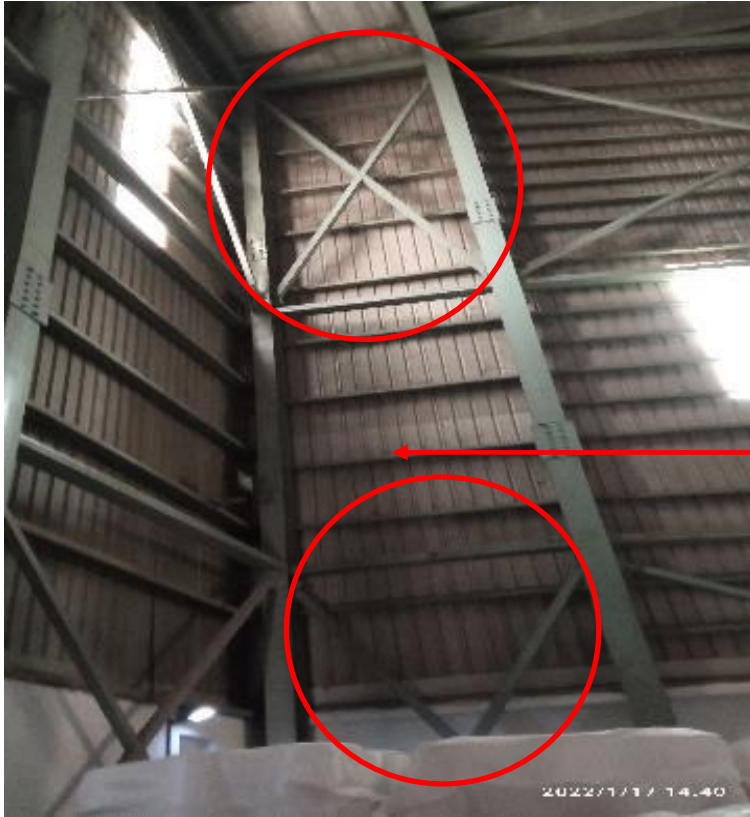
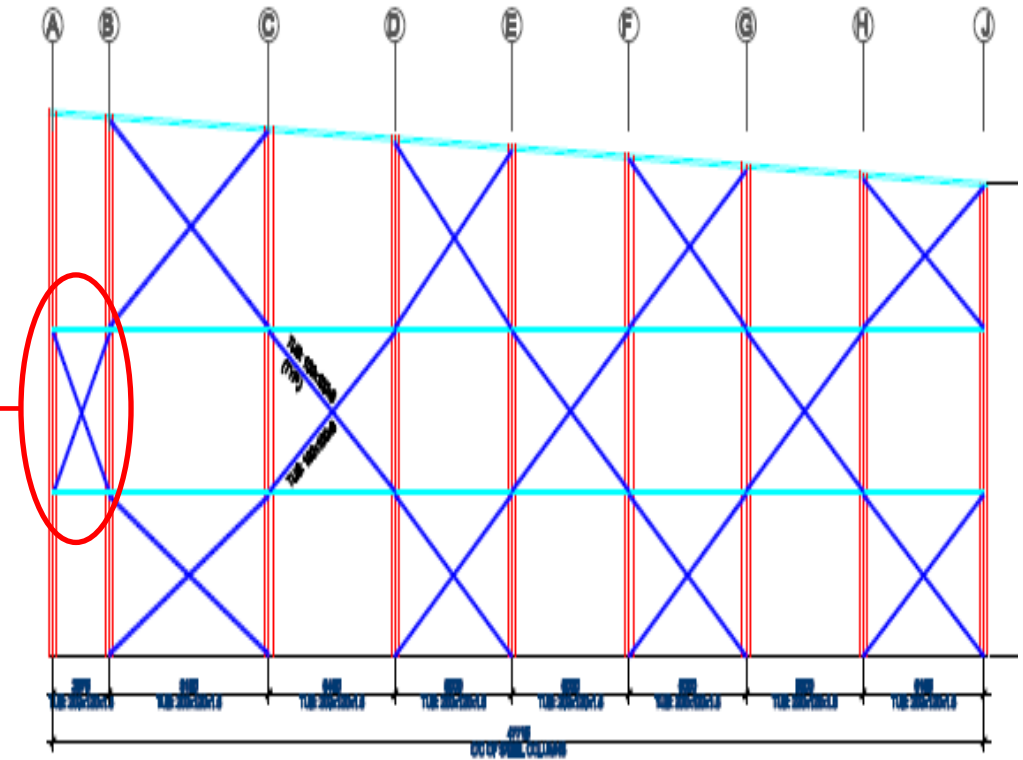
Mismatch in vertical bracing

Column schedule, rafter schedule, compression strut details, some vertical bracing layout (Grid : 1-I to 15-O), steel stair details & some connection details are missing in steel part drawings. Mismatches were observed between drawings & existing condition. The building engineer is required to survey the structural components and produce accurate structural drawings.

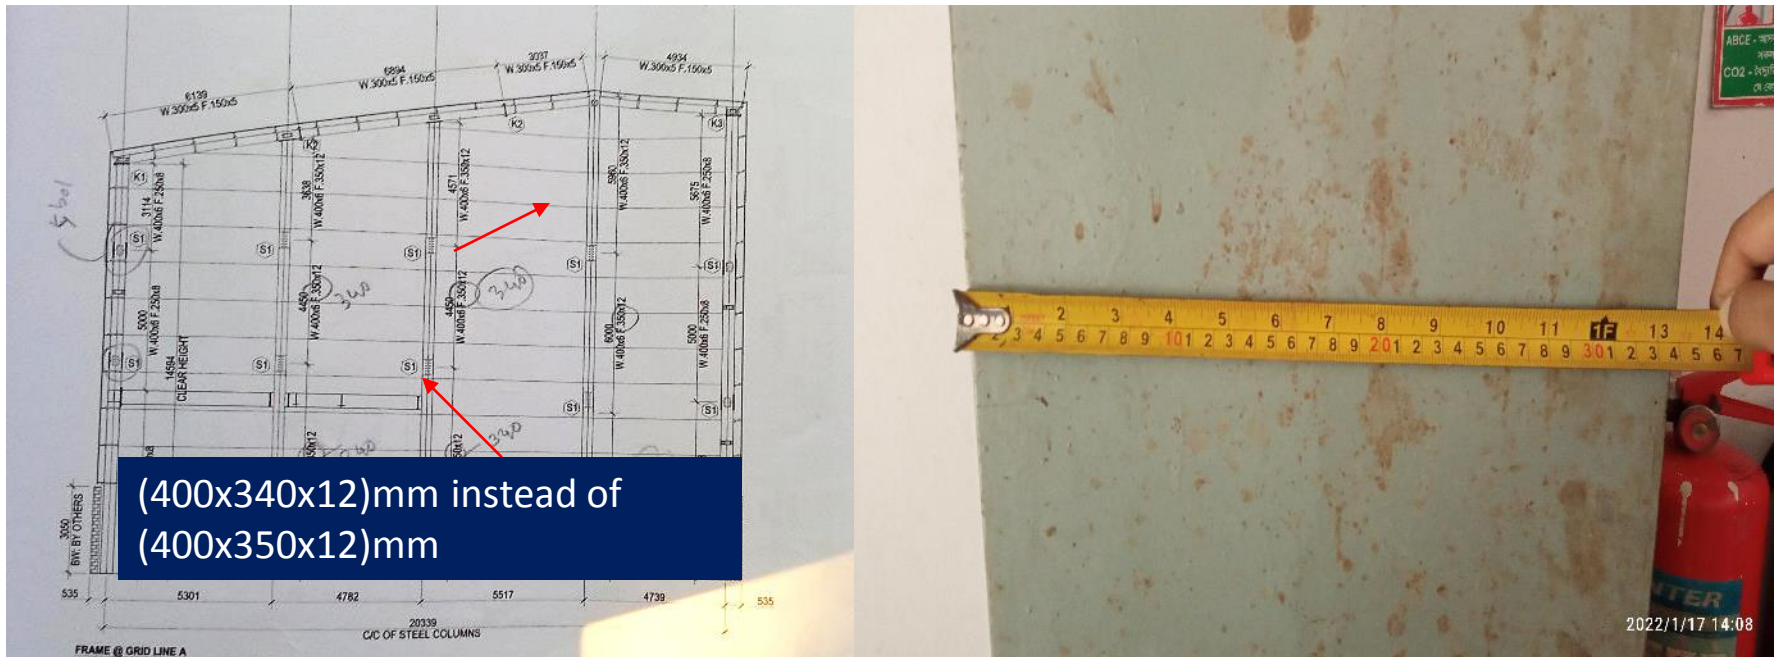
(400x340x12)mm instead of (400x350x12)mm

Mismatch in column size

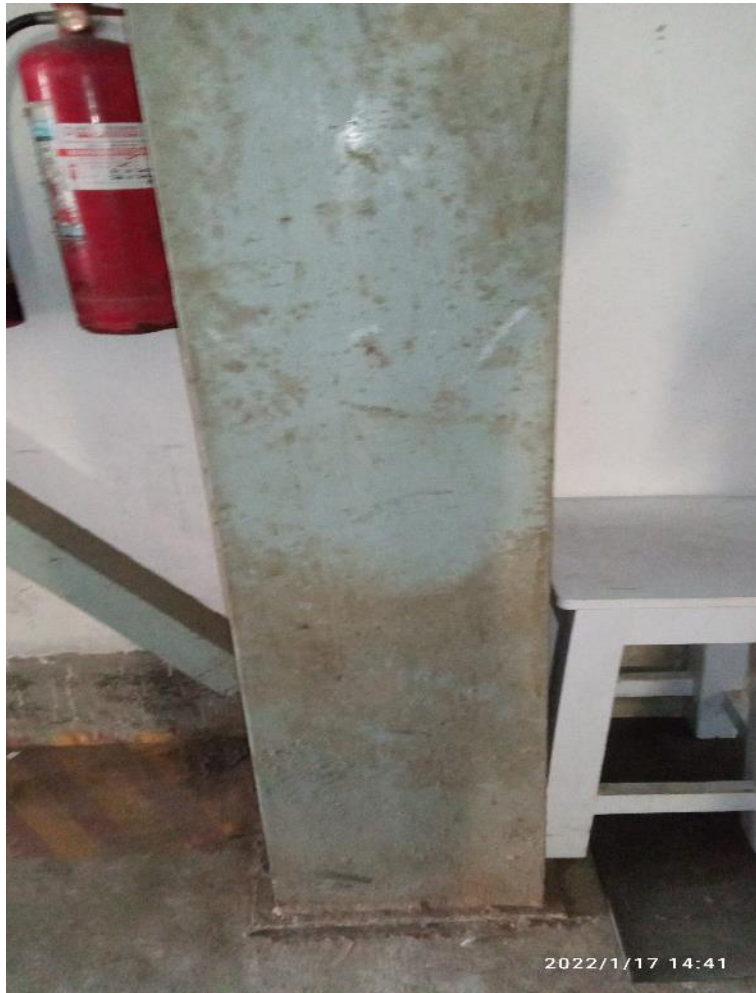
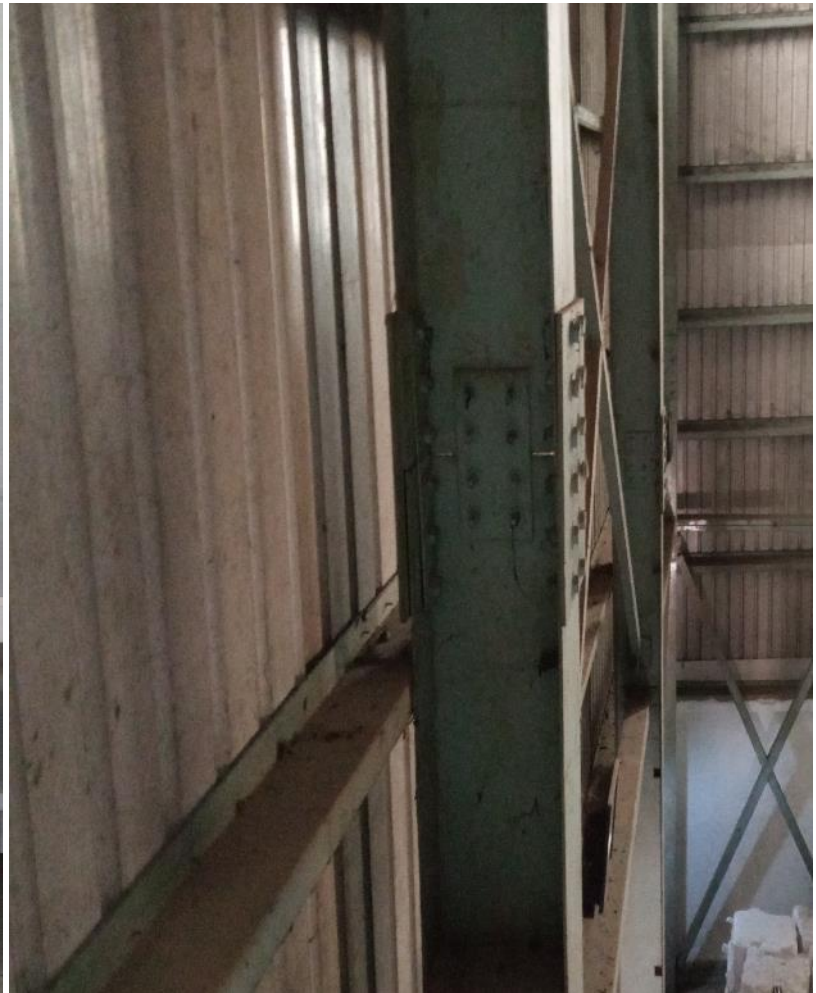
Sign of rust on steel members

Signage of rust observed of different steel members. Building engineer is required to provide rust proofing to these steel members.
