ELECTRICAL SAFETY INSPECTION REPORT

COTTON DYEING & FINISHING MILLS LTD.- CENTRAL STORE SHED

Inspected on: **January 17, 2022**

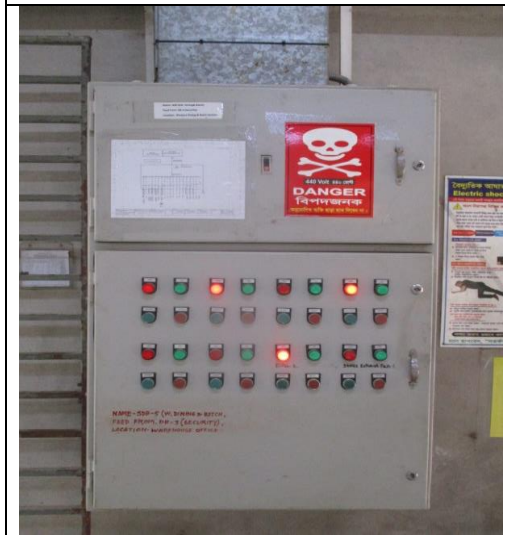
Typical electrical distribution panel.

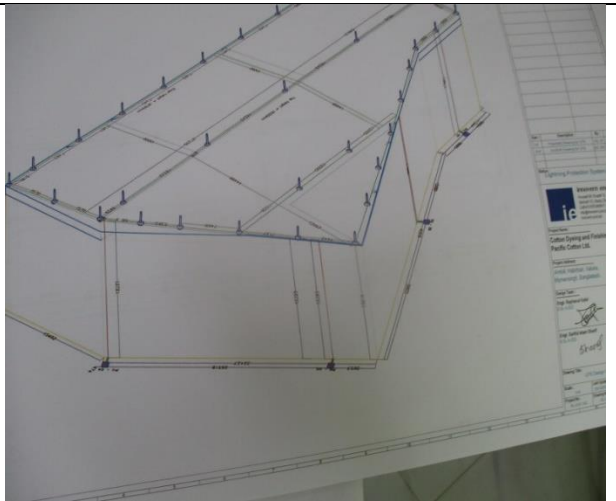
FINDING NO:	E - 1	
CATEGORY:	LIGHTNING PROTECTION SYSTEM	
FINDING:	Lightning Protection System (LPS) and drawing is available, but it needs some modification.	
RECOMMENDATION:	Factory has to design Lightning Protection System (LPS) for the whole factory (where the Risk index is more than 40). Once a LPS is designed properly, installation must be done accordingly asap.	
PRIORITY:	P1	
REMEDIATION TIME FRAME:	3 MONTHS
