International Trading Services Ltd. (10409)

25.MARCH.2014

ACCORD
on Fire and Building Safety in Bangladesh

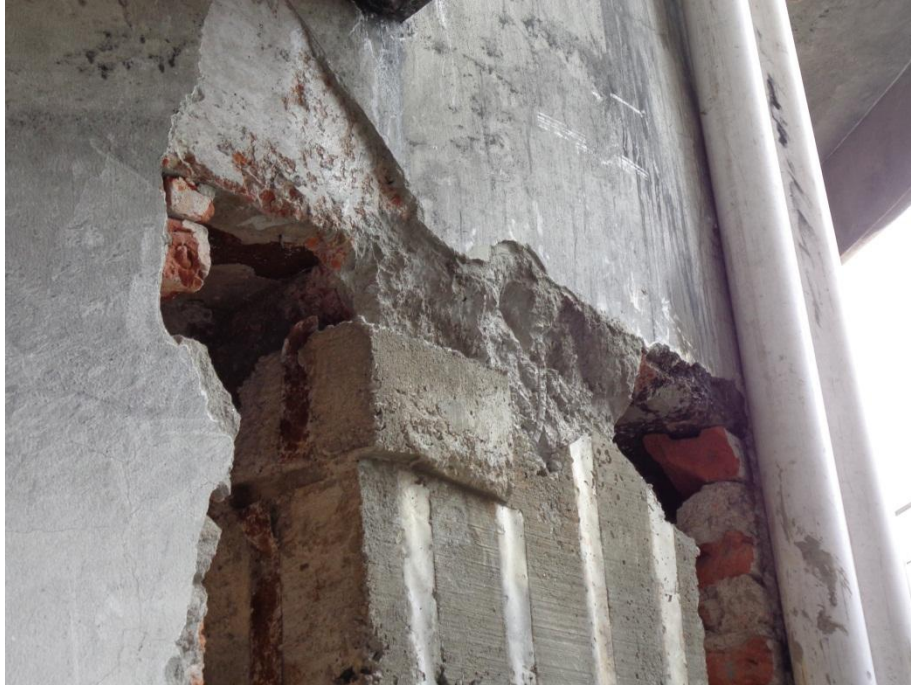
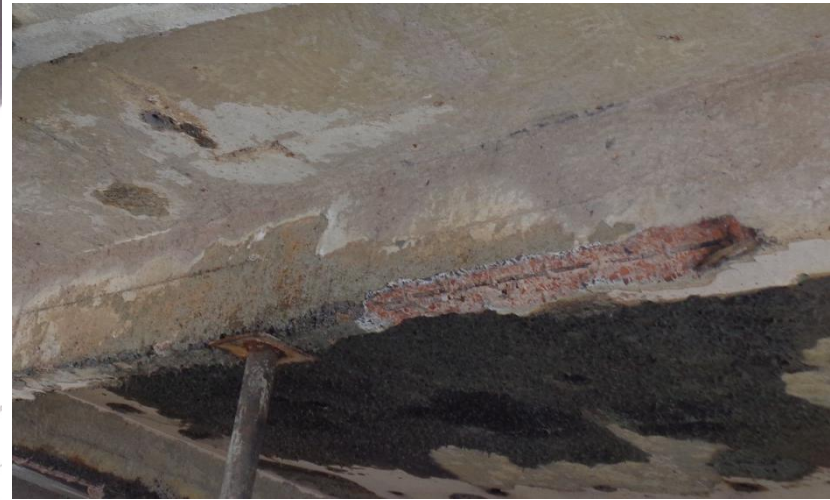
Fire Damage to 5-Storey Building

The circular 5-storey building adjacent to the 6-storey factory building shows signs of fire damage and structural instability

ITEM 1: (Priority 1) A 5-storied circular building adjacent to the 6-storied building was observed to have fire damage to structural members at the ground floor level. Rebar has been exposed and concrete has cracked and fallen away from beams and columns.

Remove Occupants from Circular 5-Storey Building.
The building wasn't being used at the time of our survey – but a small amount of storage was noted.

The 5-storey Fire Damaged building should be left unoccupied

- The circular 5-storied building should be vacated until results of ongoing engineering assessments are received. This was discussed and agreed at the time of the survey.

- Act upon any recommendations from that Detailed Engineering Assessment.

- Maintain any repairs and monitor for any residual damage.

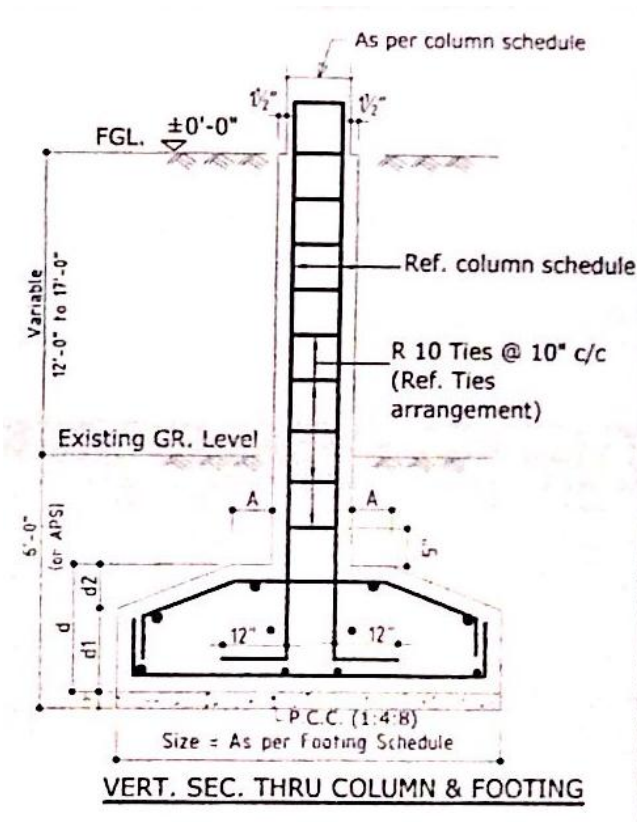
Low Soil Bearing Capacity

Based upon the provided soils reports, spread footing size is inadequate to properly distribute footing loads to the native clay soil

ITEM 2: (Priority 2) Foundations of the 11-storied and 6-storied buildings both appear of inadequate size to transmit building loads safely into the native low bearing capacity clay, described in the Geotechnical Reports.

- A Detailed Engineering Assessment to be carried out upon the 6-storey and 11-storey looking into, in particular the building foundations and the Geotechnical findings.

- Implement any recommendations or works deemed necessary by the Detailed Engineering Assessment mentioned above.

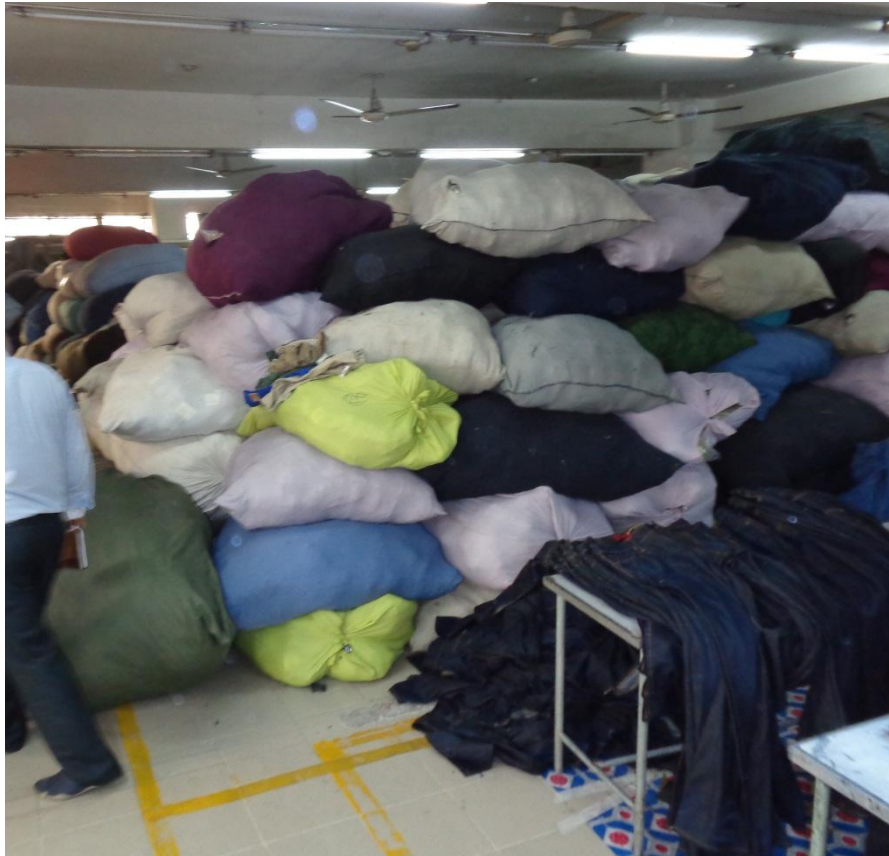
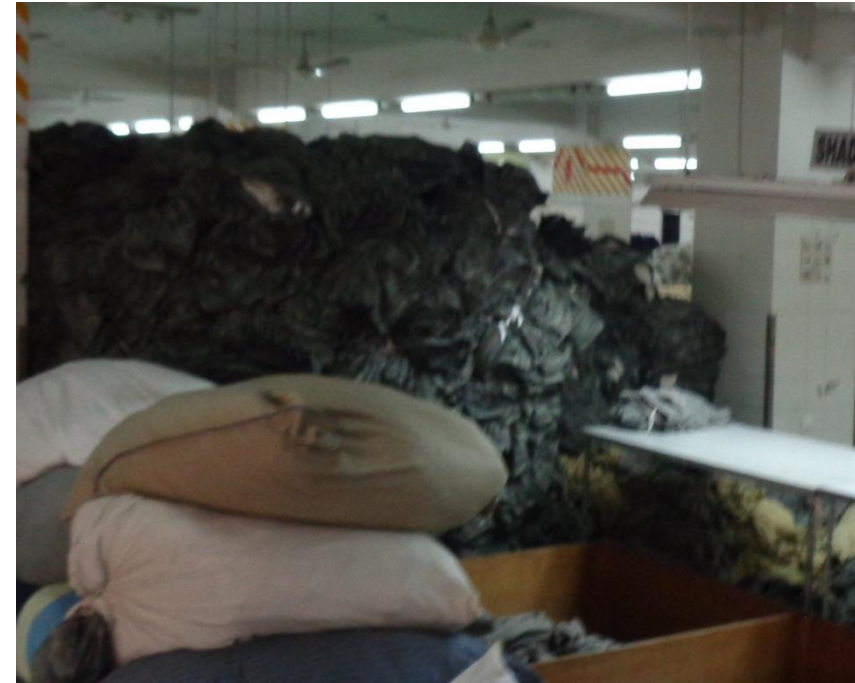
High Local Storage Loads

High local storage loadings were observed throughout both the 11-storied and 6-storied buildings

ITEM 3: (Priority 2) High levels of local storage were observed throughout the 11-storied and 6-storied buildings.

- Factory engineer to produce and actively monitor a loading plan for all floor plates within the factory complex, with consideration given to slab, column and foundation capacities.
