# Lantabur Apparels Ltd (Extension Unit)

Kewa, Boherarchala Sreepur, Gazipur  
(24.1969 N, 90.4071 E)

26 December 2021 & 23 January 2022

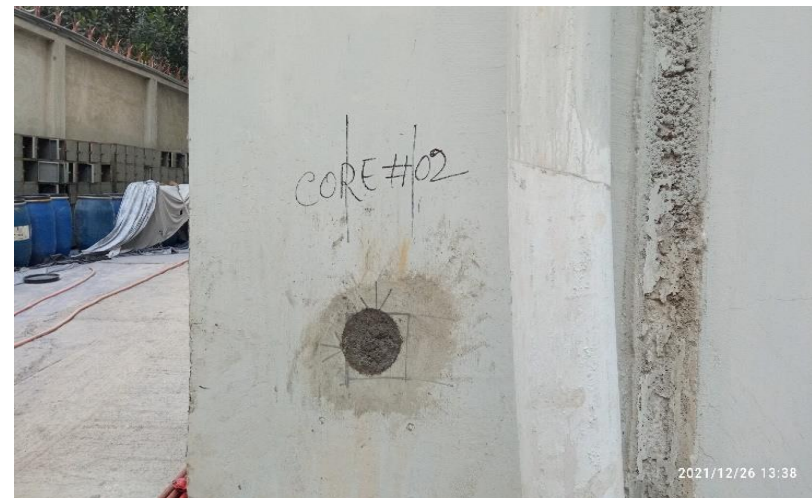
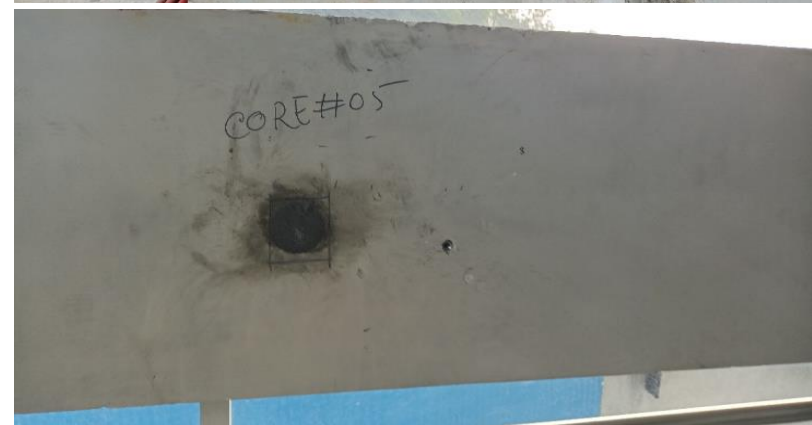
Core locations

The factory has 12 sets of cylinder test report, among them some doesn't have average value & almost all cylinder tested more than 4 to 10 month later after the sample taking date, which is not conclusive to verify the concrete design strength (24.1 MPa). However, Factory has taken cores from beams & columns to verify in-situ concrete strength, but test report was unavailable during inspection. The building engineer is required to use core test results to verify the in-situ concrete strength as a part of EA.

| Item No. | Observation | Recommended Action Plan | Recommended Timeline |
|---|---|---|---|
| 01 | Verify in-situ concrete strength. (Garments Building) | As a part of EA, the building engineer is required to use core test results to verify the in-situ concrete strength. | 6-weeks |
| 02 | Verify in-situ concrete strength. (Garments Building) | Carry out remedial works as per the EA report. | 6-months |

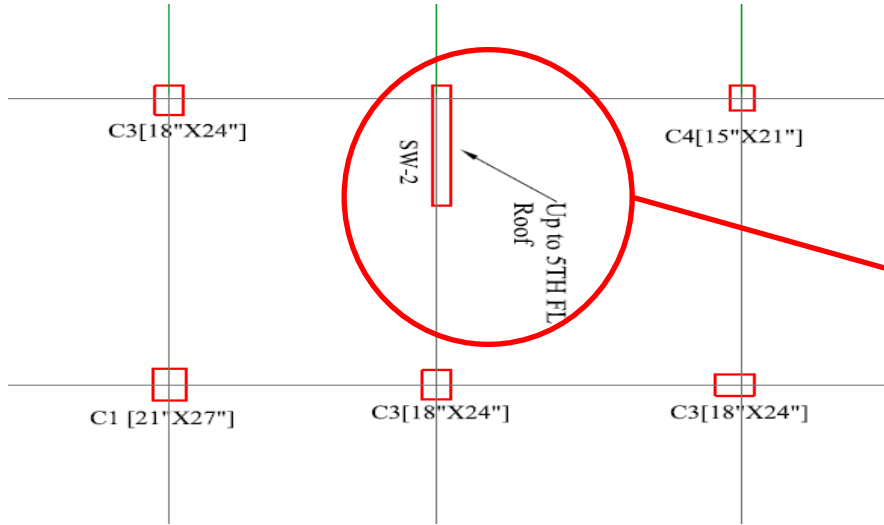
Existing shear wall drawing

**Missing shear wall at 5th floor.**

The building engineer is required to update the shear wall location in structural drawing & check the stability of the structure.

| Item No. | Observation | Recommended Action Plan | Recommended Timeline |
|---|---|---|---|
| 03 | Missing shear wall at 5th floor. (Garments Building) | As a part of Engineering Assessment (EA), the building engineer is required to update shear wall location in structural drawing & check the stability of the structure and suggest necessary remedial actions. | 6-weeks |

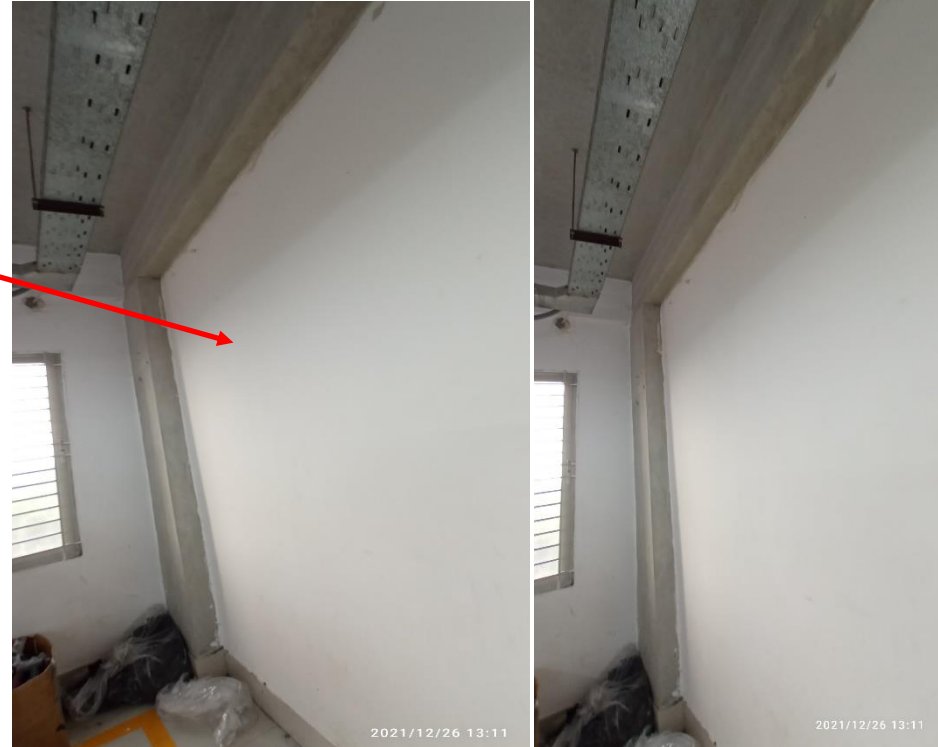
Missing shear wall at 5th floor. Brick wall constructed instead of RC shear wall

| Item No. | Observation | Recommended Action Plan | Recommended Timeline |
|---|---|---|---|
| 04 | Missing shear wall at 5th floor. (Garments Building) | Carry out remedial works as per the EA report. | 6-months |

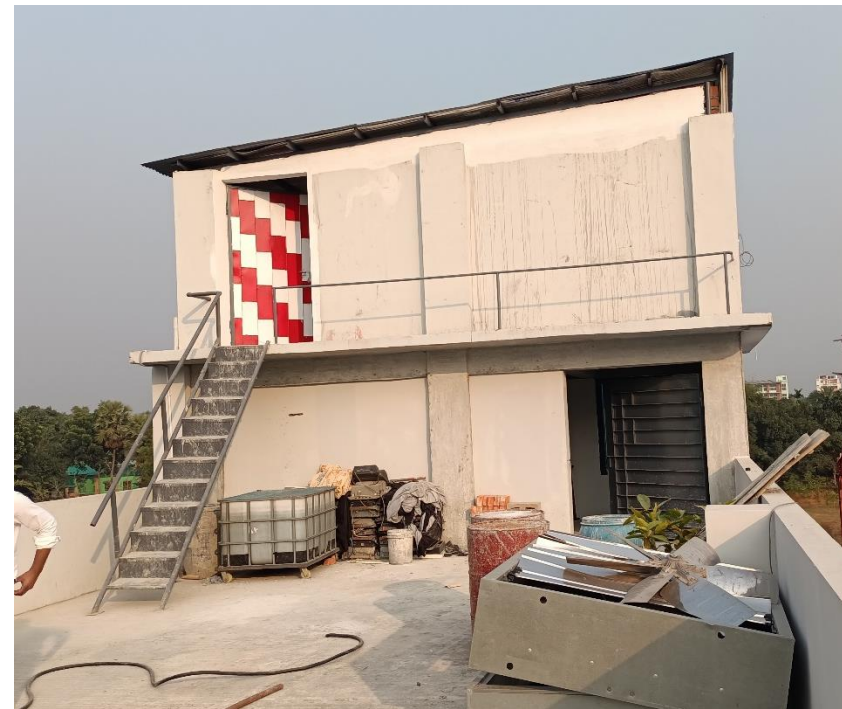
**Additional room at staircase top**

A design report with software-based analysis file was provided for Utility Building. The additional room above stair has not consider in the provided design report. Building engineer is required to revise the design report considering the full structure and submit to RSC.

| Item No. | Observation | Recommended Action Plan | Recommended Timeline |
|---|---|---|---|
| 07 | Staircase roof not considered in the design report. (Utility Building) | Building engineer is required to revise the design report considering the full structure and submit to RSC. | 6-weeks |

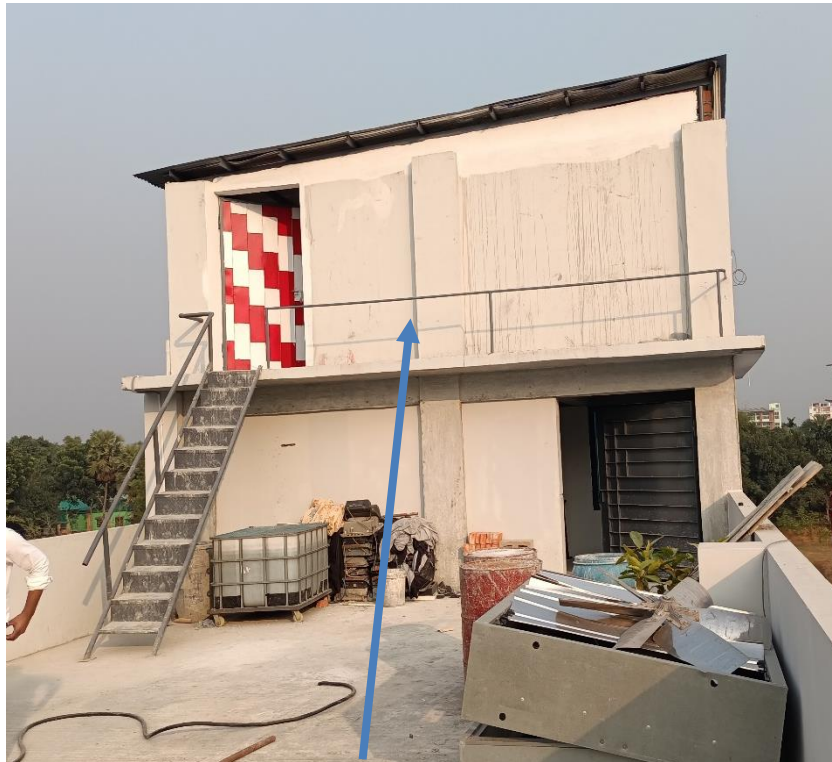
Roof Shed

Non engineered connections were observed at light weight roof. Factory engineer is required to check the connection of the roof for the up-lift pressure of wind.

| Item No. | Observation | Recommended Action Plan | Recommended Timeline |
|---|---|---|---|
| 09 | Apparently non-engineered connection at roof shed. (Utility Building) | Building engineer is required to check the connection of the steel roof shed for the up-lift pressure of wind. | 6-weeks |

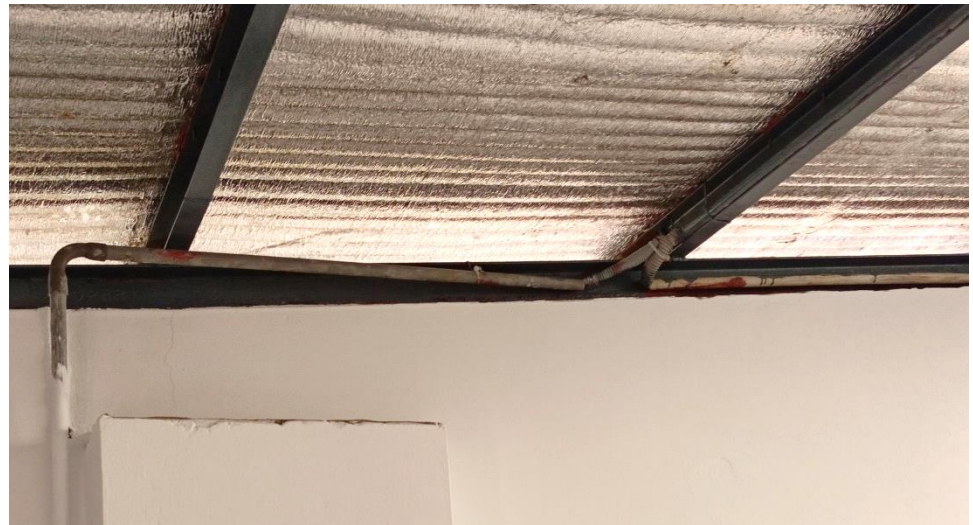
Non engineered connection

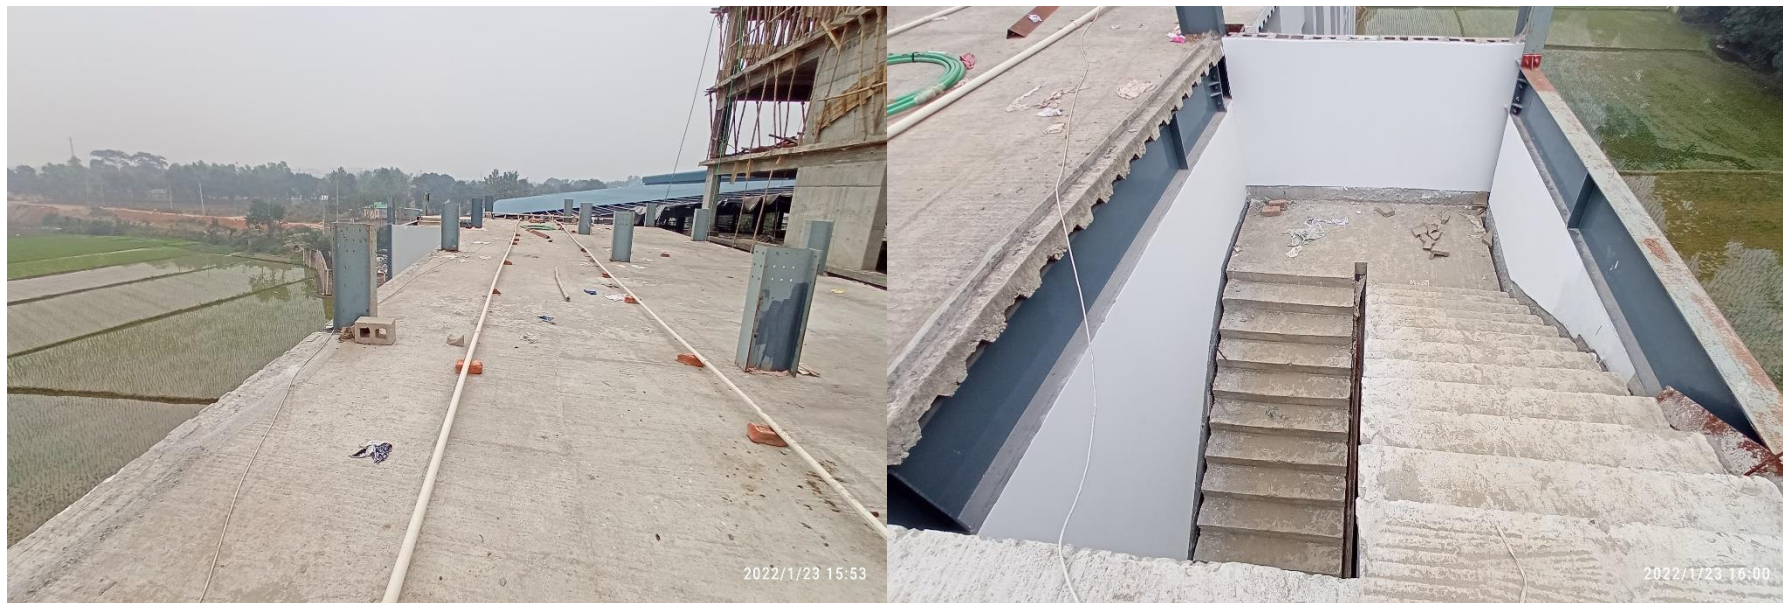
No parapet/barrier on roof & stair

The building engineer is required to provide parapet/barrier on roof and stair zone to prevent possible falling hazard.

| Item No. | Observation | Recommended Action Plan | Recommended Timeline |
|---|---|---|---|
| 13 | Falling hazard at roof & stair. (Dining building) | The factory is required to provide parapet/barrier on roof and stair zone to prevent possible falling hazard | 6-weeks |

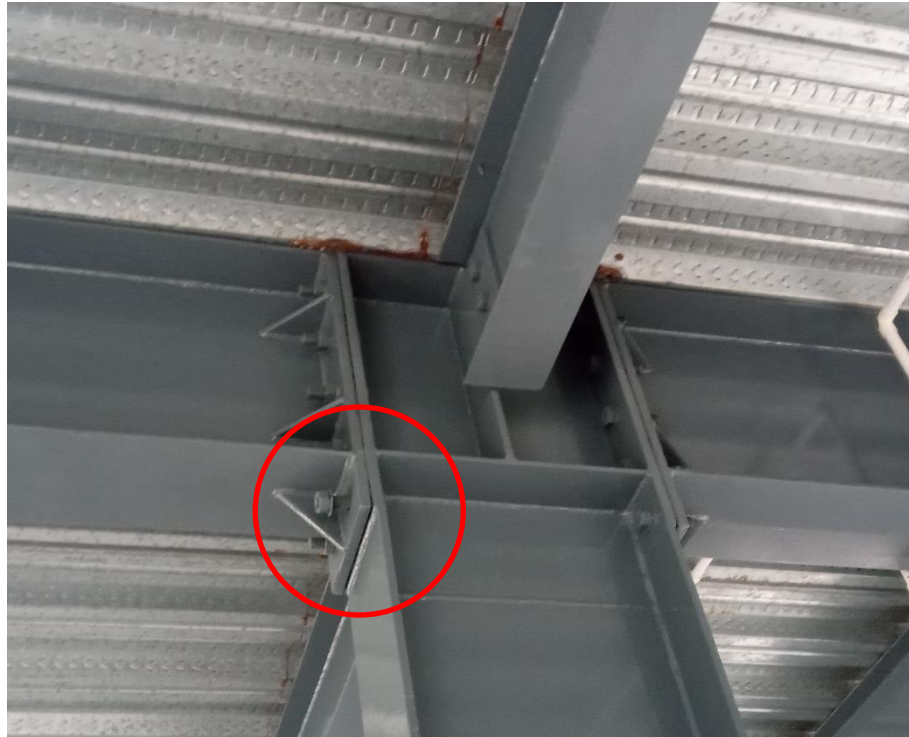
Loose bolts

Loose bolts was observed at some points. The building is required check the structure to identify the loose bolts & take action to tighten up the loose bolts.

| Item No. | Observation | Recommended Action Plan | Recommended Timeline |
|---|---|---|---|
| 14 | Loose bolts. (Dining Building) | The building is required check the structure to identify the loose bolts & take action to tighten up the loose bolts. | 6-weeks |

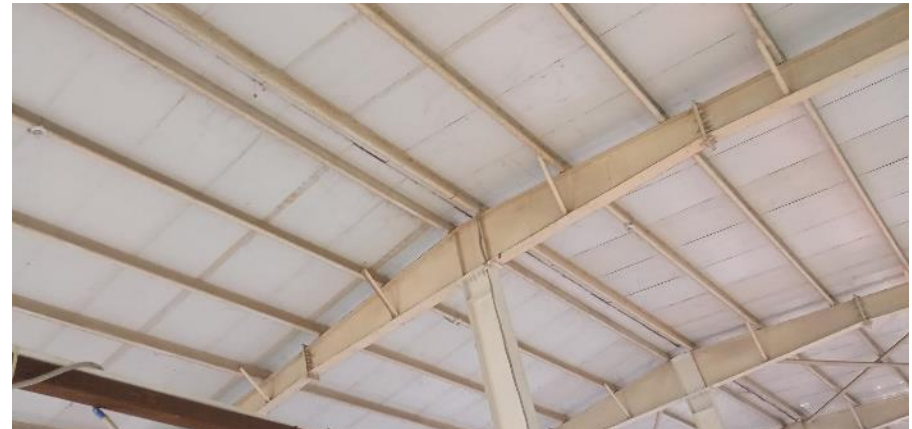
No Compression strut along ridge

A design report with software-based analysis file was provided for Printing Shed. Purlins (along ridge) are considered as compression member, but adequacy check of the purlins are not provided in the design report.

| Item No. | Observation | Recommended Action Plan | Recommended Timeline |
|---|---|---|---|
| 15 | Design check of compression member not in the design report (Printing Shed) | Address the design check of the long direction compression member in the design report. | 6-weeks |
