Victoria Intimate Limited

Dakkhin Vangnahati, Boiragirchala, Sreepur Gazipur

24th January 2022

Observations

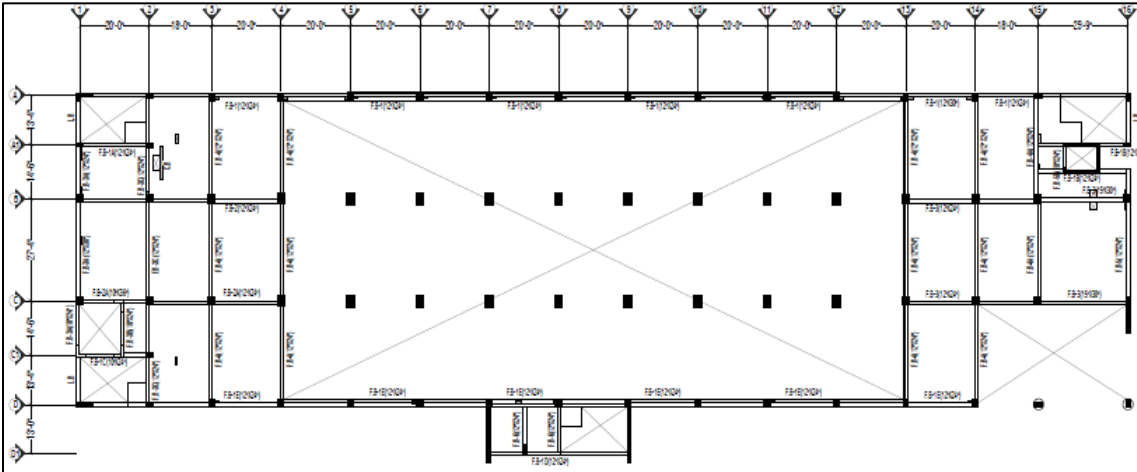
Seismic parameters

Mezzanine floor level: have no slab in the middle portion and corner of the building. More than 50% diaphragm discontinuity.

All structural irregularities check have not provided in the design report. The building has diaphragm discontinuity, but structural analysis has not been performed considering this issue. However, the factory is required to check all irregularities and revise the design report accordingly.

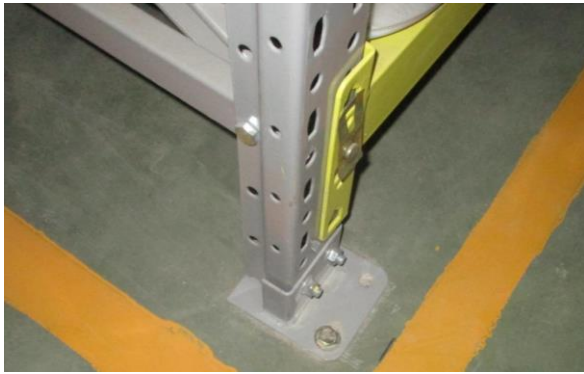
Column directly connected to ground slab; No foundation

During inspection, the steel mezzanine floor was being used for storage. The structure has no foundation isolated foundation. However, the factory engineer is required to survey the structure and prepare a set of design documents in compliance of BNBC.

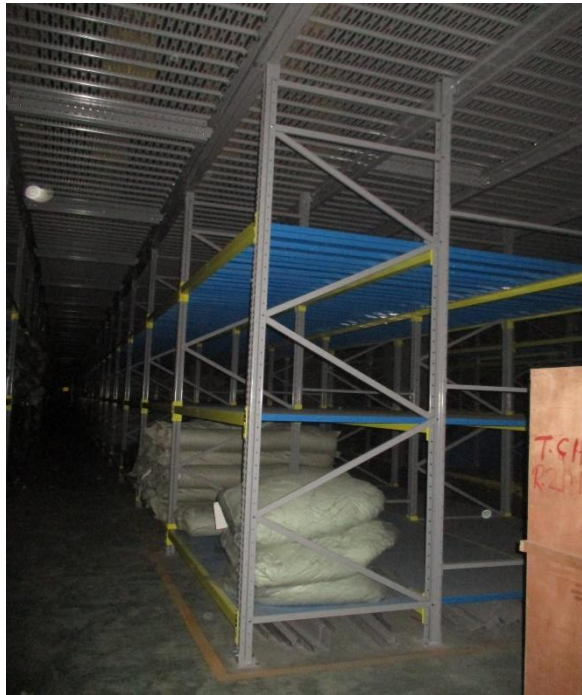
Bracing in rack frame

Chequered plate, beam and column

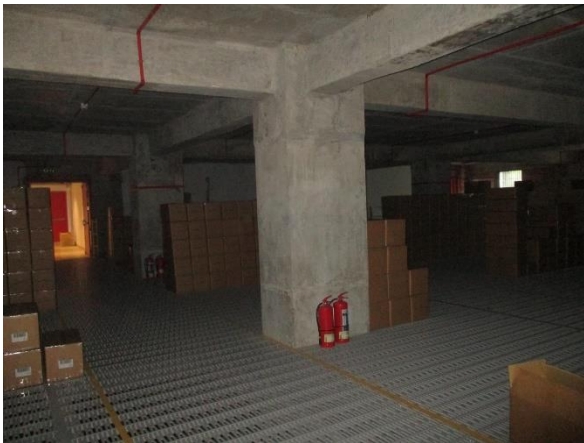
Storage on mezzanine floor

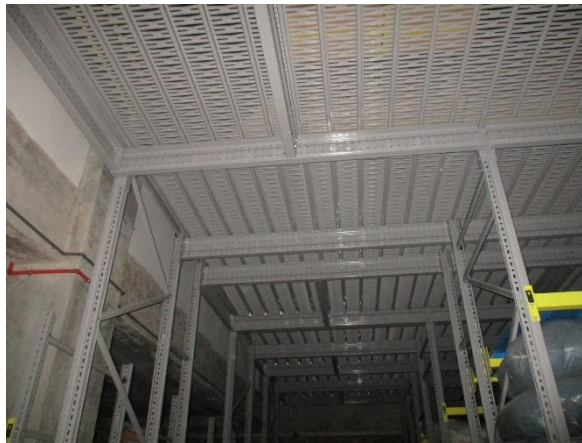
Roof system of mezzanine floor

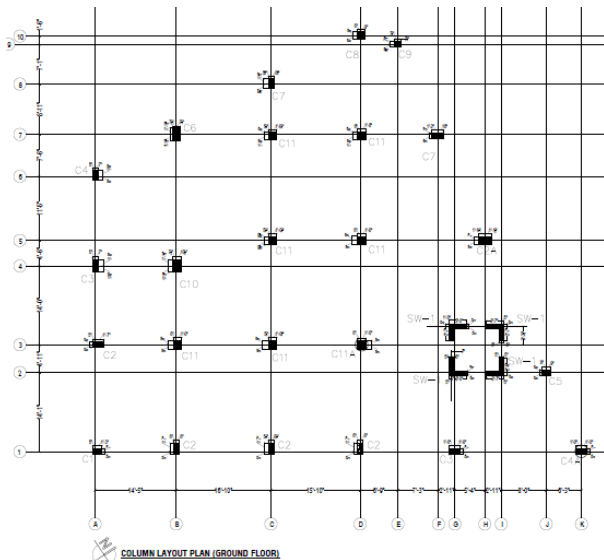
The basic structural frame system of this building is considered as DUAL system (R=9). But in the super structure of the building there is no shear wall or bracing system. However, the building engineer is required to revise the design report considering actual framing system. Also, all irregularities checks are not added in the design report which needs to be incorporated.

Column layout: No shear wall or bracing in the building

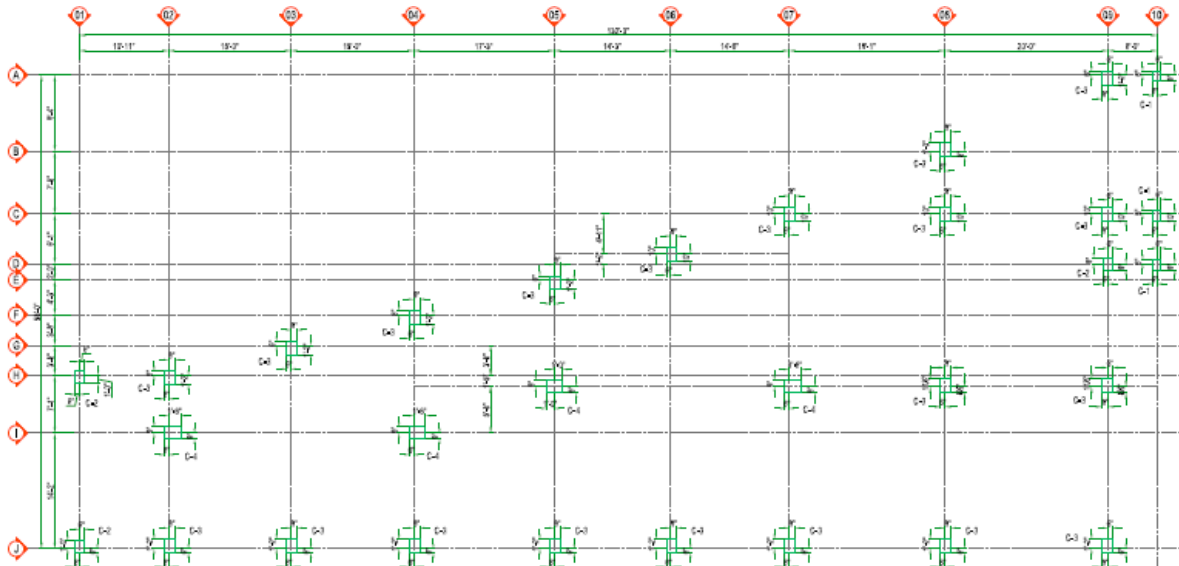
Column layout: No shear wall or bracing in the building

The basic structural frame system of this building is considered as DUAL system (R=9). But in the super structure of the building there is no shear wall or bracing system. However, the building engineer is required to revise the design report considering actual framing system. Also, all irregularities checks are not added in the design report which needs to be incorporated.

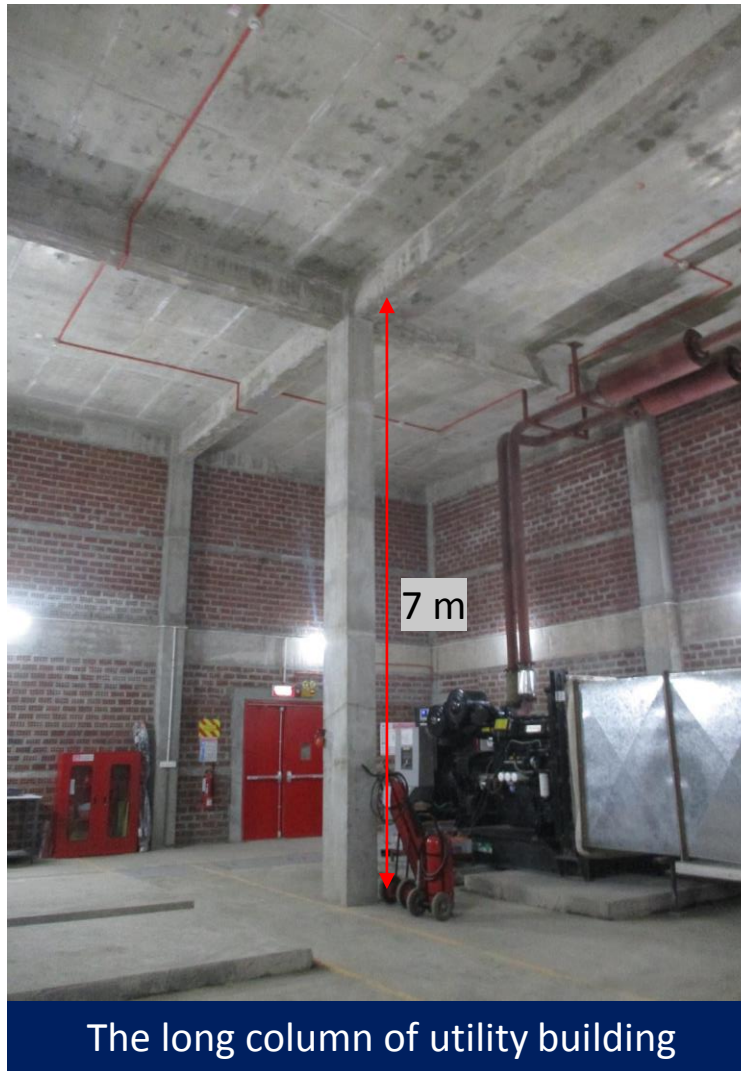
The long column of utility building

The column length is 7 m. The size of column is 375 mm x 500 mm. The building engineer to check the slenderness effect for the columns and incorporate the design in the report.

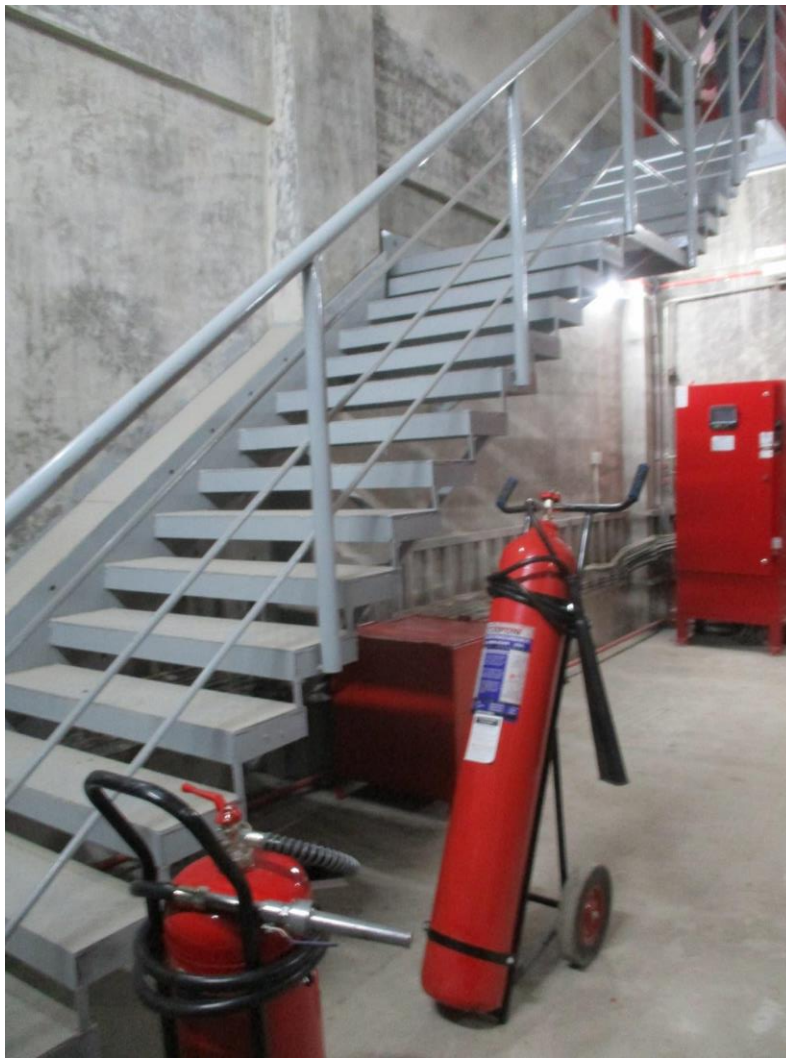
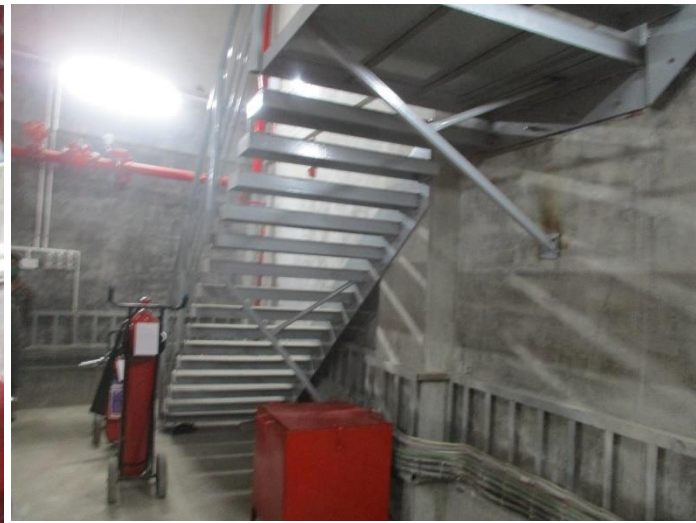
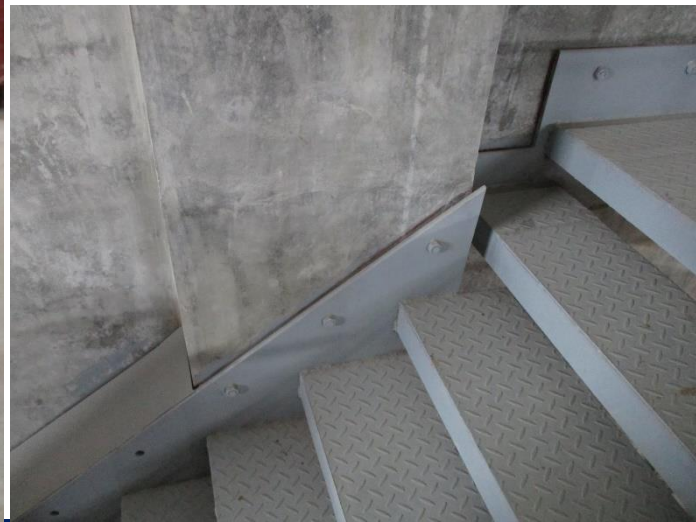
Apparently inadequate steel stair

Steel stair connected with the retaining wall of basement floor

The adequacy of the steel stair for design load is apparently inadequate. Building engineer is required to check the adequacy of the stair and suggest proper remedial actions accordingly.
