# Oasis Fashion Limited

591 Gacha Board Bazar Gazipur

6 February 2022

# Building Information:

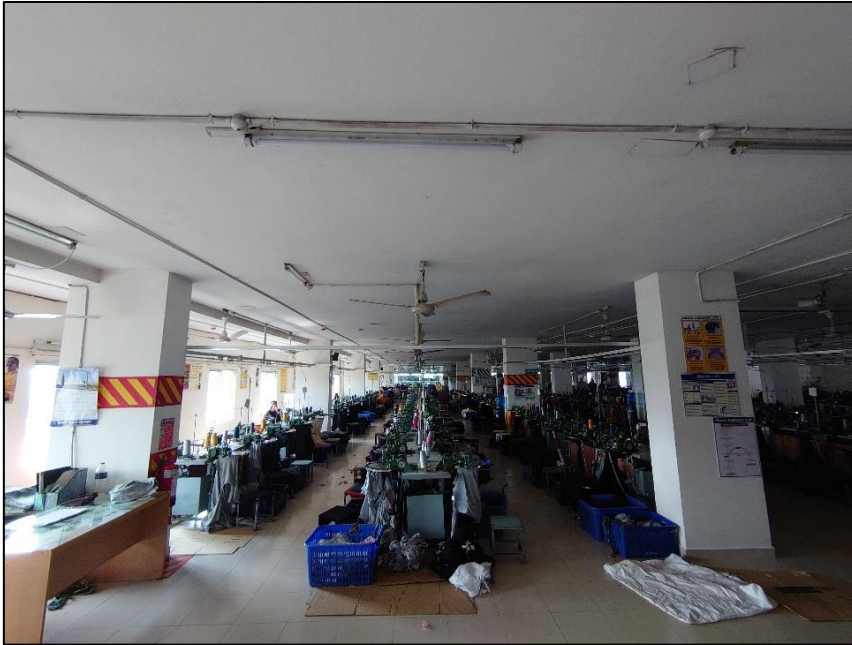
RC column and flat plate system

The building framing system (consists of RC columns & the flat plate) has no shear wall or other means to provide lateral stability against wind and seismic forces. The building engineer is required to check the lateral stability of the structure and provide necessary alternatives. Also, during the inspection, any design report was not available for this building which is required to be prepared in compliance with section 1.9.1 (part-6, BNBC).

| Item No. | Observation | Recommended Action Plan | Recommended Timeline |
|---|---|---|---|
| 01 | Lack of lateral stability system. (Main Building) | As part of engineering assessment (EA), The building engineer is required to check the lateral stability of the structure and provide necessary alternatives. | 6-weeks |
| 02 | Lack of lateral stability system. (Main Building) | Building engineer to prepare the design document including an Engineering Assessment (EA) report for the structure, in compliance with section 1.9.1.1 , part-6 of BNBC. | 6-weeks |
| 03 | Lack of lateral stability system. (Main Building) | Carry out necessary remedial works as per EA recommendation. | 6-months |

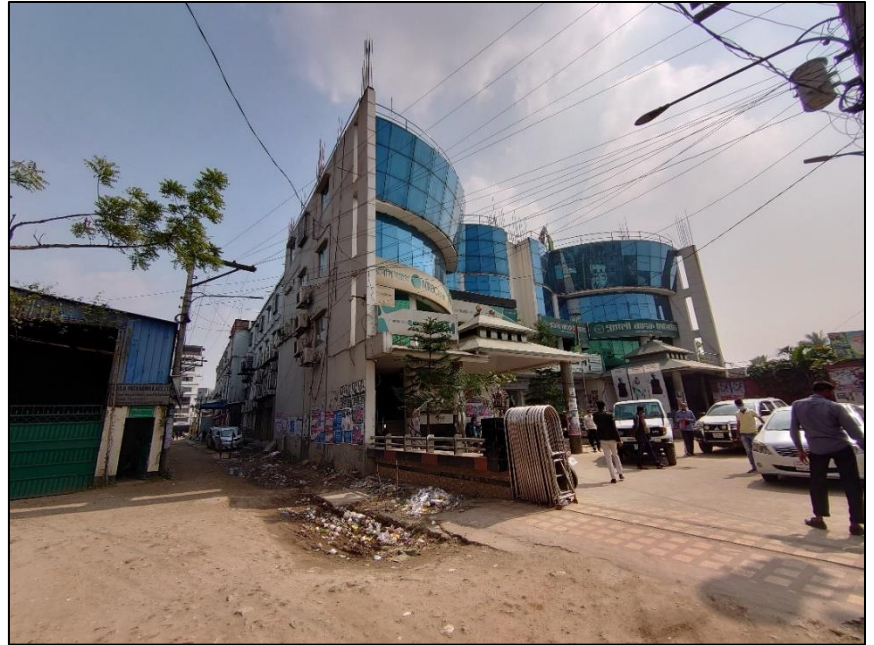
Exterior of the building

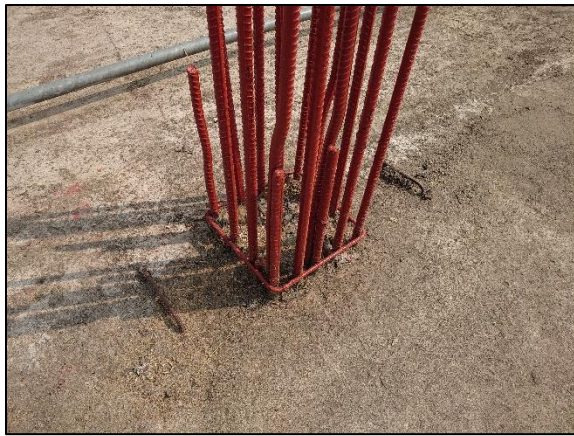
On site column C10 ( 15"x15")

During visit size of C10 column was observed 15"x15" with 14 nos rebar. However, in structural drawing size of C10 column was 15"x30". The building engineer is required to survey the structures and update drawings to the as-constructed status.

| Item No. | Observation | Recommended Action Plan | Recommended Timeline |
|---|---|---|---|
| 04 | Mismatch in as-built drawings. (Main Building) | Building engineer is required to survey the whole structure and prepare “as constructed” drawings (Architectural & Structural), in compliance with section 1.9.1.2 as per BNBC 2006. | 6-weeks |

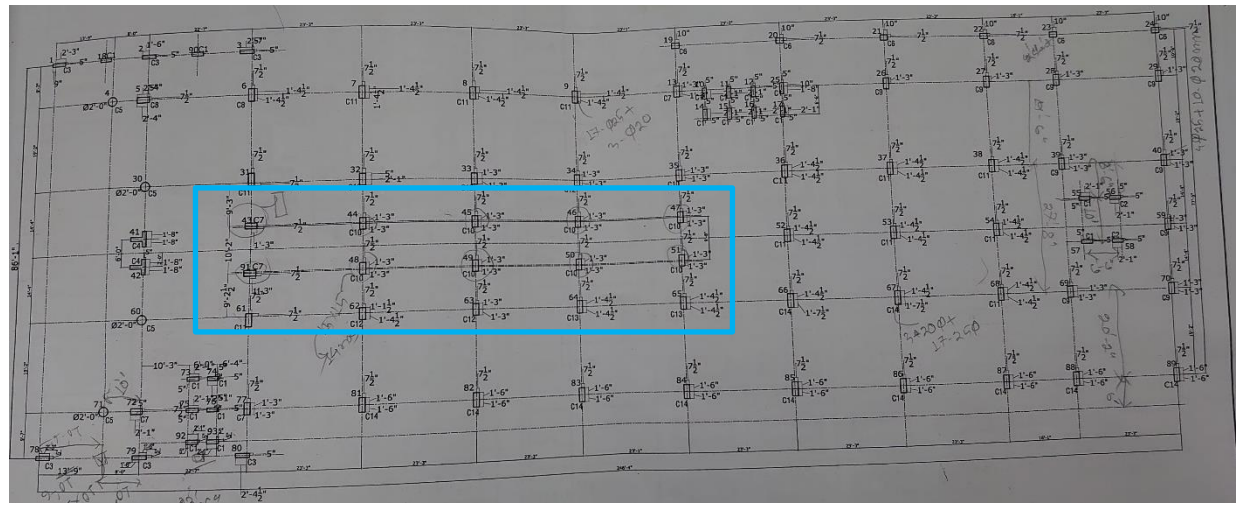
C10 column marked in column layout

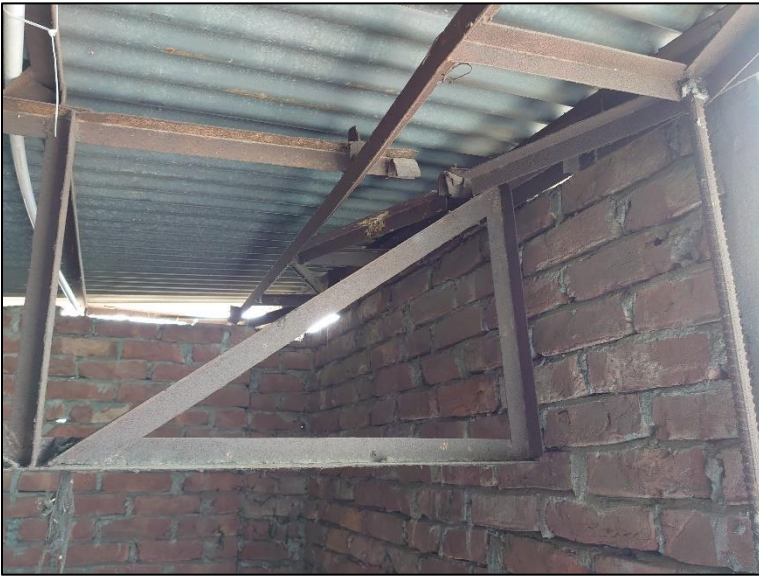
Poor connection details

The steel roof shed made of truss section which is supported by brick wall over the staircase. Apparently inadequate structural member, poor connection details found. Building engineer is required to check the adequacy of the steel members & connection for gravity and lateral forces otherwise replace with the engineered roof.

| Item No. | Observation | Recommended Action Plan | Recommended Timeline |
|---|---|---|---|
| 07 | Non-engineered roof shed over staircase. (Main Building) | Building engineer is required to check the adequacy of the steel roof shed for gravity and lateral forces or replace it with the engineered roofing. | 6-weeks |
| 08 | Non-engineered roof shed over staircase. (Main Building) | Carry out necessary remedial works arise from the EA. | 6-months |

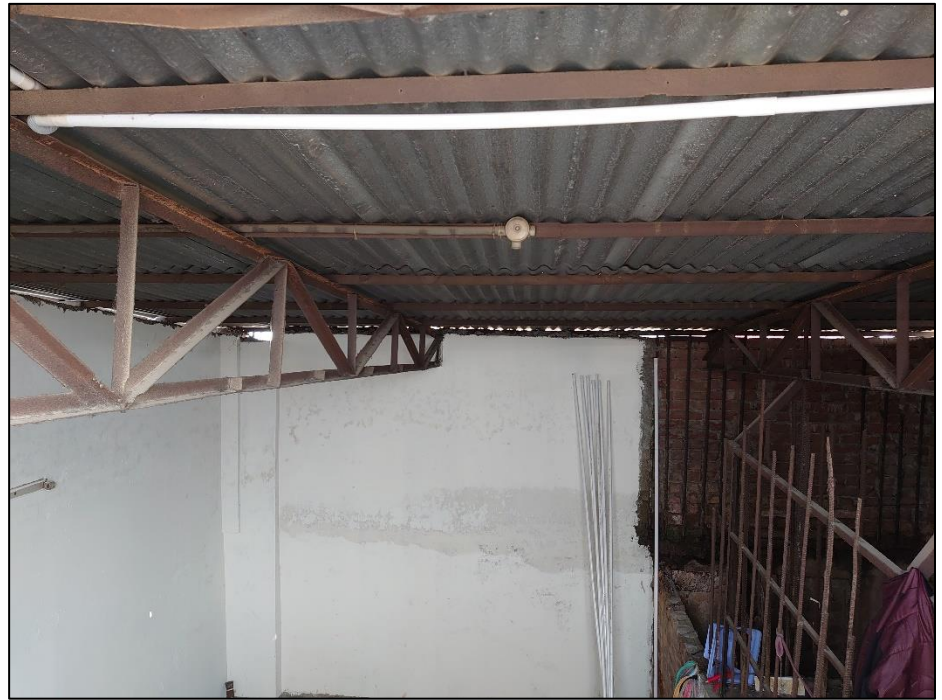
Inadequate structural members

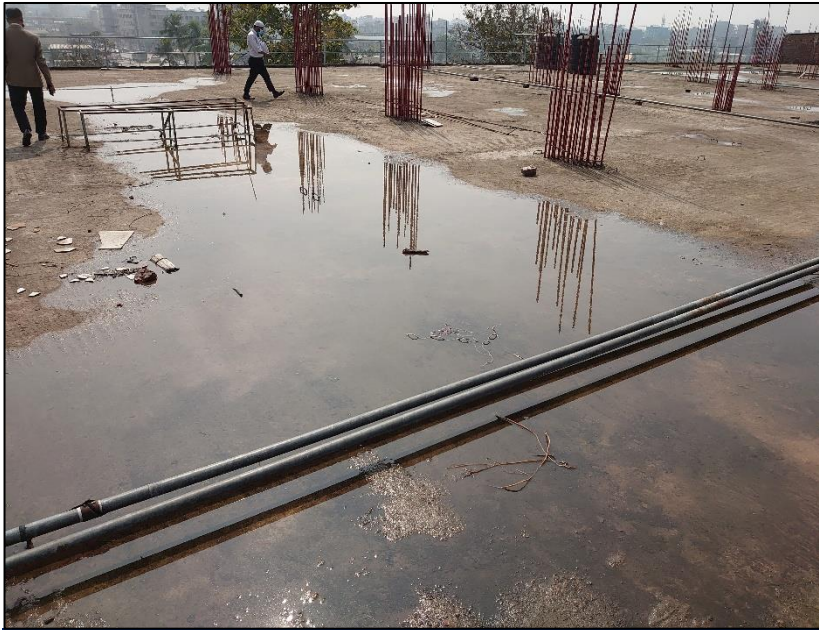
Water ponding on the roof

Stagnant of water and construction debris was observed on the roof. The roof slab is made by MCAC. Factory is required to remove construction debris, develop proper roof drainage system with adequate slope, outlets and apply water proofing compound on the roof slab to resist water ingress into the slab.

| Item No. | Observation | Recommended Action Plan | Recommended Timeline |
|---|---|---|---|
| 09 | Water ponding on roof (Main Building) | Remove the construction debris from the roof. | 6-weeks |
| 10 | Water ponding on roof (Main Building) | Develop proper drainage system on the roof with adequate slope, outlets and apply water proofing compound on the roof slab to resist water ingress into the slab. | 6-month |

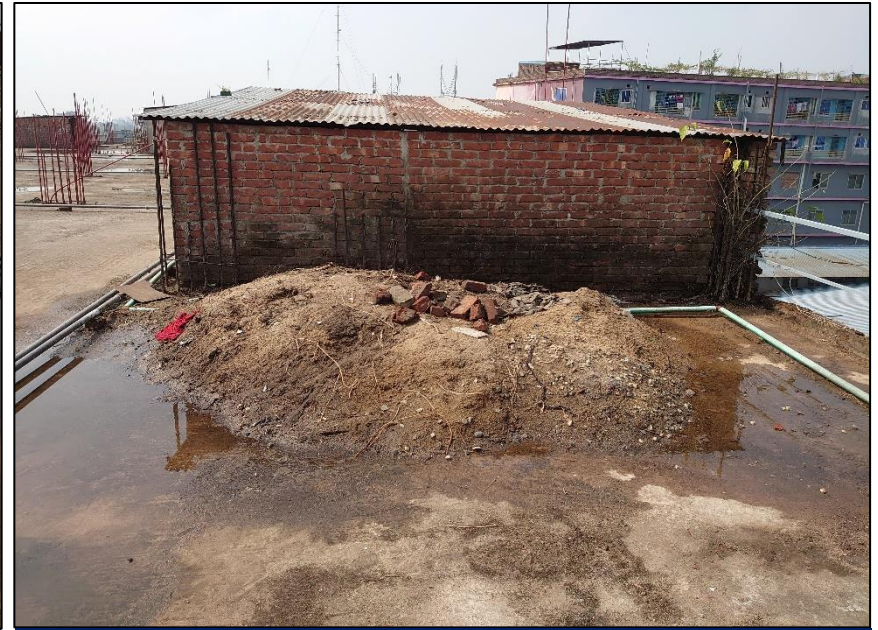
Construction debris on the roof

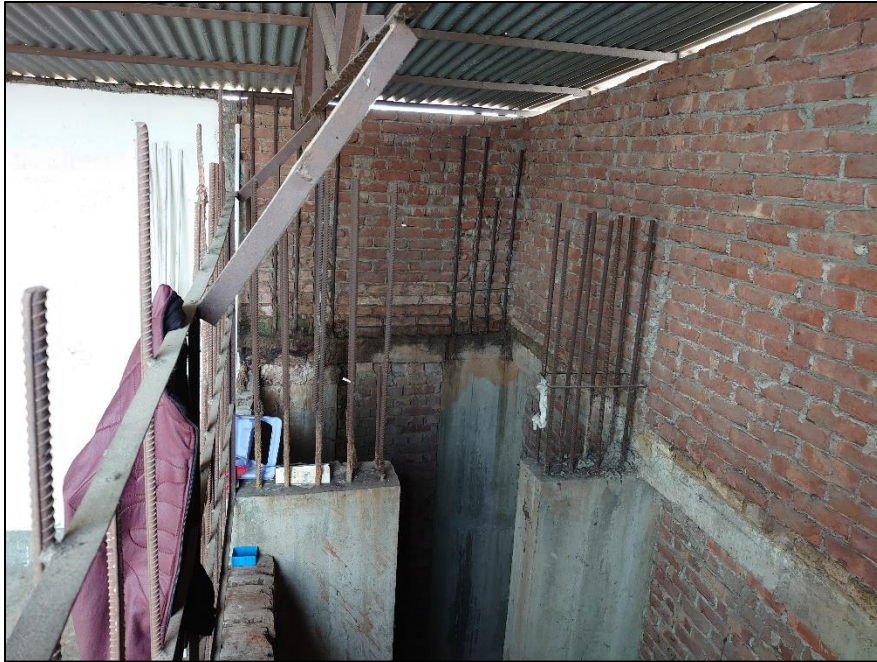
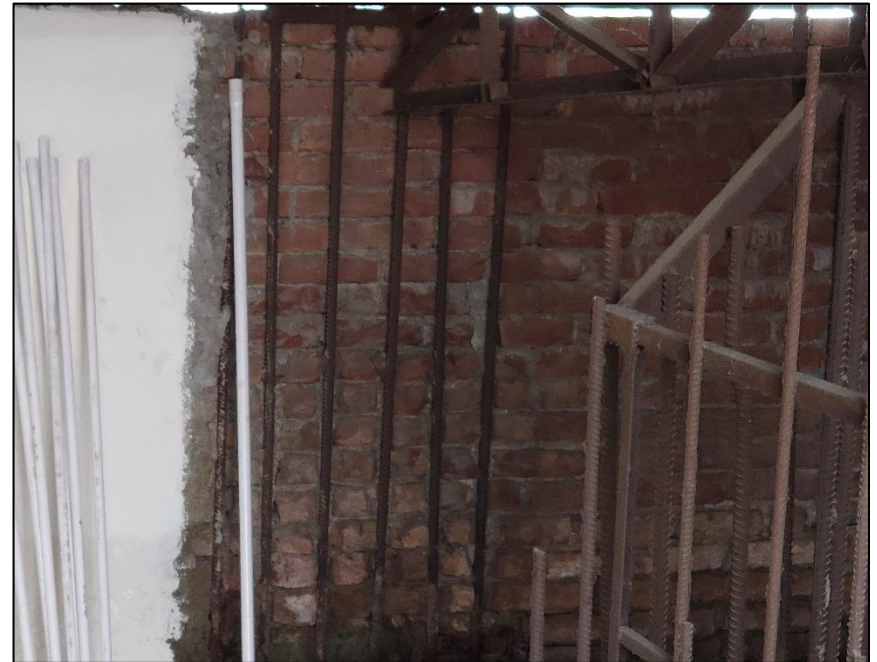
**Corroded and exposed rebar at roof**

Corrosion was observed on exposed reinforcements on roof top columns. All exposed reinforcements are to be protected from corrosion which may cause degradation of the concrete.

| Item No. | Observation | Recommended Action Plan | Recommended Timeline |
|---|---|---|---|
| 11 | Corroded and exposed rebar on roof. (Main Building) | Apply corrosion resistance paint/layer to the exposed rebars to protect from corrosion. | 6-weeks |

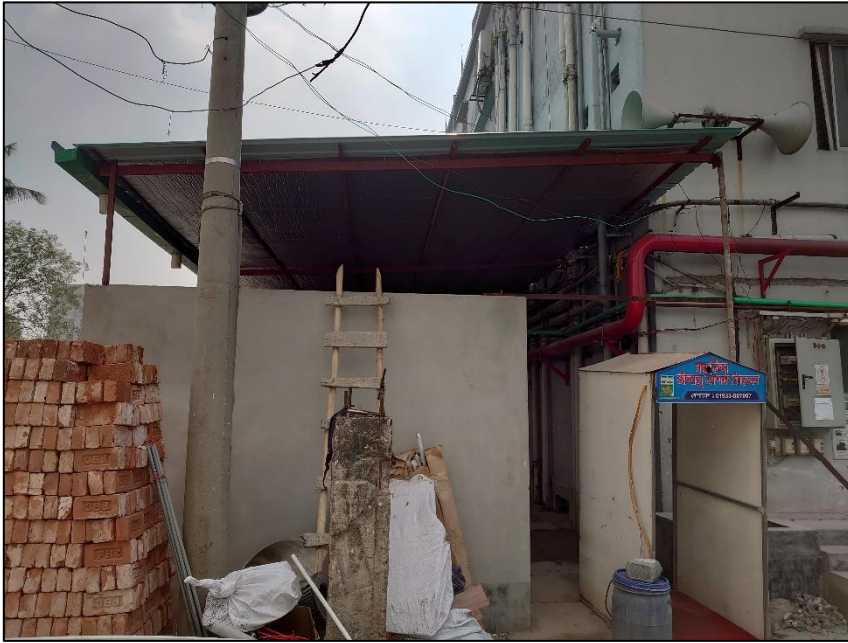
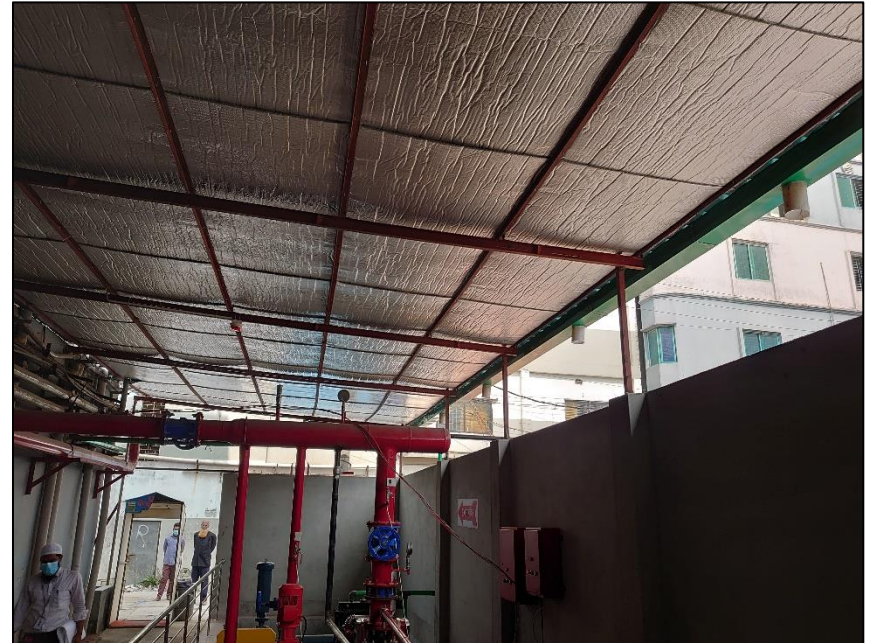
Utility Shed

No as-built drawing was provided for the utility shed. Factory engineer is required to prepare full set of as-built drawings for this structure.

| Item No. | Observation | Recommended Action Plan | Recommended Timeline |
|---|---|---|---|
| 12 | Lack of as-built drawings (Utility Shed) | Building engineer is required to prepare full set of as-built drawing for this structure. | 6-weeks |

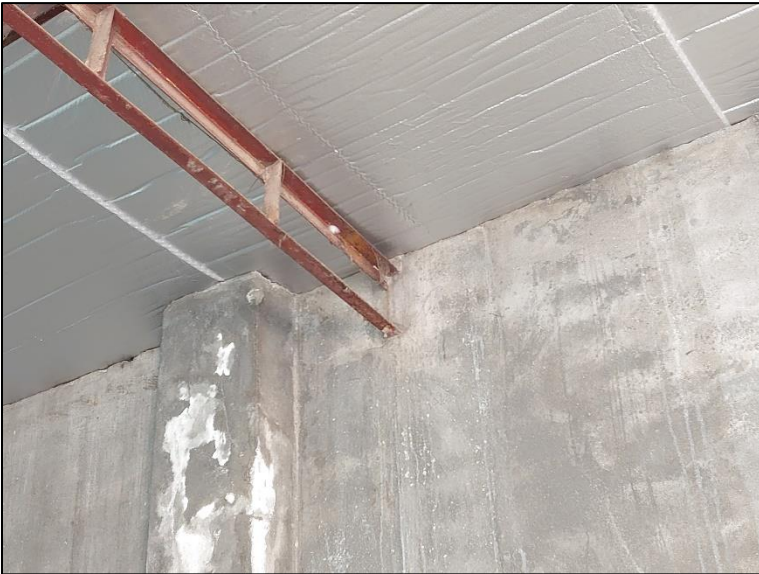
Poor connection details

Apparently Inadequate structural member, poor connection details found. Building engineer is required to check the adequacy of the steel members & connection for uplift and lateral forces otherwise replace with engineered structure.

| Item No. | Observation | Recommended Action Plan | Recommended Timeline |
|---|---|---|---|
| 13 | Apparently non-engineered shed (Utility Shed) | As part of EA, building engineer is required to check the adequacy of the steel members & uplift capacity of connections for the lateral forces. Otherwise, replace it with an engineered structure. | 6-weeks |
| 14 | Apparently non-engineered shed (Utility Shed) | Carry out necessary remedial works arise from the EA. | 6-months |

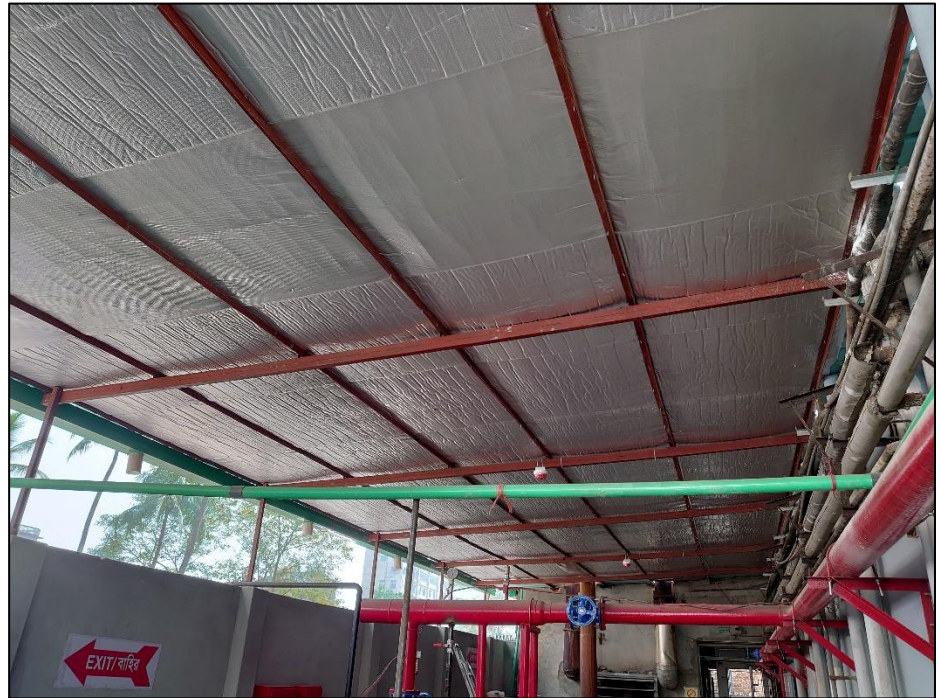
Apparently inadequate structural members
