# Azim & Son (Pvt) Ltd Unit 2 (Extension)

Gacha Road; Fakir Market; Gazipur  
(23.936126, 90.377798)

7<sup>th</sup> February 2022

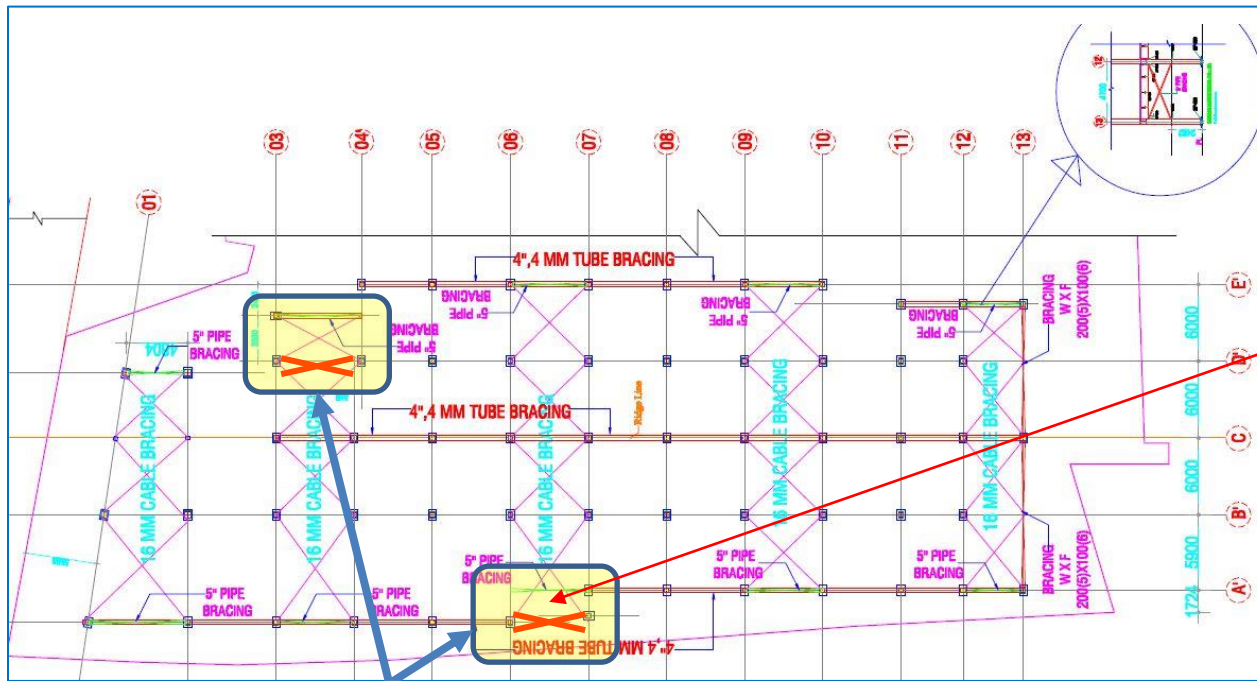
Vertical Bracing location mismatches

Connection details of column splice and vertical bracings of end grid were not found in the as-built drawings. Locations of vertical bracings were found different in between grid 3-4 & 6-7.

| Item No. | Observation | Recommended Action Plan | Recommended Timeline |
|---|---|---|---|
| 01 | Lack of information and discrepancies in as-built drawings. (Building-2) | Building Engineer is to survey the whole structure and update as-built drawings representing accurate site condition. | 6-weeks |

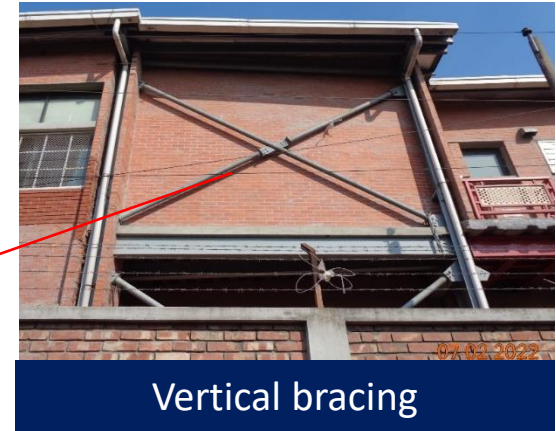
Vertical bracing

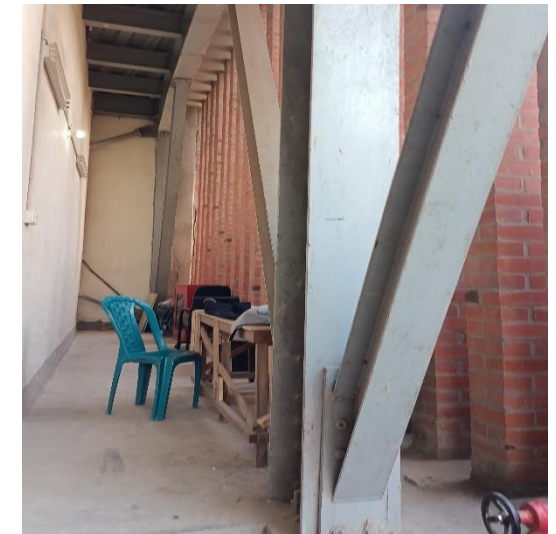
Connection of vertical bracing

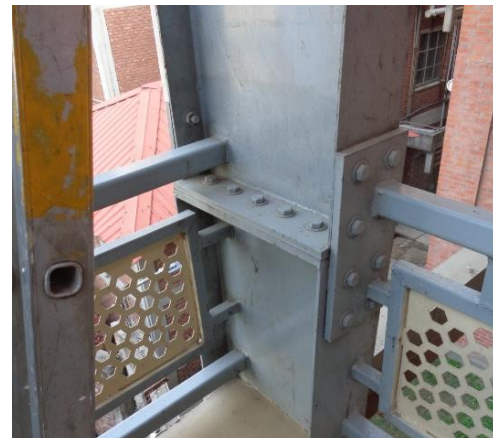
Column Splice

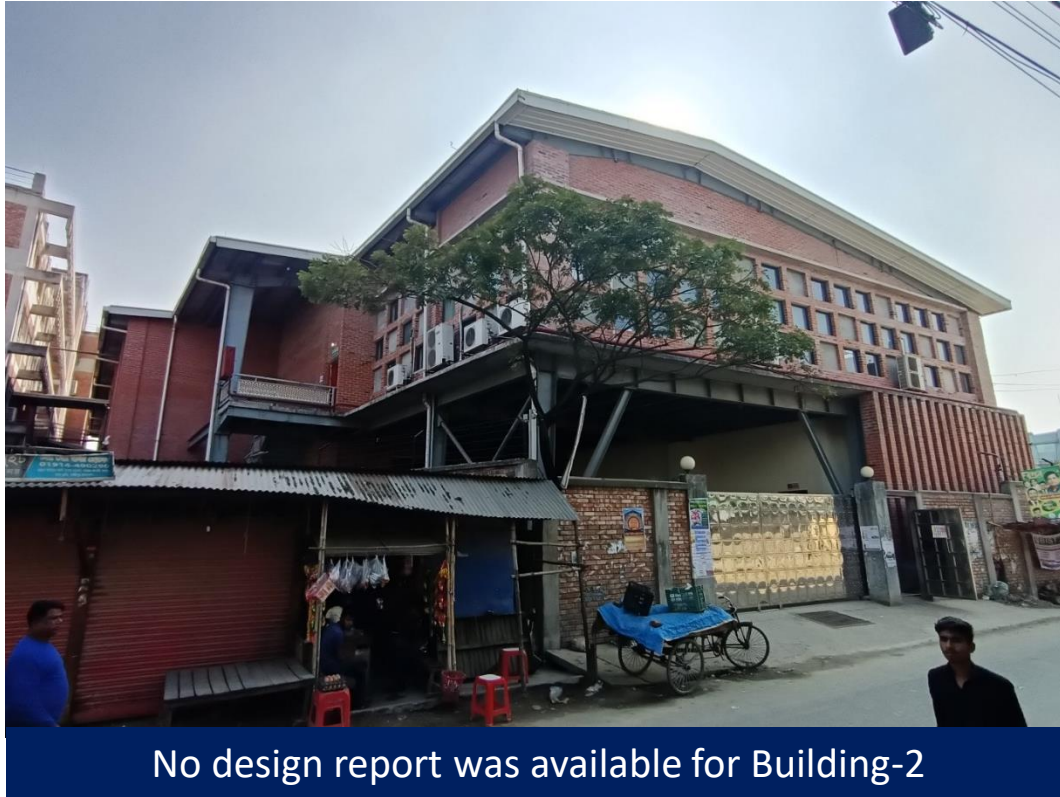
As per BNBC, every building or structure designed shall have its design documents prepared in accordance with the provision of Section 1.9.1. The design document shall include a design report, and a set of structural drawings, which shall be prepared in compliance with section 1.9.1.1 and section 1.9.1.2, part-6 of BNBC. At the time of inspection, only as-built drawing and geotechnical report were available, but no design report & load plan were available which are required to be prepared in compliance with section 1.9.1.1 (part-6, BNBC).

| Item No. | Observation | Recommended Action Plan | Recommended Timeline |
|---|---|---|---|
| 02 | Absence of design documents. (Building-2) | Factory engineer is required to prepare the design documents including a design report, and a set of structural drawings in compliance with section 1.9.1.1 and section 1.9.1.2, part-6 of BNBC and submit it to RSC for review. | 6-weeks |

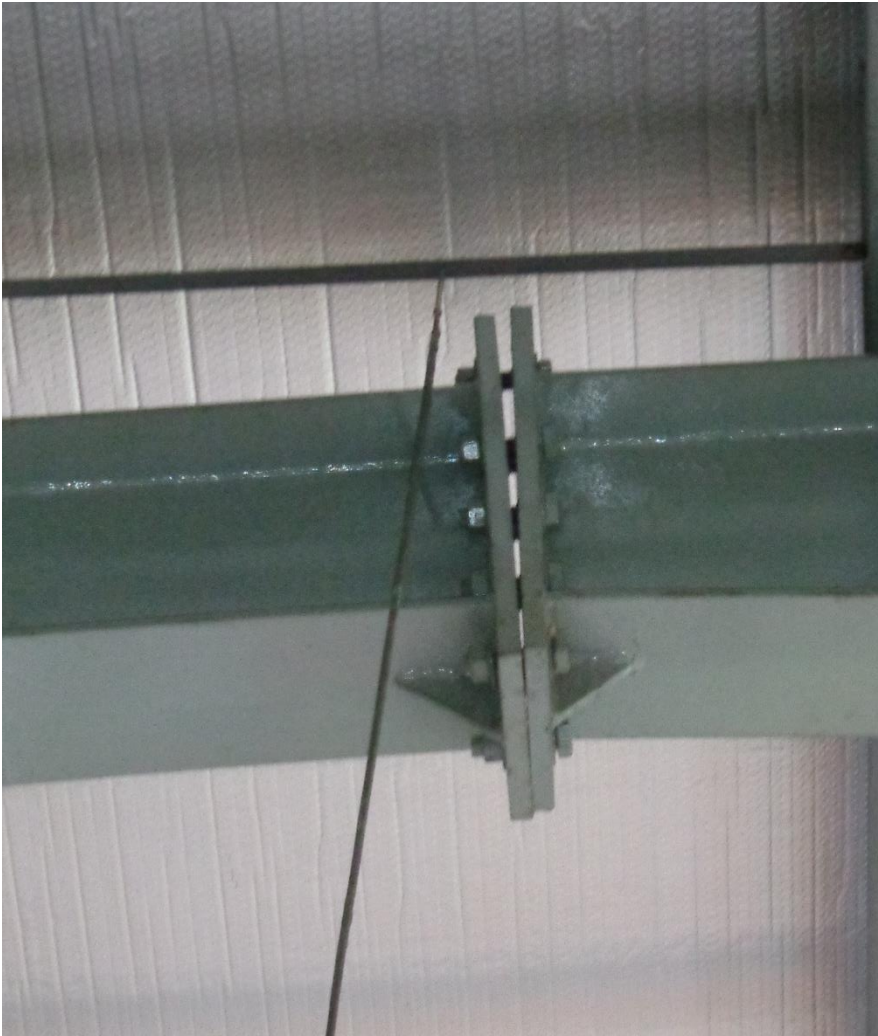
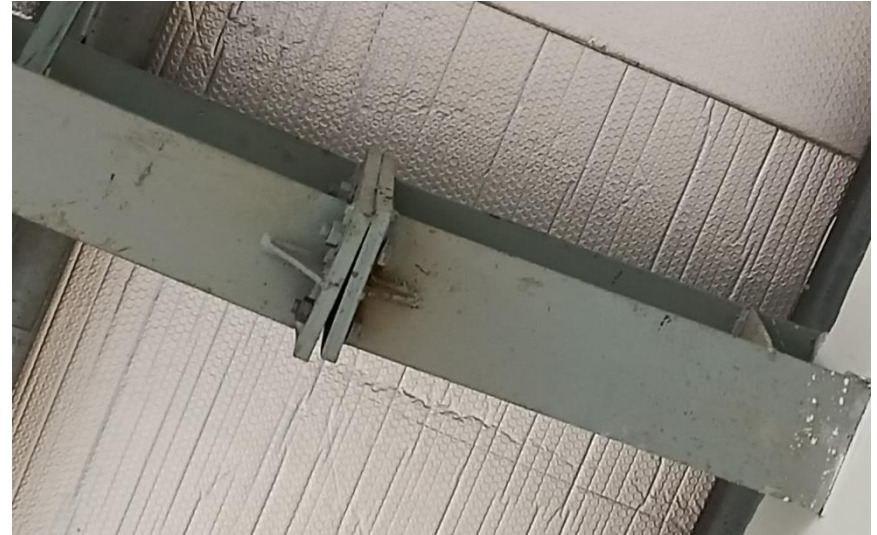
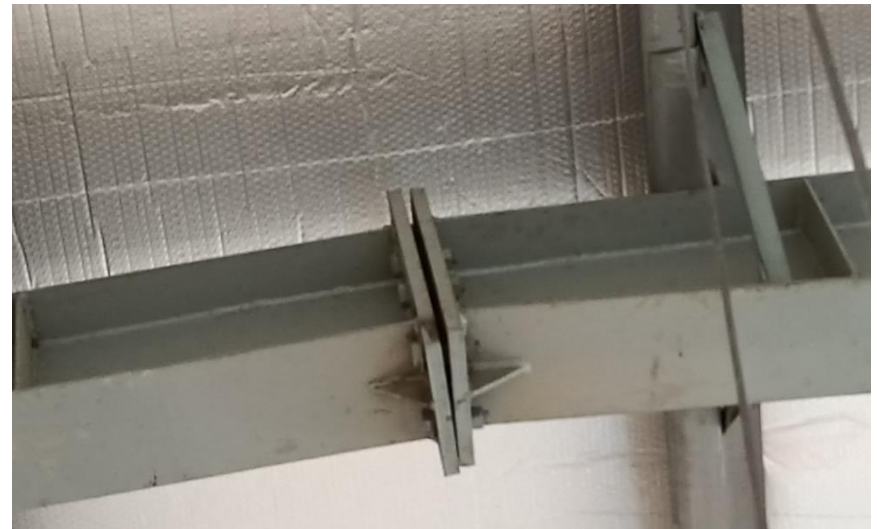
Significant gaps observed in rafter connection at several locations. Building engineer is required to carry out suitable remedial works.

Gap observed in rafter connections

| Item No. | Observation | Recommended Action Plan | Recommended Timeline |
|---|---|---|---|
| 06 | Significant connection gap. (Building-2) | Factory is required to repair the gap in connections with a suitable method suggested by the factory engineer. | 6-weeks |

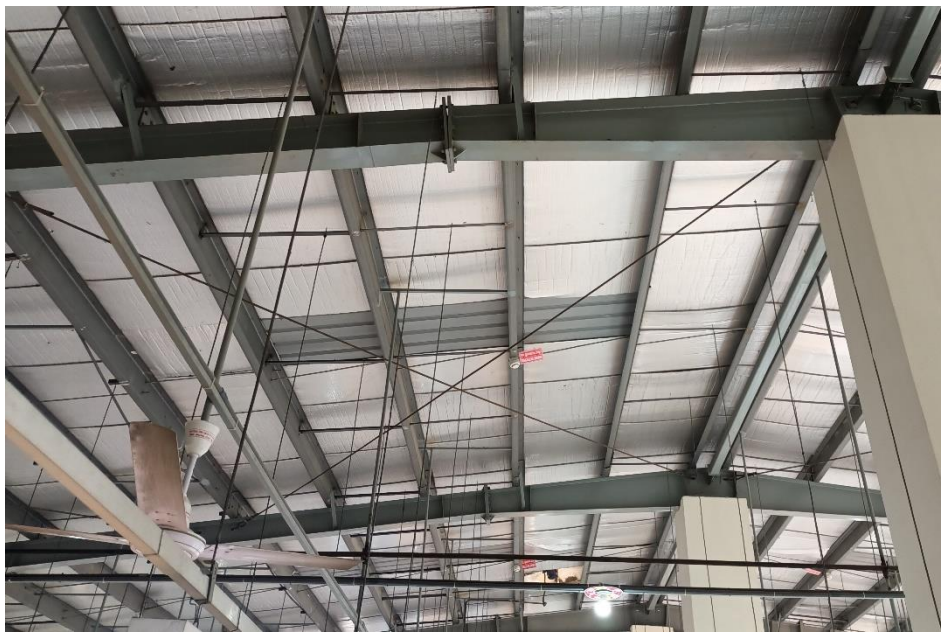
Some of the horizontal cable bracings were found loose. The factory is required to tight the bracings for transferring the lateral loads properly.

Loose cable bracing at roof

| Item No. | Observation | Recommended Action Plan | Recommended Timeline |
|---|---|---|---|
| 07 | Loose cable bracing. (Building-2) | The building engineer to check the bracing and tighten it properly. | 6-weeks |

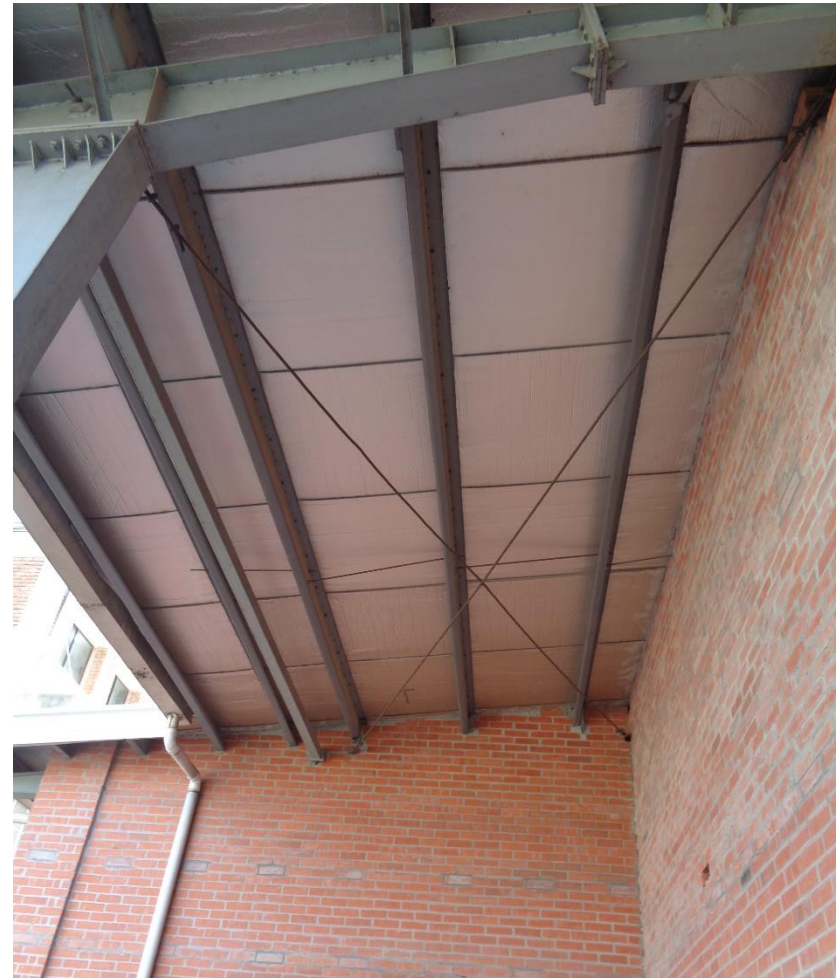
Loose cable bracing

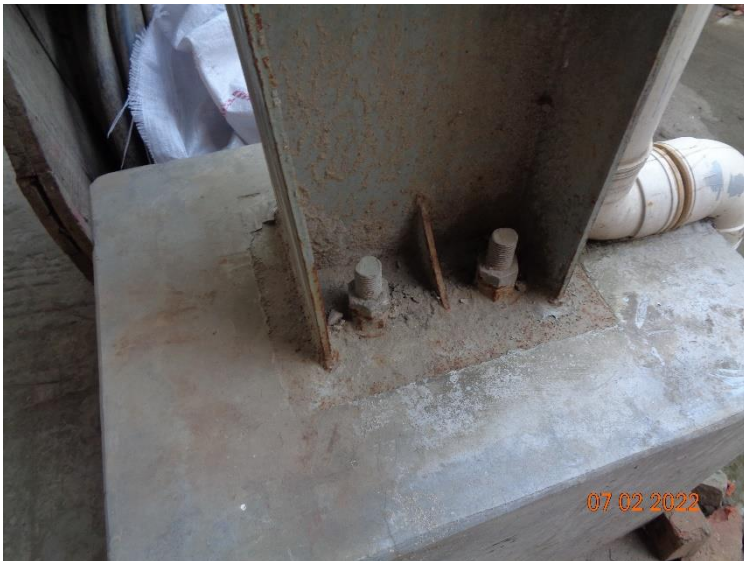
Corrosion in steel member was observed in several locations. The building engineer to suggest proper remedial measure accordingly.

Corrosion in Base Plate

| Item No. | Observation | Recommended Action Plan | Recommended Timeline |
|---|---|---|---|
| 08 | Corrosion in steel member. (Building-2) | The building engineer to remove the corrosion and apply suitable corrosion resistance coating. | 6-weeks |

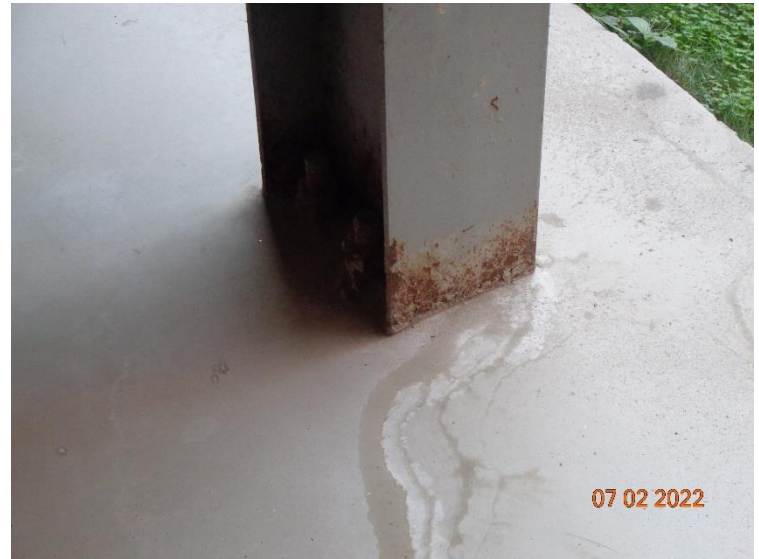
Corrosion in Column

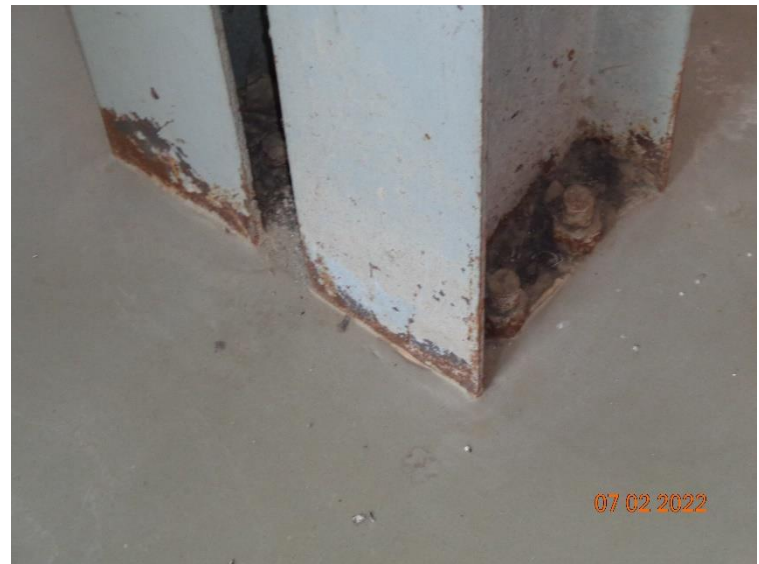
Corrosion in column

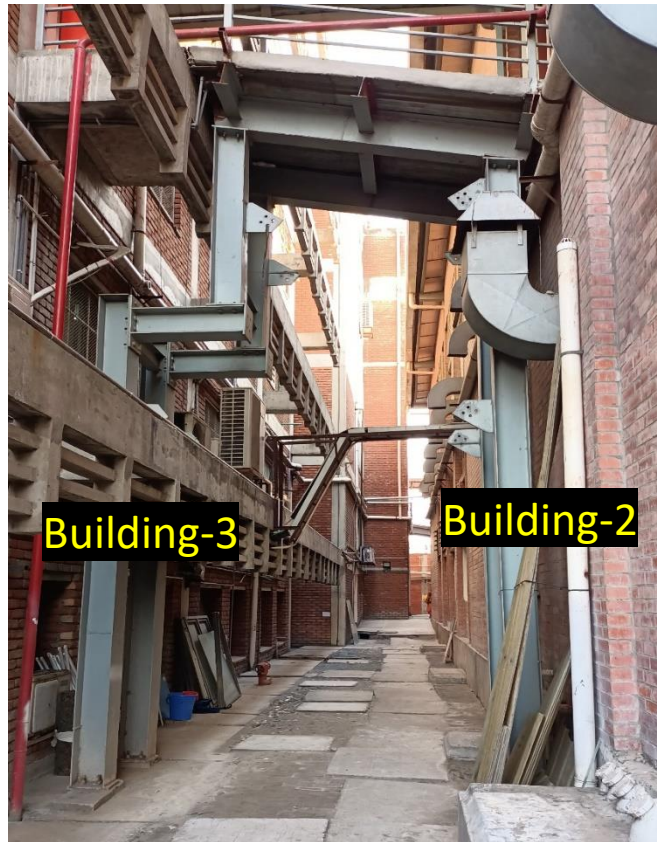
Connection Bridge 1

Connecting bridges were found between Building-2 and 3 at two different locations. No drawings were found for these bridge on site. The connecting bridge is a separate structure with independent foundation system. There is no visible stability system and load path is complex in connecting bridge-1. The factory engineer is required to check the lateral stability of the structure and prepare as-built drawings.

| Item No. | Observation | Recommended Action Plan | Recommended Timeline |
|---|---|---|---|
| 09 | Connection bridge between Building- 2 and 3. | Factory engineer is required to prepare as-built drawings. | 6-weeks |
| 10 | Connection bridge between Building- 2 and 3. | Factory engineer is required to check the lateral stability of the structure. | 6-weeks |
| 11 | Connection bridge between Building- 2 and 3. | Carry out remedial works if required. | 6-months |

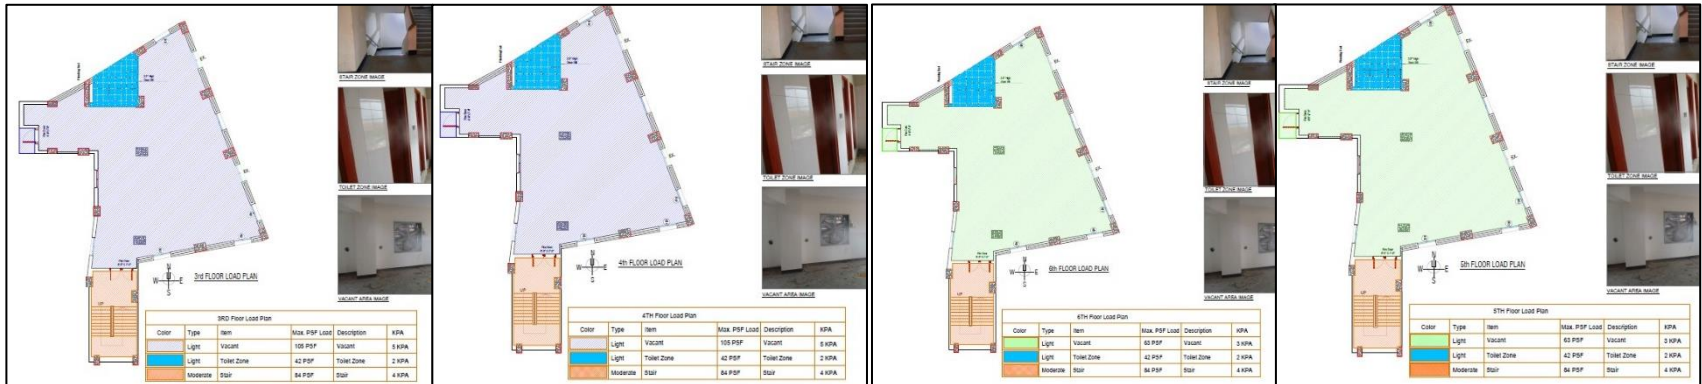
Load plan for 3<sup>rd</sup> to 6<sup>th</sup> floor.

Factory Building is being used for store purpose at 3<sup>rd</sup> & 4<sup>th</sup> floor. The 5<sup>th</sup> & 6<sup>th</sup> floor is currently vacant but proposed for store purpose.

As per BNBC, 6 kPa is required to consider as floor loading for the light storage facilities. During inspection, load plan was found posted considering 5 kPa at 3<sup>rd</sup> & 4<sup>th</sup> floor and 3kpa for 5<sup>th</sup> & 6<sup>th</sup> floor.

During inspection live load plan was not found as per requirement of BNBC. Factory engineer is required to revise the design report in compliance with BNBC chapter-2.

| Item No. | Observation | Recommended Action Plan | Recommended Timeline |
|---|---|---|---|
| 12 | Design report needs to be revised (Building-5) | Factory engineer to prepare the Engineering Assessment (EA) including a design report, and a set of structural drawings in compliance with section 1.9.1.1 and section 1.9.1.2, part-6 of BNBC. | 6-weeks |

| Item No. | Observation | Recommended Action Plan | Recommended Timeline |
|---|---|---|---|
| 13 | Design report needs to be revised (Building-5) | Produce and actively manage a loading plan for all floor plates within the factory, considering floor, column and foundation capacity. | 6-weeks |

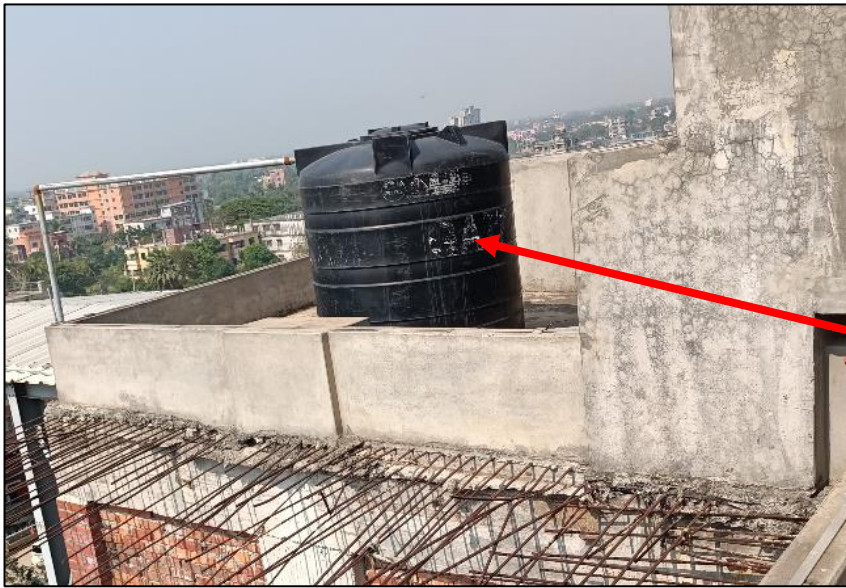
Undocumented 2000L water tank

An undocumented plastic water tank was found at roof. Factory engineer is required to survey the whole structure and update the as-built drawing. The loading from the plastic water tank is required to be considered during an adequacy check of slab.

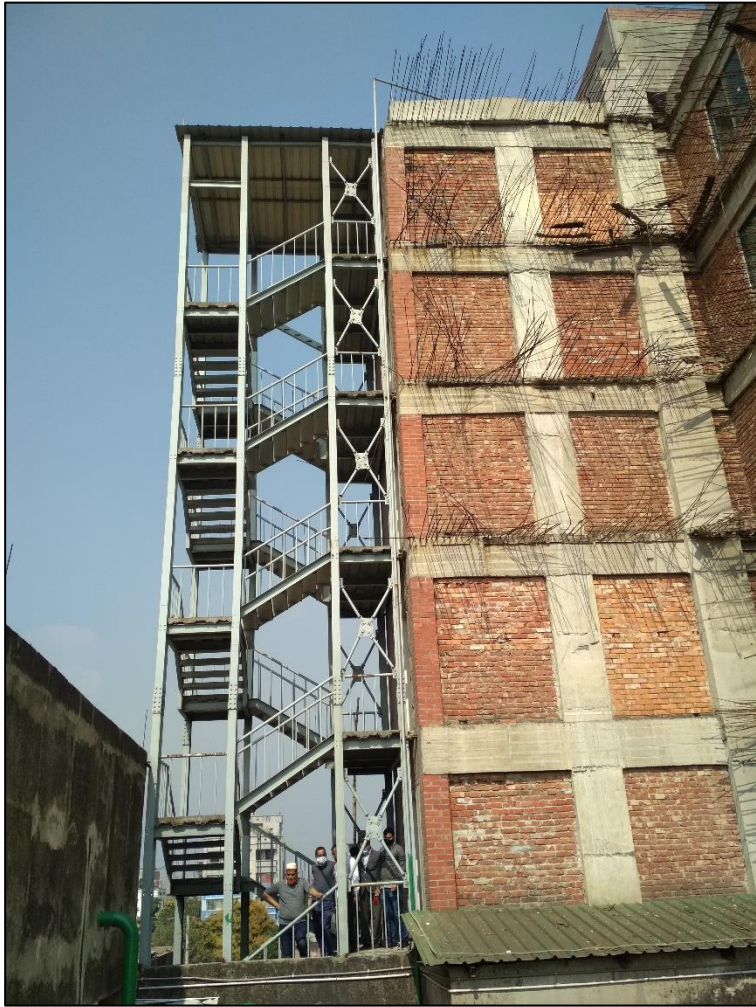
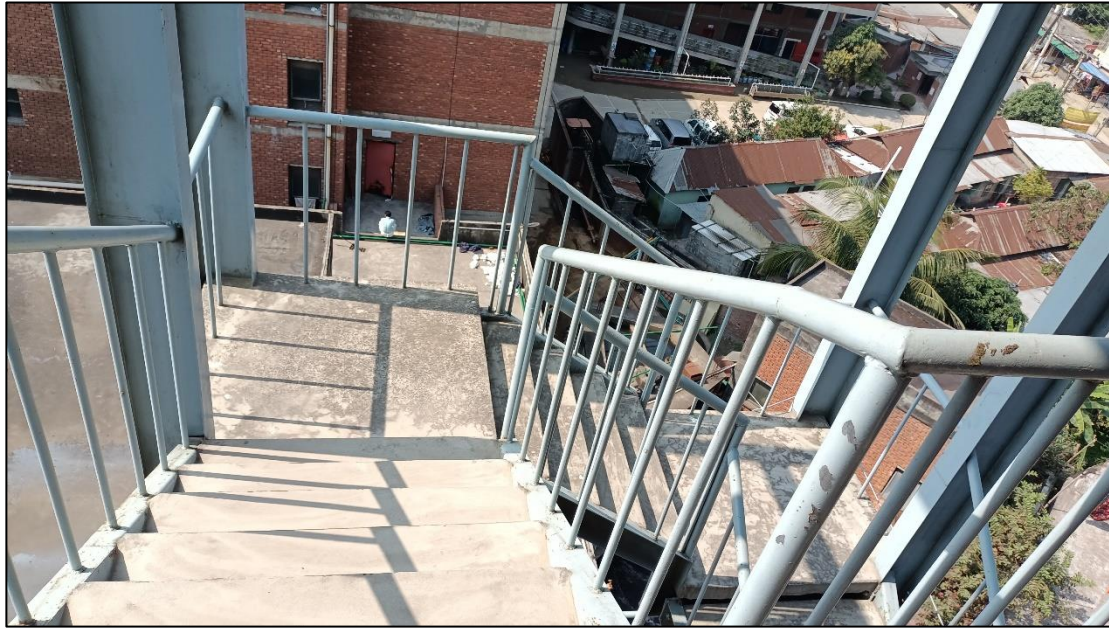
A steel stair was found at west side of the building. No structural details are available for the steel stair.

As per BNBC every building or structure designed shall have its design documents prepared in accordance with the provision of Section 1.9.1. The design document shall include a design report and a set of structural drawings. During the inspection, the as built drawings & design report was not found. However, the building engineer is required to prepare as-built drawing and design report for the structure in compliance with section 1.9.1 (part-6, BNBC).

| Item No. | Observation | Recommended Action Plan | Recommended Timeline |
|---|---|---|---|
| 15 | Lack of as-built drawing ( Steel Stair-Building-5) | Building engineer to prepare the structural drawings in compliance with section 1.9.1.2 as per BNBC. | 6-weeks |
| 16 | Lack of as-built drawing ( Steel Stair-Building-5) | Building engineer is required to check the lateral stability of the steel stair. | 6-weeks |

| Item No. | Observation | Recommended Action Plan | Recommended Timeline |
|---|---|---|---|
| 17 | Lack of as-built drawing ( Steel Stair-Building-5) | Building engineer to prepare the design documents including a design report, and a set of structural drawings in compliance with section 1.9.1.1 and section 1.9.1.2, part-6 of BNBC. | 6-weeks |

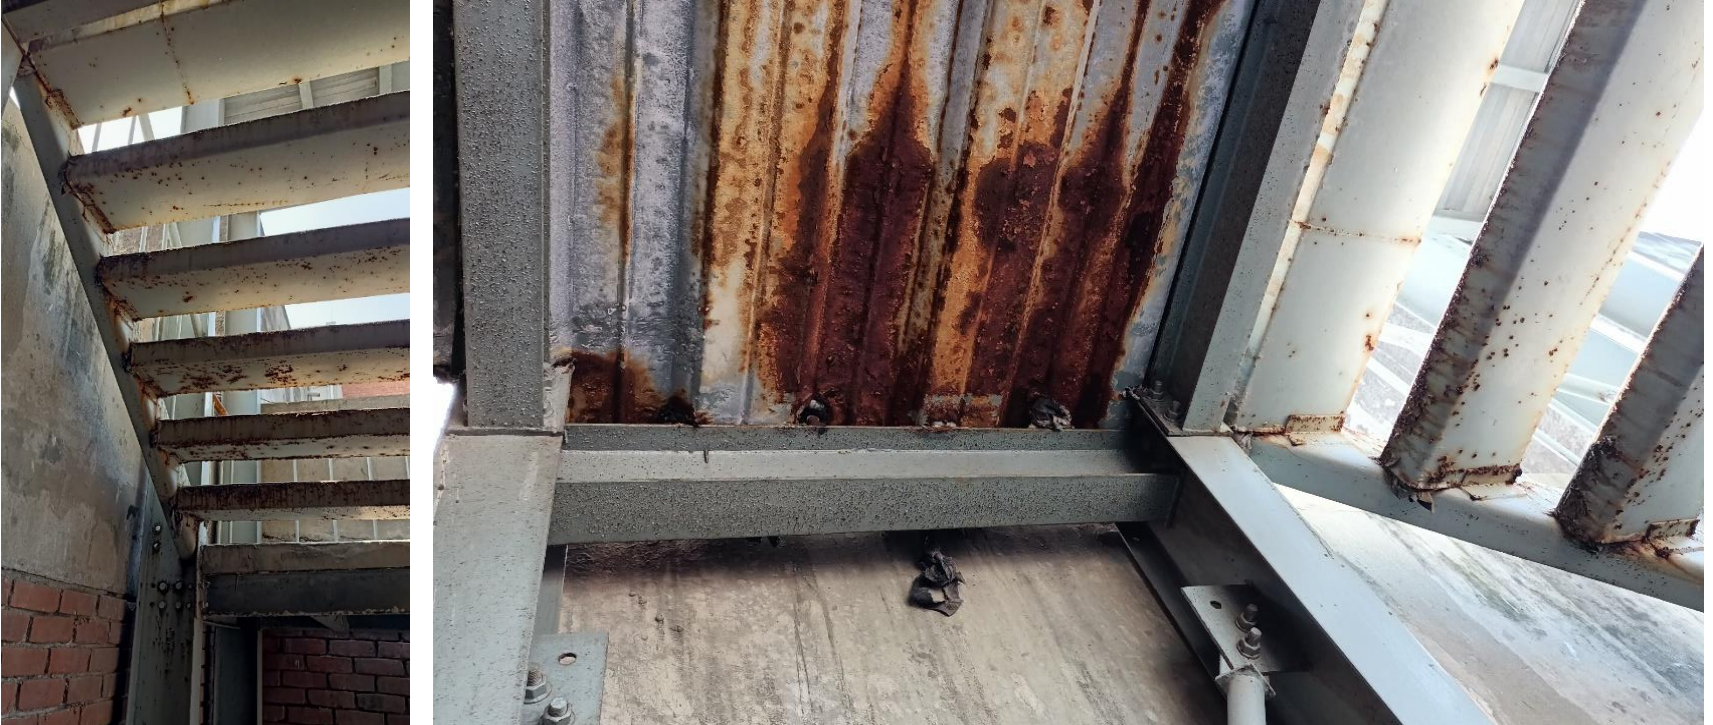
Corrosion in steel member of steel stair

Corrosion in steel member of steel stair was observed in several locations. The building engineer to suggest proper remedial measure accordingly.

| Item No. | Observation | Recommended Action Plan | Recommended Timeline |
|---|---|---|---|
| 18 | Corrosion in steel member. (Steel Stair-Building-5) | The building engineer to remove the corrosion and apply suitable corrosion resistance coating. | 6-weeks |

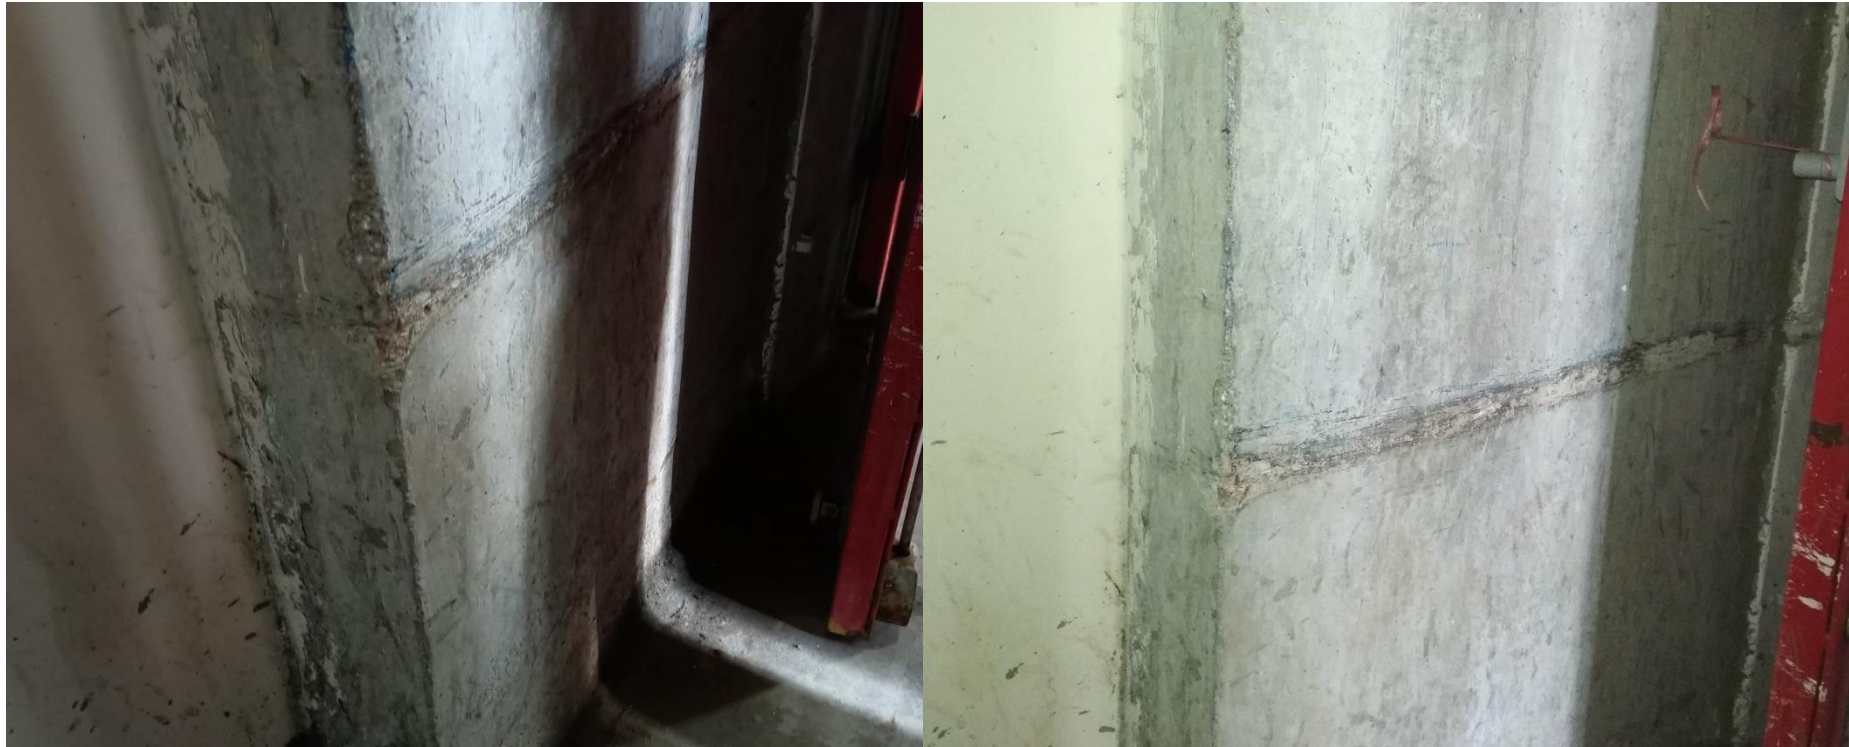
RC Column damaged due to impact of trolley

RC Column was found damaged due to the impact with trolley. Factory engineer is required to investigate the damage and suggest a remedial action as well as provide suggestion to prevent such damages in future. Factory is required to follow the suggestion of the engineer for remedial actions.

| Item No. | Observation | Recommended Action Plan | Recommended Timeline |
|---|---|---|---|
| 19 | Trolly impact on Column (Building-5) | Factory engineer is required to investigate the damage and suggest a remedial action as well as protection system to prevent such damages in future. | 6-weeks |
| 20 | Trolly impact on Column (Building-5) | Carry out remedial works as per recommendation. | 6-months |

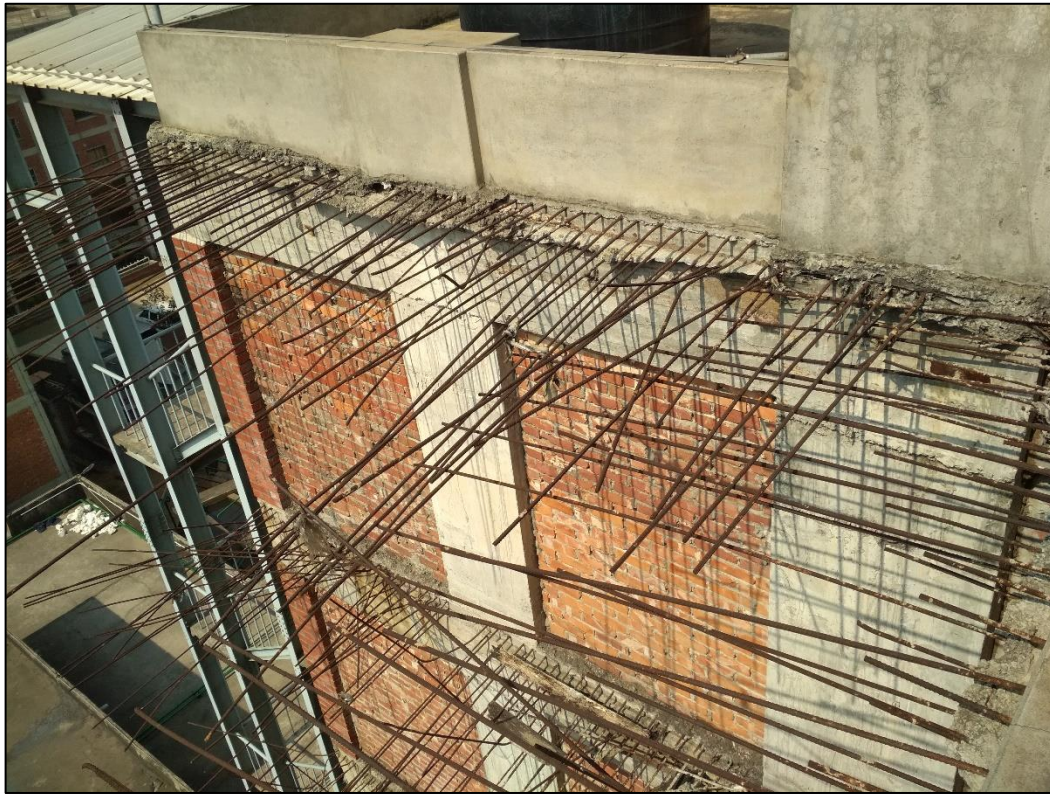
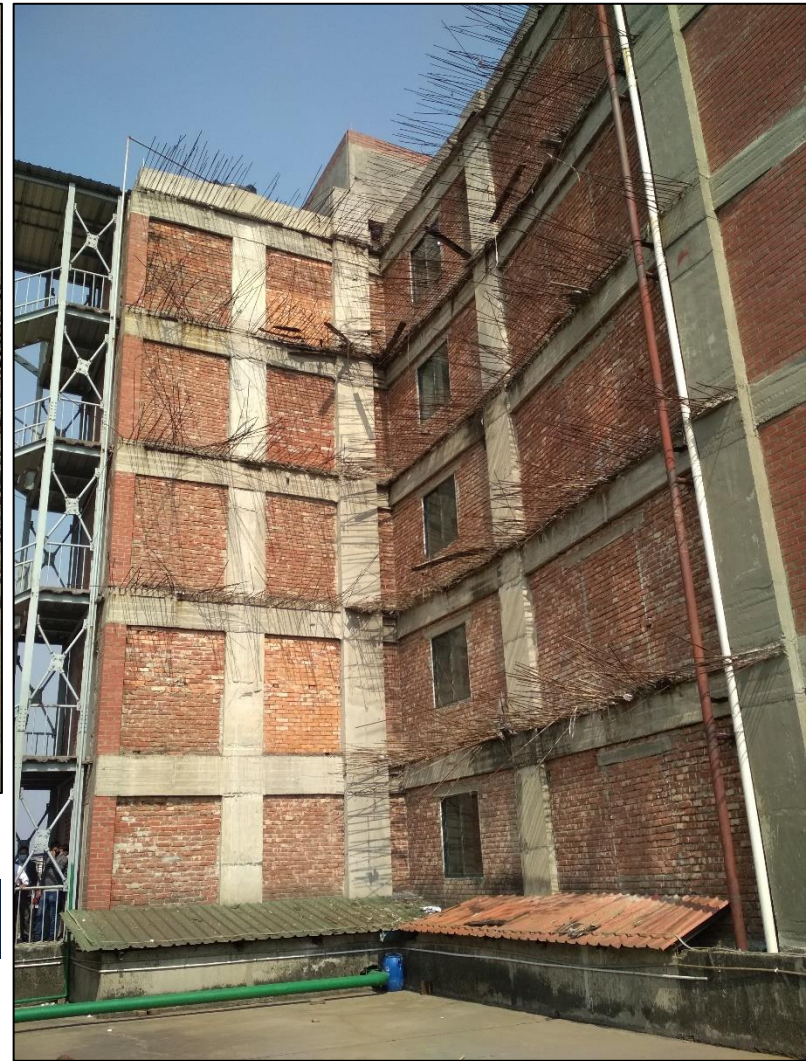
Exposed rebar of floors

Exposed reinforcement was found extended from slab & beam. All exposed reinforcement is to be protected from corrosion which may cause degradation of the concrete. Factory engineer is required to take necessary measures to prevent the corrosion in exposed rebar.

| Item No. | Observation | Recommended Action Plan | Recommended Timeline |
|---|---|---|---|
| 21 | Exposed re-bar found (Building-5) | All exposed reinforcement is to be protected from corrosion which may cause degradation of the concrete. | 6-weeks |

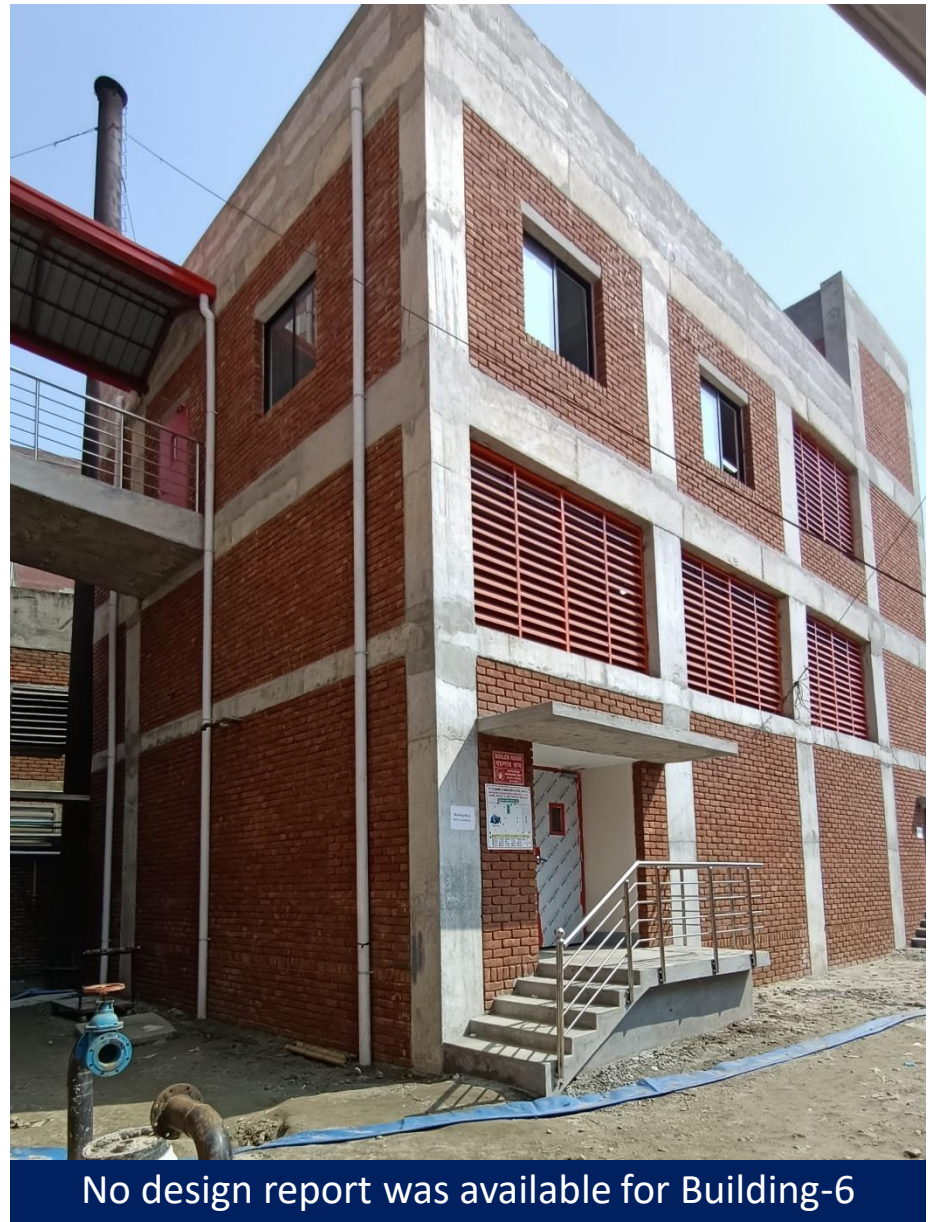
As per BNBC, every building or structure designed shall have its design documents prepared in accordance with the provision of Section 1.9.1. The design document shall include a design report, and a set of structural drawings, which shall be prepared in compliance with section 1.9.1.1 and section 1.9.1.2, part-6 of BNBC. At the time of inspection, only as-built drawing and geotechnical report were available, but no design report & load plan were available which are required to be prepared in compliance with section 1.9.1.1 (part-6, BNBC).

No design report was available for Building-6

| Item No. | Observation | Recommended Action Plan | Recommended Timeline |
|---|---|---|---|
| 22 | Absence of design documents. (Building-6) | Factory engineer is required to prepare the design documents including a design report, and a set of structural drawings in compliance with section 1.9.1.1 and section 1.9.1.2, part-6 of BNBC and submit it to RSC for review. | 6-weeks |

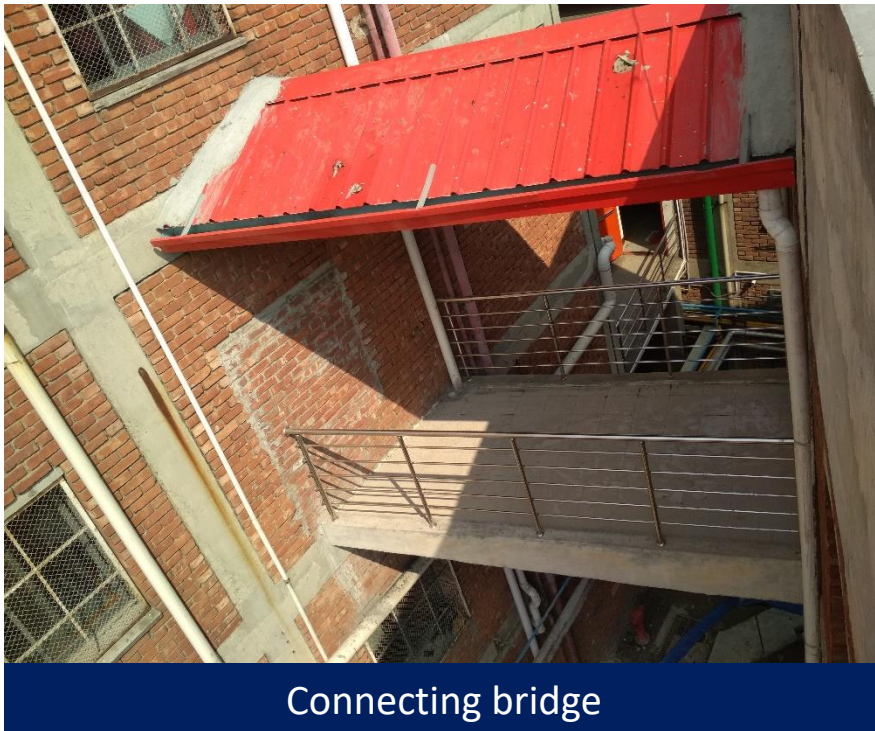
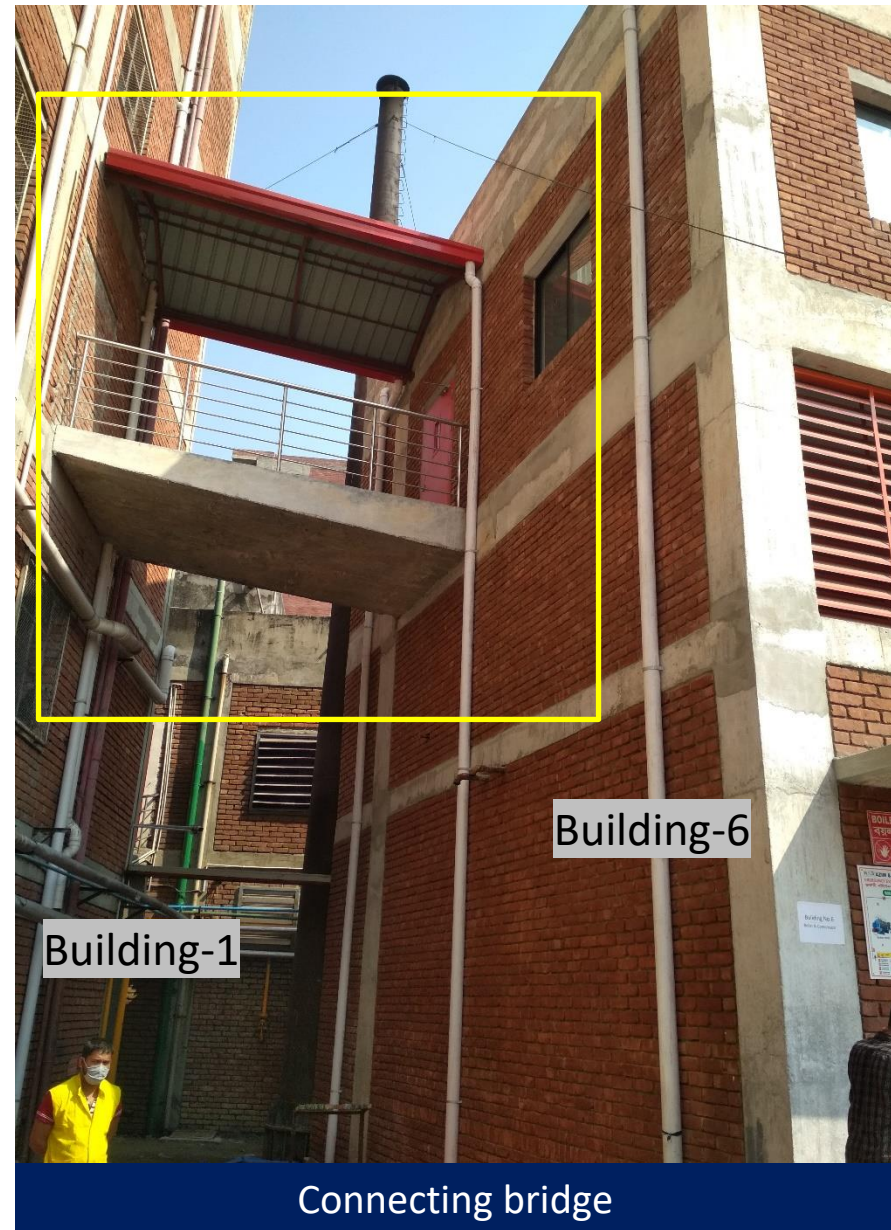
At first floor of building-6 almost 4 m cantilever connection bridge was observed. The building engineer is required to check adequacy & deflection of the cantilever slab.

Connecting bridge

| Item No. | Observation | Recommended Action Plan | Recommended Timeline |
|---|---|---|---|
| 26 | Large cantilever (connecting bridge).<br>(Building-6) | Building engineer is required to check the adequacy & deflection limit of the cantilever slab. | 6-weeks |
| 27 | Large cantilever (connecting bridge).<br>(Building-6) | Implement any remediation work if required. | 6-months |
