# Everbright sweaters ltd (New Building)

Kathgora,Ashulia,Savar,Dhaka, Bangladesh.

14 February 2022

1. Production Building 2 (G+M+5)

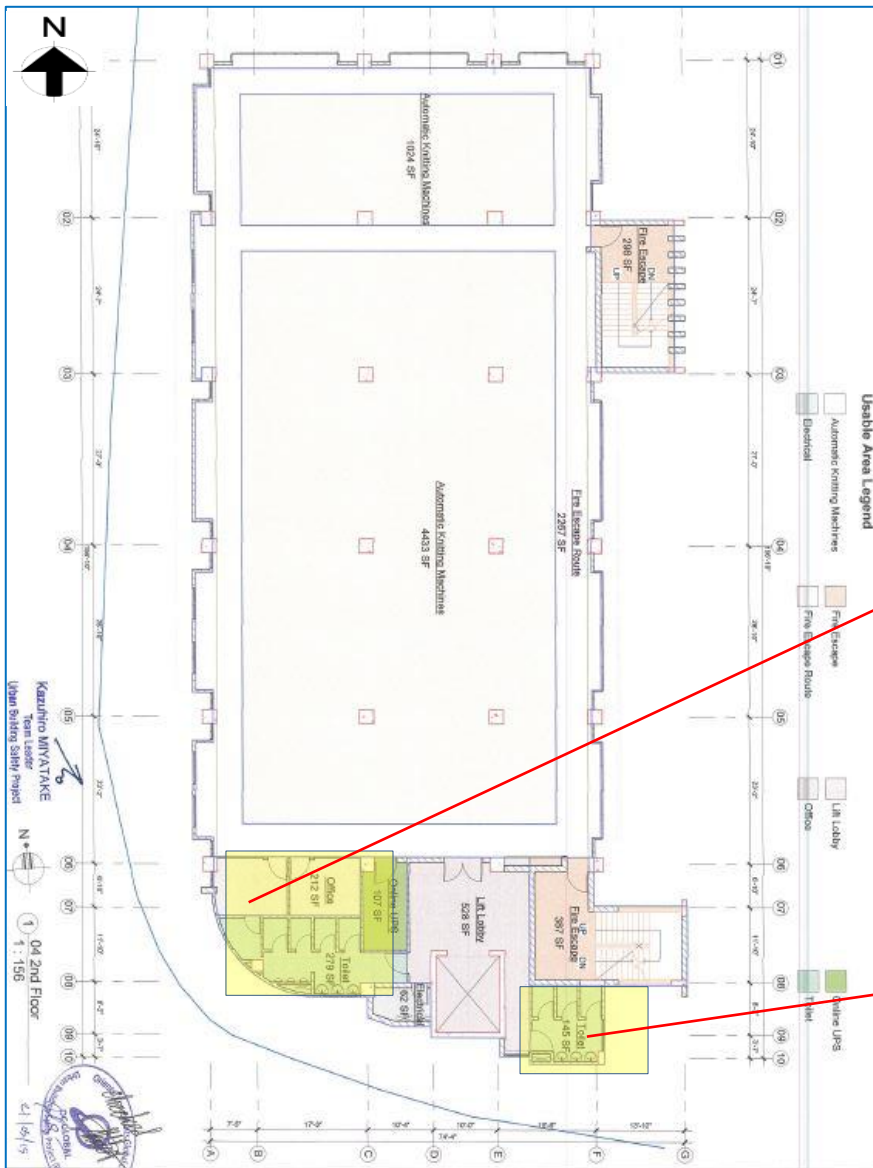
Floor Layout Plan

Some mismatches were found in architectural drawings. Partition walls of toilet block at South corner does not match with layout plan at all floor level.

| Item No. | Observation | Recommended Action Plan | Recommended Timeline |
|---|---|---|---|
| 01 | Architectural drawings not updated. | Building Engineer is to survey the whole structure and update as-built drawings representing accurate site condition. | 6-weeks |

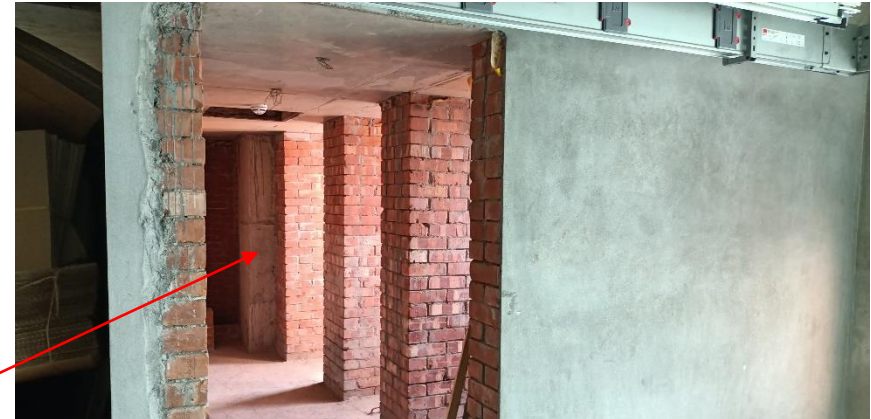
Toile partition wall

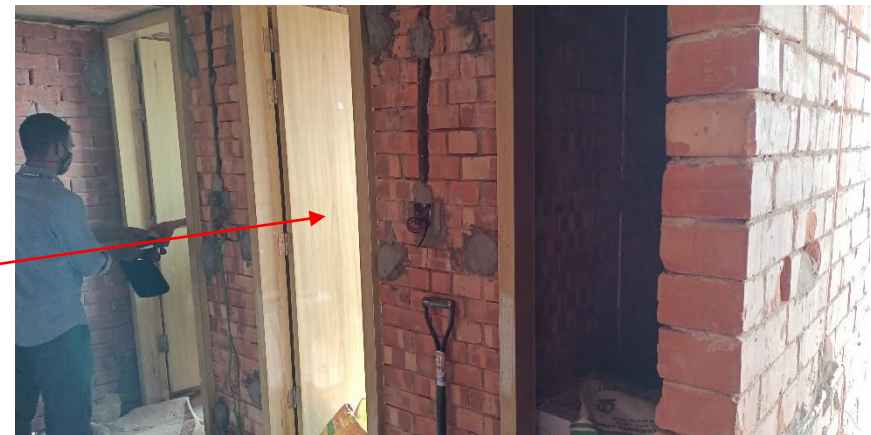
Toilet partition wall (near stair)

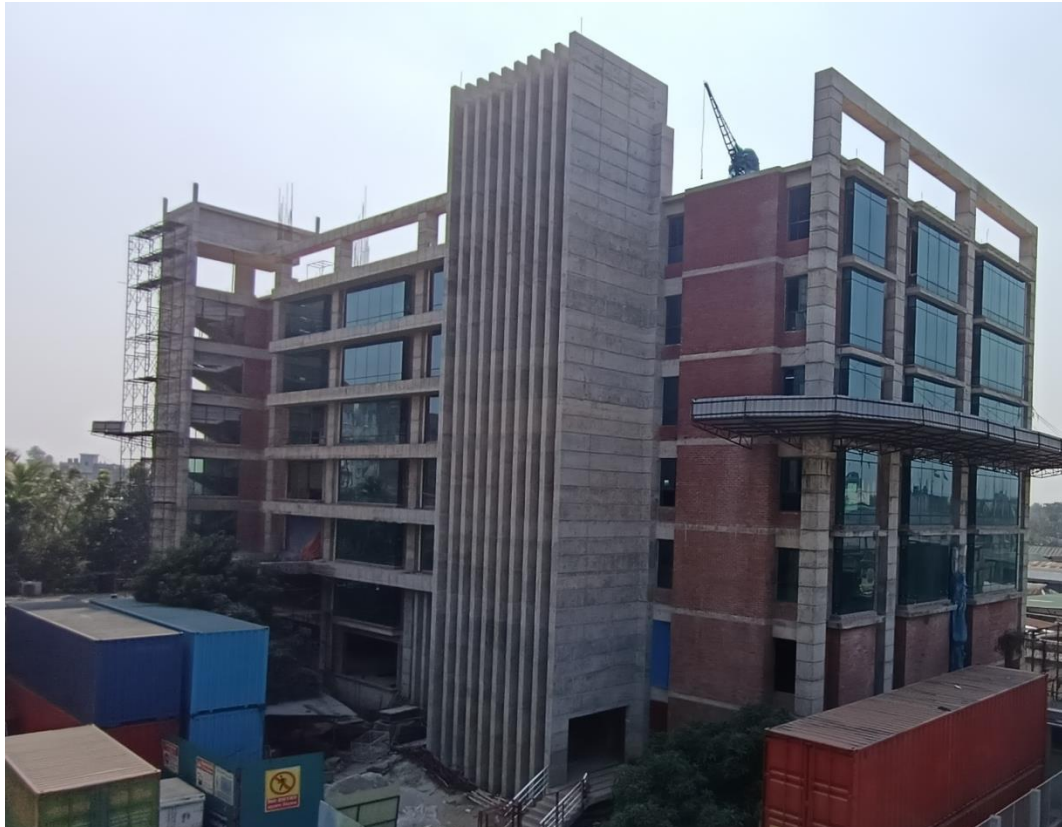
No design report was available for Production Building-2

As per BNBC, every building or structure designed shall have its design documents prepared in accordance with the provision of Section 1.9.1. The design document shall include a design report, and a set of structural drawings, which shall be prepared in compliance with section 1.9.1.1 and section 1.9.1.2, part-6 of BNBC. At the time of inspection, only as-built drawing and geotechnical report were available, but no design report & load plan were available which are required to be prepared in compliance with section 1.9.1.1 (part-6, BNBC).

| Item No. | Observation | Recommended Action Plan | Recommended Timeline |
|---|---|---|---|
| 02 | Absence of design documents. | Factory engineer is required to prepare the design documents including a design report, and a set of structural drawings in compliance with section 1.9.1.1 and section 1.9.1.2, part-6 of BNBC and submit it to RSC for review. | 6-weeks |
| 03 | Absence of design documents. | Carry out remedial works (if any) after reviewed by the RSC. | 6-months |

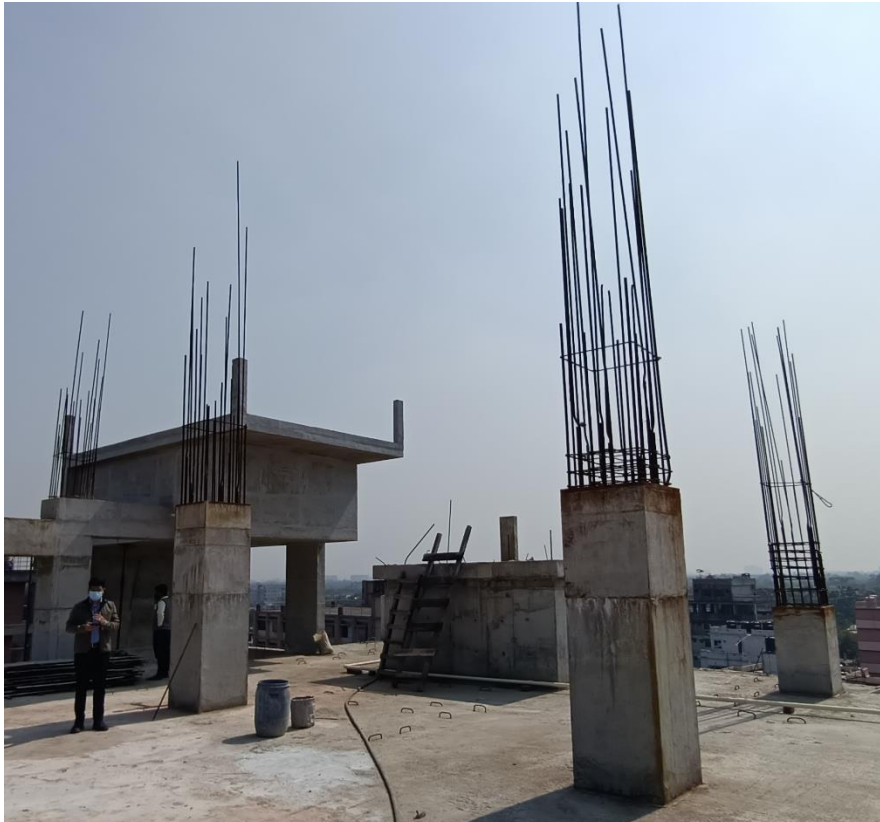
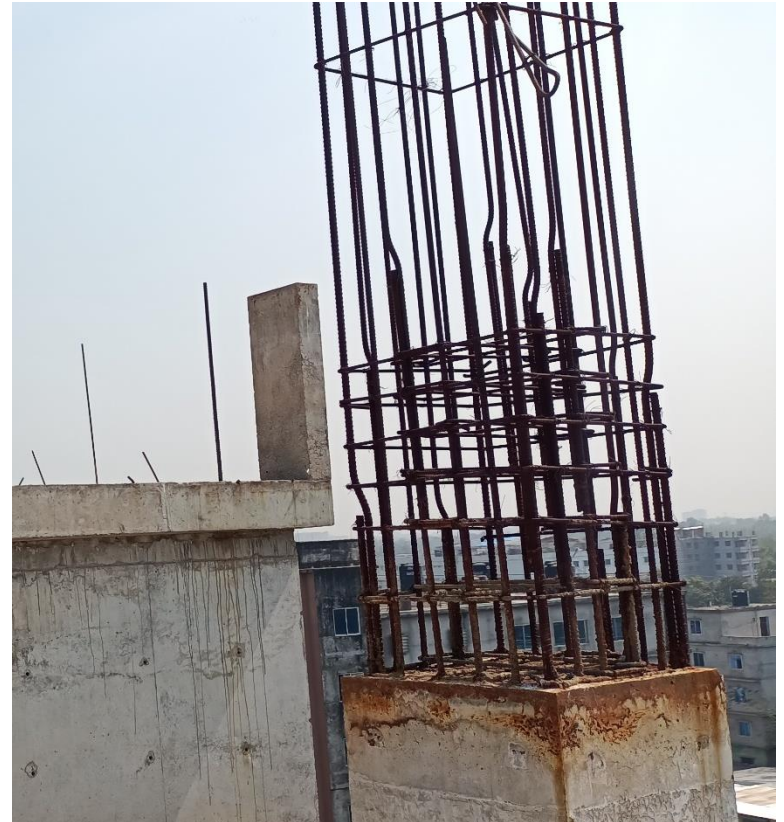
Exposed rebar at column on roof

Exposed reinforcement was found extended from column on roof. All exposed reinforcement is to be protected from corrosion which may cause degradation of the concrete. Factory engineer is required to take necessary measures to prevent the corrosion in exposed rebar.

| Item No. | Observation | Recommended Action Plan | Recommended Timeline |
|---|---|---|---|
| 04 | Exposed re-bar found. | All exposed reinforcement is to be protected from corrosion which may cause degradation of the concrete. | 6-weeks |

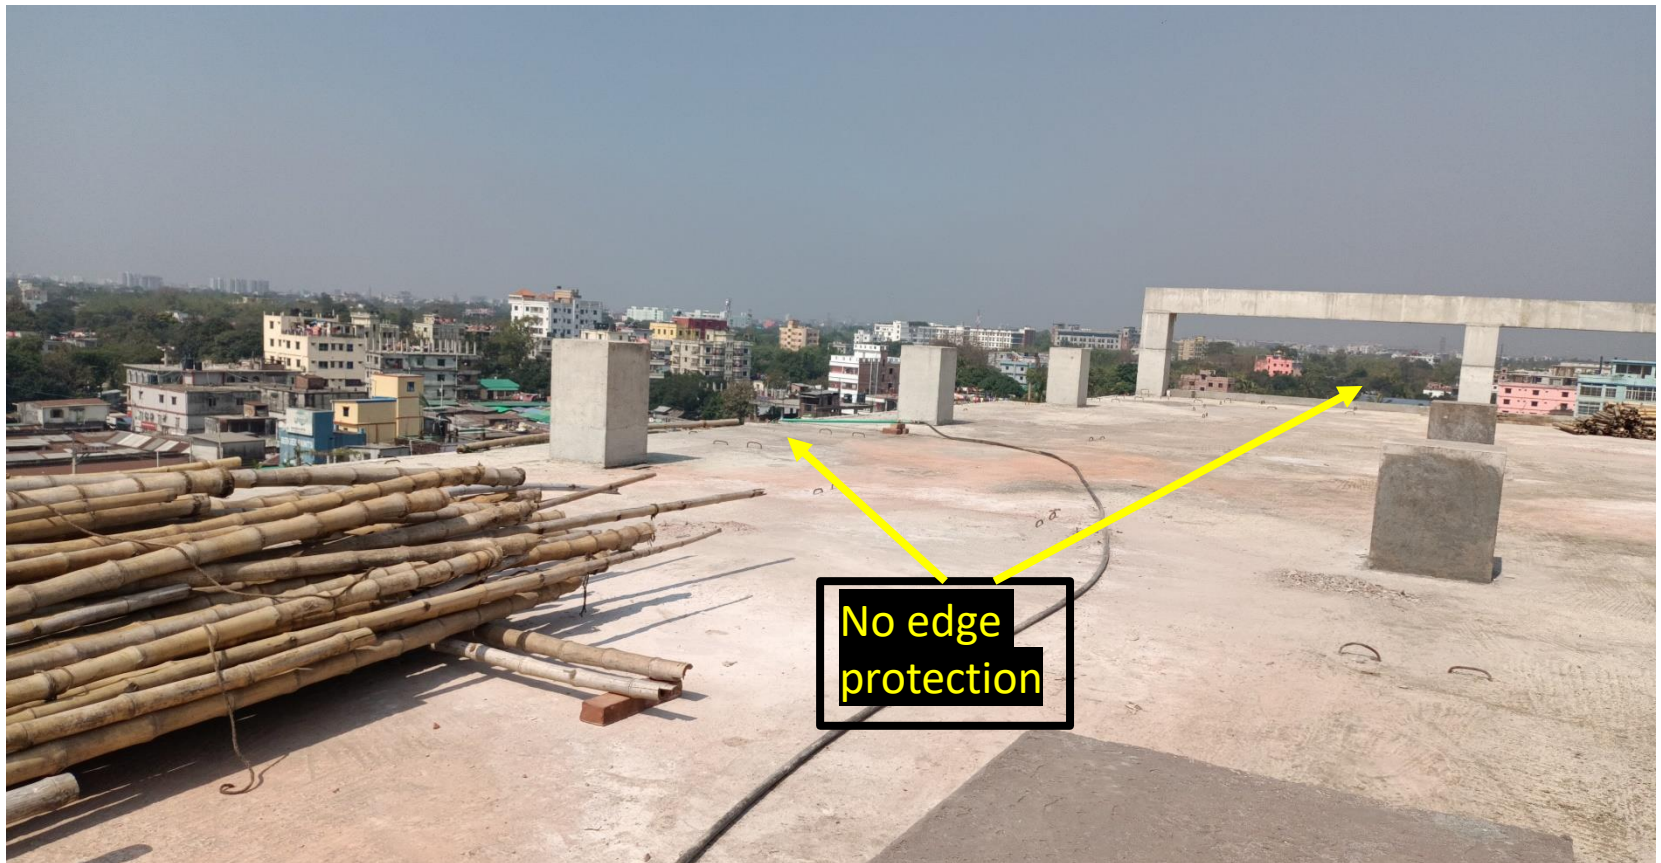
Necessary safety measures were not observed on the roof. No barrier was provided at roof to mitigate the falling hazard. The factory engineer is required to take necessary measures to provide and install construction safety barrier.

Current roof

| Item No. | Observation | Recommended Action Plan | Recommended Timeline |
|---|---|---|---|
| 05 | Lack of construction safety measures. | The factory engineer is required to take necessary measures to provide and install construction safety barrier as per BNBC Part 7. | 6-weeks |

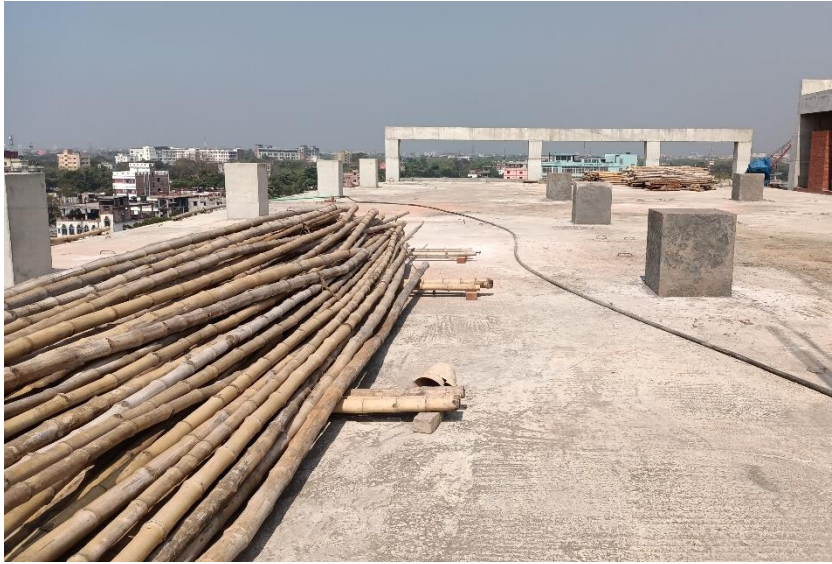
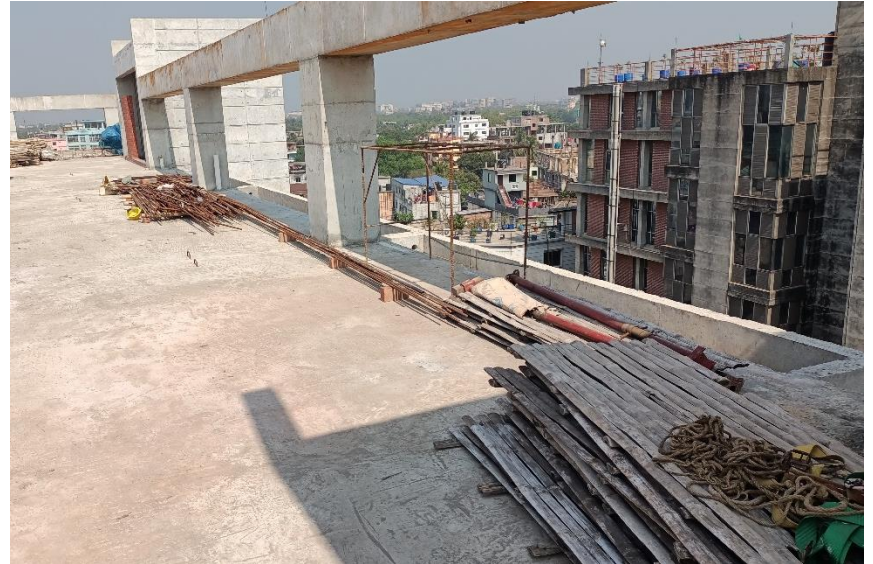
Stacking of construction materials and wastage found almost everywhere on the roof.

| Item No. | Observation | Recommended Action Plan | Recommended Timeline |
|---|---|---|---|
| 06 | Stacking of construction material on roof. | Remove construction materials and wastage from roof. | 6-weeks |

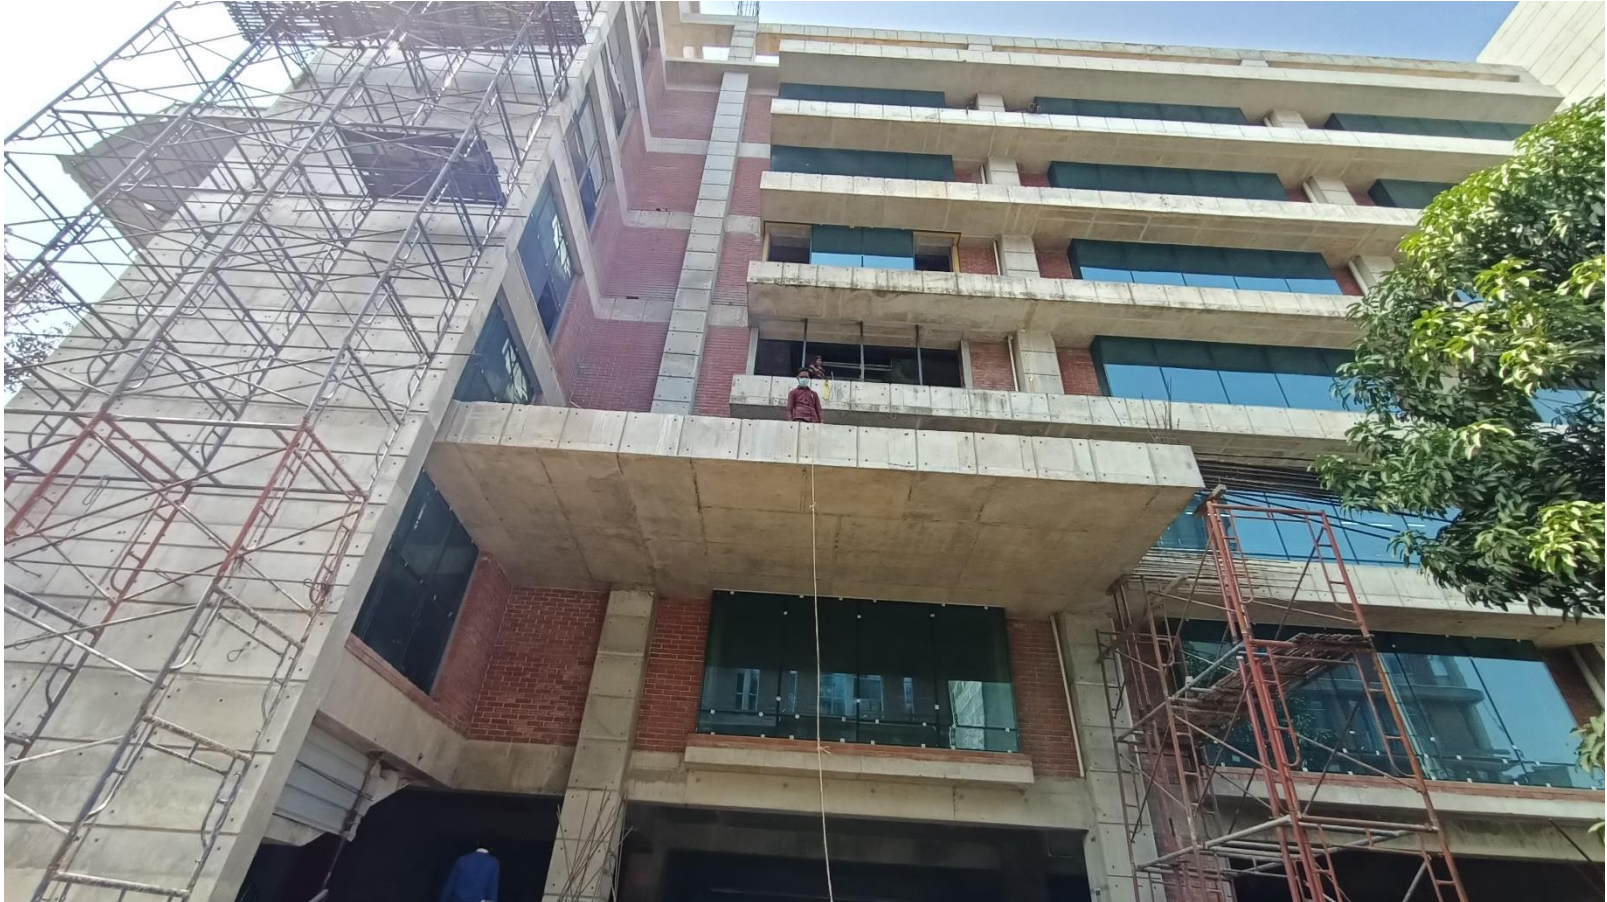
At first floor almost 4 m cantilever porch was observed. The building engineer is required to check adequacy & deflection of the cantilever slab.

Cantilever Porch

| Item No. | Observation | Recommended Action Plan | Recommended Timeline |
|---|---|---|---|
| 07 | Large cantilever (Porch at loading/unloading area). | Building engineer is required to check the adequacy & deflection limit of the cantilever slab. | 6-weeks |
| 08 | Large cantilever (Porch at loading/unloading area). | Implement any remediation work if required. | 6-months |
