# Pacific Blue (Jeans Wear) Ltd.

Radio Colony, Savar, Dhaka

15 February 2022

# Observations

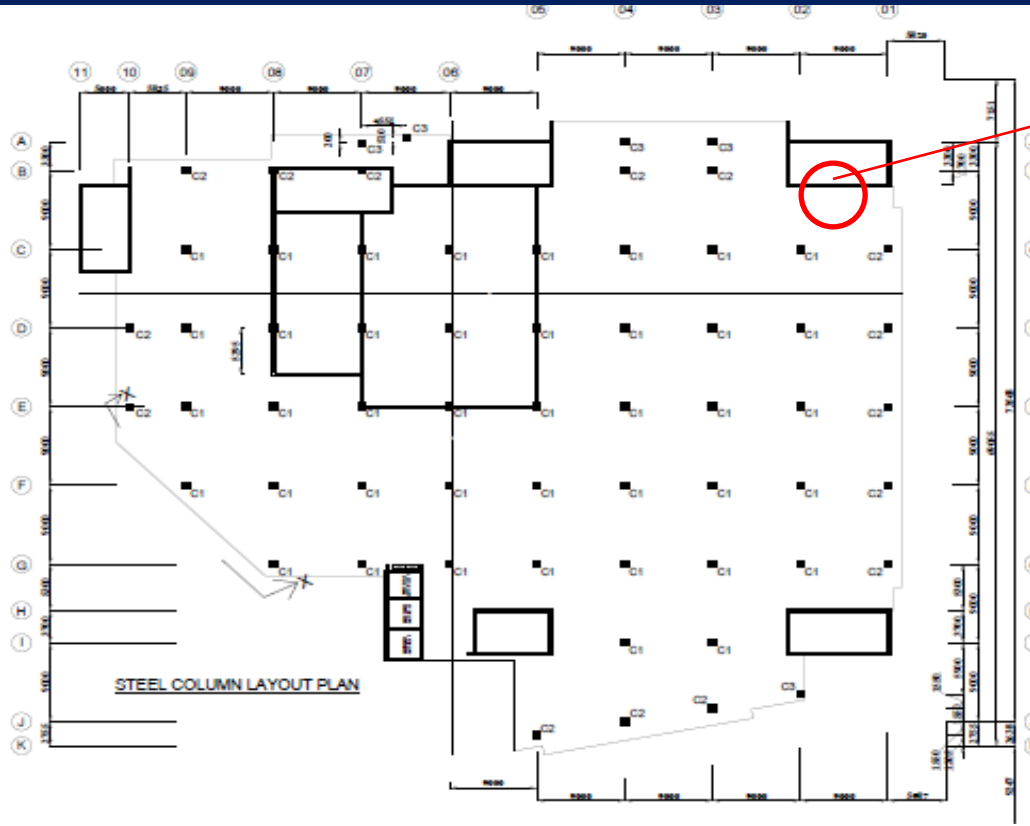
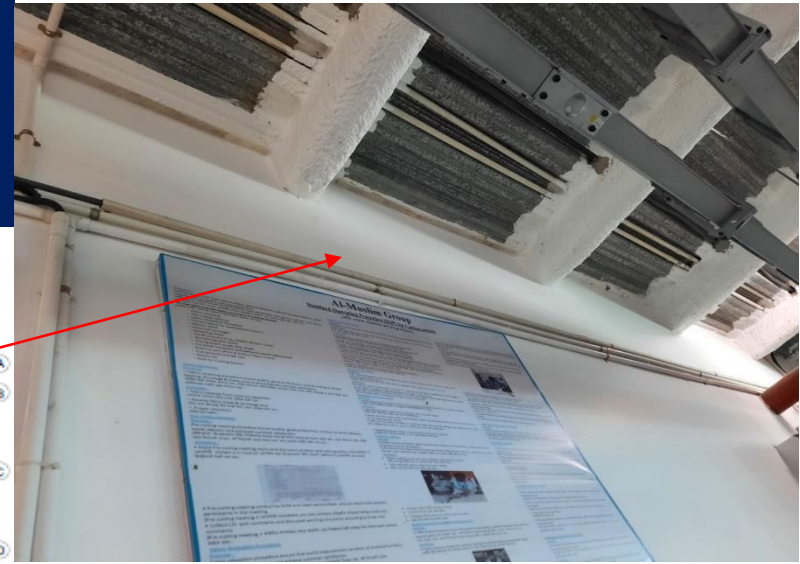
Column and RC wall layout plan

Steel beams in the several grids are connected to the shear walls. Design report was not available to determine the contribution of RC wall and diaphragm action in lateral stability system.

Building engineer is required to check the overall stability system and the connections.

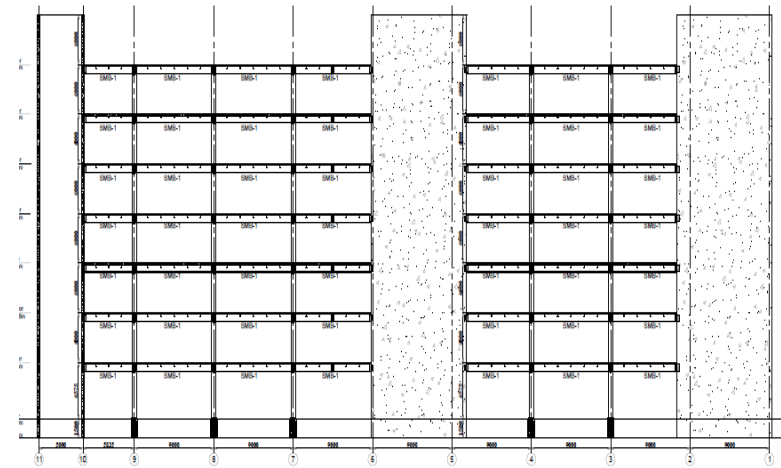
Connection between steel beam and RC wall

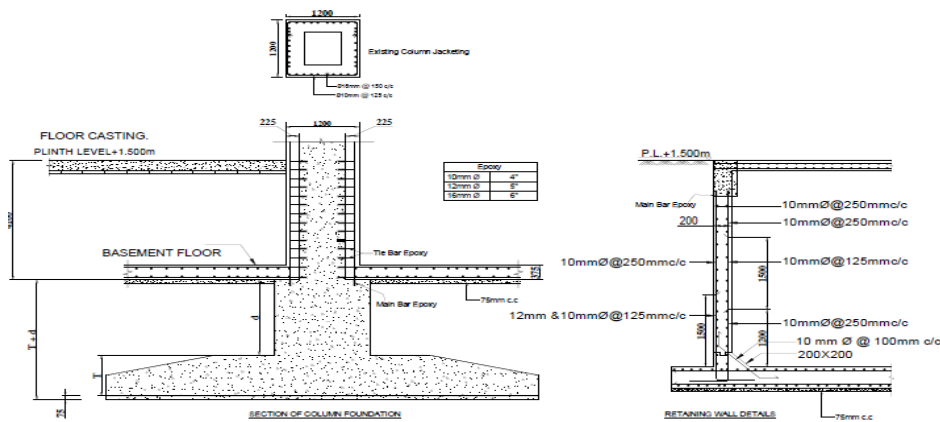
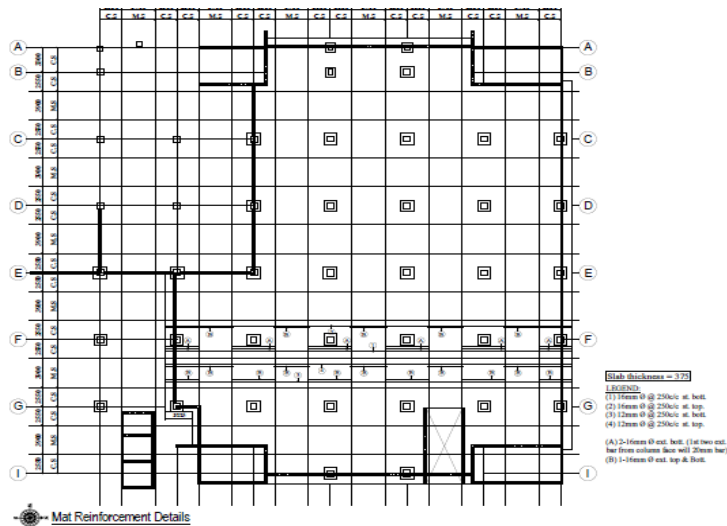
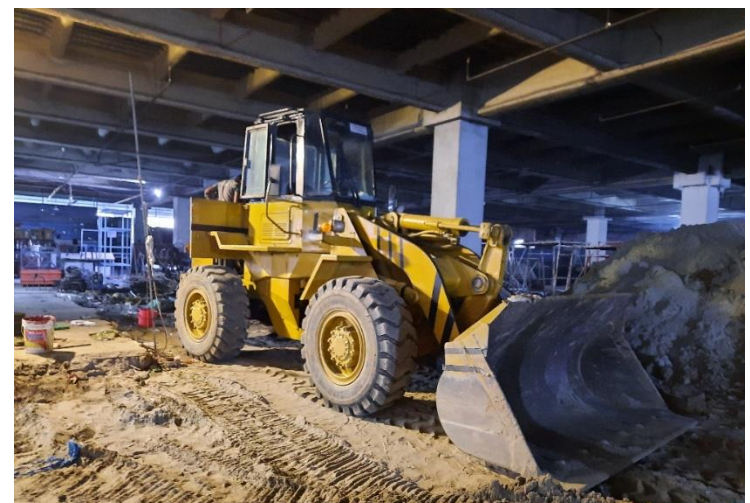
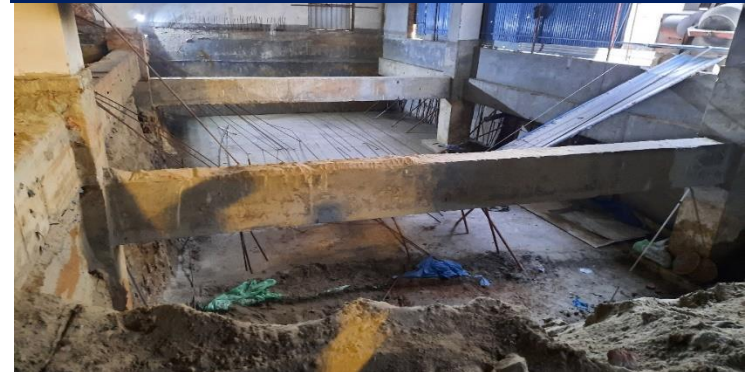
Earth excavation work and construction of additional floor is going on.

The factory is constructing a basement floor below the grade/ground beam level. Additional floor will add on the existing condition. Before construction of the additional basement floor, building engineer is required to check the foundation and column stress of the considering the additional floor loading. Also building engineer is required to check the capacity of the existing ground/grade beam to carry the load of ground floor slab. Building engineer also required to follow and prepare the documents according to the BNBC Part VII for Construction responsibilities & practice, Safety during construction works.

06	Construction of proposed basement below GB level.	Carryout remedial works arise from Detail Engineering Assessment where necessary.	6-months

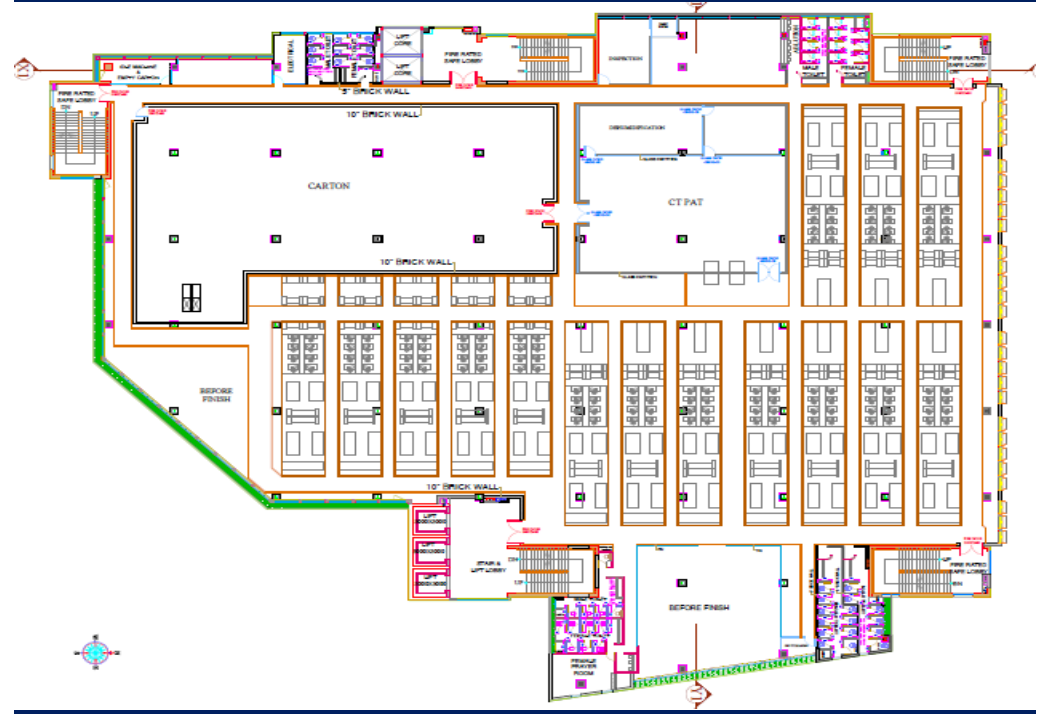
Typical floor layout plan

As per BNBC, every building or structure designed shall have its design documents prepared in accordance with the provision of Section 1.9.1. The design document shall include a design report, and a set of structural drawings, which shall be prepared in compliance with section 1.9.1.1 and section 1.9.1.2 of part-6, BNBC. However, design report was not available during inspection. The building engineer is required to prepare a design report in compliance with BNBC.

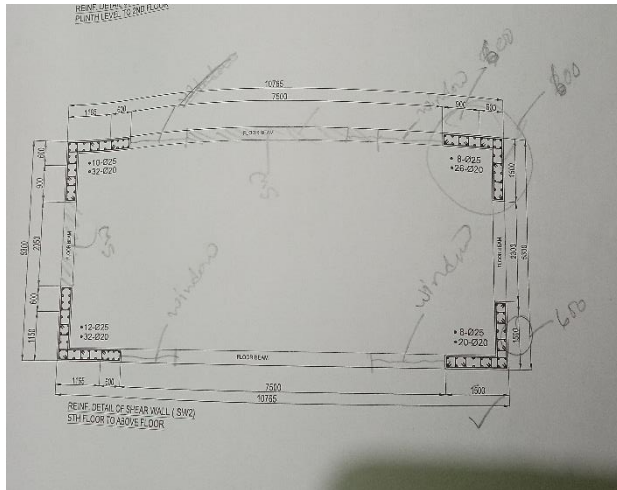
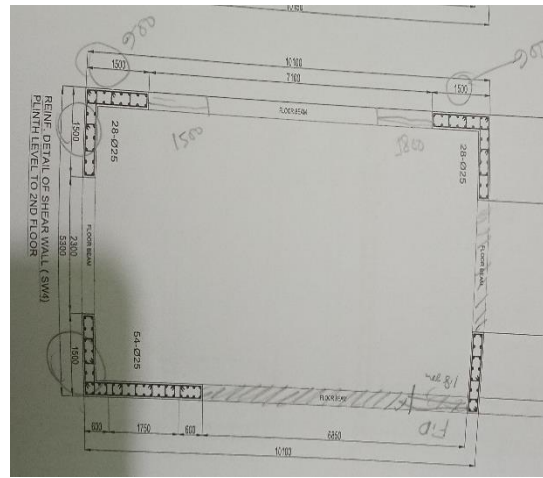
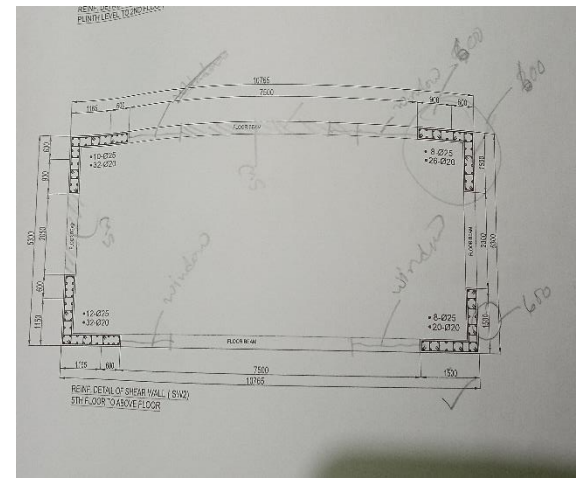
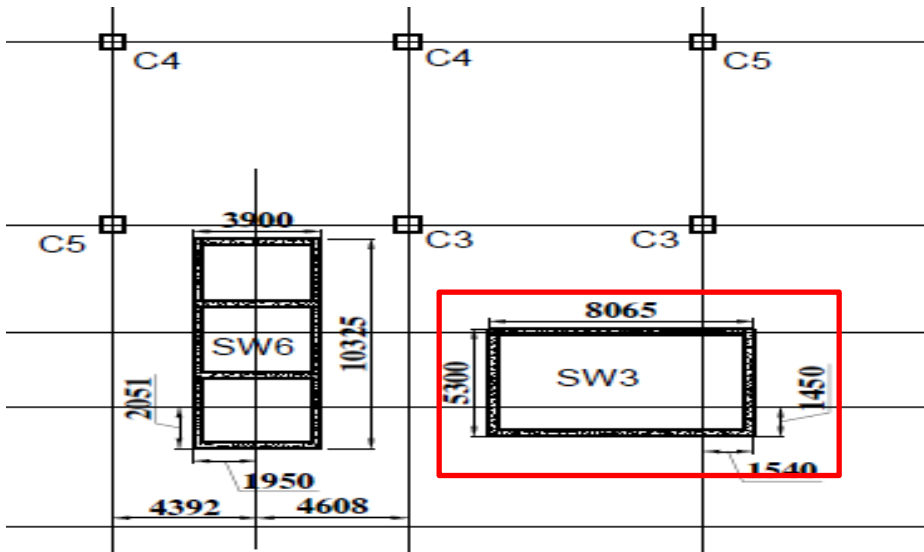
## Inconsistency in dimension of lift shear wall core

Dimension of lift core doesn't match with the existing condition. Structural details of SW-3 not shown in the structural drawings. The building engineer is required to survey the structural components and produce accurate structural details & as built drawings.

No details of SW-3

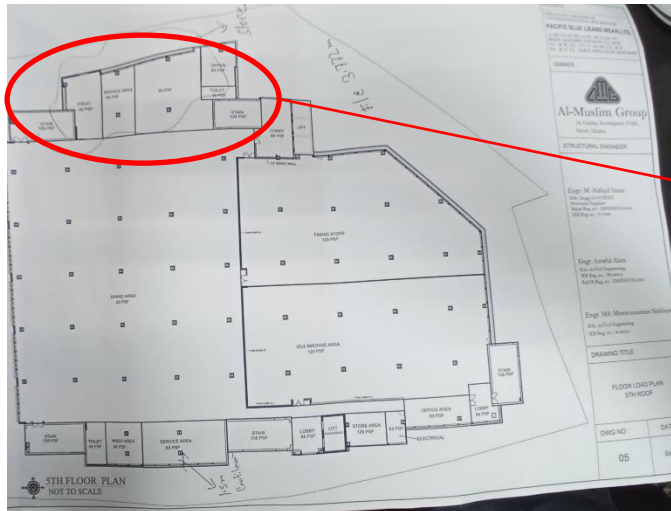
5th floor plan (production) 3 kPa considered in the load plan

On the 5th and 6th floor storage was observed on production area (3kPa). The building engineer is required to check the occupancies and update the floor live loading plan for all floors based on BNBC requirements and manage the floor loading accordingly.

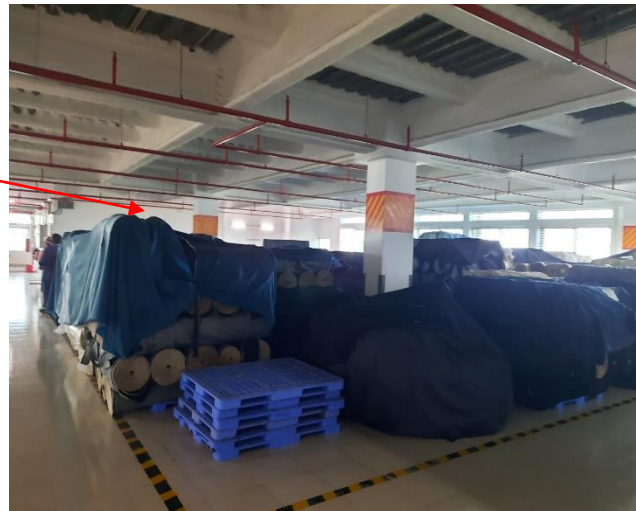
Onsite storage observed on the 5th floor

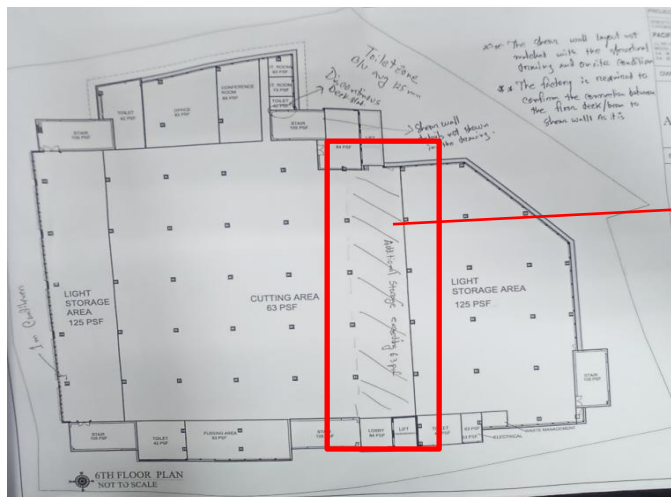
6th floor plan (production) 3 kPa considered in the load plan

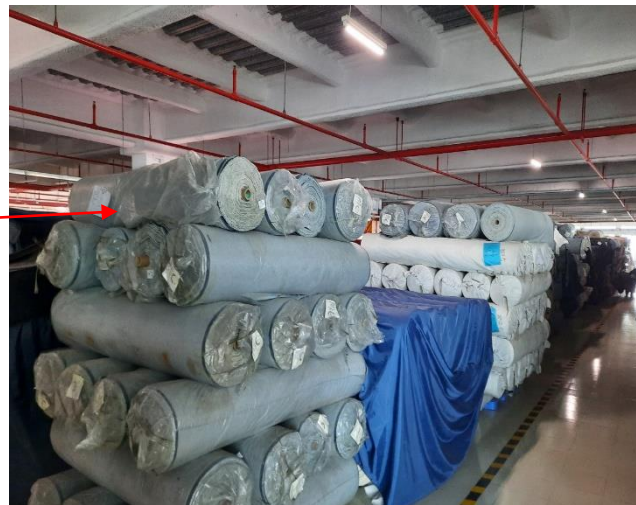
Onsite storage observed on the 6th floor.
