# Anupam Hosiery Industry (Pvt.) Ltd. (Steel Shed)

Vulta, Rupgonj, Narayangonj  
(23.77472, 90.56012)  
13<sup>th</sup> February 2022

# Building Information

Steel Shed: Single storied steel Shed.

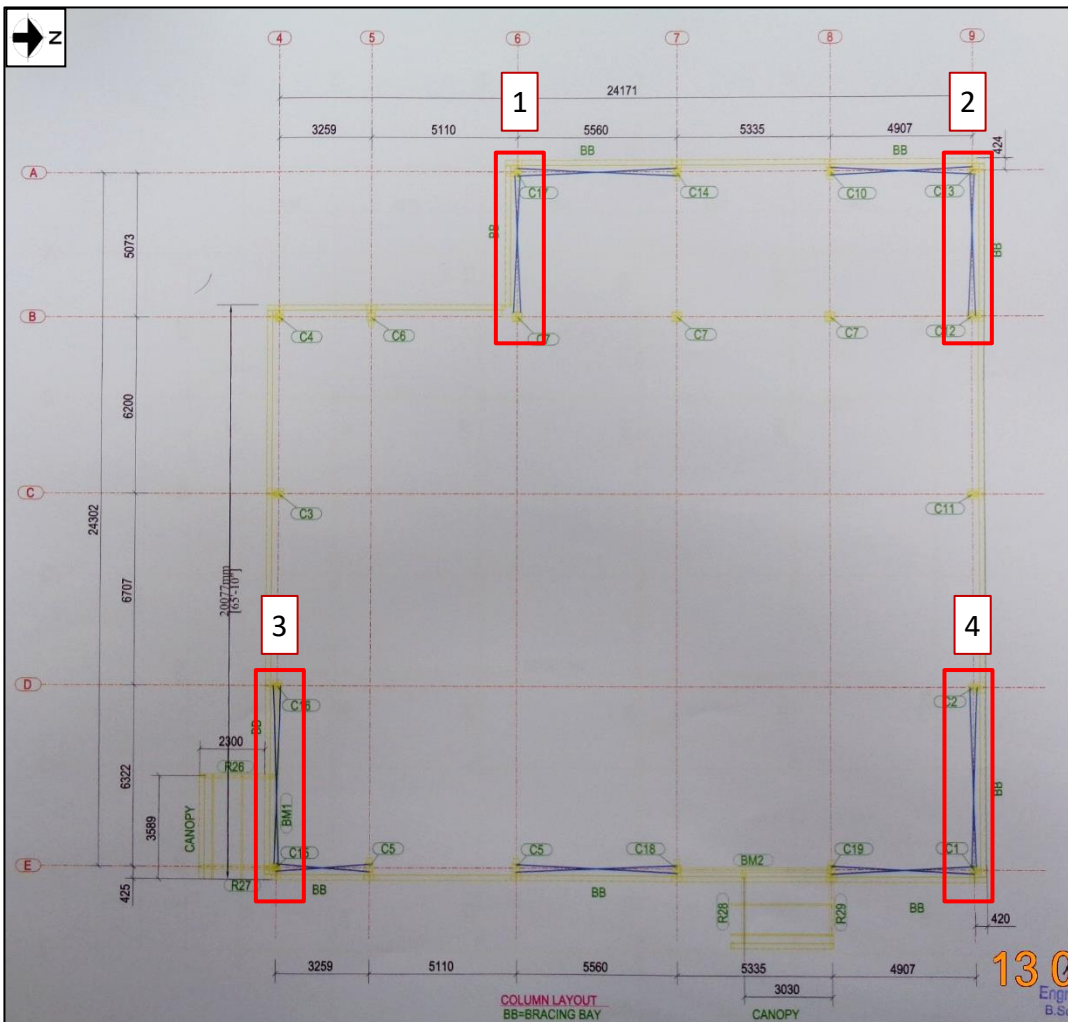
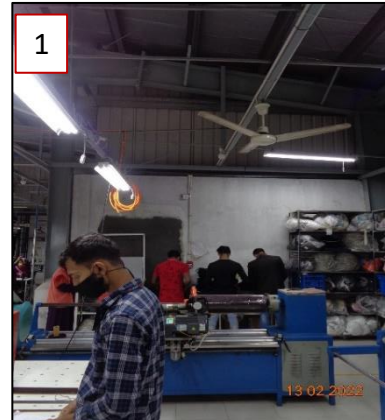
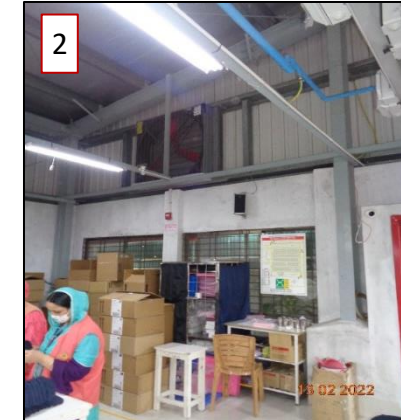
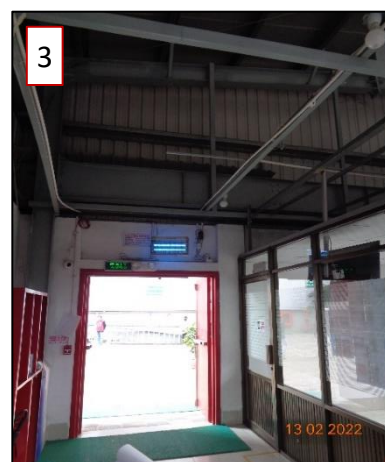
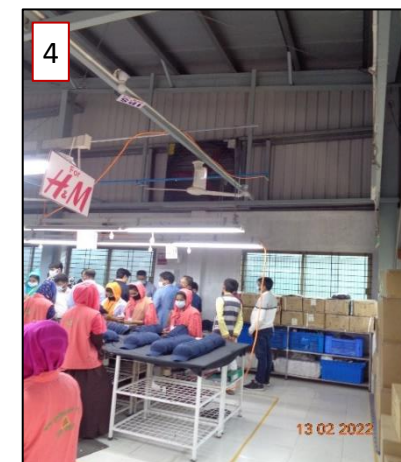
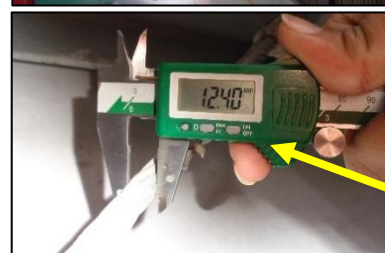
# Discrepancies in as-built drawing

Cable Bracing size has not been shown in drawing which was found 12mm diameter

During inspection, bracing was not found at marked location as per as-built drawing. Factory engineer is required to develop the accurate as built drawing and submit to RSC for further review.

Item No.	Observation	Recommended Action Plan	Recommended Timeline
01	Discrepancy in as-built drawing	Building Engineer to survey the structure and prepare accurate as-built (architectural & structural) drawings in compliance with section 1.9.1.2, part-6 of BNBC.	6-weeks
02	Discrepancy in as-built drawing	Building engineer to update the design document including a design report in compliance with section 1.9.1, part-6 of BNBC.	6-weeks
03	Discrepancy in as-built drawing	Implement the recommendations of design report.	6-months
04	Design report needs to be revised	Building engineer to update the design document including a design report in compliance with section 1.9.1, part-6 of BNBC.	6-weeks

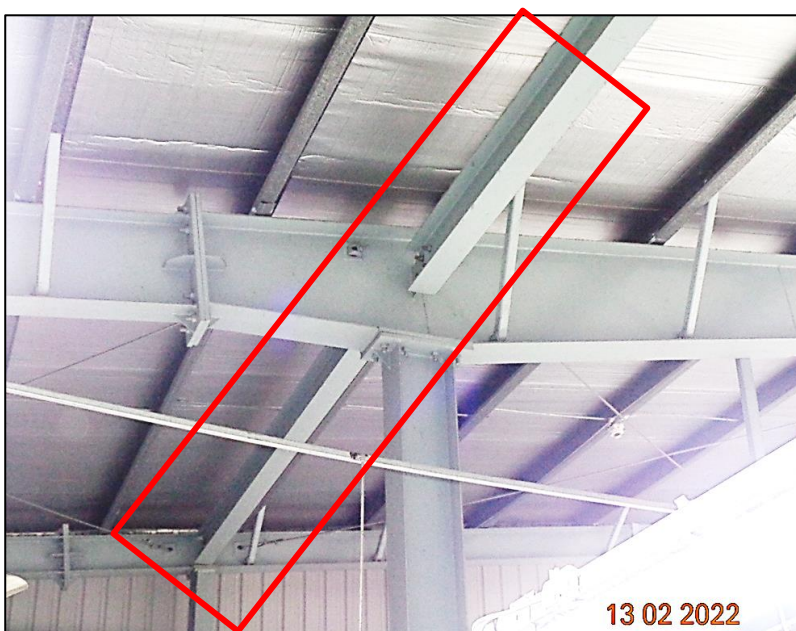
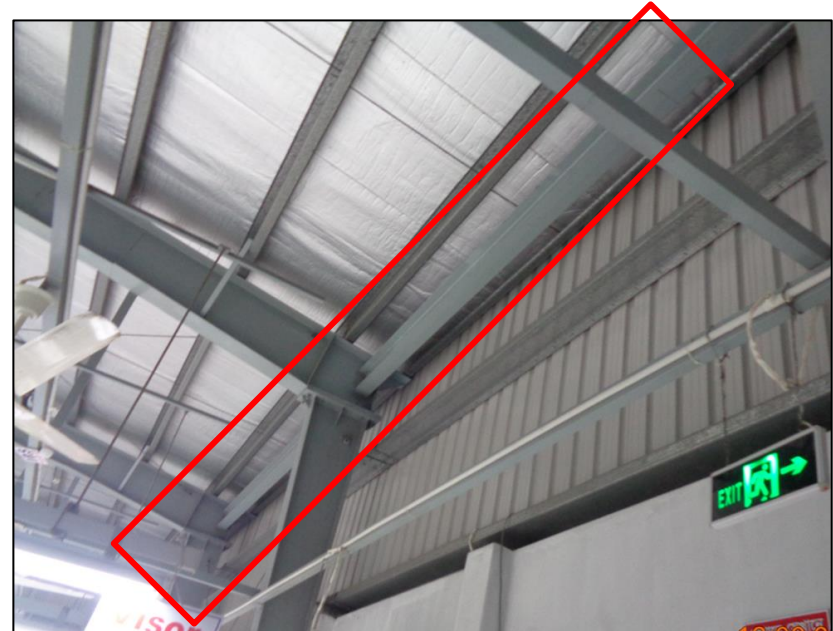
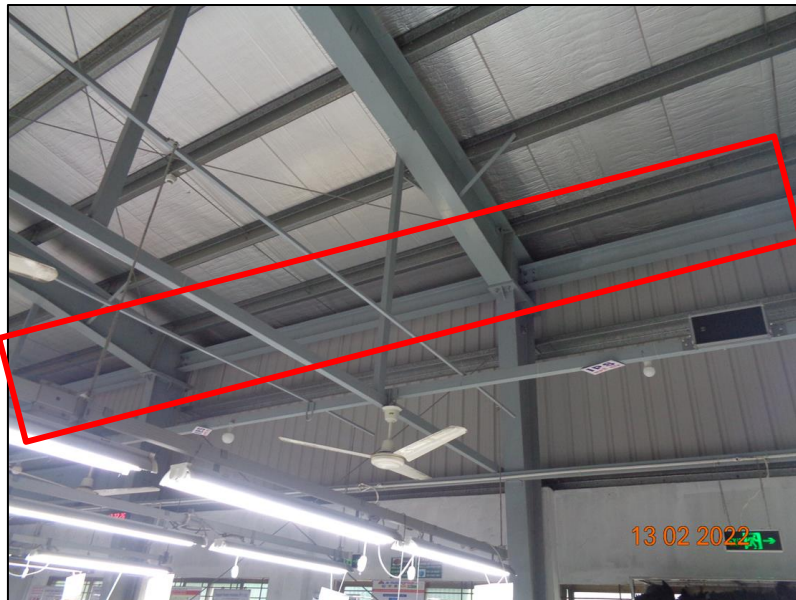
Compression Strut – Marked location

During inspection, compression strut was found at site. But in as-built drawing, the compression strut section details has not been provided. The size was found W250(8)XF150(10).

As per BNBC, every building or structure designed shall have its design documents prepared in accordance with the provision of Section 1.9.1. The design document shall include a design report, and a set of structural drawings, which shall be prepared in compliance with section 1.9.1.1 and section 1.9.1.2 as per BNBC. Factory engineer is required to update the drawing and revise the design report and FEA model following BNBC requirements.

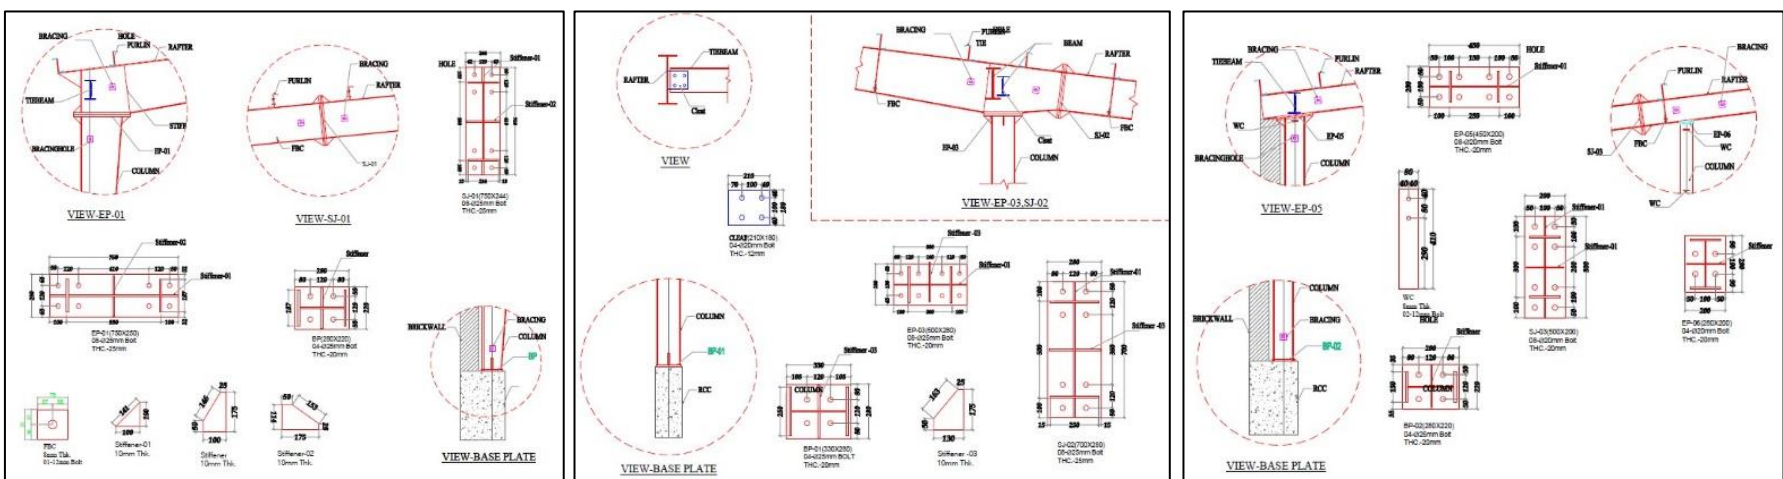
Connection details in as-built drawing

In Design report, connection design has been only shown for the anchor rod & Basement, EP-1, SJ-01 & Tile Beam connection. Factory engineer is required to provide adequacy check for all the types of connections.

As per design report, structural analysis and design software “STAAD PRO” has been used. But Softcopy of “STAAD PRO” was not available for review. Factory engineer is required to revise the full set of design documents including FEA model following BNBC requirements and submit to RSC for review.

Item No.	Observation	Recommended Action Plan	Recommended Timeline
05	Design report needs to be revised	Implement the recommendations of design report.	6-months
06	Cable bracing found loose	Keep tighten the roof bracings.	6-months

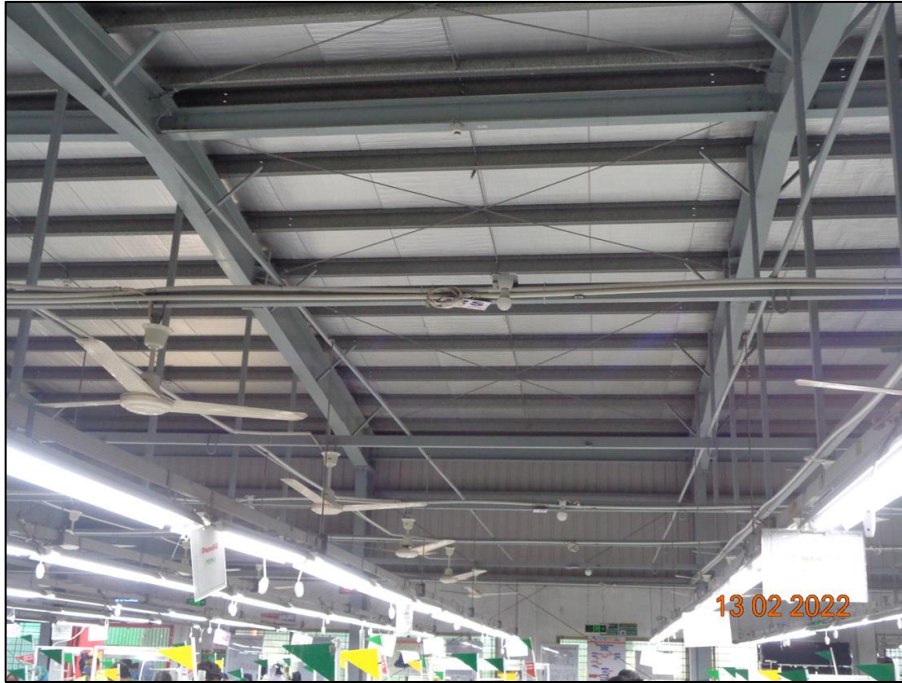
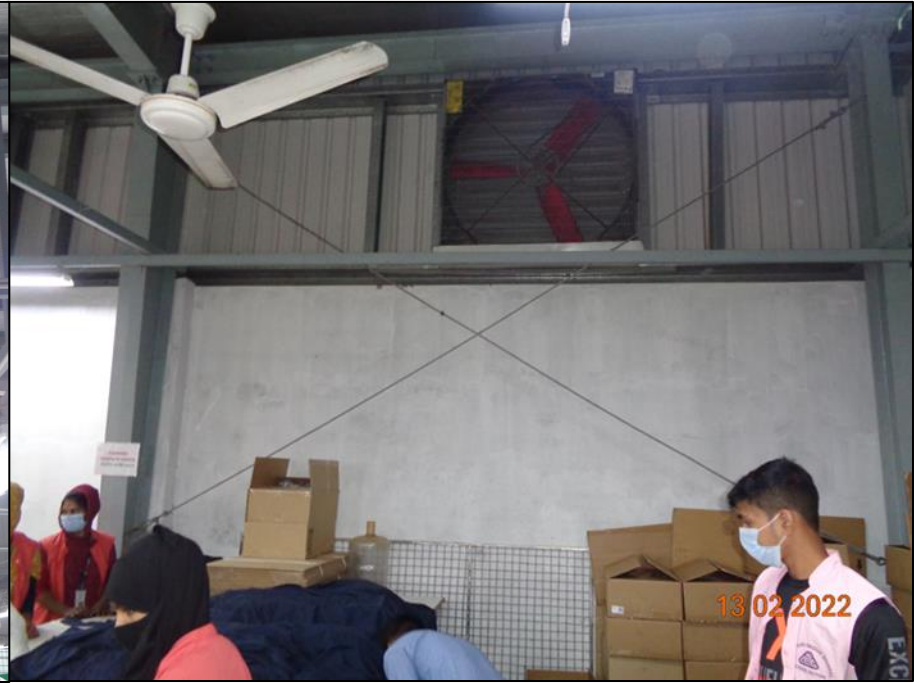
# Cable bracing found loose

Wall & Roof cable bracing was found loose. Factory is required to take necessary measures to tighten the roof bracings.
