Crosswear Industries Limited

Ashu/Shilpa-16, Ward-01, Kathgara, Zirabo, Ashulia, Dhaka-1341, Bangladesh
(23.916381 N, 90.294261 E)

20 February 2022

Observations

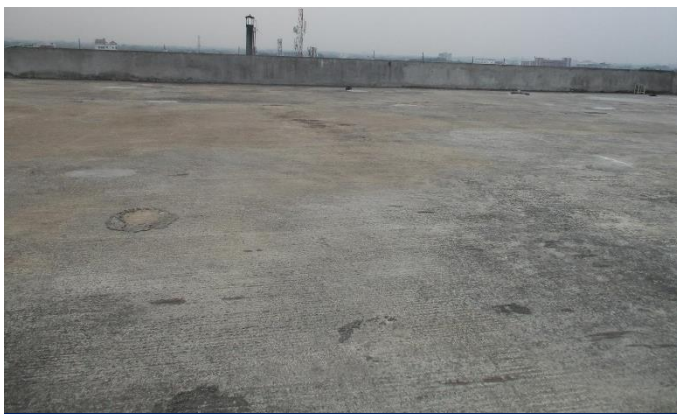
Sign of water ponding on roof slab

Damage due to water intrusion was observed in the several locations of the roof slabs. The building engineer is required to identify the location of water intrusion and suggest remedial measures accordingly. Provide water proofing layer on the roof slab with adequate slope. Develop proper water drainage system on the roof.

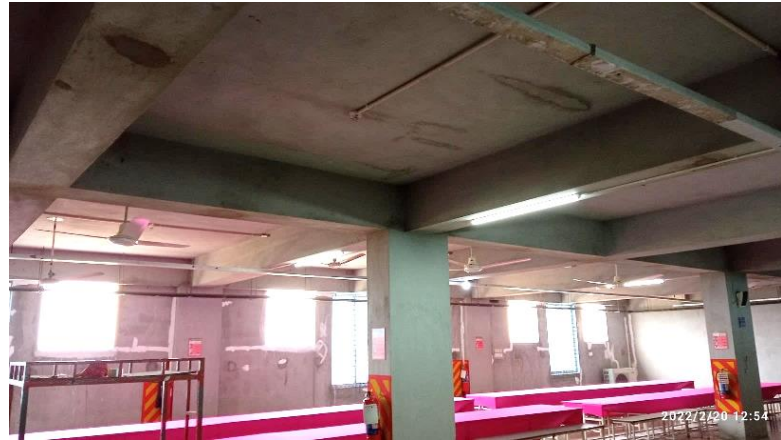
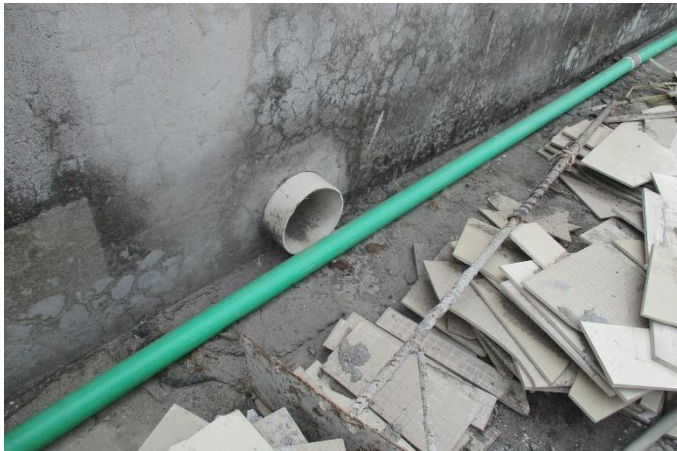
Inactive water outlet, 50 mm above roof level

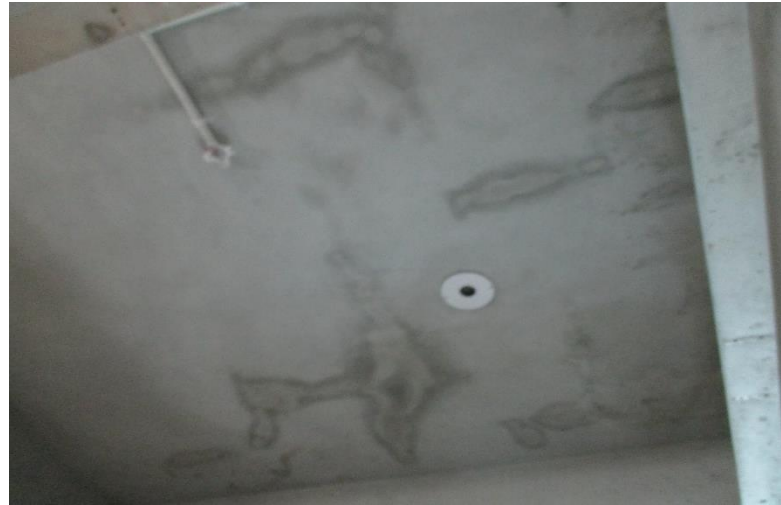
Sign of water intrusion into the roof slab

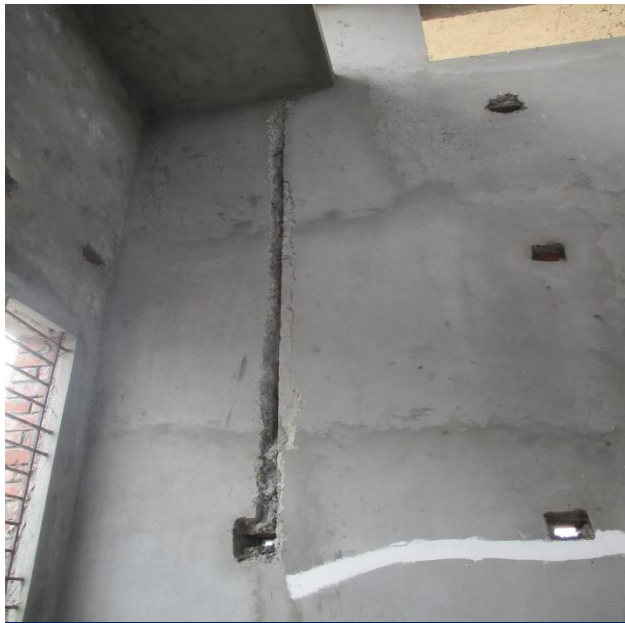
Crack in brick wall on stair landing

Crack in brick walls were observed in several locations especially in the cantilever areas. Also, crack in beam edge observed in the 1st floor cantilever beam. The building engineer is required to investigate the crack extent, reason of cracks and prepare an investigation report with proper remedial actions.

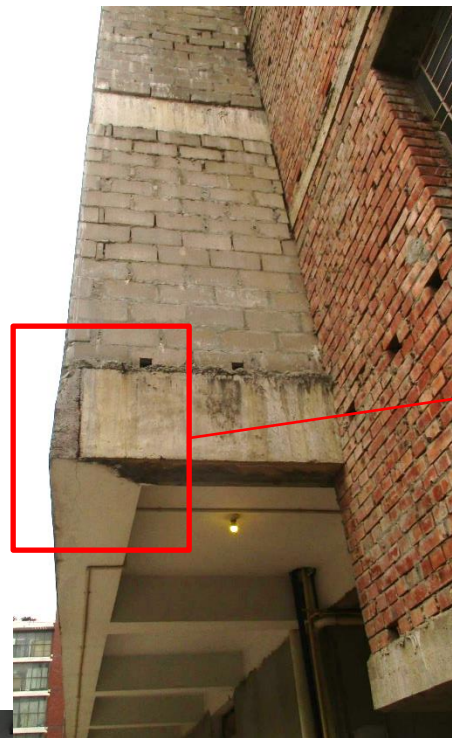
Crack in cantilever beam edge

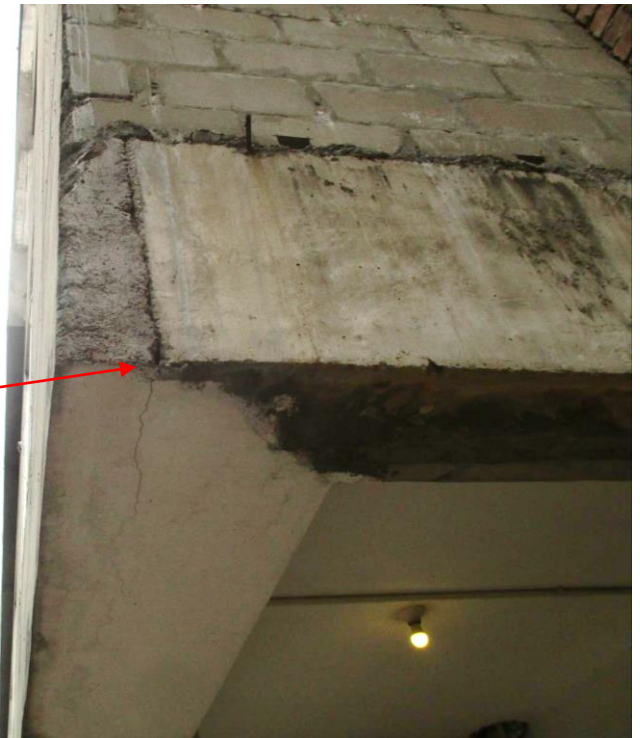
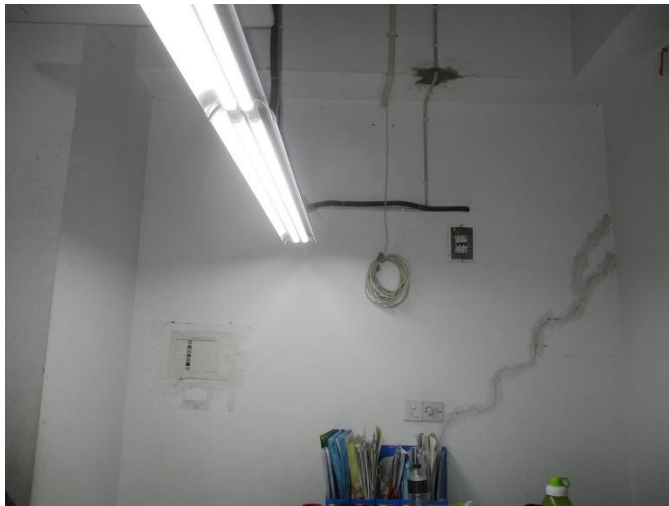
Crack in brick wall on cantilever area

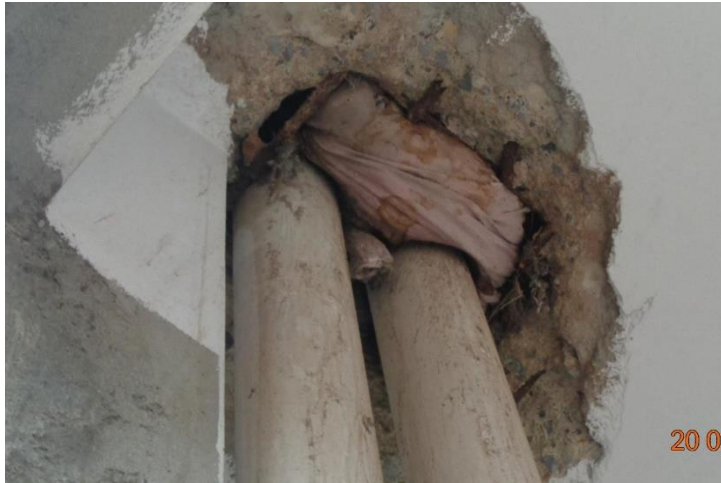
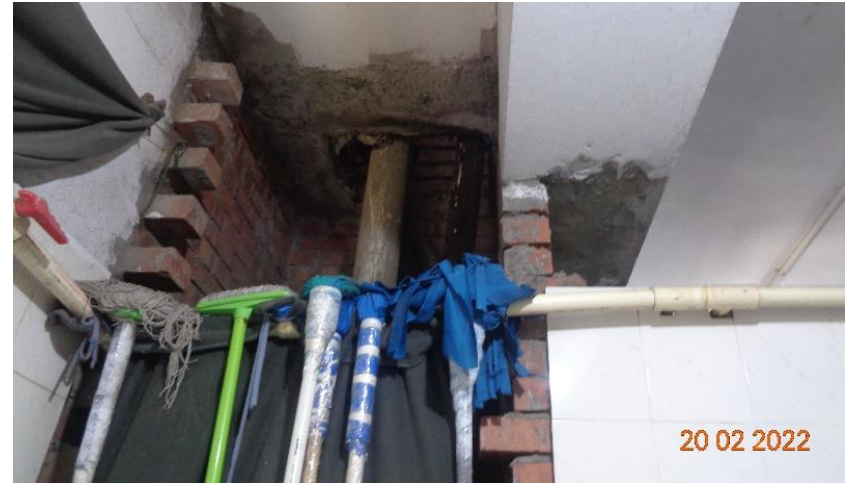
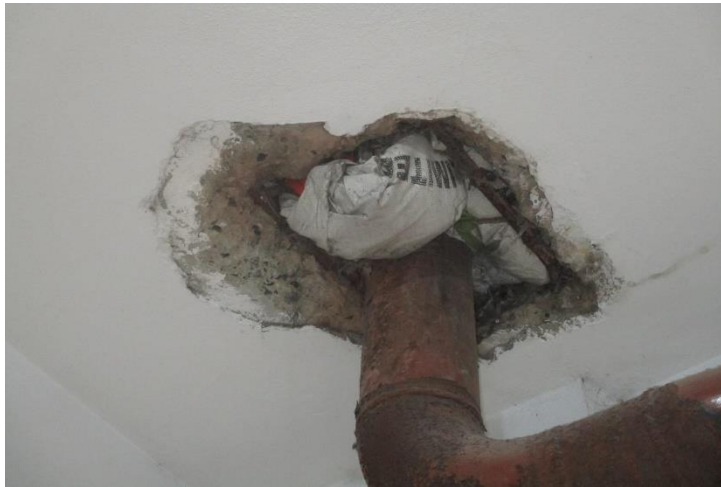
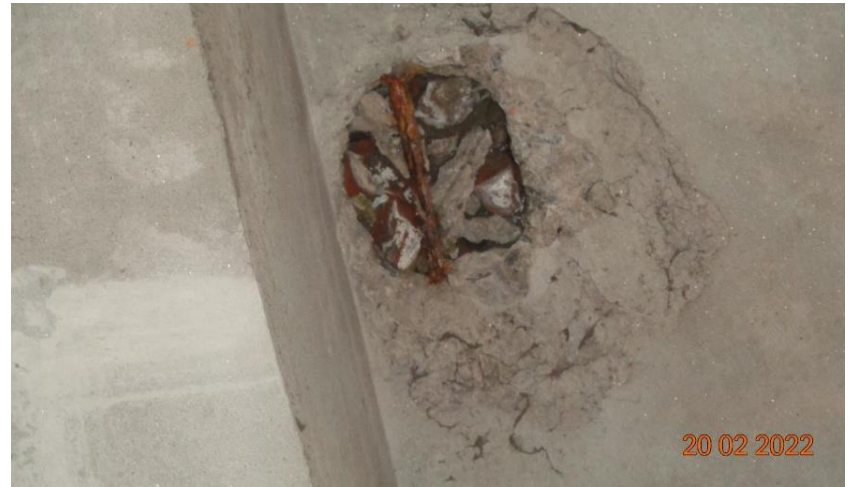
Slab holes due to pipping were observed in several locations of slab. Also, corrosion in rebar was observed. The factory is required to remove the corrosion and fill the holes as per building engineer's suggestion.

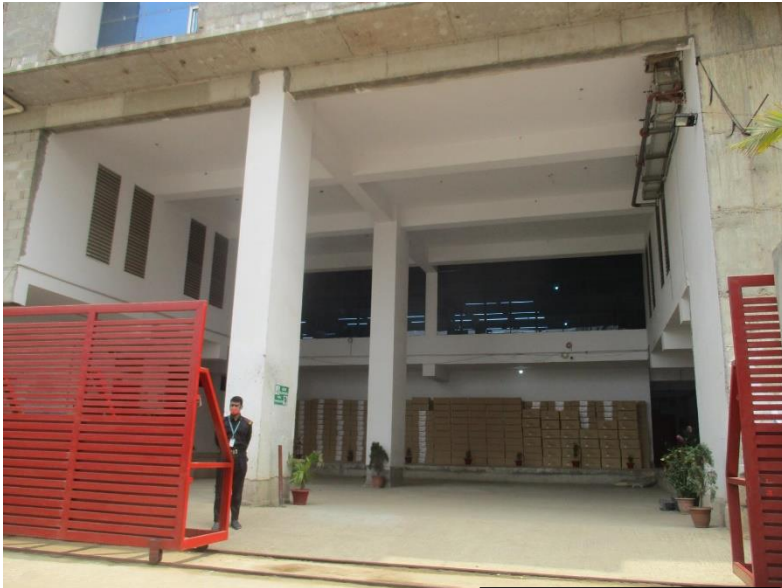
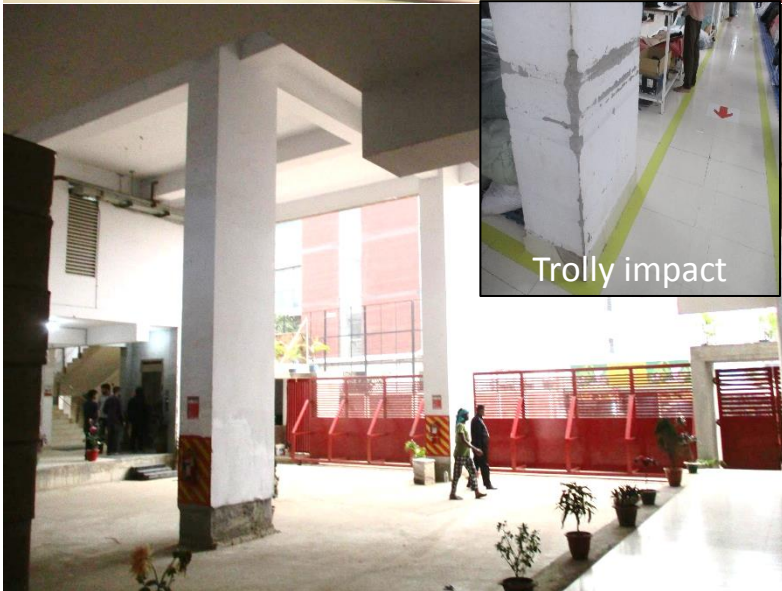
Ground floor column at loading-unloading zone is susceptible to vehicle impact

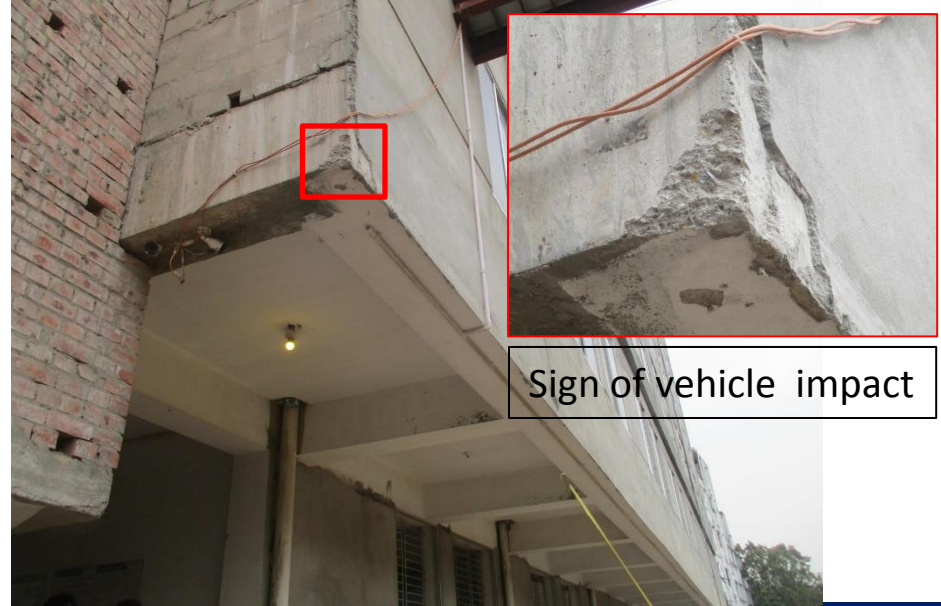
1st floor beam- susceptible to vehicle impact

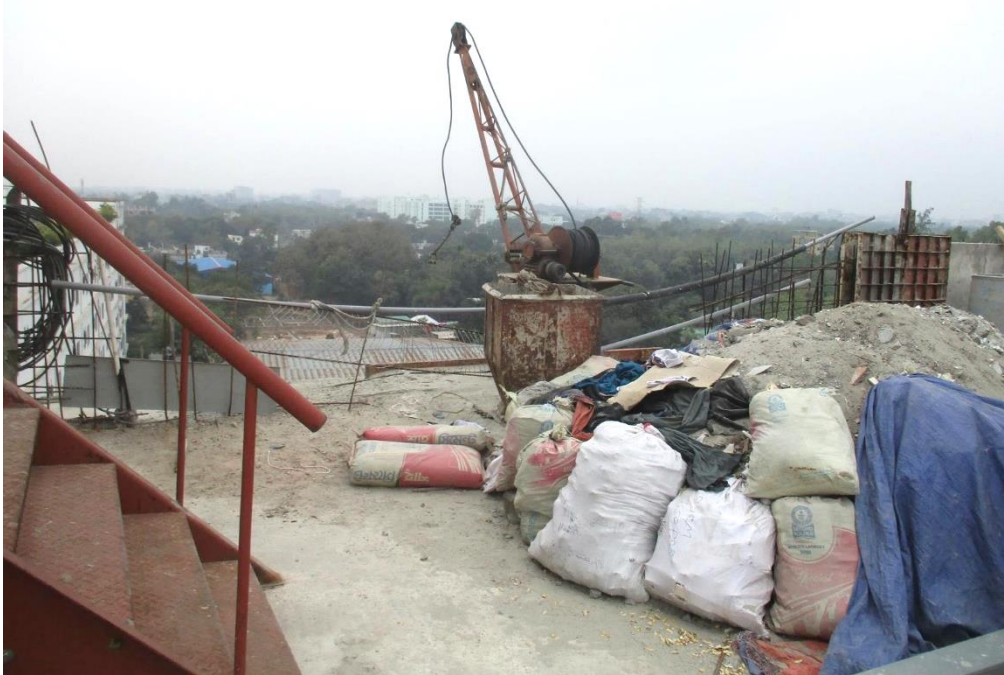
Incomplete parapet wall and construction debris

Falling hazard was observed on the roof due to incomplete parapet wall and hanging steel shutter. The factory is required to provide protection barrier at roof edges. Remove the hanging steel shutter and construction debris from the roof.

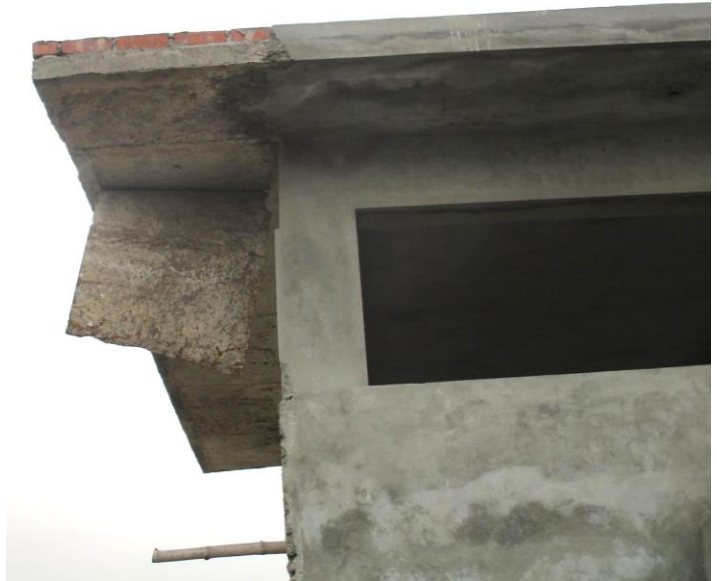
Hanging steel shutter

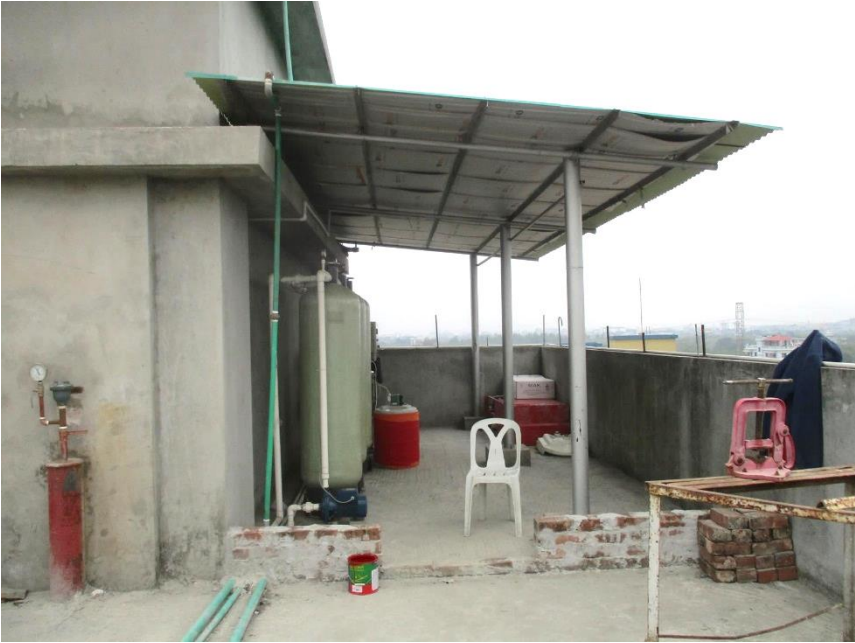
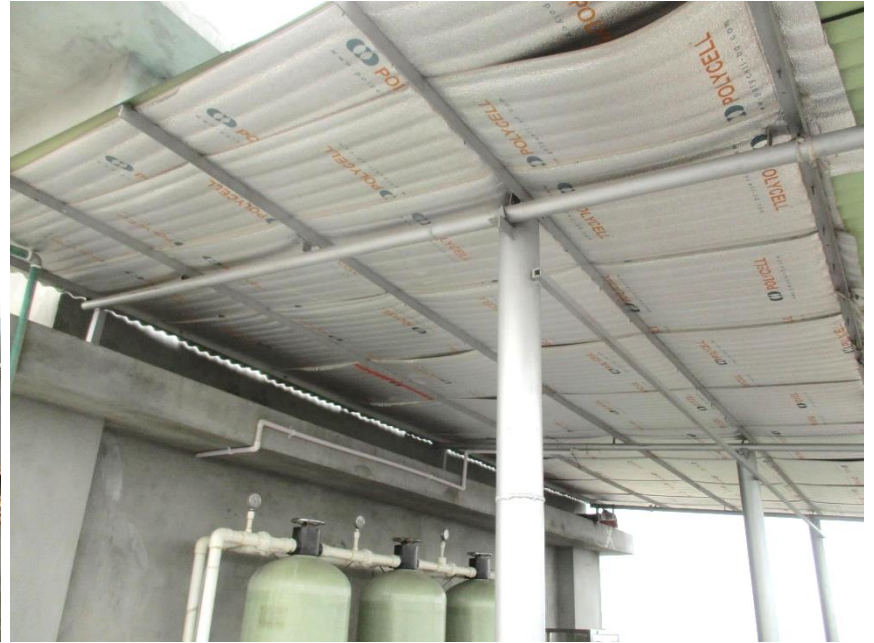
RO shed on the roof

Undocumented RO water treatment plant has been found on roof. The building engineer is required to survey the RO shed and produce as-built documents.

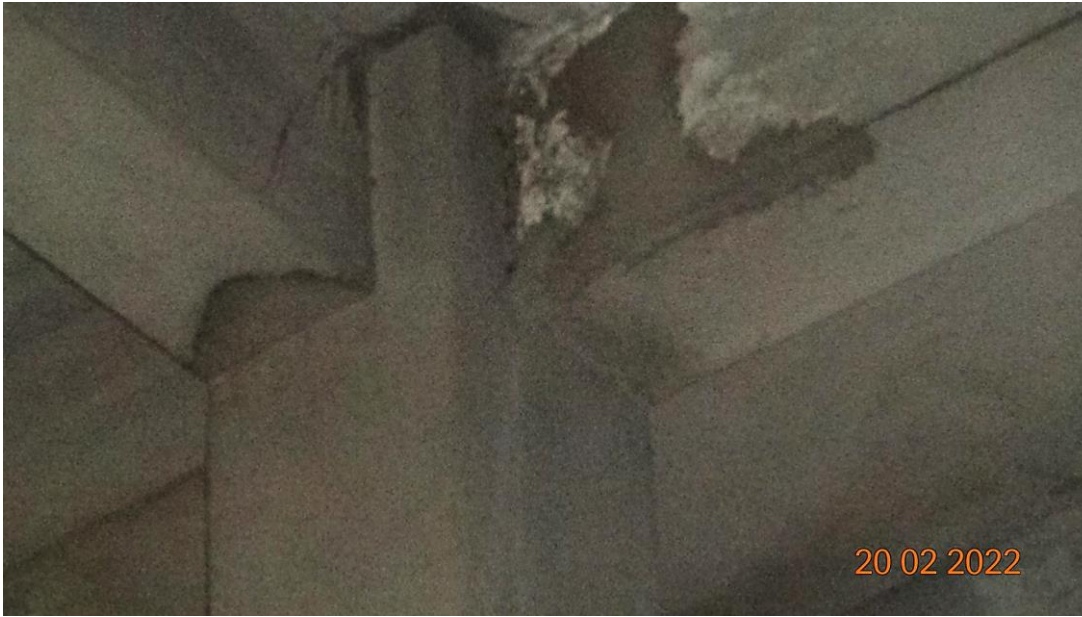
Water intrusion into the slab

Damage due to water intrusion was observed in the roof slab and brick wall. The building engineer is required to identify the location of water intrusions and suggest remedial measures accordingly. Provide water proofing layer on the roof slab with adequate slope. Develop proper water drainage system on the roof.

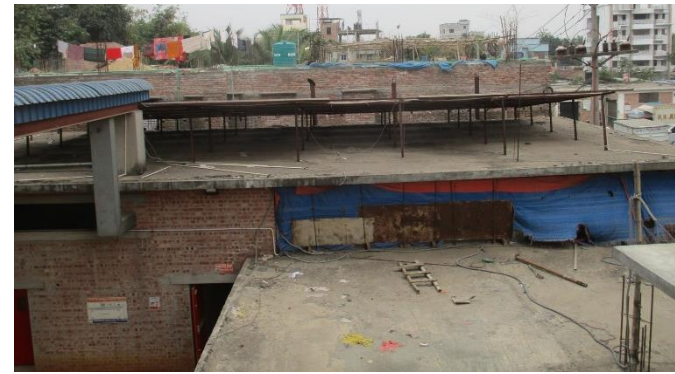
No water proofing layer on the roof

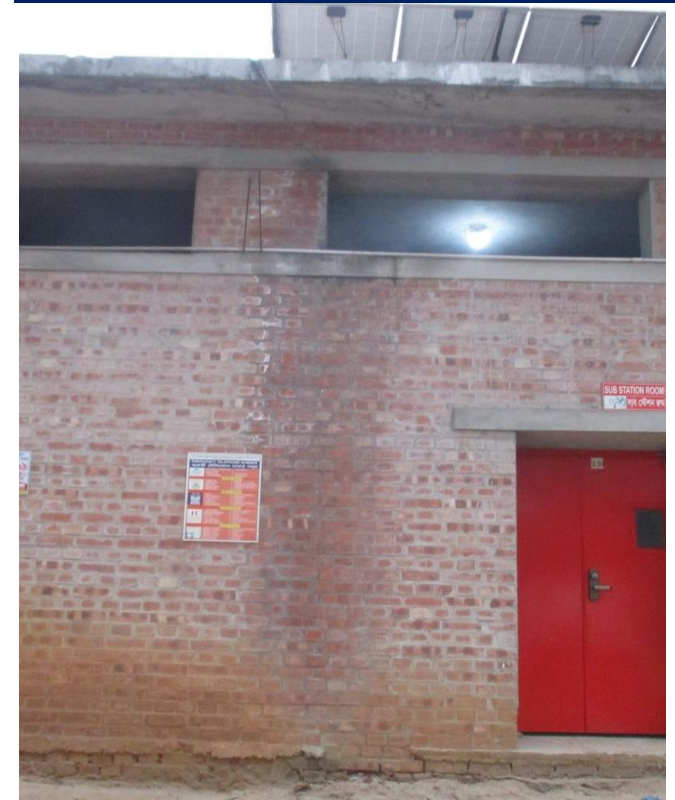
Water intrusion into the brick wall

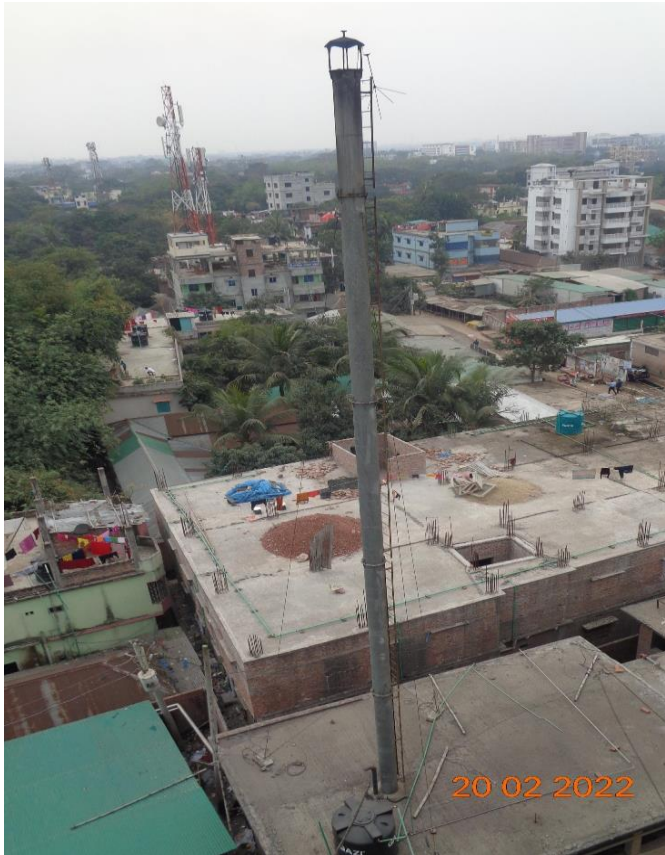
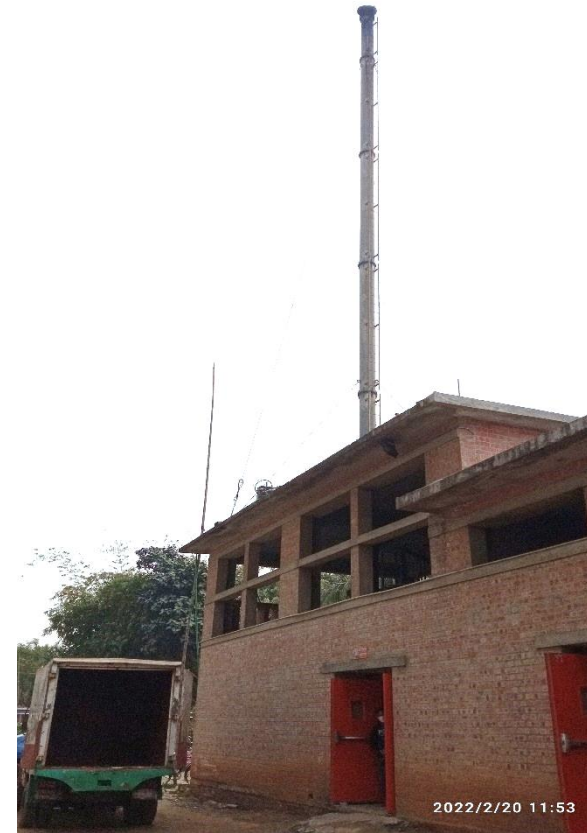
Tall generator chimney

The building engineer is required to check the stability of the chimney and suggest adequate bearing and lateral support system accordingly.

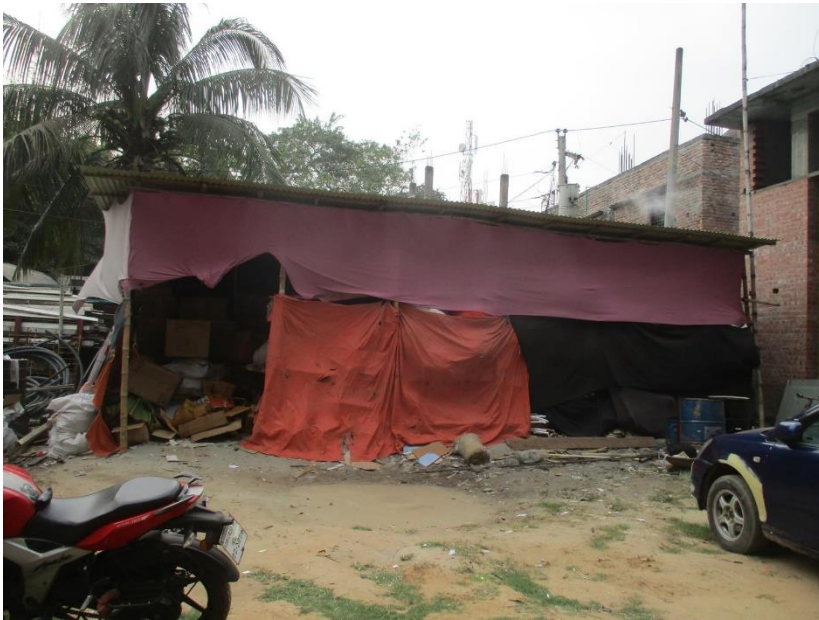
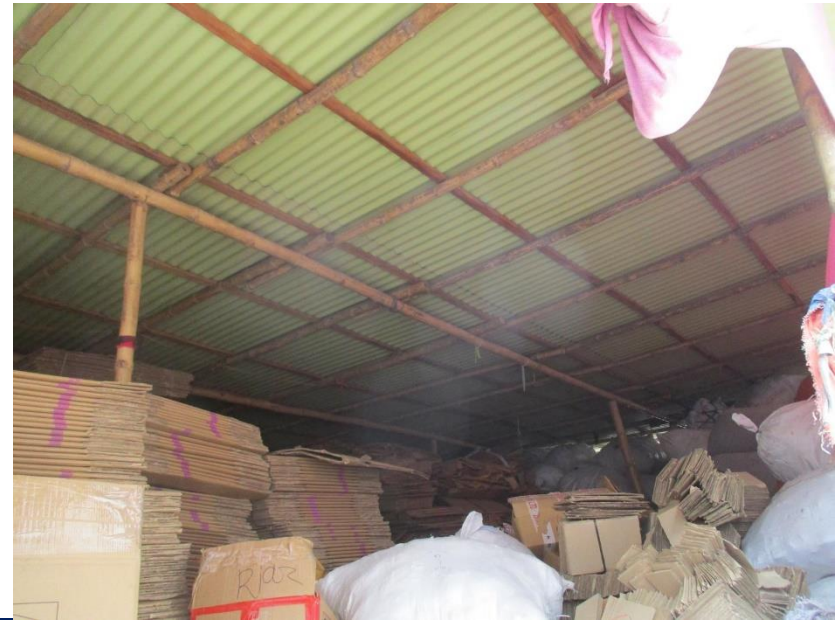
Undocumented temporary wastage shed made by bamboo frame.

The temporary wastage shed is undocumented and non-engineered. The factory is required to demolish the bamboo shed or replace with engineered structure.

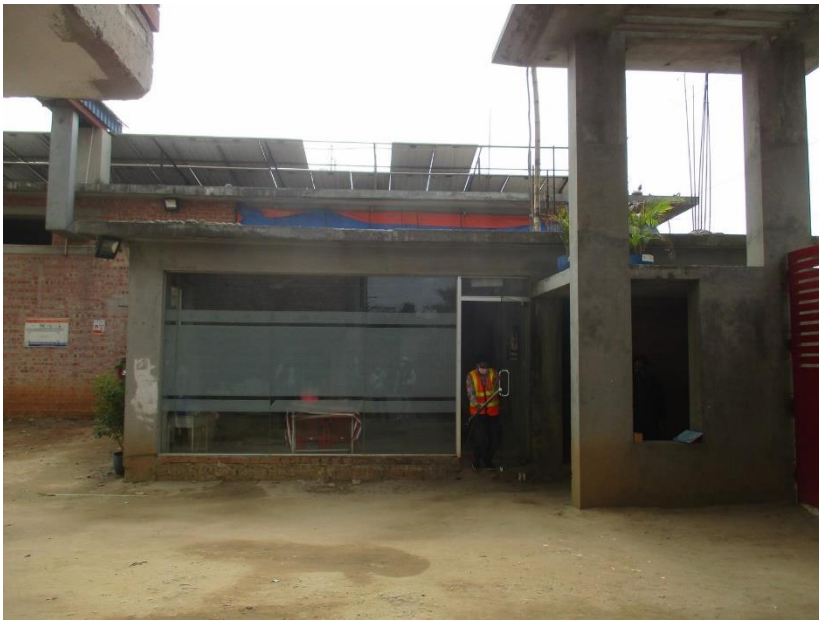
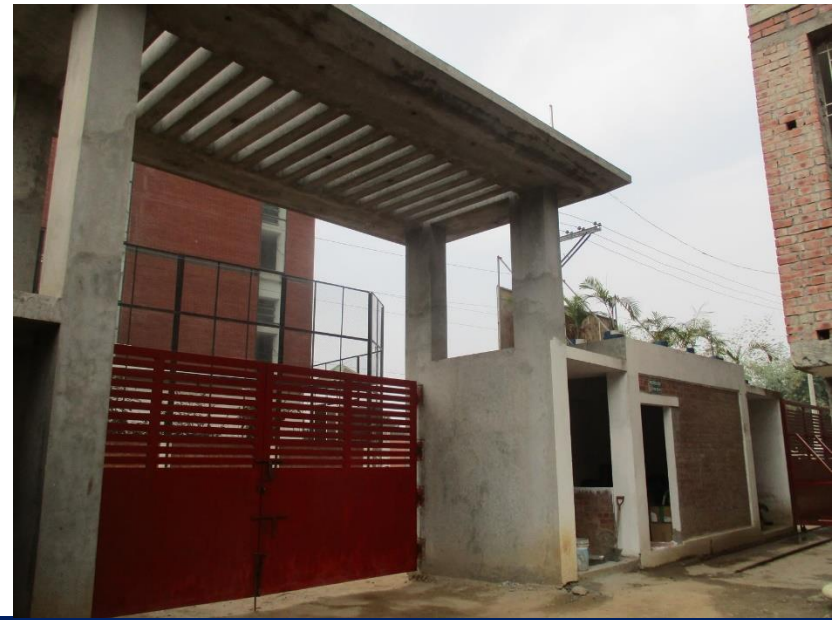
Gate structure is structurally connected with utility building at south and adjacent security room at north.

The structural connection details were not available in the drawings. The building engineer is required to produce detail of structural connections and incorporate in the as-built documents.
