# Liz Knitting & Printing Industry.

Holding-1,Block-C, Shaheed Mosharaf Hossain Road,  
Purbo Chandora, Sofipur, kaliakoir, Gazipur.  
(24.032036 N, 90.270180 E)  
28 February 2022

# Observations

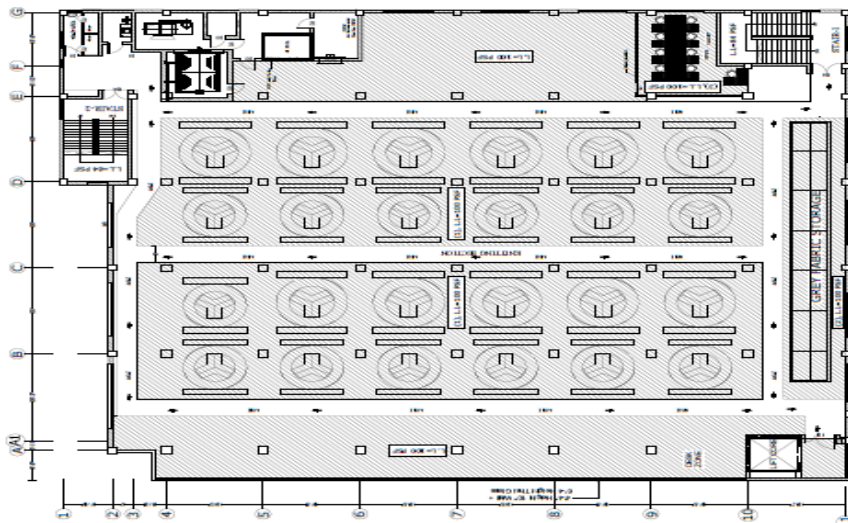
4<sup>th</sup> floor layout plan

Load consideration on 4<sup>th</sup> floor (5 kPa)

Uncontrolled loading on floors

As per BNBC, the minimum floor live load for light storage is 6 kN/m<sup>2</sup> (126 psf). The storage in this building is designed for 5 kN/m<sup>2</sup> live loads. The building engineer is required to check the occupancies and update the floor live loading plan for all floors based on BNBC requirements and manage the floor loading accordingly.

| Item No. | Observation | Recommended Action Plan | Recommended Timeline |
|---|---|---|---|
| 01 | Floor load plan management (Building-2) | The building engineer is required to check the occupancies and update the floor live loading plan for the building based on BNBC loading requirements and capacity of building floor, column & foundations. | 6-weeks |
| 02 | Floor load plan management (Building-2) | Implement the floor loading plan (by posting in each floor level, providing signage and maintaining loadings) | 6-months |

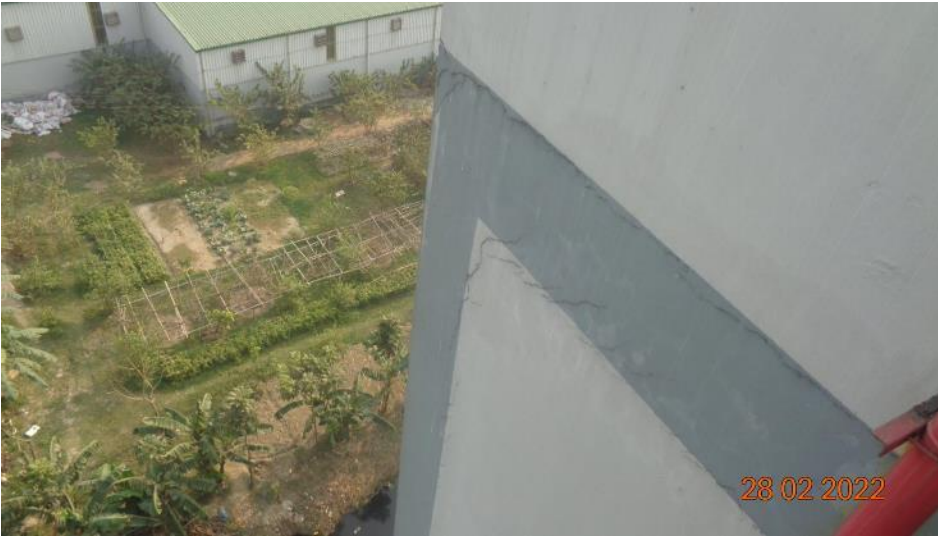
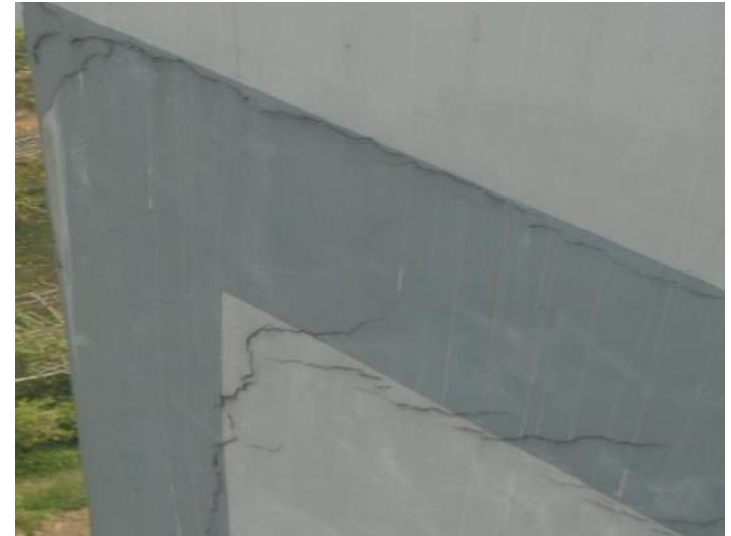
Fig- Crack on façade wall

Crack observed in the several locations of the façade wall and partition wall of the building-2. Factory Engineer is required to investigate the crack in the brick wall and carry out remedial measure as per investigation report.

| Item No. | Observation | Recommended Action Plan | Recommended Timeline |
|---|---|---|---|
| 03 | Crack found in the façade wall and brick wall (Building-2) | The building engineer is required to investigate the crack in the brick wall and carry out remedial measure as per investigation report. | 6-weeks |

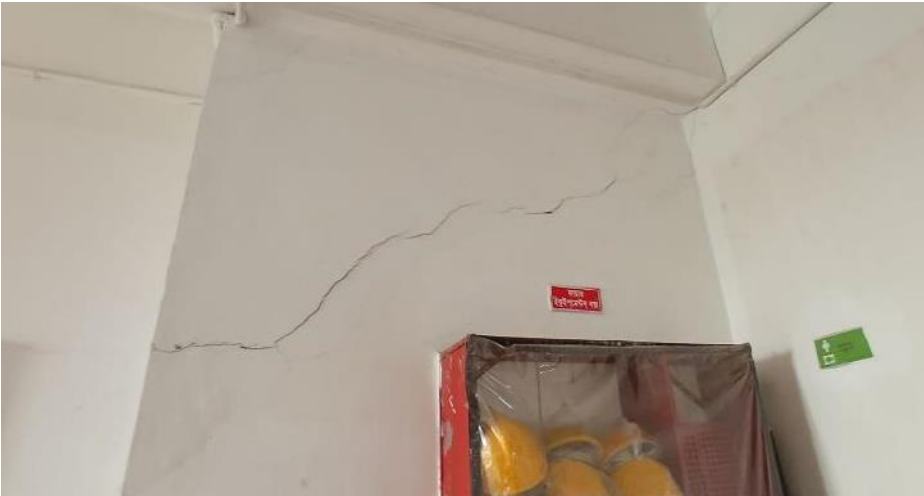
Fig- Crack on the brick wall

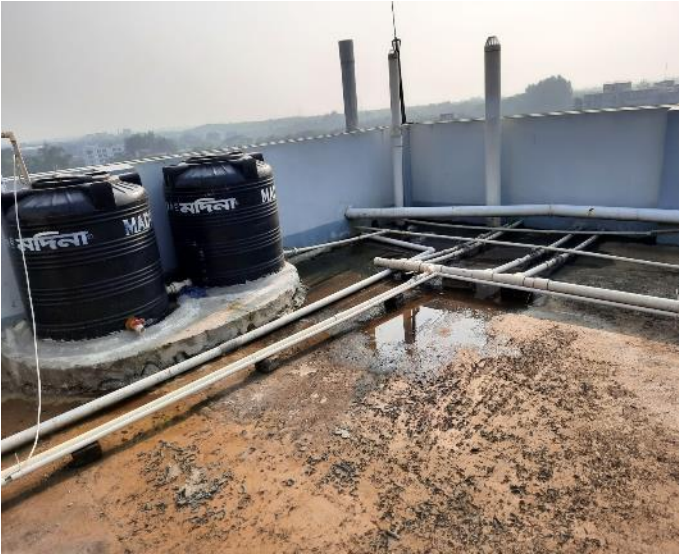
Water ponding on the roof slab

Standing water observed on the roof of the building-2 due to lack of proper sloping. The building engineer is required to provide proper sloping and clear all kinds of obstacles near the outlet of drainage pipe to wash out the storm water properly.

| Item No. | Observation | Recommended Action Plan | Recommended Timeline |
|---|---|---|---|
| 04 | Water ponding on the roof (Building-2) | The building engineer is required to improve the roof drainage system with adequate slope and clear all kinds of obstacles near the outlet of drainage pipe. | 6-months |

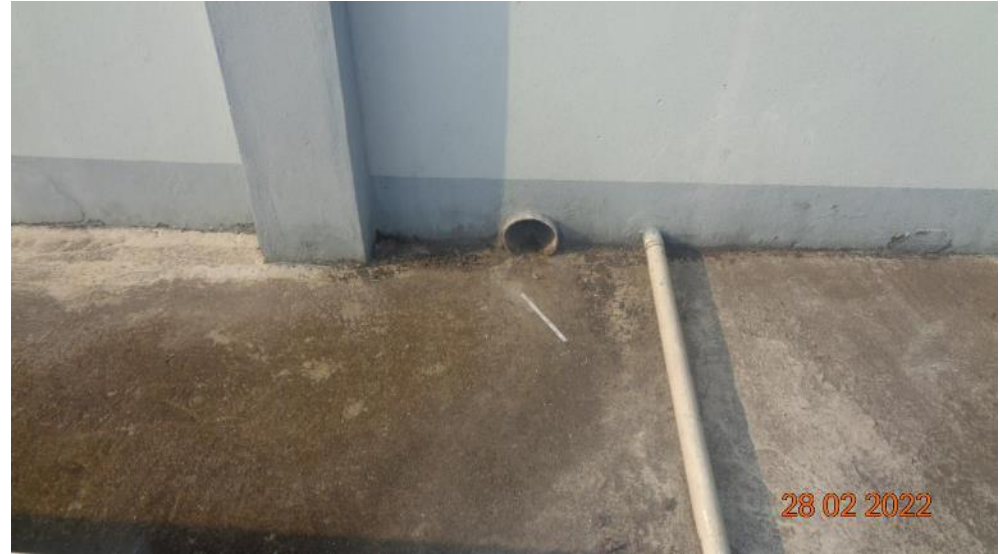
Signage of water ponding due to lack of proper sloping

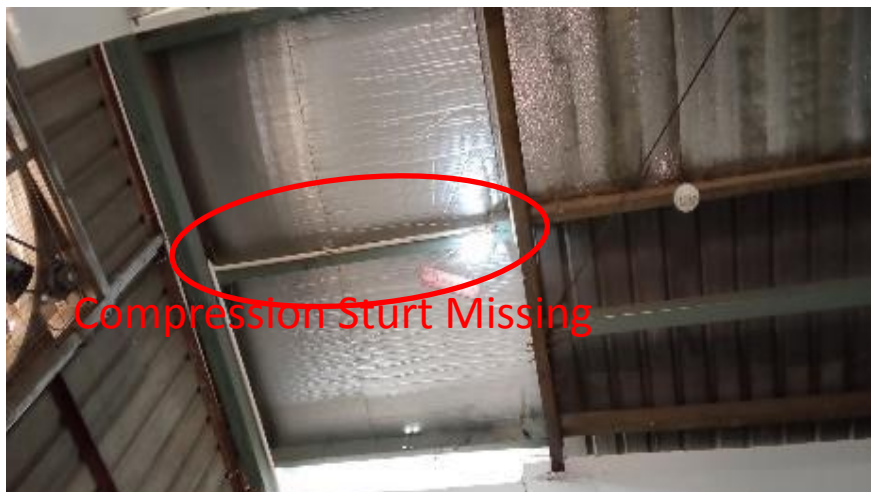
Compression Strut Missing

Missing compression strut on roof

The building engineer is required to check the stability of the structure. Also take proper remedial action where required.

| Item No. | Observation | Recommended Action Plan | Recommended Timeline |
|---|---|---|---|
| 05 | Lack of lateral load transfer media (Shed-1) | The factory engineer is required to check the stability system of the structure and suggest the remedial actions accordingly. | 6-weeks |
| 06 | Lack of lateral load transfer media (Shed-1) | Carry out remedial works where necessary. | 6-months |

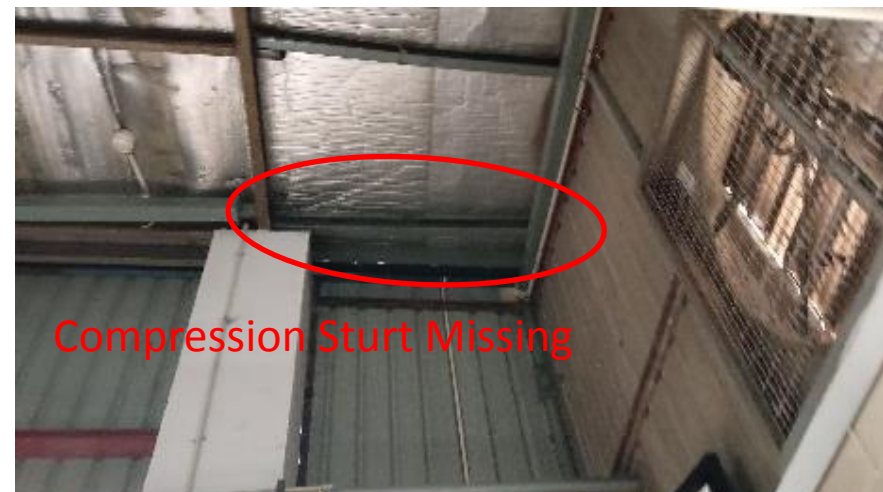
Compression Strut Missing

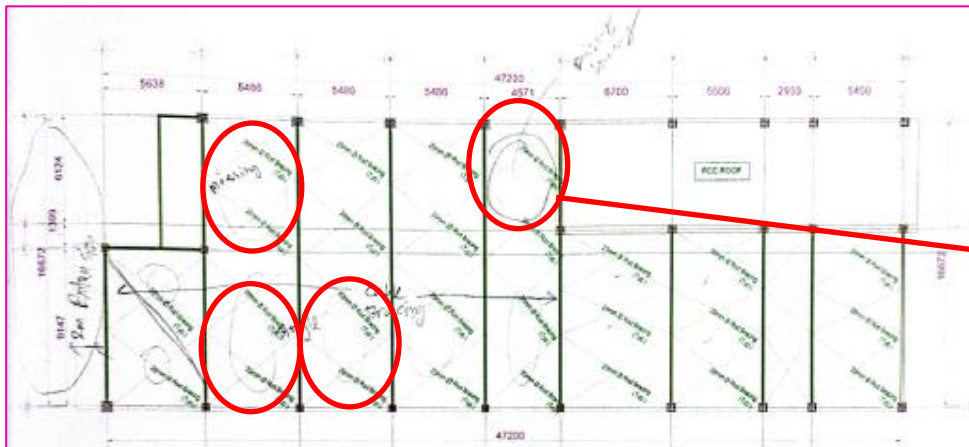
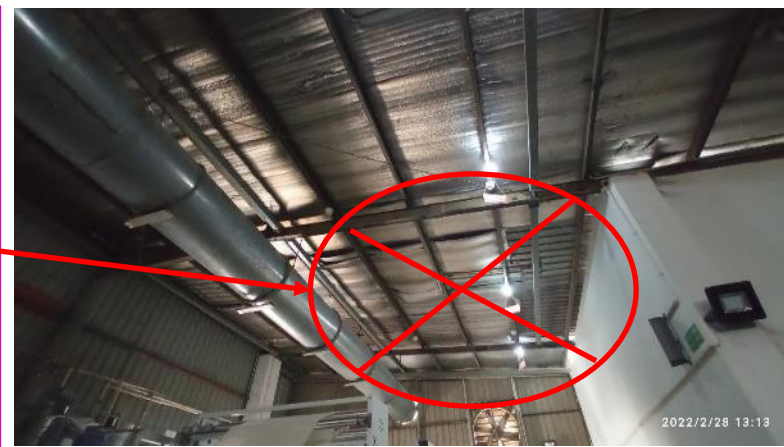
Missing bracing at roof

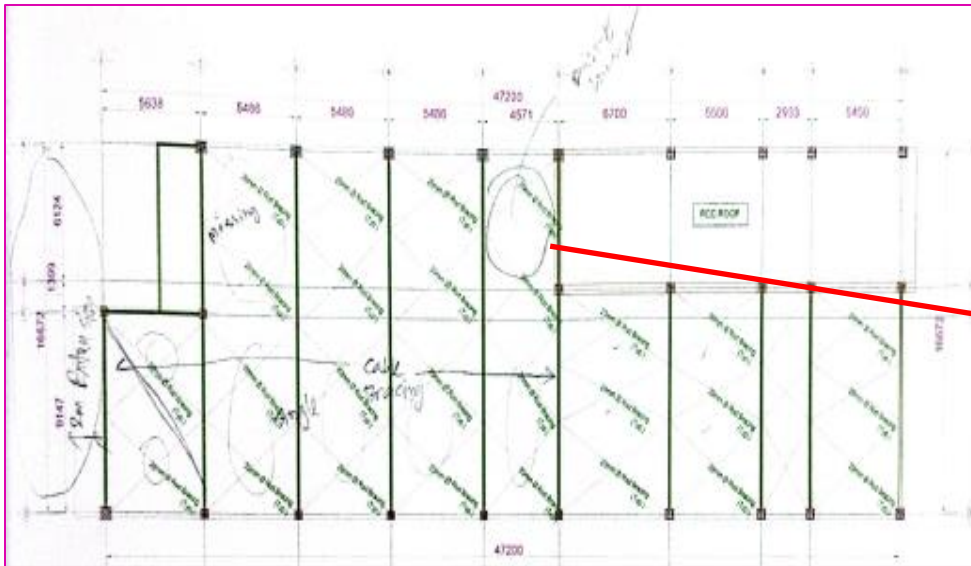
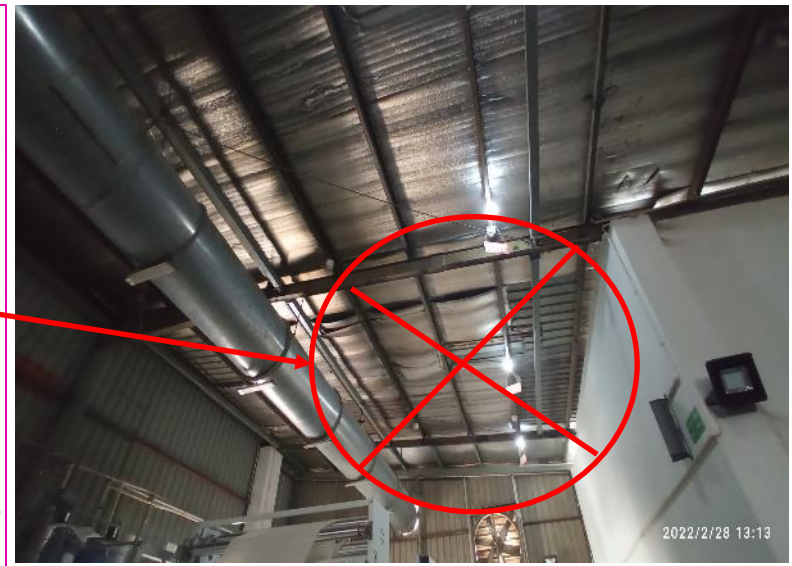
Missing bracing at roof

Missing bracing & undocumented extension of shed has been found on south side of the structure. The building engineer is required to survey the structure and produce accurate as built drawings.

| Item No. | Observation | Recommended Action Plan | Recommended Timeline |
|---|---|---|---|
| 07 | Discrepancies between drawings and as-built condition (Shed-1) | The building engineer is required to survey the structure and produce accurate as built drawings. | 6-weeks |

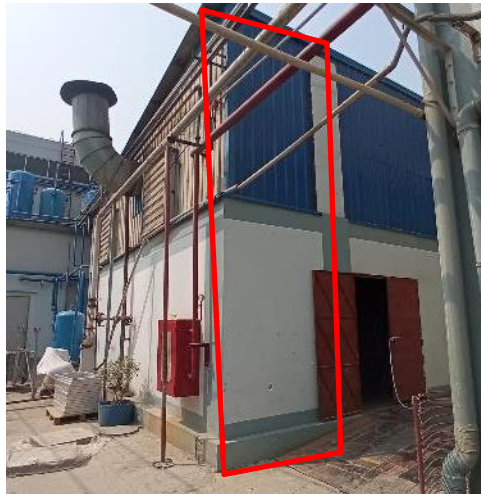
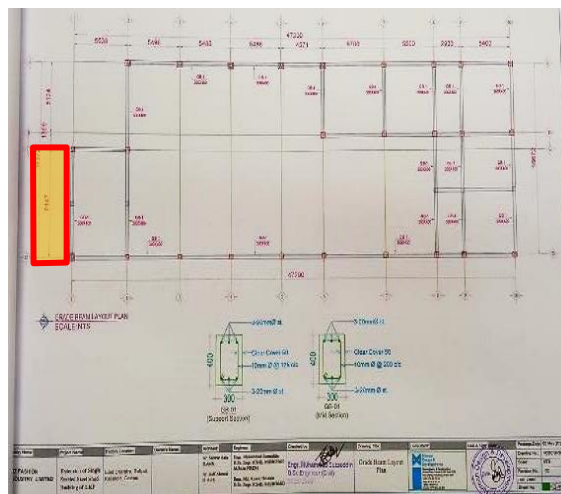
Undocumented extension

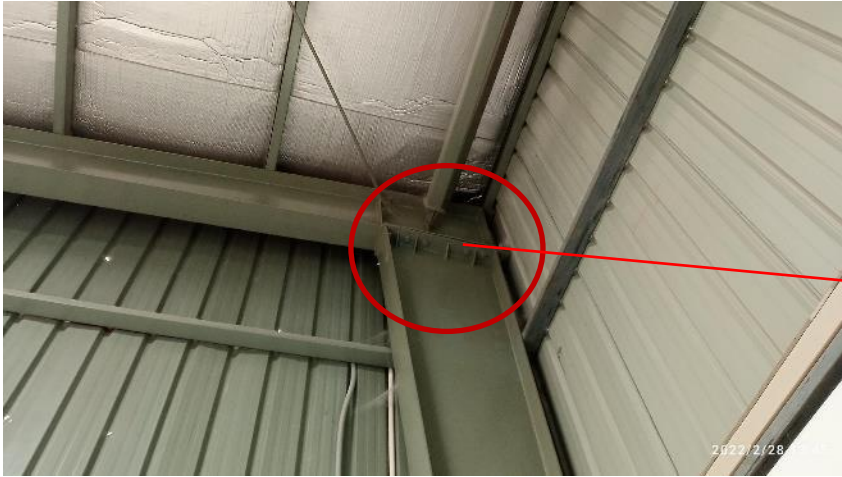
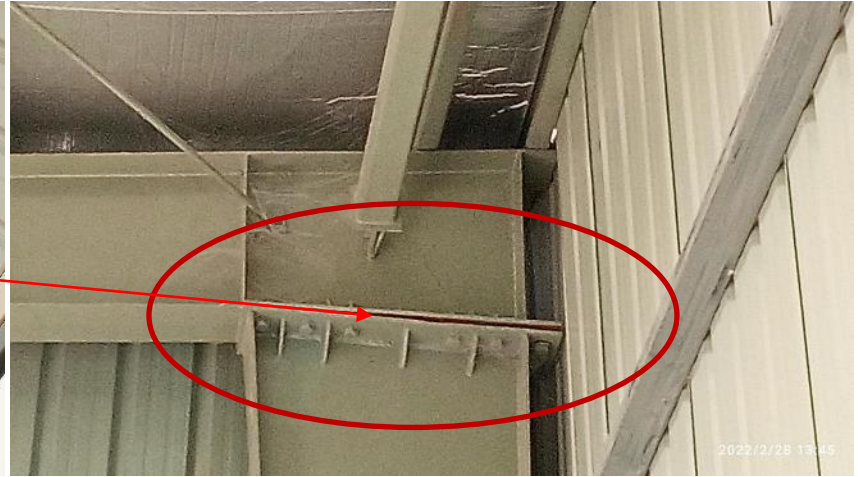
Gaps between connection plates

Missing bolts and connection gaps in several locations were observed. The building is required check the structure to identify the missing bolts & connection gaps and take necessary actions as per the engineer's suggestion.

| Item No. | Observation | Recommended Action Plan | Recommended Timeline |
|---|---|---|---|
| 08 | Significant gaps in connection & bolt missing (Shed-1) | The building is required check the structure to identify the missing bolts & connection gaps and take necessary actions as per the engineer's suggestion. | 6-weeks |

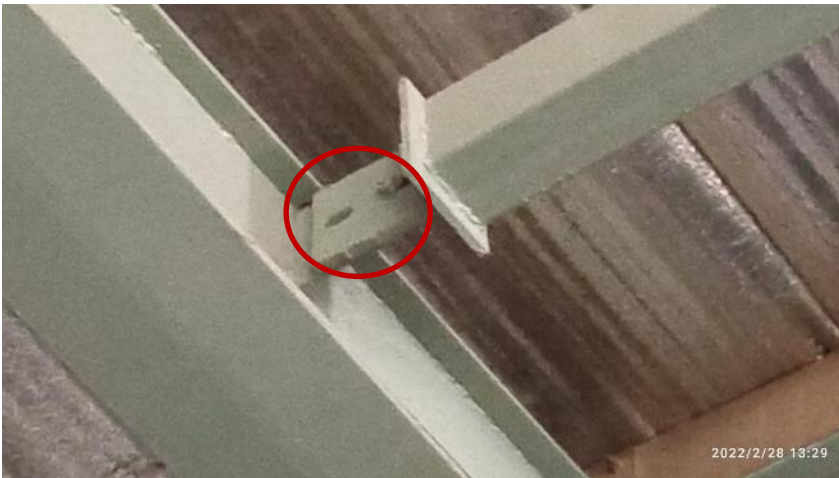
Missing bolts

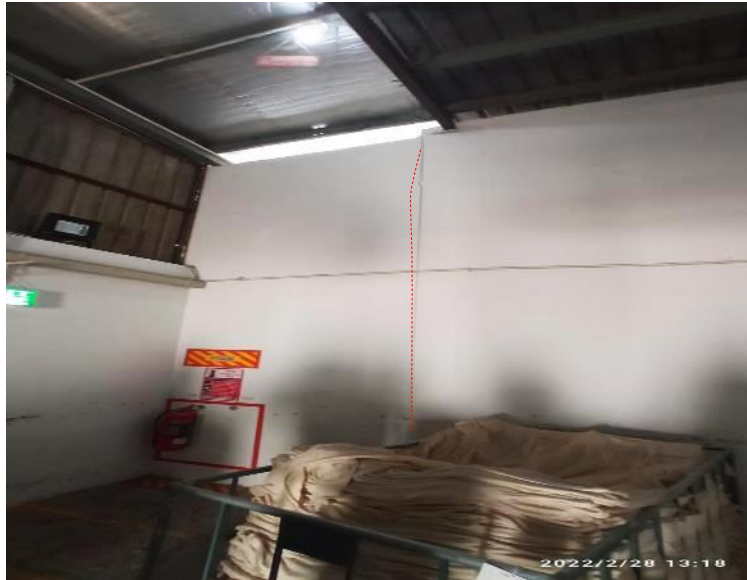
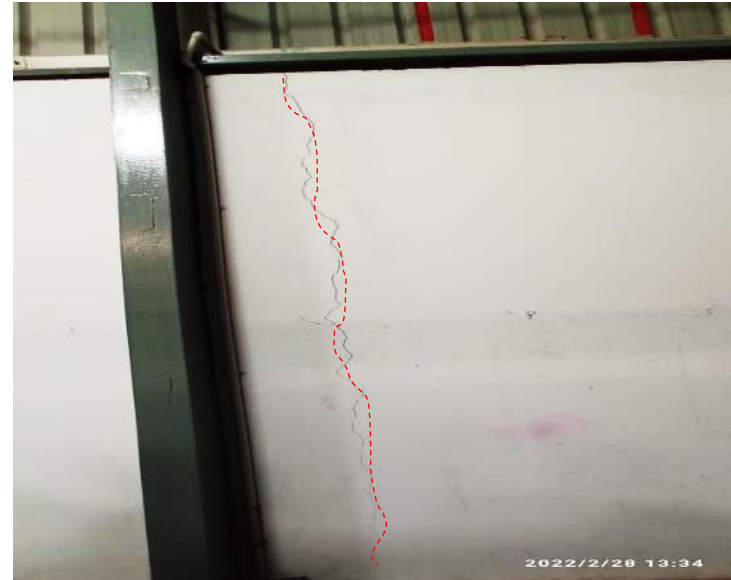
Crack on the brick wall

Crack on the brick wall found in the several locations of the shed-1. The building engineer is required to investigate the crack in the brick wall and carry out remedial measure as per investigation report.

| Item No. | Observation | Recommended Action Plan | Recommended Timeline |
|---|---|---|---|
| 09 | Crack found on the brick wall (Shed-1) | The building engineer is required to investigate the crack in the brick wall and carry out remedial measure as per investigation report. | 6-weeks |
