# **FIRE SAFETY INSPECTION REPORT**

**WELDONE APPAREL LTD**  
**BARAIDRCHALAE, SREEPUR, GAZIPUR**

**ACCORD**  
on Fire and Building Safety in Bangladesh

June 1, 2014

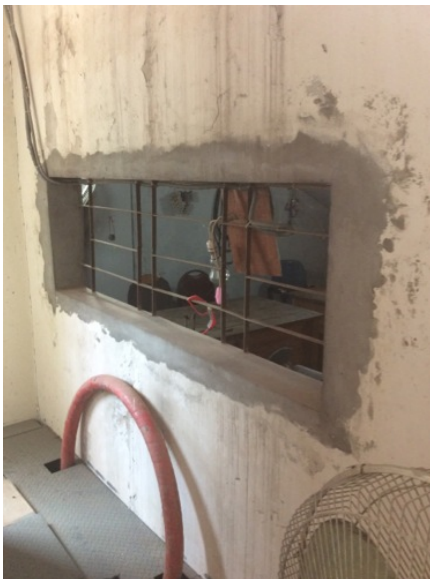
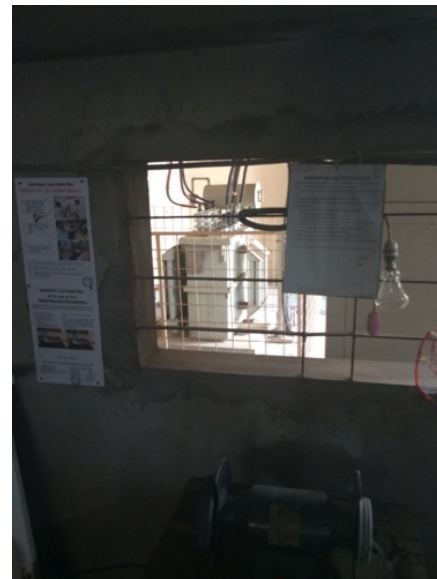
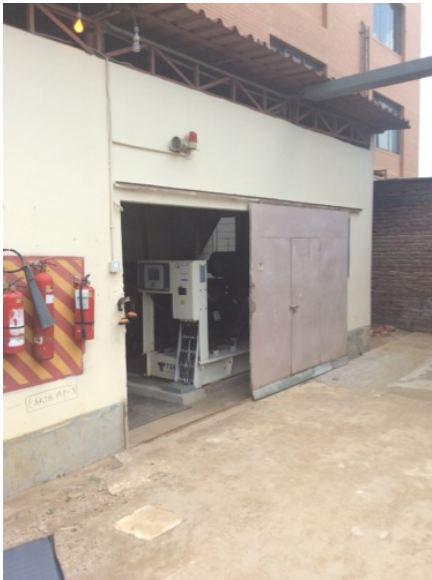
| No. | Category | Finding | Recommendation | Remediation Timeframe |
|---|---|---|---|---|
| F-1 | Fire Rated Construction | The boiler, generator and transformer room is not separated by fire-rated construction. Openings, non-rated doors and penetrations all noted between partition walling and non fire rated door assemblies. | Separate the boiler, generator and transformer room by a minimum 2-hr fire-rated construction. Seal all unprotected openings to maintain the required fire separations. | Within 3 months |

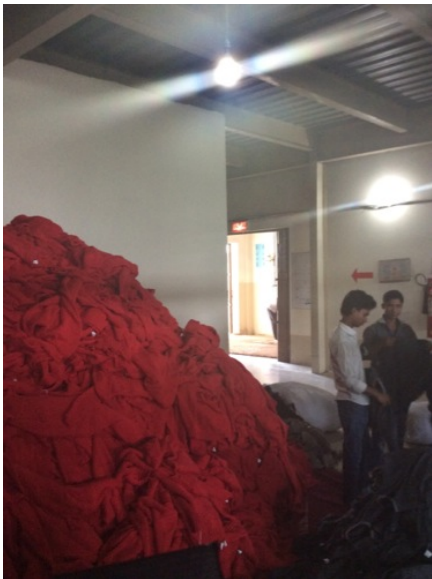
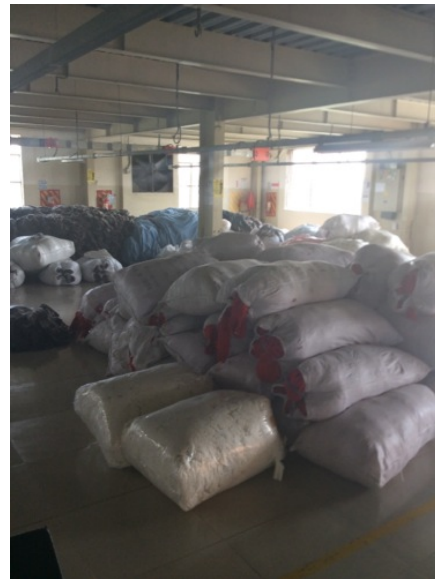
| F-2 | Fire Rated Construction | Areas used for combustible storage are not separated by fire-rated construction on the ground and first floor. | Provide dedicated storage rooms separated by minimum 1-hr fire-rated construction. | Within 3 months |

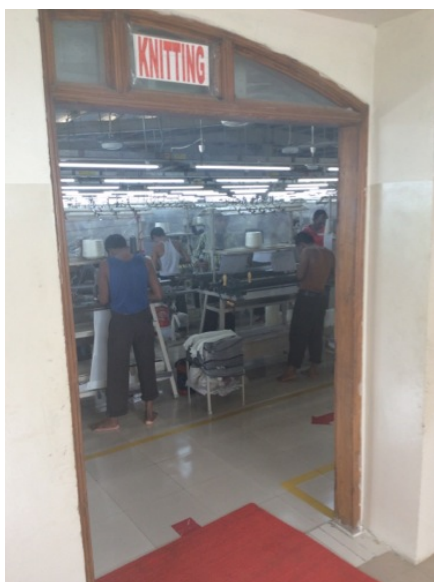
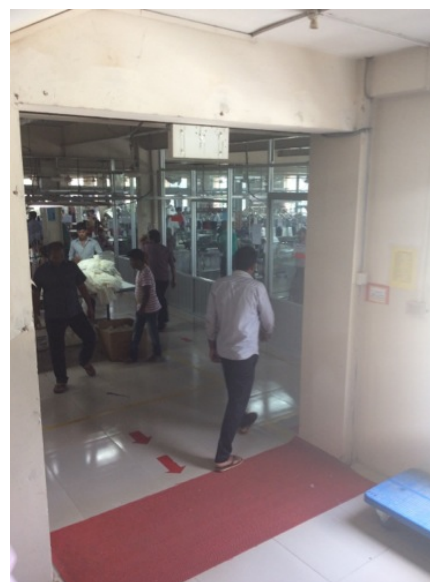
| F-3 | Fire Rated Construction | The exit stairs are not separated from work areas on each floor by fire-rated construction through out the factory building. | Provide minimum 1.5-hr fire rated doors and seal all unprotected openings to separate the exit stairs from work areas and other building spaces on all floor levels. Ensure that the fire doors are self-closing and positive latching and that they are provided with fire exit (panic) hardware where serving production floors. | Within 3 months |

If fire doors are required to be held open for functional reasons, provide automatic-closing devices tied to the fire alarm system.

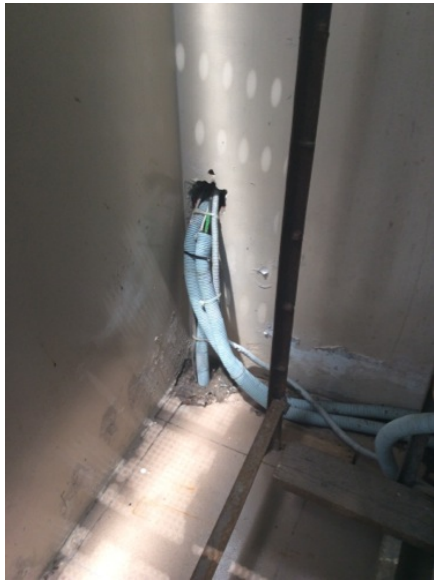
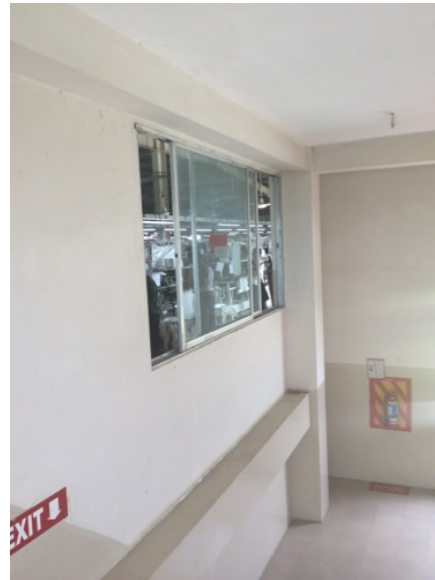
| F-4 | Fire Rated Construction | Unsealed penetrations and openings are located in the South exit stair enclosure. | Seal all penetrations and openings in exit stair enclosure walls to maintain the fire separation. | Within 3 months |

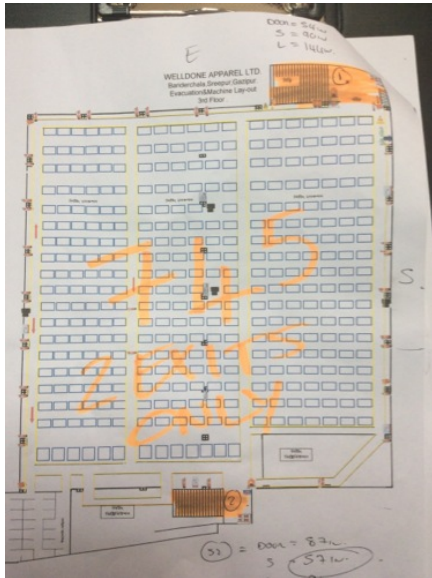
| F-5 | Egress | Exit capacity is not adequate for the occupant load on the second and third floors due to the number of employees being 500 and 745, as the building has 2 exits the maximum on this floor must be 490 due to the egress capacity measurements of each stairwell. | Reduce occupant load to not more than available exit capacity of 490 on the second and third floors.<br><br>In the future provide additional exits to allow for increased number of employees. | Immediate |

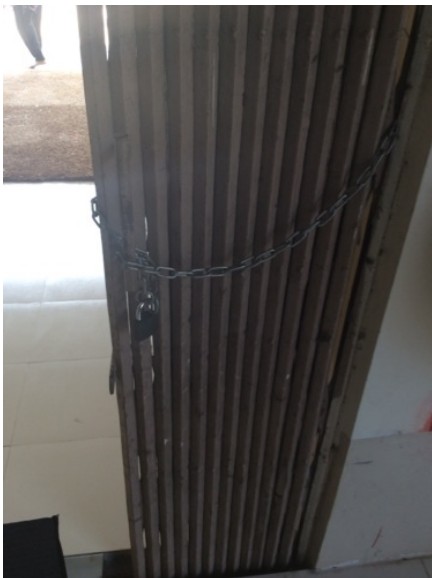
| F-6 | Egress | Egress doors and gates with locking features are provided at building exits. All gates/doors were open and unlocked during the inspection. | Remove locking features from all egress doors / gates.<br><br>If locks are required for security reasons, utilize special door locking features complying with NFPA 101. | Immediate |

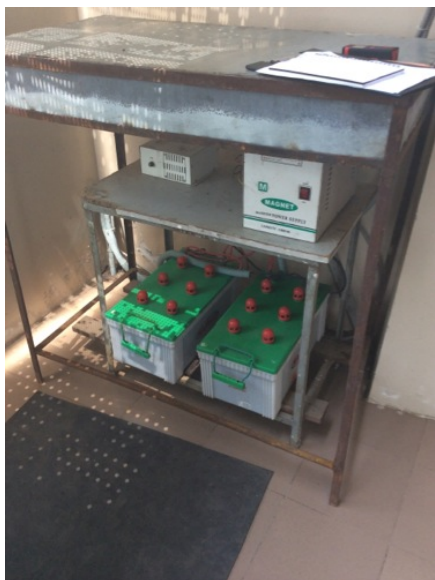
| F-7 | Egress | IPS system was located in the South exit stair. | Remove all storage from exit stairs and egress paths. | Immediate |

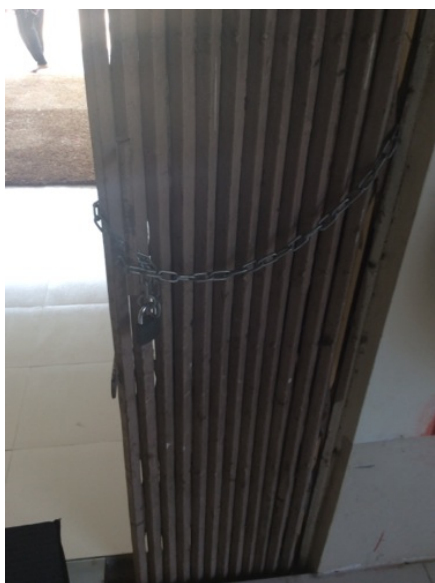
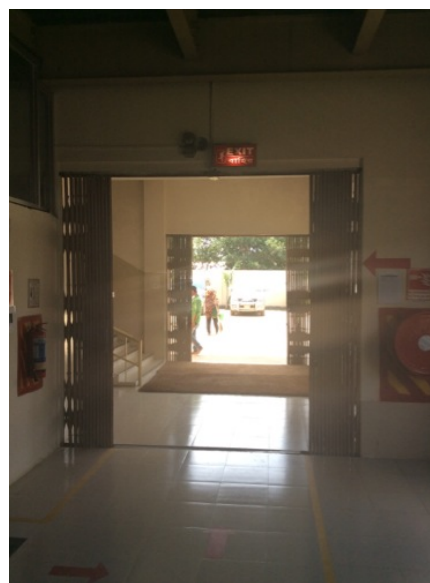
| F-8 | Egress | Collapsible gates and sliding doors are provided at both main building exits. | Replace all gates / sliding doors along the means of egress with side-hinged, swinging egress doors. | Within 1 month |

| | | | If locks are required for security reasons, utilize special door locking features complying with NFPA 101. | |

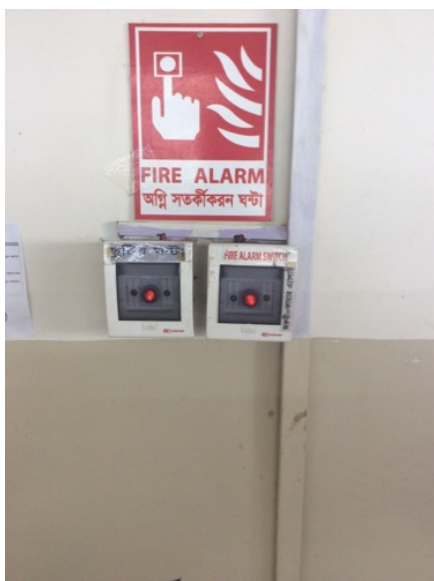
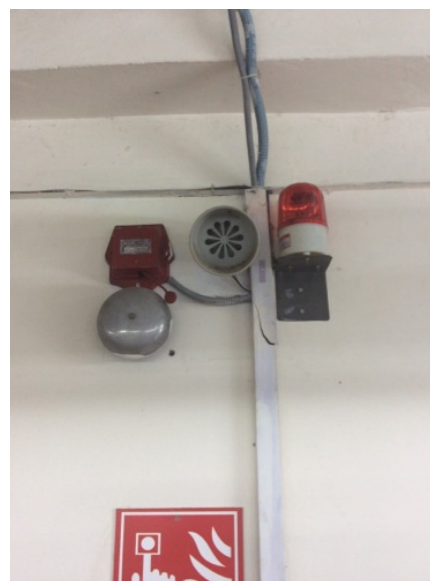
| F-9 | Fire Protection | The fire alarm system is antiquated, not a listed system, and does not provide alarm and notification features consistent with acceptable standards. | Replace the fire alarm system with a new, listed addressable fire alarm system in accordance with NFPA 72. | Design within 4 months, install within 9 months |

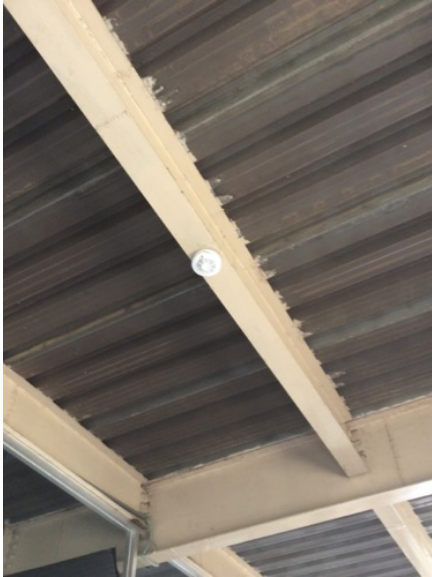
| F-11 | Fire Protection | The building is equipped with single-station smoke alarms. Smoke alarm activation sounds only a local alarm and does not provide automatic fire alarm notification of occupants. | Remove single-station smoke alarms. Provide automatic smoke detection throughout the building in accordance with NFPA 72. | Within 6 months |

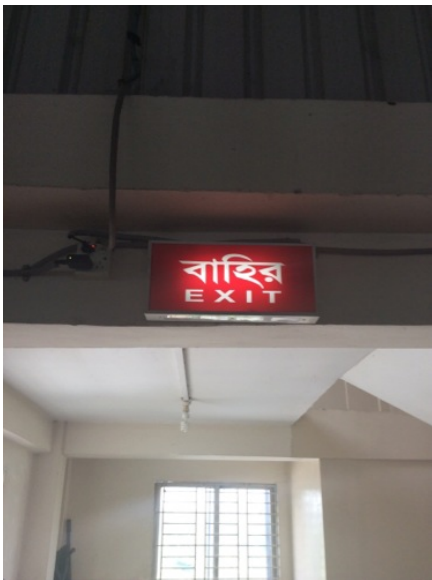
| F-12 | Egress Lighting | Manual on-off switch is provided for exit signage units, throughout the factory building | Remove manual on/off switches from exit signage units to prevent them from being switched off. | Within 1 month |
