# PURBANI FASHION LIMITED

## (New Building)

Kamarpara, Shernagar, Belkuchi, Sirajgong.  
(24.282920, 89.688431)  
15<sup>th</sup> March 2022

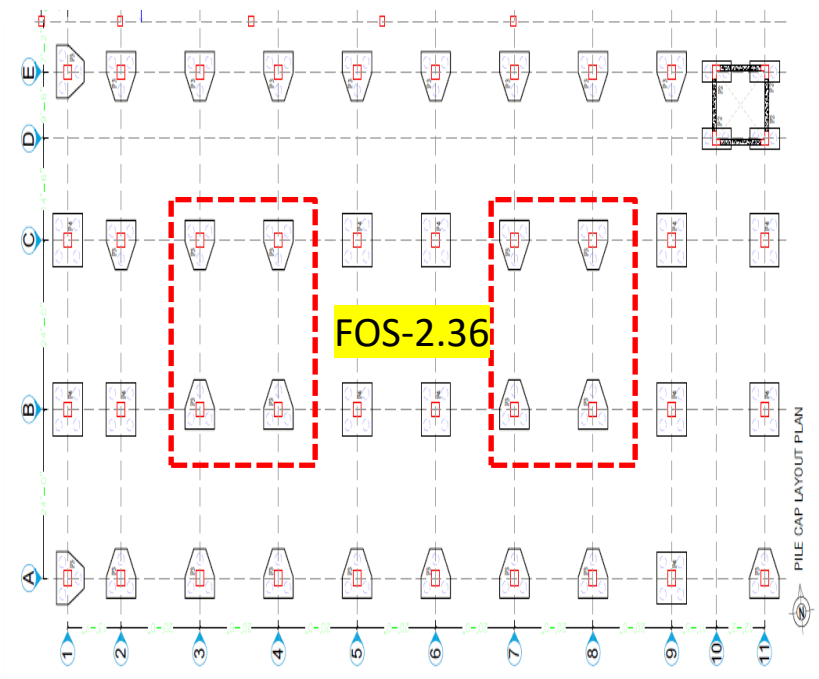
Foundation layout plan

**Foundation stress marginally exceeds the normal design limit**

Foundation Check in DEA report

Cursory calculation indicates that the foundation stress marginally exceeds normal design limit for central column considering prepared live load plan and bearing capacity of foundation as per soil test report. Building engineer is required to review the design, load and foundation capacity.

| Item No. | Observation | Recommended Action Plan | Recommended Timeline |
|---|---|---|---|
| 01 | Foundation stress marginally exceeds the normal design limit. (Production building) | Building engineer is required to review the design, load and foundation capacity. | 6-weeks |
| 02 | Foundation stress marginally exceeds the normal design limit. (Production building) | Produce and actively manage a loading plan for all floor plates within the factory considering floor, column and foundation capacity. | 6-weeks |
| 03 | Foundation stress marginally exceeds the normal design limit. (Production building) | Carry out remedial works where required. | 6-months |
| 04 | Foundation stress marginally exceeds the normal design limit. (Production building) | Continue to implement floor loading plan. | 6-months |

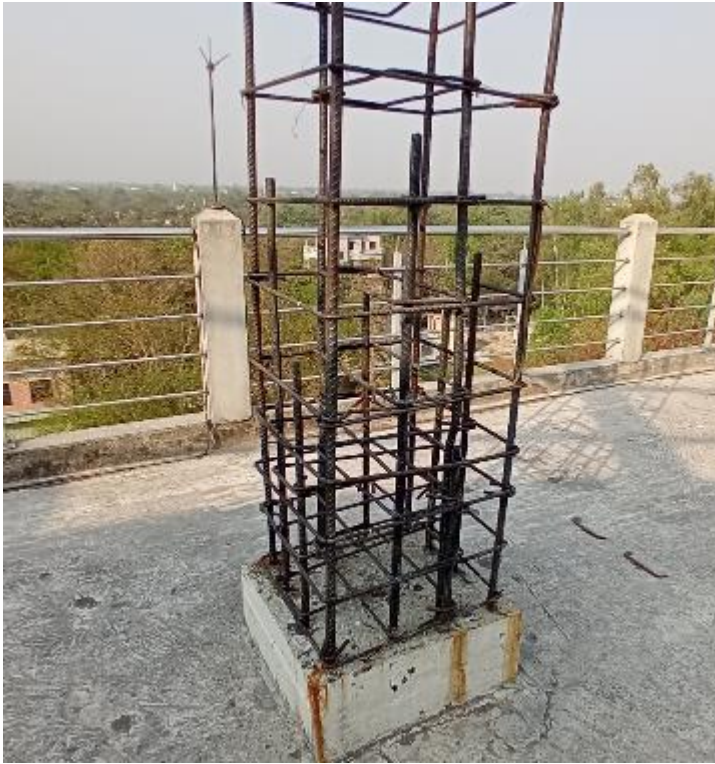
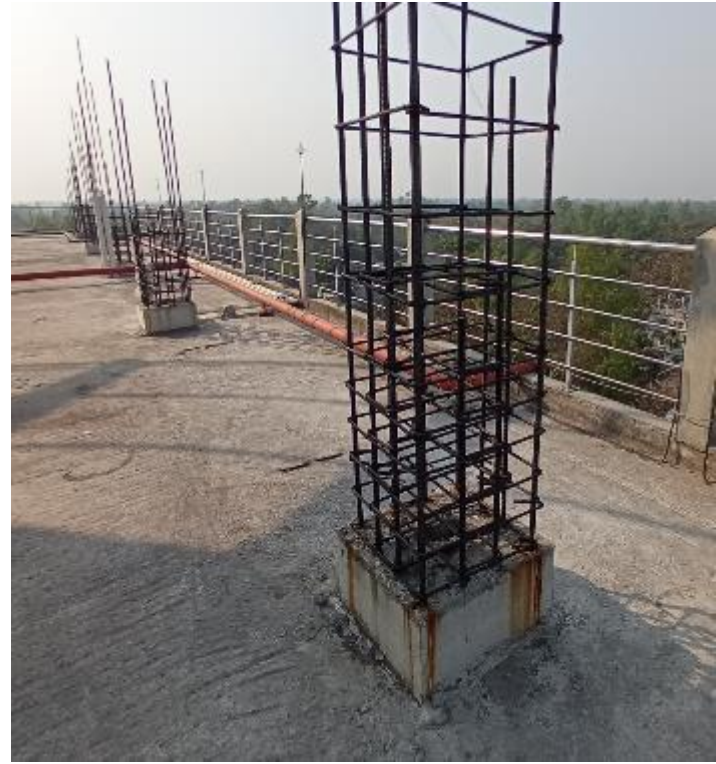
**Exposed rebar at roof**

Corroded exposed rebar at roof

Building engineer is required to remove the corrosion from the rebar and provide suitable coating to protect it from further corrosion.

| Item No. | Observation | Recommended Action Plan | Recommended Timeline |
|---|---|---|---|
| 05 | Exposed rebar at roof. (Production Building) | Building engineer is required to remove the corrosion from the rebar and provide suitable coating to protect it from further corrosion. | 6-weeks |

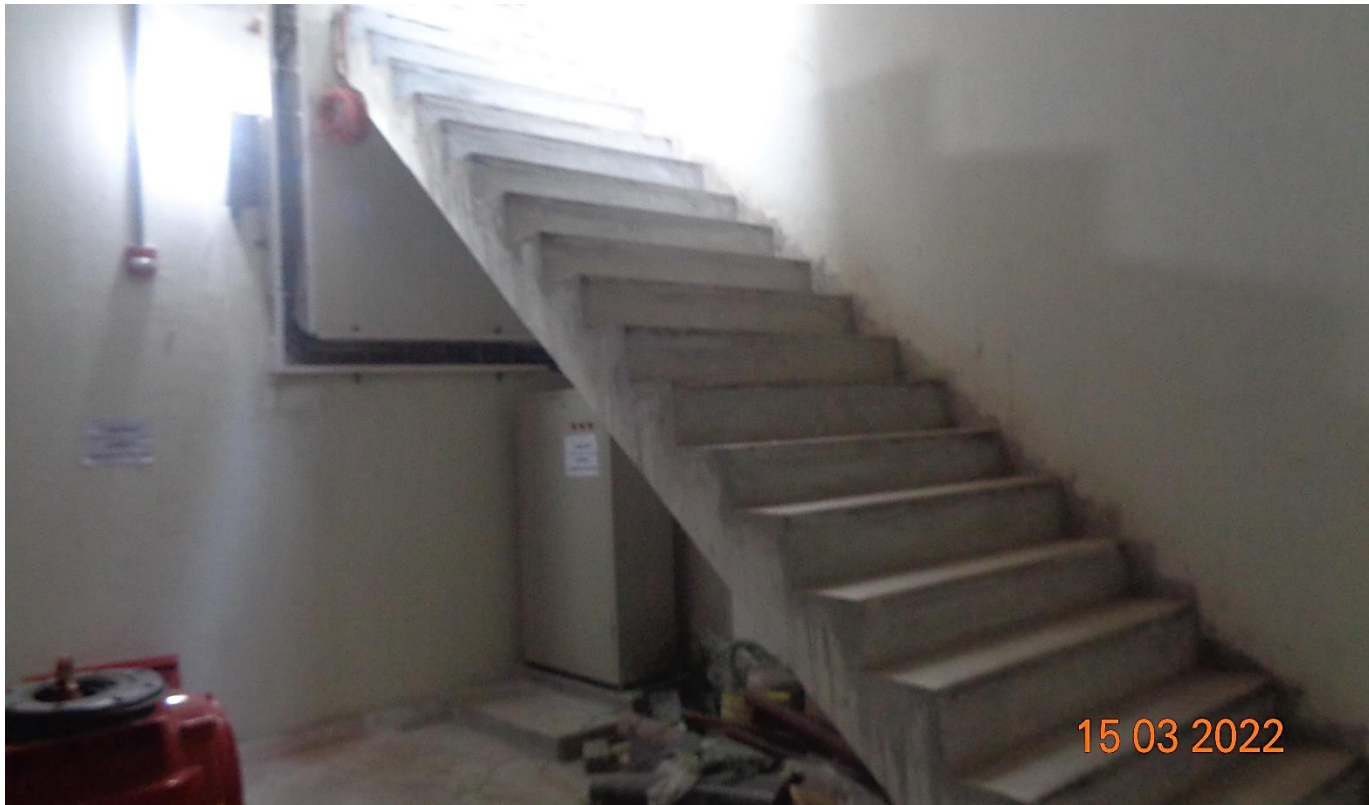
# **Falling hazard at pump room stair**

Falling hazard at pump room stair

Building engineer is required to provide protection barrier at stair edges.

| Item No. | Observation | Recommended Action Plan | Recommended Timeline |
|---|---|---|---|
| 06 | Falling hazard at pump room stair: (Utility Building) | Provide protection barrier at stair edges. | 6-weeks |

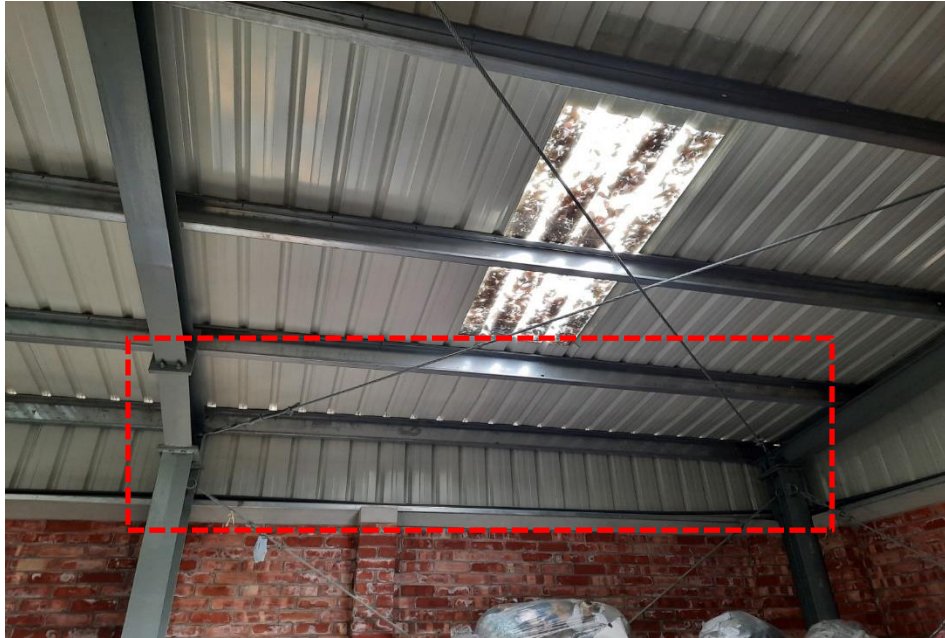
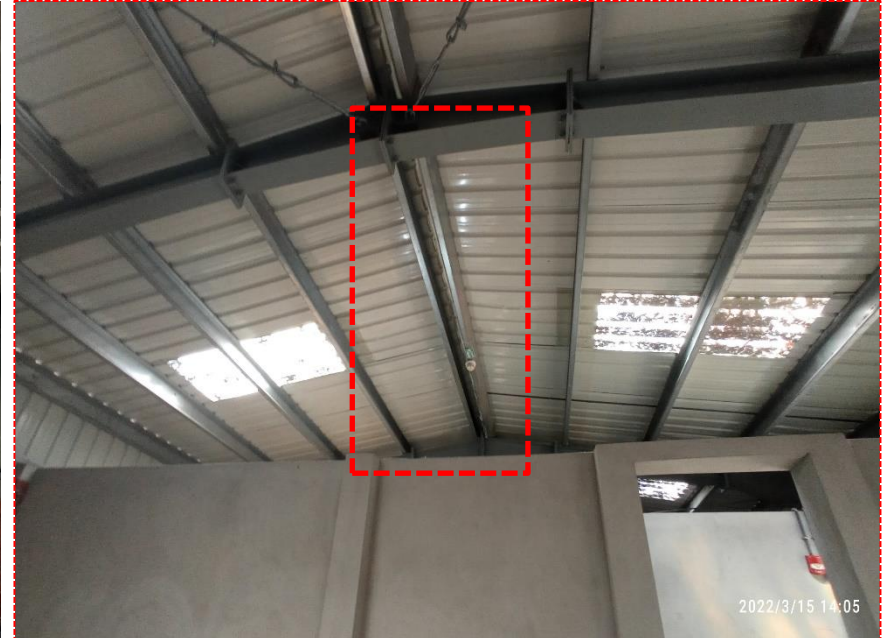
**Absence of load transfer media in long direction**

Absence of lateral load transfer media (compression strut) on roof

Building engineer is required to check the structural system of the structure and provide the appropriate load transfer media where required.

| Item No. | Observation | Recommended Action Plan | Recommended Timeline |
|---|---|---|---|
| 07 | Absence of load transfer media in long direction. (Wastage Godown) | As part of Engineering Assessment (EA), the building engineer is required to check the stability of the structure and suggest necessary remedial actions. | 6-weeks |
| 08 | Absence of load transfer media in long direction. (Wastage Godown) | Carry out remedial works as the EA. | 6-months |

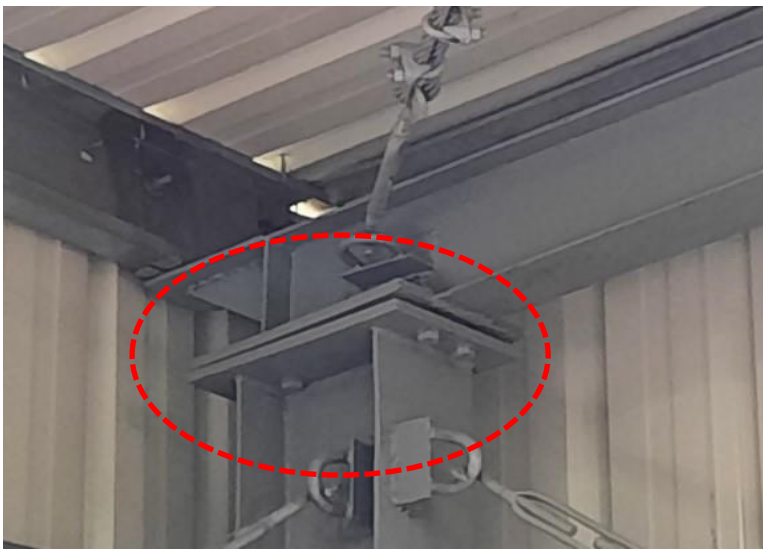
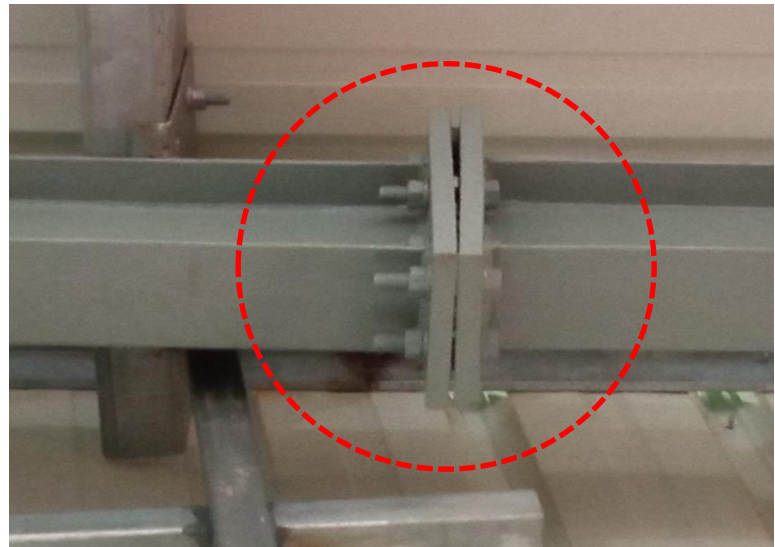
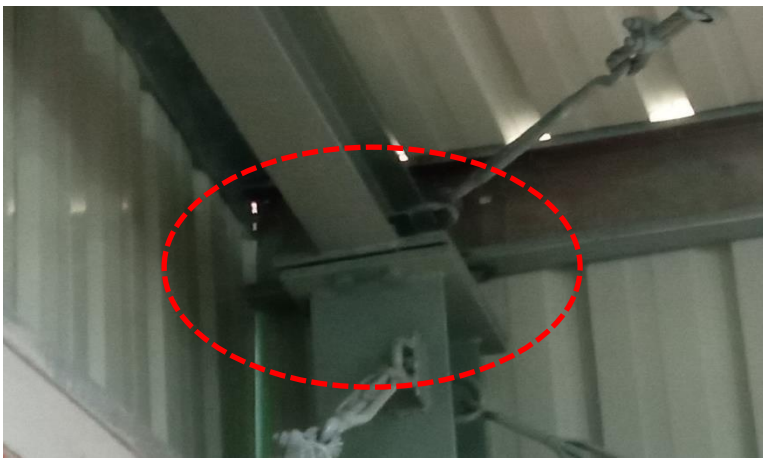
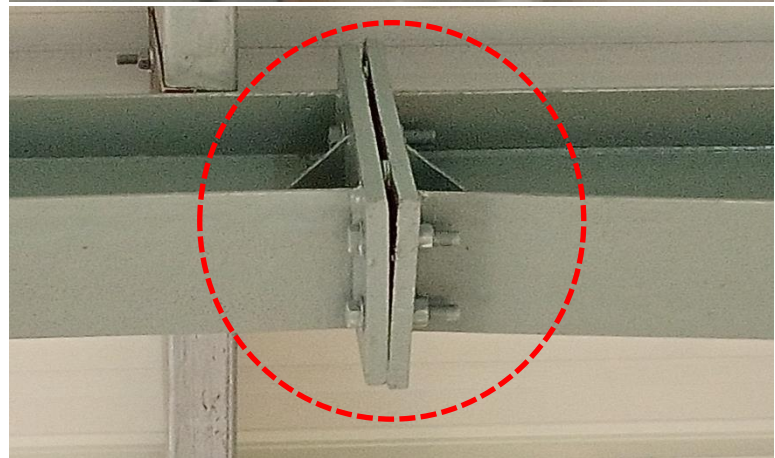
## **Significant gaps in connection**

Connection gap in joints

Connection gaps in several locations were observed. Building engineer is required check the structure to identify the connection gaps and take action to fill up the connection gaps properly.

| Item No. | Observation | Recommended Action Plan | Recommended Timeline |
|---|---|---|---|
| 09 | Significant gaps in connection. (Wastage Godown) | Building is required check the structure to identify the connection gaps and take action to fill up the connection gaps properly. | 6-weeks |

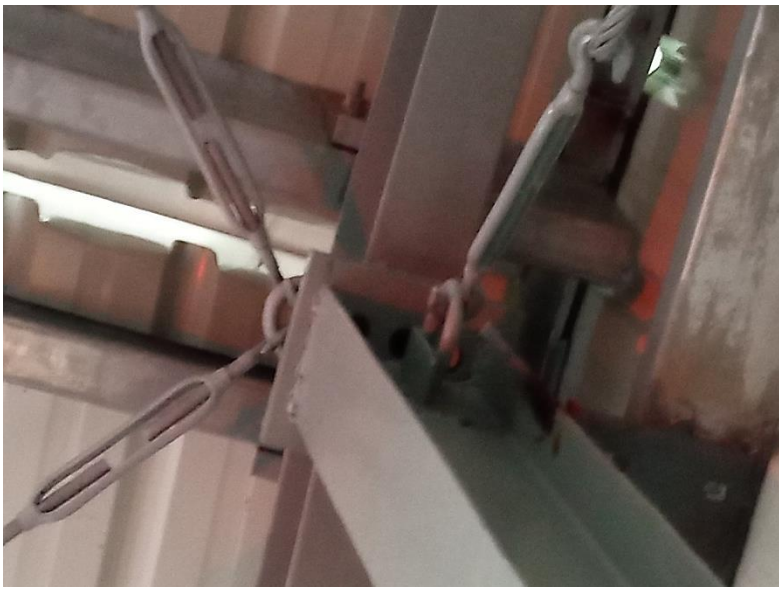
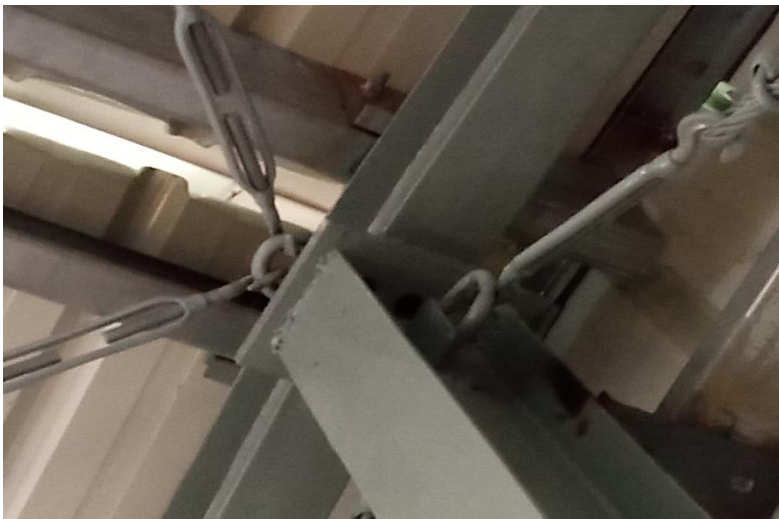
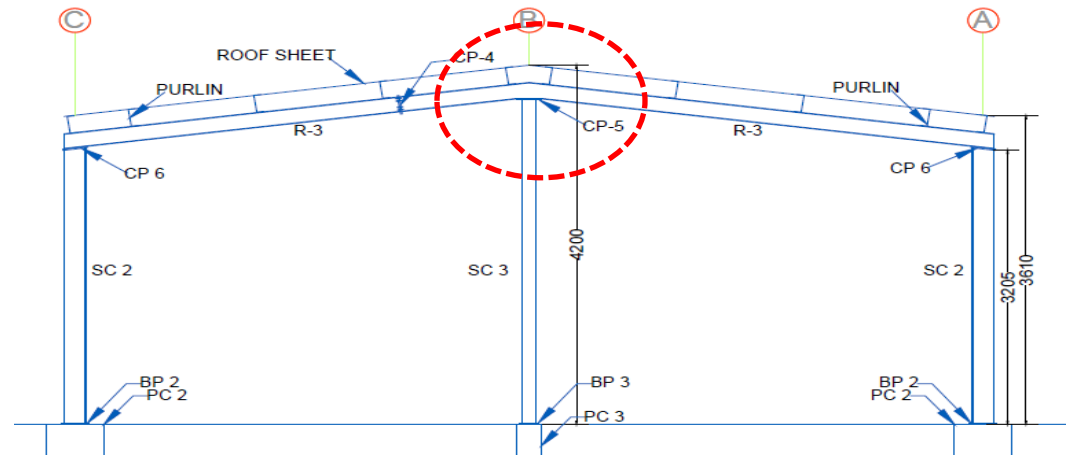
## **Inconsistency in connection details**

Welding connection found instead of bolt connection in drawing

Building engineer to update the connection detail or install bolt as per structural drawings.

| Item No. | Observation | Recommended Action Plan | Recommended Timeline |
|---|---|---|---|
| 10 | Inconsistency in connection details. (Wastage Godown) | Building engineer to update the connection detail or install bolt as per structural drawings. | 6-weeks |

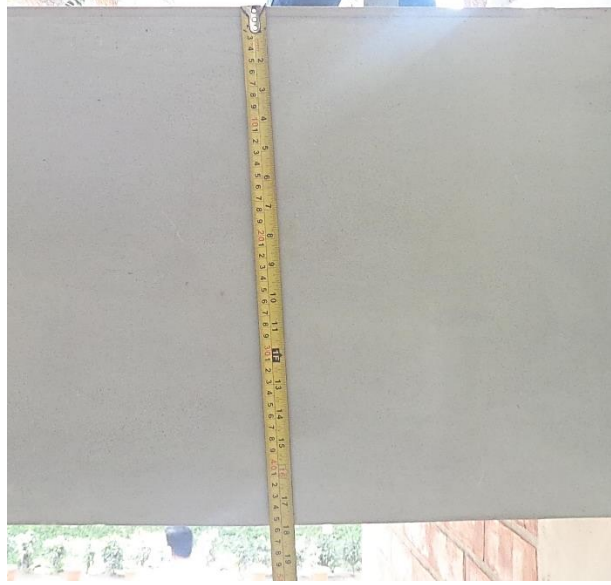
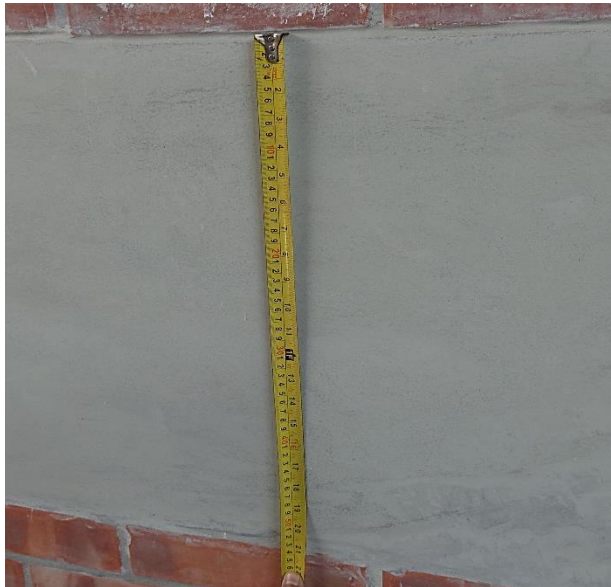
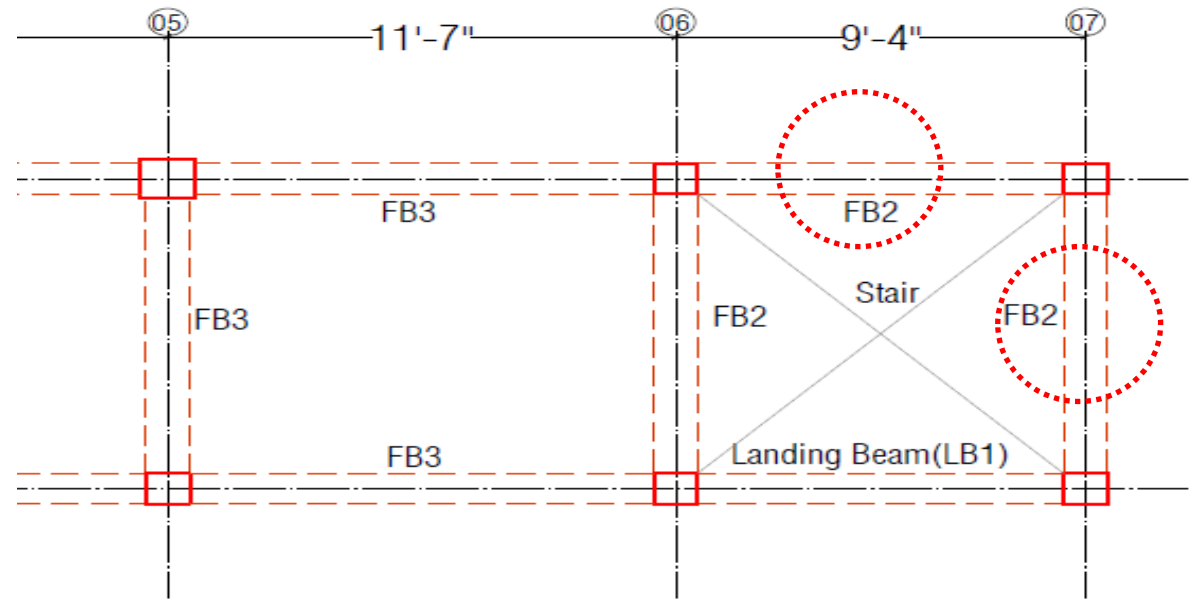
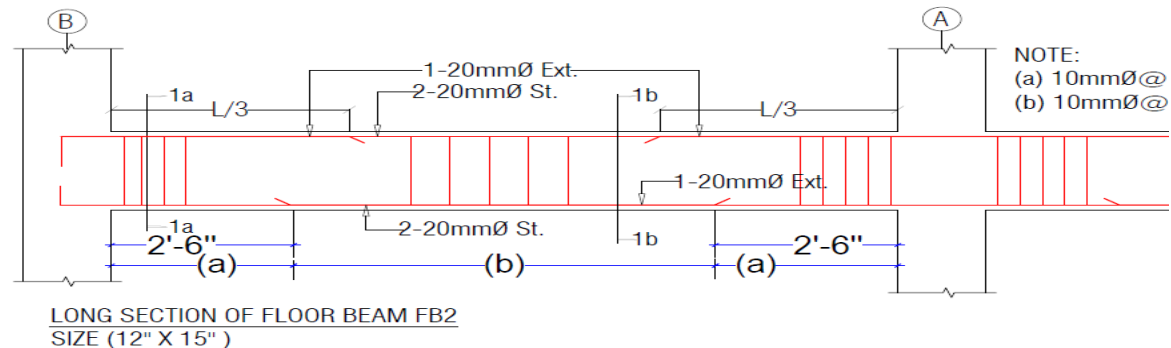
## **Discrepancy in the drawings**

Existing beam dimension  
(300x 500)

Existing beam dimension (FB-2-300x500) doesn't match with the as built structural drawing beam layout (FB-2-300x375). Building engineer to survey the structure and prepare accurate as-built drawings.

| Item No. | Observation | Recommended Action Plan | Recommended Timeline |
|---|---|---|---|
| 11 | Discrepancy in the drawings. (Security Building) | Building engineer is required to survey the structure and produce accurate as-built drawings. | 6-weeks |
