Jeans Manufacturing Co. Ltd (New location)

RISHIPARA, SHINGAIR ROAD, HEMAYETPUR, SAVAR, DHAKA
(23.792031, 90.259013)

20th March 2022

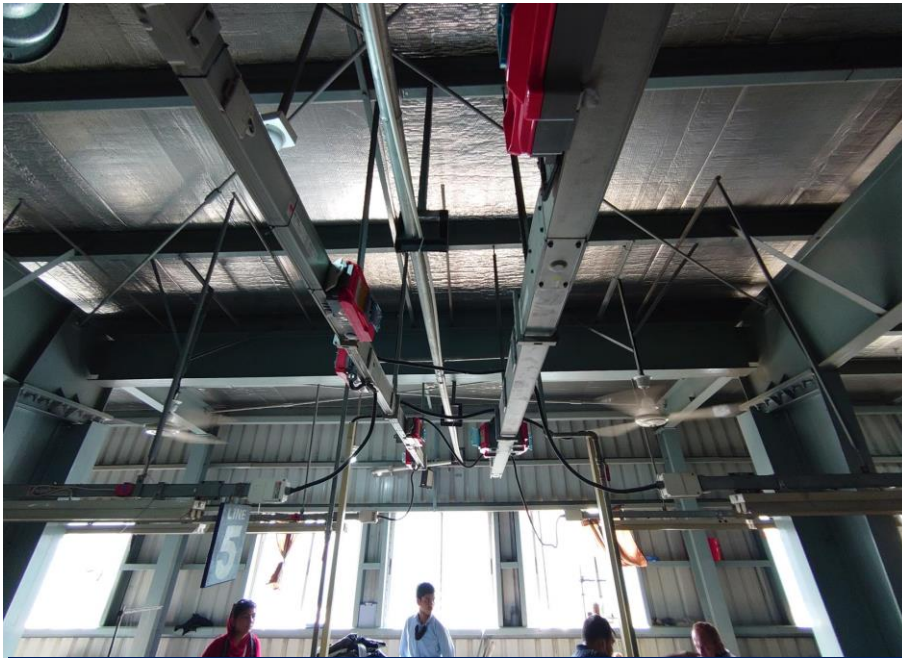
Some of the horizontal bracings were found loose. The factory is required to tight the bracings for transferring the lateral loads properly.

Loose rod bracing at roof

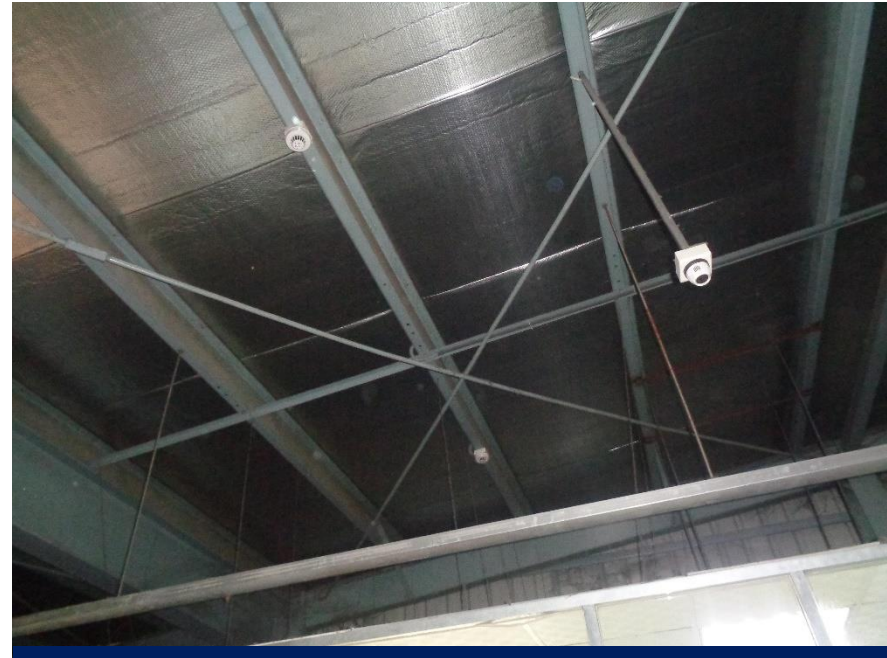
Loose rod bracing

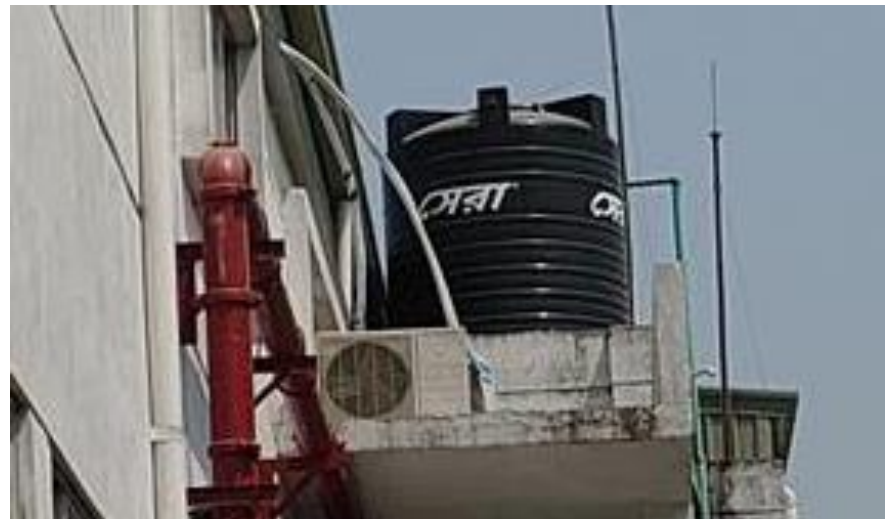
Some plastic tanks resting on the rooftop and racks on the ground floor are not adequately anchored or braced to resist earthquake forces.

Water tank

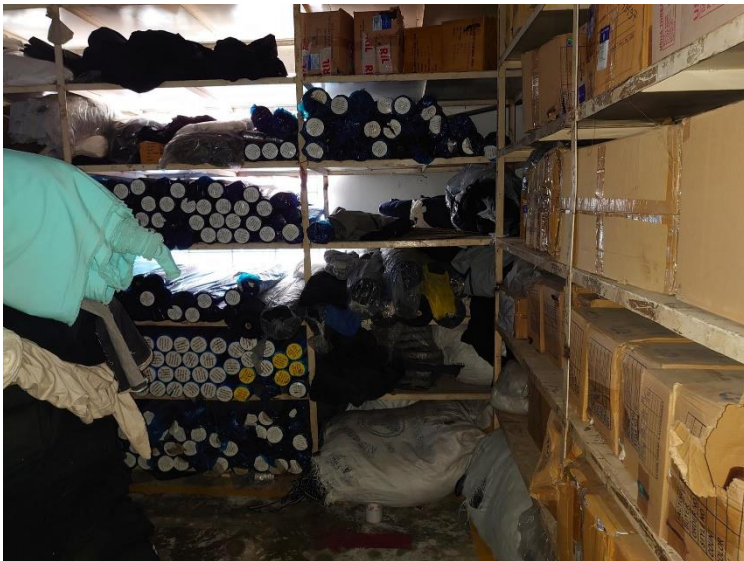
Racks at GF

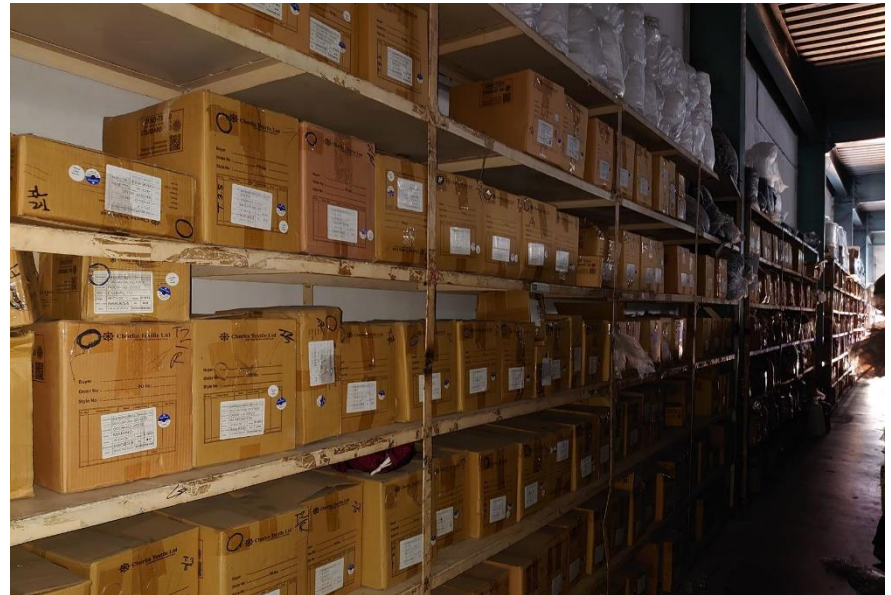
Racks at GF

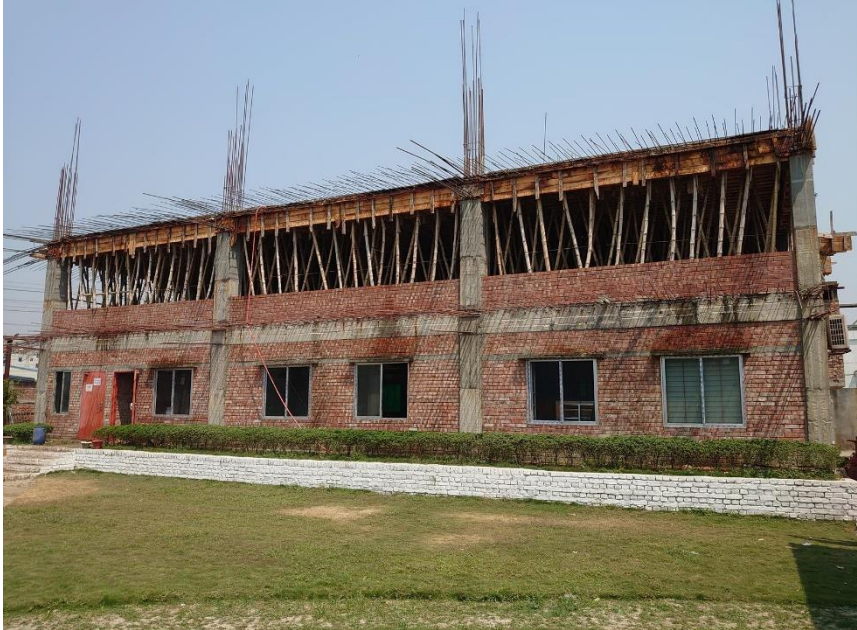
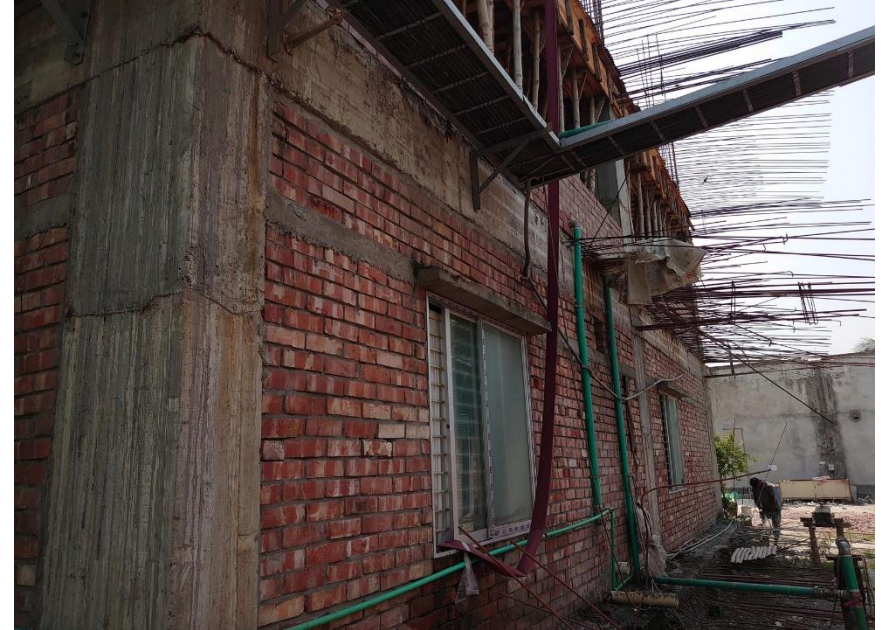
Exposed rebar of floors

Exposed reinforcement was found extended from slab & beam. All exposed reinforcement is to be protected from corrosion which may cause degradation of the concrete. Factory engineer is required to take necessary measures to prevent the corrosion in exposed rebar.

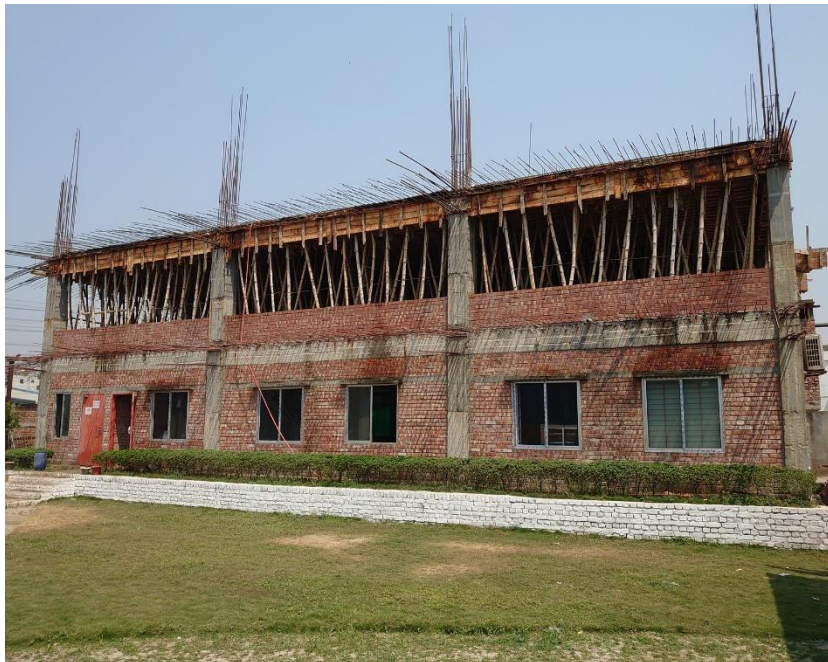
Column & Slab reinforcements are exposed on roof and west side of structures. Moreover, this building is permitted for 4 (G+3) storied from local authority. Extension work may be carried out in the existing structure. Factory engineer is required to carry out a Detail Engineering Assessment considering BNBC provision prior to any further extension work.

Expose rebar
