Purbasha Composite Tex Ltd

Jamirdia (Square Masterbari), Bhaluka, Mymensingh
(24.305554, 90.393209)
21st March 2022

Building Information

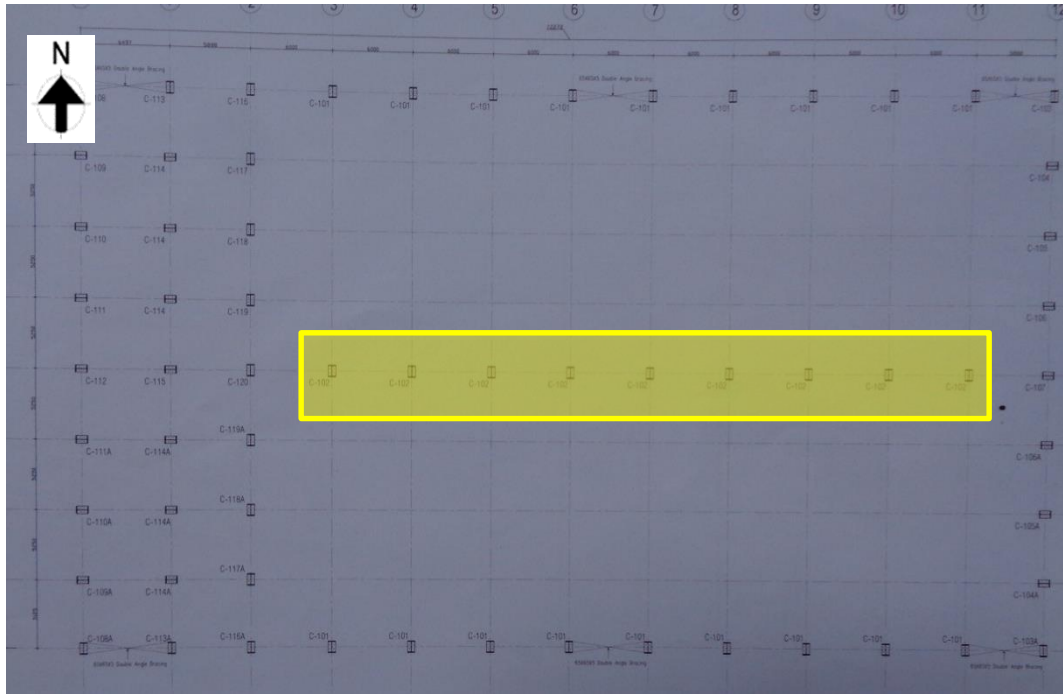
Stress in column exceeds normal design limit

Stressed columns in layout

Cursory calculation indicates that stress in column exceeds the normal design limit (yellow marked) due to large tributary area considering the roof live load (1 kPa) and strength of steel 345 MPa from the available MS plate test report. Building engineer is required to review the design, loads and column stresses for the marked columns.

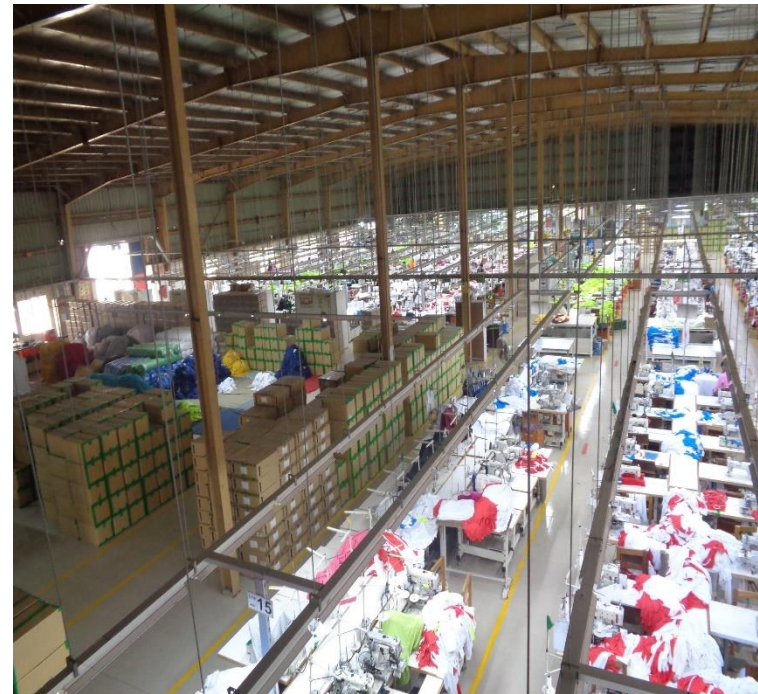
Typical stressed columns along ridge

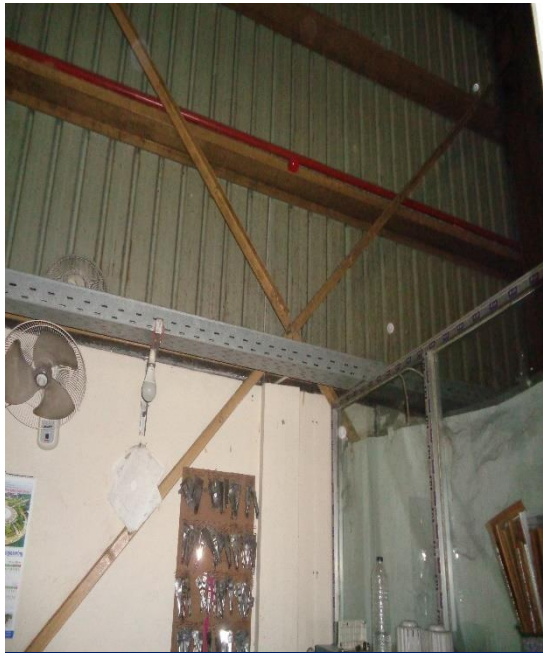
Roof & wall bracing provided

Roof and wall bracing provided at some location, but no-load transfer media provided from frame to frame to transfer the lateral load therefore lateral stability system of the shed is apparently incomplete. Also, the wall bracing seems to be inadequate if considered as both tension-compression Building engineer is required to check the lateral stability of the structure.

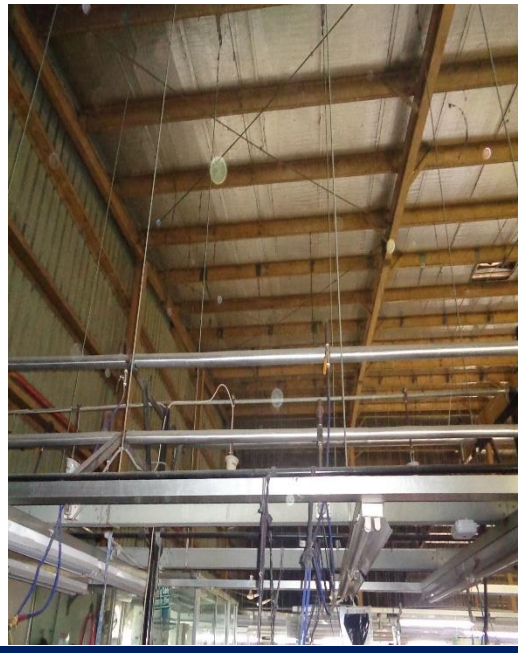
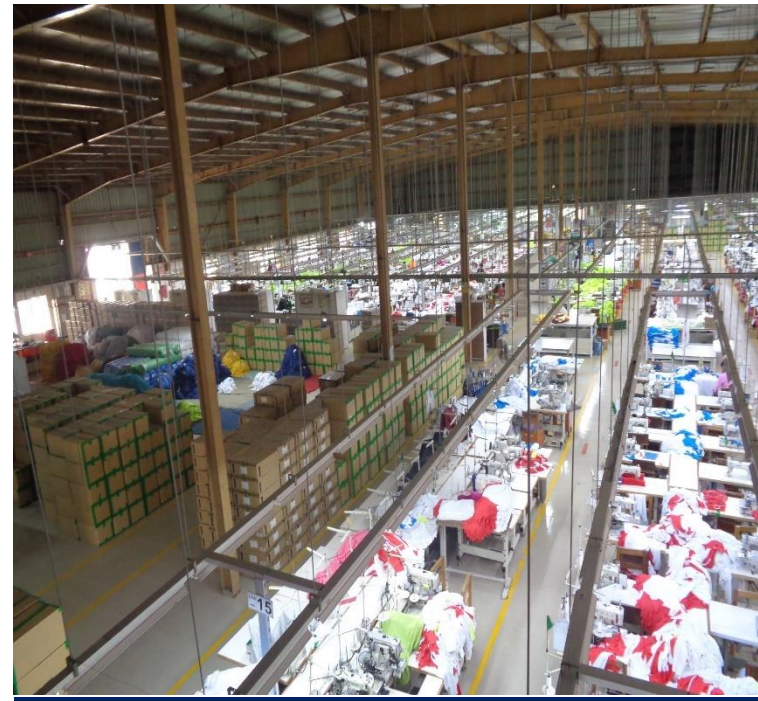
No load transfer media provided

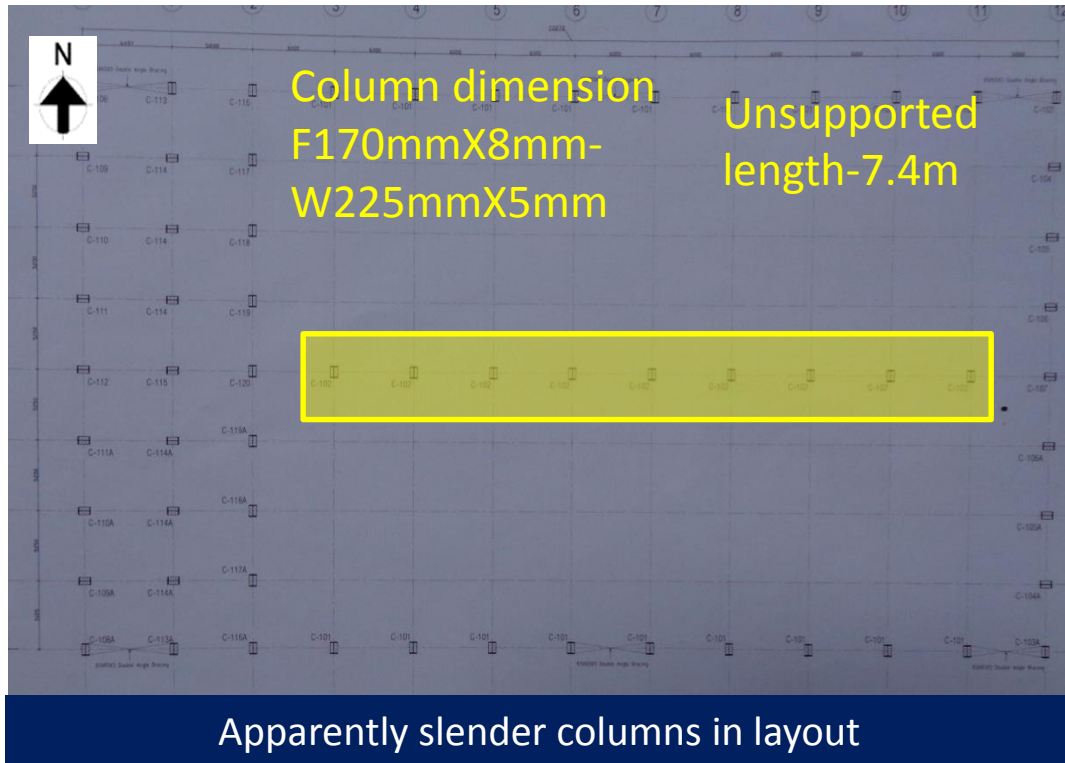
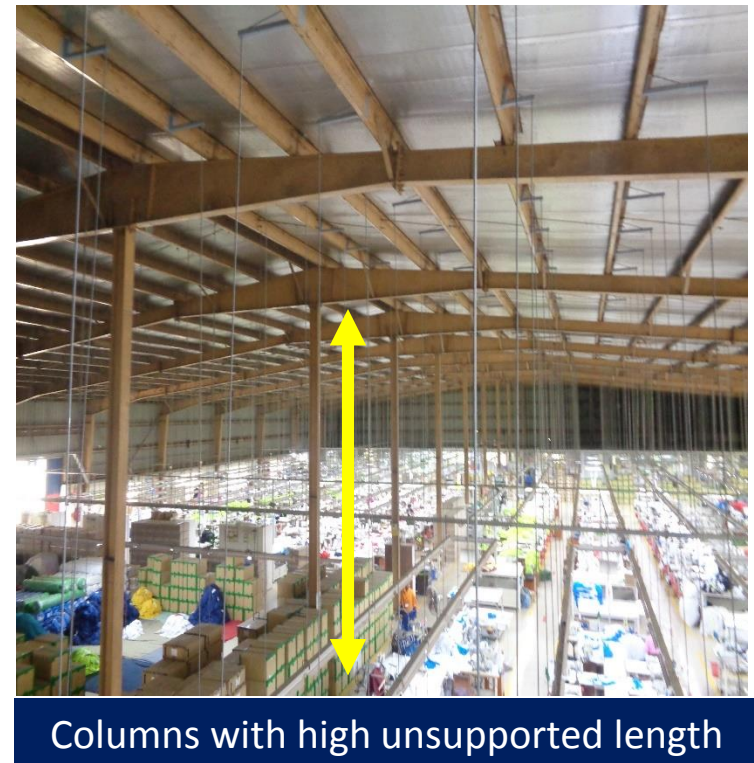
Columns appear to be slender

Cursory calculation shows that slenderness in highlighted columns exceeds normal design limit due to long unsupported length. Factory engineer is required to carryout adequacy check of the highlighted column considering slenderness effect.

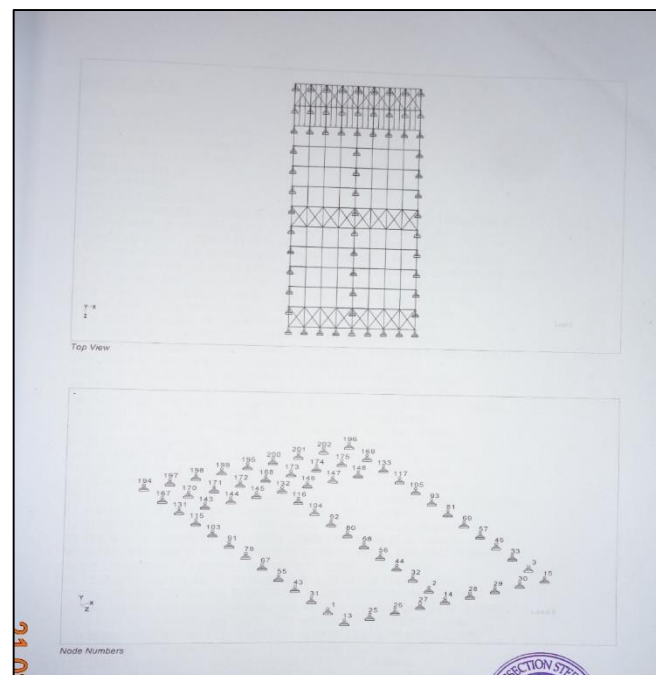
“Structural Analysis Report” based on FEA model

A “Structural Analysis Report” was available based on software-based analysis for this structure. However, no software model was available to review the analysis report. Also, there is not foundation capacity check is included in this report.

As per BNBC, every building or structure designed shall have its design documents prepared in accordance with the provision of Section 1.9.1. The design document shall include a design report, and a set of structural drawings, which shall be prepared in compliance with section 1.9.1.1 and section 1.9.1.2 as per BNBC. Building engineer is required to produce a full set of analysis report as per section 1.9.1 including adequacy check of all type steel members, pedestal column, Grade beam & foundation and submit along with the software model for further review.

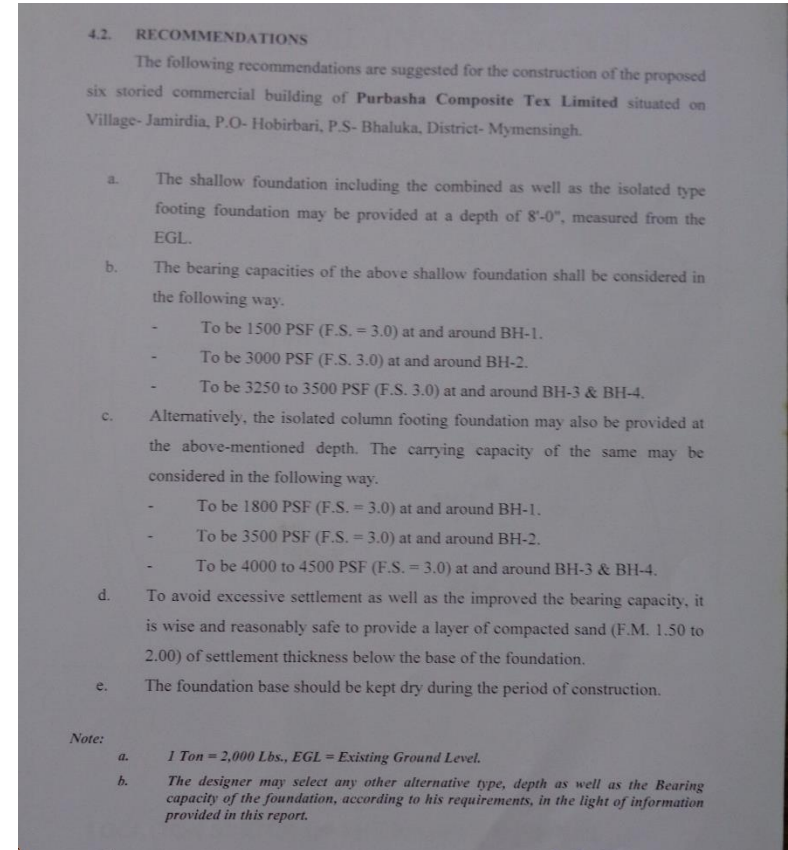
Geotechnical investigation report

A geotechnical investigation report was available based on 4 borehole data which recommend isolated footing foundation for this structure. However, no foundation drawing was available to review the foundation capacity. Building engineer is required to produce structural drawing for the foundation and check the foundation capacity accordingly.

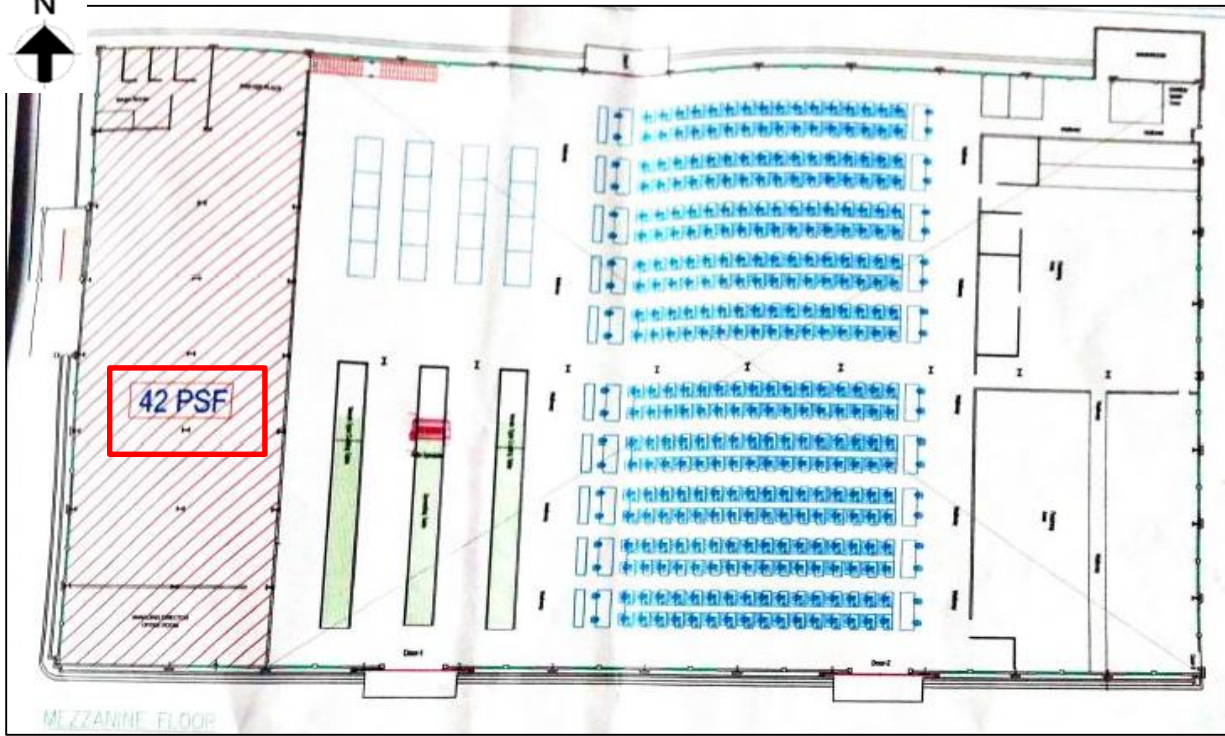
Live load plan-Mezzanine floor -2 kPa

Live load on Mezzanine floor is considered as 2 kPa in prepared load plan. As per BNBC- Part 6, live load for light storage and prayer areas is required to be considered minimum 6 kPa and 3 kPa respectively. However, the building engineer is required to revise the load plan as per BNBC requirement and check the design accordingly.

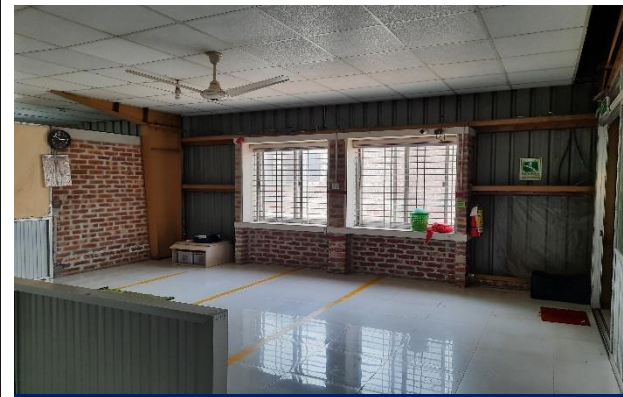
Prayer area on Mezzanine floor

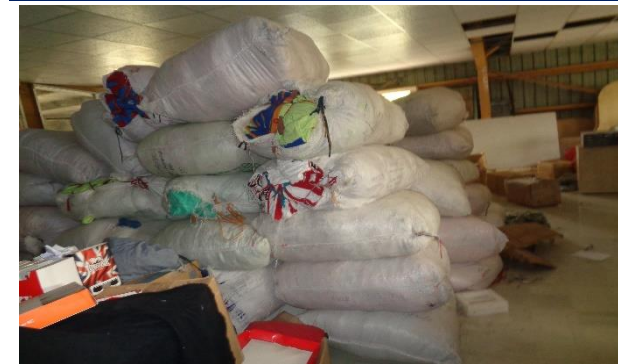
Storage on Mezzanine floor

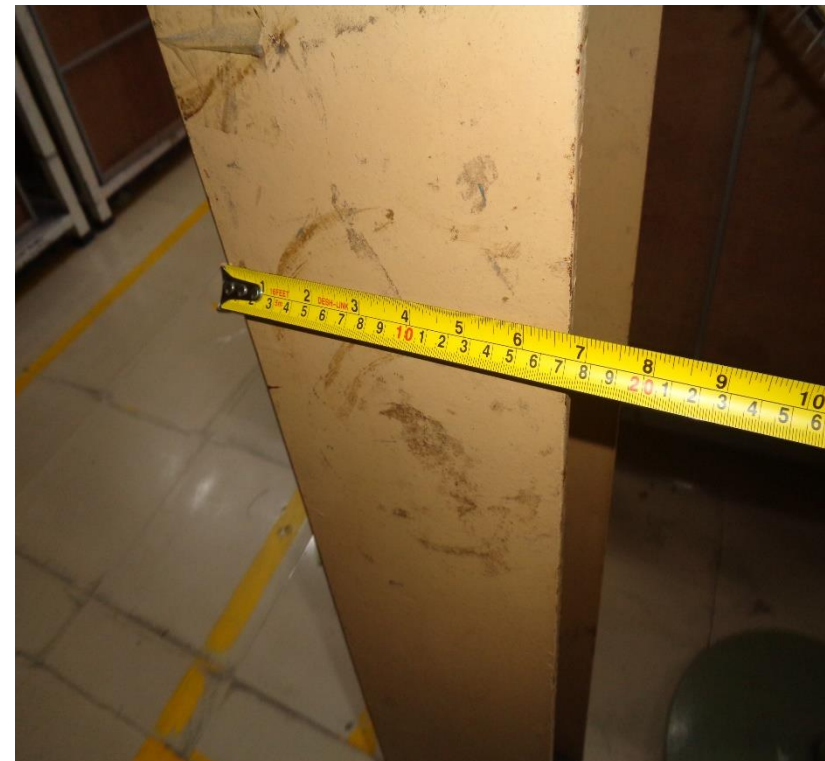
Flange measured as 170mm

Dimension of flange shown as 175mm for C102 but measured as 170mm. Due to the change, the FOS of the columns significantly changed. Building engineer is required to resurvey the whole structure and update the as-built drawing as per onsite condition for all steel members.

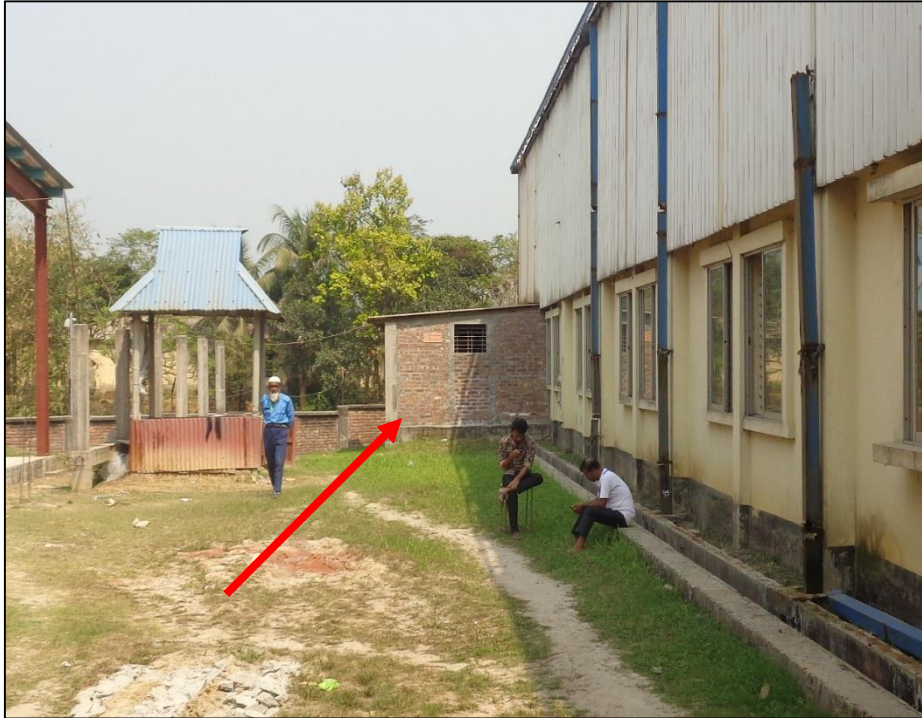
Toilet block at north-east corner

Two single storied toilet block were observed adjacent to Shed-1 but no as-built drawing was available for those block. Building engineer is required to produce as-built drawing for both toilet blocks.

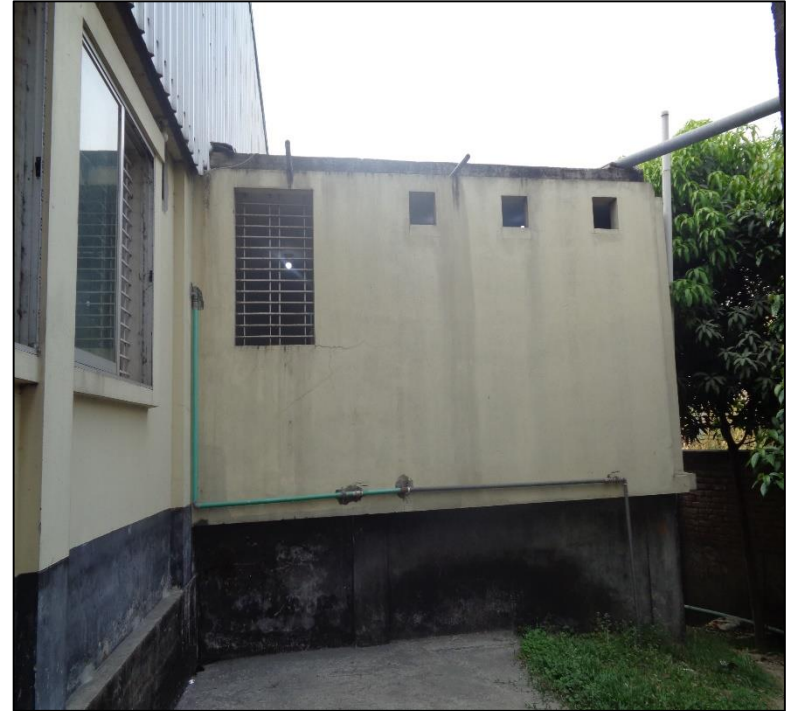
Toilet block at east side

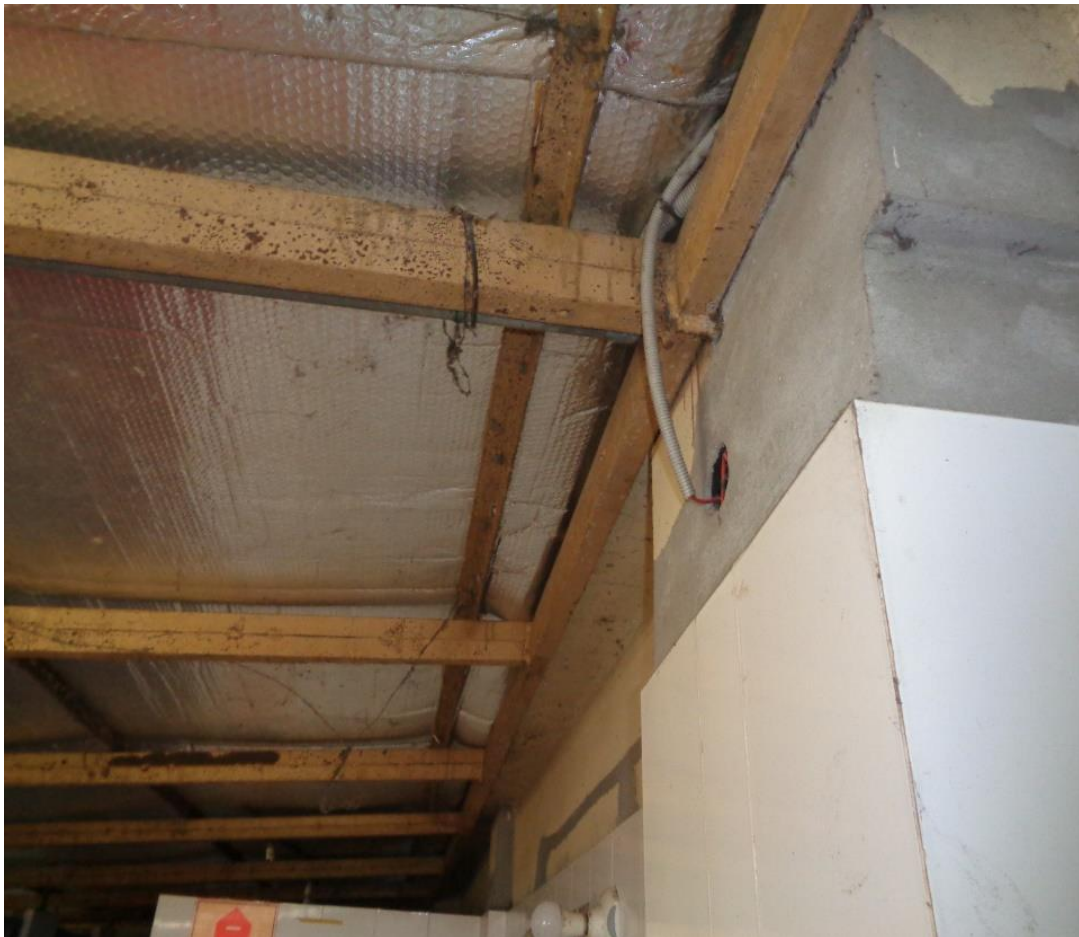
Toilet block at north-east corner

Connections of steel at toilet block at north-east corner was appeared to be inadequate. Building engineer is required to check the connection adequacy for uplift forces.

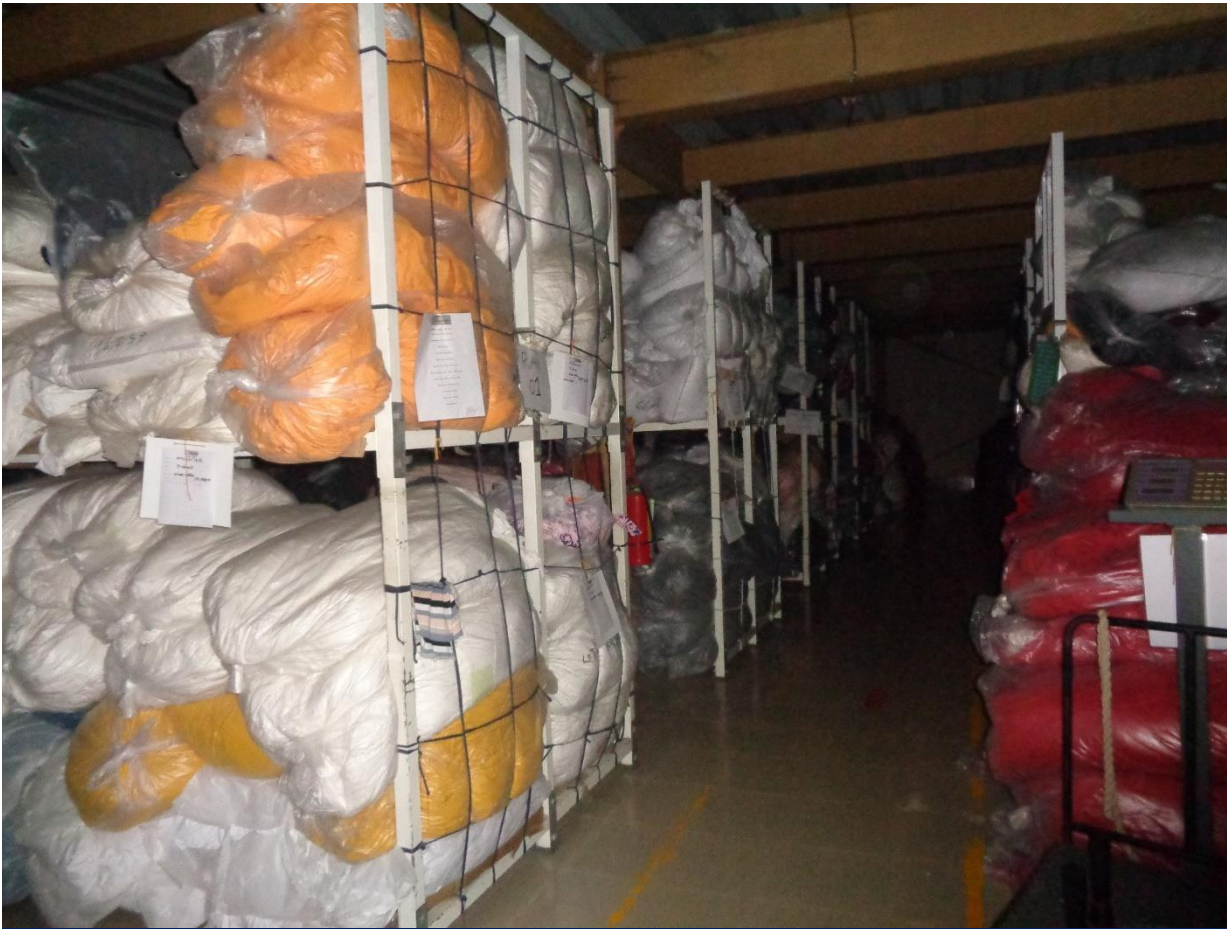
Storage rack found within the building without braced/anchored

Factory is required to brace/anchor all non structural elements.

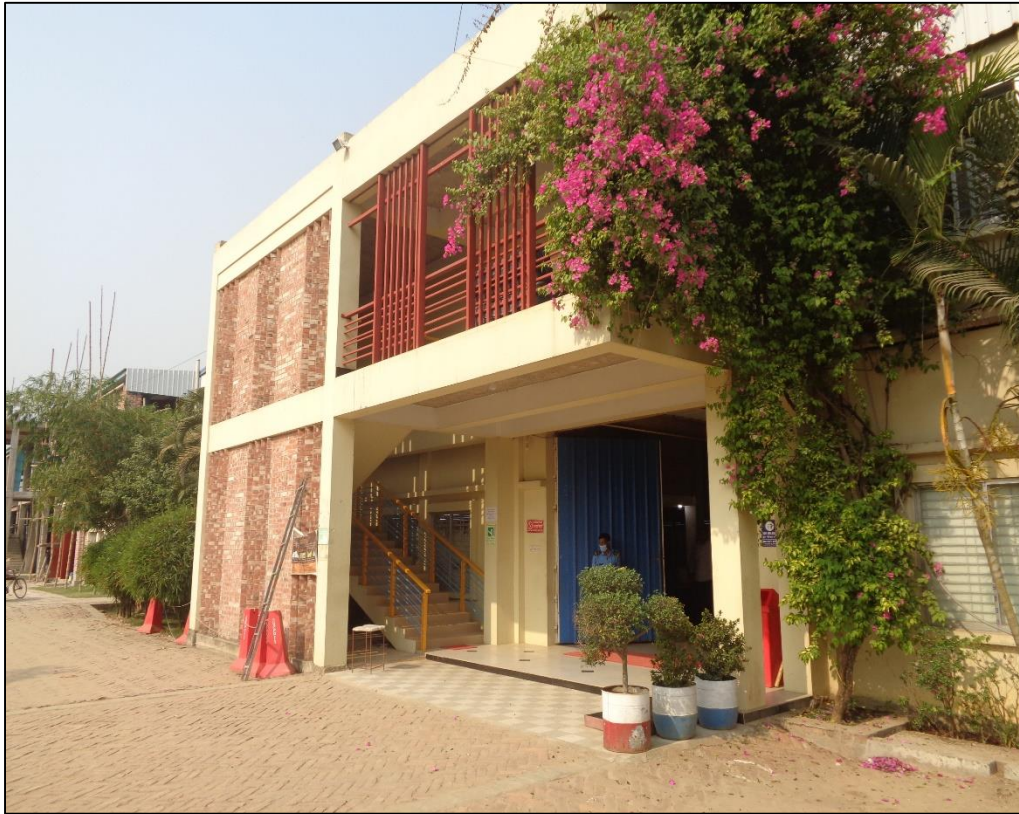
Absence of design documents and as-built drawing

Independent RC Stair at Shed-1 (Factory Building)

As per BNBC, every building or structure designed shall have its design documents prepared in accordance with the provision of Section 1.9.1. The design document shall include a design report, and a set of structural drawings, which shall be prepared in compliance with section 1.9.1.1 and section 1.9.1.2 as per BNBC. At the time of inspection, no as-built drawing or design report was available which are required to be prepared in compliance with section 1.9.1.1 and section 1.9.1.2 (part-6, BNBC).

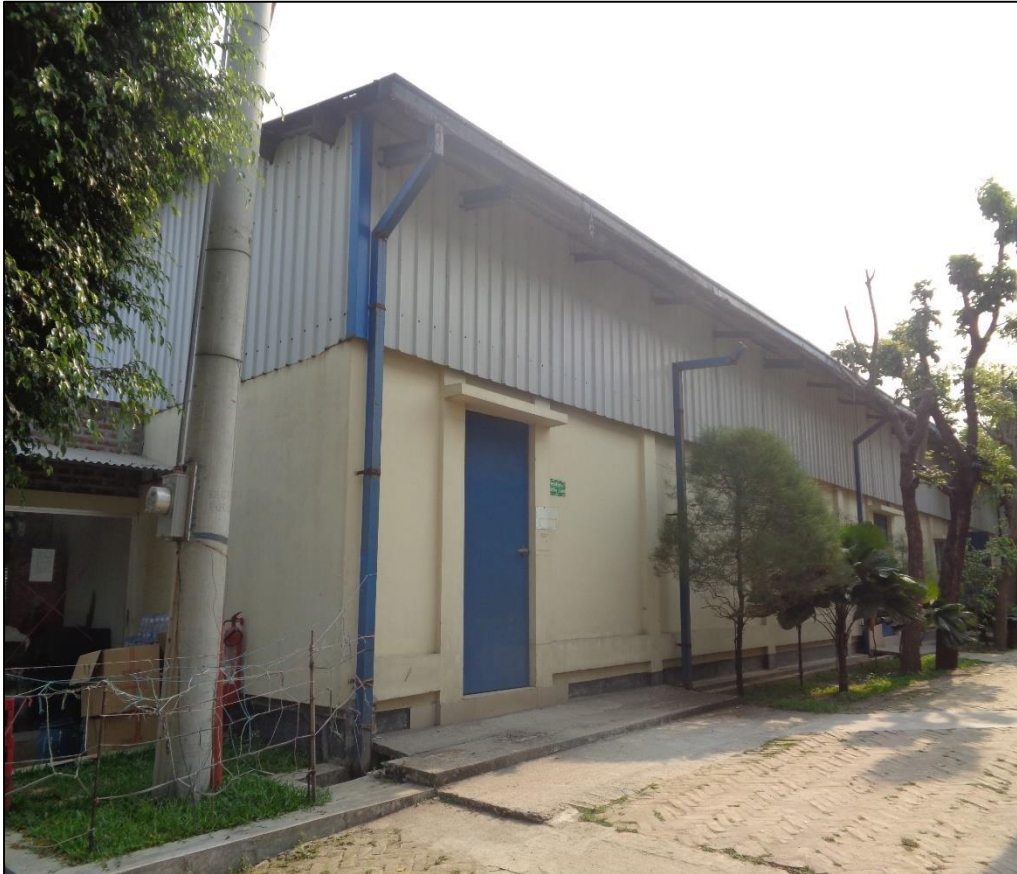
Absence of design documents and as-built drawing

Shed-2 (Compliance Building)

As per BNBC, every building or structure designed shall have its design documents prepared in accordance with the provision of Section 1.9.1. The design document shall include a design report, and a set of structural drawings, which shall be prepared in compliance with section 1.9.1.1 and section 1.9.1.2 as per BNBC. At the time of inspection, no as-built drawing or design report was available which are required to be prepared in compliance with section 1.9.1.1 and section 1.9.1.2 (part-6, BNBC).

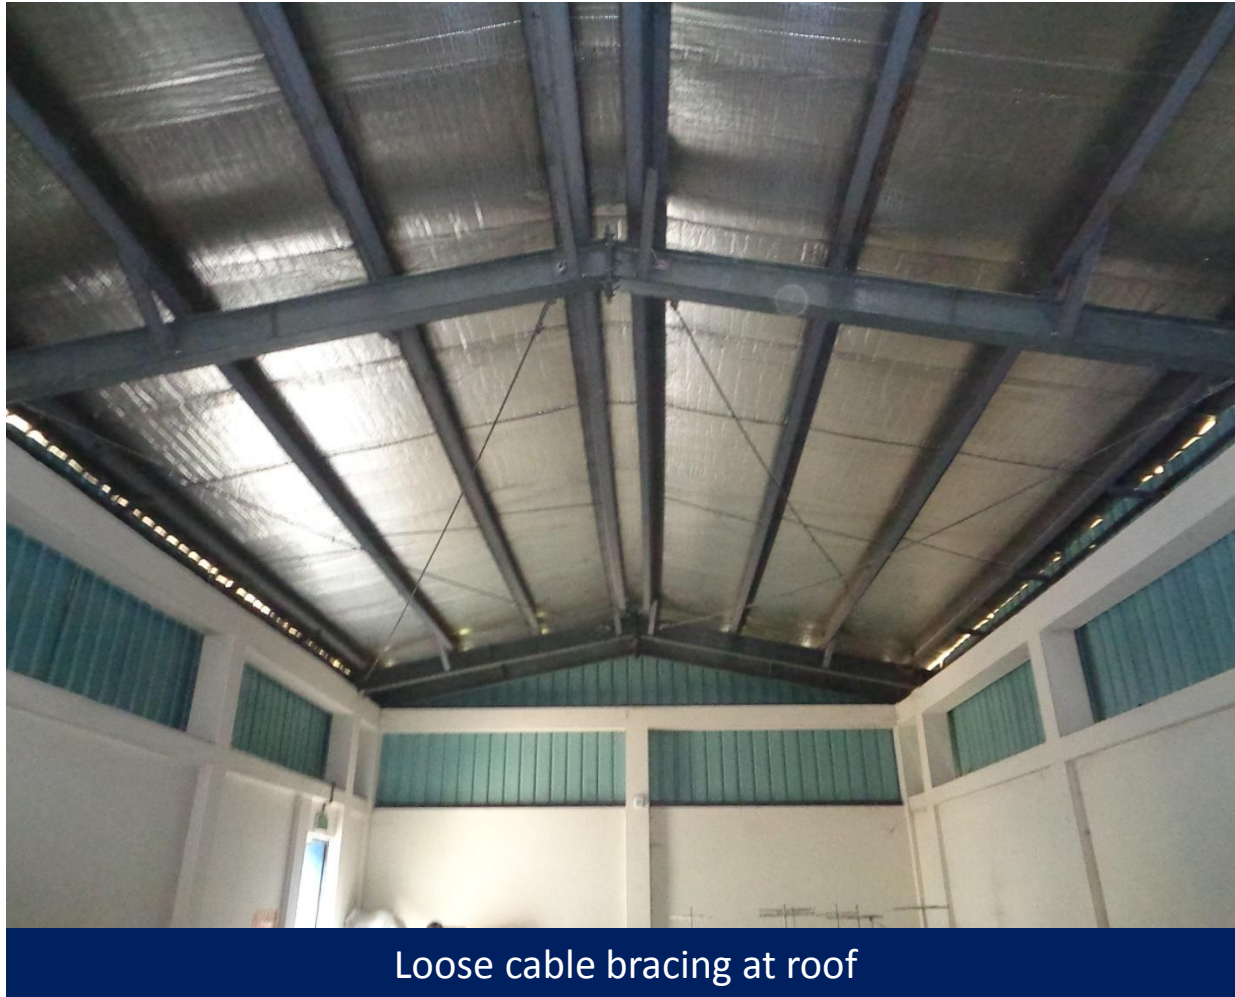
Loose cable bracing at roof

Some of the roof cable bracings were found loose. The factory is required to tight the bracings for transferring the lateral loads properly.

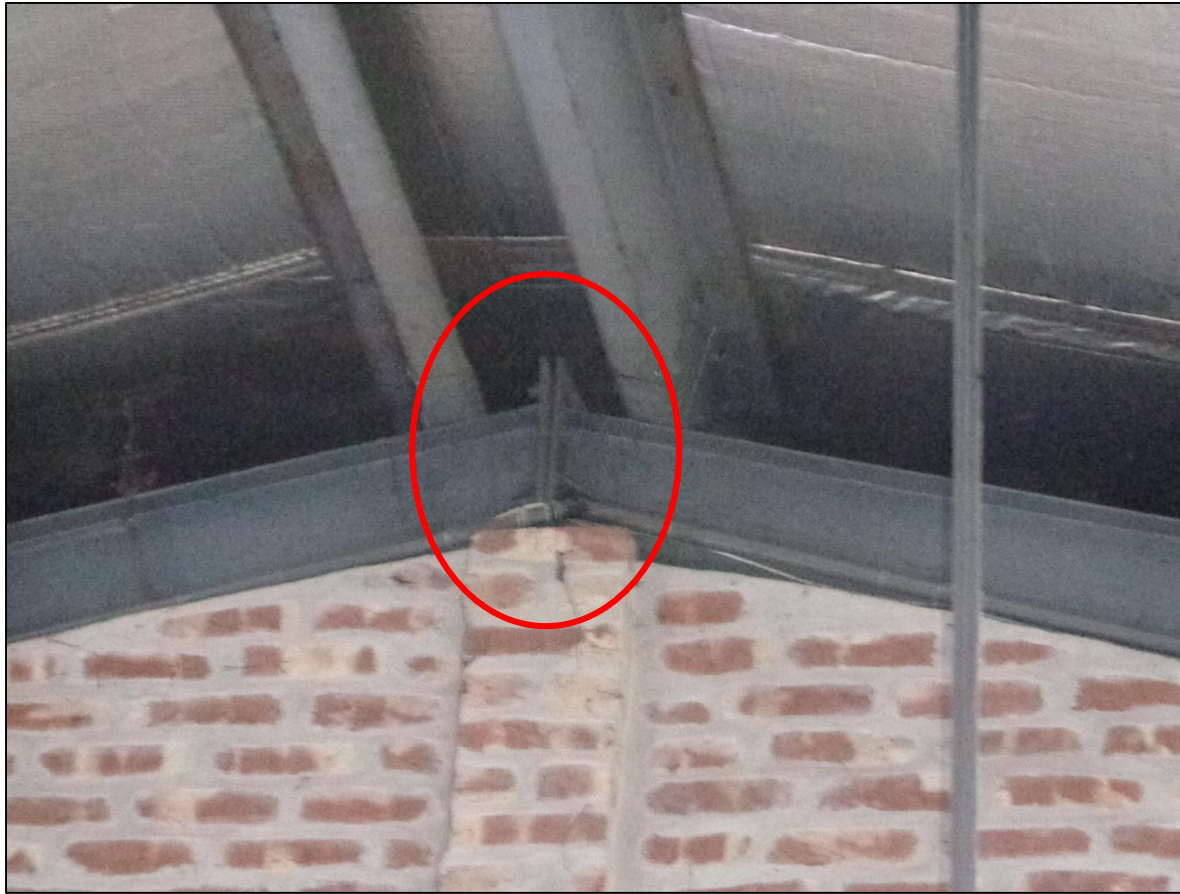
Significant gap in connection

Significant gap was observed in connection at several locations. Factory is required to repair the connection gap with a suitable method suggested by the factory engineer.

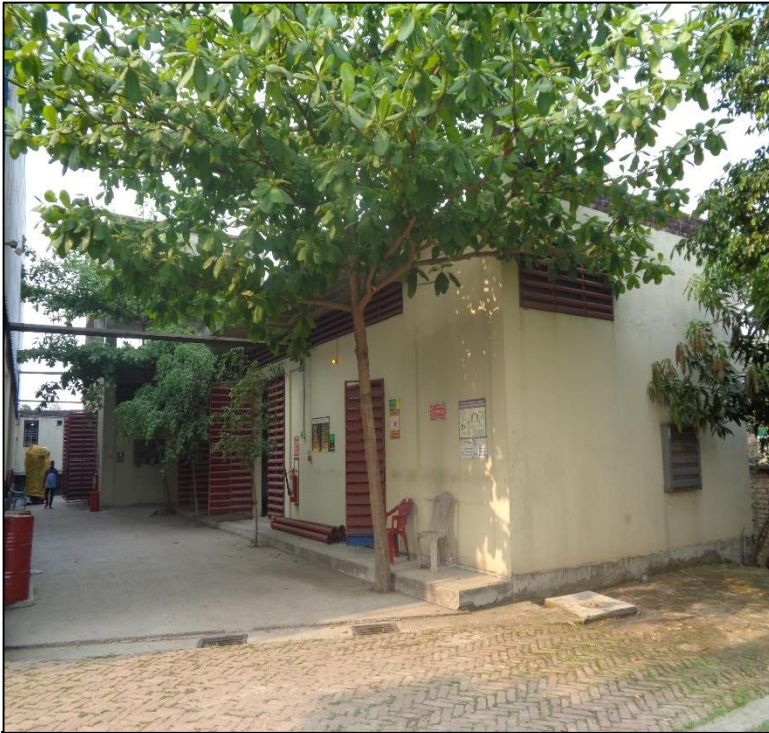
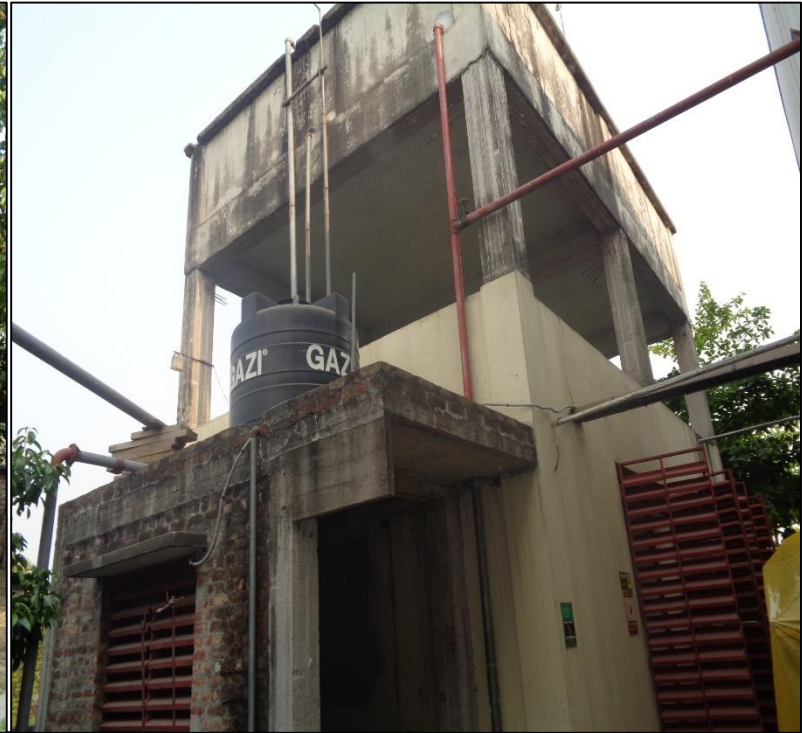
Utility Building

Absence of design documents and as-built drawing

As per BNBC, every building or structure designed shall have its design documents prepared in accordance with the provision of Section 1.9.1. The design document shall include a design report, and a set of structural drawings, which shall be prepared in compliance with section 1.9.1.1 and section 1.9.1.2 as per BNBC. At the time of inspection, no as-built drawing or design report was available which are required to be prepared in compliance with section 1.9.1.1 and section 1.9.1.2 (part-6, BNBC).
