# Kaniz Fashions Ltd. (10025)

228/A, Tejagaon Industrial Area, Dhaka  
29.MARCH.2014

## Client Summary Report Observations & Actions

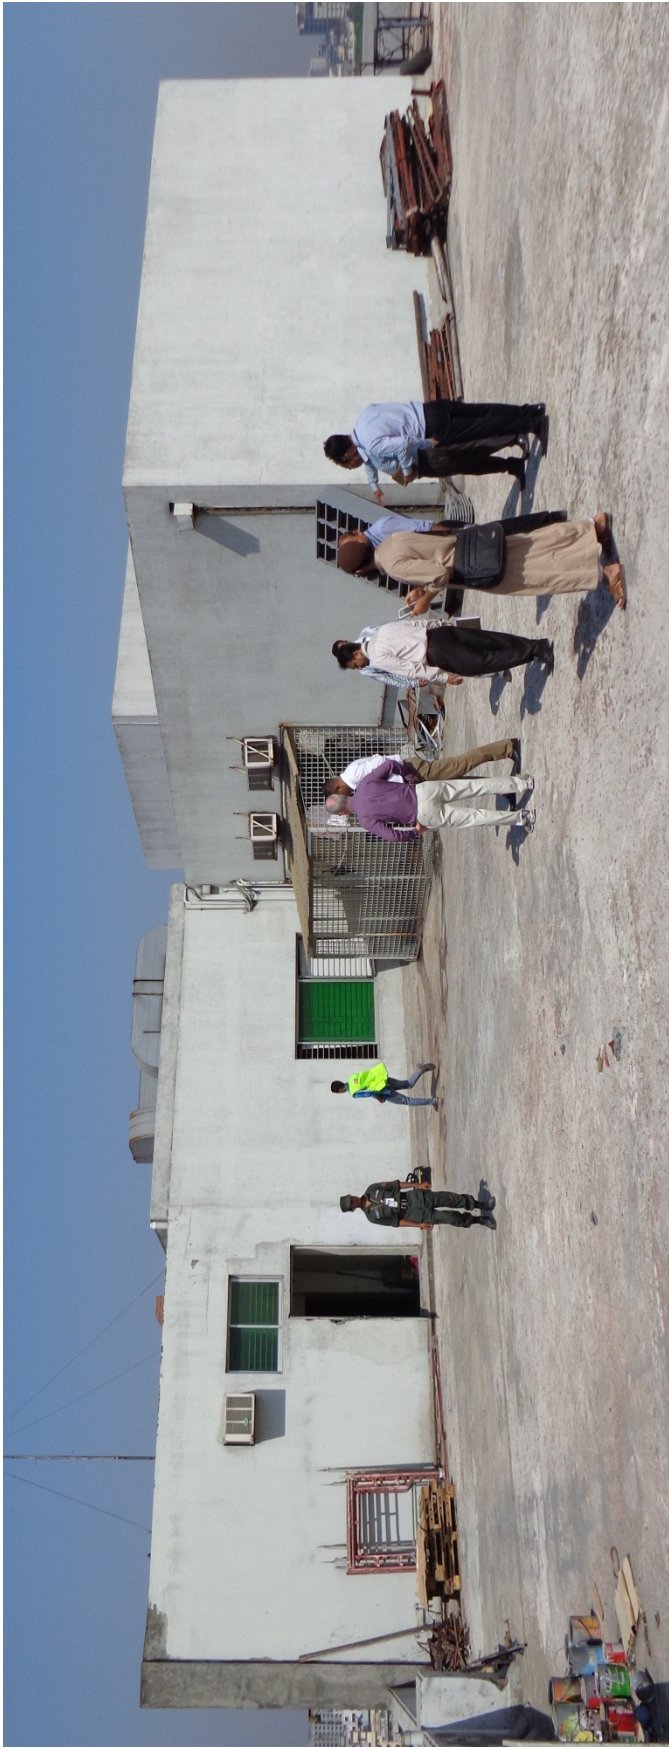
## Localized 10<sup>th</sup> Storey Workspace at Rooftop

Building is designed for 9 stories. However, there is currently a workspace occupying approximately 1/5<sup>th</sup> of the rooftop area imposing loads of one additional storey.

**ITEM 1: (Priority 1) The additional work area atop the roof slab applies loads of an additional storey to the columns beneath it.**

Remove rooftop work area

- Remove workers and equipment from rooftop work area.

- Demolish existing rooftop work area and remove demolition remnants from the roof.

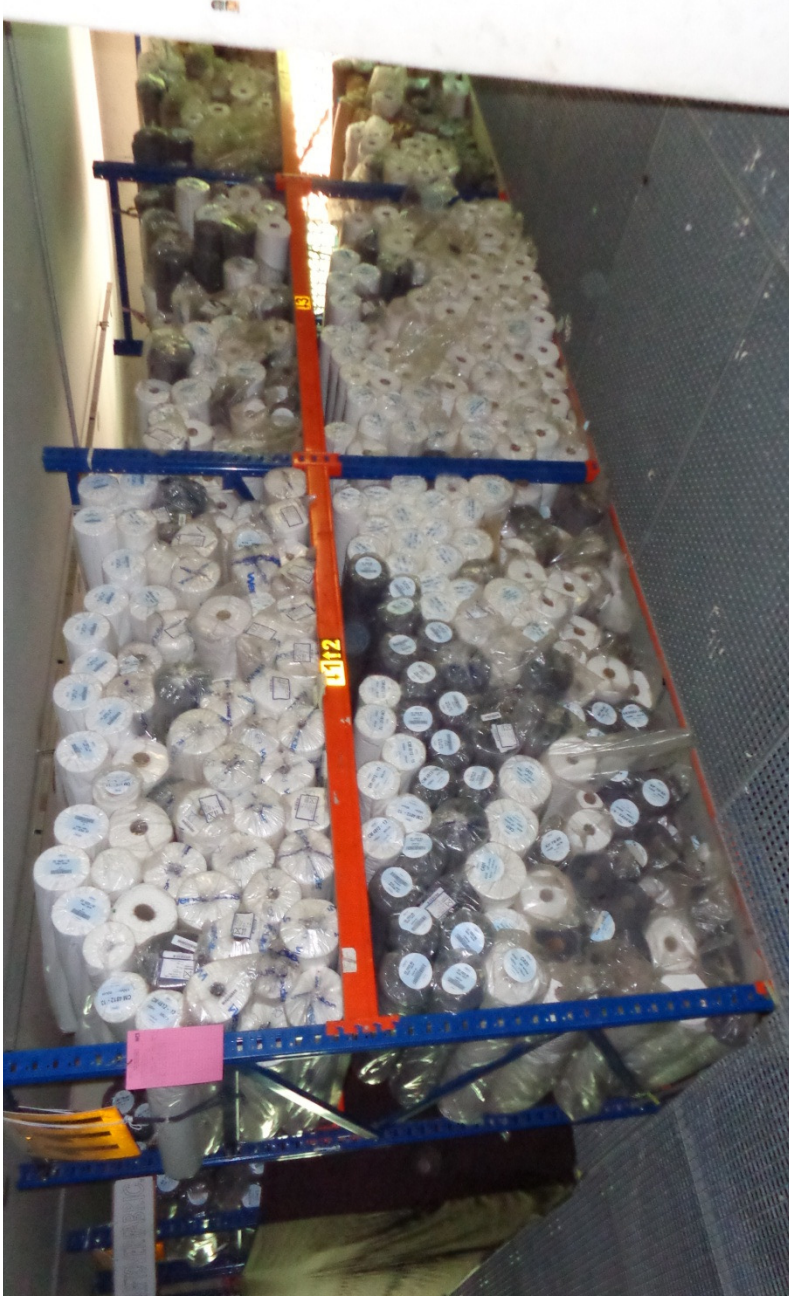
## High Ground Floor Storage Loads

Slab loadings applied to the ground floor in storage areas are excessive.

**ITEM 2: (Priority 1) Ground floor storage loads exceed allowable limits in localized areas.**

- Reduce and distribute storage at ground floor level to allowable loads indicated by slab loading plan

- Develop and implement protocols for the monitoring of slab loadings in accordance with the existing slab loading plans.

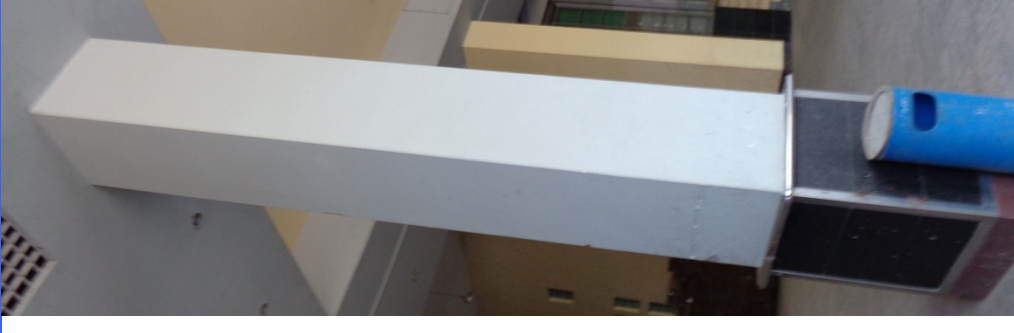
## Low Column Safety Factors

Under minimum allowable gravity loads the column safety factors are lower than desirable.

**ITEM 3: (Priority 2) Column safety factors are lower than required.**

- Factory engineer to conduct a review of design, loads and column stresses throughout the factory.

- Amend existing loading plan according to findings of engineering review mentioned above.

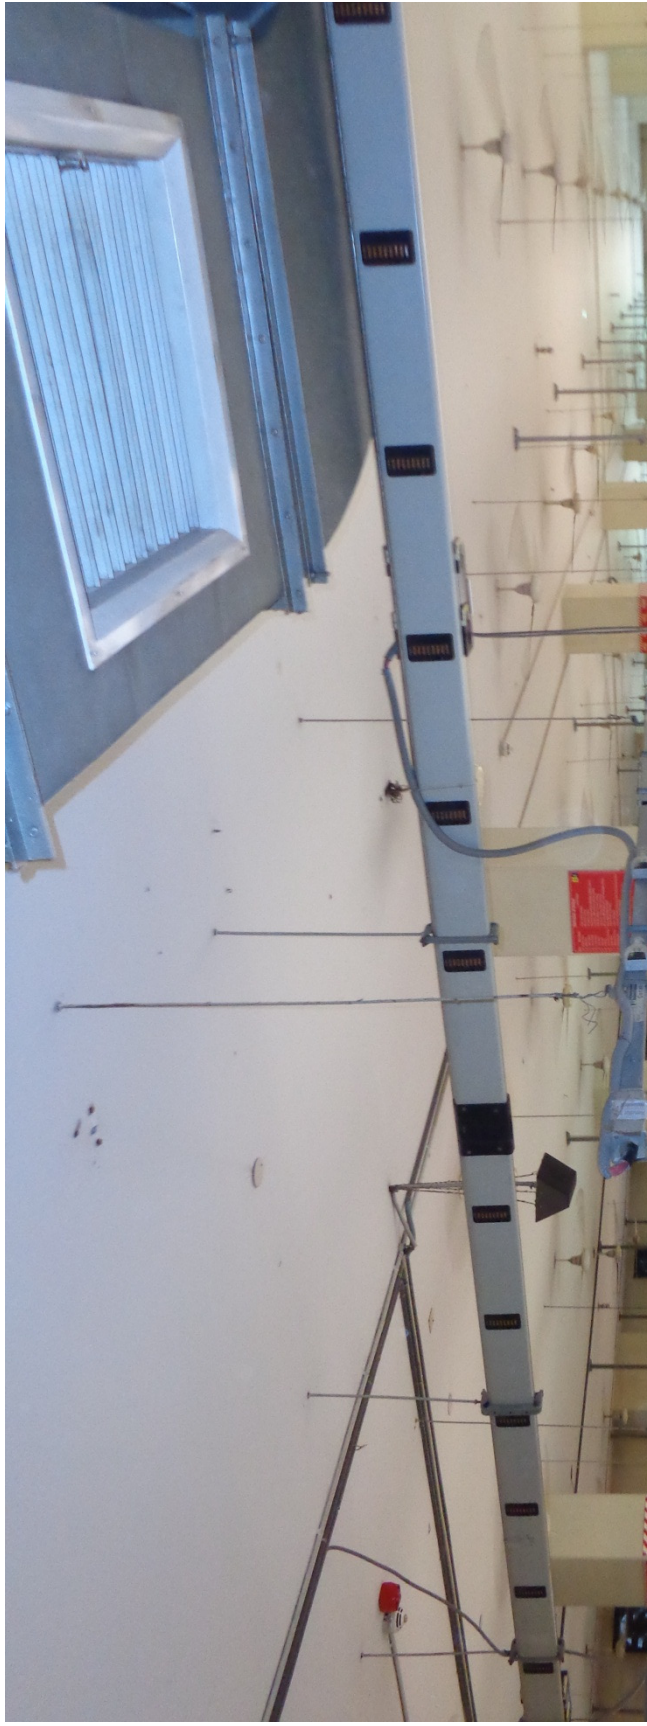
## Lack of Lateral Stability

The structure contains no apparent lateral stability system. Flat slabs sit atop columns without rigid frames or shear walls to resist seismic or wind loadings.

**ITEM 4: (Priority 2) Building composed of flat slabs lacks an apparent lateral restraint system.**

- Factory engineer to conduct a review of structure's lateral stability system.

- If required, implement measures to bolster lateral stability.
