# Ariyan Socks Industries Ltd

Mawna, Tengra , Sreepur, Gazipur, Bangladesh  
(24.23112N,90.45715E)  
29<sup>th</sup> March 2022

# Building Information

# Observations

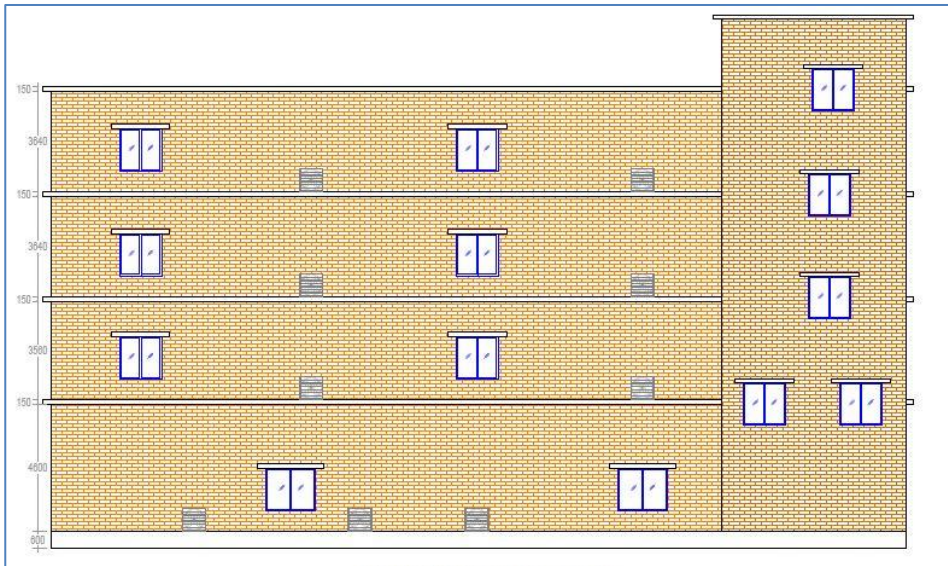
Proposed elevation of 4 storied

The factory has a plan to construct the building up to 4-storied.

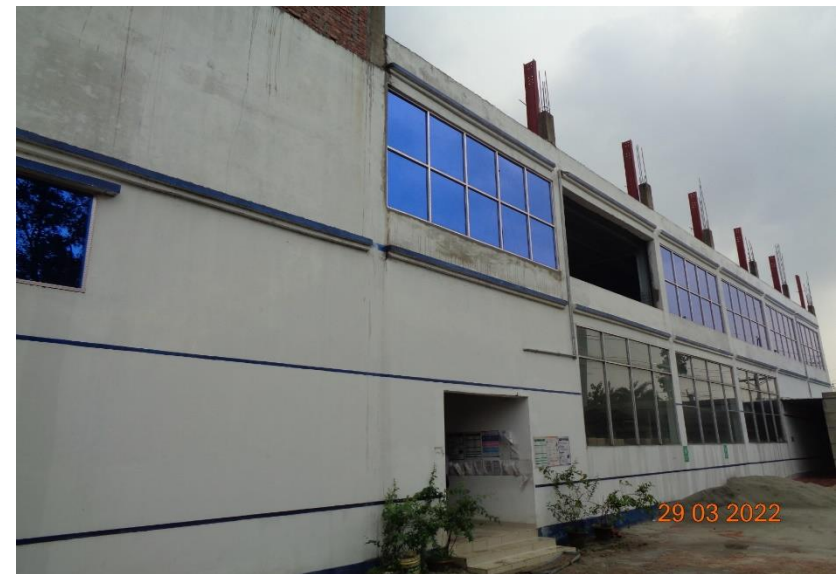
Building is currently 2 storied

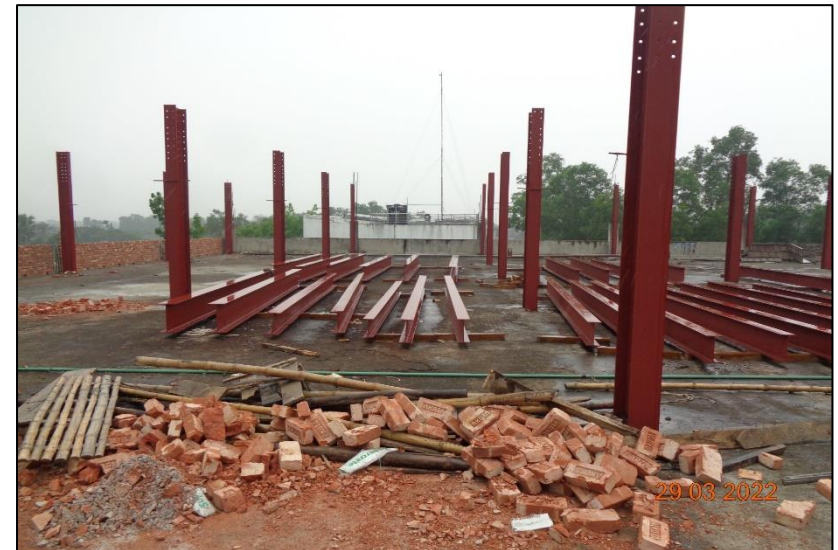
Ongoing construction on 2nd floor

| Item No. | Observation | Recommended Action Plan | Recommended Timeline |
|---|---|---|---|
| 01 | Ongoing vertical extension works require to be ceased immediately<br>(Factory Building) | Cease the ongoing vertical extension works immediately. | Immediate |

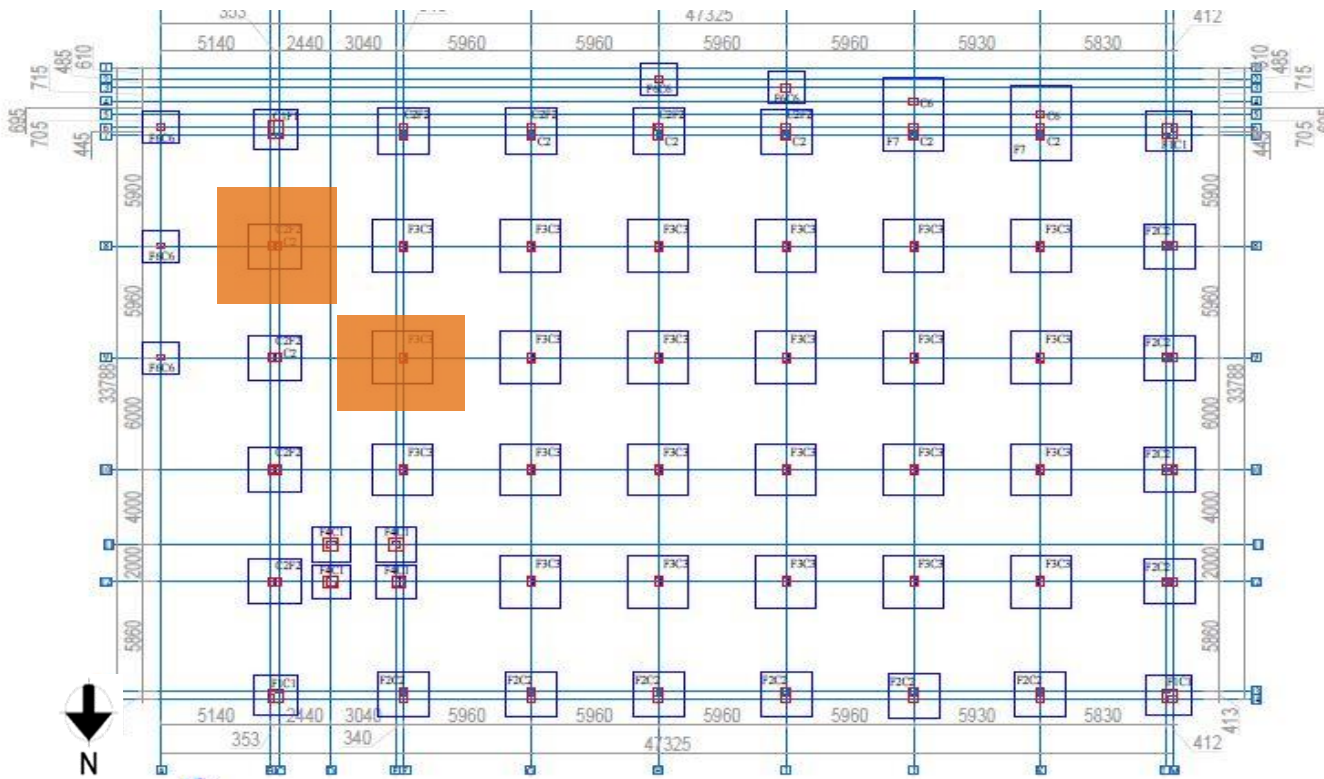
Column/footing layout

Cursory calculation indicates the high stress level in highlighted columns (marked in the layout) for above of 2 storied building. Factory is required to cease all kind of extension work immediately. Factory engineer is required to review, design of column stress and prepare a Detail Engineering Assessment (DEA) report prior conducting any vertical extension.

| Item No. | Observation | Recommended Action Plan | Recommended Timeline |
|---|---|---|---|
| 02 | Ongoing vertical extension works require to be ceased immediately<br>(Factory Building) | Factory engineer is required to review, design of column stress and prepare a Detail Engineering Assessment (DEA) report with necessary remedial action prior conducting any vertical extension above two storied. | 6-weeks |

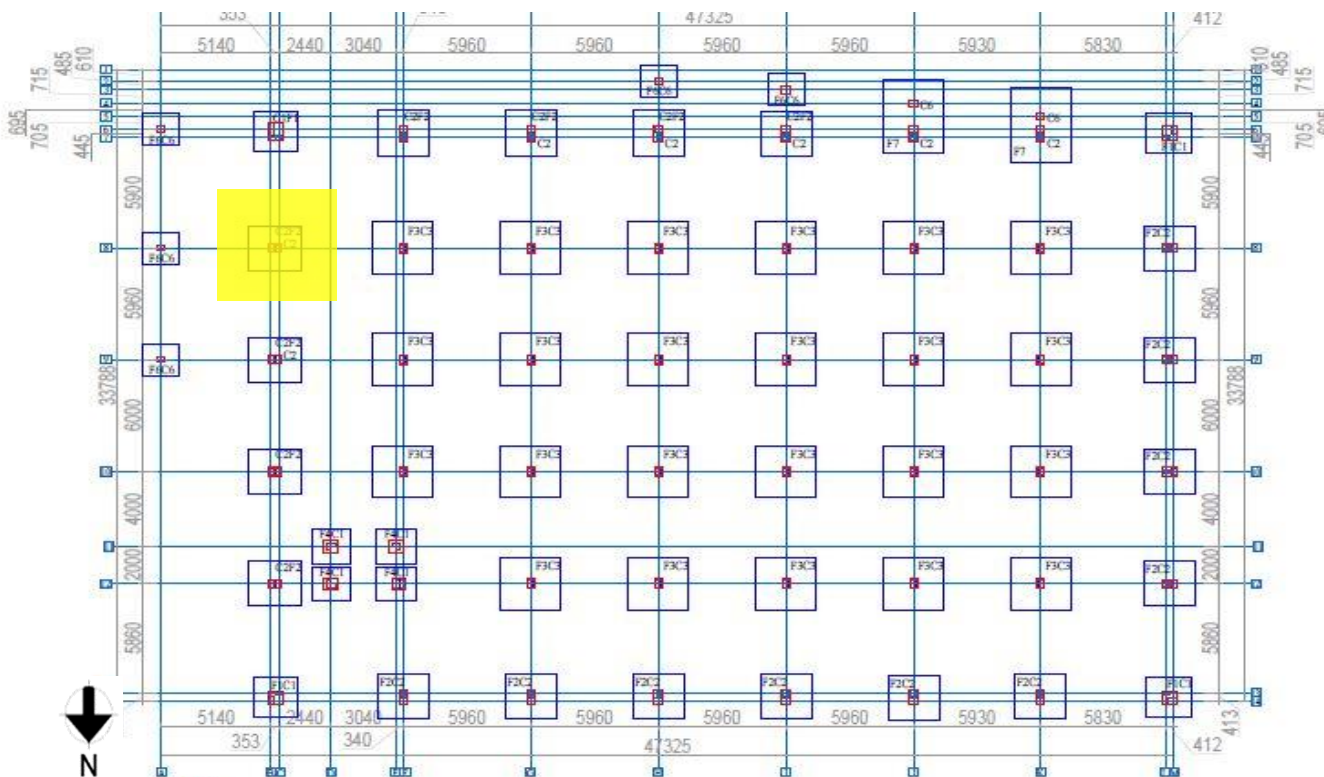
Cursory calculation indicates that stress in foundation exceeds normal design limit in highlighted foundation (marked in the layout) for above of 2 storied. Factory engineer is required to review, design of foundation stress and prepare a Detail Engineering Assessment (DEA) report prior conducting any vertical extension.

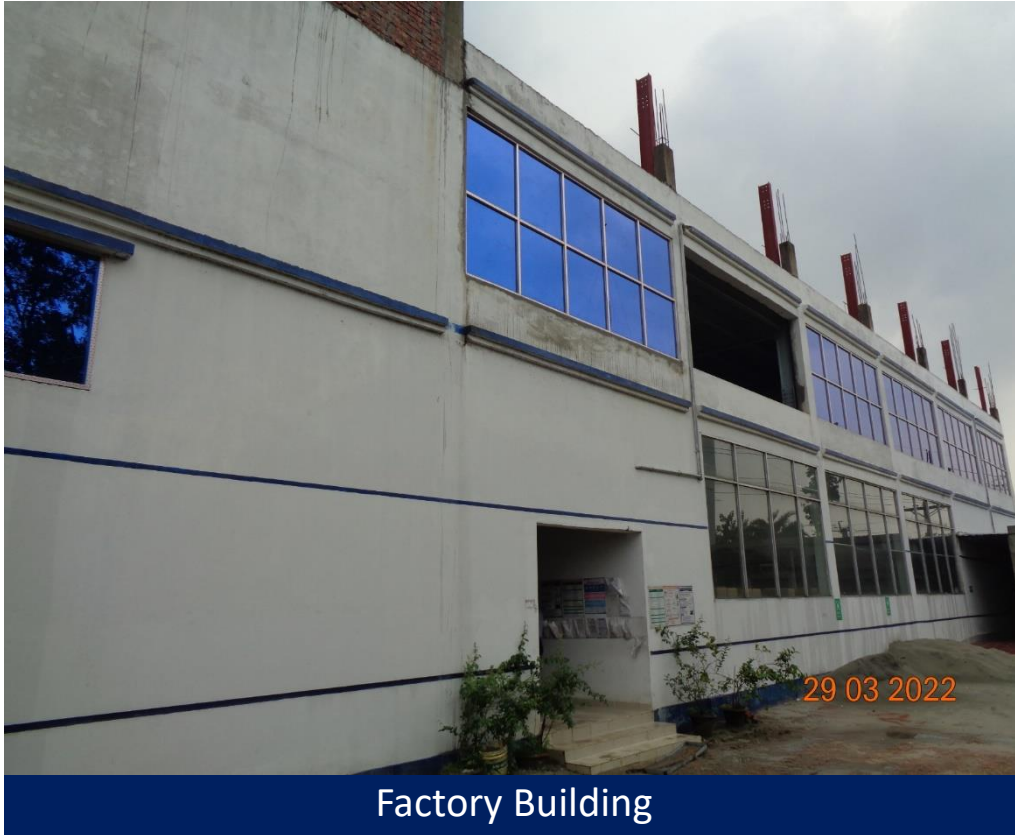
As per BNBC, every building or structure designed shall have its design documents prepared in accordance with the provision of Section 1.9.1. The design document shall include a design report, and a set of structural drawings, which shall be prepared in compliance with section 1.9.1.1 and section 1.9.1.2 as per BNBC. At the time of inspection, design report was not available which is required to be prepared in compliance with section 1.9.1.1 (part-6, BNBC).

| Item No. | Observation | Recommended Action Plan | Recommended Timeline |
|---|---|---|---|
| 07 | Absence of design documents<br>(Factory Building) | Factory engineer is required to prepare the design report in compliance with section 1.9.1.1 (part-6, BNBC). | 6-weeks |

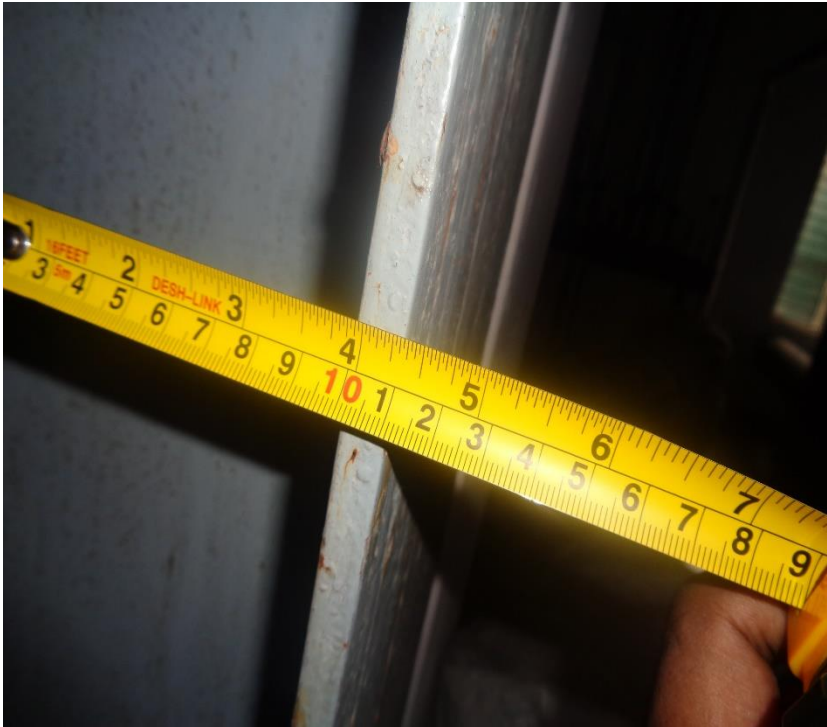
Flange thickness of column C-2 was measured as 10mm at ground floor

Flange thickness of column C-2 was measured as 10mm but shown in drawing as 14mm. Due to the change, the FoS of the columns significantly changes at ground floor level. Factory engineer is required to resurvey the whole structure and update as-built drawing accordingly.

| Item No. | Observation | Recommended Action Plan | Recommended Timeline |
|---|---|---|---|
| 09 | Discrepancy and missing information in as-built drawing<br>(Factory Building) | Factory engineer is required to update the as-built drawing. | 6-weeks |

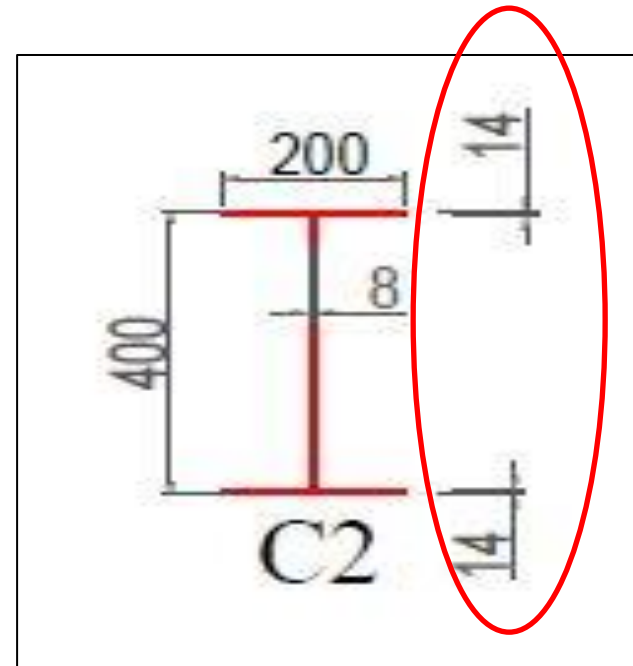
Flange thickness of column C-2 shown as 14mm

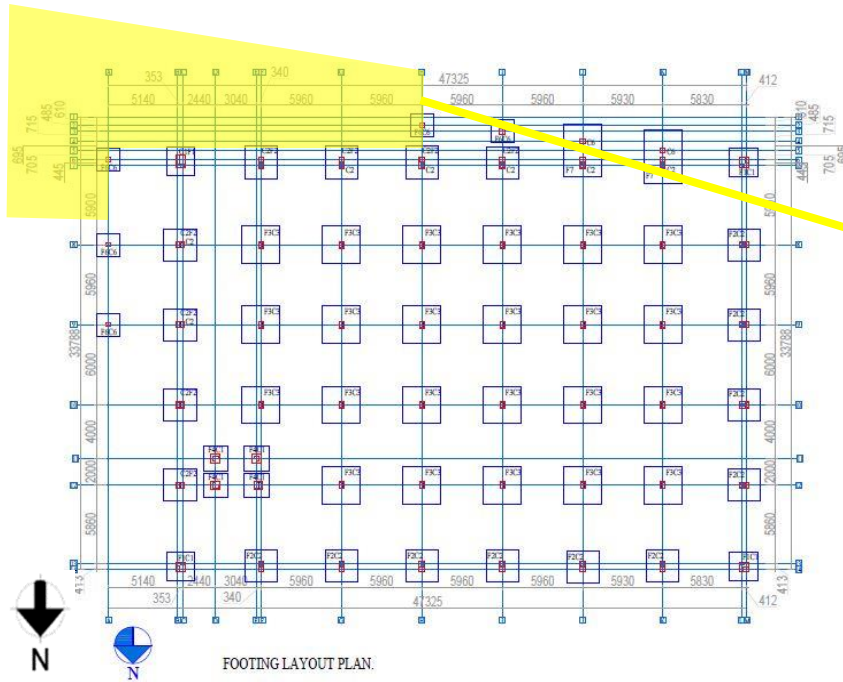
Column and footing for the yellow marked area not shown in layout

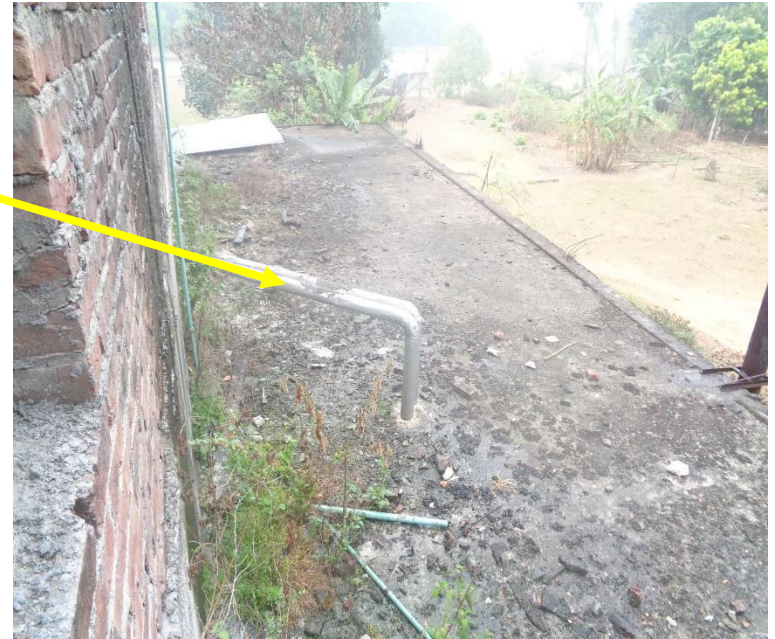
Utility part at ground floor

Column and footing of Utility part at GF not shown in layout. Factory engineer is required to resurvey the whole structure and update as-built drawing accordingly.

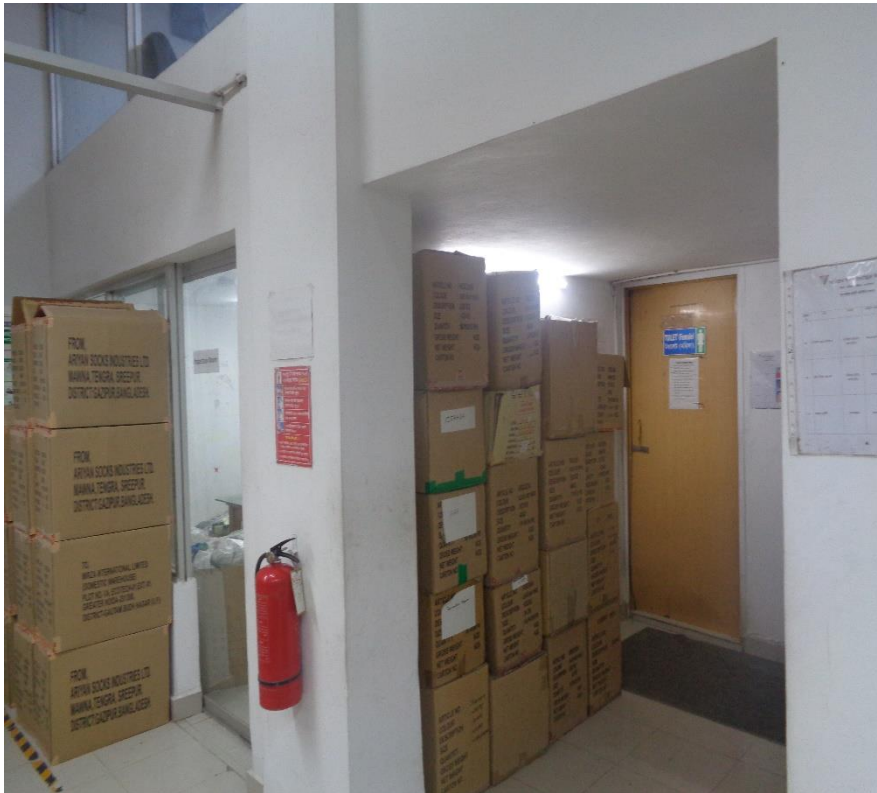
Dimension or thickness of mezzanine floor slab not shown in drawing

Dimension or thickness of mezzanine floor slab, dimension of sub-beam are not shown in drawing. Factory engineer is required to update the as-built drawing including all missing information.

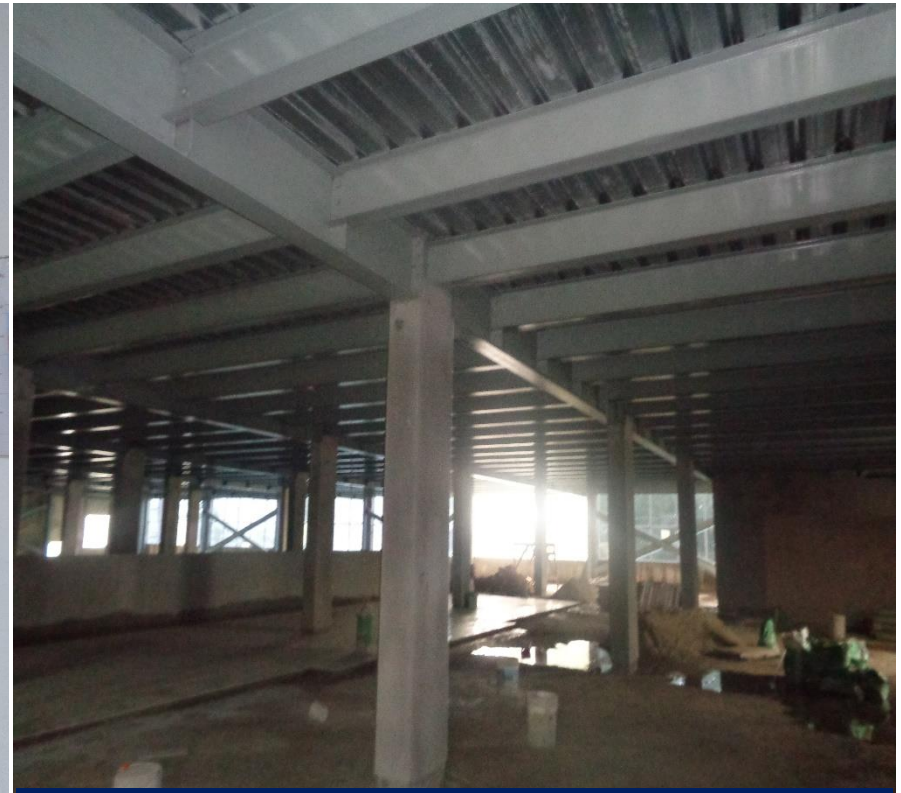
Dimension of sub-beam not shown in drawing

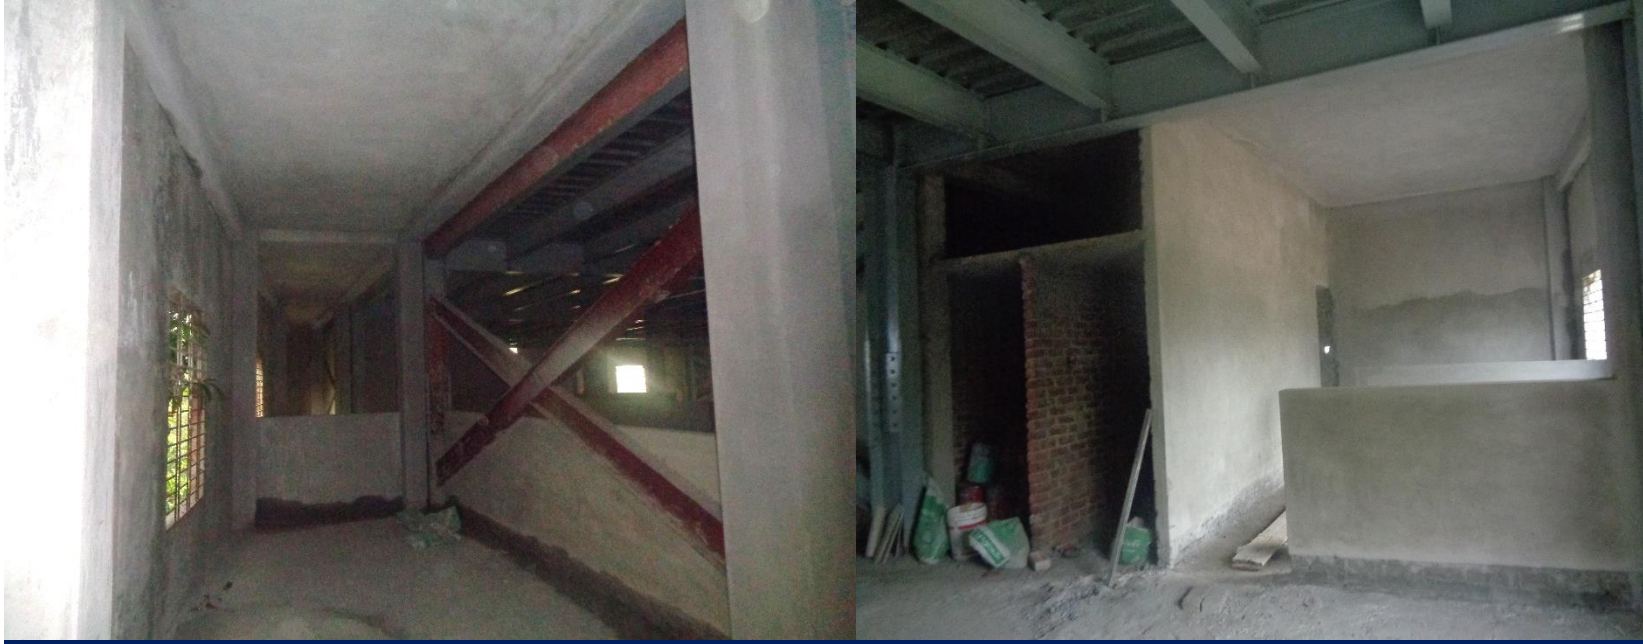
Dimension/layout of RC floor beam and slab not shown in drawing

Dimension/layout of RC floor beam and slab not shown in drawing. Factory engineer is required to update the as-built drawing including all missing information.

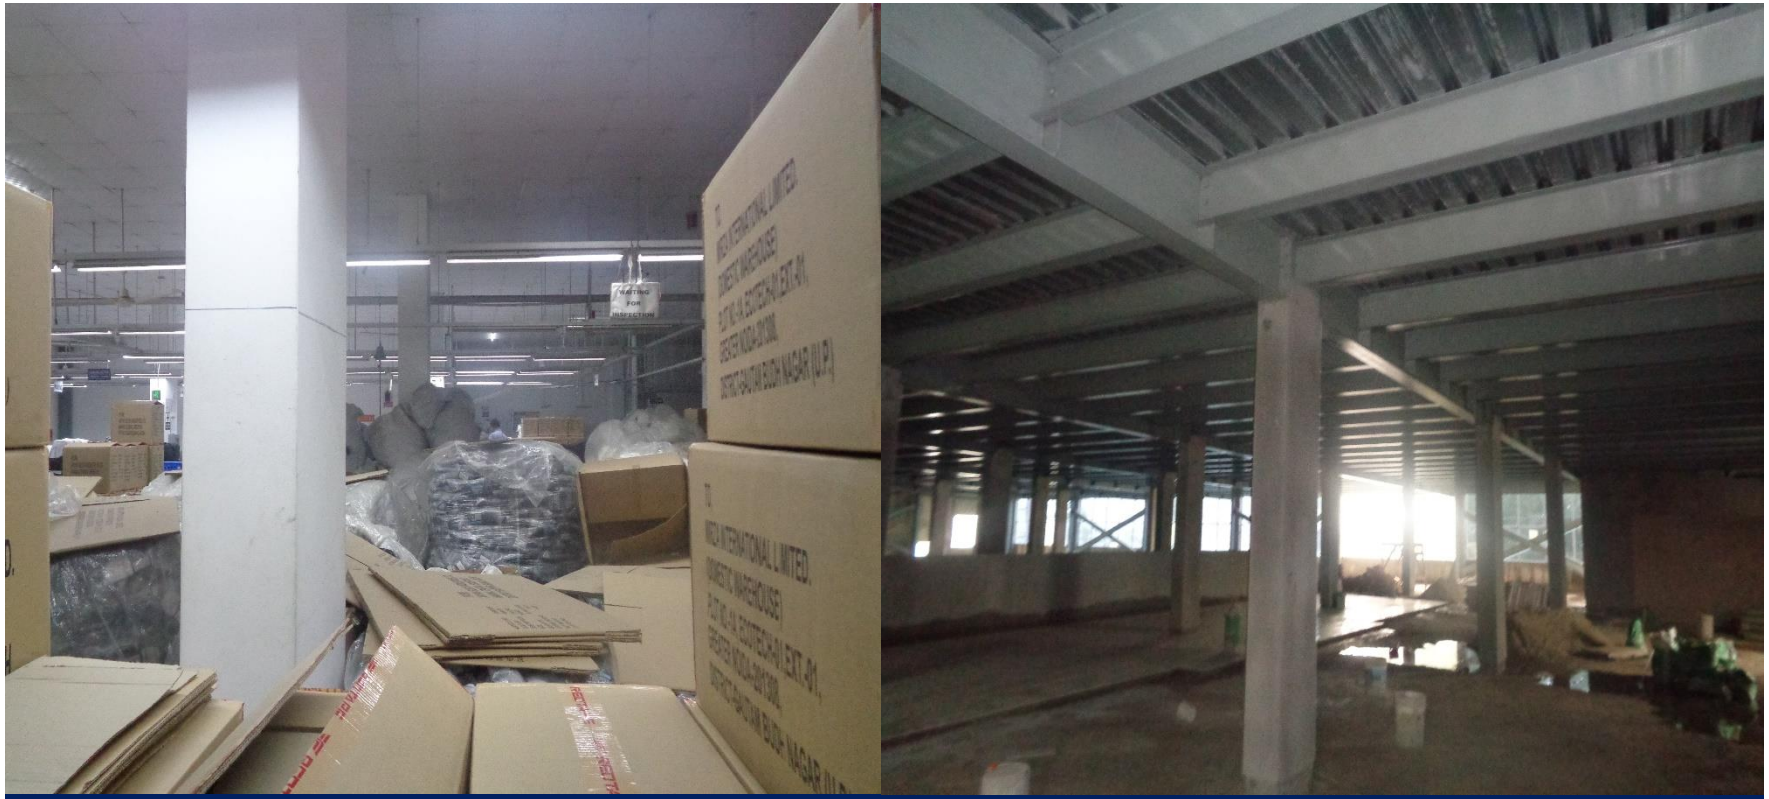
All internal steel columns are enclosed by RC casting

All internal steel columns were found enclosed by RC casting therefore the dimension/thickness of internal steel columns couldn't be verified. Factory engineer is required to confirm the dimension/thickness of all internal steel columns.

| Item No. | Observation | Recommended Action Plan | Recommended Timeline |
|---|---|---|---|
| 10 | Discrepancy and missing information in as-built drawing<br>(Factory Building) | Factory engineer is required to confirm the dimension/thickness of all internal steel columns. | 6-weeks |

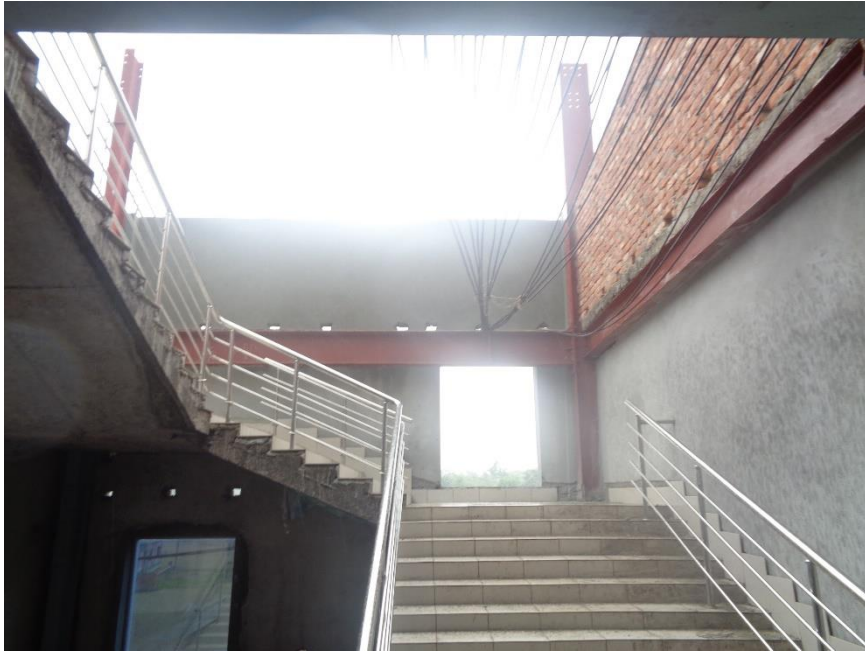
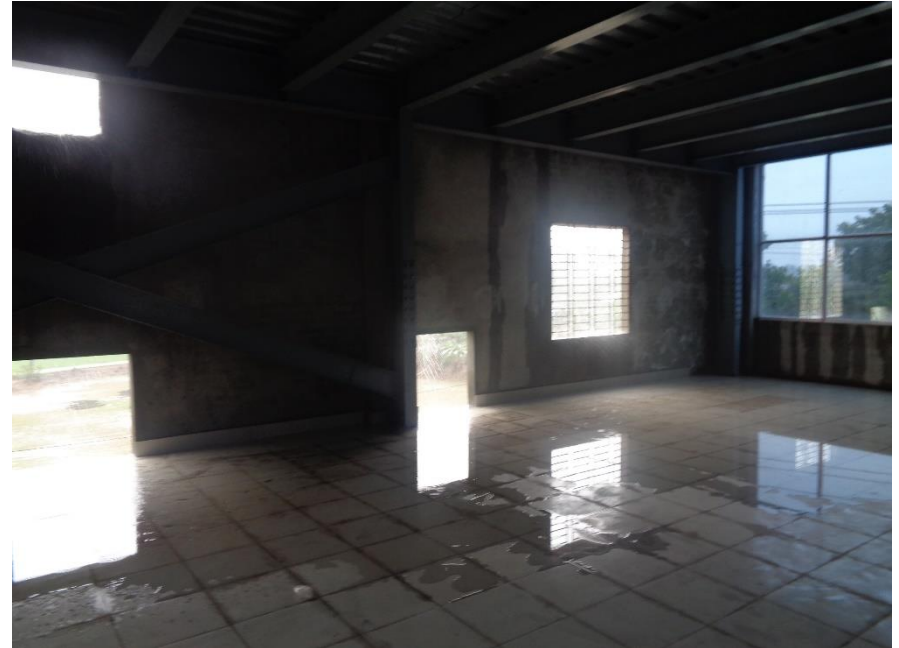
Water ingress was observed through periphery wall and staircase top

Water ingress was observed through periphery wall and staircase top. Factory is required to provide protection to prevent the water ingress.

| Item No. | Observation | Recommended Action Plan | Recommended Timeline |
|---|---|---|---|
| 11 | Water ingress through periphery wall and staircase (Factory Building) | Factory is required to provide protection to prevent the water ingress. | 6-months |

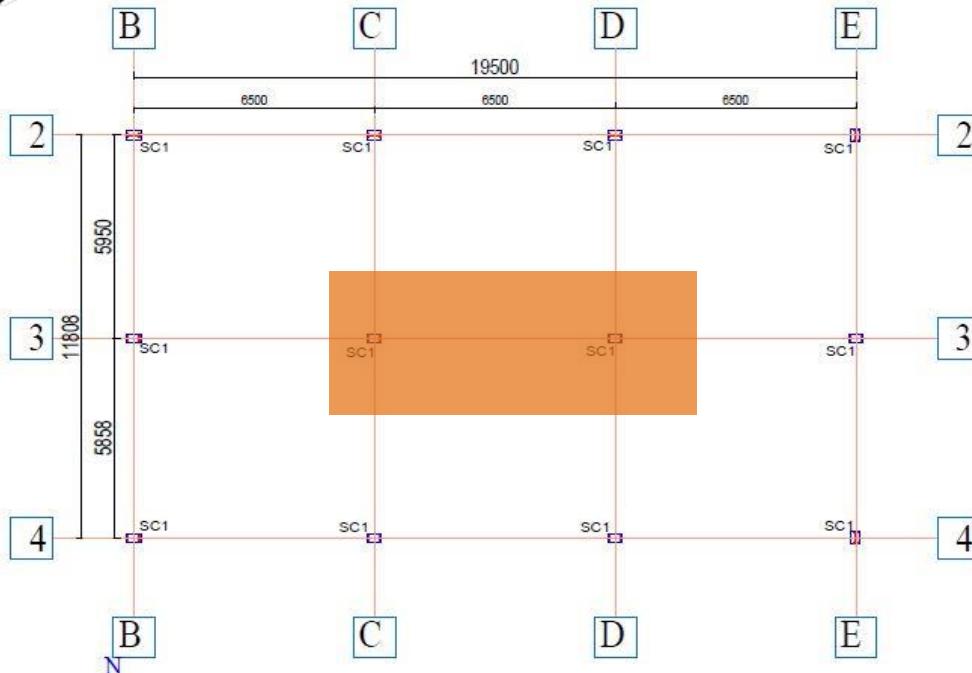
Highly stressed columns in layout

Cursory calculation indicates the high stress level in ground floor (amber marked) considering the live load 3 kPa for typical floor, 2 kPa for roof open to sky (as per load plan), strength of steel 289 MPa from the available MS plate test report. Factory engineer is required to review the design, loads and column stresses for the marked columns and carry out a Detail Engineering Assessment (DEA). Maintain the floor live load 2 kPa at 1<sup>st</sup> floor and roof.

| Item No. | Observation | Recommended Action Plan | Recommended Timeline |
|---|---|---|---|
| 12 | High Stress level in ground floor column<br>(Office Building) | Maintain 2 kPa live load at all floor levels. | Immediate |

| Item No. | Observation | Recommended Action Plan | Recommended Timeline |
|---|---|---|---|
| 13 | High Stress level in ground floor column (Office Building) | Factory engineer is required to review the design, loads and column stresses for the marked columns. | 6-weeks |

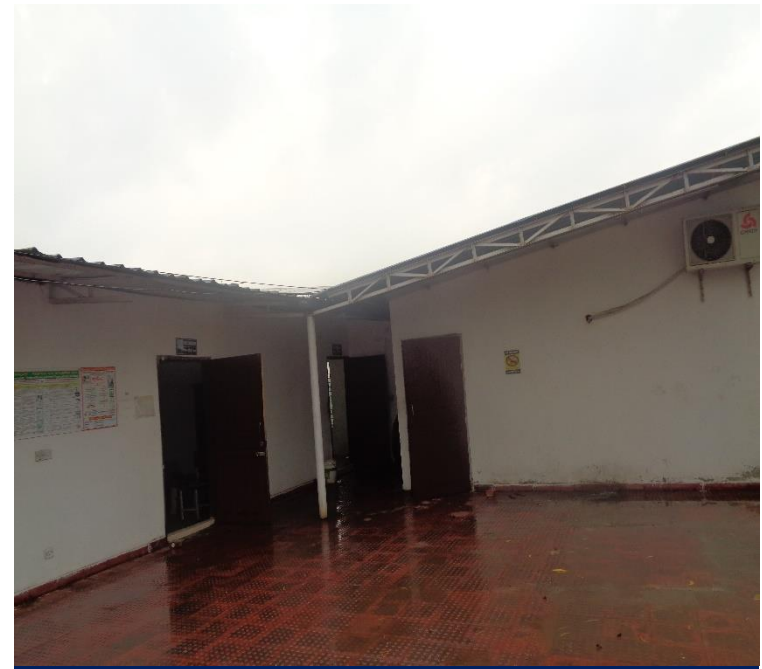
Load from brick wall and dining at roof

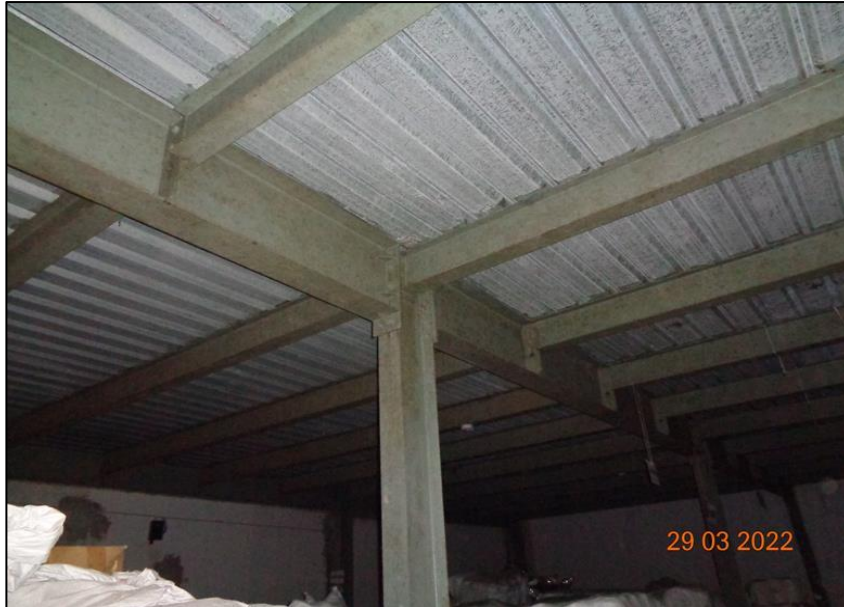
Moment resisting frame is only provided along long direction

Moment resisting frame is only provided along long direction and no wall bracing is provided therefore there is apparently lack of lateral stability along short direction. Factory engineer is required to check the lateral stability of the structure.

| Item No. | Observation | Recommended Action Plan | Recommended Timeline |
|---|---|---|---|
| 18 | Lack of lateral stability (Office Building) | Factory engineer is required to check the lateral stability of the structure. | 6-weeks |

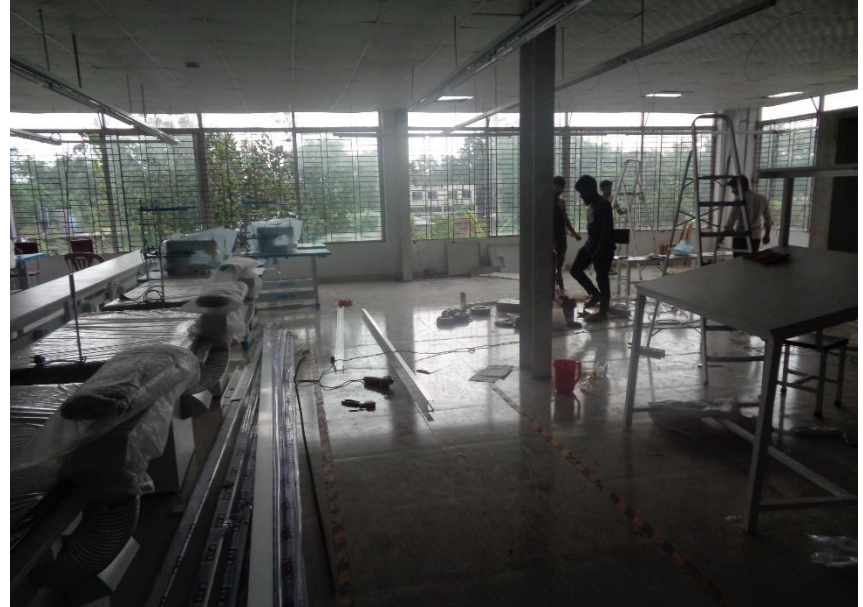
No wall bracing is provided

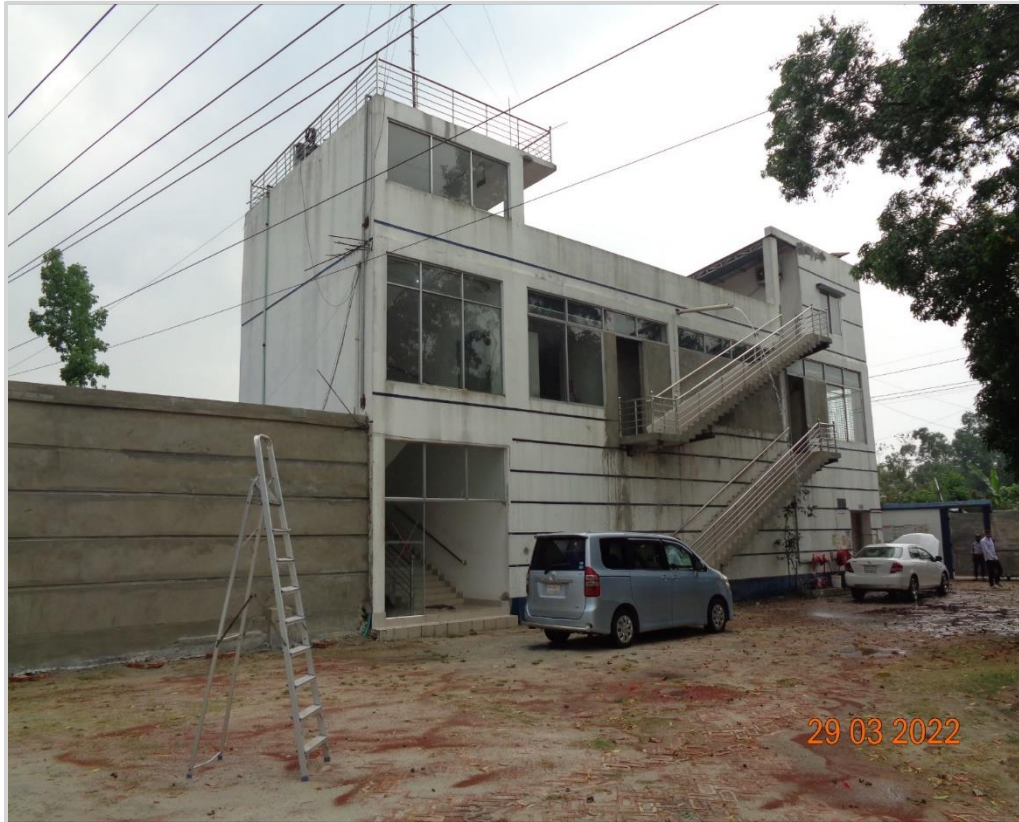
Office Building-front view

As per BNBC, every building or structure designed shall have its design documents prepared in accordance with the provision of Section 1.9.1. The design document shall include a design report, and a set of structural drawings, which shall be prepared in compliance with section 1.9.1.1 and section 1.9.1.2 as per BNBC. At the time of inspection, no design report was available which is required to be prepared in compliance with section 1.9.1.1 (part-6, BNBC).

| Item No. | Observation | Recommended Action Plan | Recommended Timeline |
|---|---|---|---|
| 20 | Absence of design documents (Office Building) | Factory engineer is required to prepare the design report in compliance with section 1.9.1.1 (part-6, BNBC). | 6-weeks |

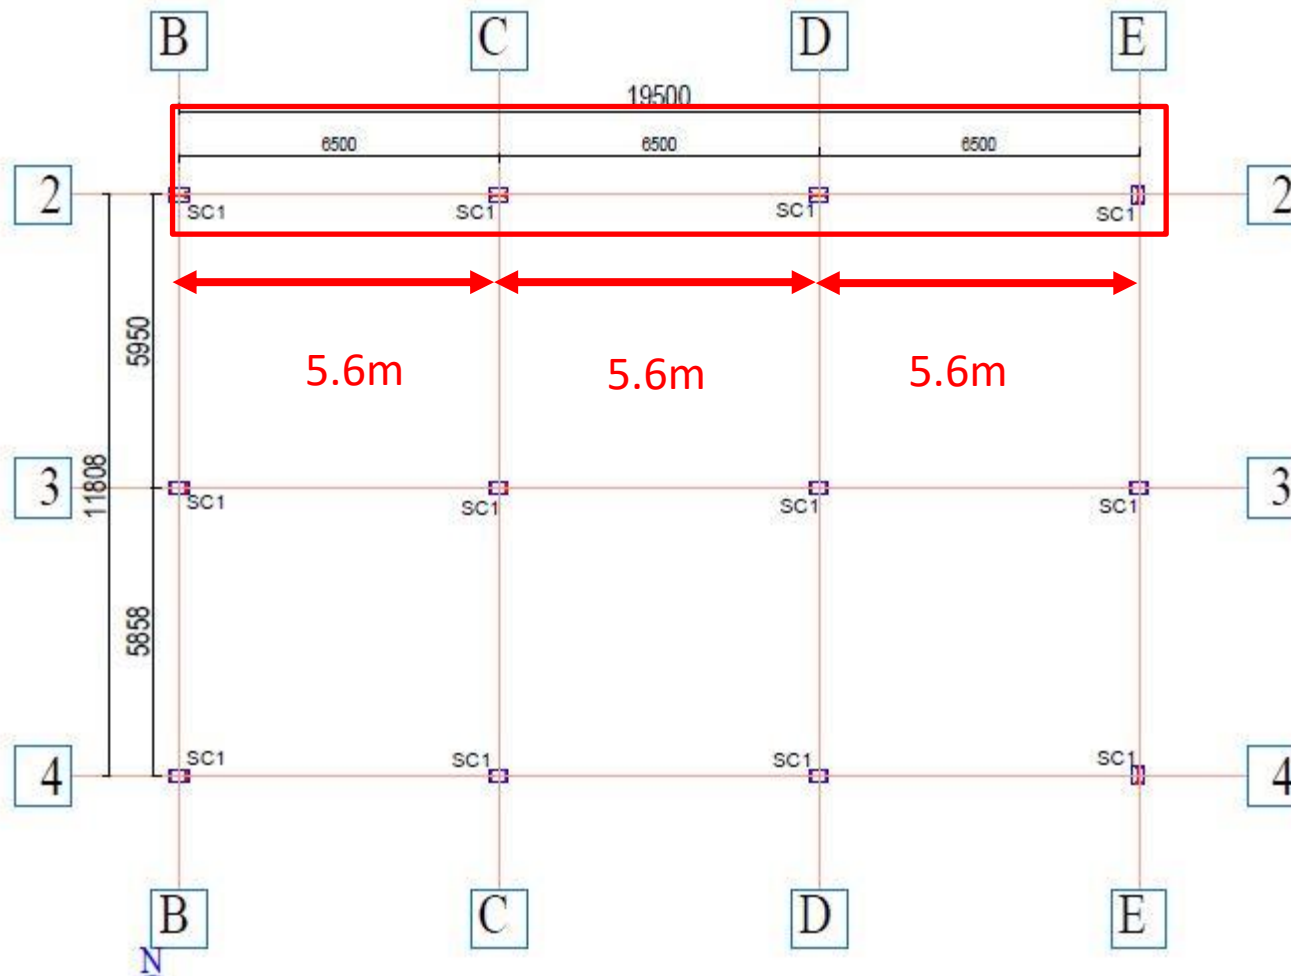
Grid dimension was measured 5.6m instead of 6.5m (marked)

Factory engineer is required to resurvey the whole structure and update as-built drawing accordingly.

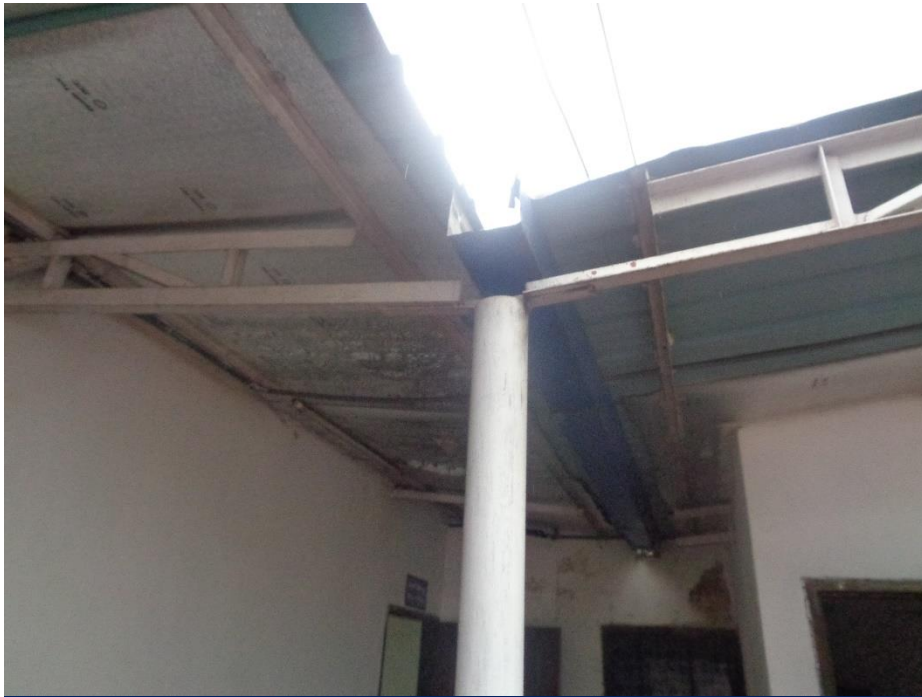
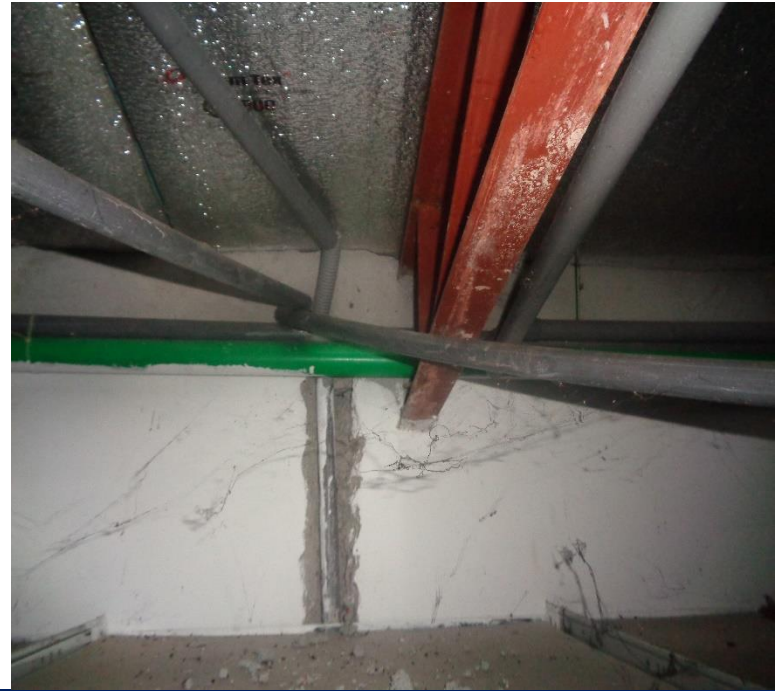
Connection of truss to steel pipe and brick wall

Connection of steel members to pipe column and brick wall were appeared to be inadequate. Factory engineer is required to check the connection adequacy for uplift forces as part of EA.

| Item No. | Observation | Recommended Action Plan | Recommended Timeline |
|---|---|---|---|
| 23 | Apparently inadequate connections (Roof Shed: Office Building) | Factory engineer is required to check the connection adequacy for uplift forces. | 6-weeks |

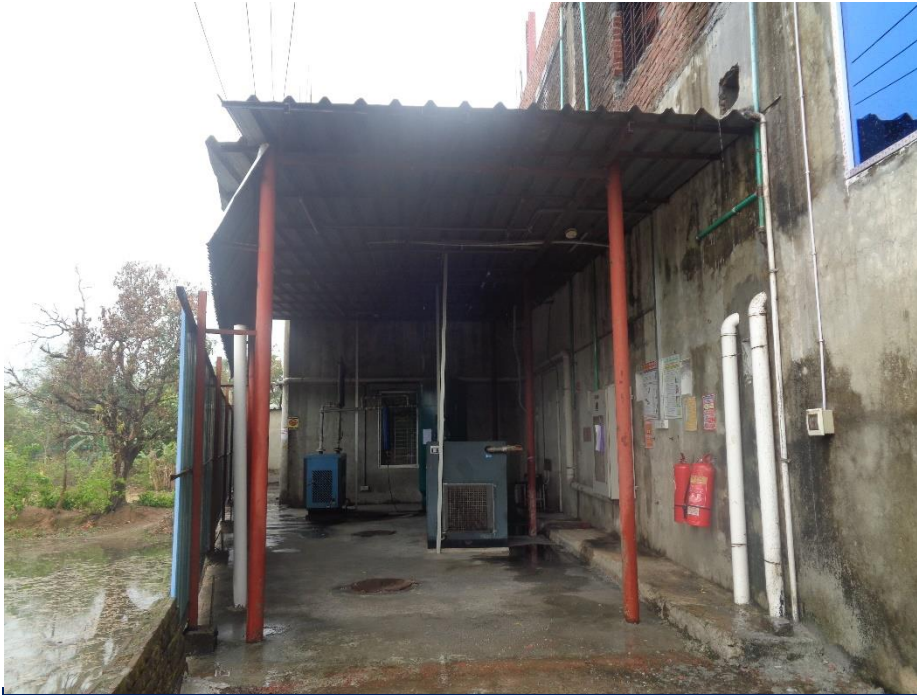
Both Shed-1 and Shed-2 were appeared to be non engineered due to lack of apparent load path, poor connection and apparently inadequate member size. Factory engineer is required to check the connection adequacy for uplift forces as part of EA otherwise replace with well designed structure.

| Item No. | Observation | Recommended Action Plan | Recommended Timeline |
|---|---|---|---|
| 25 | Apparently non engineered shed (Shed-1:Compressor Room; Shed-2: Sub-Store & CT-PAT) | Factory engineer is required to check the connection adequacy for uplift forces otherwise replace the sheds with well designed structure. | 6-weeks |

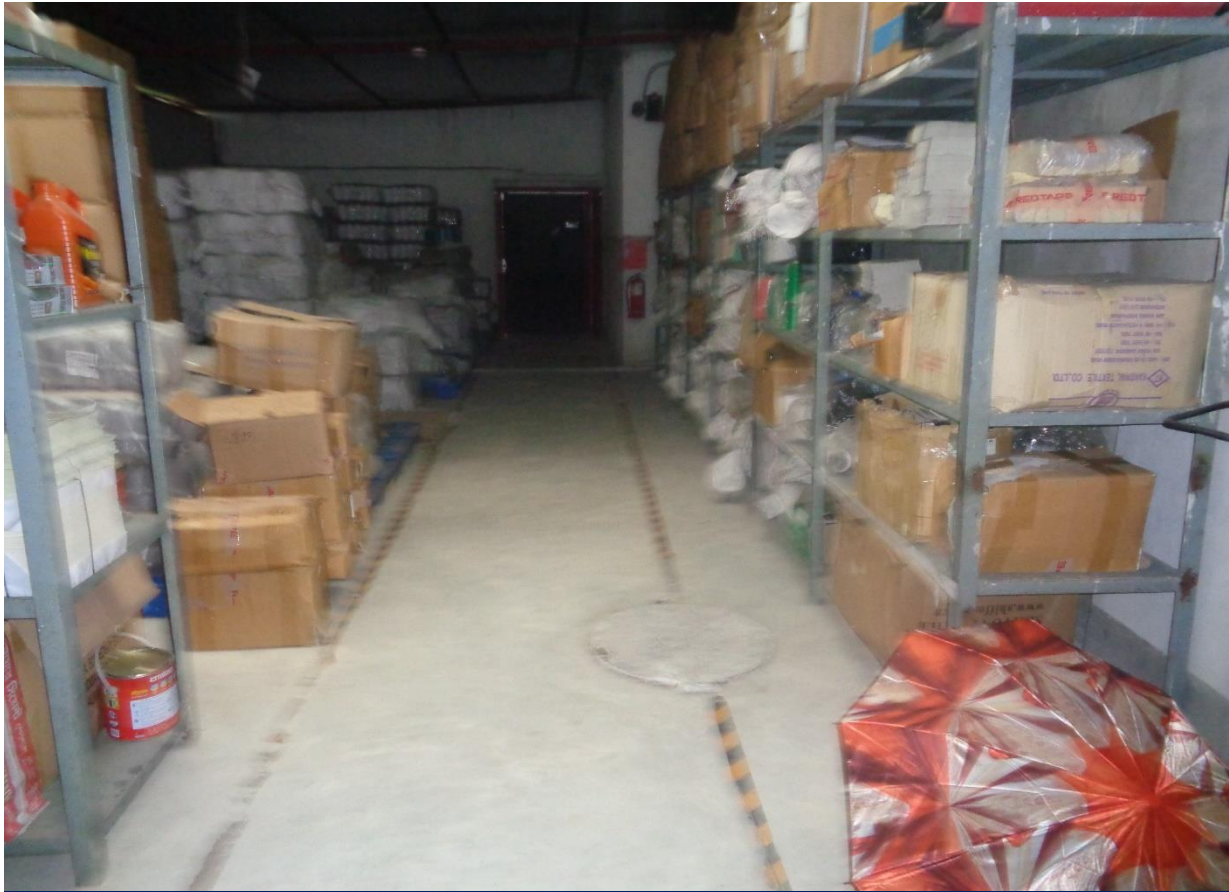
Storage rack found within the building without braced/anchored

Factory is required to brace/anchor all non structural elements.
