# Arkay Knit Dyeing Mills Ltd.

Tongabari, Bangabandhu Road, Ashulia, Savar, Dhaka - Bangladesh.  
(23.89747, 90.31463)

28 March 2022

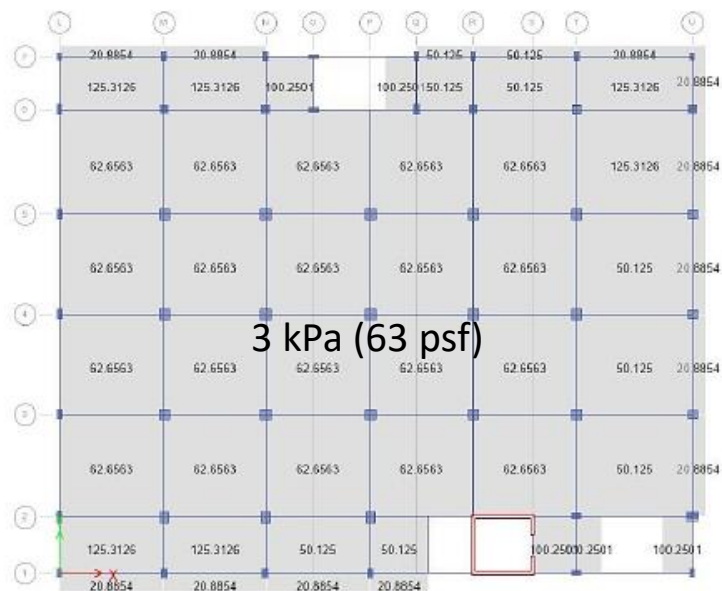
Figure 6.16: Assigned Live Load on 3<sup>rd</sup> Floor (part 2) (psf)

As per BNBC 2020 the minimum floor live load for the light garments manufacturing is 4 kPa.  
3 kPa live load considered for the 3<sup>rd</sup> and 4<sup>th</sup> floor.

| Item No. | Observation | Recommended Action Plan | Recommended Timeline |
|---|---|---|---|
| 04 | Design report doesn't fully comply BNBC. (Building-1) | Prepare the floor live load plan as per BNBC. | 6-weeks |

| Item No. | Observation | Recommended Action Plan | Recommended Timeline |
|---|---|---|---|
| 07 | Design report doesn't fully comply BNBC. (Building-1) | Implement floor load plan. | 6-months |

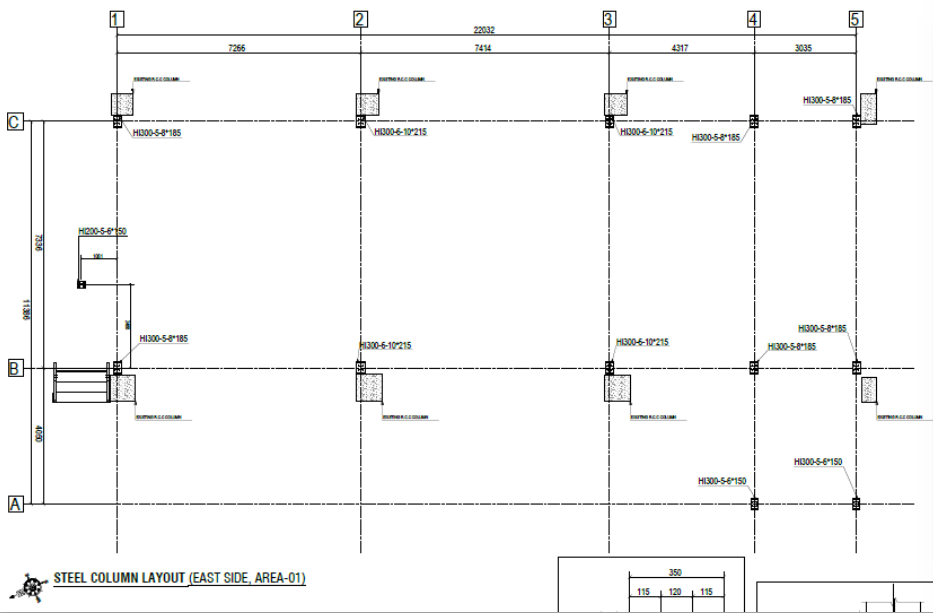
Self supported steel mezzanine floor

Columns of mezzanine floor supported on the ground slab of the Building 1. In design report the foundation adequacy of the mezzanine floor not included. Building engineer is required to check the punching shear capacity of the ground slab of the Building 1.

| Item No. | Observation | Recommended Action Plan | Recommended Timeline |
|---|---|---|---|
| 08 | Punching shear adequacy check of the mezzanine column supported ground slab. (Building-1) | Building engineer is required to check the punching shear capacity of the ground slab of the Building 1. | 6-weeks |
| 09 | Punching shear adequacy check of the mezzanine column supported ground slab. (Building-1) | Implement the remedial works where required. | 6-months |

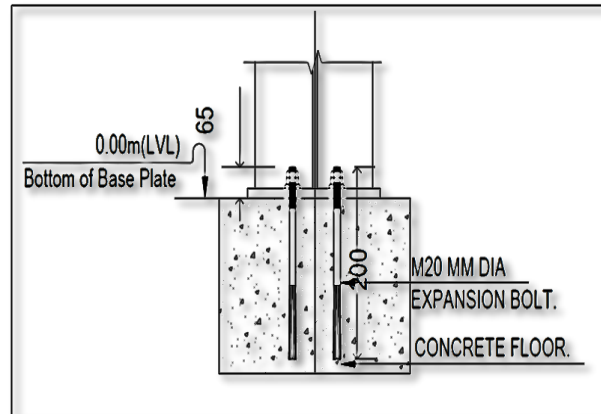
Connection of steel column of mezzanine floor and ground slab

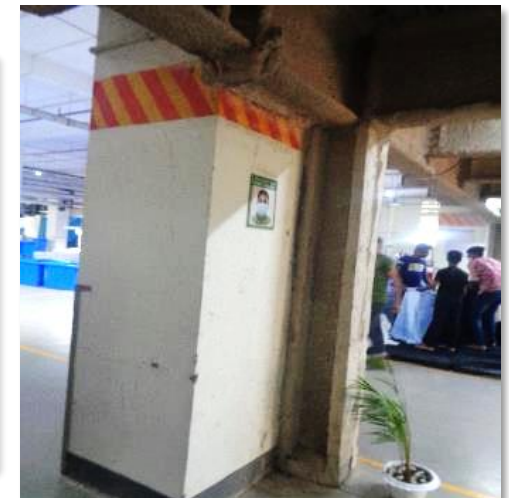
Steel mezzanine floor column on ground slab

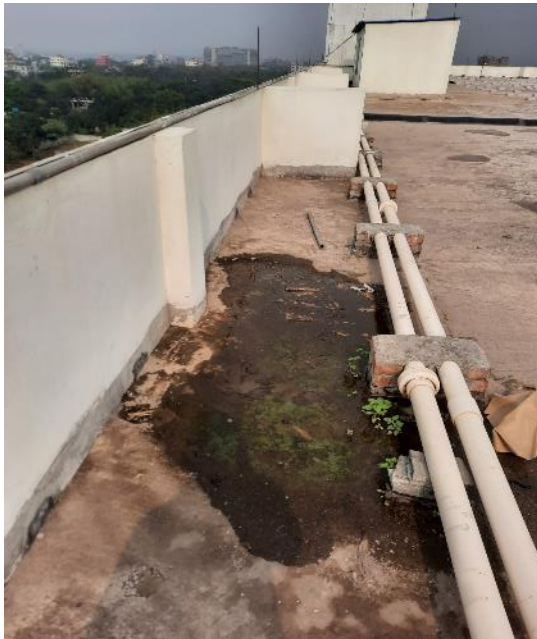
Water ponding at the roof of Building-1

Water clogging was observed on roof of the buildings due to leakage of pipeline & improper drainage system. Building engineer is required to improve the roof drainage system & to repair the leakage of pipeline.

| Item No. | Observation | Recommended Action Plan | Recommended Timeline |
|---|---|---|---|
| 10 | Improve roof drainage system. (Building-1 & 2) | Building engineer is required to improve the roof drainage system with adequate slope & repair the leakage of pipeline | 6-weeks |

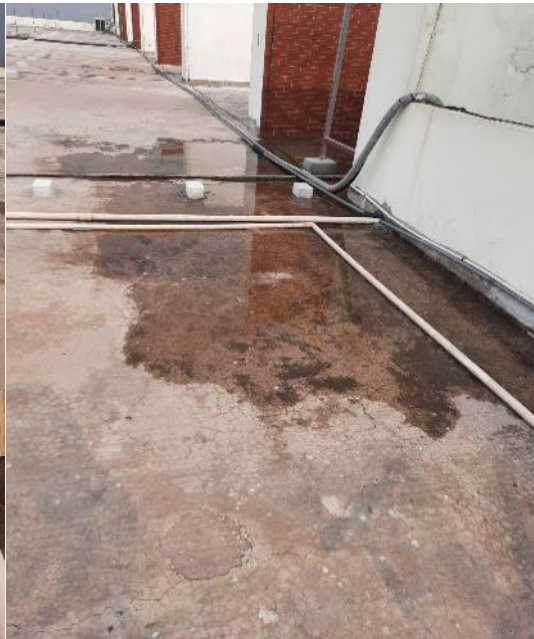
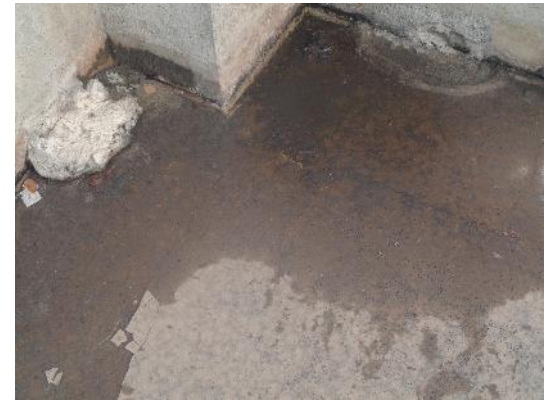
Water ponding at the roof of Building-2

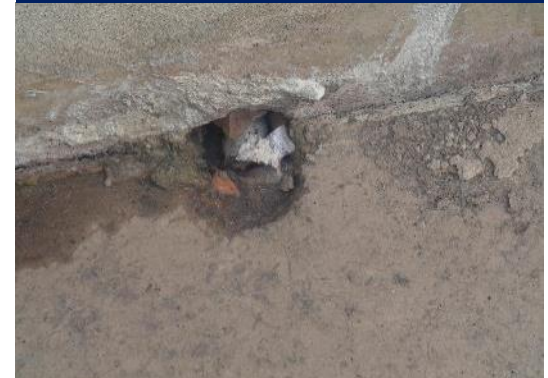
Inactive outlet at the roof of Building-2

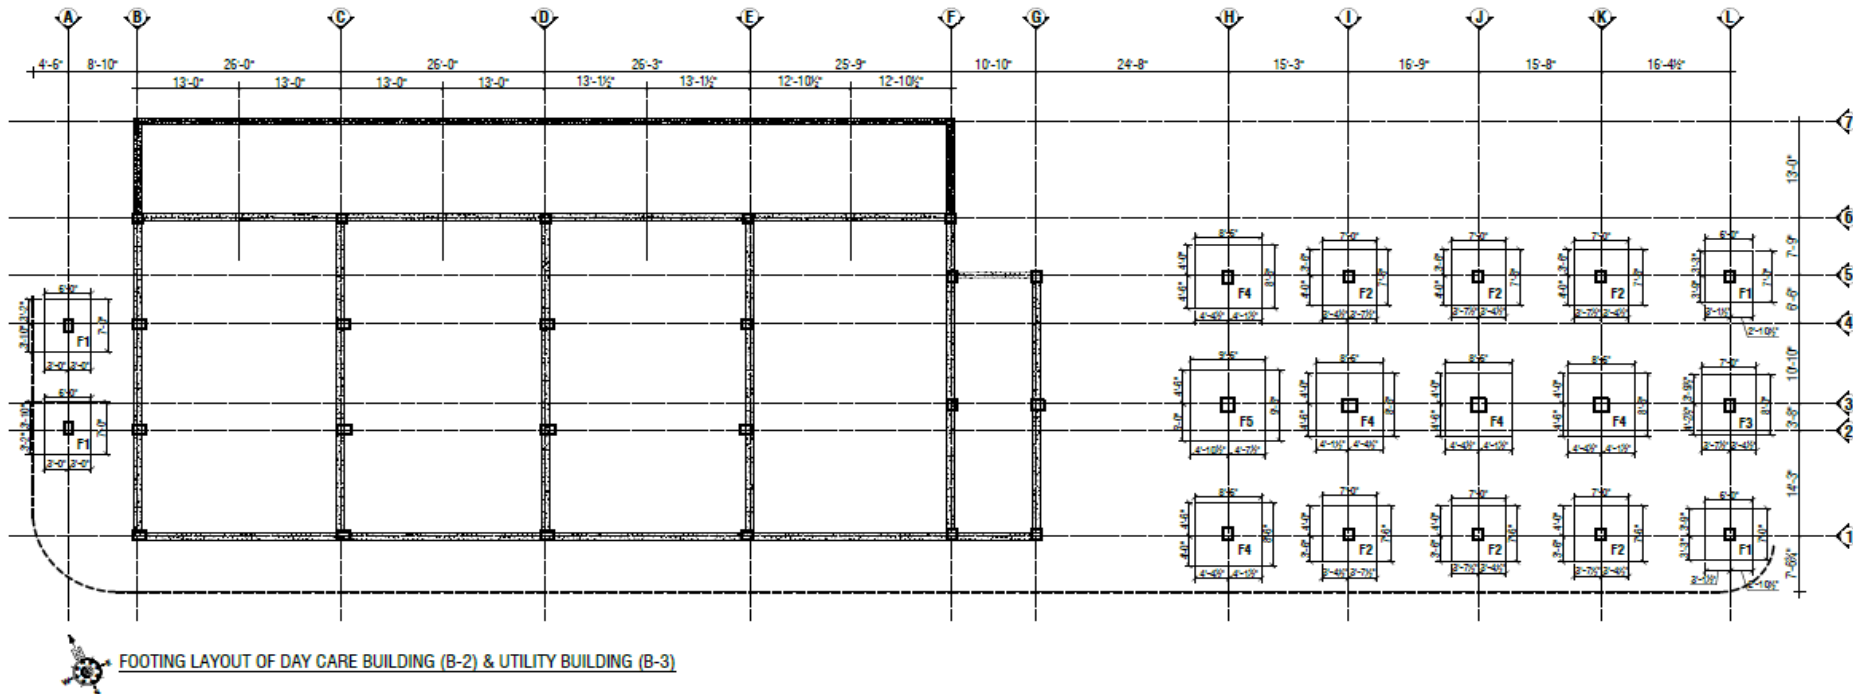
Different foundation system observed in the drawing. Settlement check of the shallow foundation not included in the design report. The building engineer is required to incorporate the settlement of the foundation system in the design report.

| Item No. | Observation | Recommended Action Plan | Recommended Timeline |
|---|---|---|---|
| 11 | Settlement check of foundation absent in the design report. (Building 2) | Building engineer is required to survey the structure and produce accurate as-built drawings. | 6-weeks |
| 12 | Settlement check of foundation absent in the design report. (Building 2) | Implement any remediation work where required. | 6-months |

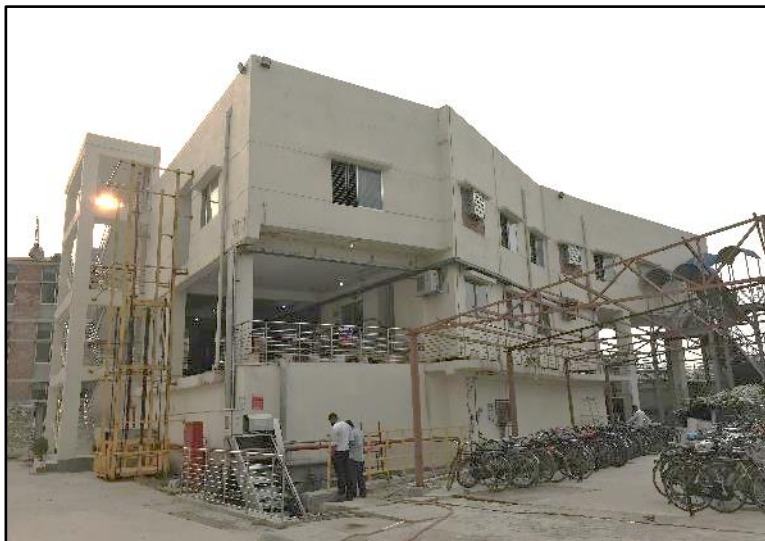
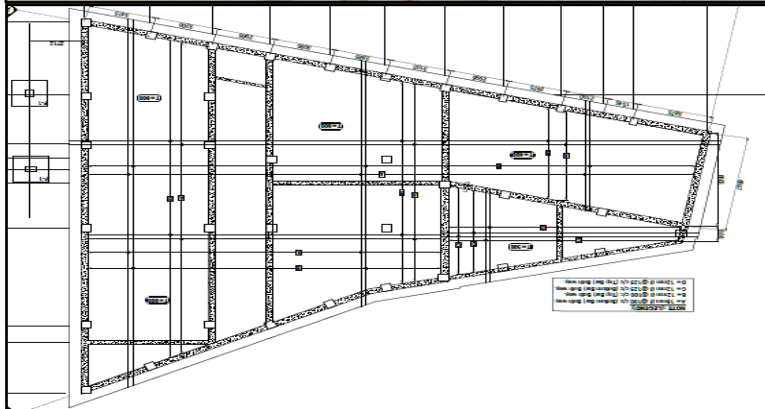
Building-5 : Irregular in shape

The building shape is geometrically irregular. Due to lateral forces, the building might be affected for torsional irregularities. In design report, extreme torsional irregularities found. Building engineer is required to suggest remedial action for the torsional irregularities.

| Item No. | Observation | Recommended Action Plan | Recommended Timeline |
|---|---|---|---|
| 13 | Torsional effect due to the irregular shape of the building. (Building-5) | Building engineer is required to suggest remedial action for the torsional irregularities. | 6-weeks |
| 14 | Torsional effect due to the irregular shape of the building. (Building-5) | Implement any remediation work where required. | 6-months |
