# Vintage Denim Studio Ltd.(Extended Building)

MSSFB-2, EPZ, PAKSHI, ISHWARDI, PABNA  
(24.089065, 89.033439)

2<sup>nd</sup> June 2021

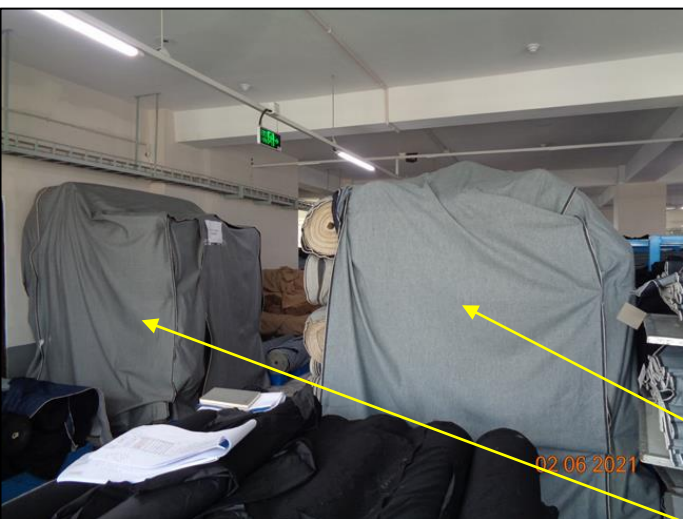
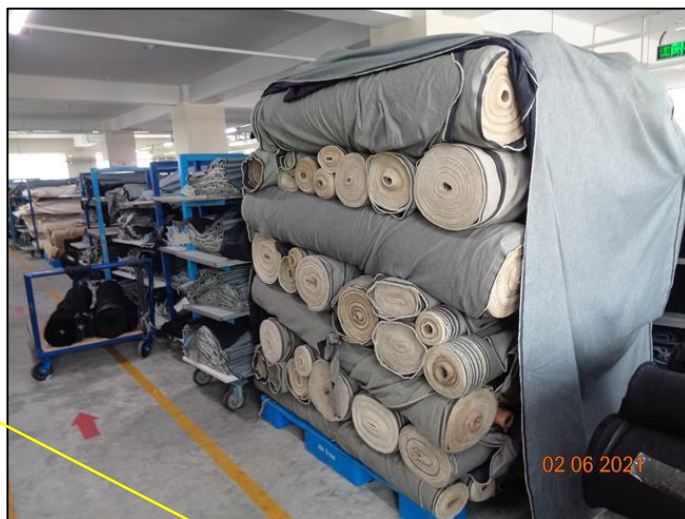
Uncontrolled loading was found on 3<sup>rd</sup> floor of the building due to stack of the denim roll. Loading was found more than 4 kPa. Factory is required to maintain the floor live load within 4 kPa as per prepared live load plan.

| Item No. | Observation | Recommended Action Plan | Recommended Timeline |
|---|---|---|---|
| 03 | Uncontrolled loading at 3rd Floor (Main Building) | Factory is required to maintain the prepared floor live load plan. | 6-weeks |

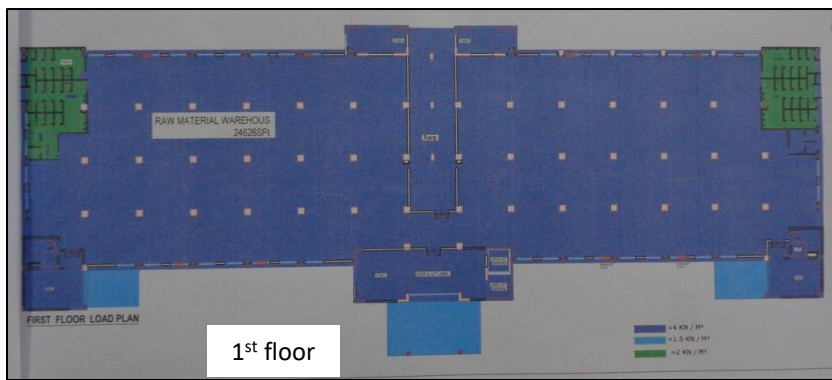
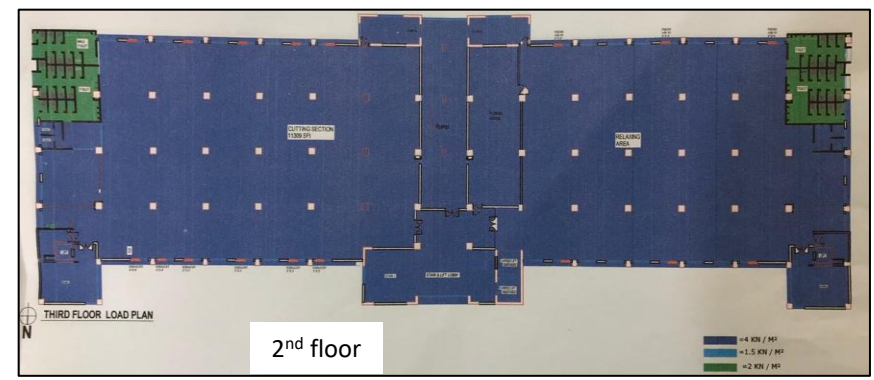
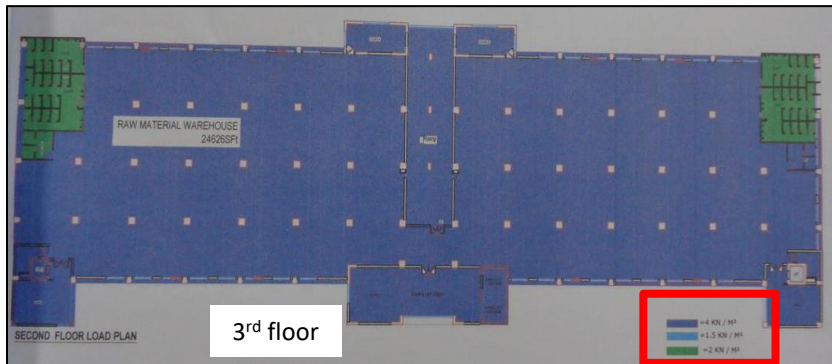
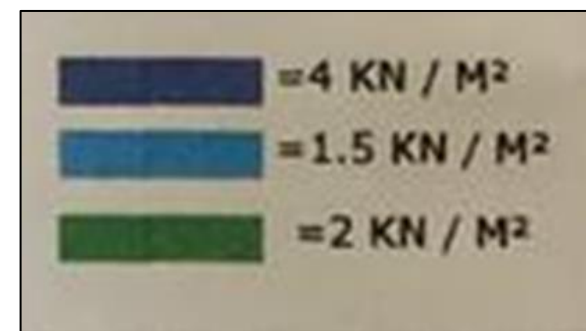
Floor loading for 1<sup>st</sup> to 3<sup>rd</sup> Floor has been shown 4 kPa.

As per BNBC, 6 kPa is required to consider as floor loading for the light storage facilities. During inspection, load plan was found posted considering 4 kPa from 1<sup>st</sup> to 3<sup>rd</sup> floor.

Factory engineer is required to update the live load plan as per live load Table-6.2.3 of BNBC-2006 and updated load plan is required to be considered while preparing the Design Report.

| Item No. | Observation | Recommended Action Plan | Recommended Timeline |
|---|---|---|---|
| 04 | Load plan needs to be revised (Main Building) | Factory engineer is required to revise the live load plan as per live load Table-6.2.3 of BNBC-2006 and based on capacity of structural members. | 6-weeks |

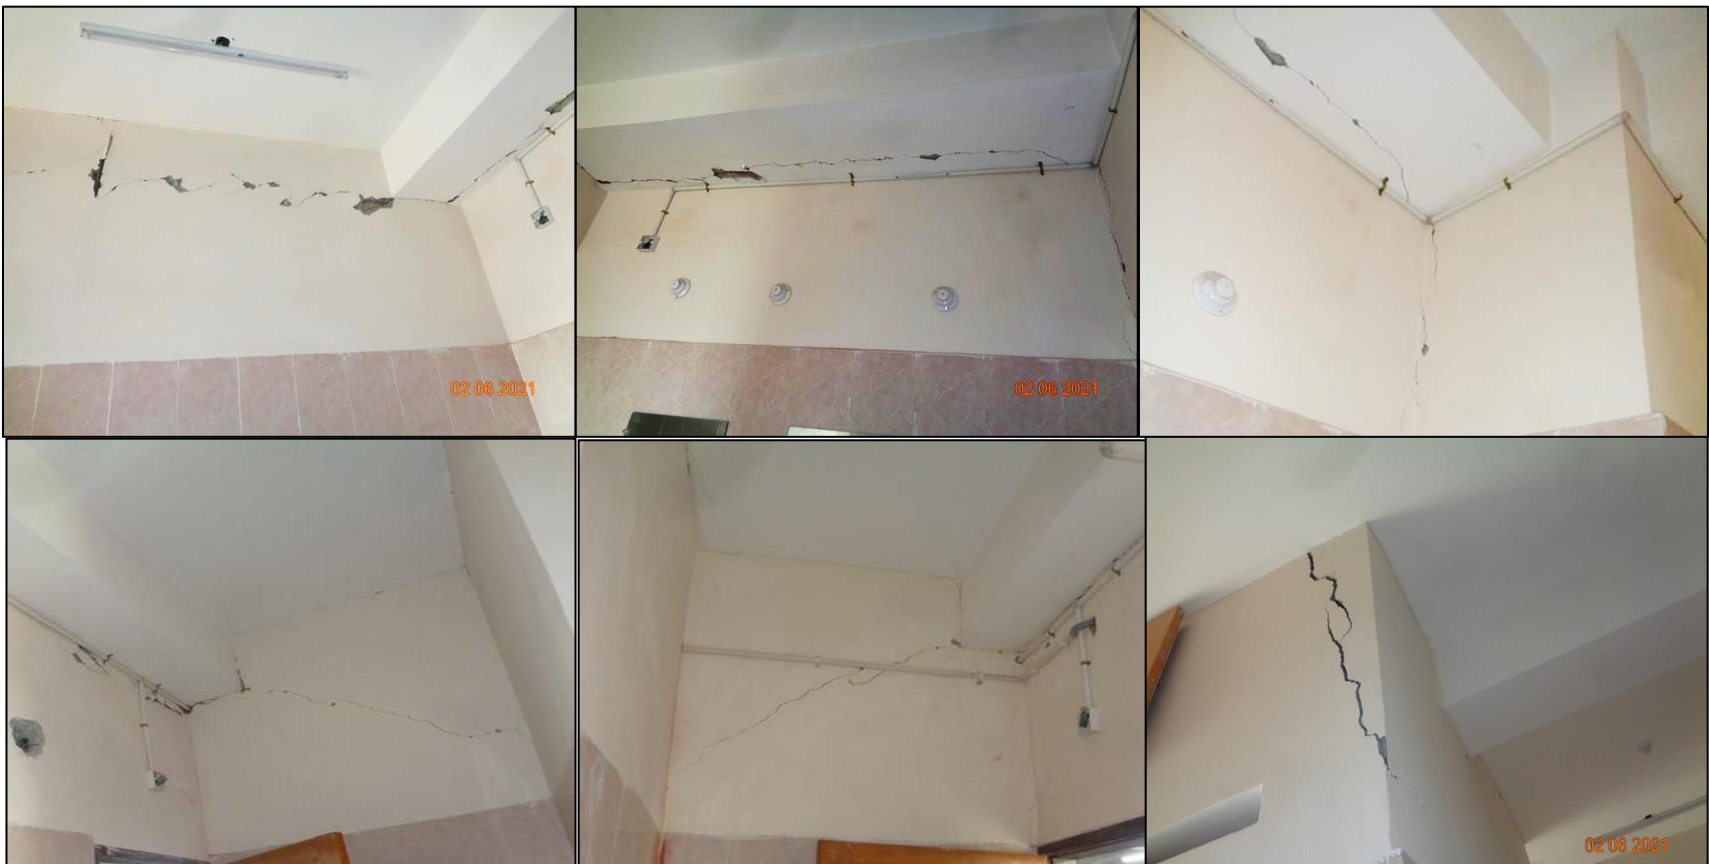
Crack in brick wall

Severe crack was found in brick wall at 3<sup>rd</sup> floor toilet zone area. Also, cracks were found at façade wall. These cracks may have been generated due to the torsional irregularity of the structure or/and deflection of slab.

Factory engineer is required to investigate the cause of crack and repair the crack as per recommendation from investigation report.

| Item No. | Observation | Recommended Action Plan | Recommended Timeline |
|---|---|---|---|
| 06 | Cracks in brick wall (Main Building) | Factory engineer is required to investigate the cause of crack and repair the crack as per recommendation from investigation report. | 6-weeks |

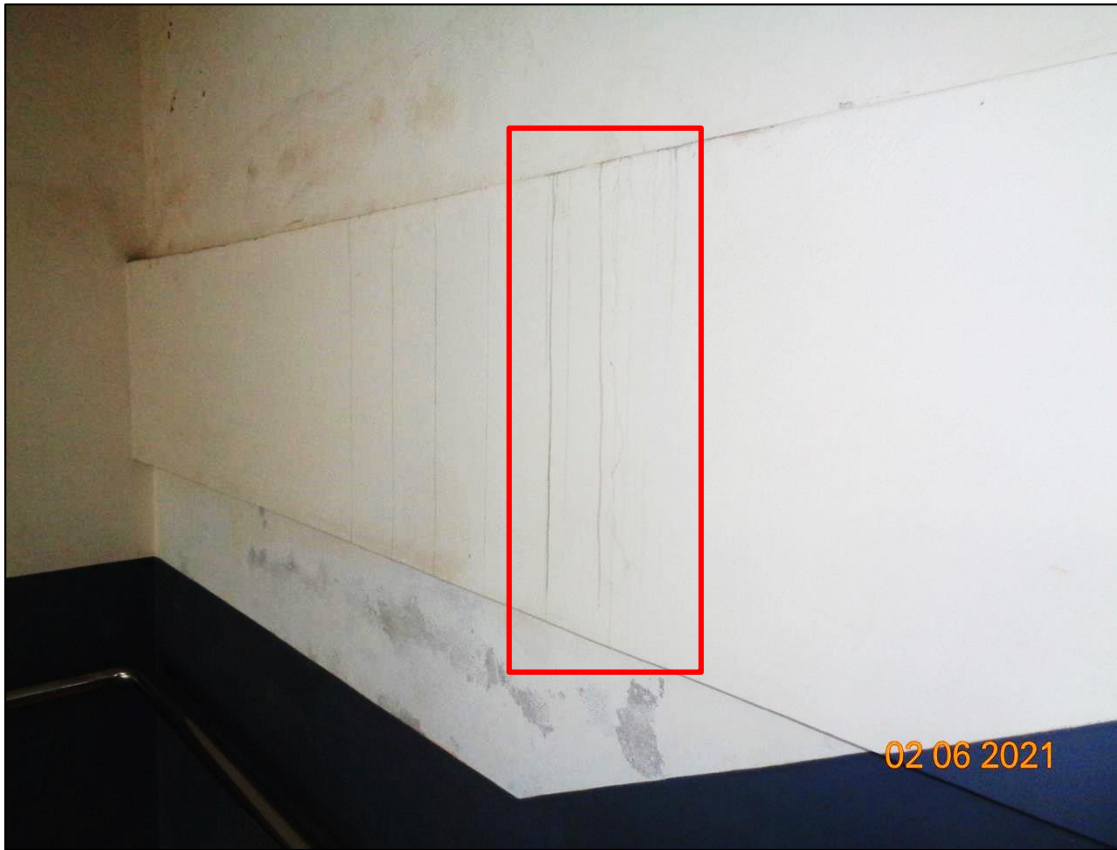
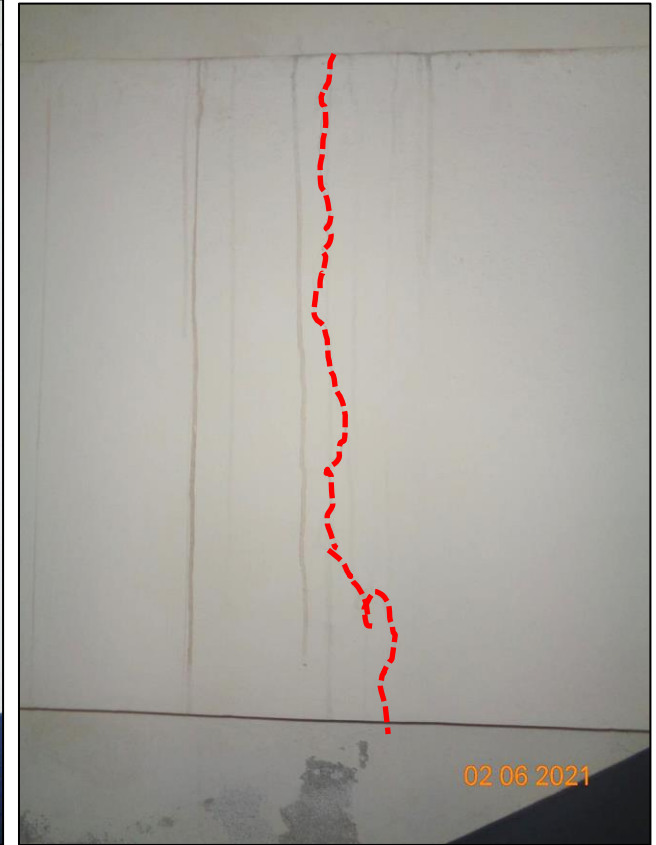
Hairline crack was found in the North-West side stair beam. Factory engineer is required to investigate the crack and carry out suitable repair works.

| Item No. | Observation | Recommended Action Plan | Recommended Timeline |
|---|---|---|---|
| 07 | Hairline cracks in beam (Main Building) | Factory engineer is required to investigate the cause of crack and repair the crack as per recommendation from investigation report. | 6-weeks |

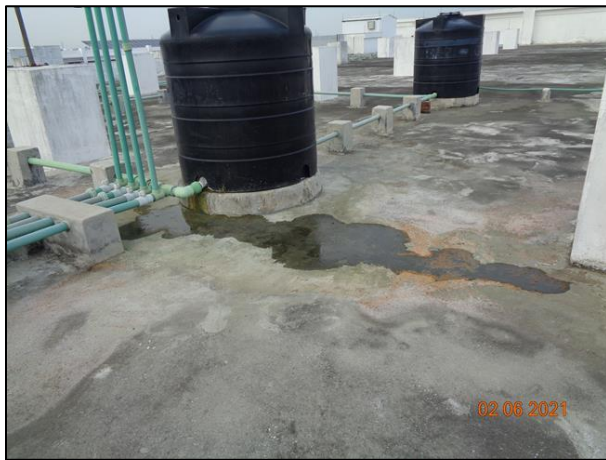
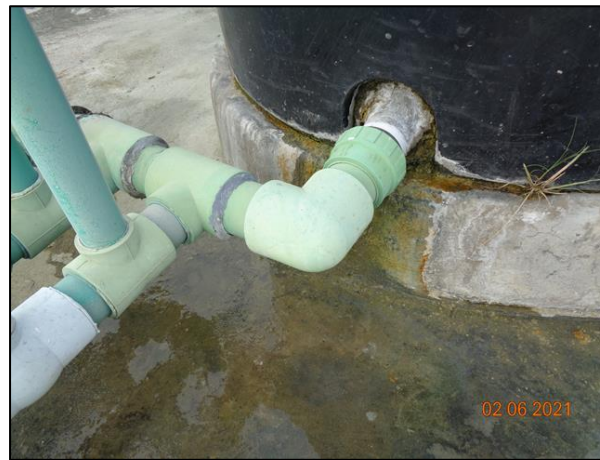
Due to leakage in the water supply line water ponding found at roof. Also, signage of water ponding found at roof due to depression in water proofing layer.

Factory engineer is required to take necessary measures to repair the leakage in the water supply line and improve the drainage system to prevent the water ponding at roof.

| Item No. | Observation | Recommended Action Plan | Recommended Timeline |
|---|---|---|---|
| 08 | Leakage in water supply line and signage of water ponding at roof<br>(Main Building) | Factory management is required to take necessary measures to proof the leakage in water supply line. | 6-weeks |

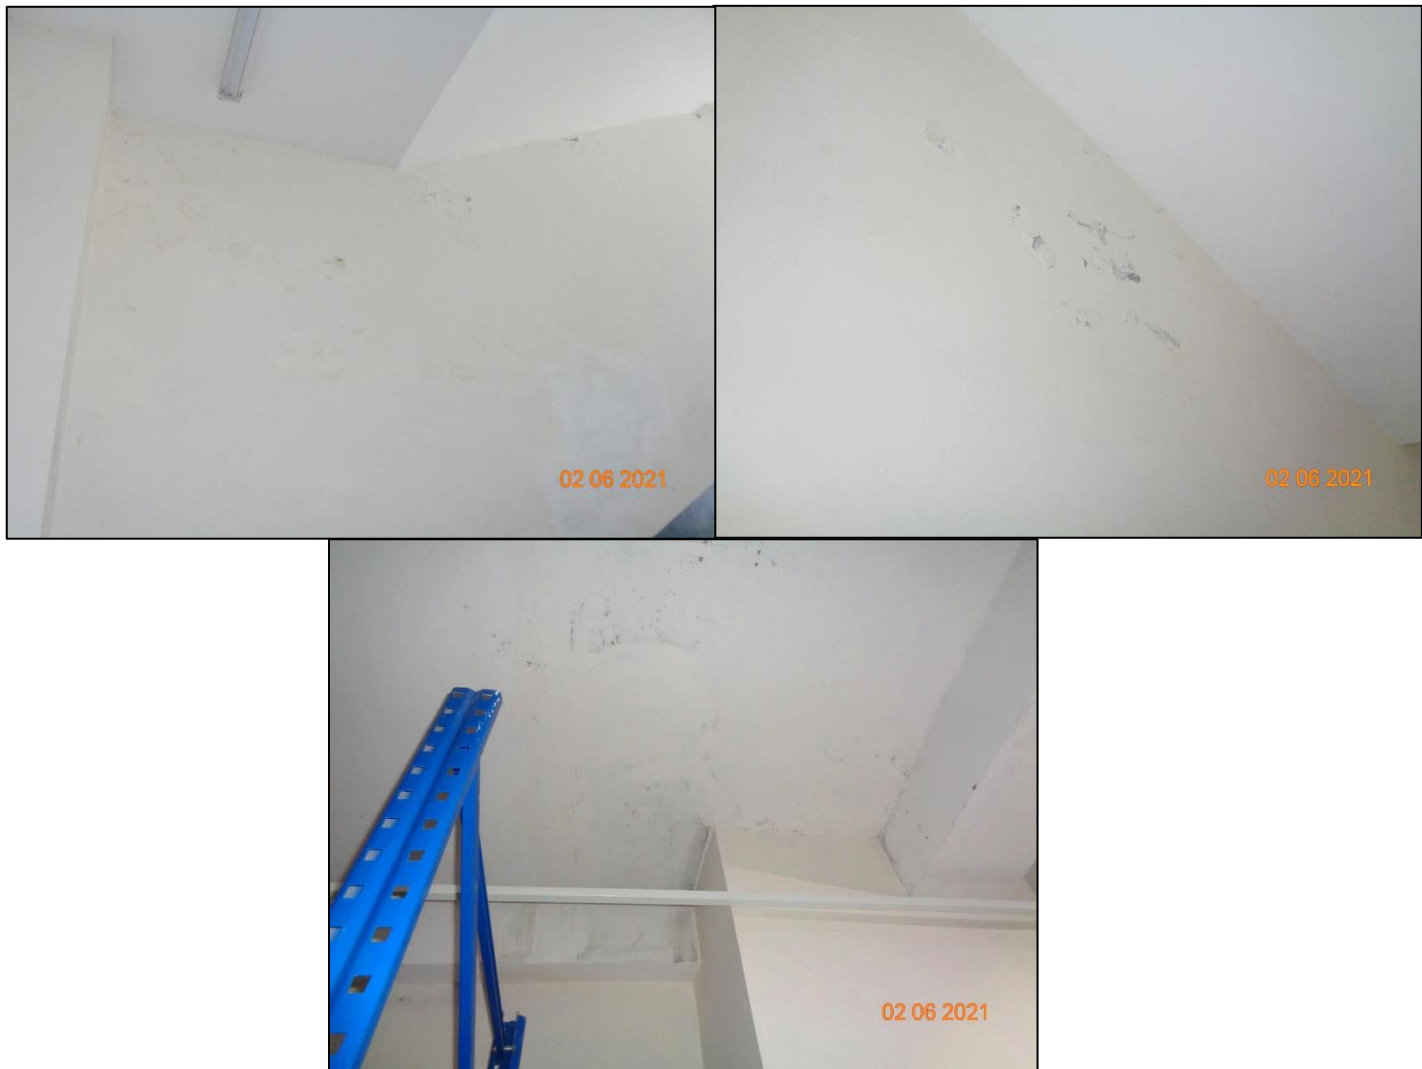
Dampness was found several locations of the structure. Factory engineer is required to investigate the source of dampness and take necessary measures to prevent the dampness.

| Item No. | Observation | Recommended Action Plan | Recommended Timeline |
|---|---|---|---|
| 10 | Dampness at several locations<br>(Main Building) | Building Engineer is required to investigate the reason of dampness & apply suitable method to repair dampness. | 6-weeks |

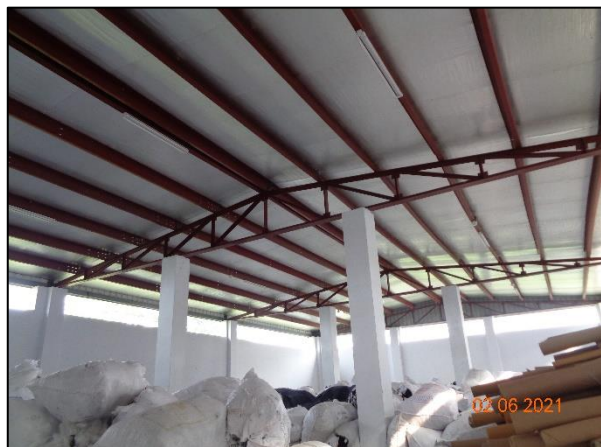
Truss roof System

The steel roof truss is supported by RC column. There is no vertical & roof bracing was found. As a result, there is no apparent load path to transfer the lateral loading along the long direction. Building Engineer is required to check the lateral stability of the steel shed and check the adequacy of the connection.

| Item No. | Observation | Recommended Action Plan | Recommended Timeline |
|---|---|---|---|
| 11 | Lack of lateral stability (Utility Shed) | Building Engineer is required to check the lateral stability of the steel shed. | 6-weeks |

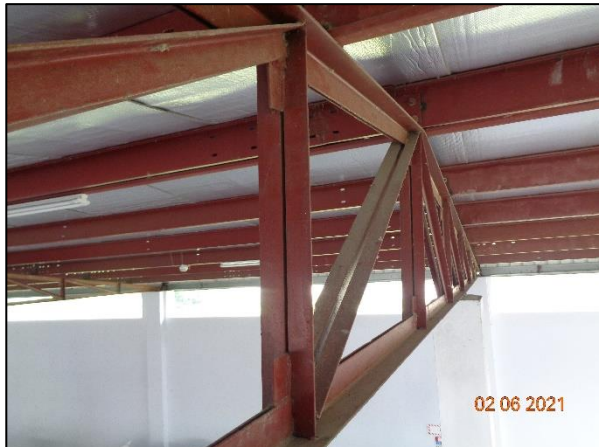
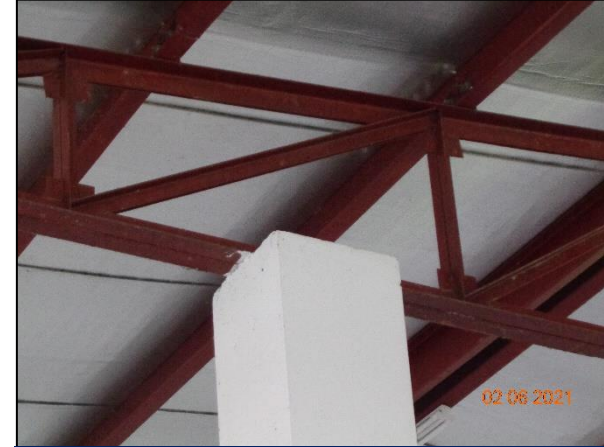
Poor connection details

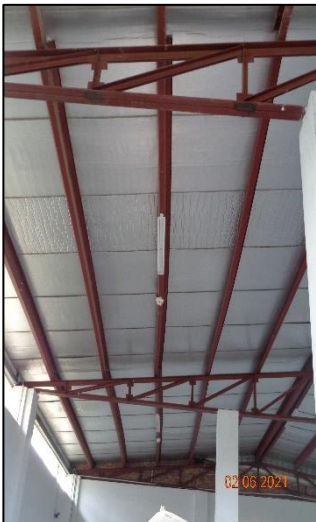
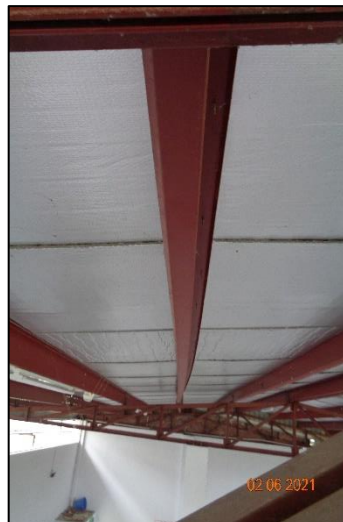
Purlin was found sagging

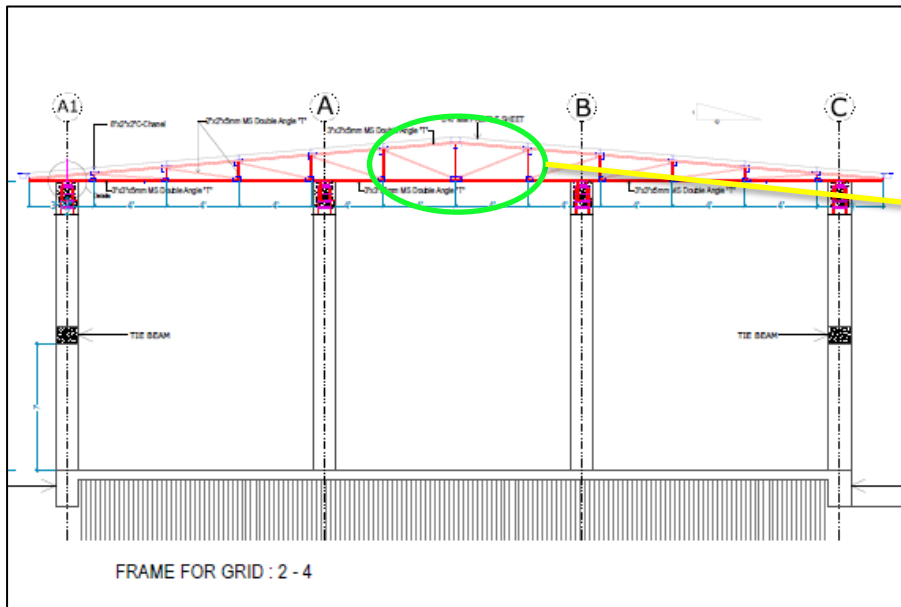
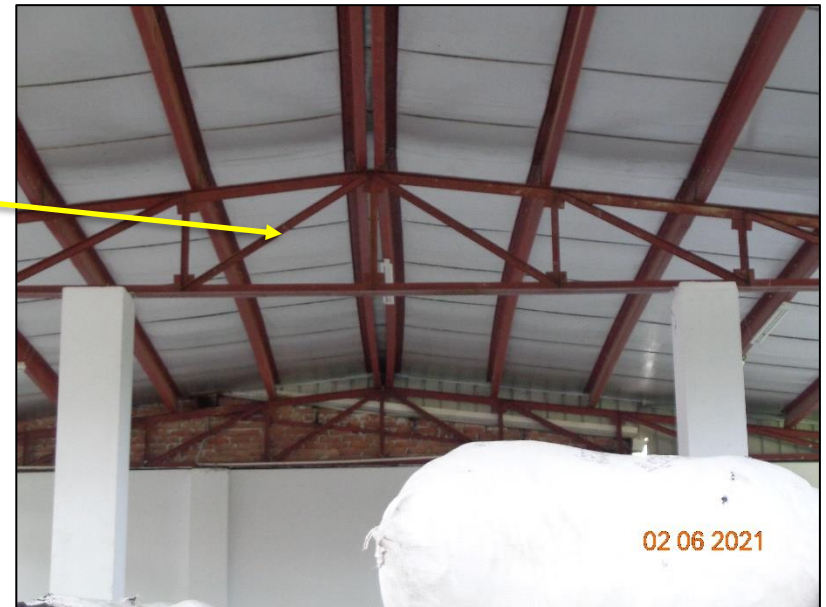
Orientation of truss diagonal members

Orientation of truss diagonal members were found different from as-built drawing. Building Engineer is required to survey the whole structure and prepare accurate as-built (both architectural & structural) drawings.

| Item No. | Observation | Recommended Action Plan | Recommended Timeline |
|---|---|---|---|
| 14 | Discrepancies in as-built drawing (Utility Shed, Fire pump room and Fire command & Security room) | Building Engineer to survey the structure and prepare accurate as-built (both architectural & structural) drawings in compliance with section 1.9.1.2 as per BNBC. | 6-weeks |

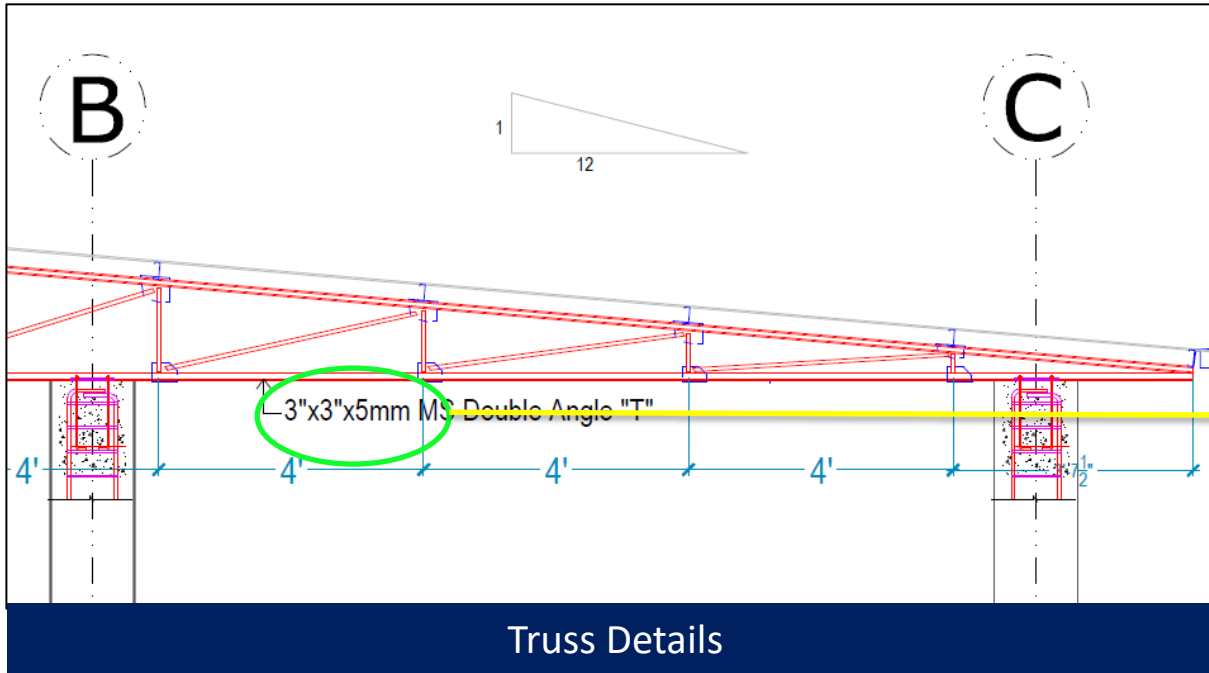
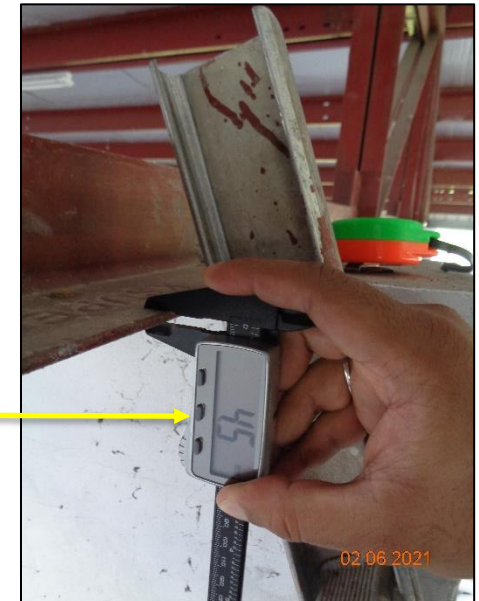
Measurement of truss bottom angle thickness

Truss bottom angle thickness was measured 4.5 mm but in as-built drawing it was found 5 mm. Building Engineer is required to survey the whole structure and prepare accurate as-built (both architectural & structural) drawings.

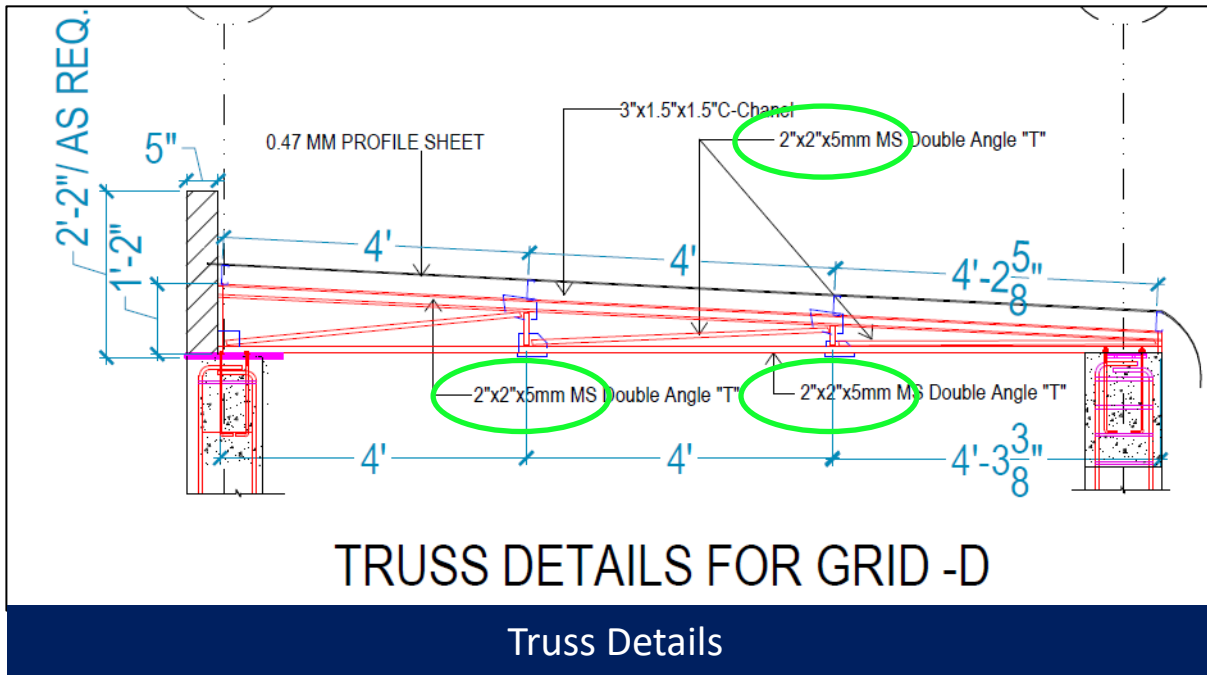
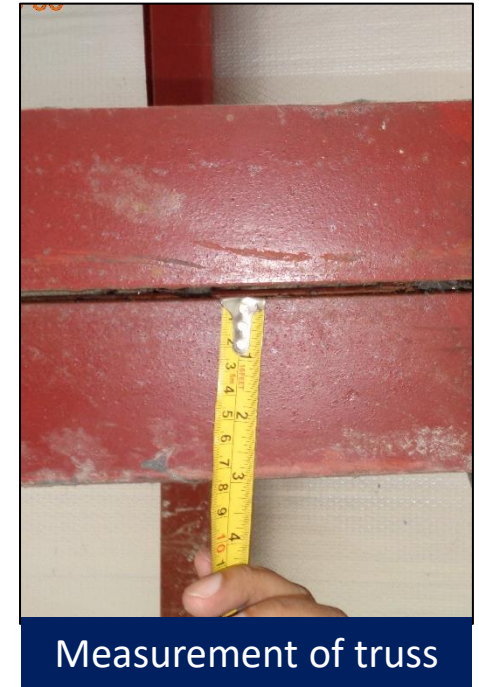
Truss section was measured 75X75X5 mm but in as-built drawing it was found 50X50X5 mm. Building Engineer is required to survey the whole structure and prepare accurate as-built (both architectural & structural) drawings.

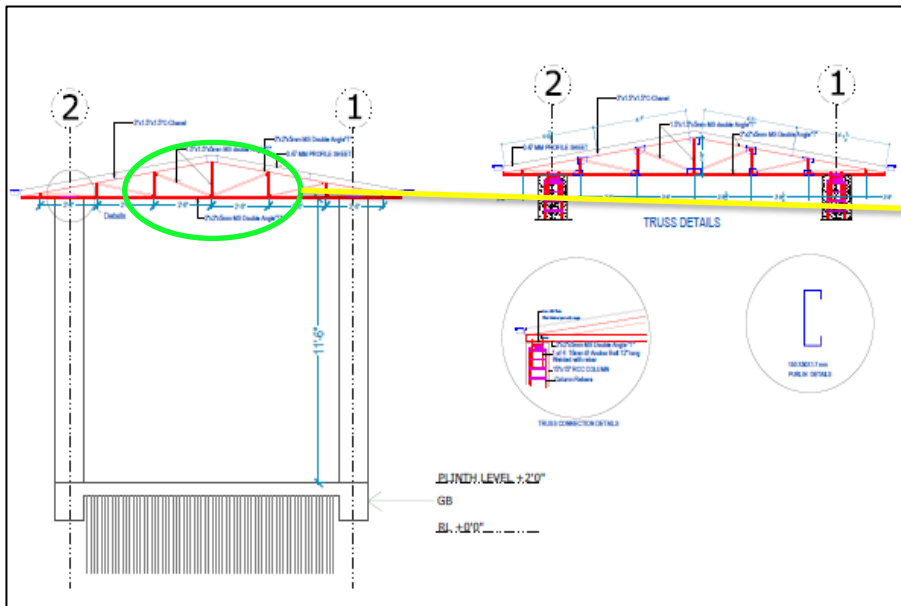
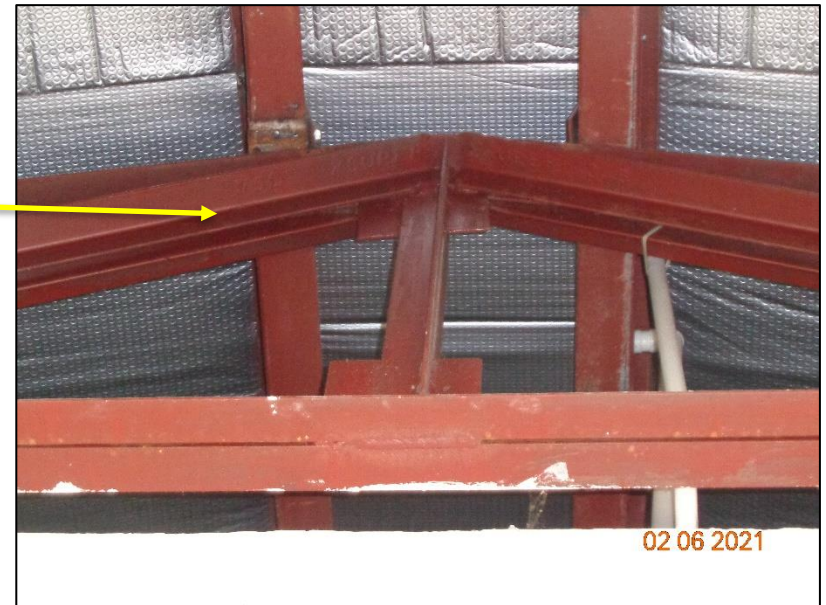
Orientation of truss diagonal members

Orientation of truss diagonal members were found mismatch with as-built drawing. Building Engineer is required to survey the whole structure and prepare accurate as-built (both architectural & structural) drawings.
