Glory Textile & Apparels Ltd.

Kharuail, Ward No.7, Bhaluka Municipal Area, Bhaluka
(24.3947 N, 90.3886 E)

11 April 2022

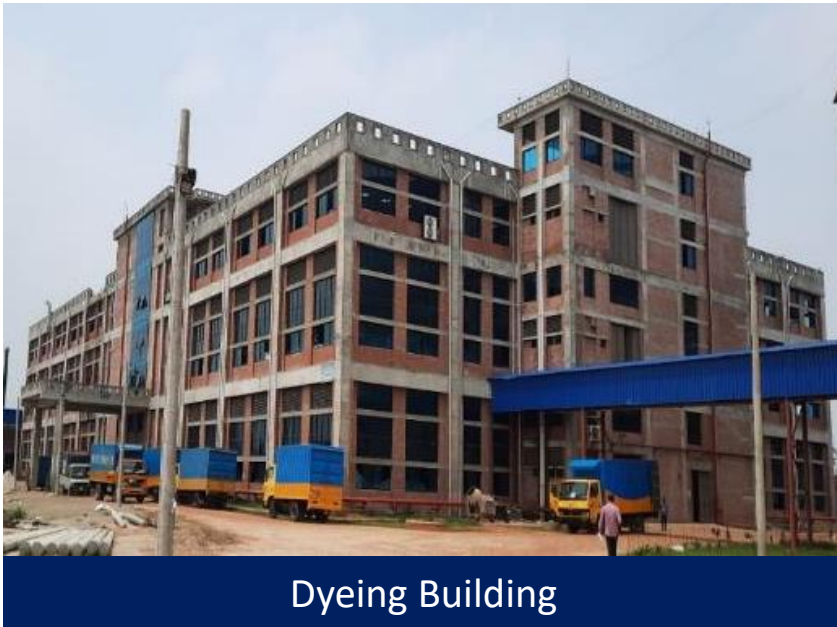
Dyeing Building

Design report not available

As per BNBC, every building or structure designed shall have its design documents prepared in accordance with the provision of Section 1.9.1. The design document shall include a design report, and a set of structural drawings, which shall be prepared in compliance with section 1.9.1.1 and section 1.9.1.2 of part-6, BNBC.

However, design report was not available during inspection. The building engineer is required to prepare a design report in compliance with BNBC.

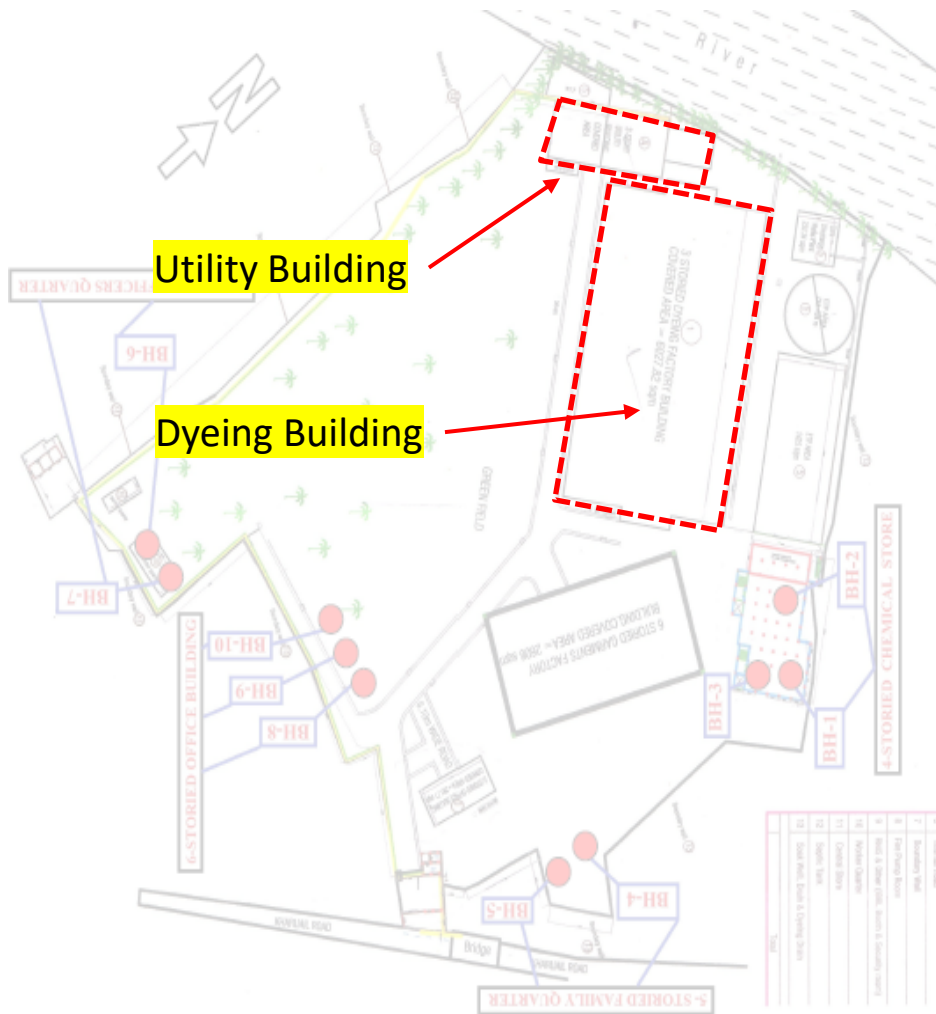
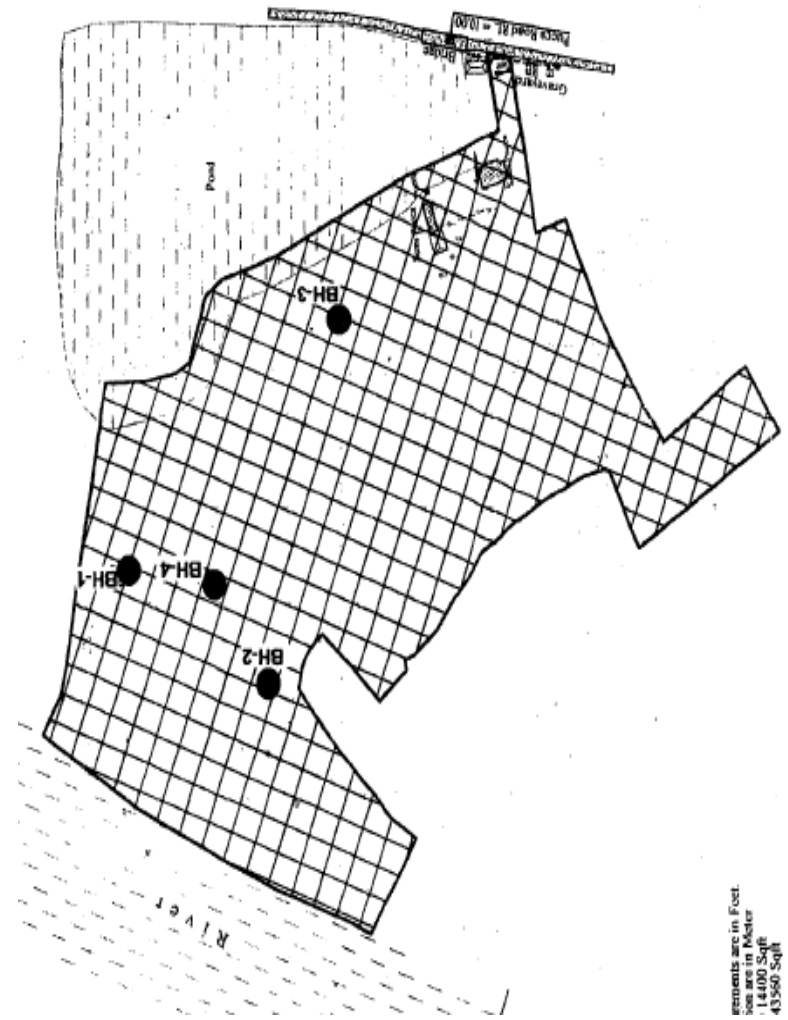
Inconsistency in soil test report

No bore hole location cover the area of dyeing building & utility building in the soil test reports.

Conduct geotechnical investigation to close vicinity of the structure, determine actual soil bearing capacity and check the foundation adequacy accordingly. Maintain proper records of testing.

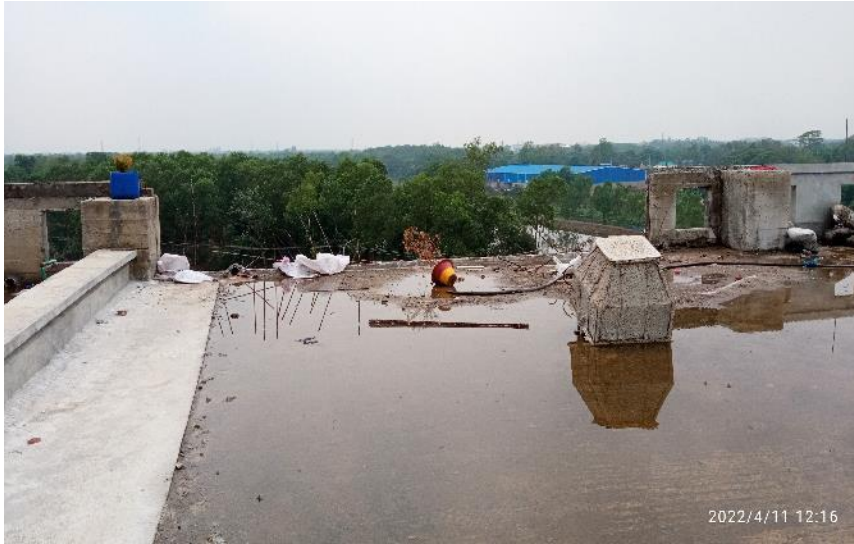
Falling hazard at roof

The factory is required to provide protection barrier at roof edges.
Also, remove the construction debris from the roof.

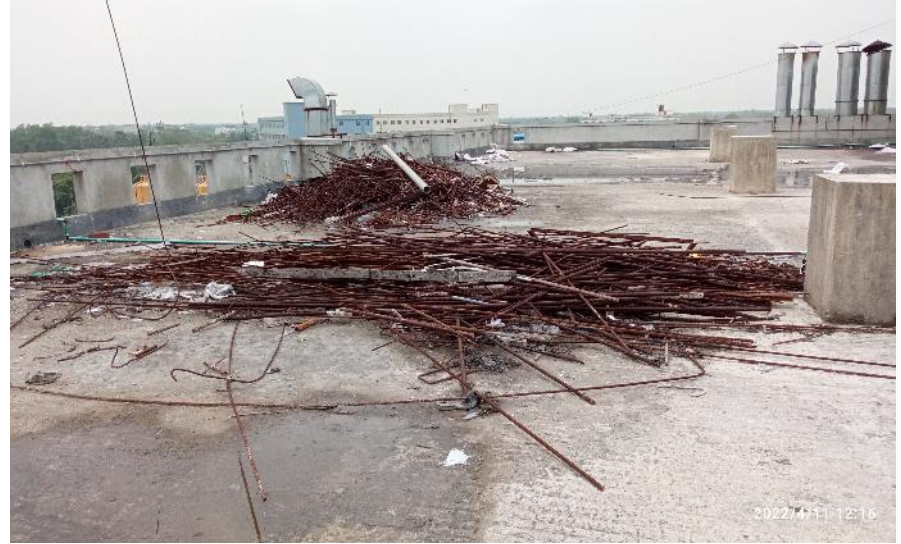
Construction debris on roof

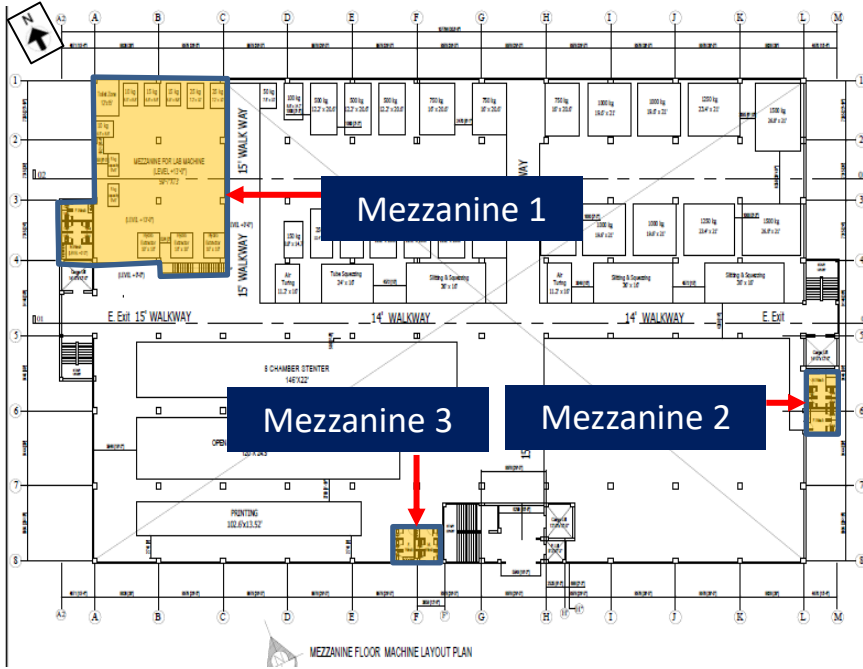
Mezzanine floor layout

Lack of structural details

Structural details of OHWT & mezzanine floors of M-2 & M-3 are not shown in the structural drawings. The building engineer is required to survey the structure and produce accurate structural details.

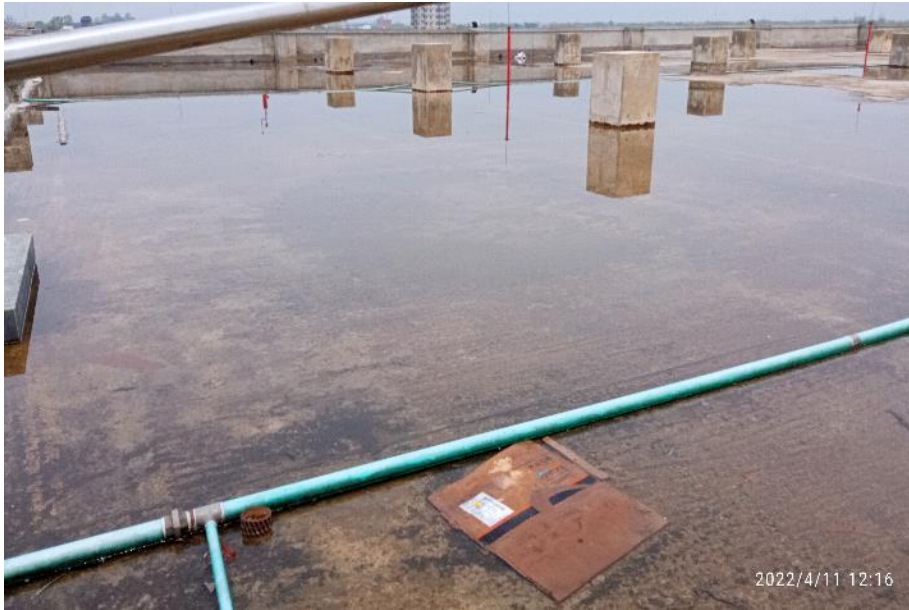
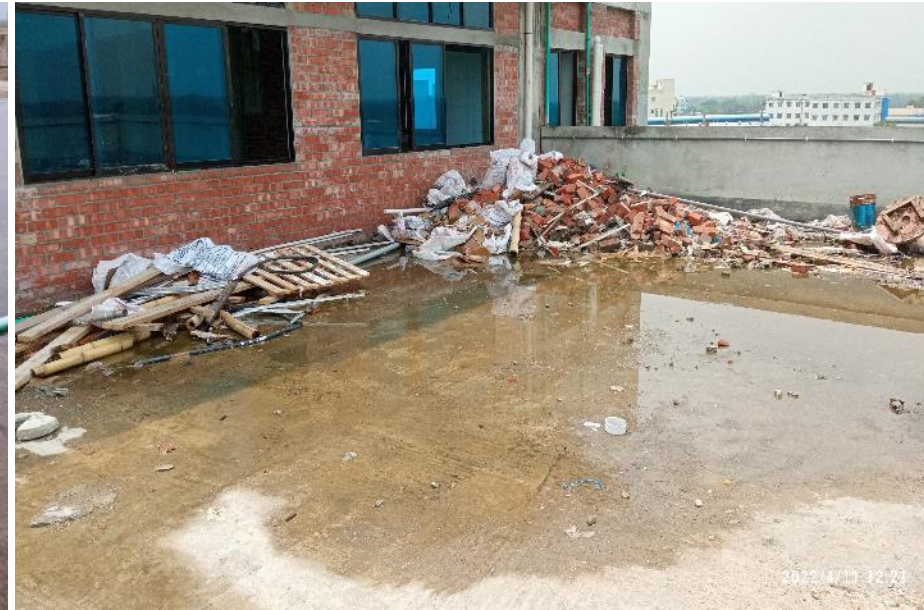
Stagnant water observed on the roof and roof top slab

Develop proper drainage system on the roof with adequate slope.

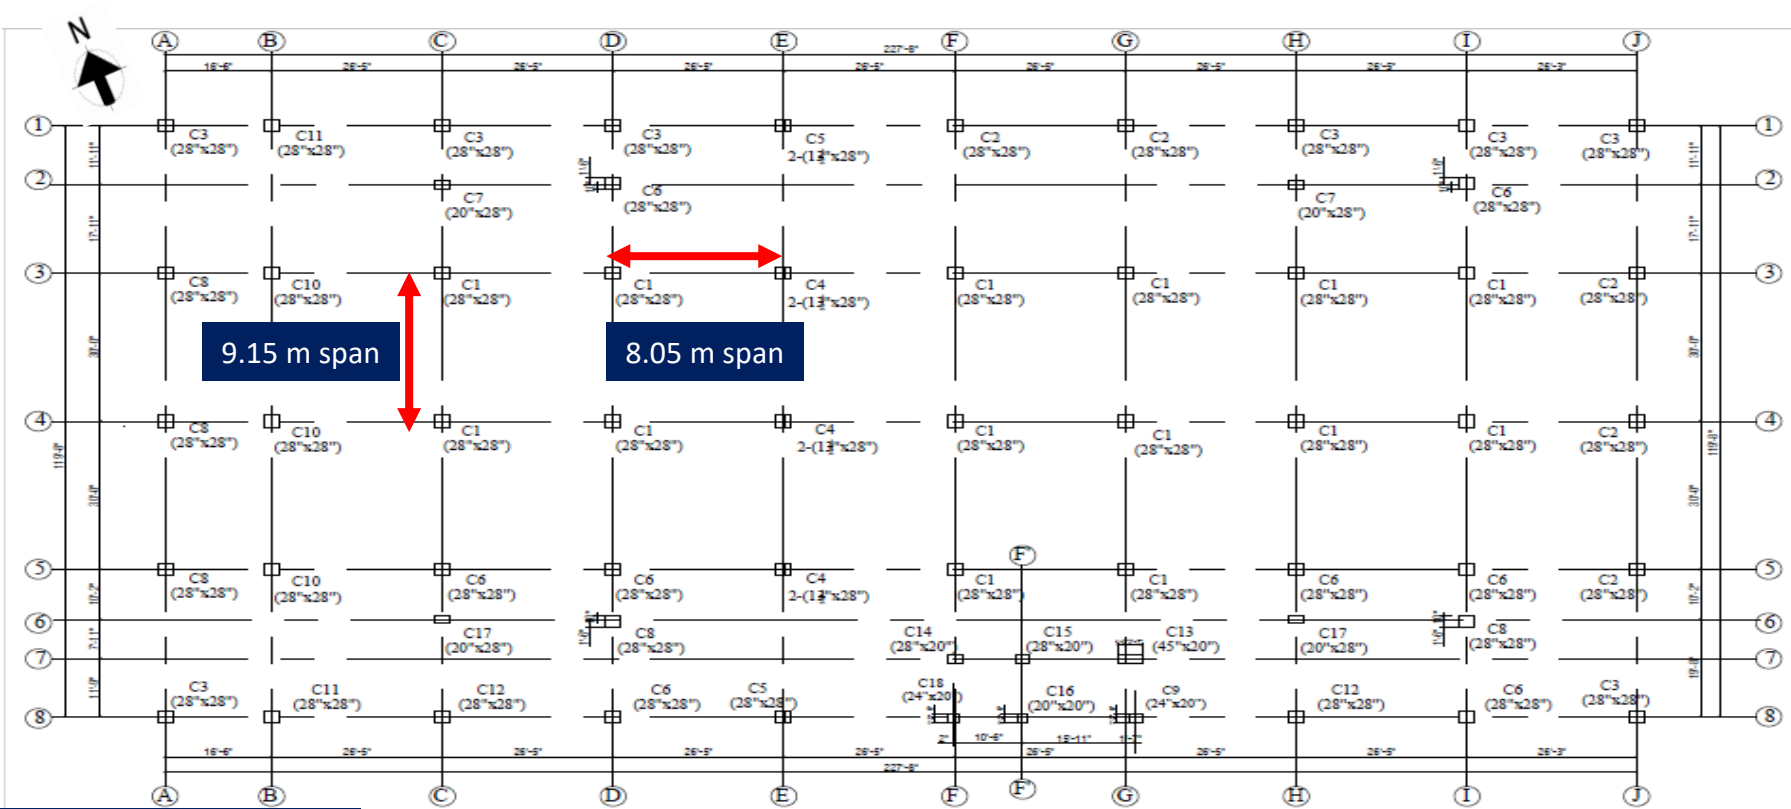
Column layout plan

Columns are stressed above normal design limit

The cursory calculation indicates that columns are stressed above the normal design limit considering the prepared live load plan of 5 kPa and the concrete strength from the available cylinder test data. Building engineer is required to review design, load & column stress.

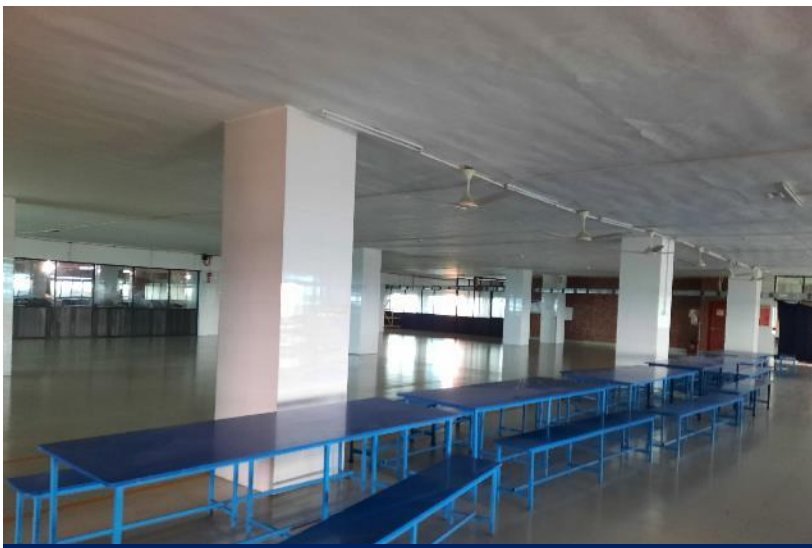
Flat plate system with edge beam at 5th floor

There are different structural system acting together to provide lateral stability of the building. Due to difference of stiffness in same structure, the lateral stability system need to be verified by further design check.

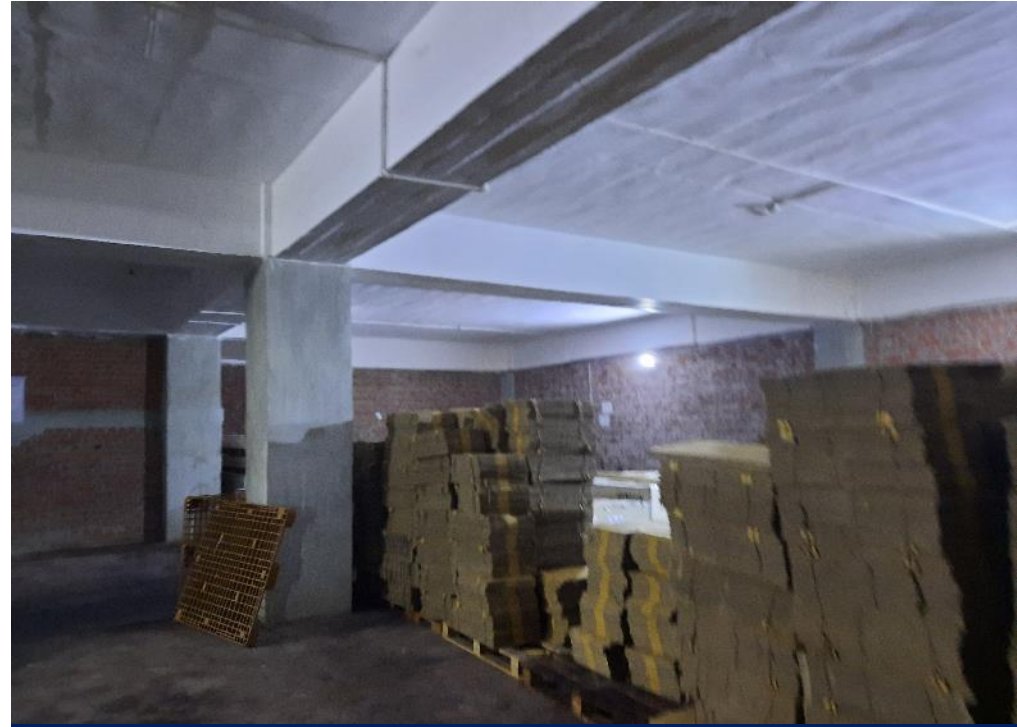
Beam column framing system Ground floor to 3rd floor

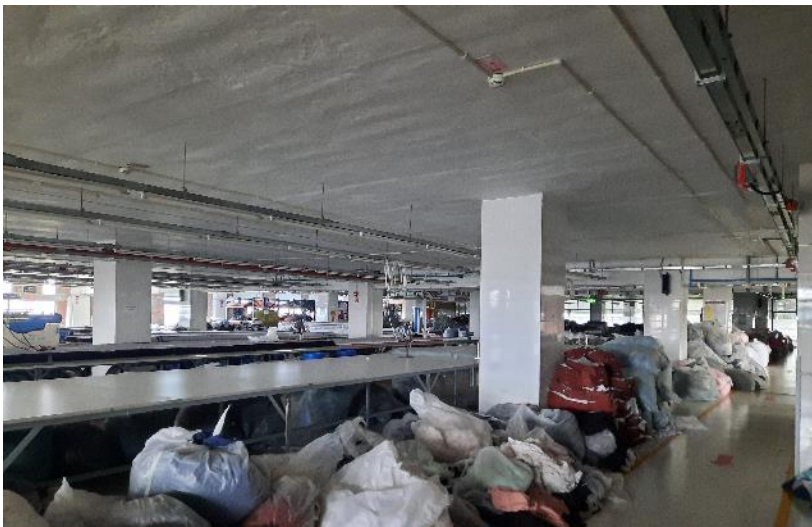
Flat plate system with and without edge beam at 4th floor

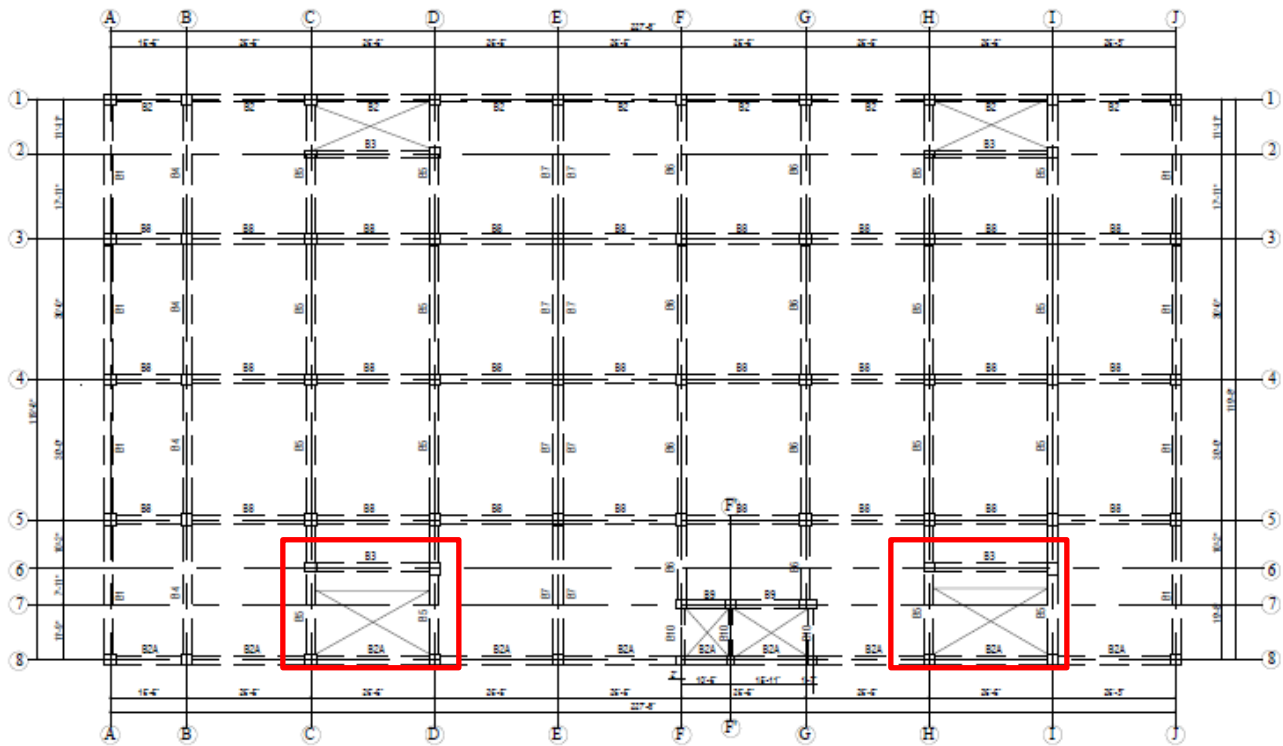
BEAMLAYOUT PLAN

Typical beam layout plan

Beam layout of the staircases are not matched with the site condition. Building engineer is required to update the drawings as per site condition.

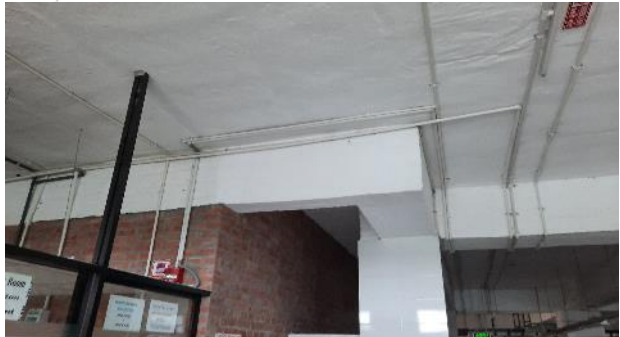
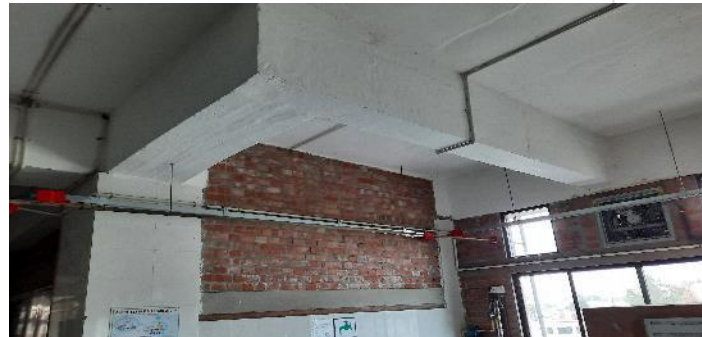
Inconsistency in beam layout of staircase

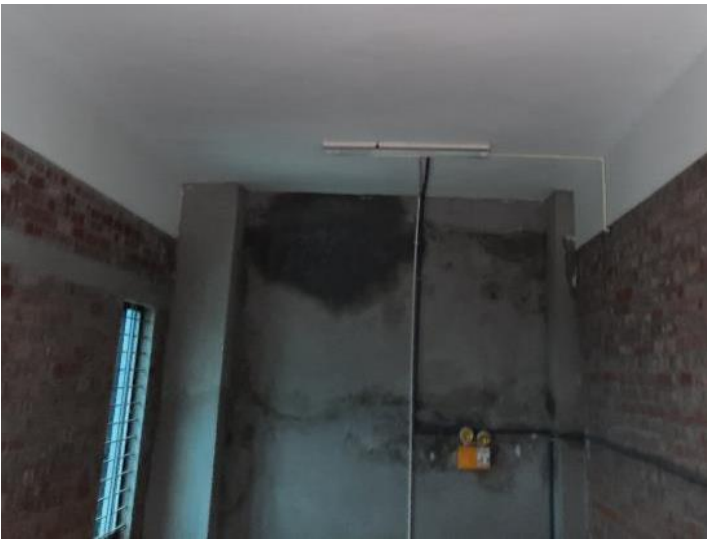
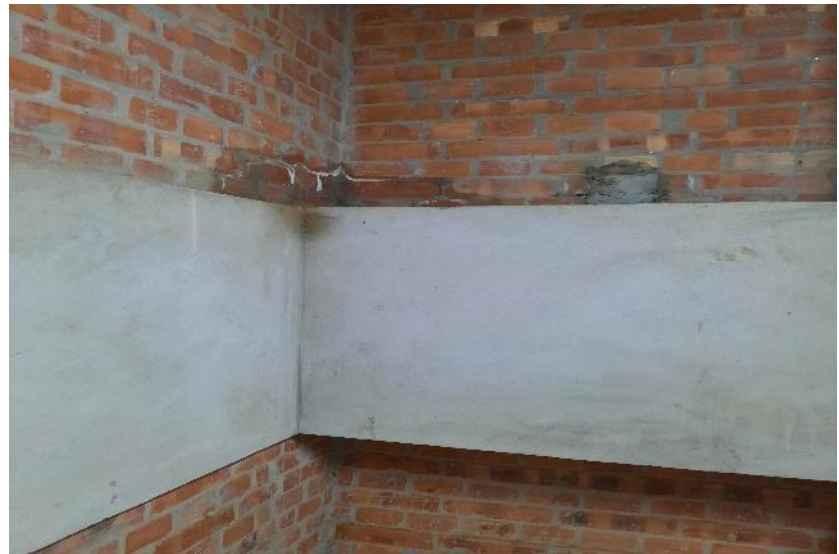
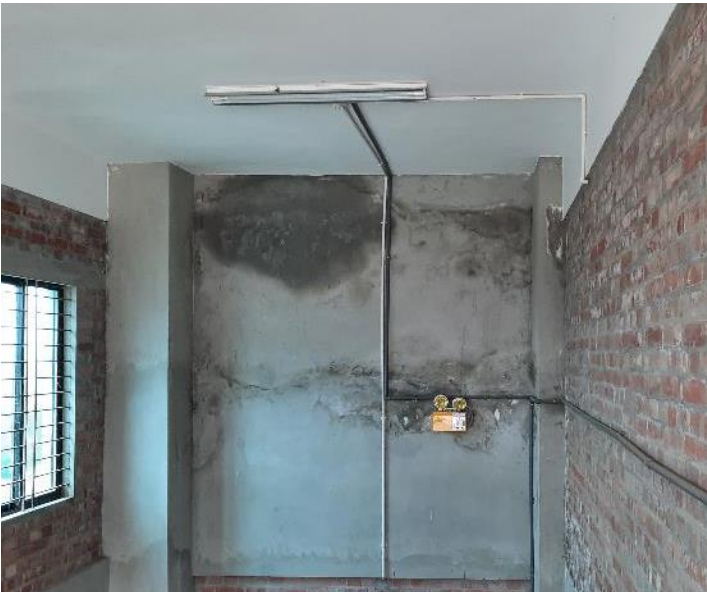
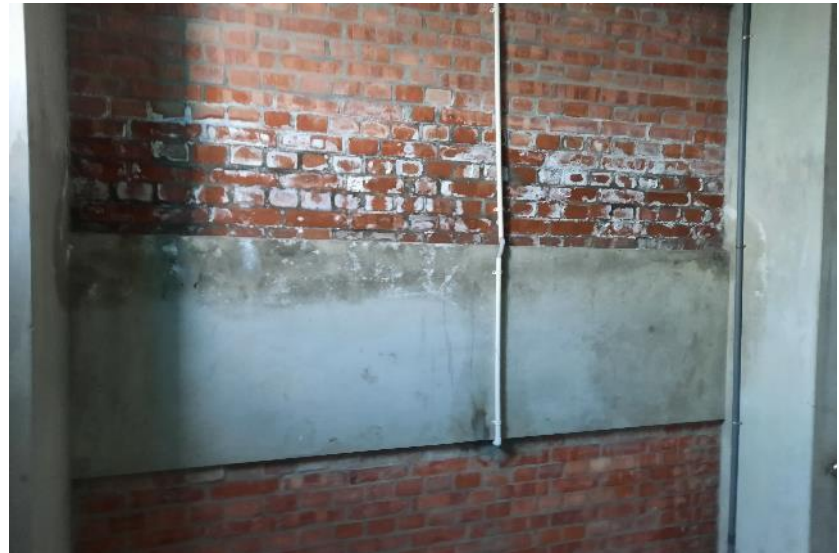
Dampness throughout the building

Dampness observed throughout the building. Building engineer is required to check the reason and extent of the dampness and suggest suitable repair method.

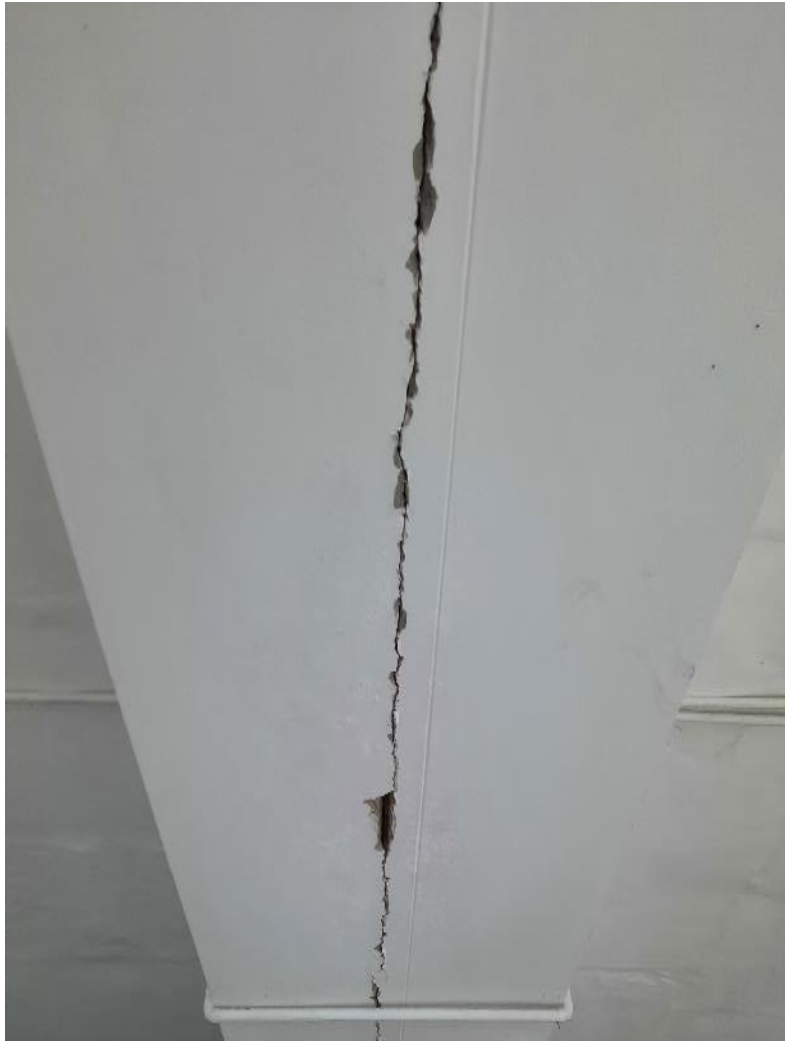
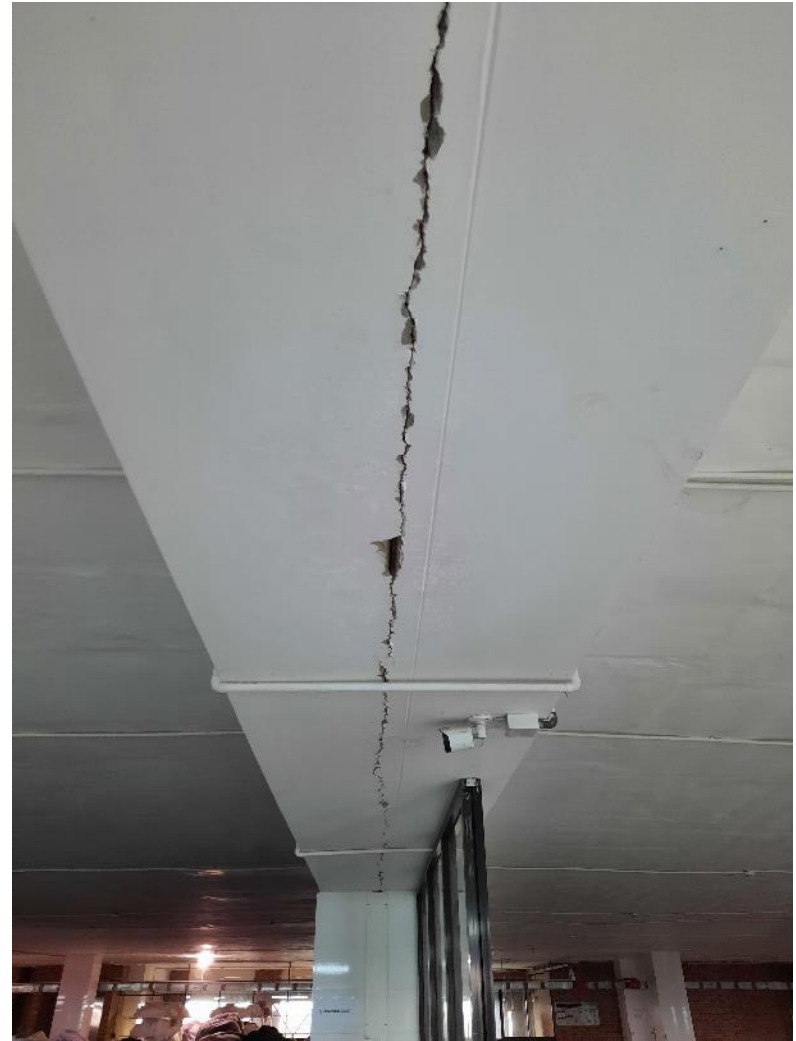
Loose concrete around the expansion joint

Loose concrete observed around the expansion joint which may cause falling hazard. Building engineer is required to remove the loose concrete and fill the expansion joint by compressible fireproof materials.

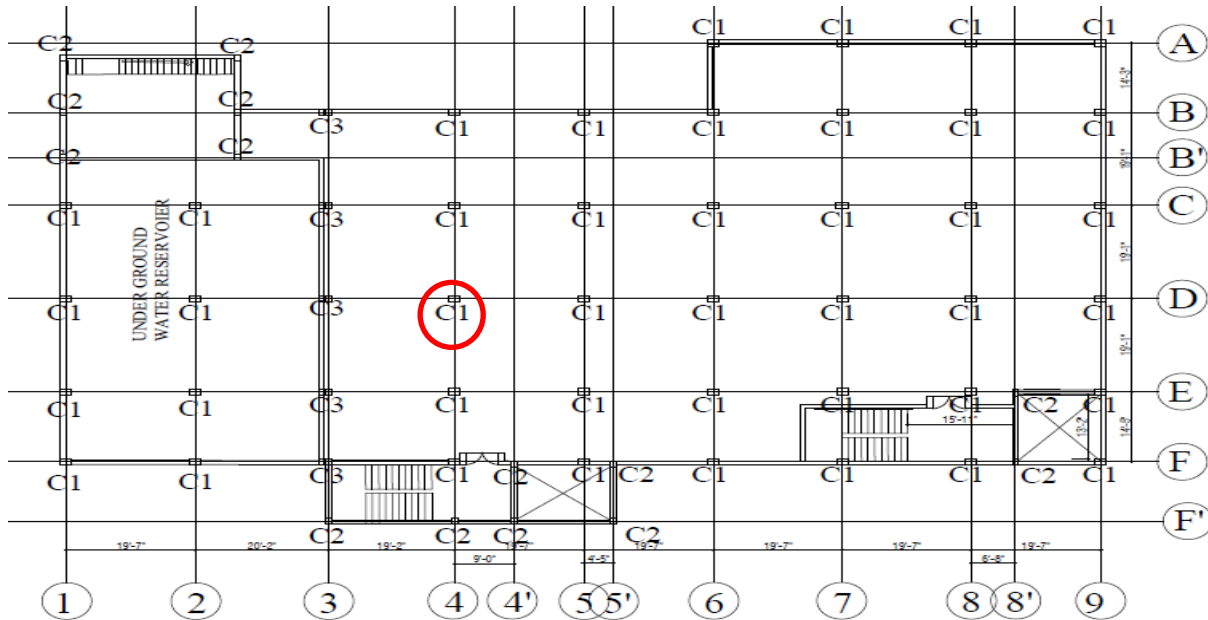
Column Layout Plan

Columns are stressed above normal design limit

Cursory calculation indicates that columns are stressed above normal design limit considering minimum storage live load 6 kPa and minimum concrete strength (16.3MPa) based on aggregate type. Building engineer is required to review design, load & column stresses of the building.

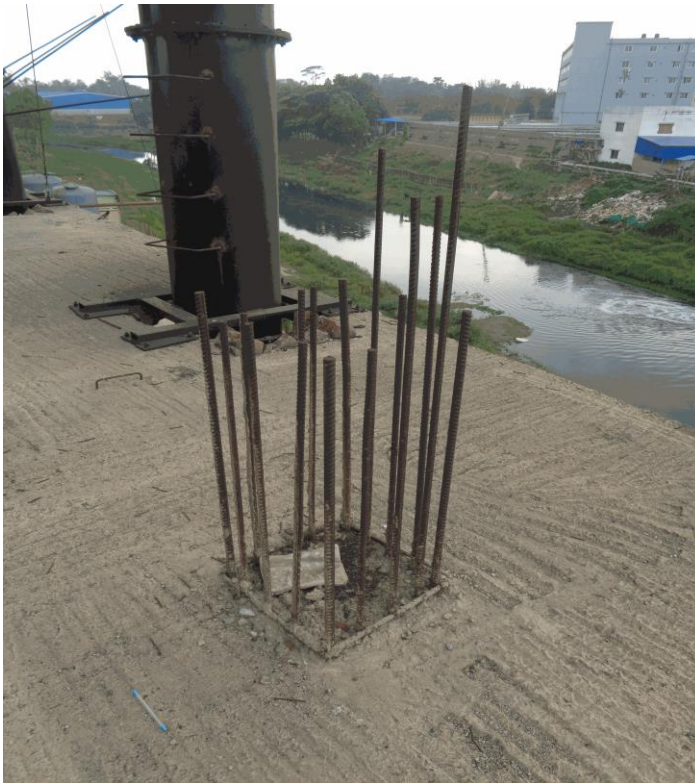
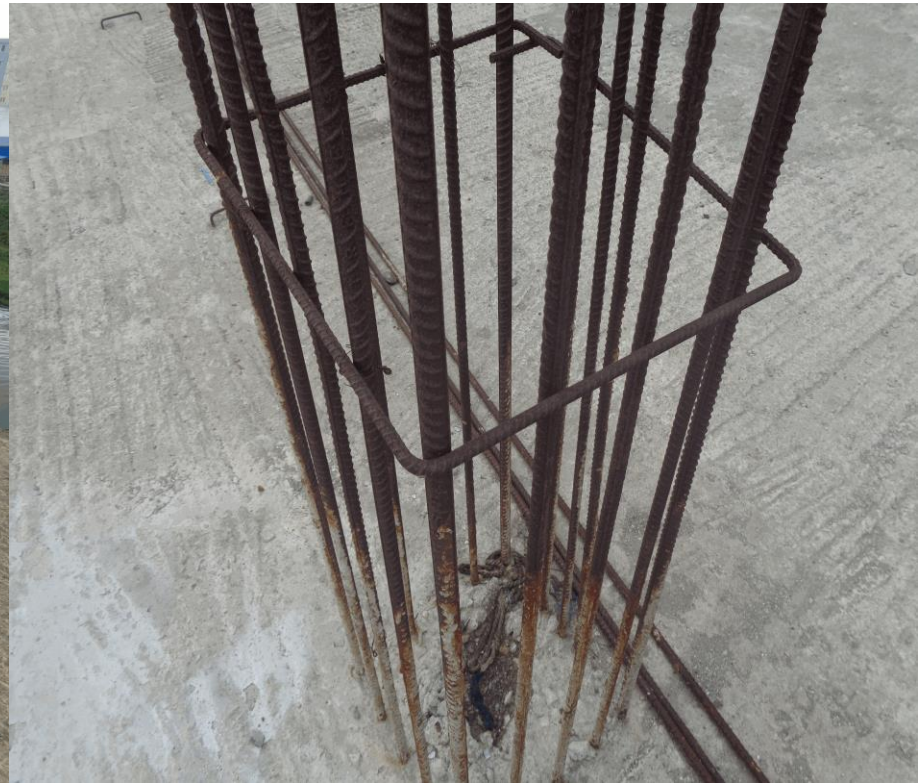
Corroded exposed rebar at roof

Building engineer is required to remove the corrosion from the rebar and provide suitable coating to protect it from further corrosion.

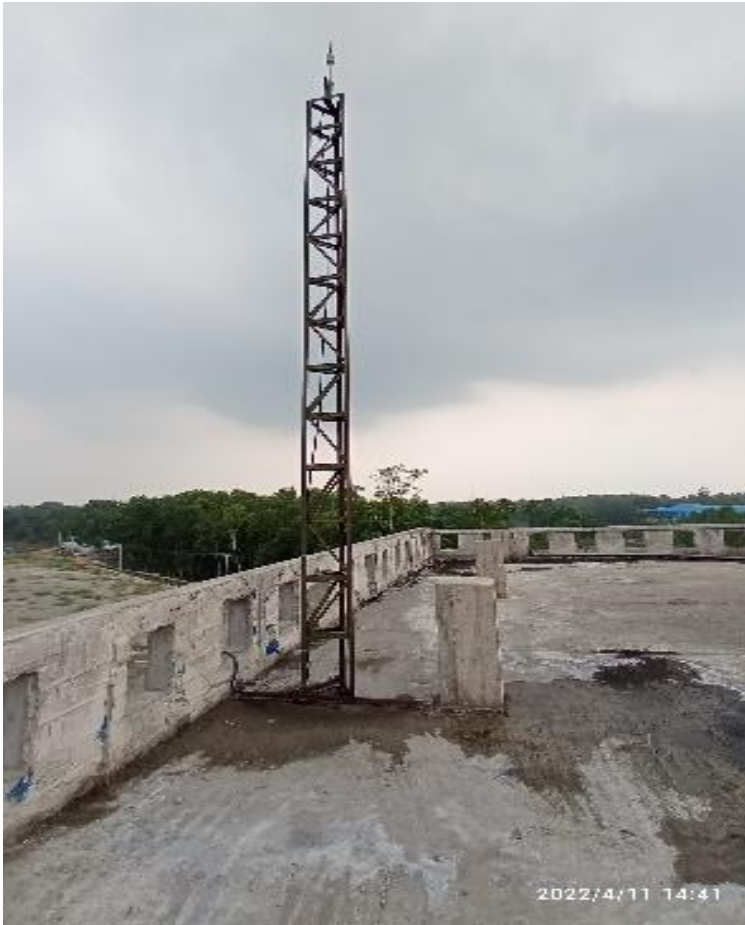
Telecom mast at roof

Undocumented chiller & mobile tower has been found on roof . The building engineer is required to survey the structure and incorporate undocumented part into the as-built drawings.

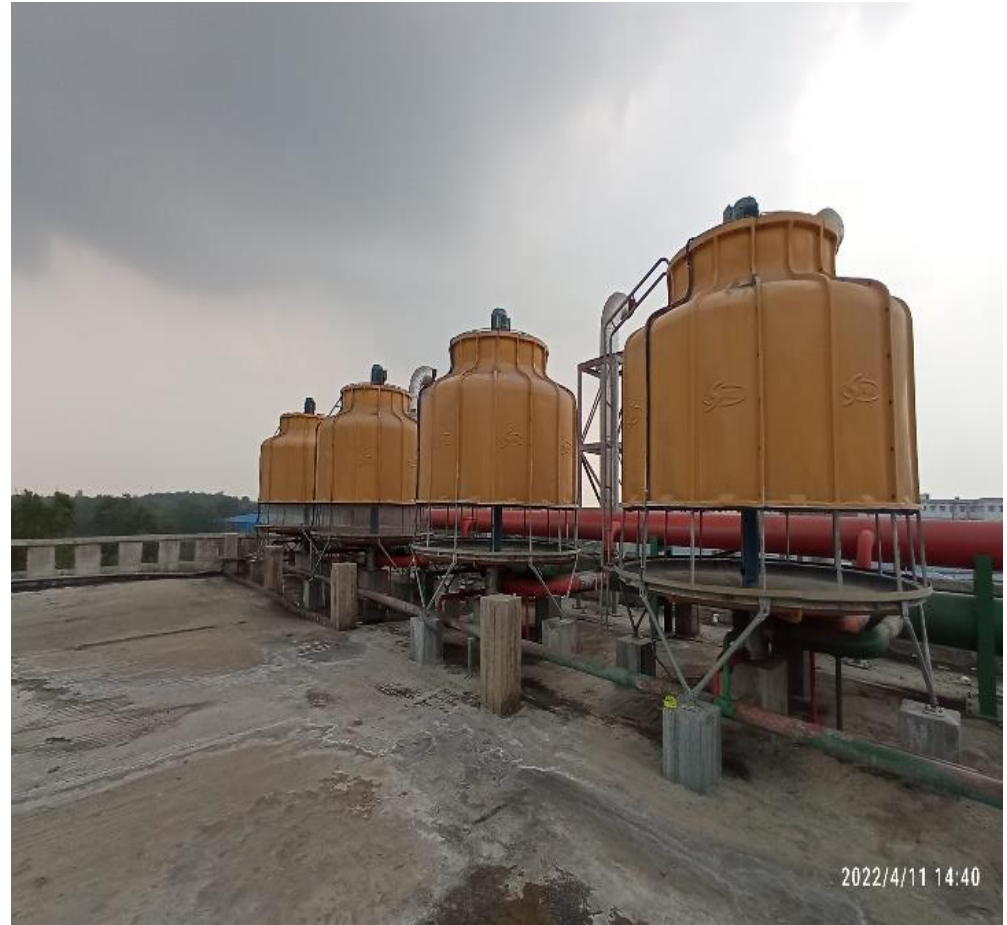
Chiller at roof

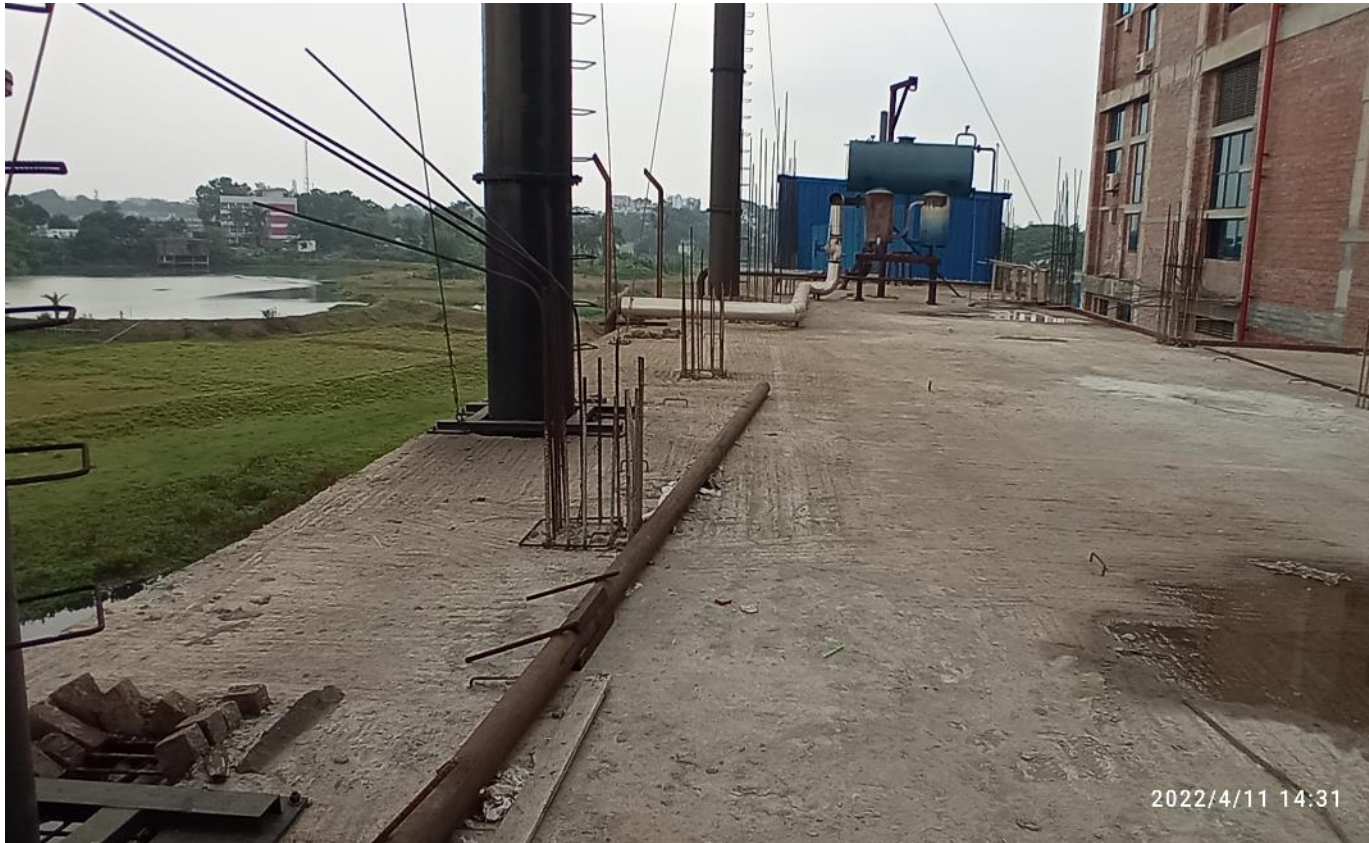
Falling hazard at roof (single storied portion)

Building engineer is required to provide protection barrier at roof edges.
