# MARK DESIGNERS LIMITED (10144)

Plot # 12-14, Road #3, Section #11, Mirpur, Dhaka

30.MARCH.2014

ACCORD  
on Fire and Building Safety in Bangladesh

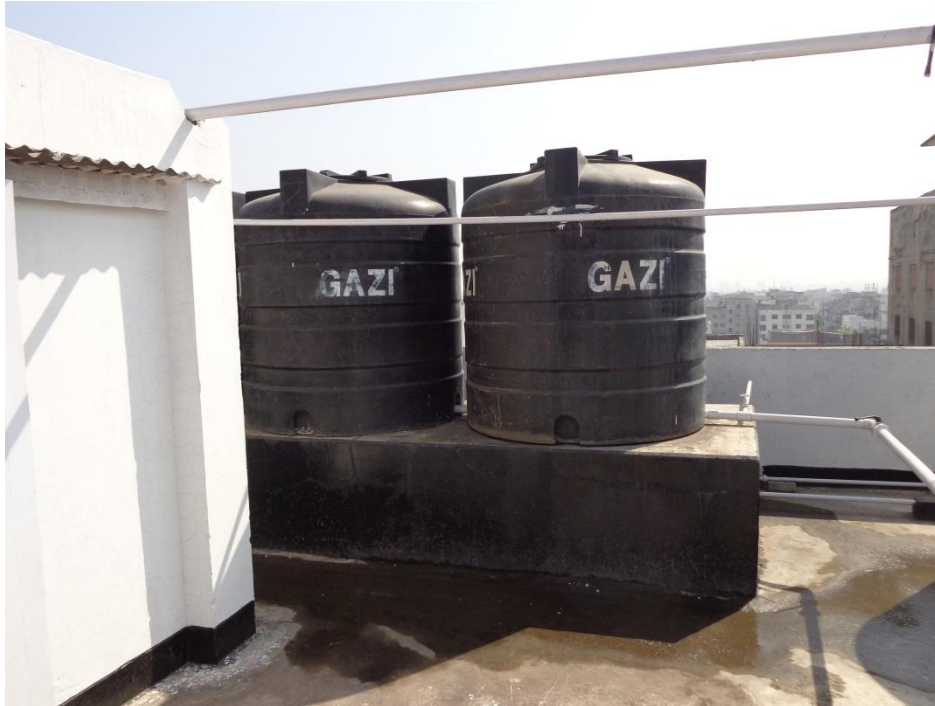
No waterproofing membrane was visible on the roof of the building. This means that any cracks in the surface finishes on the roof will allow water to seep into the concrete slab beneath the finishes, and cause long-term soaking of the slab.

**Roof Floor does not appear to have any waterproof membrane to protect lower floor from water damage**

Roof appears not to have any waterproofing system applied.

- Consider applying a new waterproofing membrane.
