# Integra Design Ltd.

522,Dhour,Nishatnagar,Turag,Dhaka  
(23.892847, 90.377118)

16 May 2022

# Observations

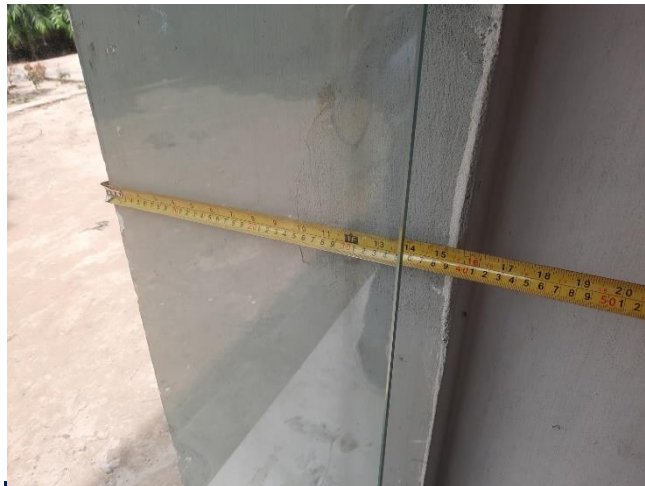
C1 Column size in drawing (500x 500 mm)

As per provided drawing C1 column was found 375mm X 500mm instead of 500mmX 500mm, Also rebar was found 4 nos (Ø20mm) by ferro scanning instead of 12 nos (Ø20mm). Building engineer is required to check the quantity of rebar and the adequacy of the column.

| Item No. | Observation | Recommended Action Plan | Recommended Timeline |
|---|---|---|---|
| 02 | Inconsistency and lack of information in as-built drawing. (Building 01) | Building engineer is required to check the quantity of rebar and the adequacy of the column. | 6-weeks |

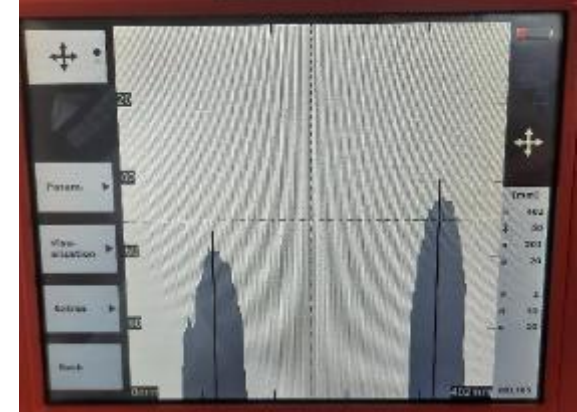
C1 column rebar by ferro scanning

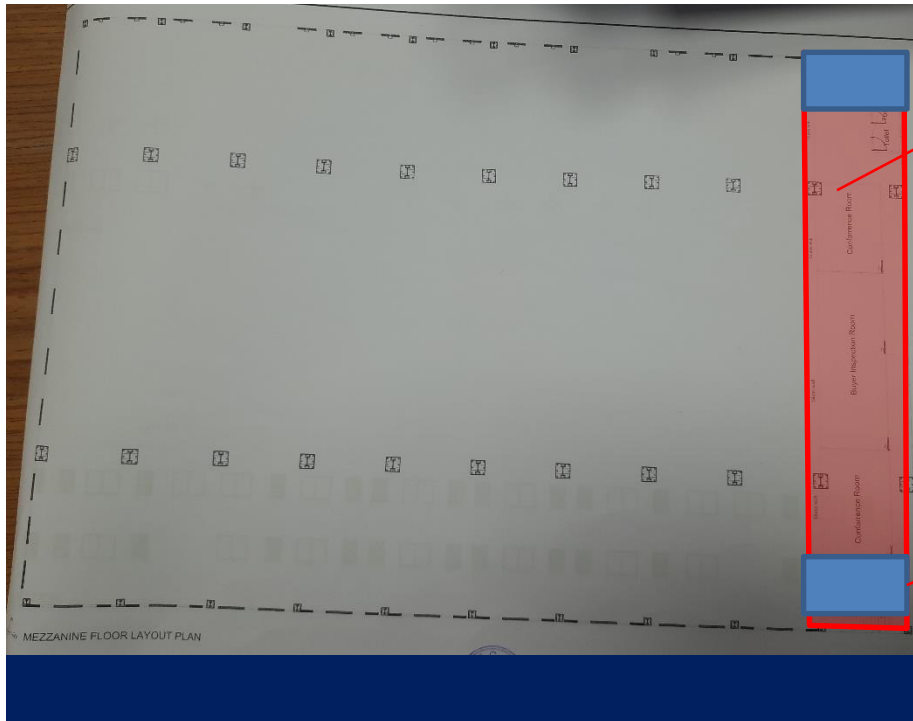
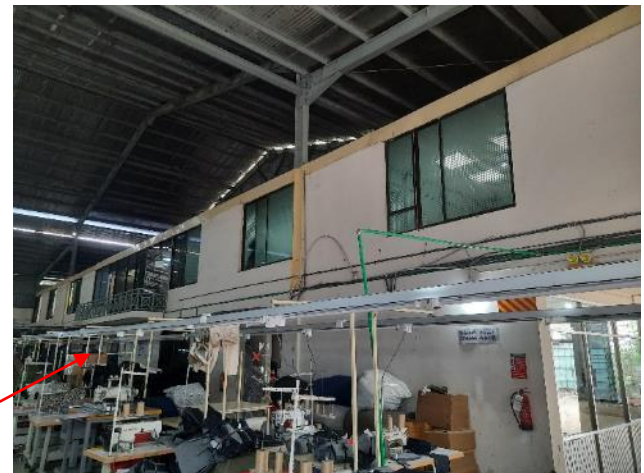
On site Mezzanine floor at north side

No Structural design and drawing of RC mezzanine floor and steel stair was available.

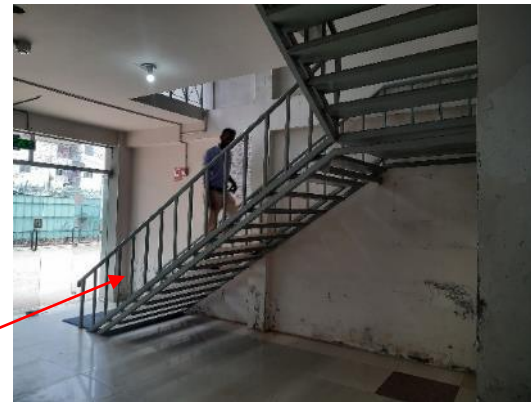
On site steel stair

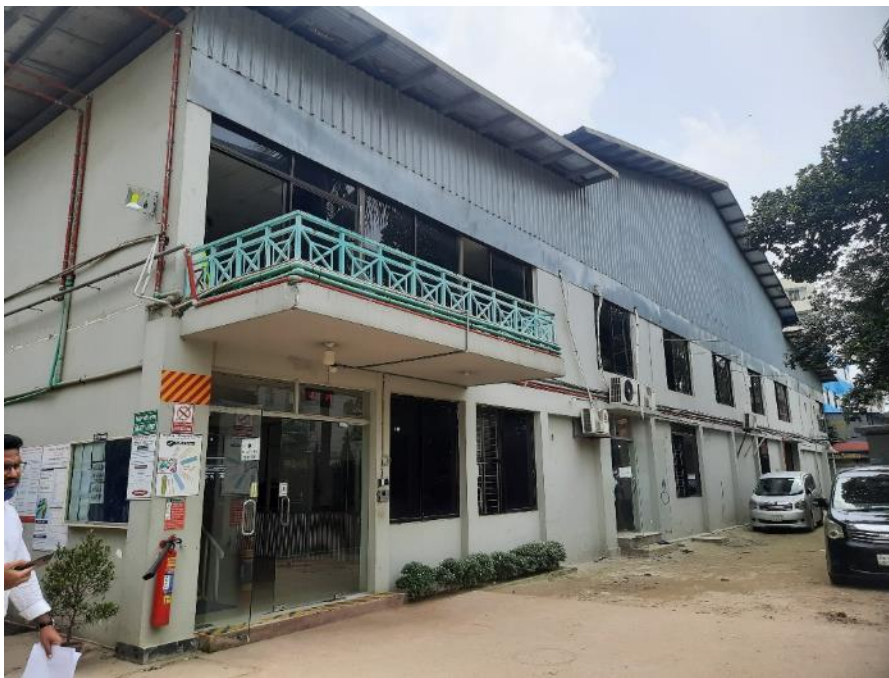
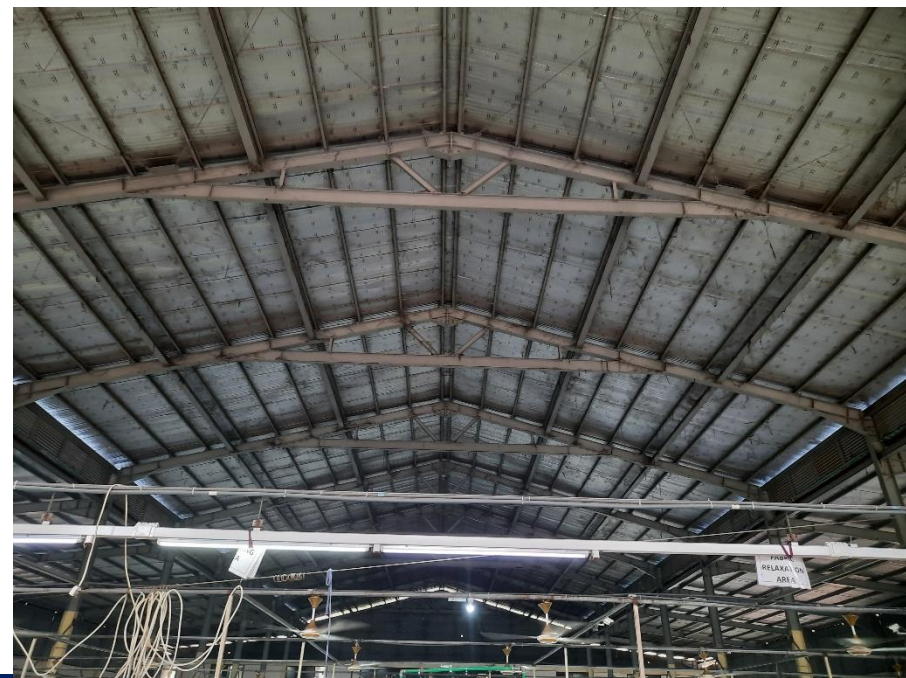
Onsite typical structural system

As per BNBC every building or structure designed shall have its design documents prepared in accordance with the provision of Section 1.9.1. The design document shall include a design report, and a set of structural drawings, which shall be prepared in compliance with section 1.9.1.1 and section 1.9.1.2 as per BNBC. Design report was not found which is required to be prepared in compliance with section 1.9.1.1 (part-6, BNBC).

| Item No. | Observation | Recommended Action Plan | Recommended Timeline |
|---|---|---|---|
| 04 | Structural design report not available. (Building 01) | Building engineer is required to be prepared design documents in compliance with section 1.9.1.1 (part-6, BNBC). | 6-weeks |

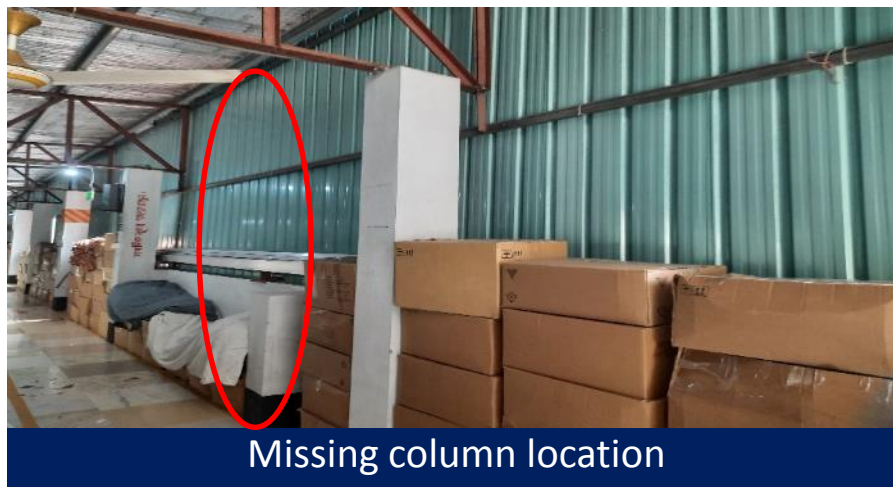
Missing column location

Marked columns were found missing at 1<sup>st</sup> floor level as per column layout.

| Item No. | Observation | Recommended Action Plan | Recommended Timeline |
|---|---|---|---|
| 06 | Missing structural elements from frame. (Building 01) | Building engineer is required to review the design of the portal frames at grid 9 & 10. | 6-weeks |

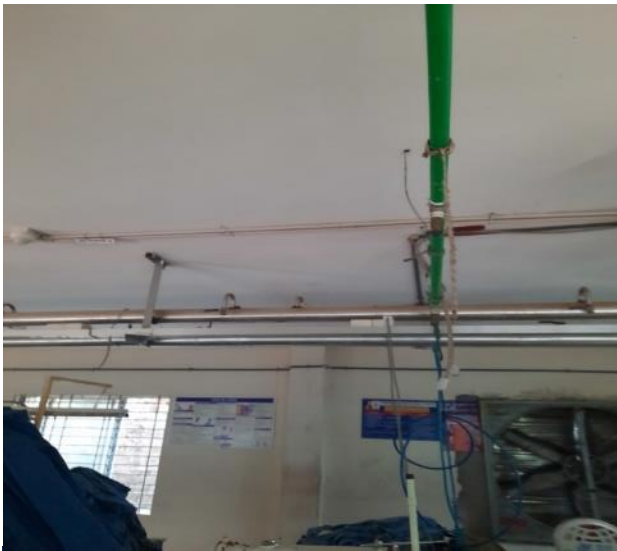
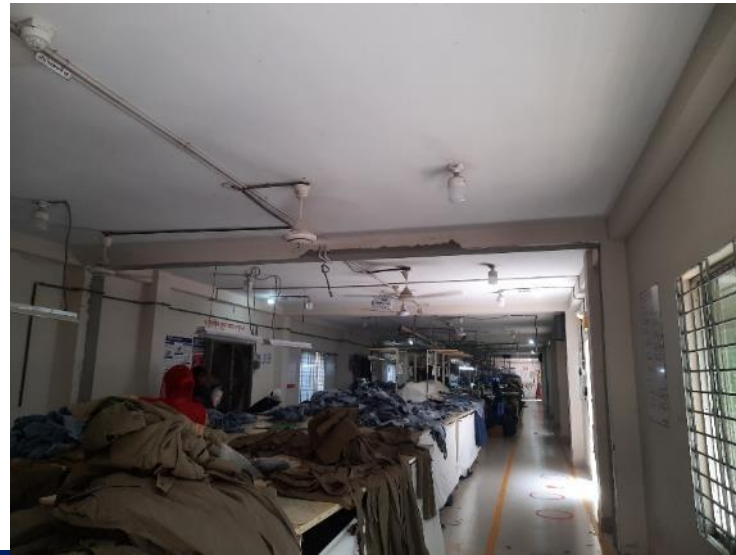
Missing beam location

Marked beam was found missing at ground floor roof beam layout.

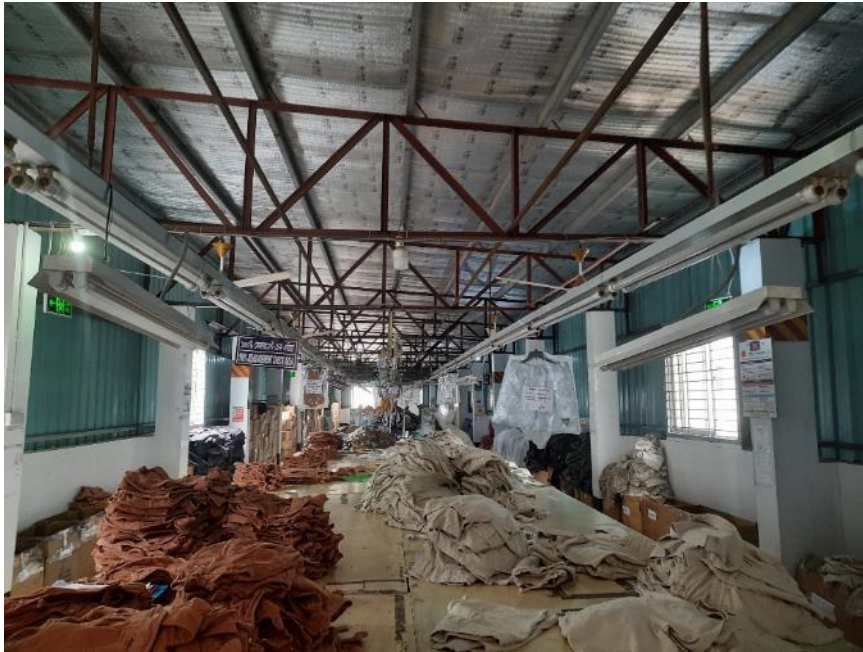
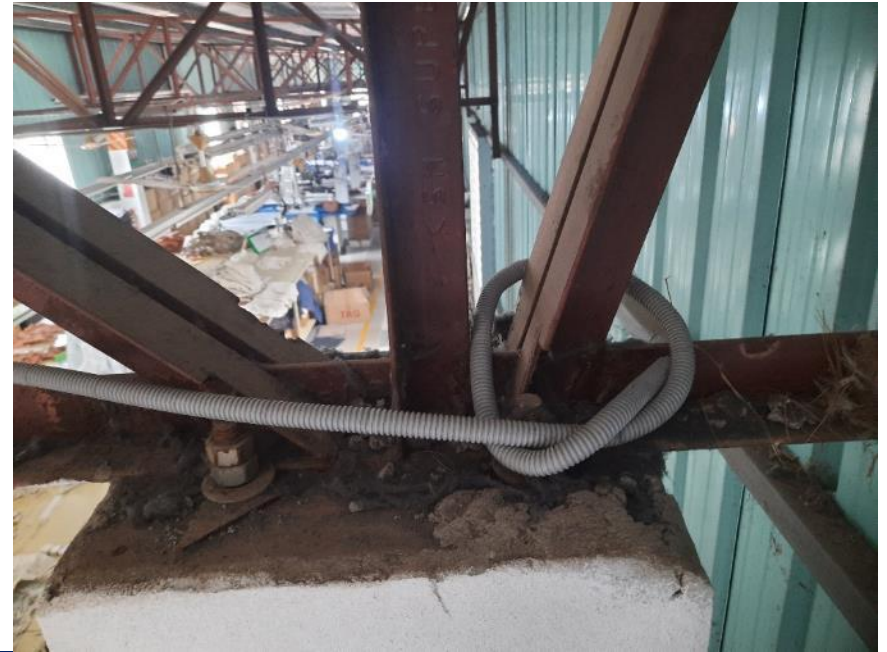
Onsite condition of truss member

All truss member was found 2L-50mm X 50mm X 4mm which was not as per provided drawing.

| Item No. | Observation | Recommended Action Plan | Recommended Timeline |
|---|---|---|---|
| 08 | Discrepancies between drawings and as-built condition. (Building 02) | Building engineer is required to survey the structure and prepare accurate as-built drawing. | 6-weeks |

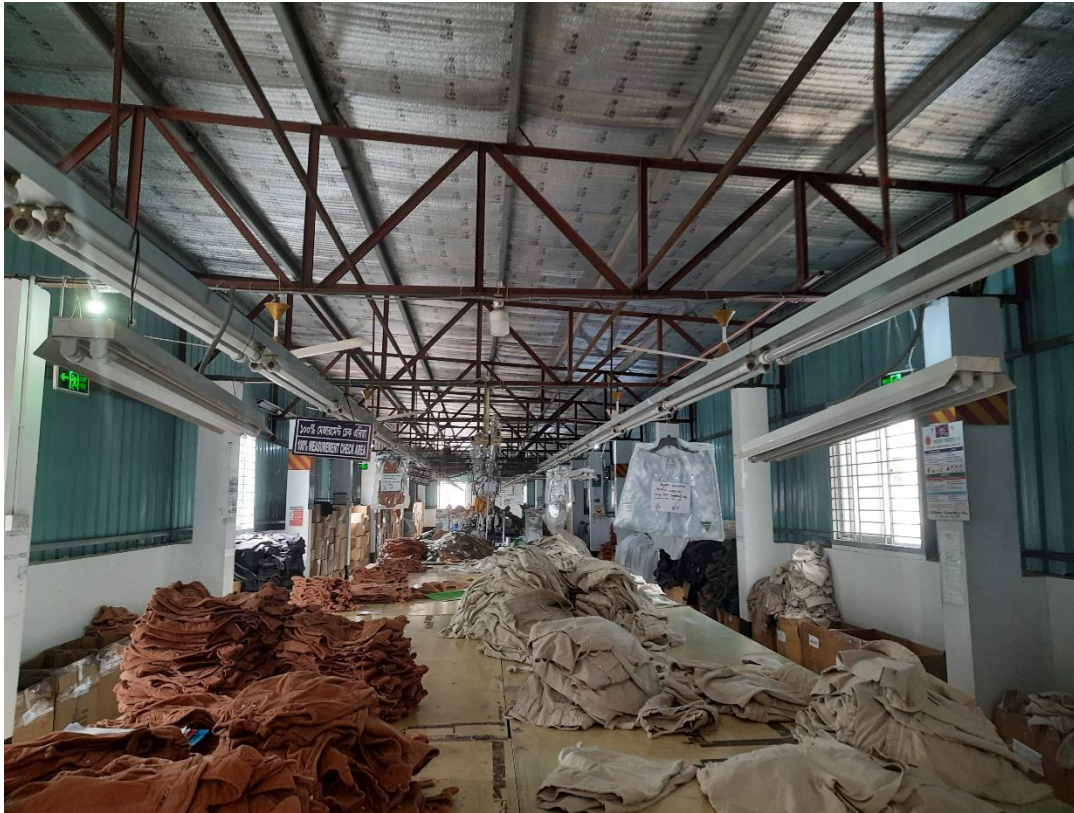
No roof bracing observed in the truss

Bracing system and load transfer media were not observed on the shed. As part of the Engineering Assessment (EA) building engineer is required to check the lateral stability system of the roof shed.

| Item No. | Observation | Recommended Action Plan | Recommended Timeline |
|---|---|---|---|
| 09 | Lateral stability system of roof shed. (Building 02) | As part of the Engineering Assessment (EA) building engineer is required to check the lateral stability system of the roof shed. | 6-weeks |

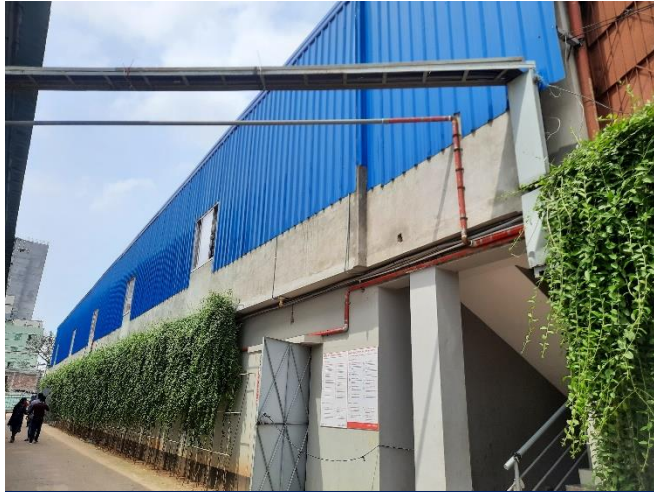
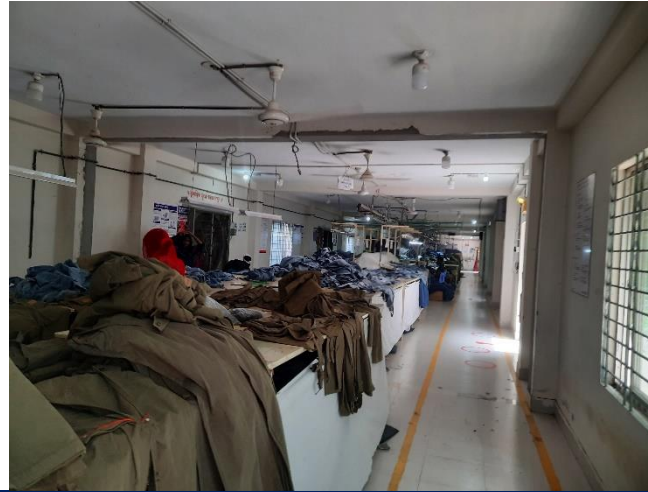
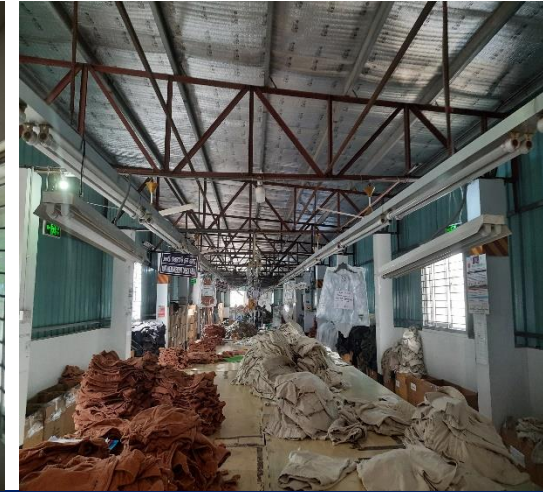
Onsite typical structural system

As per BNBC every building or structure designed shall have its design documents prepared in accordance with the provision of Section 1.9.1. The design document shall include a design report, and a set of structural drawings, which shall be prepared in compliance with section 1.9.1.1 and section 1.9.1.2 as per BNBC. Design report was not found which is required to be prepared in compliance with section 1.9.1.1 (part-6, BNBC).

| Item No. | Observation | Recommended Action Plan | Recommended Timeline |
|---|---|---|---|
| 11 | Structural design report not available. (Building 02) | Building engineer is required to be prepared design documents in compliance with section 1.9.1.1 (part-6, BNBC). | 6-weeks |

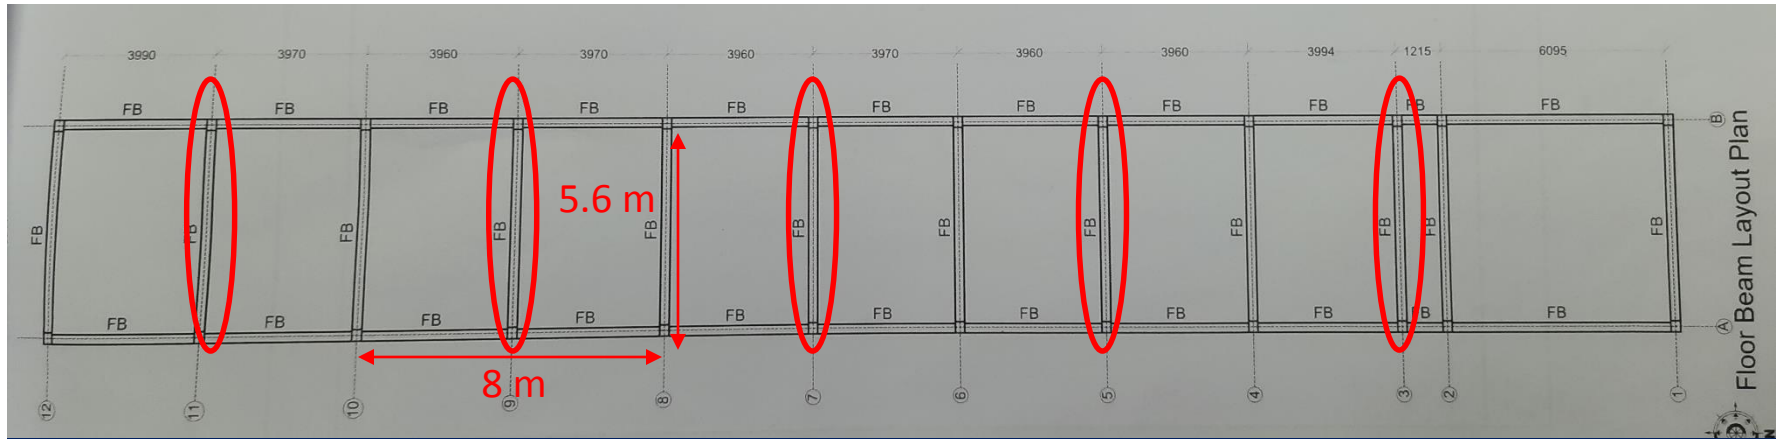
Beam & slab layout

Due to missing of floor beams (as marked in figure) span length was measured 8m X 5.6 m. Slab thickness was measured (T=125mm slab thickness) and no information of rebar was shown in drawing. Building engineer is required to check the adequacy of the slab.

| Item No. | Observation | Recommended Action Plan | Recommended Timeline |
|---|---|---|---|
| 13 | Adequacy of large span slab. (Building 02) | Building engineer is required to check the adequacy of the slab. | 6-weeks |

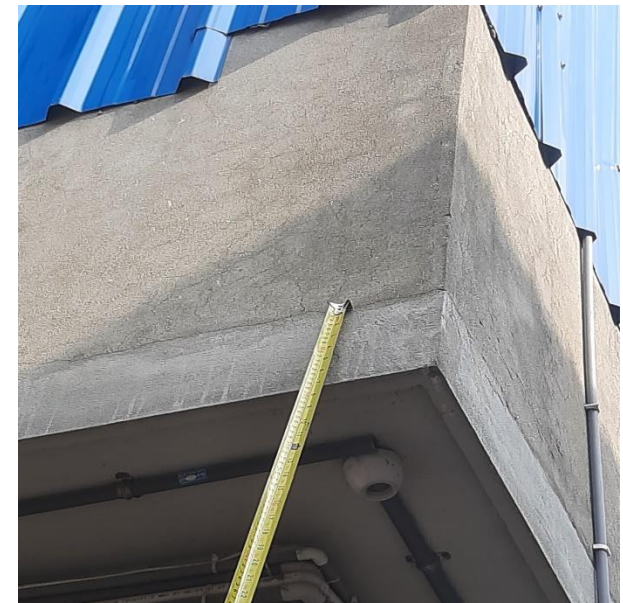
T=125mm slab thickness

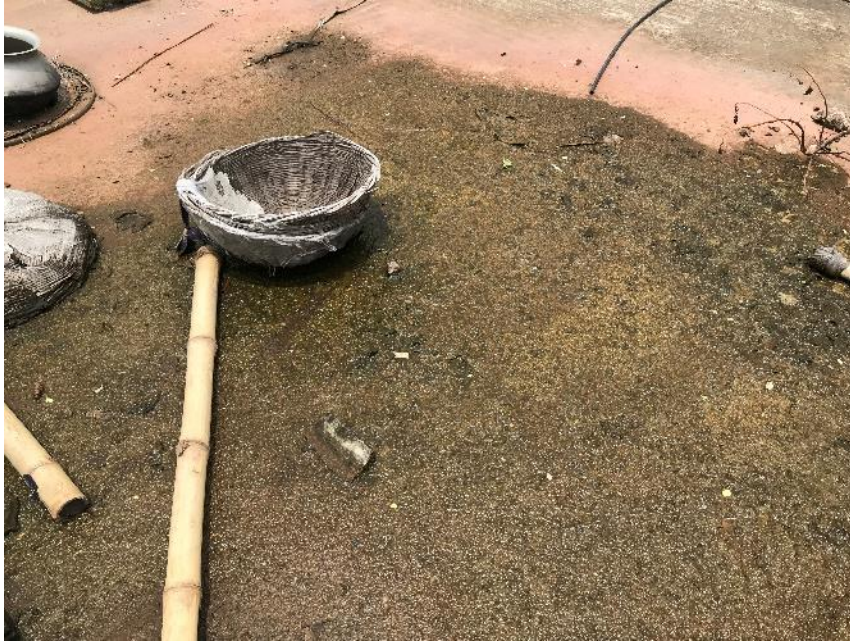
Water ponding on roof slab

Water ponding & blockage in drainage system was observed on the roof. The factory is required to develop a proper water drainage system on the roof.

| Item No. | Observation | Recommended Action Plan | Recommended Timeline |
|---|---|---|---|
| 15 | Water ponding & inadequate drainage system on the roof. Building- 4 (Warehouse Building) | The factory is required to develop a proper water drainage system on the roof. | 6-weeks |

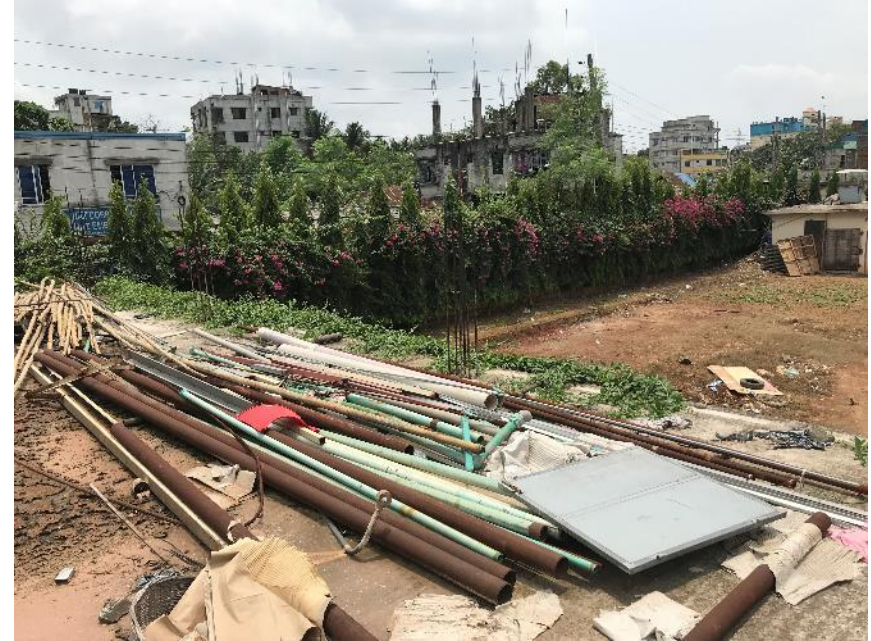
Blockage of drainage by construction debris

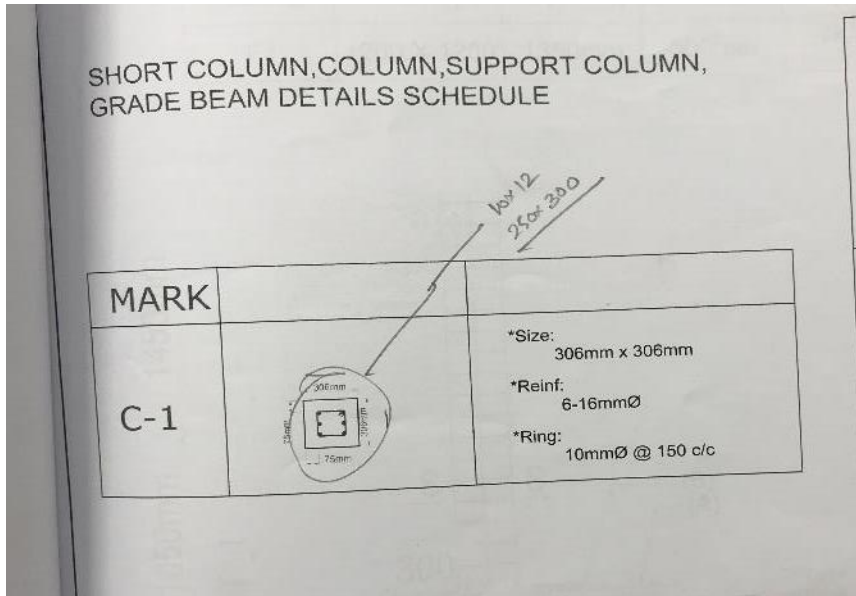
Column size in drawing (300x 300 mm)

The building engineer to required to survey the structure & prepare accurate as-built structural drawings.

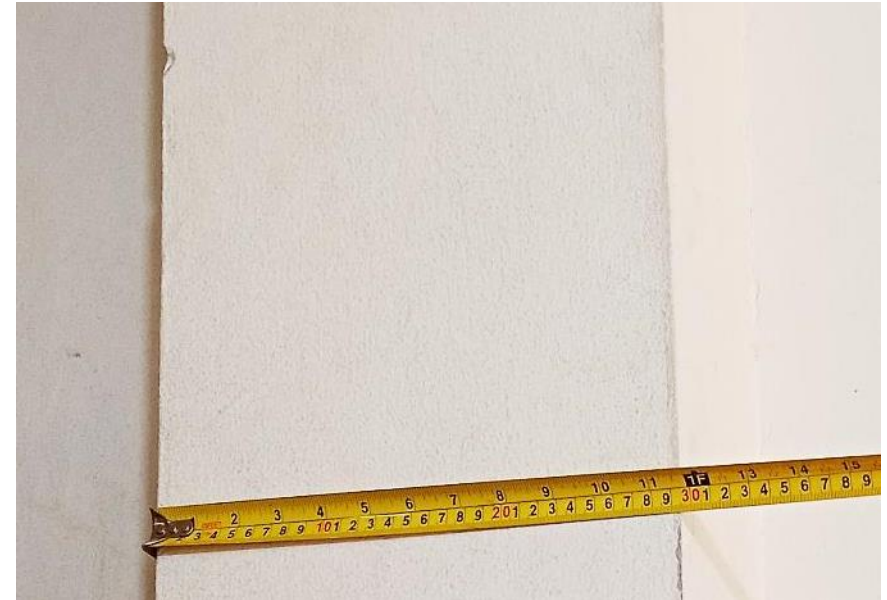
Existing column size (250X300 mm)

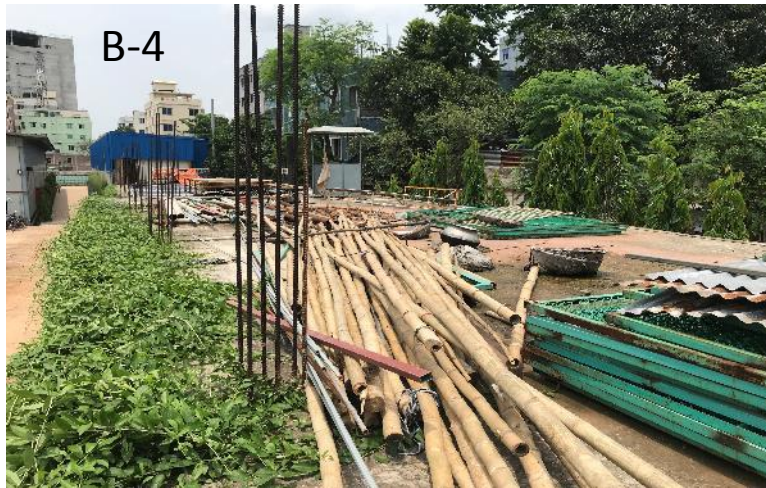
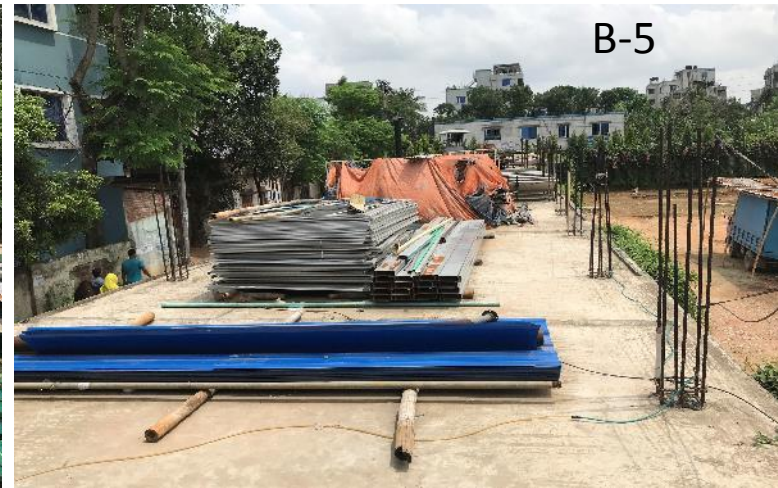
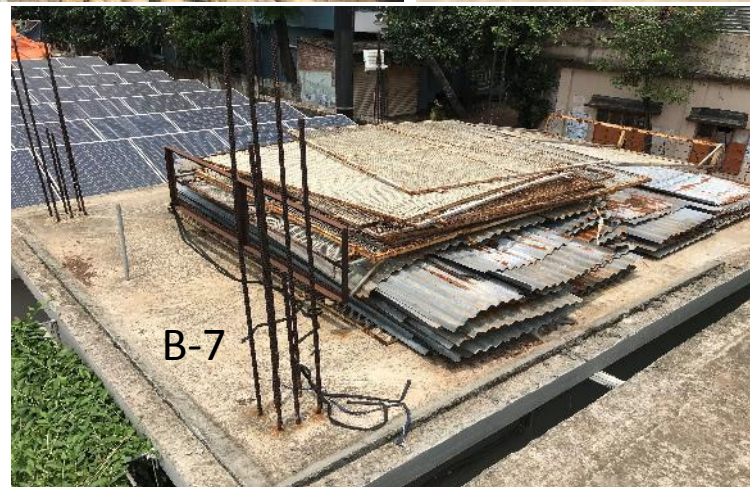
Falling hazard & construction debris on roof

Falling hazard was observed on the roof due to no parapet wall on B-4,B-5,B-6, B-7 . The factory is required to provide edge protection/barrier at roof and remove construction debris from the roof.

| Item No. | Observation | Recommended Action Plan | Recommended Timeline |
|---|---|---|---|
| 17 | Falling hazard & construction debris on the roof. (Building- 4, 5 & 7) | The factory is required to provide protection barrier at roof edges and remove construction debris from the roof. | 6-weeks |

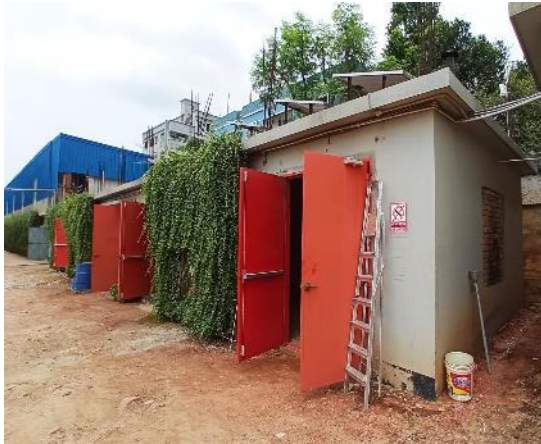
Building-5

No as-built drawings were available for B-5, B-6, B-7, B-8, B-10. Building engineer is required to survey the structures and prepare accurate as-built drawings for the above buildings.

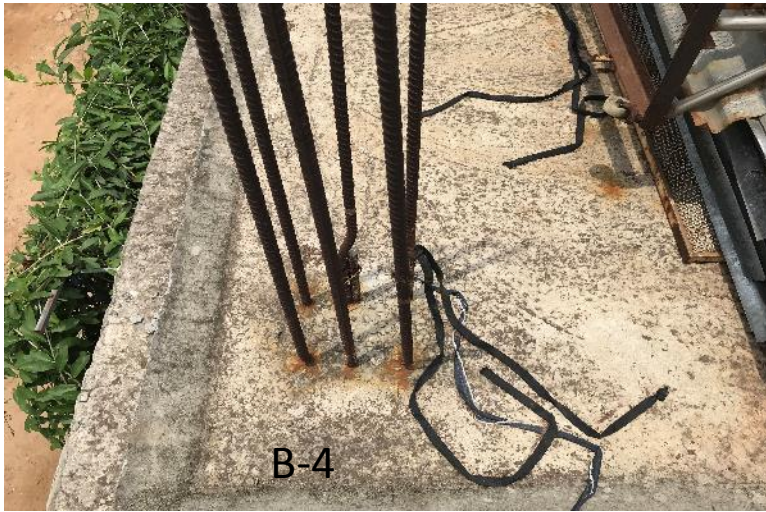
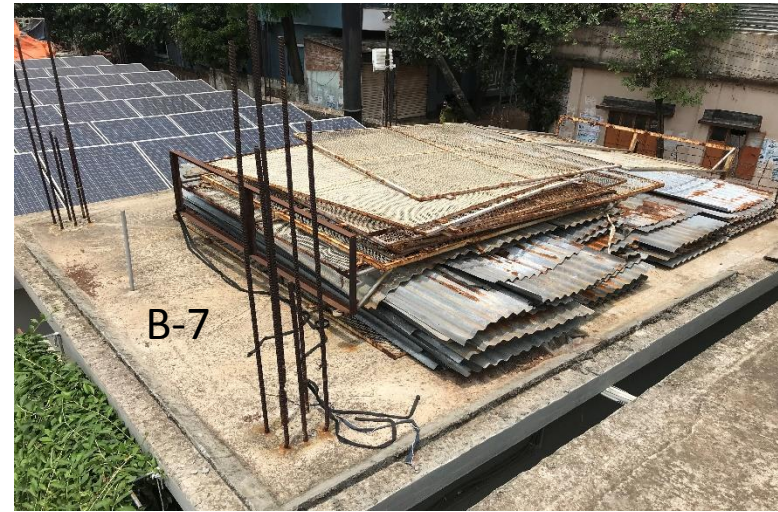
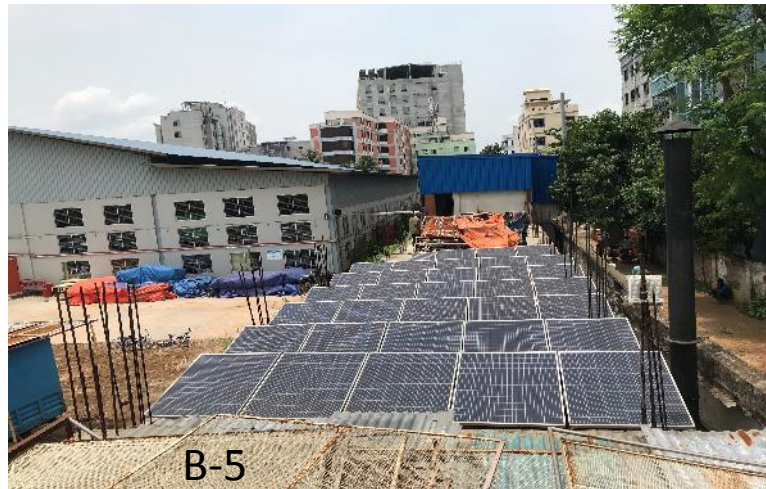
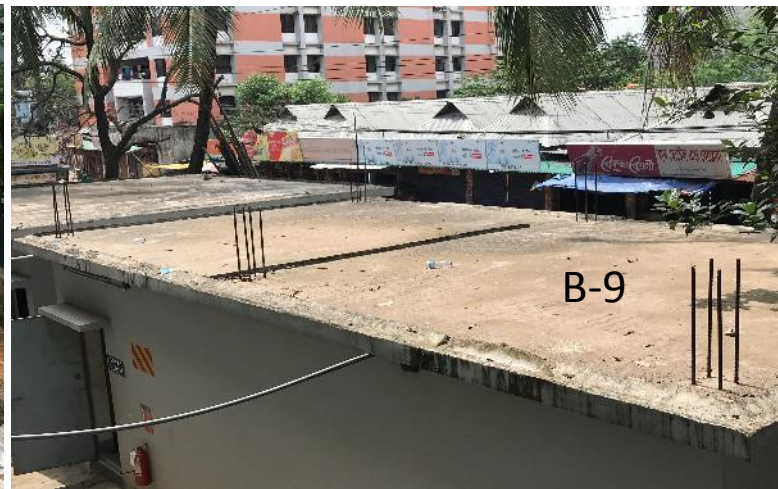
Corrosion on exposed rebar at roof

Corrosion observed on exposed rebar on roof of B-4, B-5, B-7, B-9. The factory is required to remove the corrosion and apply corrosion resistance coating to the exposed rebars.

| Item No. | Observation | Recommended Action Plan | Recommended Timeline |
|---|---|---|---|
| 19 | Expose rebar at roof. (Building- 4, 5, 7 & 9) | The factory is required to remove the corrosion and apply corrosion resistance coating to the exposed rebars. | 6-weeks |

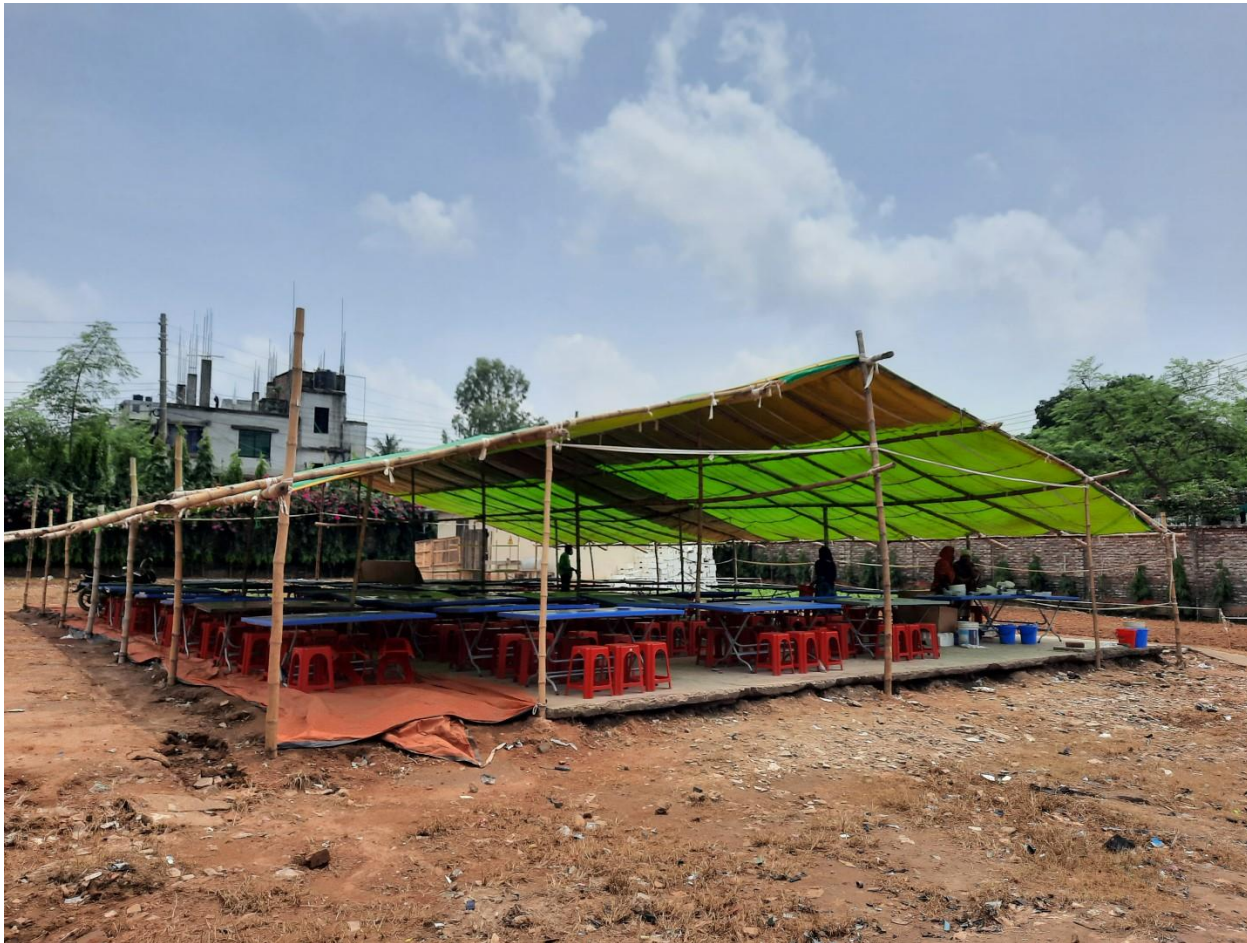
Non-engineered bamboo dining shed observed. Building engineer is required to suggest alteration of the existing structure.

| Item No. | Observation | Recommended Action Plan | Recommended Timeline |
|---|---|---|---|
| 20 | Apparently non-engineered structure. (Dining Shed & Tin shed) | Building engineer is required to suggest the alternation of the existing dining shed and carry out the replacement works. | 6-weeks |

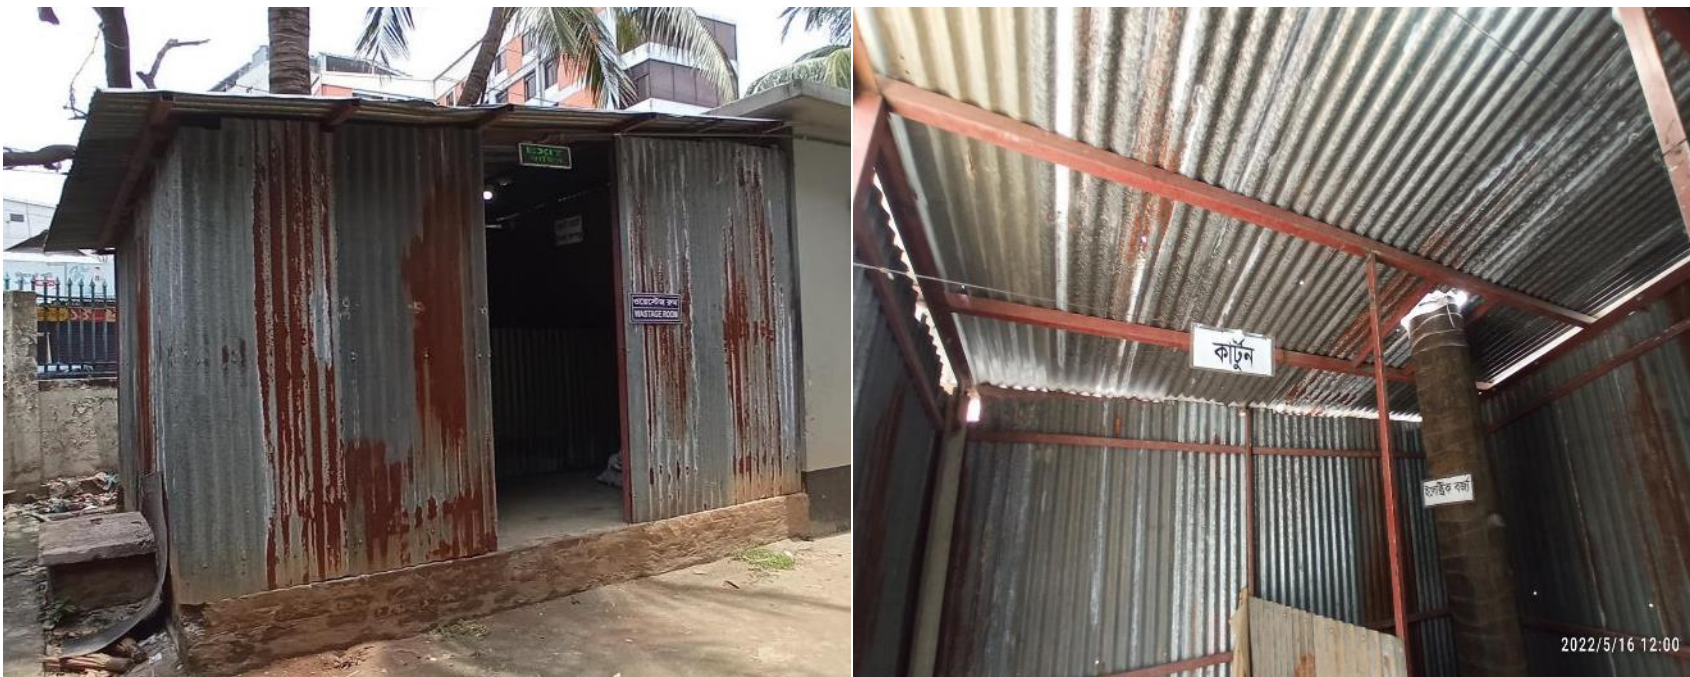
Tin Shed

Poor connections, inadequate members were observed on-site. Therefore, the structural system seems to be non-engineered. Building engineer to survey the structure, check the roof system, connections, member adequacy and suggest required actions. Otherwise, replace the structure with engineered one.

| Item No. | Observation | Recommended Action Plan | Recommended Timeline |
|---|---|---|---|
| 21 | Apparently non-engineered structure.<br>(Dining Shed & Tin shed) | Building engineer to survey the structure, check the roof system, connections, member adequacy and suggest required actions. | 6-weeks |
| 22 | Apparently non-engineered structure.<br>(Dining Shed & Tin shed) | Implement the actions suggested by the engineer. | 6-months |
