# Lariz Fashion Limited

Madanpur, Bandar, Narayanganj

18 May 2022

## 1. Factory Building (B+G+9)

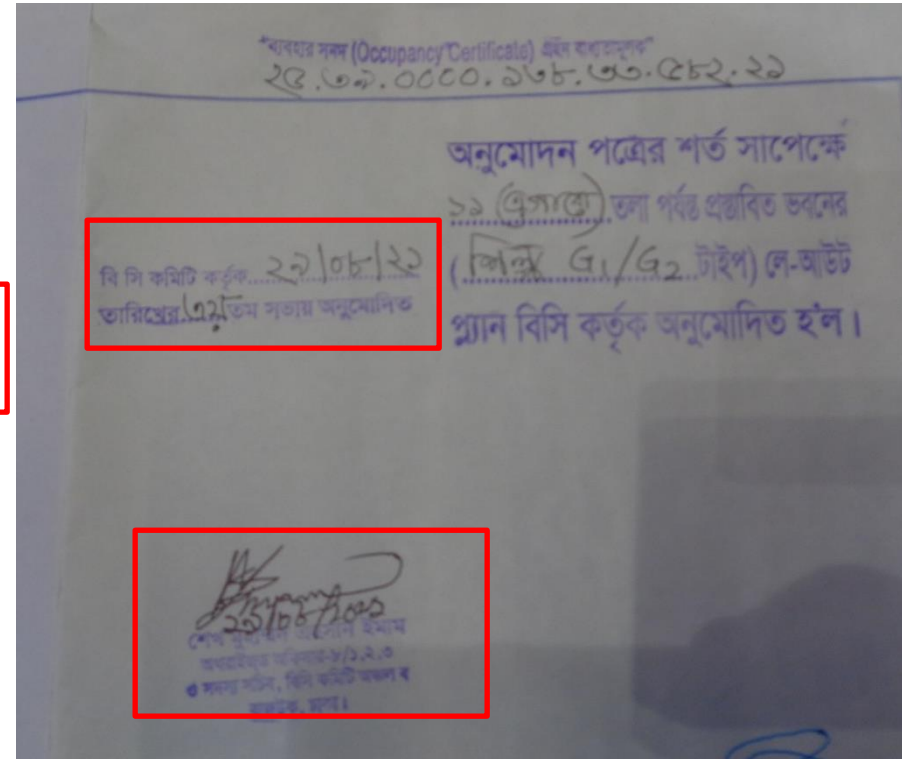
Engineering Assessment Report is prepared as per  
BNBC-2006

The permit drawing of building was approved on  
29 August 2021

The permit drawing of building was approved on 29 August 2021 (after 11 February 2021, publication date of BNBC 2020) but Engineering Assessment Report for this building is prepared as per BNBC-2006. Factory engineer is required to prepare the design code according to the BNBC 2020 provision and requirements.

| Item No. | Observation | Recommended Action Plan | Recommended Timeline |
|---|---|---|---|
| 02 | Design code consideration for the existing building. | Factory engineer is required to prepare the design code according to the BNBC 2020 provision and requirements. | 6-weeks |

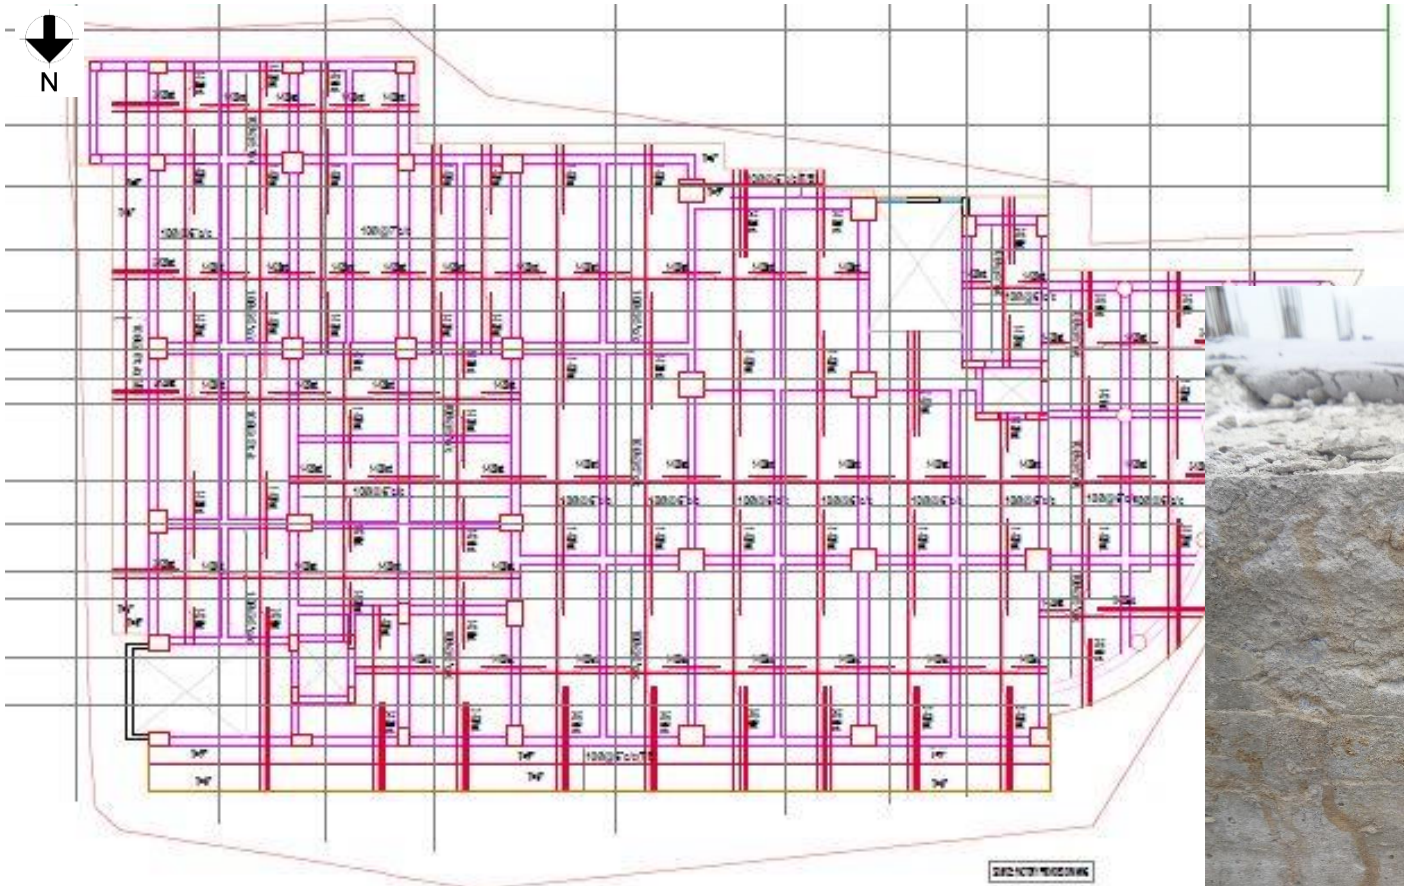
3RD TO 10TH FLOOR SLAB REINFORCEMENT DETAILS.  
SLAB THICKNESS=8"

Slab thickness mentioned as 200 mm in provided drawing

Slab thickness mentioned as 200 mm in provided drawing  
 Factory engineer is required to survey the whole structure and update the as-built drawing as per onsite condition. Also, check the slab adequacy for original thickness.

| Item No. | Observation | Recommended Action Plan | Recommended Timeline |
|---|---|---|---|
| 04 | Discrepancies in as-built drawing (Factory Building) | Factory engineer is required to survey the whole structure and update the as-built drawing as per onsite condition. | 6-weeks |
| 05 | Discrepancies in as-built drawing (Factory Building) | Also, check the slab adequacy for original thickness. | 6-weeks |

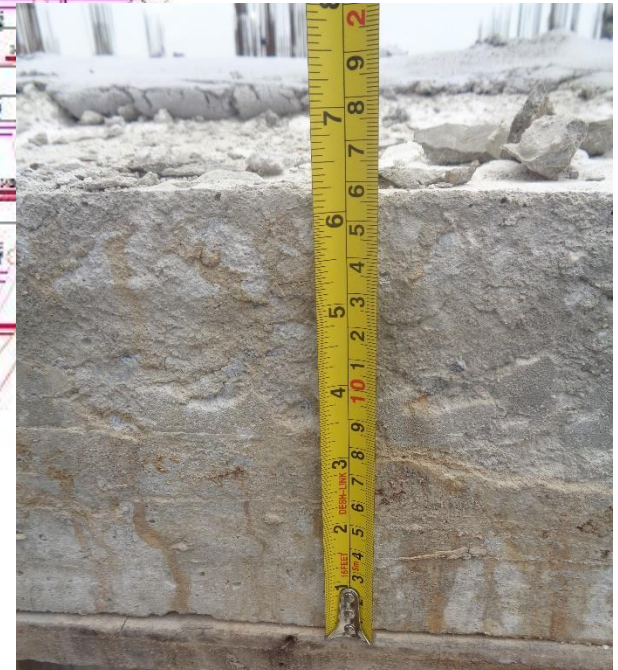
Slab thickness measured as 150 mm on site

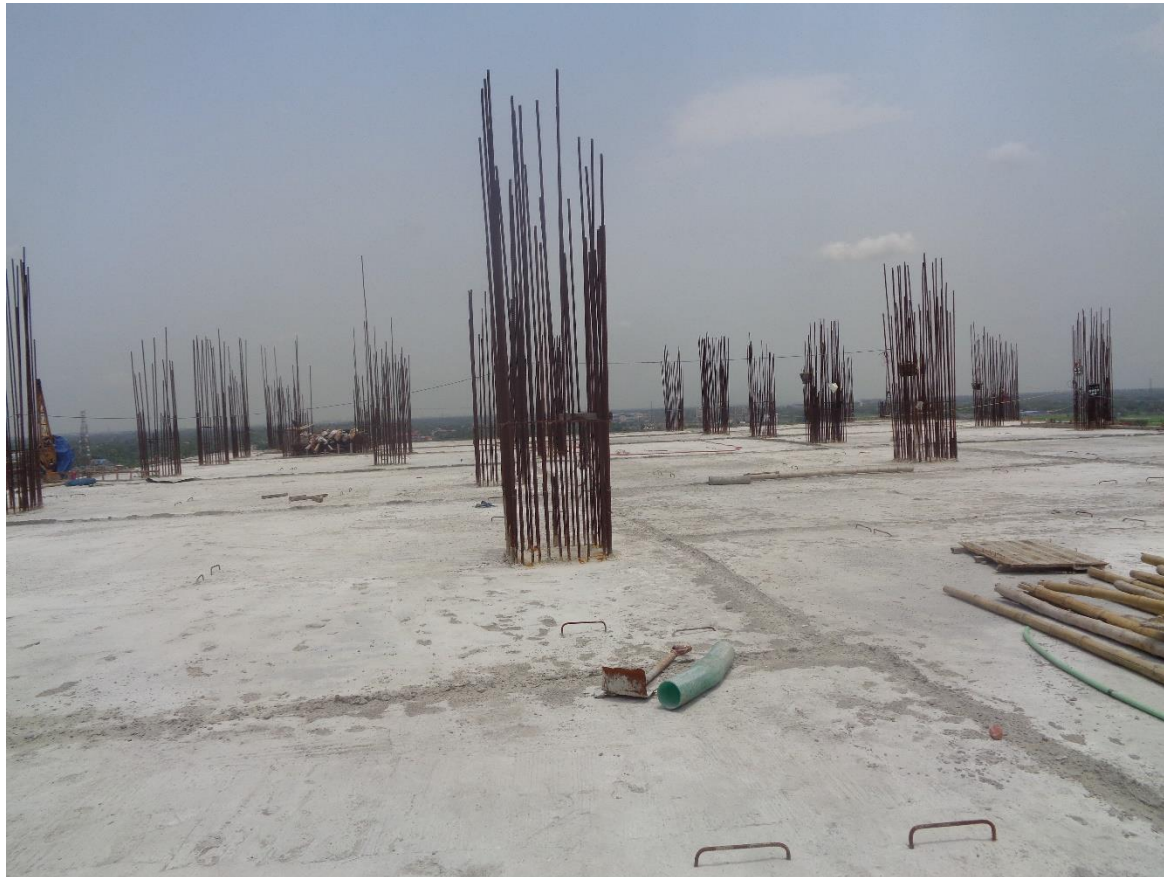
Exposed reinforcement left at roof

Exposed reinforcement is left at roof level which is prone to corrosion. Factory is required to provide rust proof paint on exposed reinforcement to protect from corrosion.

| Item No. | Observation | Recommended Action Plan | Recommended Timeline |
|---|---|---|---|
| 07 | Exposed reinforcement left at roof level (Factory Building) | Factory is required to provide rust proof paint on exposed reinforcement to protect from corrosion. | 6-weeks |

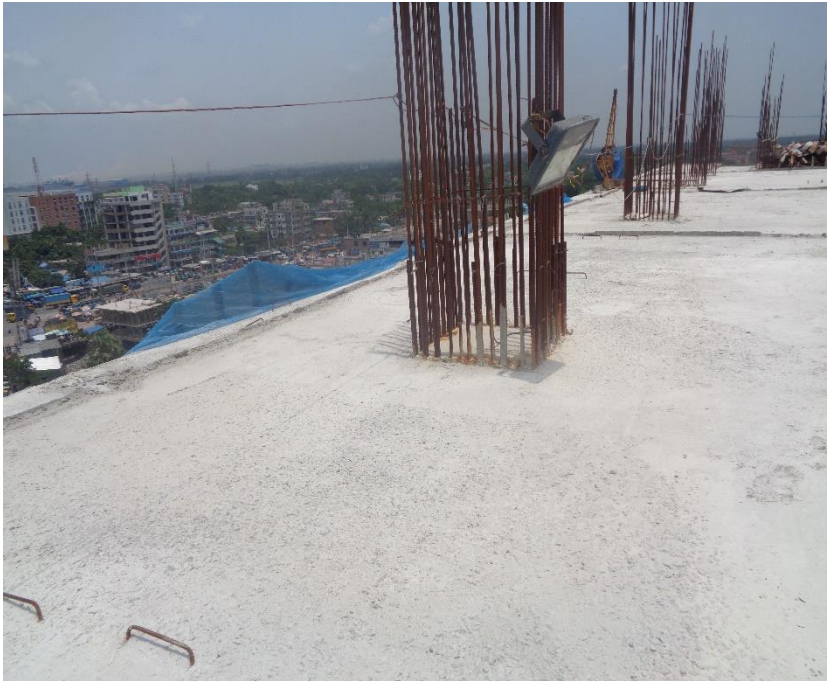
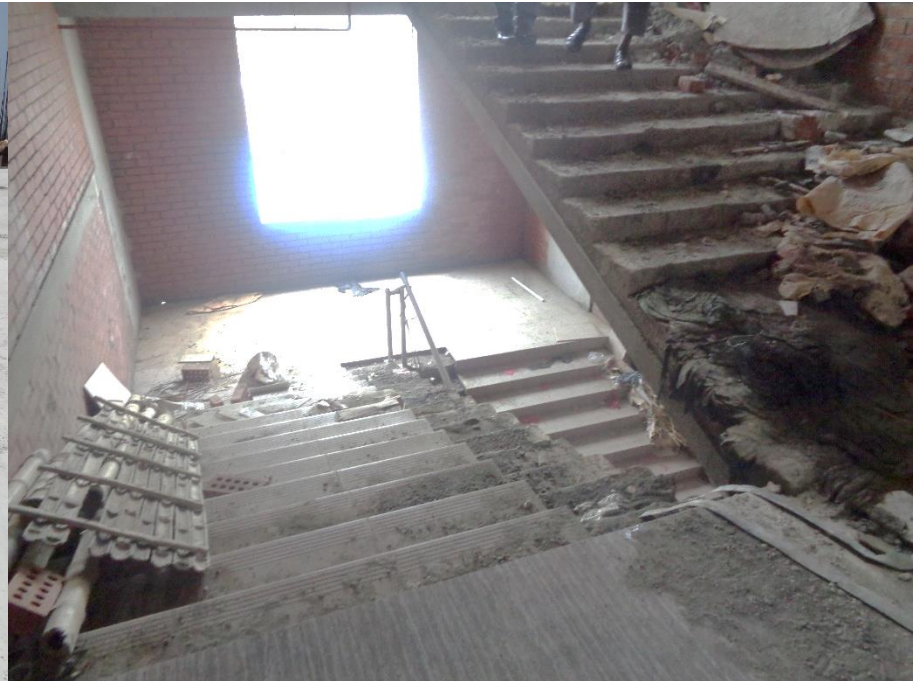
Parapet/railing was missing at roof and stair area

Factory is required to provide parapet/railing at all locations of roof and staircase to avoid possible falling hazard.

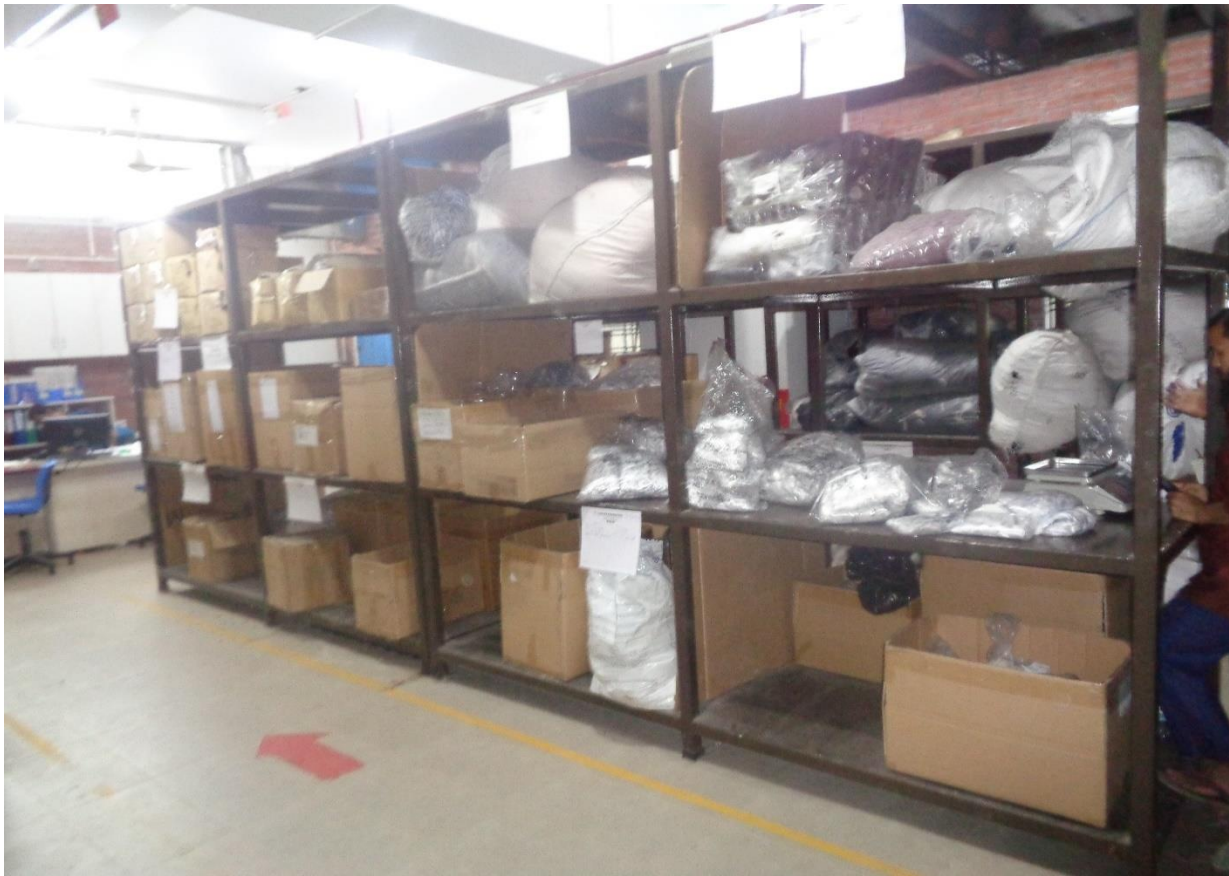
Storage rack found within the building without braced/anchored

Factory is required to brace/anchor all non structural elements.
