# J.M. Fabrics Ltd. (9497)

South Nayapara, 6 No Dogri, Bhawal, Mirzapur

30.MARCH.2014

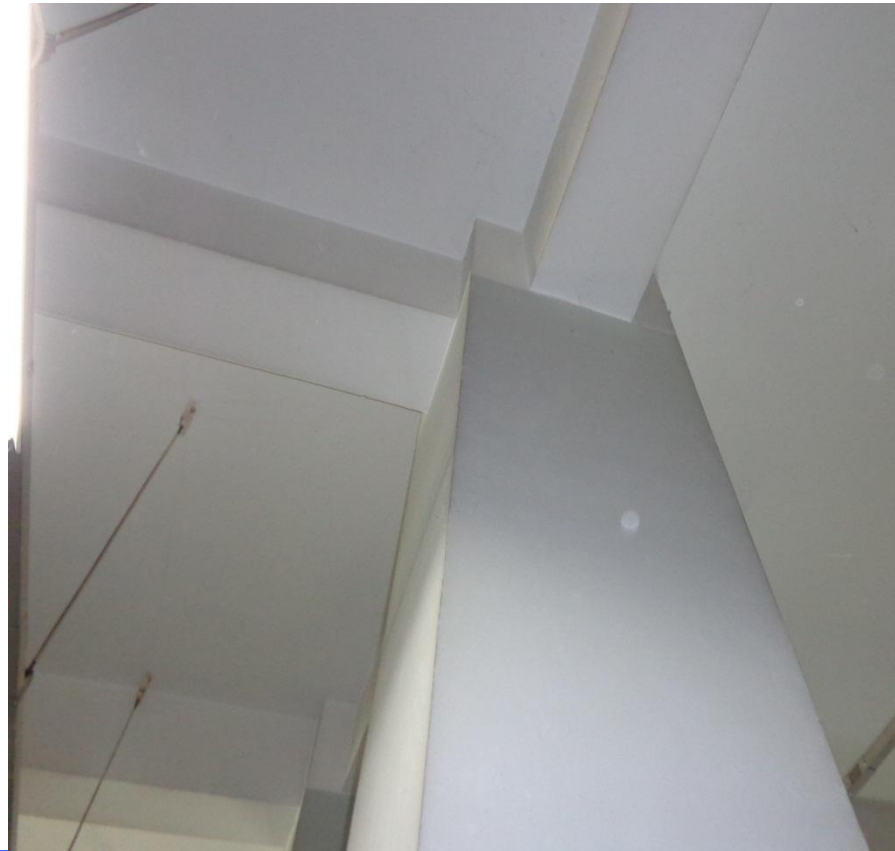
COLUMN SCHEDULE - EXISTING BUILDING

### **Low Column Safety Factors in Original 6-Storey Building**

Under minimum allowable loading column checks in the original 6-Storey building yield lower than desirable safety factors.

High column stresses within the original portion of the 6-storey building

- Factory engineer to review design, loads and column stresses in area identified above.

- Actively manage the existing loading plan for all floor plates within the factory complex.
