# Nasa Hitech Style Limited

Madhokhola, Sreepur, Gazipur

22 May 2022

# Observations

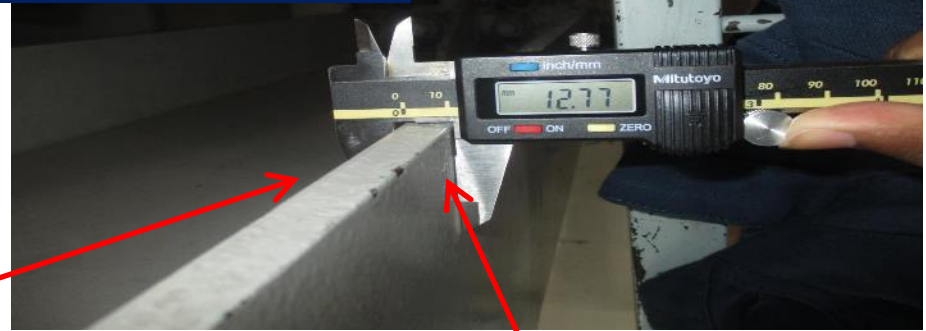
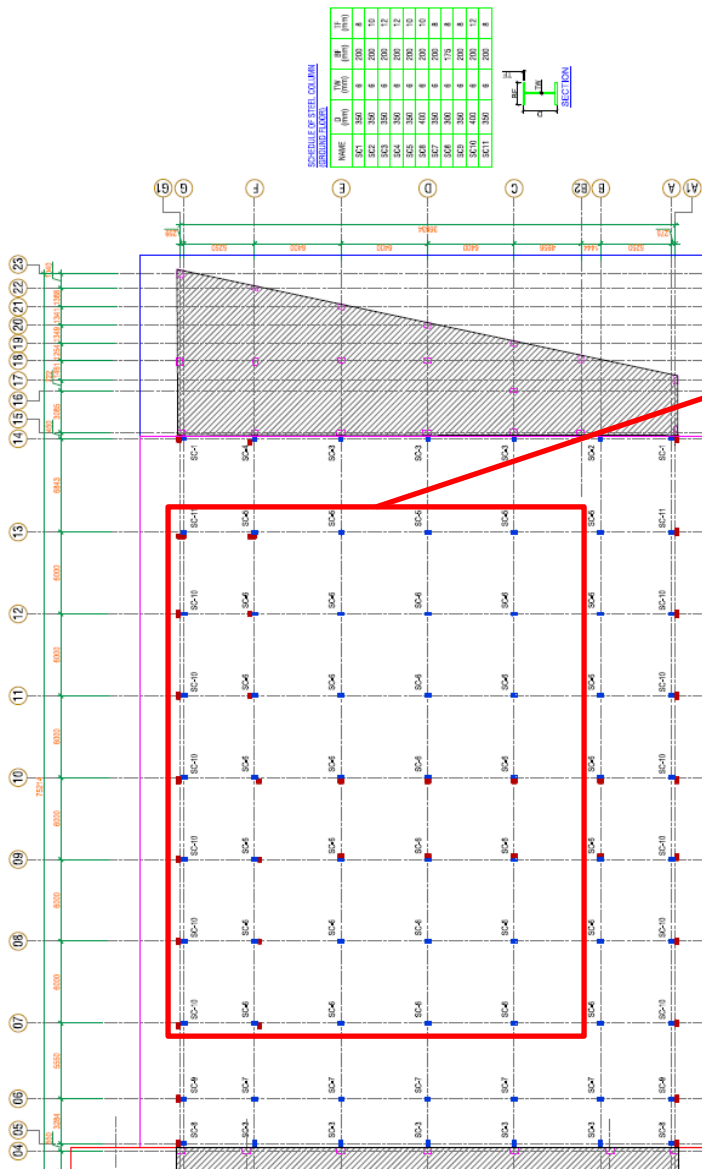
12 mm flange thickness  
measured on-site

12mm flange  
thickness found  
instead of 10 mm  
for SC2, SC5 & SC6  
column. Factory  
engineer is  
required to survey  
the structure &  
prepare accurate  
as- built drawings  
with structural  
details.

| Item No. | Observation | Recommended Action Plan | Recommended Timeline |
|---|---|---|---|
| 02 | Discrepancy between as-built drawing and on-site condition. (Factory Building) | Factory engineer is required to survey the structure & prepare accurate as- built drawings with structural details. | 6-weeks |

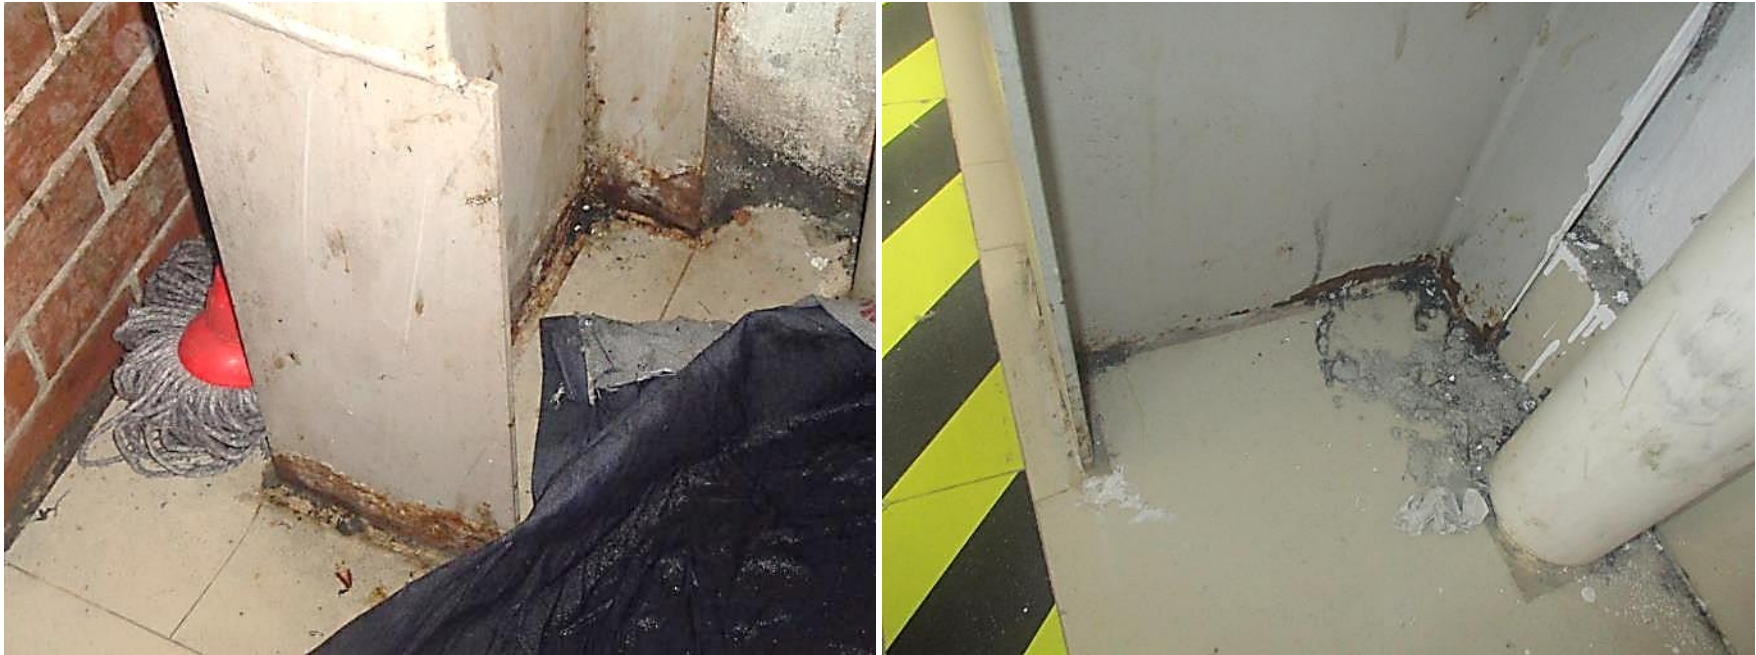
Corrosion observed in the steel column due to presence of water source nearby

Factory is required to remove the water source near by the steel members, take necessary actions to remove the corrosion & apply suitable corrosion resistance coating on the steel columns.

| Item No. | Observation | Recommended Action Plan | Recommended Timeline |
|---|---|---|---|
| 03 | Corrosion in the steel column. (Factory Building) | Factory is required to remove the water source near by the steel members, take necessary actions to remove the corrosion & apply suitable corrosion resistance coating on the steel columns. | 6-weeks |

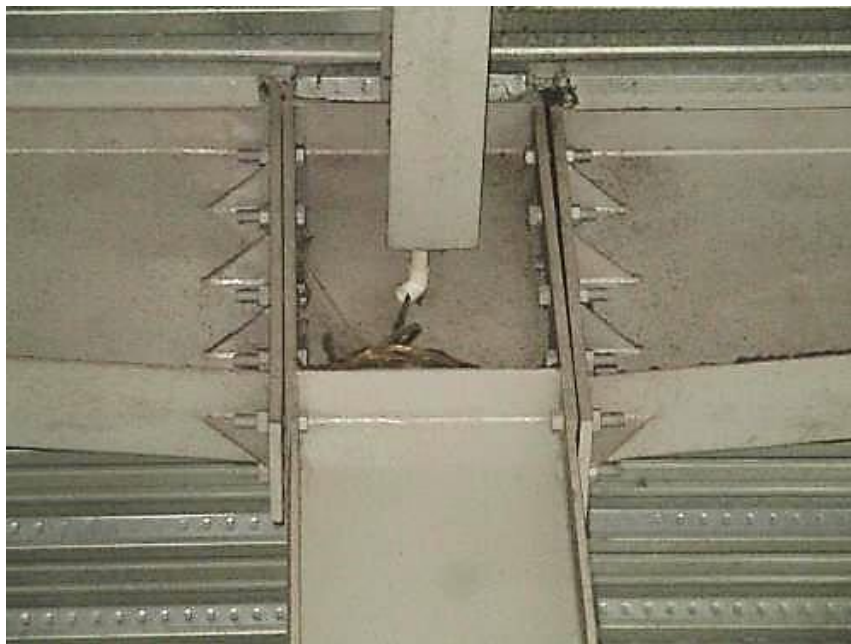
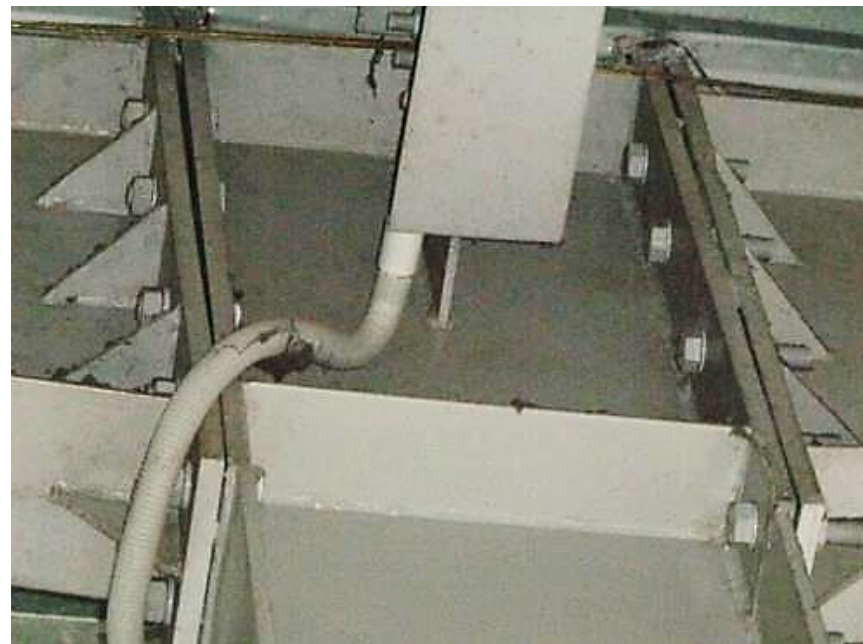
Significant connection gap observed in steel beam-column joint. Factory engineer is required to check the connections & suggest the proper repair methodology accordingly.

| Item No. | Observation | Recommended Action Plan | Recommended Timeline |
|---|---|---|---|
| 04 | Significant Connection Gap. (Factory Building) | Factory engineer is required to check the connections, suggest the proper repair methodology accordingly. | 6-weeks |
| 05 | Significant Connection Gap. (Factory Building) | Carry out repair works as per the suggestion of factory engineer. | 6-weeks |

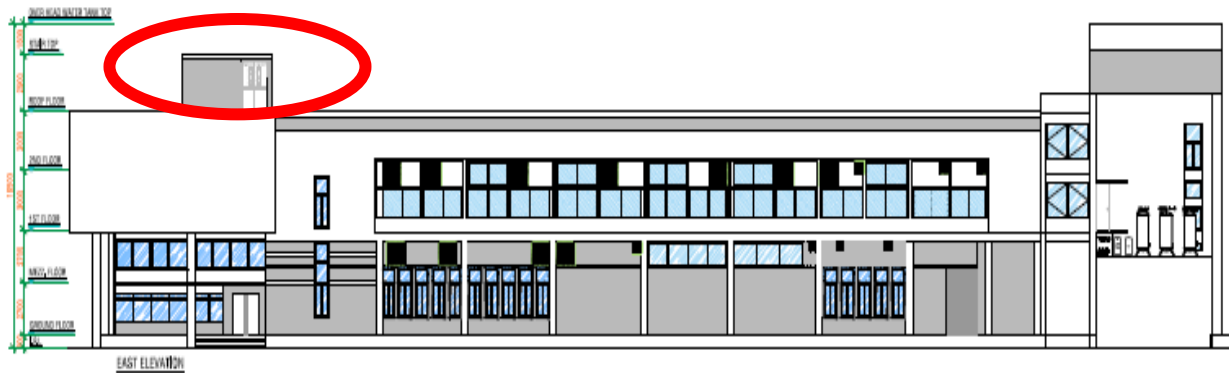
South Elevation of Office Building

Telecommunication mast on the O.H.W.T of the office building but it was not considered in the as-built drawing. Factory engineer is required to update the drawing according to the site condition.

| Item No. | Observation | Recommended Action Plan | Recommended Timeline |
|---|---|---|---|
| 06 | Undocumented telecommunication mast on the staircase. (Office Building) | Factory engineer is required to update the drawing according to the site condition. | 6-weeks |

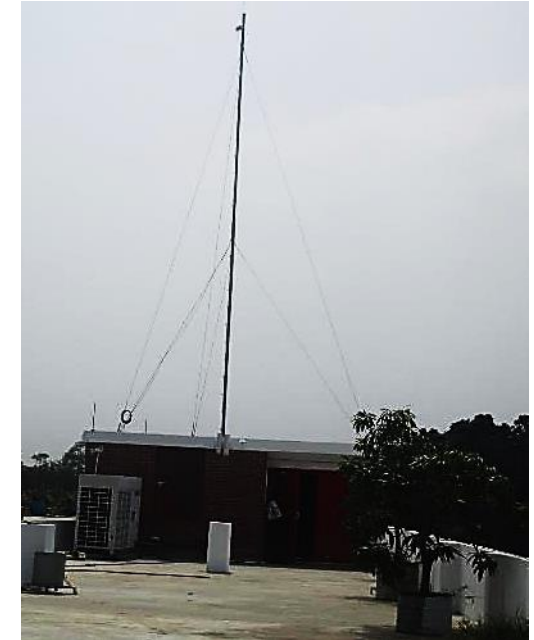
Telecommunication mast on the staircase.

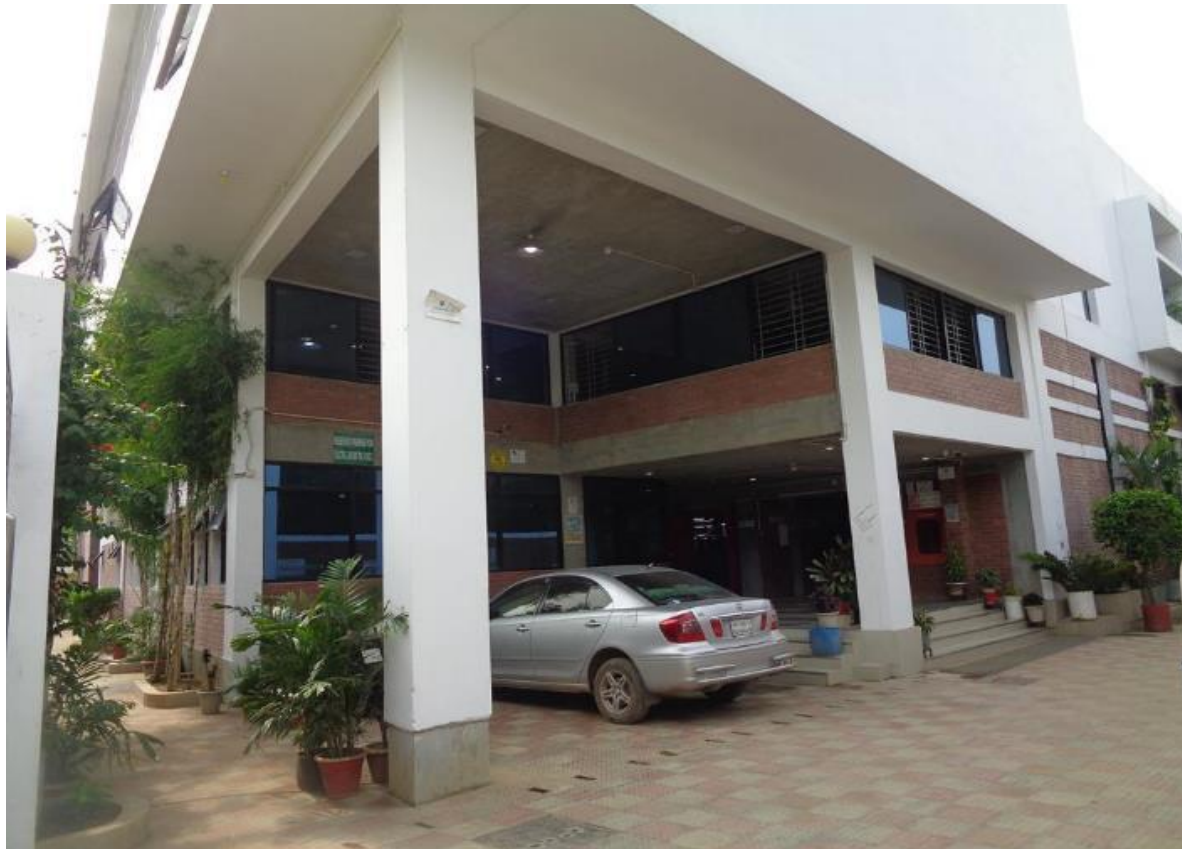
Ground Floor Column at Parking

No column guard provided to protect the ground floor column from the vehicle impact. Factory engineer is required to install column guard around the column to avoid the vehicle impact.

| Item No. | Observation | Recommended Action Plan | Recommended Timeline |
|---|---|---|---|
| 07 | Possibility of vehicle impact on column. (Office Building) | Factory engineer is required to install column guard around the column to avoid the vehicle impact. | 6-weeks |

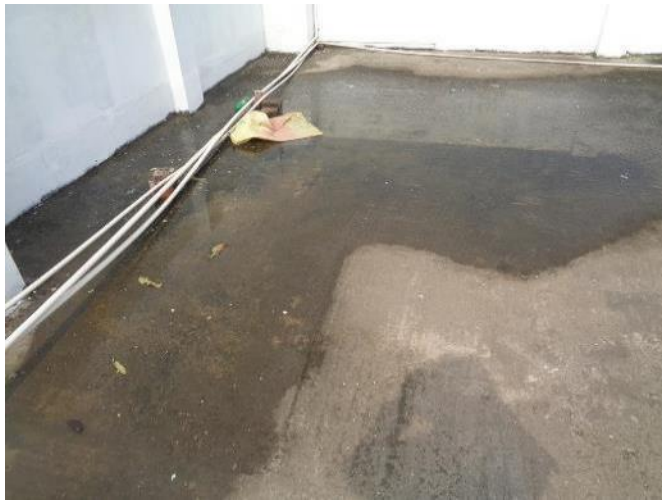
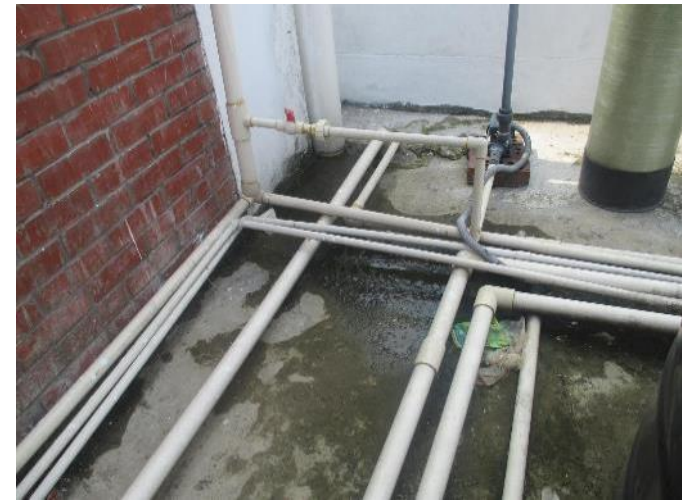
Standing water on the roof

Standing water on roof observed due to improper drainage system. Adjacent RC column and brick wall become damped. Factory engineer is required to provide adequate slope to wash out the storm water & investigate the intensity of the damage of the column and to take proper remedial actions.

| Item No. | Observation | Recommended Action Plan | Recommended Timeline |
|---|---|---|---|
| 08 | Standing water on the roof. (Facility Building) | Factory is required to provide adequate slope to drain out the storm water. | 6-weeks |

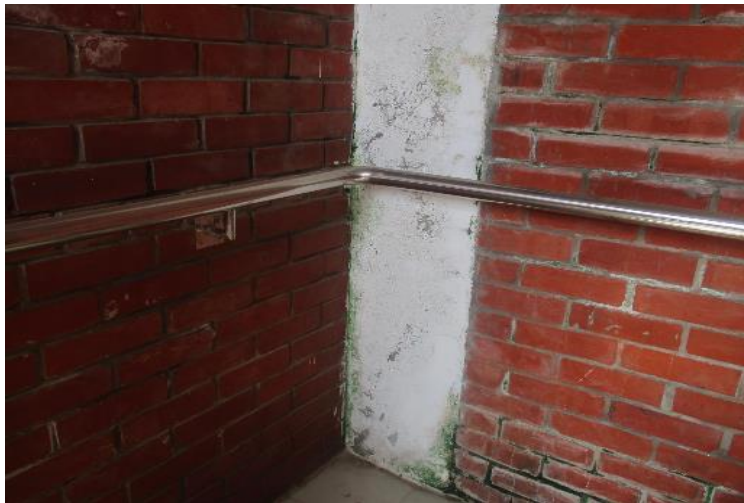
RC Column and wall in the staircase observed in damped condition due to the standing water.

| Item No. | Observation | Recommended Action Plan | Recommended Timeline |
|---|---|---|---|
| 09 | Standing water on the roof. (Facility Building) | Factory engineer is required to investigate the intensity of the damaged of the column and to take proper remedial actions. | 6-weeks |

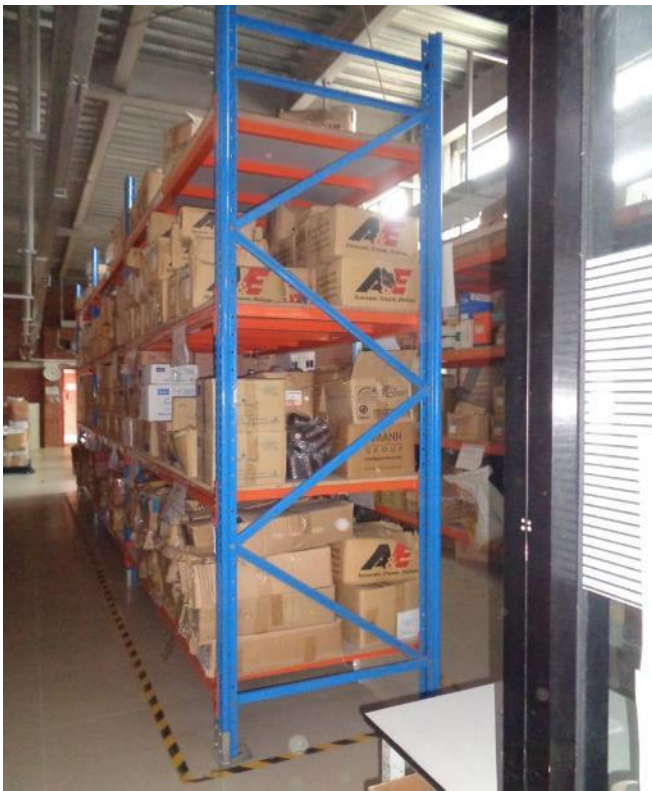
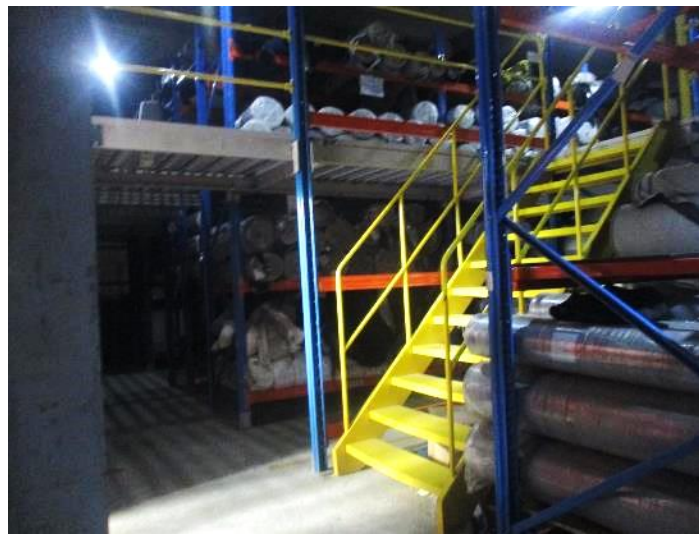
Storage racks on the ground floor were not adequately anchored or braced to resist earthquake forces.

Factory Engineer is required to anchored/braced the storage rack and all kinds of non-structural elements.

| Item No. | Observation | Recommended Action Plan | Recommended Timeline |
|---|---|---|---|
| 10 | Storage racks found without bracing/anchored. (Factory Building & Facility Building) | Factory engineer is required to anchored or braced the storage rack and all kinds of non-structural elements. | 6-weeks |

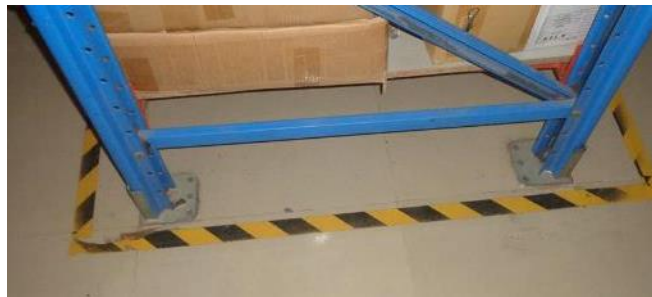
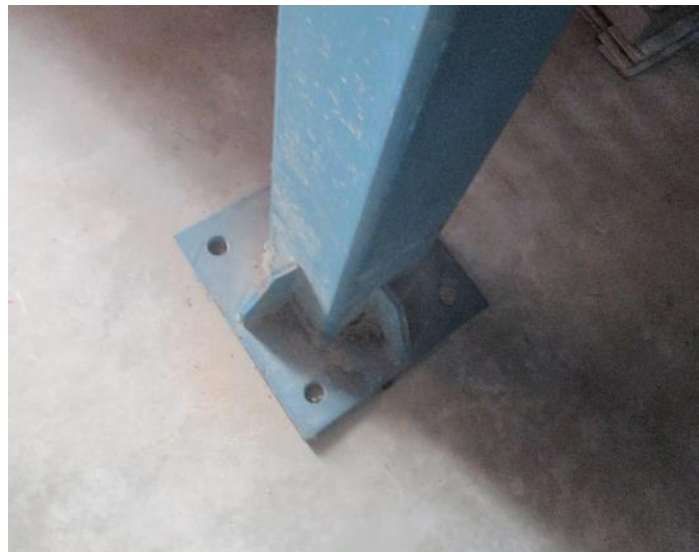
Storage rack not anchored or braced
