# KM Nobely Garments Ltd (Extension Building)

8/1 Zorun, Konabari Gazipur- 1702

24<sup>th</sup> May 2022

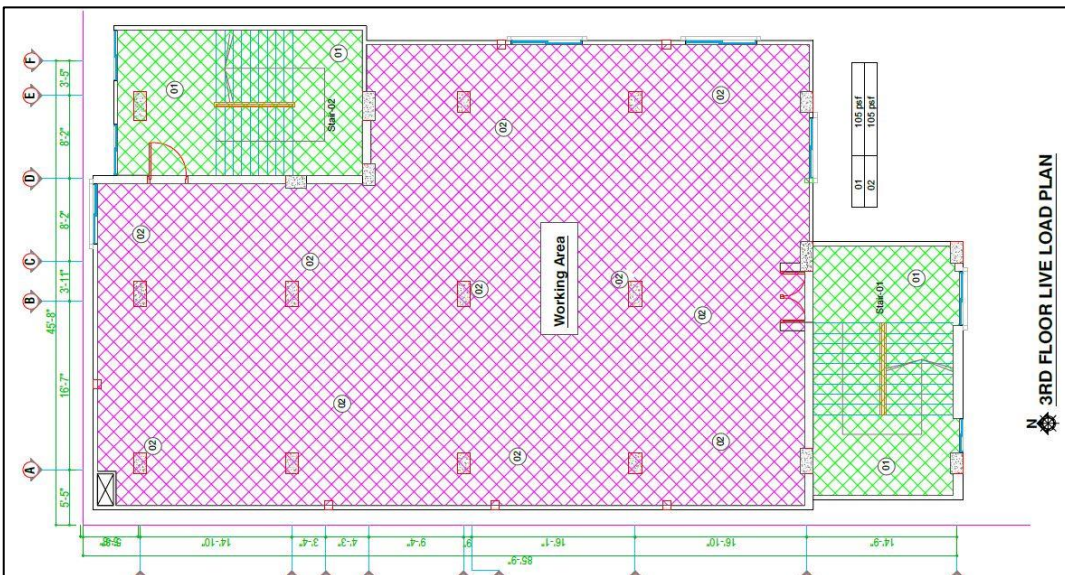
Floor live load plan with 105 psf (5 kN/m<sup>2</sup>) loading limit

Floor Loading

As per factory management, the 3<sup>rd</sup> & 4<sup>th</sup> floor is allotted for finished goods area. As per BNBC, the minimum floor live load for light storage is 6 kN/m<sup>2</sup> (125 psf). The storage in this building is designed for 5 kN/m<sup>2</sup> live loads.

The building engineer is required to revise the storage live load limit and related design documents accordingly based on BNBC requirement.

| Item No. | Observation | Recommended Action Plan | Recommended Timeline |
|---|---|---|---|
| 01 | Design report needs to be revised (6 storied RC Building) | The building engineer is required to revise the storage live load limit and related design documents accordingly based on BNBC requirement. | 6-weeks |
| 02 | Design report needs to be revised (6 storied RC Building) | Revise and actively manage a set of floor loading plan following BNBC. | 6-weeks |

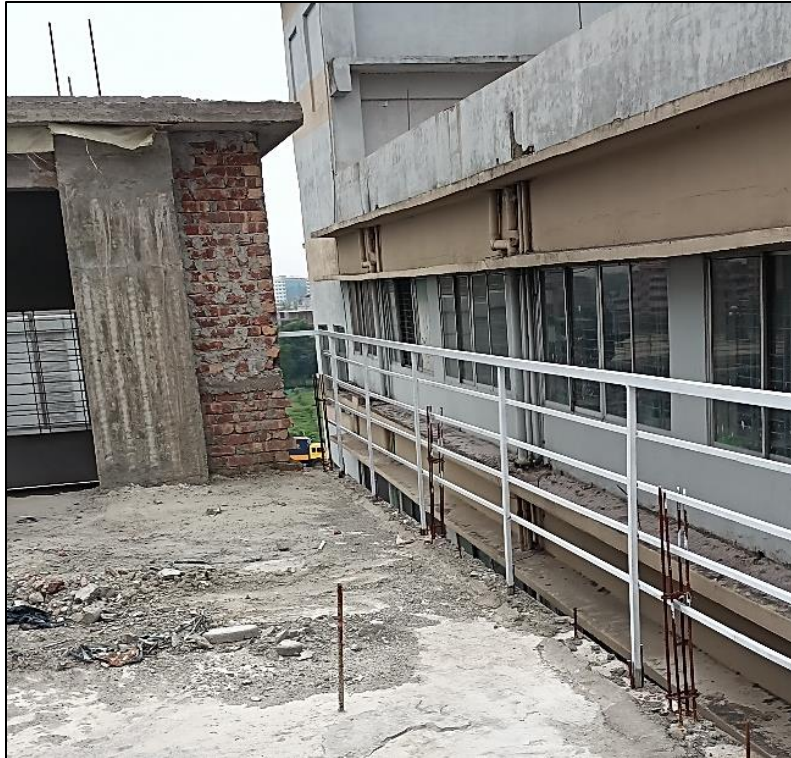
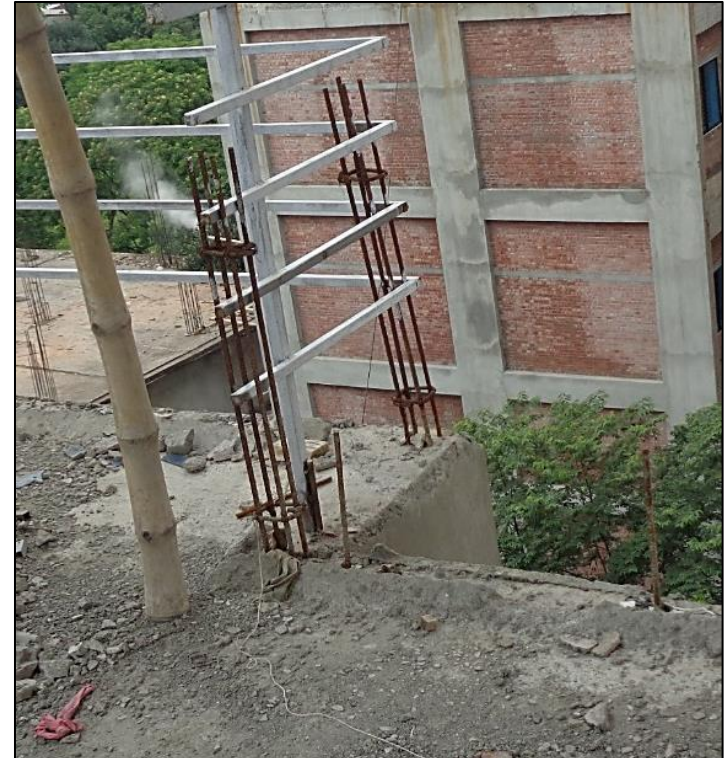
**Expose rebar at roof**

Exposed rebar at column on the roof

Exposed reinforcement was found extended from parapet on roof. All exposed reinforcement is to be protected from corrosion which may cause degradation of the concrete. Factory engineer is required to take necessary measures to prevent the corrosion in exposed rebar.

| Item No. | Observation | Recommended Action Plan | Recommended Timeline |
|---|---|---|---|
| 05 | Exposed rebar found (6 storied RC Building) | All exposed reinforcement is to be protected from corrosion. | 6-weeks |

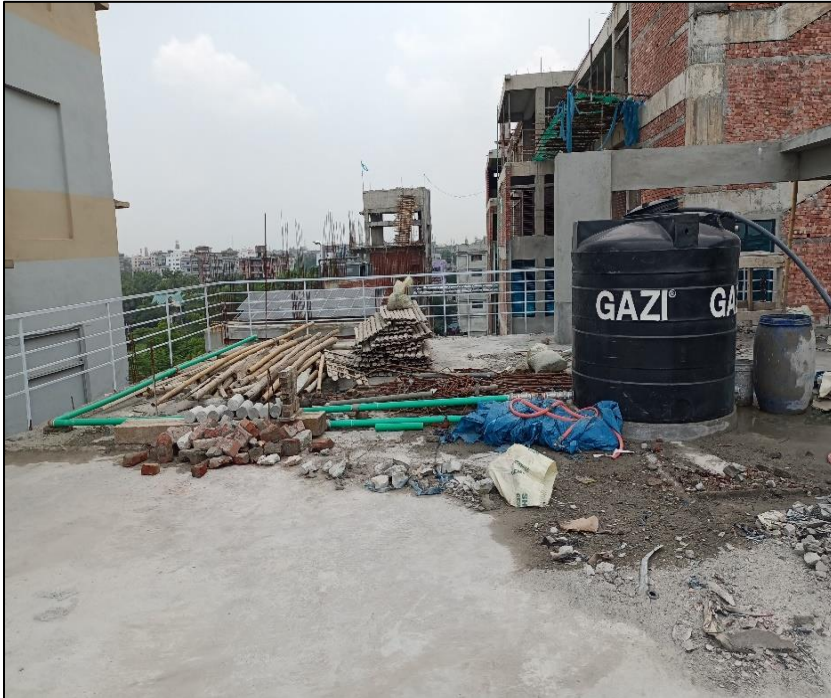
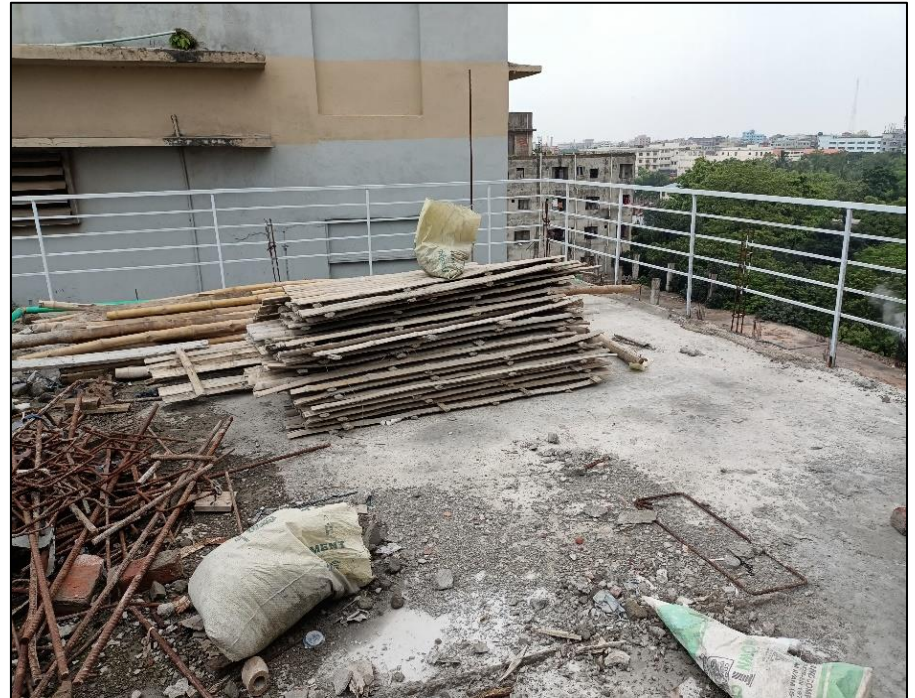
# **Stacking of construction material on the roof**

Stacking of construction materials and debris found on the roof.

| Item No. | Observation | Recommended Action Plan | Recommended Timeline |
|---|---|---|---|
| 06 | Stacking of construction material on the roof (6 storied RC Building) | Remove construction materials and debris from the roof. | 6-weeks |

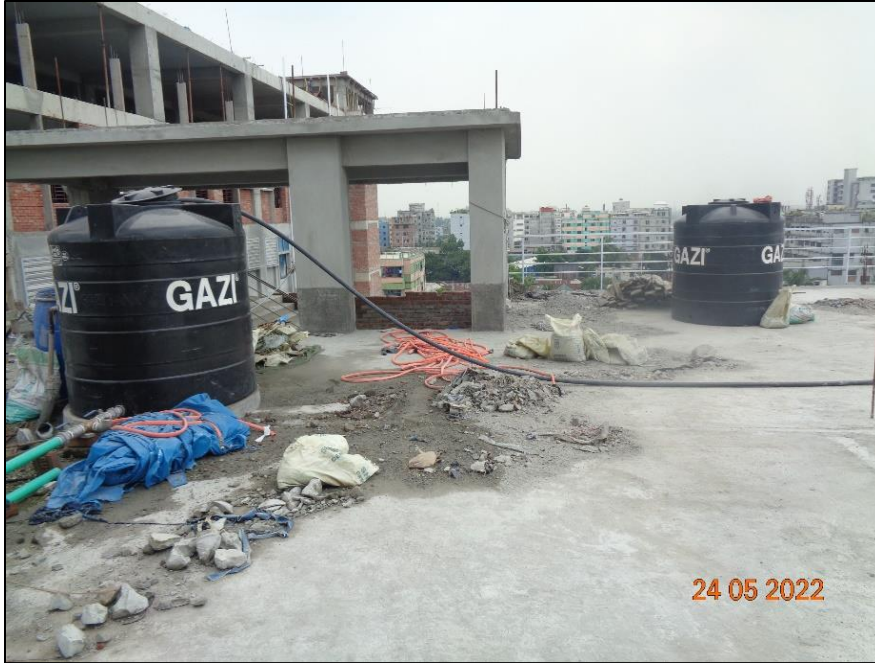
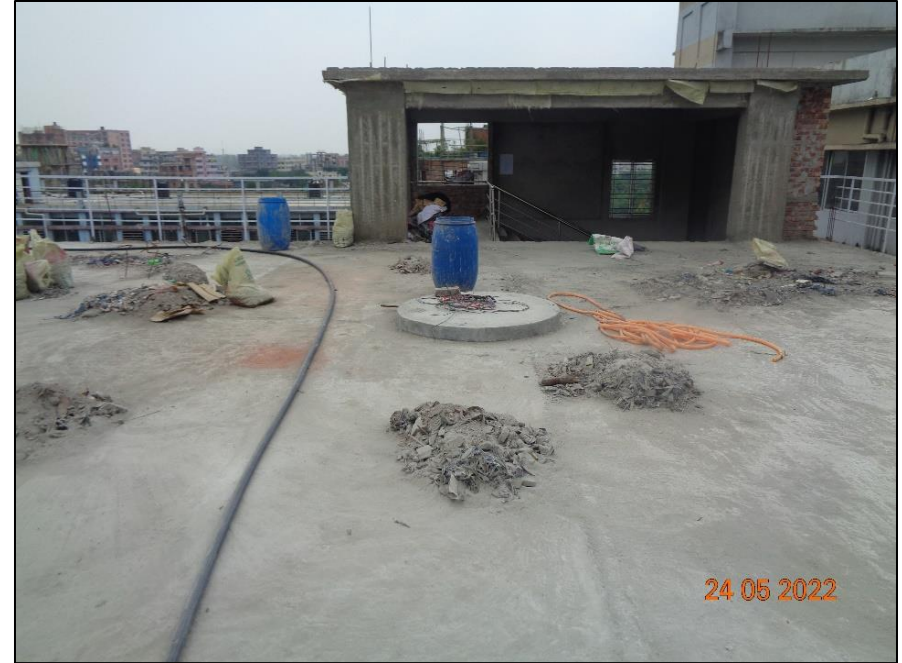
**Water proofing layer not found**

The roof slab is made of brick aggregate. Water proofing layer has not been applied yet. The factory engineer is required provide water proofing layer with proper drainage system and adequate sloping on the roof to avoid water ponding.

| Item No. | Observation | Recommended Action Plan | Recommended Timeline |
|---|---|---|---|
| 07 | Water proofing layer not found<br>(6 storied RC Building) | The factory engineer is required provide water proofing layer with proper drainage system and adequate sloping on the roof. | 6-months |

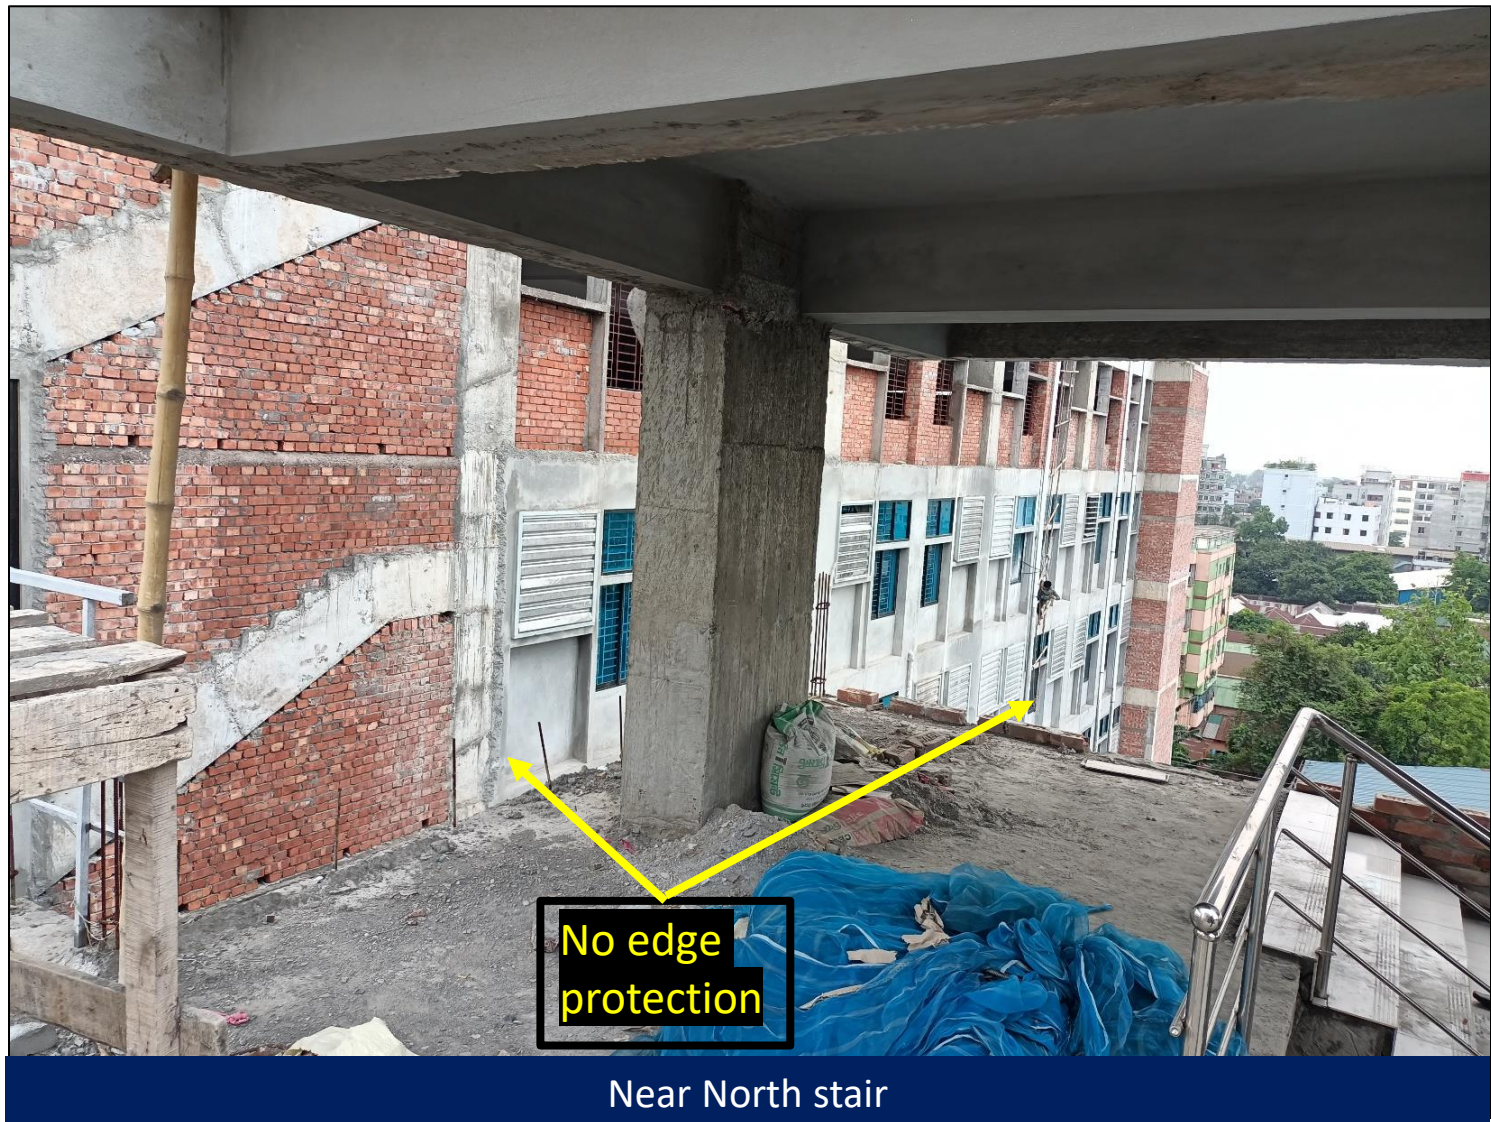
# Falling Hazard

No handrail/edge protection was provided near stair on roof. The factory engineer is required to take necessary measures to provide railing to mitigate the falling hazard.

| Item No. | Observation | Recommended Action Plan | Recommended Timeline |
|---|---|---|---|
| 08 | Falling Hazard<br>(6 storied RC Building) | The factory engineer is required to provide railing/barrier to mitigate the falling hazard. | 6-weeks |

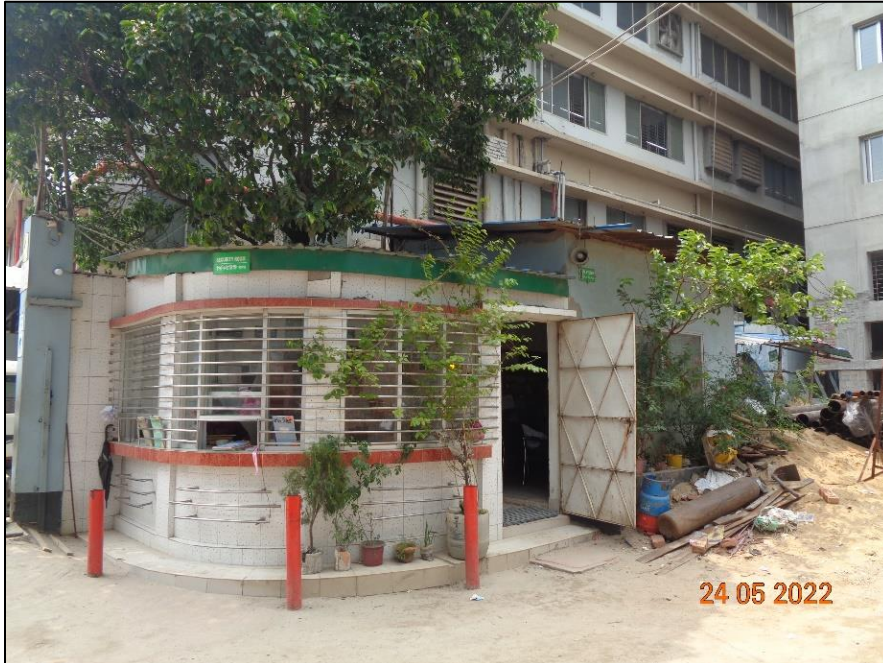
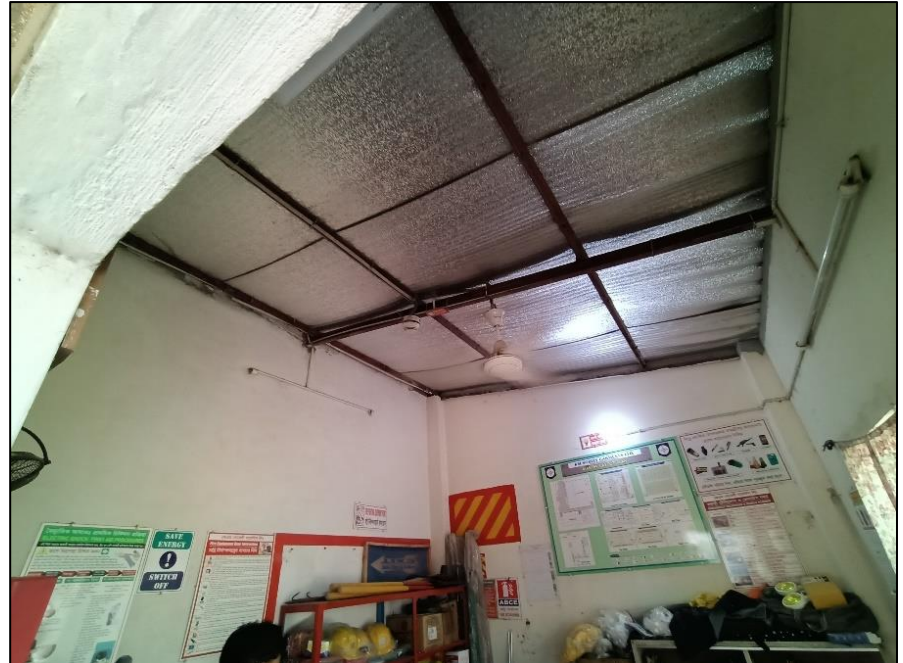
**Observation: Security Building**

No drawing was found for the Security Building. Building engineer is required to survey the structure and produce as-built drawing as per BNBC.

| Item No. | Observation | Recommended Action Plan | Recommended Timeline |
|---|---|---|---|
| 09 | Lack of as-built drawings<br>(Security Building) | Building engineer is required to survey the structure and produce as-built drawing as per BNBC. | 6-weeks |
