# Urmi Garments Ltd. (New Factory)

17 May 2022

# Observations

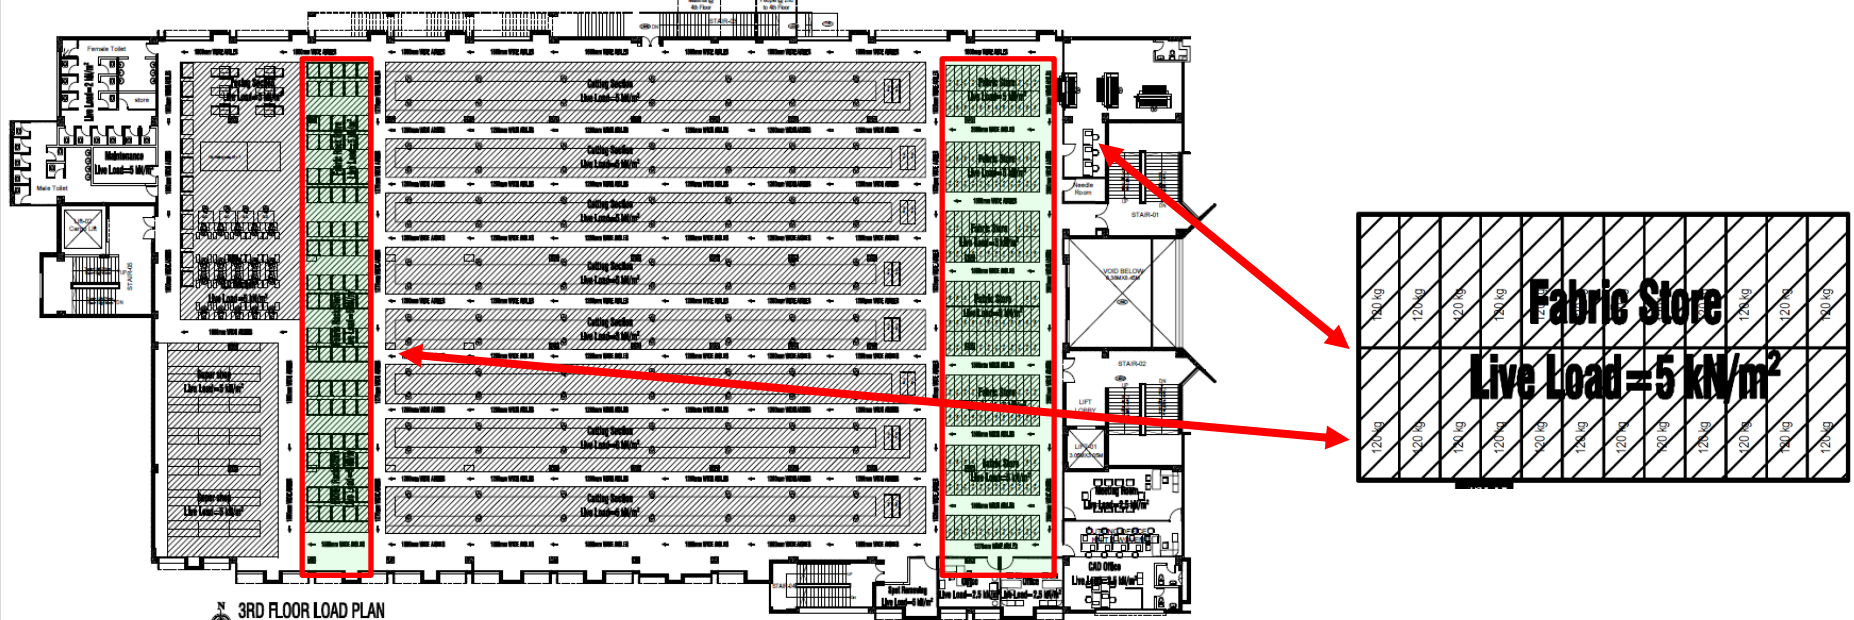
3RD FLOOR LOAD PLAN

3<sup>rd</sup> floor Layout Plan. Fabric store at marked area.

At 3<sup>rd</sup> floor, fabric store has been shown in layout in marked location. The live load of that area has been considered 5 kPa. As per BNBC, minimum loading 6 kPa is required for the light storage. Factory engineer is required to update the floor loading plan, software-based analysis and design report following BNBC loading requirement.

| Item No. | Observation | Recommended Action Plan | Recommended Timeline |
|---|---|---|---|
| 01 | Design report need to be revised. (Building-1) | Building engineer to update the design document including load plan, FEA model & design report in compliance with section 1.9.1.1 and section 1.9.1.2 as per BNBC. | 6-weeks |

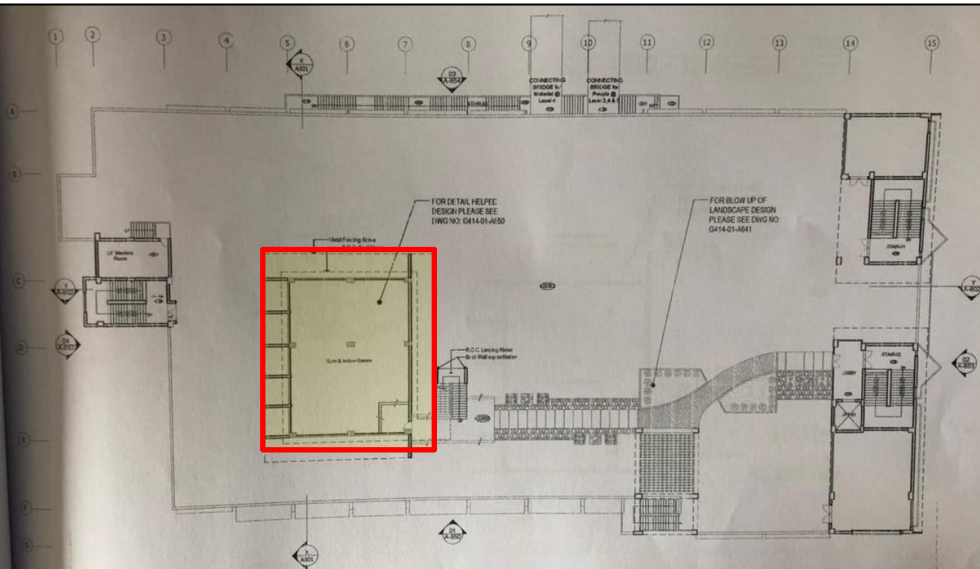
Gymnasium & indoor game room has been proposed at roof level below helipad frame. The live load of that area has been considered 32 psf (1.5 kPa) in FEA model and load plan was not available for the roof level. As per BNBC, minimum loading 3 KPa is required for the fixed seat gymnasium. Factory engineer is required to update the floor loading plan, software-based analysis and design report following BNBC loading requirement.

Gym & indoor game room at marked location

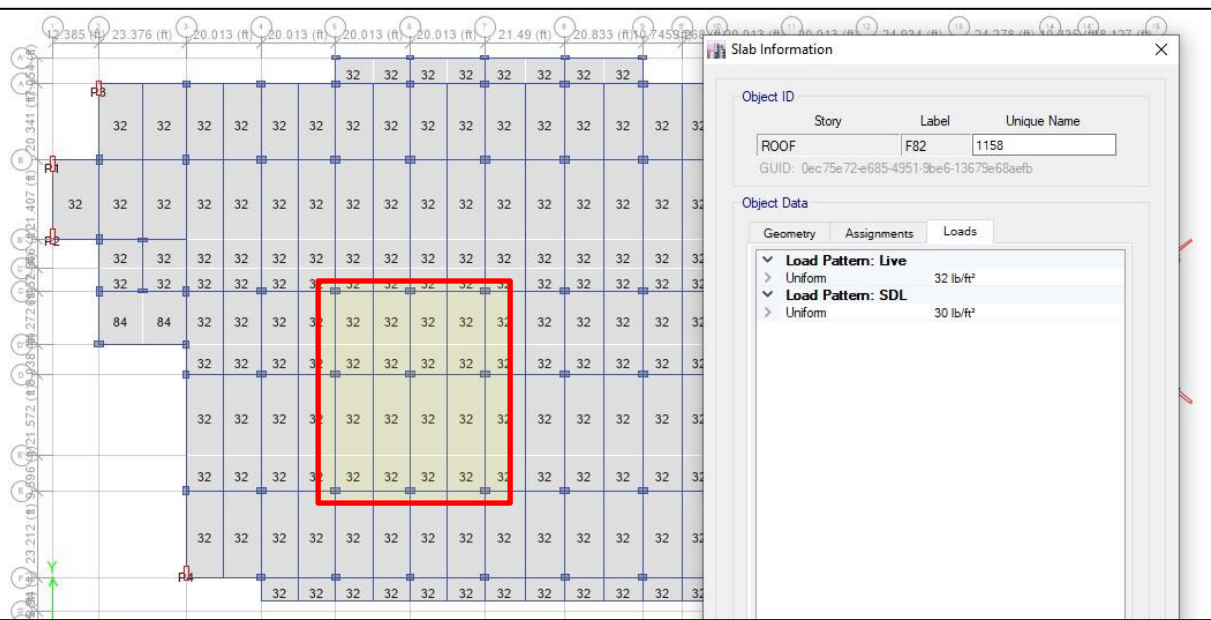
Live load considered 32 psf (1.5 kPa) in FEA model

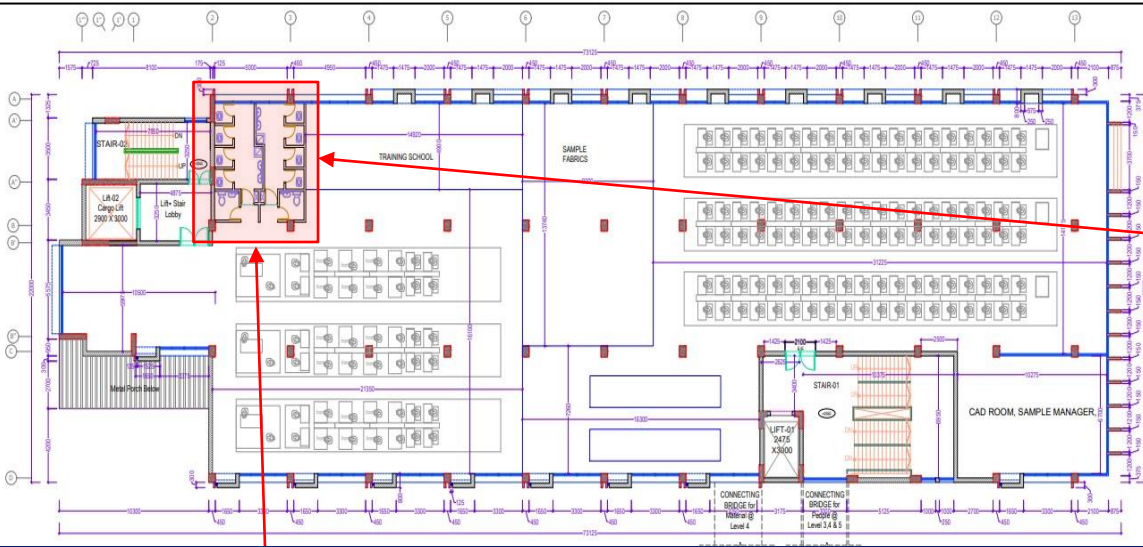
1<sup>st</sup> floor Layout plan

At 1<sup>st</sup> floor, 2.44 m toilet partition wall was found. But the loading from the 125 mm brick wall has not been in ETABS FEA model. Factory engineer is required to update the floor loading plan, software-based analysis and design report following BNBC loading requirement.

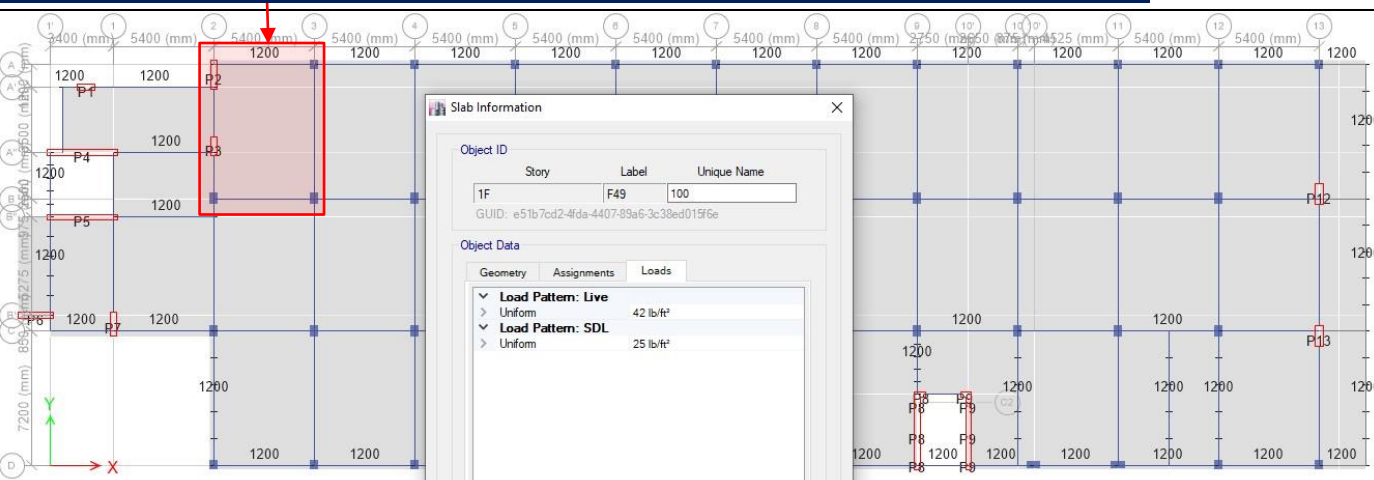
Toilet partition wall loading not considered – marked location

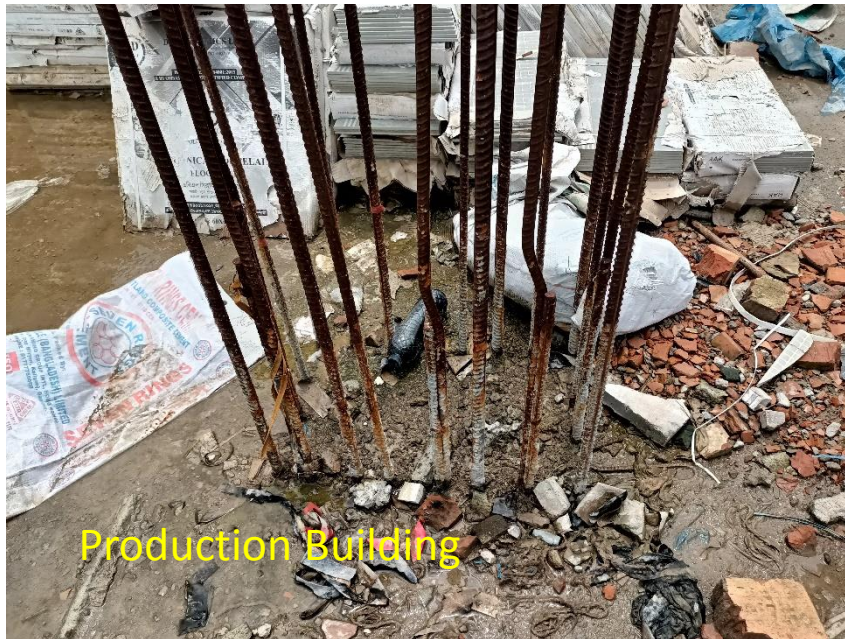
Production Building

Exposed rebar at column on roof of Production & Warehouse Building

Exposed reinforcement was found extended from column on roof. All exposed reinforcement is to be protected from corrosion which may cause degradation of the concrete. Factory engineer is required to take necessary measures to prevent the corrosion in exposed rebar.

| Item No. | Observation | Recommended Action Plan | Recommended Timeline |
|---|---|---|---|
| 05 | Exposed rebar found. (Building-1 & Building-2) | All exposed reinforcement is to be protected from corrosion which may cause degradation of the concrete. | 6-weeks |

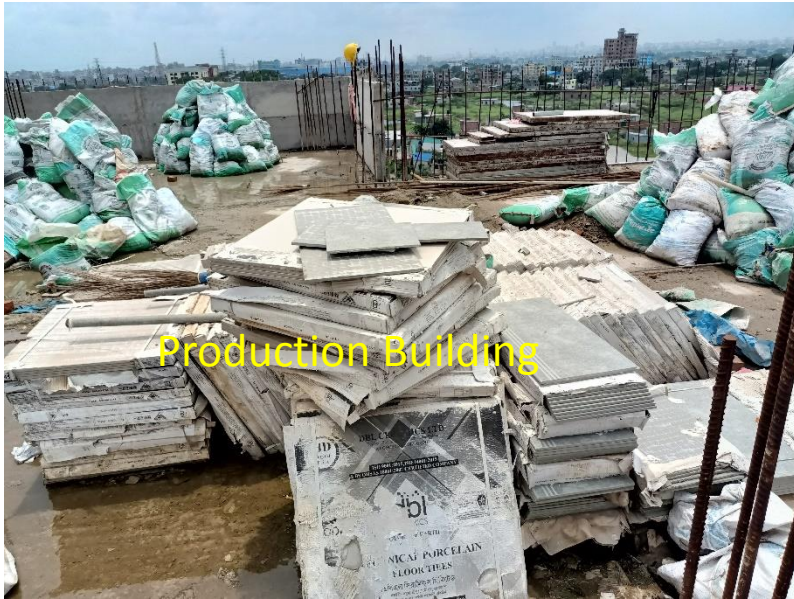
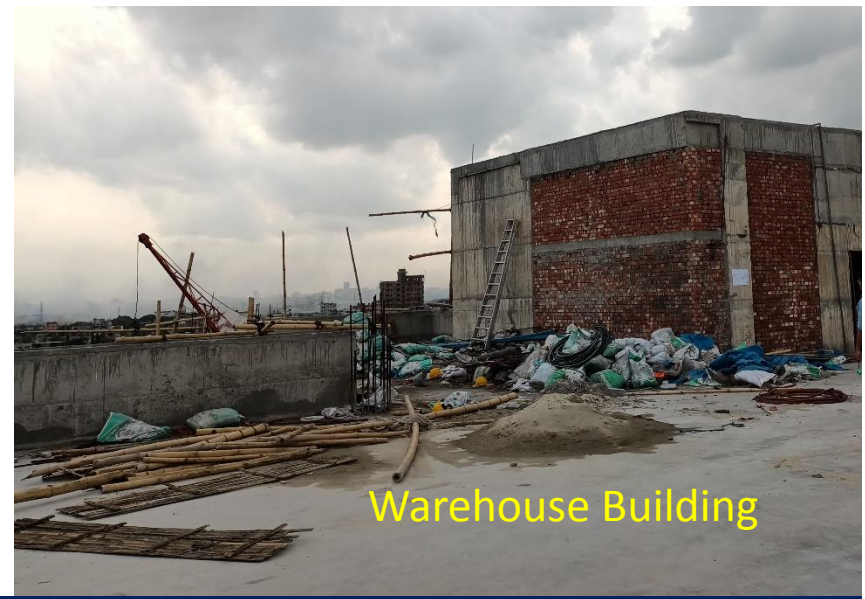
Stacking of construction materials and wastage found on the roof.

| Item No. | Observation | Recommended Action Plan | Recommended Timeline |
|---|---|---|---|
| 06 | Stacking of construction material on roof. (Building-1 & Building-2) | Remove construction materials and wastage from roof. | 6-weeks |

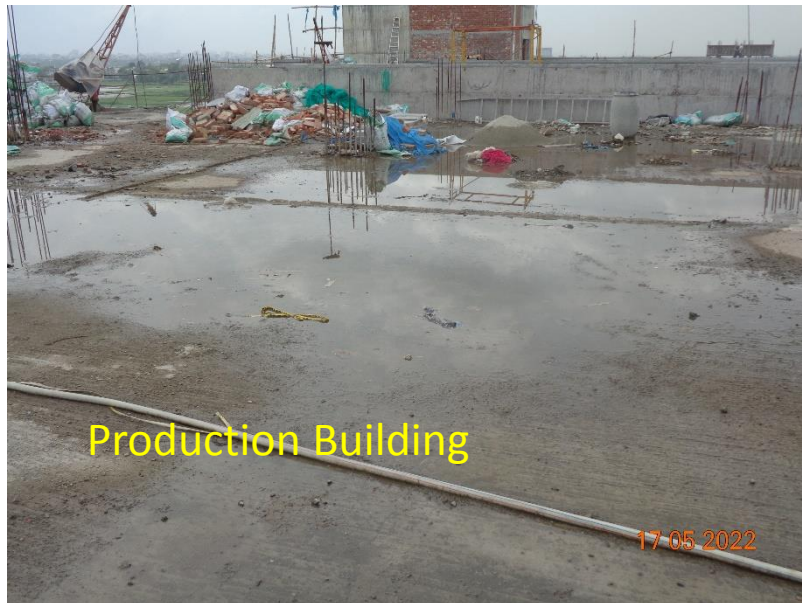
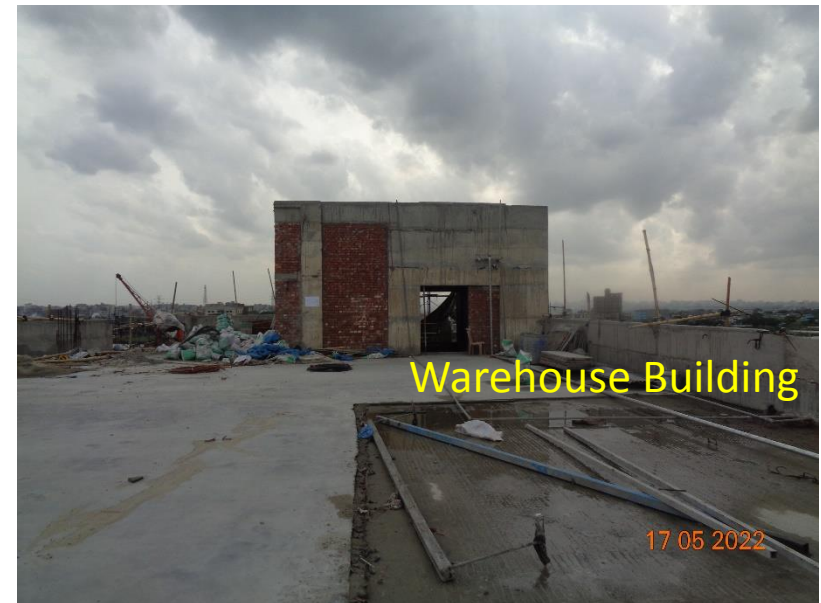
Water ponding was found at roof. The water drainage system was found but adequate sloping was not found. Water proofing layer casting was ongoing at time of inspection. The factory engineer is required to develop proper drainage system with adequate sloping on the mentioned area.

| Item No. | Observation | Recommended Action Plan | Recommended Timeline |
|---|---|---|---|
| 07 | Water ponding on roof (Building-1 & Building-2) | The factory engineer to develop proper drainage system with adequate sloping to resist water ponding on roof. | 6-months |

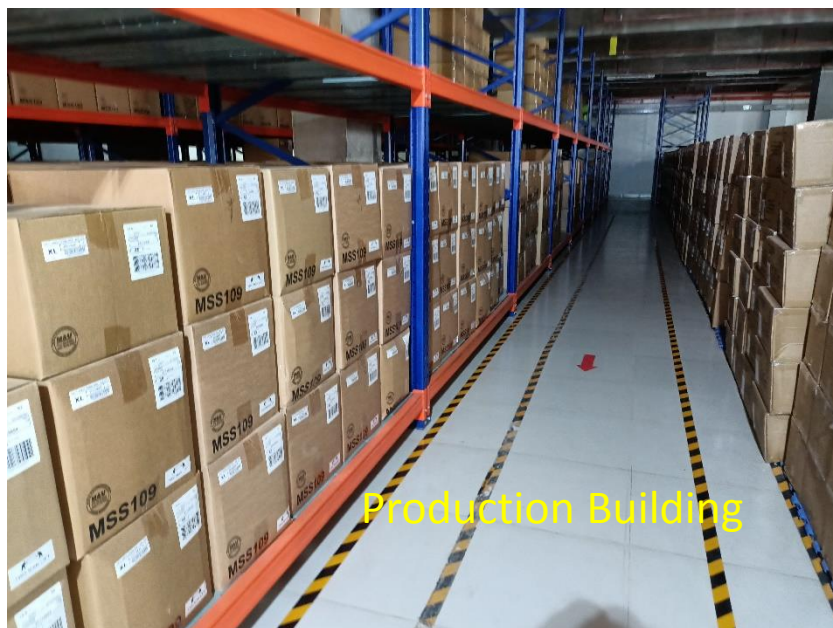
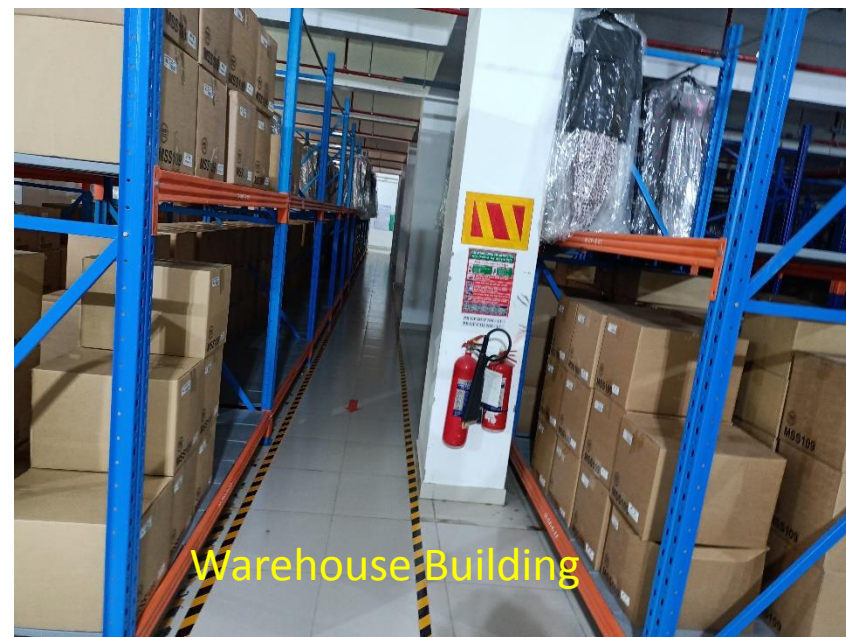
Racks on different floors are not adequately anchored or braced to resist earthquake forces. The factory engineer is required to anchor and brace all nonstructural elements to resist earthquake forces.

| Item No. | Observation | Recommended Action Plan | Recommended Timeline |
|---|---|---|---|
| 08 | Non-structural element not braced/anchored. (Building-1 & Building-2) | Adequately anchor and brace all non-structural elements to resist earthquake forces and comply with the BNBC. | 6-weeks |
