## **FIRE SAFETY INSPECTION REPORT**

# **Urmi Garments Ltd. (New Factory)**

**RSC ID: 24420**

**Date: 17-May-2022**

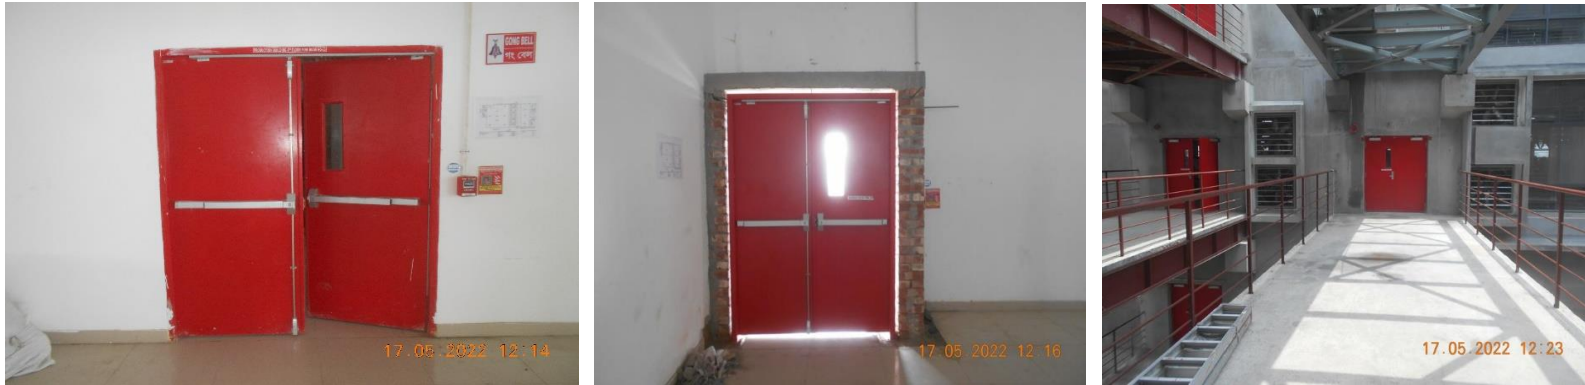
| SI No. | Category | Findings | Required Action | Remediation Time Frame |
|---|---|---|---|---|
| F-01 | Fire Rated Construction | <b>Building-01:</b><br>The exit stairs are not separated from [work areas, other spaces] on each floor by fire-rated construction. | <p>Provide minimum 2-hr fire rated construction for buildings 4 storied or more and 1-hr for upto 3 storied. Seal all unprotected openings to separate the exit stairs from work areas and other spaces on all floor levels by 90 minutes for 2 hr construction and 60 minutes for 1-hr construction. Ensure that the fire rated doors are self-closing and positive latching and that they are provided with fire exit (panic) hardware where serving production floors and provide vestibules to avoid direct discharge from storage to exit stair enclosure.</p> <p>If fire rated doors are required to be held open for functional reasons, provide automatic closing devices tied to the fire alarm system.</p> <p>Once fire doors are installed, every door in a stair enclosure serving more than 5 stories shall be provided with re-entry unless it meets ACCORD /RSC Technical Guidelines (Standard) 6.8.3.1</p> <p>If fire doors are required to be held open for functional reasons, provide automatic-closing devices tied to the fire alarm system.</p> | Within 3 months |

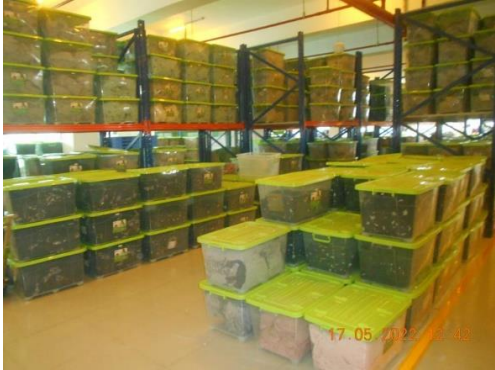
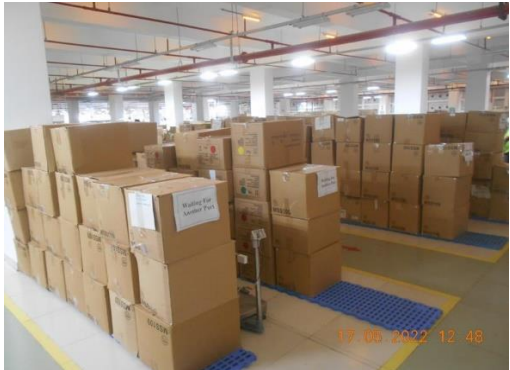
| SI No. | Category | Findings | Required Action | Remediation Time Frame |
|---|---|---|---|---|
| F-02 | Fire Rated Construction | <p>Areas used for in-process storage of combustible materials are open to the surrounding occupancy.</p> <p>Location: On 2nd and 3rd floor of production building (B-1)</p> | <p>Provide defined storage areas and limit the storage arrangement as follows: -</p> <ol style="list-style-type: none"> <li>1. General Condition: Maximum height of 2.4m and maximum area of 23m<sup>2</sup>. Separate areas of unenclosed combustible storage by a minimum clear distance of 3m.</li> <li>2. If sprinkler protected: maximum height of 3.66m and maximum area of 93m<sup>2</sup>. Separate areas of unenclosed combustible storage by a minimum clear distance of 3m.<br/>or</li> <li>3. Enclose the storage area from the surrounding occupancy with a minimum 1-hour construction.</li> </ol> | Within 3 months |

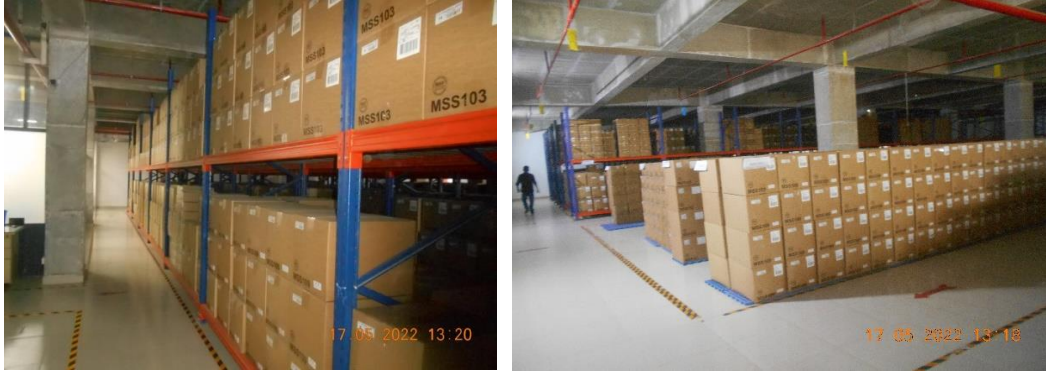
| SI No. | Category | Findings | Required Action | Remediation Time Frame |
|---|---|---|---|---|
| F-03 | Fire Rated Construction | <p>Storage discharges directly into the exit stair discharge.<br/>Location: On ground floor of production building (B-1).</p> | <p>Openings from exit enclosure to storage room, generator and transformer spaces shall be provided with a vestibule with fire rated construction and openings.</p> <p>Provide a 1.5 hr. fire rated door on the exit stair side and a 1-hr. fire rated door on the Store, generator, sub-station room side. Ensure that the fire rating of the vestibule construction matches that of the exit stair enclosure.</p> | Within 3 months |

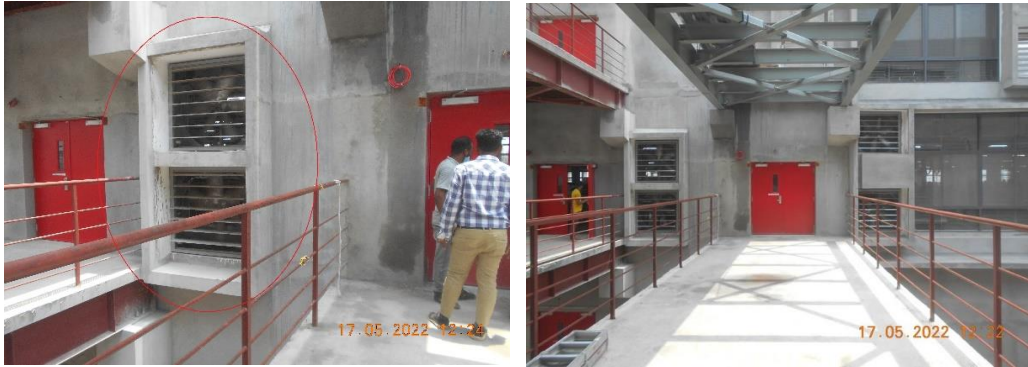
| SI No. | Category | Findings | Required Action | Remediation Time Frame |
|---|---|---|---|---|
| F-04 | Fire Rated Construction | Exterior exit stairs are not properly separated from the building and stair exit discharge. | Exterior exit stairs shall be separated from the building with a rating requirement of 2 hr fire rating for 4 or more stories. The rating of the exterior wall shall extend 3.05 m (10 ft) beyond the ends of the stair structure. | Within 3 months |

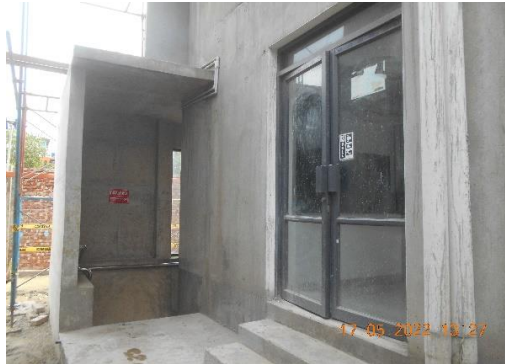
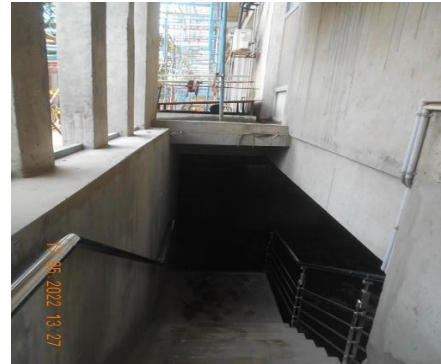
| SI No. | Category | Findings | Required Action | Remediation Time Frame |
|---|---|---|---|---|
| F-05 | Fire Rated Construction | The fire pump room is not provided with adequate fire separation.<br>Location: Basement floor of production building (B-1). | Provide fire pump room with 2 hr rated fire separation when not sprinklered and 1 hr rated fire separation when provided with automatic sprinklers in accordance with NFPA 20<br>Or,<br>Physically separate the pump room from the protected building by a minimum of 50 ft (15.3 m) in accordance with NFPA 20. | Within 3 months |

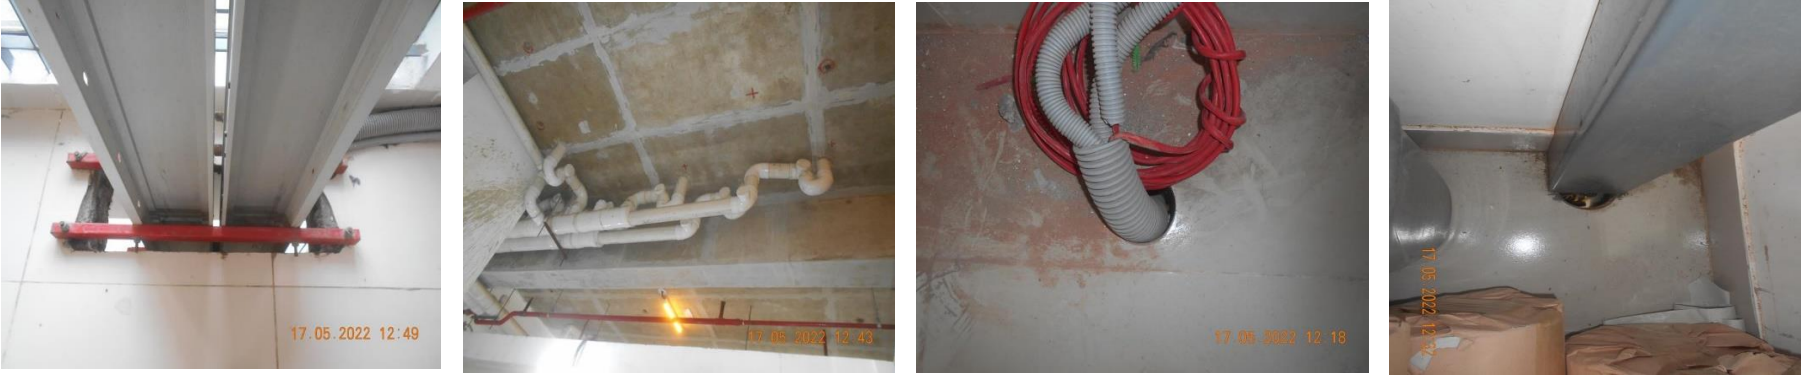
| SI No. | Category | Findings | Required Action | Remediation Time Frame |
|---|---|---|---|---|
| F-06 | Fire Rated Construction | <p>Unsealed penetrations and openings are located in the fire rated floor/ceiling assemblies. Followings are the description of openings or penetrations indicating specific locations:</p> <ol style="list-style-type: none"> <li>1. Passing of BBT through rated walls from MDB room to the production area in each floor of production building (B-1).</li> <li>2. PVC pipes penetrate the floor slabs in toilet block of production building (B-1).</li> <li>3. Floor penetrations due to fire alarm, IT and electrical cable riser in production building (B-1).</li> <li>4. Compressor pipes penetrate the floor slabs of production building (B-1).</li> </ol> | <p>Seal all penetrations and openings in floor/ceiling (full thickness of the floor/ceiling) assemblies by fire rated materials to maintain the fire resistance rating.</p> <p>Provide a minimum 2-hr fire rated shaft to separate the utility risers from each floor if required.</p> | Within 3 months |

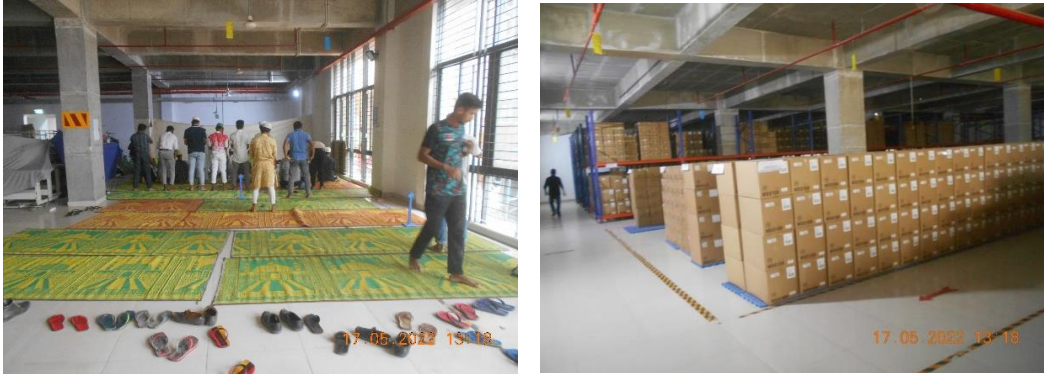
| SI No. | Category | Findings | Required Action | Remediation Time Frame |
|---|---|---|---|---|
| F-07 | Fire Rated Construction | <p>Prayer area (E-4, capacity less than 300) was not separated by fire rated construction with adjacent store room.</p> <p>Location: On ground floor of production building (B-1).</p> | <p>Relocate the prayer area to or from this building to meet the requirement as per BNBC 2006, part 4 chapter 3 section 3.21.3 and table 3.2.1.</p> <p>Or, Prayer area shall be separated from Storage area by minimum 3hr fire rated separation. Seal and/or protect all openings to maintain the required fire separation. Also provide at least two means of exits leading directly to the street or leading to a corridor or open space having access to exits in two independent and different direction.</p> | Within 3 months |

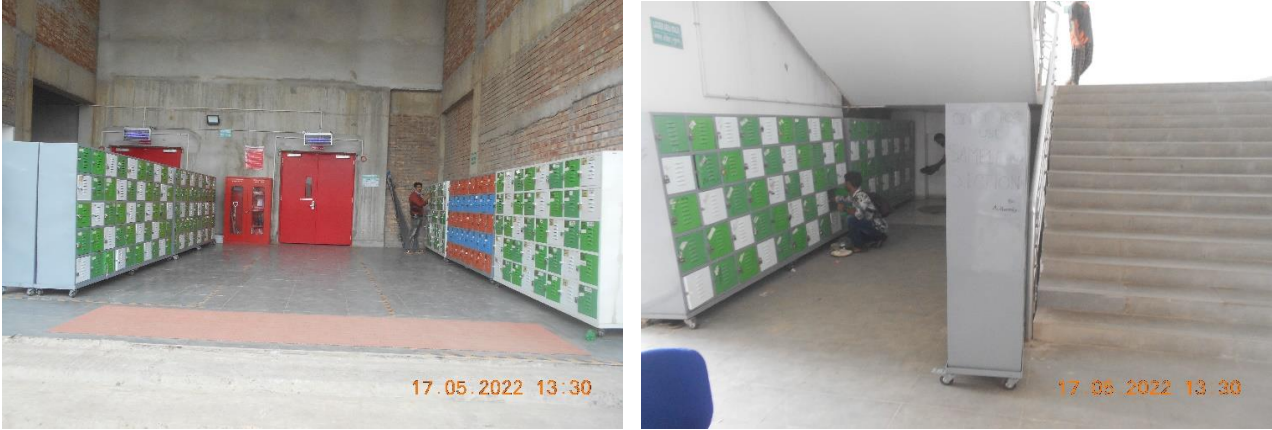
| SI No. | Category | Findings | Required Action | Remediation Time Frame |
|---|---|---|---|---|
| F-08 | Means of Egress | Storage was located in exit stair.<br>Location: Stair-2 on ground floor of production building(B-1). | Remove storage from the exit stairs and egress path. | Immediately |

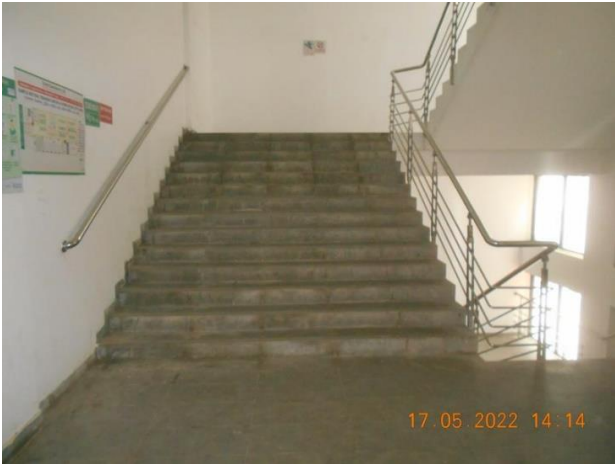
| SI No. | Category | Findings | Required Action | Remediation Time Frame |
|---|---|---|---|---|
| F-11 | Means of Egress | The stair width exceeds 2.2 m (87 in.) but intermediate handrails were not provided.<br>Location: Stair-1 and Stair-2 of production building (B-1). | Intermediate handrails shall be provided when the stair width exceeds 2.2 m (87 in.). | Within 3 months |

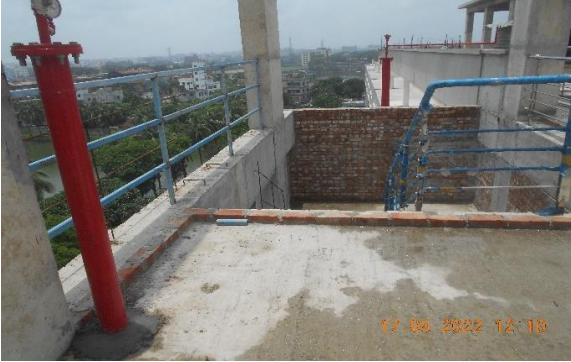
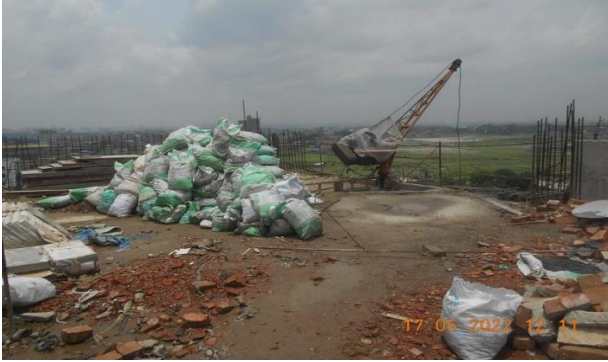
| SI No. | Category | Findings | Required Action | Remediation Time Frame |
|---|---|---|---|---|
| F-12 | Roof | Parapets or guards (partially) are not provided in occupied roof.<br>Location: Production building (B-1) | Provide parapets or guards with a minimum height of 1067mm (42 inch.). | Within 3 months |

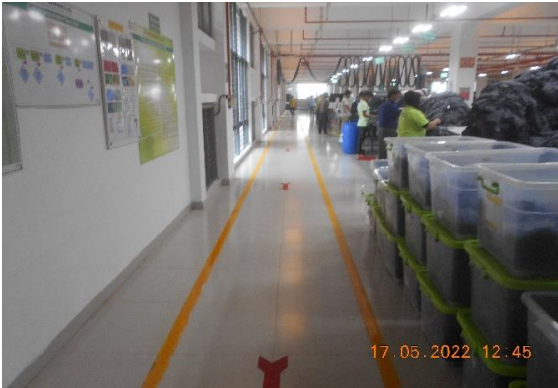
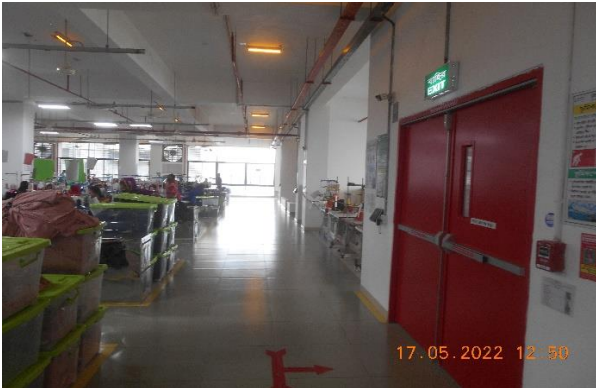
| SI No. | Category | Findings | Required Action | Remediation Time Frame |
|---|---|---|---|---|
| F-13 | Egress Lighting | <p>The directional signs are not provided where there is a change in direction and where the continuation of the egress path is not obvious.</p> <p>Location: Several floors of production building (B-1).</p> | <p>Install illuminated directional signs shall be provided where there is a change in the direction for the path of travel and the direction to an exit is not obvious.</p> | Within 1 month |

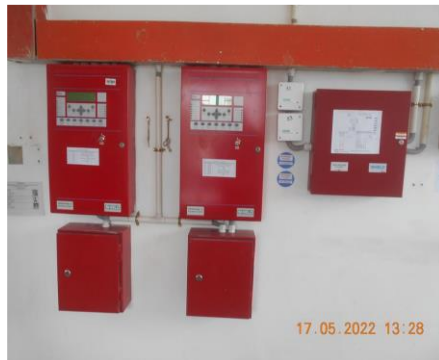
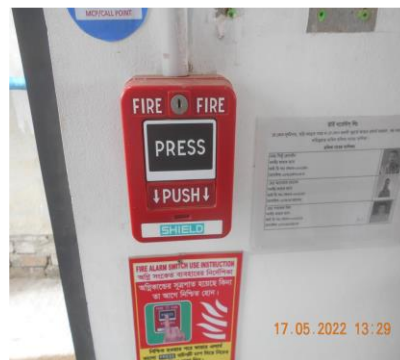
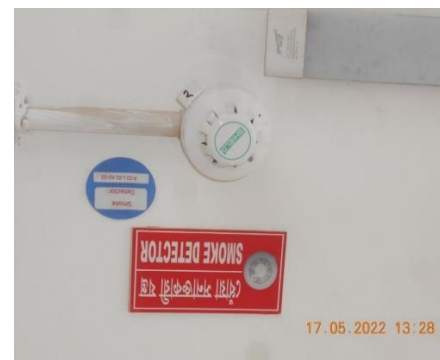
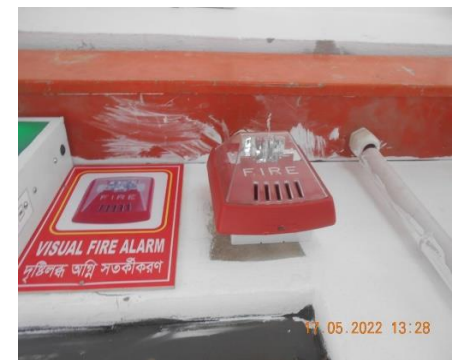
| SI No. | Category | Findings | Required Action | Remediation Time Frame |
|---|---|---|---|---|
| F-15 | Fire Alarm & Detection system | Automatic fire alarm and detection system installation complete which requires detailed review to confirm compliance with NFPA 72 and RSC Technical Guidelines (Standard). | Submit the fire alarm system design to RSC for review. Once the design is reviewed, install and modify the fire detection and alarm system throughout the buildings in accordance with review comment, Accord/ RSC Technical Guidelines (Standard) and NFPA 72. After installation the owner shall conduct internal testing and commissioning and then contact the RSC for witness of final acceptance testing. Also inspect, test and maintain the fire alarm system, and keep written records on-site, in accordance with Table-14.3.1 of NFPA 72. | Design Review within 2 months and installation within 6 months |

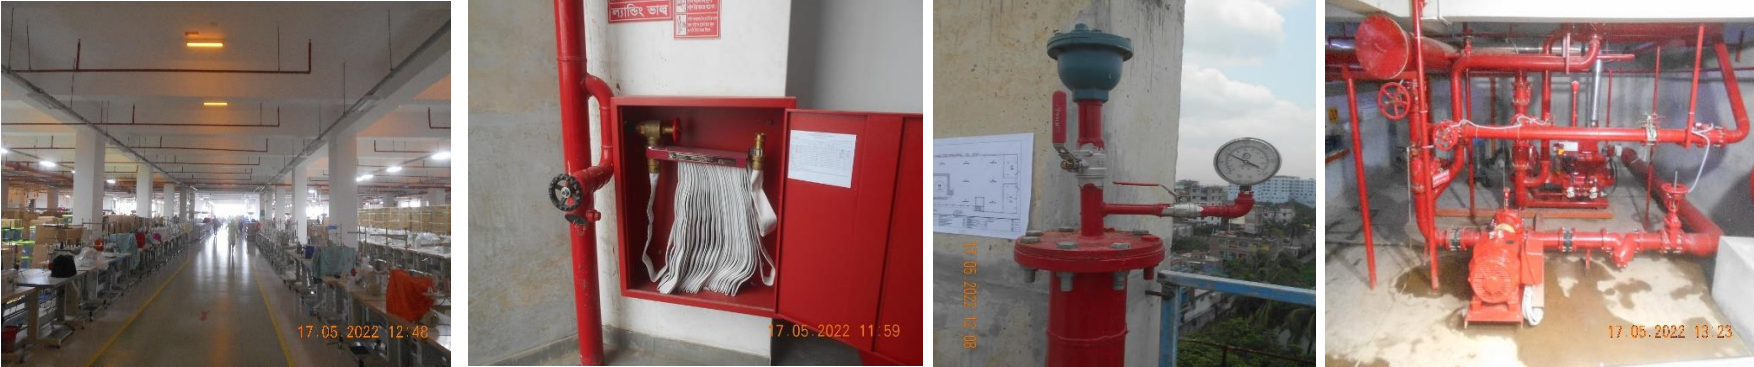
| SI No. | Category | Findings | Required Action | Remediation Time Frame |
|---|---|---|---|---|
| F-17 | Fire Protection System | The existing building has an occupied floor greater than 10 meter (33 feet), therefore, standpipe system is required. The factory has installed automatic fire sprinkler system throughout the building in lieu of the detection system. So automatic fire sprinkler system is mandatory for this building.<br>Location: Production building (B-1). | Submit the Fire Pump, Standpipe and Automatic Sprinkler System drawing NFPA 13, 14, 20, 22 and 24 to RSC for review. Once reviewed, install or modify the Automatic Sprinkler System throughout the building in accordance with RSC Technical Guideline (Standard) and NFPA 13, 14, 20, 22 and 24. After installation the owner shall contact the RSC for witness of conducting the final acceptance testing of the standpipe system. | Design Review within 2 months and installation within 4 months. |

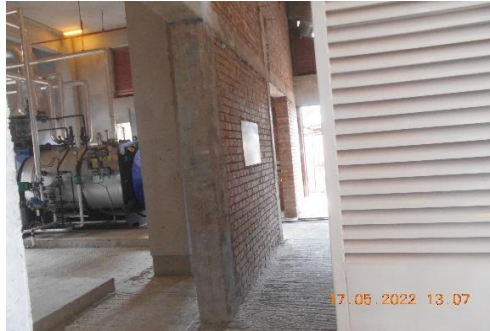
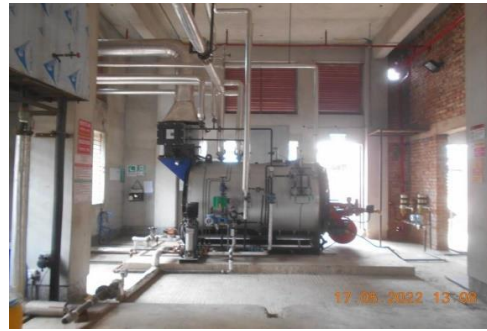
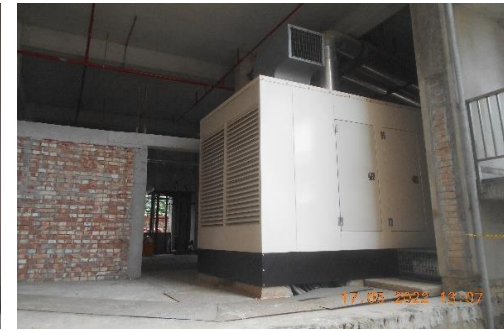
| SI No. | Category | Findings | Required Action | Remediation Time Frame |
|---|---|---|---|---|
| F-23 | Fire Rated Construction | <b>B-3</b><br>Generator room and boiler room was not separated by fire rated construction.<br>Location: On ground floor of Utility building (B-3). | Provide minimum 2-hr fire rated construction from each other.<br>Seal all penetrations and openings in floor/ceiling/wall (full thickness of the floor/ceiling) assemblies by fire rated materials to maintain the fire resistance rating. | Within 3 month |

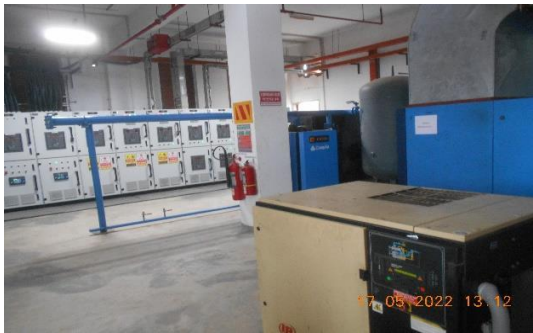
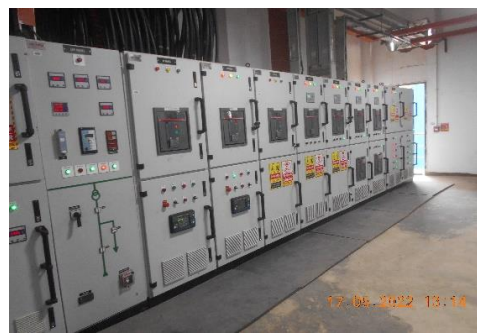
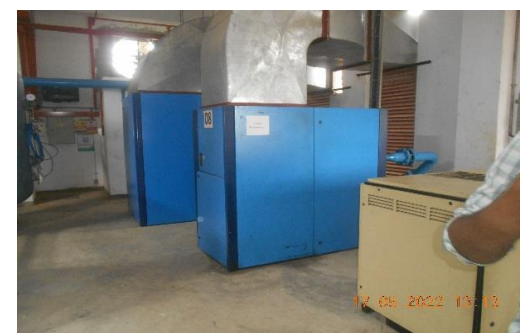
| SI No. | Category | Findings | Required Action | Remediation Time Frame |
|---|---|---|---|---|
| F-24 | Fire Rated Construction | <p><b>B-3</b></p> <p>Compressor room and LT panel room was not separated by fire rated construction.</p> <p>Location: On 1st floor of Utility building (B-3).</p> | <p>Provide minimum 2-hr fire rated construction from each other.</p> <p>Seal all penetrations and openings in floor/ceiling/wall (full thickness of the floor/ceiling) assemblies by fire rated materials to maintain the fire resistance rating.</p> | Within 3 month |

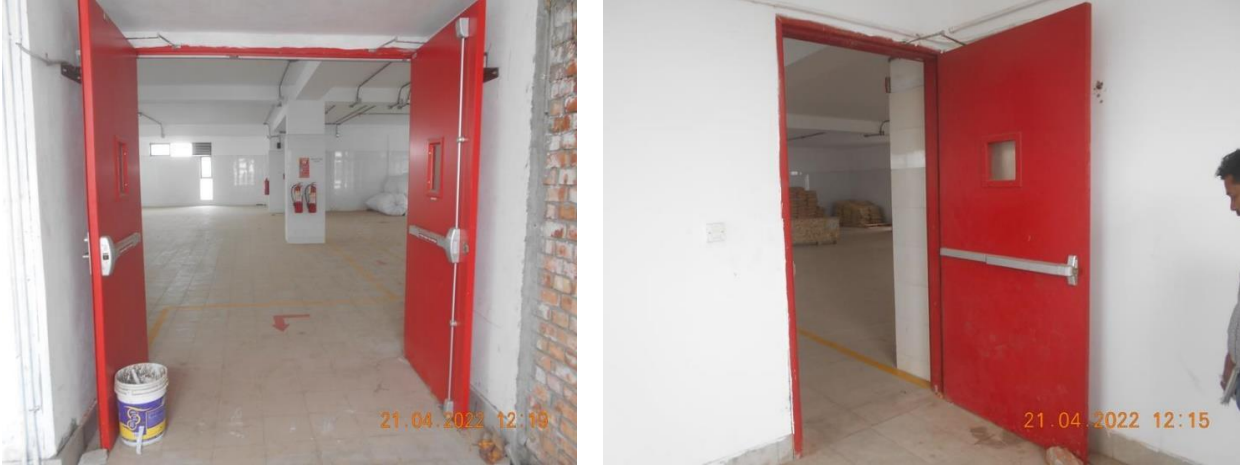
| SI No. | Category | Findings | Required Action | Remediation Time Frame |
|---|---|---|---|---|
| F-25 | Fire Rated Construction | <p><b>Building-02</b></p> <p>The exit stairs are not separated from [work areas, other spaces] on each floor by fire-rated construction.</p> | <p>Provide minimum 2-hr fire rated construction for buildings 4 storied or more and 1-hr for upto 3 storied. Seal all unprotected openings to separate the exit stairs from work areas and other spaces on all floor levels by 90 minutes for 2 hr construction and 60 minutes for 1-hr construction. Ensure that the fire rated doors are self-closing and positive latching and that they are provided with fire exit (panic) hardware where serving production floors and provide vestibules to avoid direct discharge from storage to exit stair enclosure.</p> <p>If fire rated doors are required to be held open for functional reasons, provide automatic closing devices tied to the fire alarm system.</p> <p>Once fire doors are installed, every door in a stair enclosure serving more than 5 stories shall be provided with re-entry unless it meets ACCORD/ RSC Technical Guidelines (Standard) 6.8.3.1</p> <p>If fire doors are required to be held open for functional reasons, provide automatic-closing devices tied to the fire alarm system.</p> | Within 3 months |

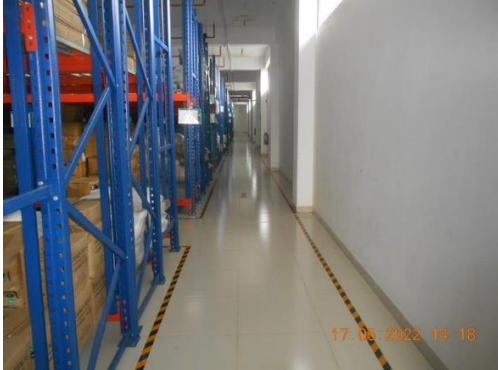
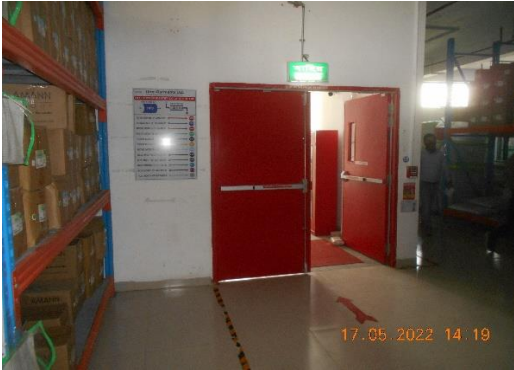
| SI No. | Category | Findings | Required Action | Remediation Time Frame |
|---|---|---|---|---|
| F-26 | Fire Rated Construction | Storage discharges directly into the exit stair discharge.<br>Location: On 2nd and 3rd floor of warehouse building (B-2). | Openings from exit enclosure to storage room, generator and transformer spaces shall be provided with a vestibule with fire rated construction and openings.<br><br>Provide a 1.5 hr. fire rated door on the exit stair side and a 1-hr. fire rated door on the Store, generator, sub-station room side. Ensure that the fire rating of the vestibule construction matches that of the exit stair enclosure. | Within 4 months |

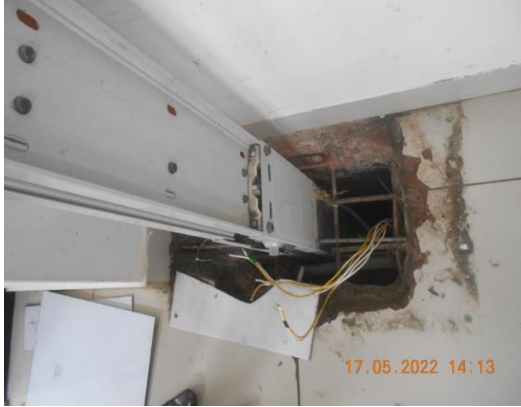
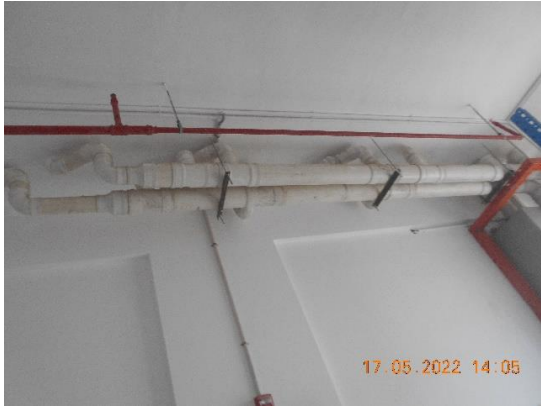
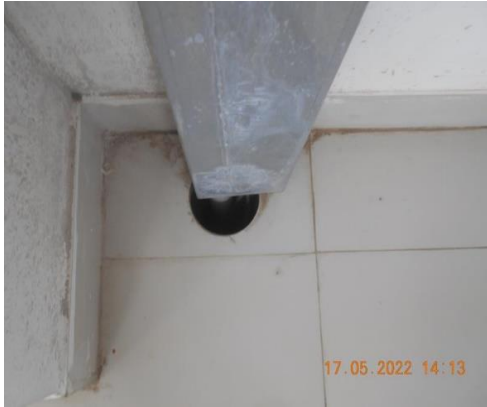
| SI No. | Category | Findings | Required Action | Remediation Time Frame |
|---|---|---|---|---|
| F-27 | Fire Rated Construction | <p>Unsealed penetrations and openings are located in the fire rated floor/ceiling assemblies. Followings are the description of openings or penetrations indicating specific locations:</p> <ol style="list-style-type: none"> <li>1. Passing of BBT through rated walls from MDB room to the production area in each floor of production building (B-2).</li> <li>2. PVC pipes penetrate the floor slabs in toilet block of production building (B-2).</li> <li>3. Floor penetrations due to fire alarm/ IT/ electrical cable riser in production building (B-2).</li> </ol> | <p>Seal all penetrations and openings in floor/ceiling (full thickness of the floor/ceiling) assemblies by fire rated materials to maintain the fire resistance rating.</p> <p>Provide a minimum 2-hr fire rated shaft to separate the utility risers from each floor if required.</p> | Within 3 months |

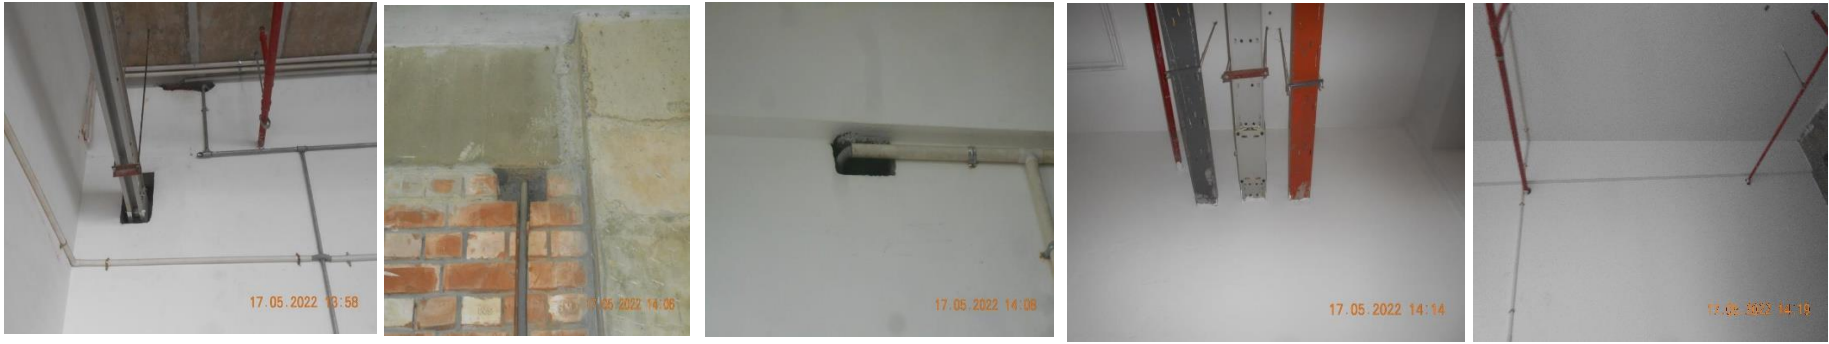
| SI No. | Category | Findings | Required Action | Remediation Time Frame |
|---|---|---|---|---|
| F-28 | Fire Rated Construction | Unsealed penetrations and openings are located in the exit stair enclosures.<br>Location: On all floors of warehouse building (B-2) | Seal all penetrations and openings in exit stair enclosure walls to maintain the fire separations. | Within 3 months |

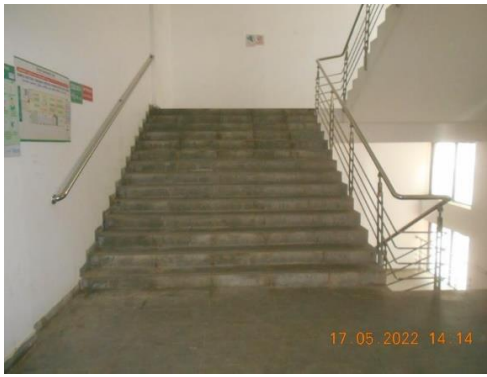
| SI No. | Category | Findings | Required Action | Remediation Time Frame |
|---|---|---|---|---|
| F-31 | Means of Egress | The stair width exceeds 2.2 m (87 in.) but intermediate handrails were not provided.<br>Location: Stair-1 of warehouse building (B-2). | Intermediate handrails shall be provided when the stair width exceeds 2.2 m (87 in.). | Within 3 months |

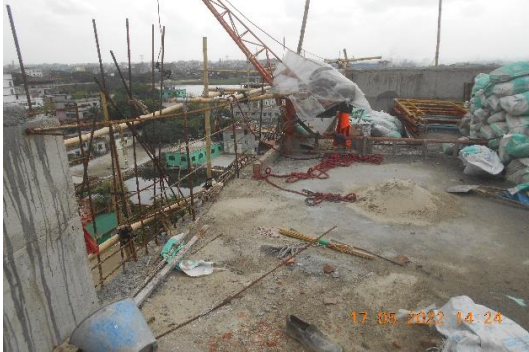
| SI No. | Category | Findings | Required Action | Remediation Time Frame |
|---|---|---|---|---|
| F-32 | Roof | Parapets or guards (partially) are not provided in occupied roof.<br>Location: Production building (B-1) | Provide parapets or guards with a minimum height of 1067mm (42 inch.). | Within 3 months |

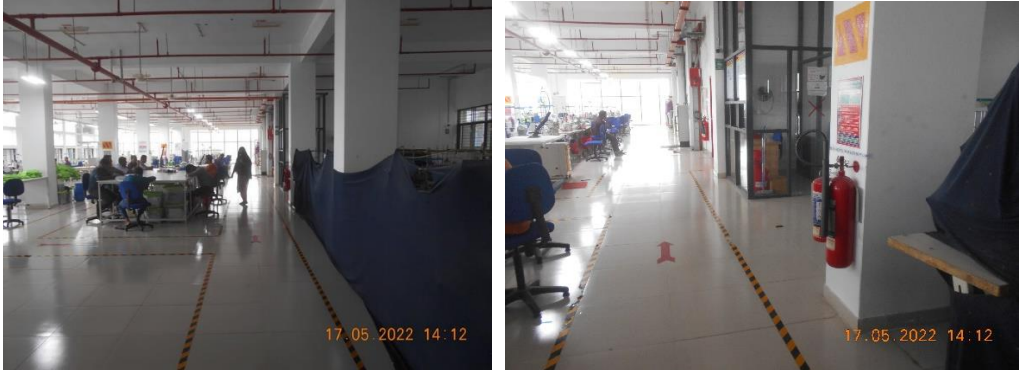
| SI No. | Category | Findings | Required Action | Remediation Time Frame |
|---|---|---|---|---|
| F-33 | Egress Lighting | <p>The directional signs are not provided where there is a change in direction and where the continuation of the egress path is not obvious.</p> <p>Location: Several floors of production building (B-2).</p> | <p>Install illuminated directional signs shall be provided where there is a change in the direction for the path of travel and the direction to an exit is not obvious.</p> | Within 1 month |

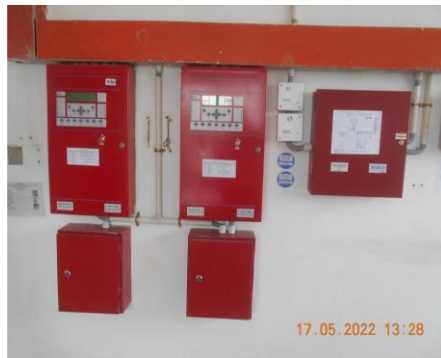
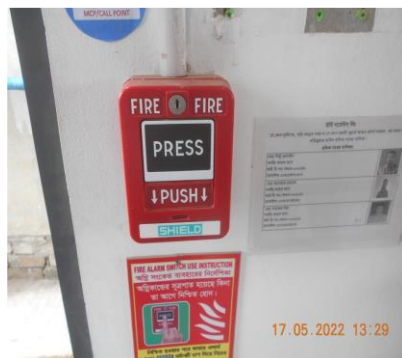
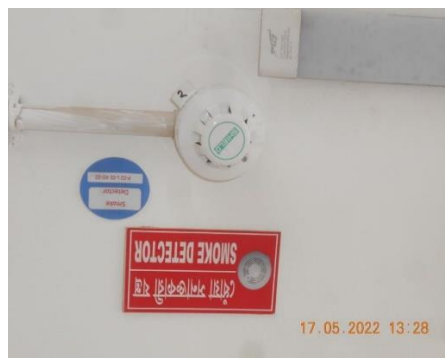
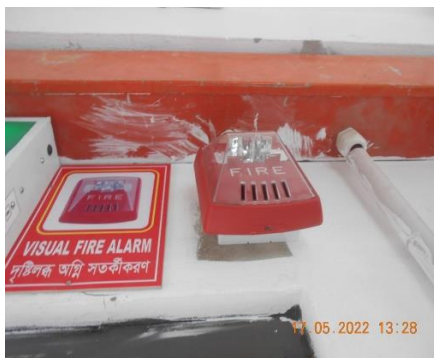
| SI No. | Category | Findings | Required Action | Remediation Time Frame |
|---|---|---|---|---|
| F-35 | Fire Alarm & Detection system | Fire alarm and detection system installation complete which requires detailed review to confirm compliance with NFPA 72 and RSC Technical Guidelines (Standard). | Submit the fire alarm system design to RSC for review. Once the design is reviewed, install and modify the fire detection and alarm system throughout the buildings in accordance with review comment, Accord/ RSC Technical Guidelines (Standard) and NFPA 72. After installation the owner shall conduct internal testing and commissioning and then contact the RSC for witness of final acceptance testing. Also inspect, test and maintain the fire alarm system, and keep written records on-site, in accordance with Table-14.3.1 of NFPA 72. | Design Review within 2 months and installation within 6 months |

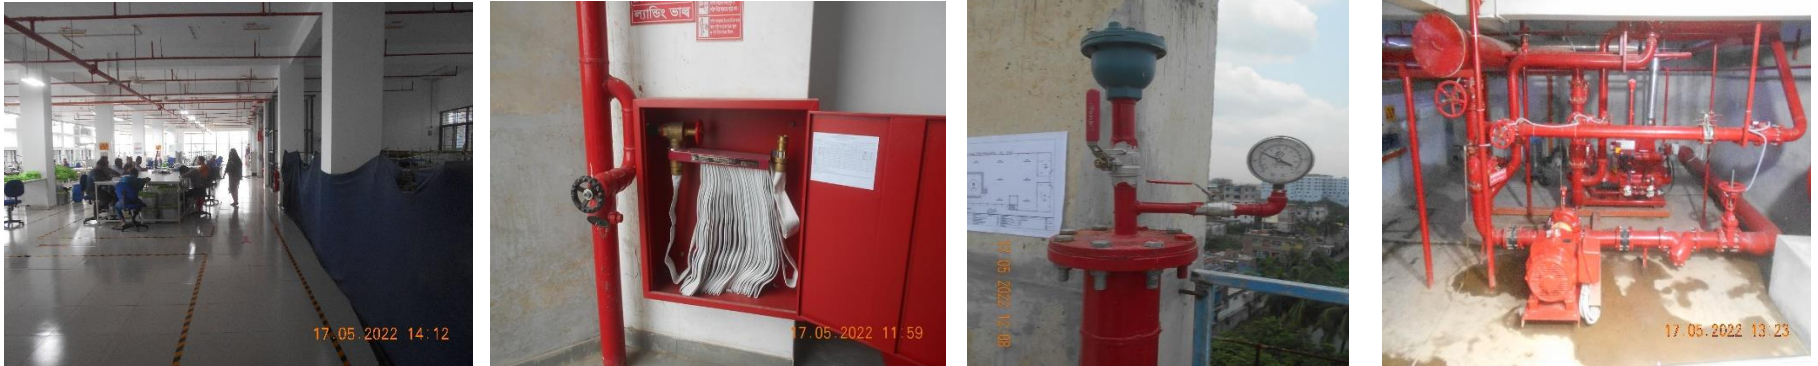
| SI No. | Category | Findings | Required Action | Remediation Time Frame |
|---|---|---|---|---|
| F-37 | Fire Protection System | <p>The existing building has an occupied floor greater than 10 meter (33 feet), therefore, standpipe system is required. The factory has installed automatic fire sprinkler system through the building in lieu of the detection system. So automatic fire sprinkler system is mandatory for this building. Location: Production building (B-2).</p> | <p>Submit the Fire Pump, Standpipe and Automatic Sprinkler System drawing NFPA 13, 14, 20, 22 and 24 to RSC for review. Once reviewed, install or modify the Automatic Sprinkler System throughout the building in accordance with RSC Technical Guideline (Standard) and NFPA 13, 14, 20, 22 and 24. After installation the owner shall contact the RSC for witness of conducting the final acceptance testing of the standpipe system.</p> | <p>Design Review within 2 months and installation within 4 months.</p> |
