# Colotex Apparels Ltd

Plot:10/1, South Salna, Joydebpur, Gazipur, Bangladesh

07 June 2022

# Observations

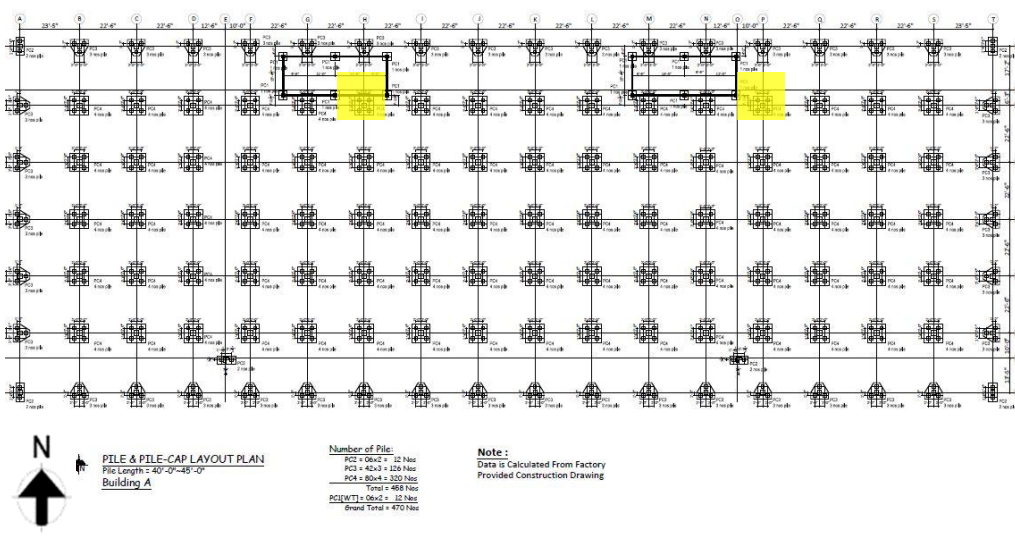
Pile Layout plan

**Factor of Safety of several pile foundations are  
below the allowable limit**

Cursory calculation indicates that factor of safety (FoS) of some pile foundations is below the allowable limit considering the floor live load 3 kPa for typical floor, 5 kPa for stair area, 1.5 kPa for roof, super imposed load from overhead water tank and ultimate pile capacity 180 Ton. Factory engineer to required to review the design, loads and foundation stresses and prepare a remediation plan.

| Item No. | Observation | Recommended Action Plan | Recommended Timeline |
|---|---|---|---|
| 01 | Factor of Safety of several pile foundations are below the allowable limit (Building-A) | Factory engineer is required to review the design, loads and foundation stresses for the marked area. | 6-weeks |
| 02 | Factor of Safety of several pile foundations are below the allowable limit (Building-A) | Actively manage floor loading plan. | 6-weeks |
| 03 | Factor of Safety of several pile foundations are below the allowable limit (Building-A) | Implement remediation work if required. | 6-months |
| 04 | Factor of Safety of several pile foundations are below the allowable limit (Building-A) | Implement load plan. | 6-months |

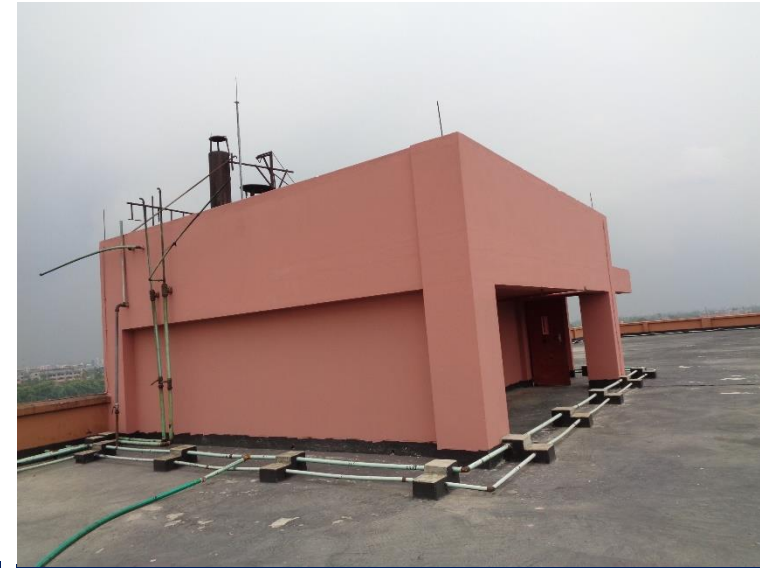
Load coming from OHT

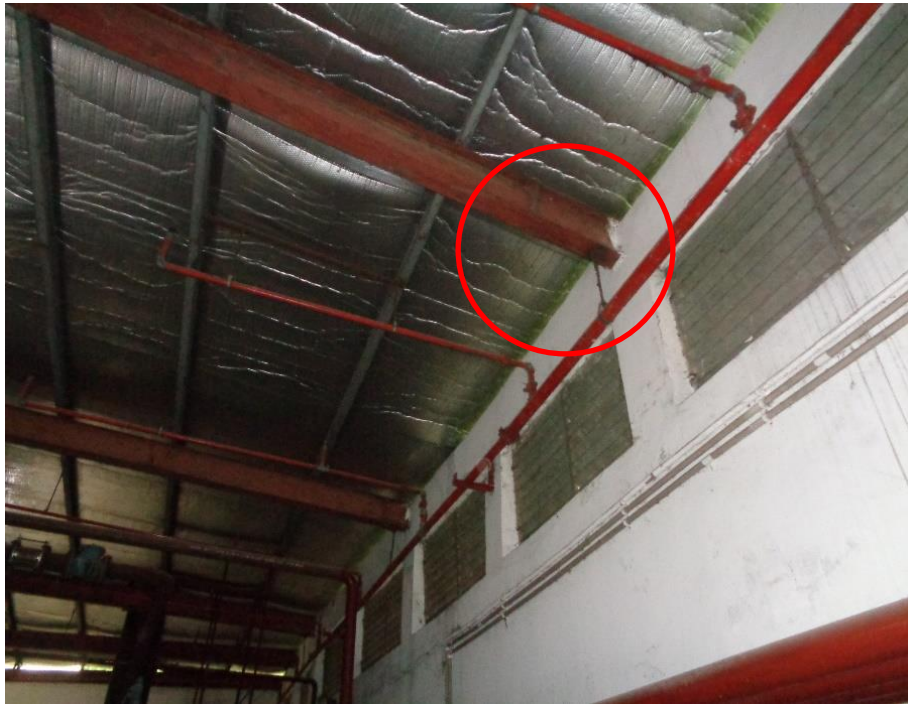
Apparently inadequate connection: rafter connected to brick wall (extended part)

Connection of steel part (Main and extended part) of Utility Building was appeared to be in adequate. As part of EA, factory engineer is required to check the connection adequacy of all the connections against uplift forces.

| Item No. | Observation | Recommended Action Plan | Recommended Timeline |
|---|---|---|---|
| 02 | Apparently inadequate connections (Utility Building) | As part of EA, factory engineer is required to check the connection adequacy of all the connections against uplift forces. | 6-weeks |
| 03 | Apparently inadequate connections (Utility Building) | Carryout remedial works if required. | 6-months |

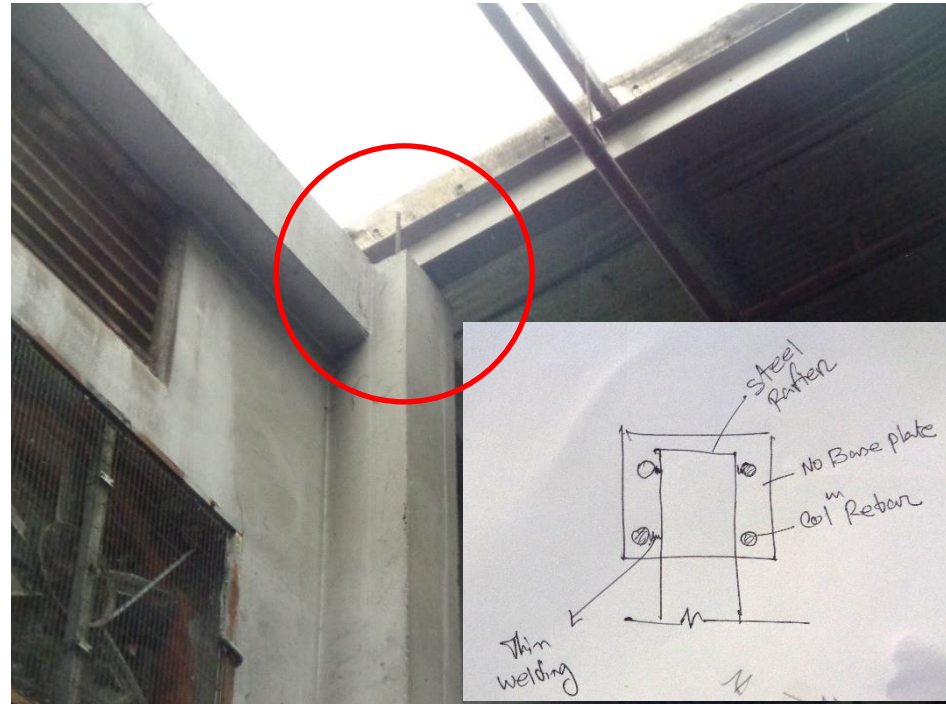
Apparently inadequate connection: No baseplate (Main part)

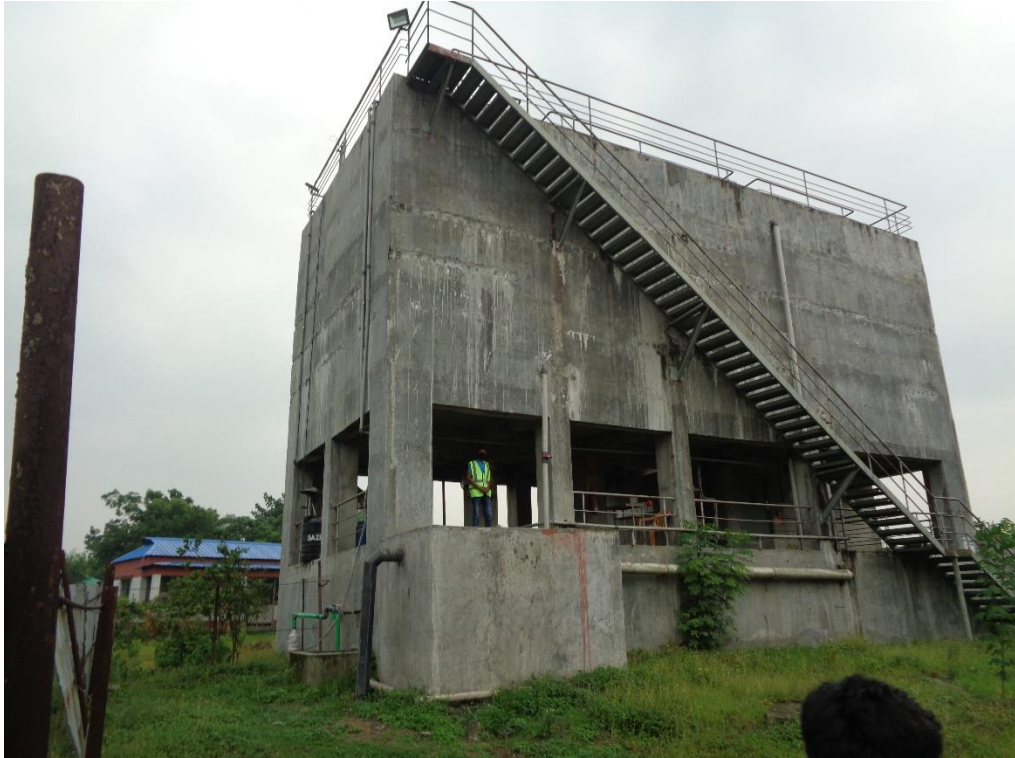
ETP Building

As per BNBC, every building or structure designed shall have its design documents prepared in accordance with the provision of Section 1.9.1. The design document shall include a design report, and a set of structural drawings, which shall be prepared in compliance with section 1.9.1.1 and section 1.9.1.2 as per BNBC. At the time of inspection, design report was not available which is required to be prepared in compliance with section 1.9.1.1 (part-6, BNBC).

| Item No. | Observation | Recommended Action Plan | Recommended Timeline |
|---|---|---|---|
| 04 | Absence of design documents (ETP Building) | Factory engineer is required to prepare a design report in compliance with section 1.9.1.1 (part-6, BNBC). | 6-weeks |
| 05 | Absence of design documents (ETP Building) | Carryout remedial works if required. | 6-months |

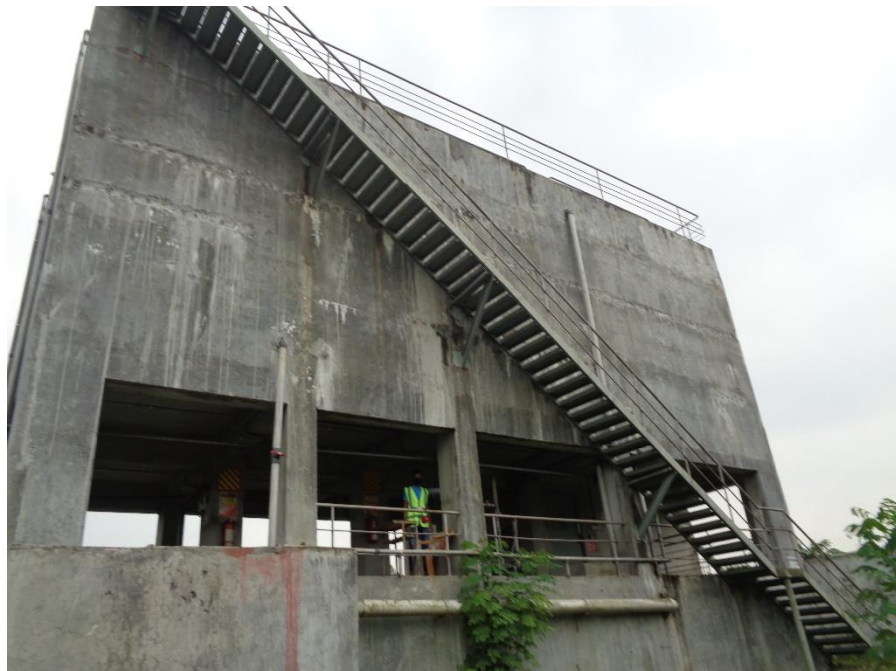
Apparently inadequate member size

Steel stair at ETP Building was appeared to be inadequate due to apparently inadequate member size and connections. Factory engineer is required to check the structural stability of the steel stair.

| Item No. | Observation | Recommended Action Plan | Recommended Timeline |
|---|---|---|---|
| 01 | Apparently in adequate steel stair (ETP Building) | Factory engineer is required to check the structural stability of the steel stair. | 6-weeks |
| 02 | Apparently in adequate steel stair (ETP Building) | Carryout remedial works if required. | 6-months |

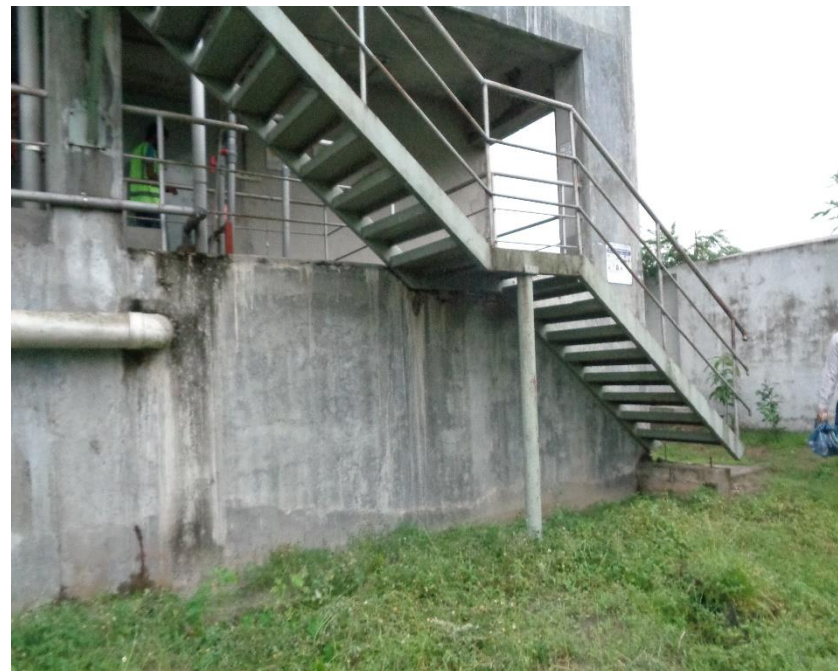
Apparently inadequate connection
