# Square Apparels Limited.

Mamarishpur, Mallikbari, Bhaluka, Mymensingh  
(24.27937, 90.36931)

06 June 2022

# Observations

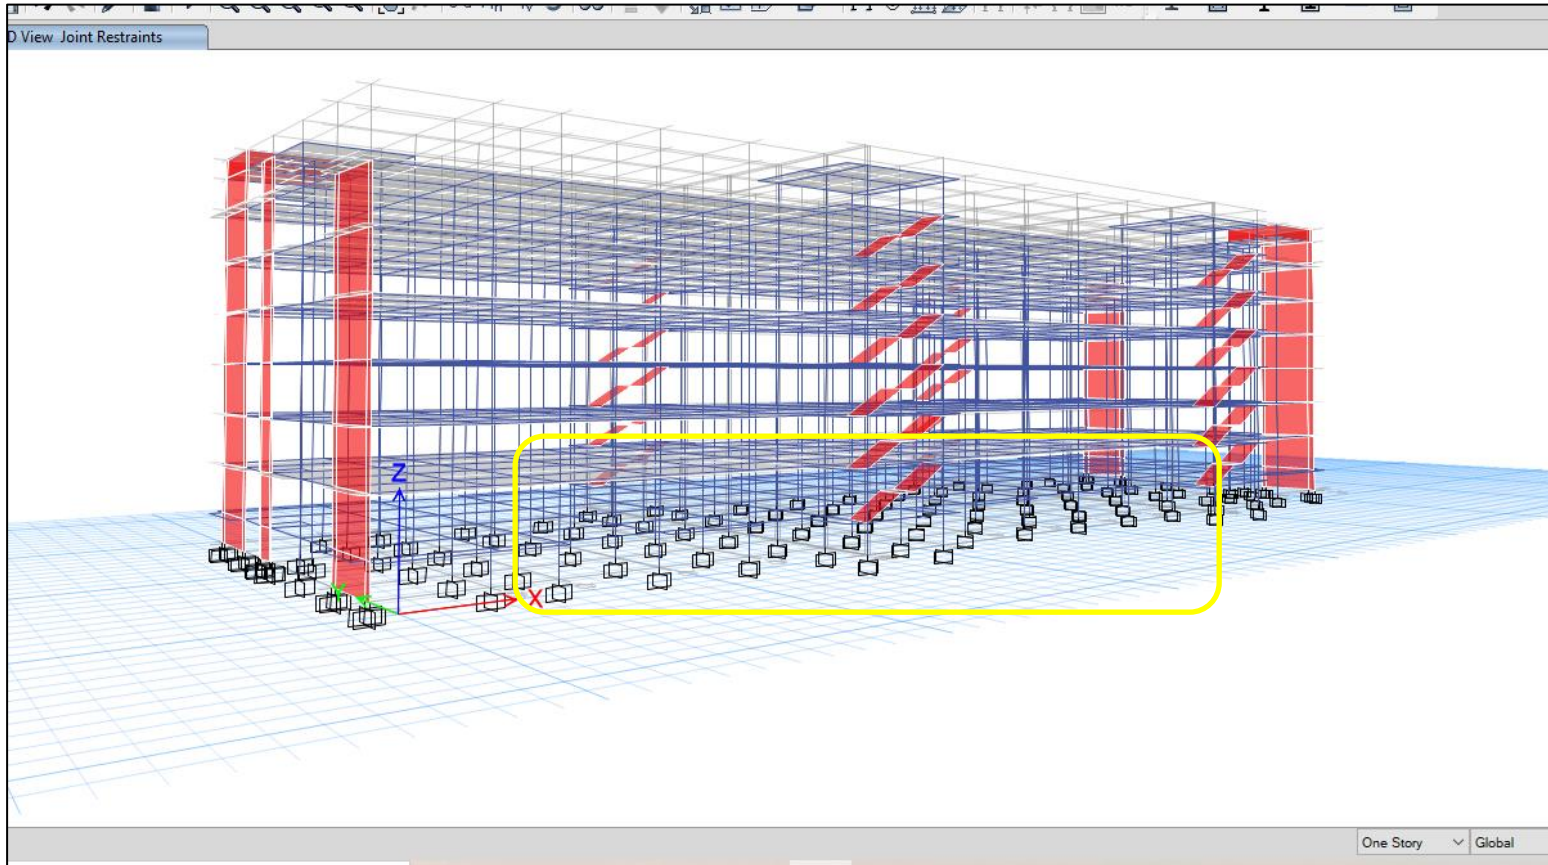
Foundation system of the building is single footings which are rested on compressible soil but fixed support at the end of R.C.C columns have been assigned in the FEA model. Factory engineer is required to review the support system of the foundation.

| Item No. | Observation | Recommended Action Plan | Recommended Timeline |
|---|---|---|---|
| 01 | Lack of information in design report and details of seismic design criteria.<br>(Building-1) | Building engineer is required to review the design of the building for special seismic design criteria and support system | 6-weeks |

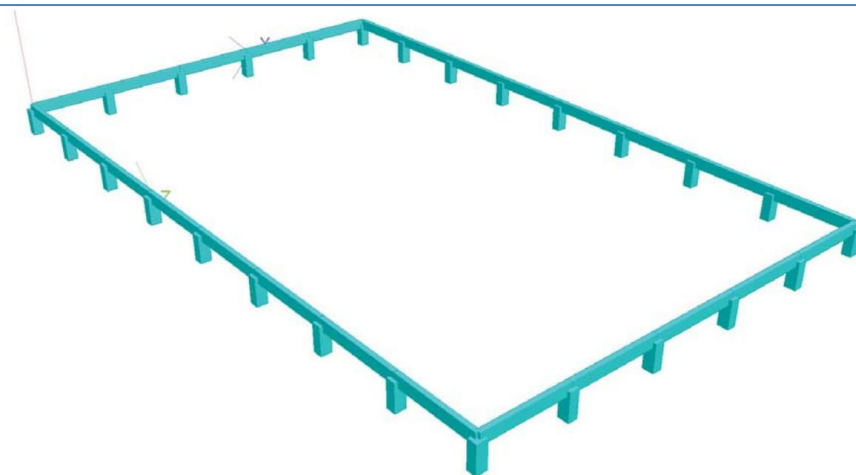
Fig: RCC Column and Grade

In DEA report, overstress has been found in steel members. Also, it has been noted that pedestal RC columns of the building are inadequate. Remedial actions has not been carried out as per recommendation of DEA report.

| Item No. | Observation | Recommended Action Plan | Recommended Timeline |
|---|---|---|---|
| 04 | Overstressed structural member.<br>(Building-4) | Building engineer is required to review the design of the building and carry out remedial works as per suggestion of the DEA report. | 6-weeks |

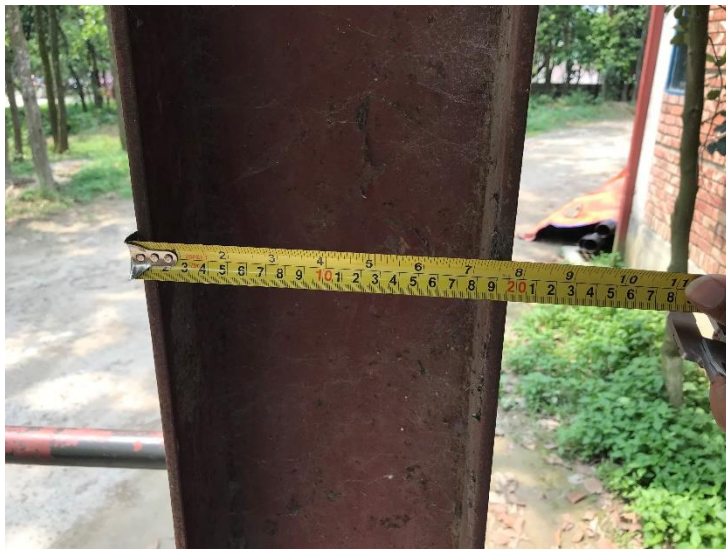
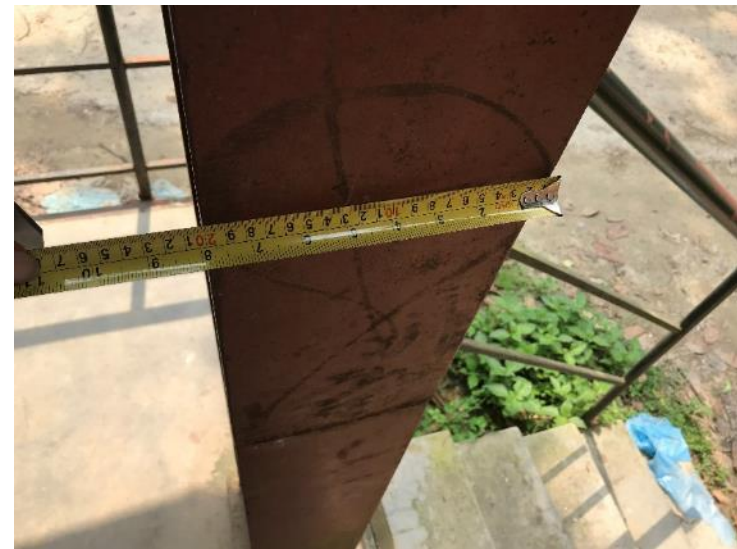
Steel Column Size- (W: 200 mmx 6 mm; F: 200 mm x 8 mm)

During inspection C-104 steel column size was found W- 200 mmx 6 mm; F- 200 mm x 8 mm instead of W- 250 mmx 6 mm; F- 250 mm x 8 mm. Factory engineer is required to update as built structural drawing as per existing condition.

| Item No. | Observation | Recommended Action Plan | Recommended Timeline |
|---|---|---|---|
| 05 | Mismatch in structural drawings. (Building-4) | Building engineer is required to produce full set of as-built drawing reflecting the as constructed condition. | 6-weeks |

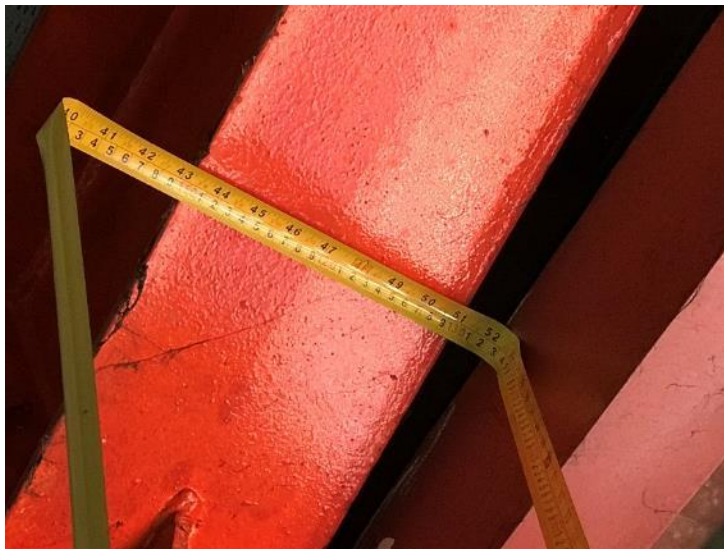
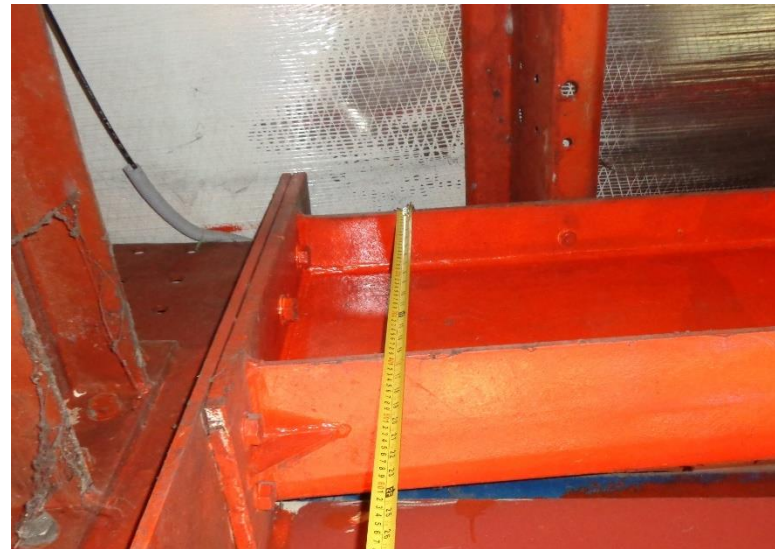
Steel Rafter Size- (W: 390 mm x 5 mm; F: 200 mm x 8 mm)

During inspection R-204 steel rafter size was found W- 390 mmx 5 mm; F- 200 mm x 8 mm instead of W- 250 mmx 5 mm; F- 250 mm x 8 mm. Factory engineer is required to update as built structural drawing as per existing condition.

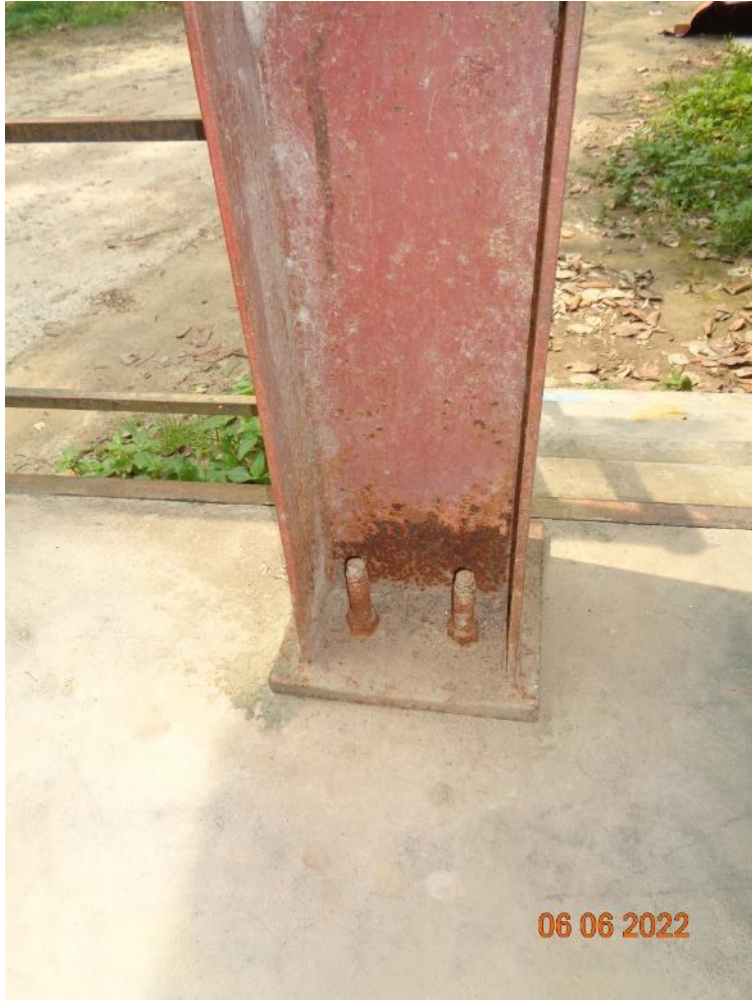
Corrosion in steel column (Canopy)

During inspection corrosion was found in steel column & rafter. Factory is required to take proper remedial measures for preventing the corrosion from steel members.

| Item No. | Observation | Recommended Action Plan | Recommended Timeline |
|---|---|---|---|
| 06 | Corrosion in steel members. (Building-4) | Apply suitable method to protect the steel members from corrosion. | 6-weeks |

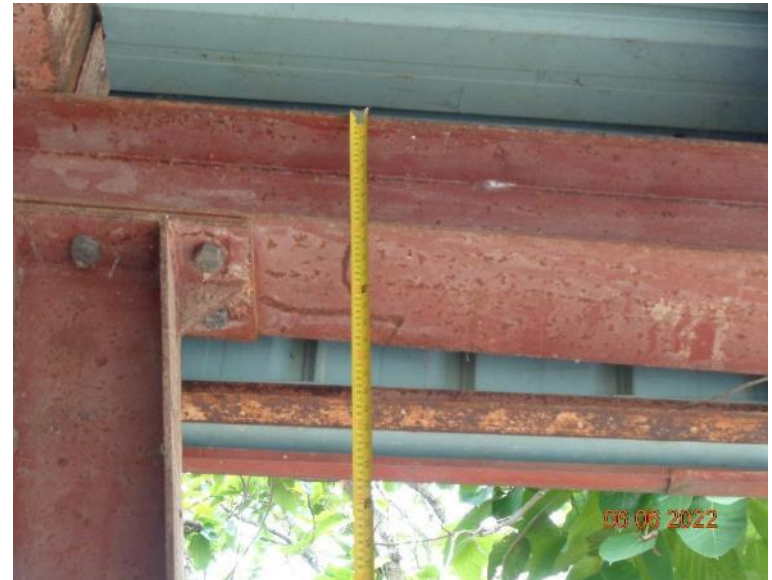
Corrosion in steel safter at Canopy

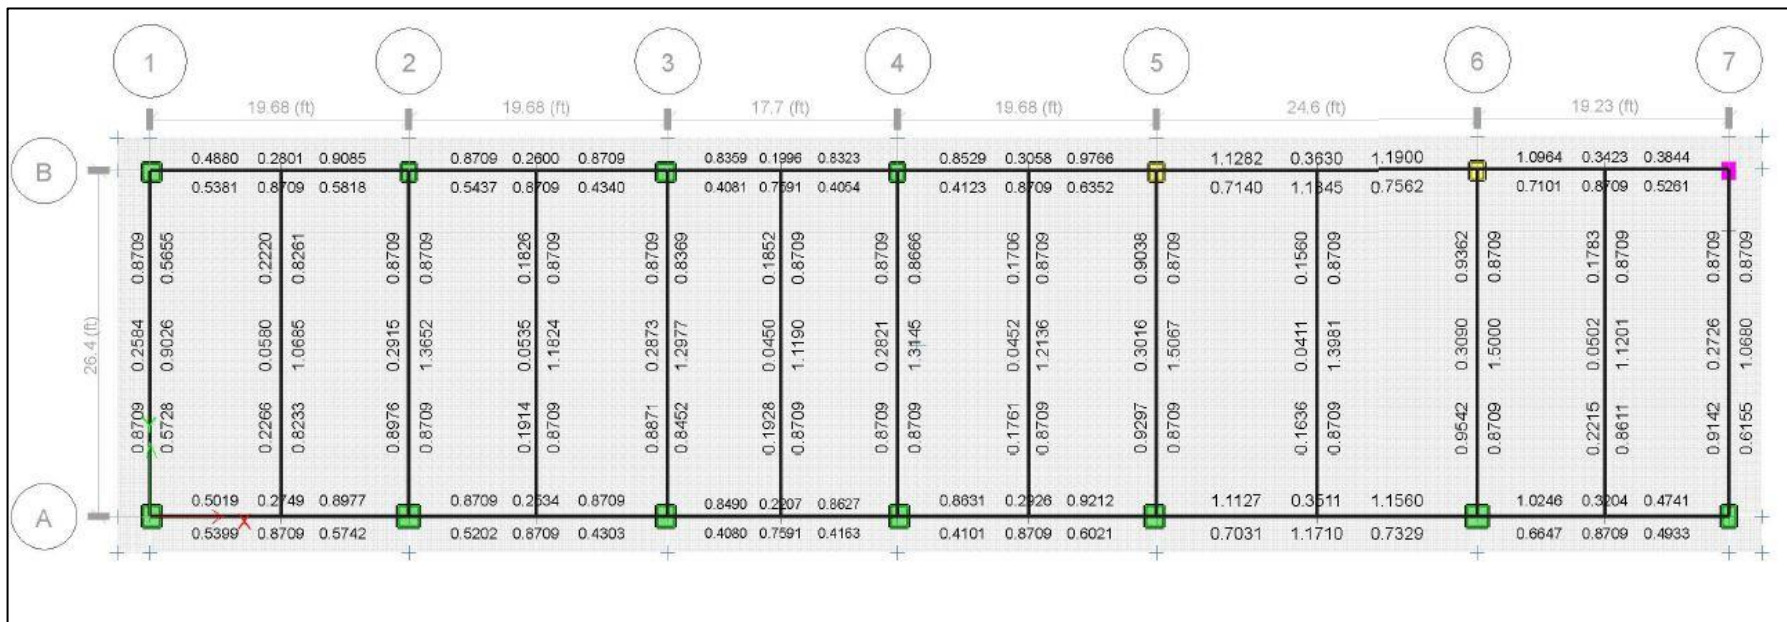
Design report was available on site for Building-5. In which concrete compressive strength  $f_c'$  was considered 3500 psi but no material test report was found for justifying the strength.

Building engineer is required to confirm the design concrete compressive strength.

| Item No. | Observation | Recommended Action Plan | Recommended Timeline |
|---|---|---|---|
| 07 | Material strength consideration in design report. (Building-5) | Building engineer is required to confirm the design concrete compressive strength and review the design as per the concrete strength. | 6-weeks |

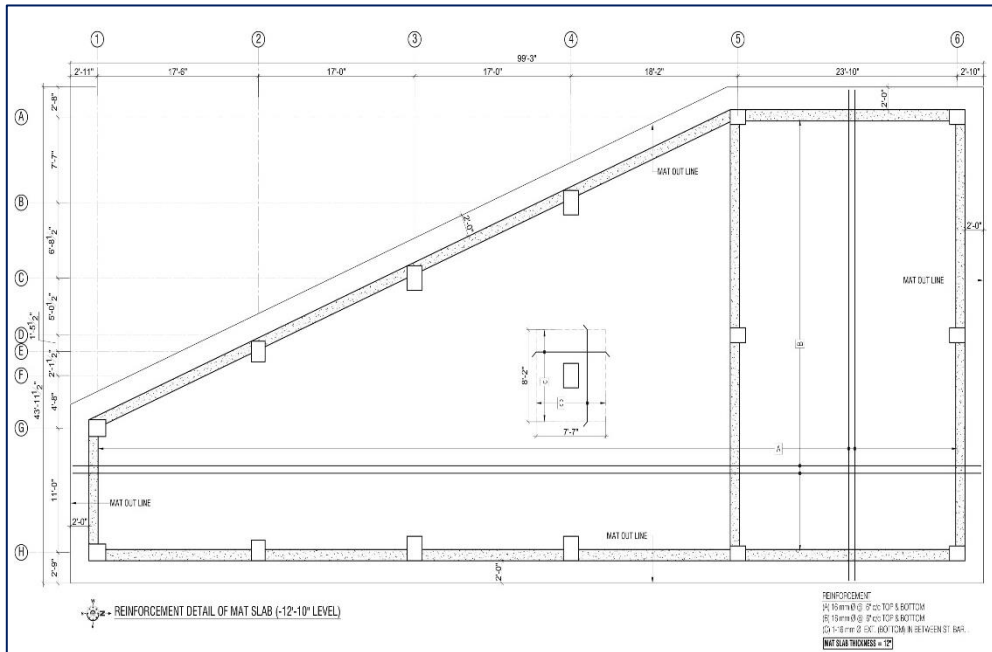
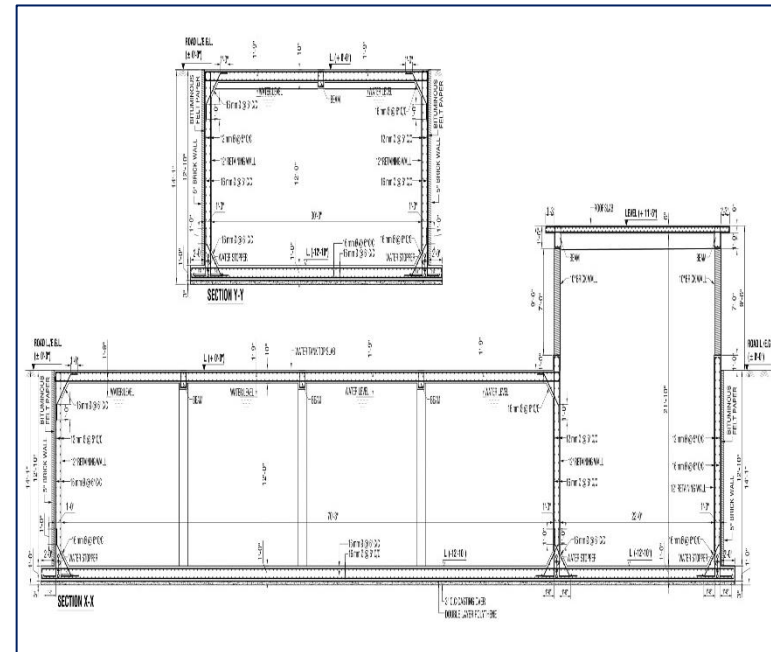
Reinforcement & Sectional Details of Mat Foundation

The soil investigation report was not available on site. So, the foundation capacity could not be verified. The factory is required to investigate the soil bearing capacity and verify the foundation adequacy accordingly.

| Item No. | Observation | Recommended Action Plan | Recommended Timeline |
|---|---|---|---|
| 09 | Geotechnical investigation report not available. (Building-6) | The factory is required to investigate the bearing capacity of soil for the buildings. | 6-weeks |
| 10 | Geotechnical investigation report not available. (Building-6) | Verify the foundation adequacy of the buildings. | 6-weeks |

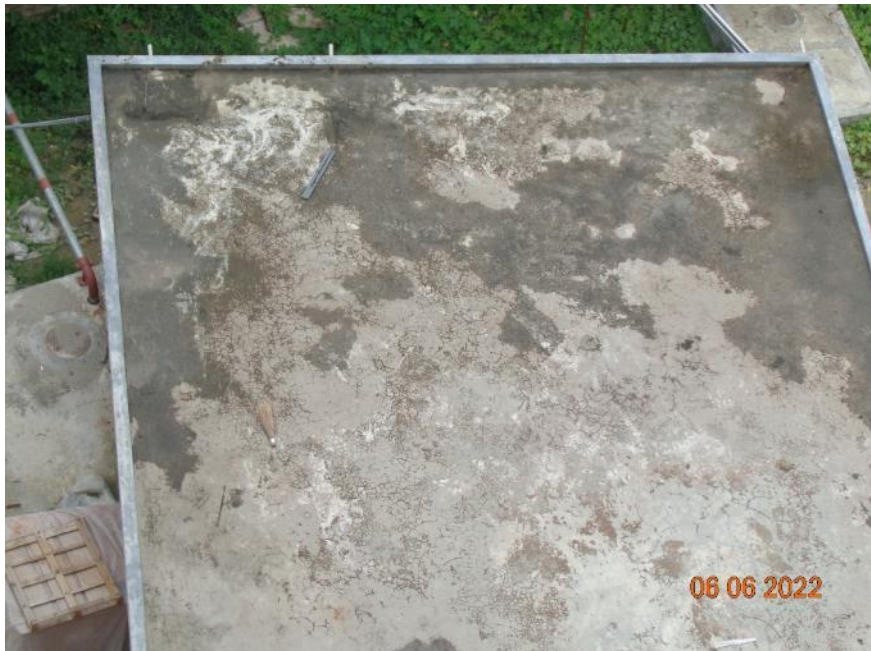
Water ponding was found at roof of the pump house building. During inspection sign of water clogging & dampness at slab soffit was found. Factory is required to improve water drainage system to avoid water clogging at roof.

Water Ponding on Roof

| Item No. | Observation | Recommended Action Plan | Recommended Timeline |
|---|---|---|---|
| 12 | Water ponding & dampness on slab soffit. (Building-6) | Building engineer is required to improve water drainage system with adequate slope to avoid water clogging. | 6-weeks |

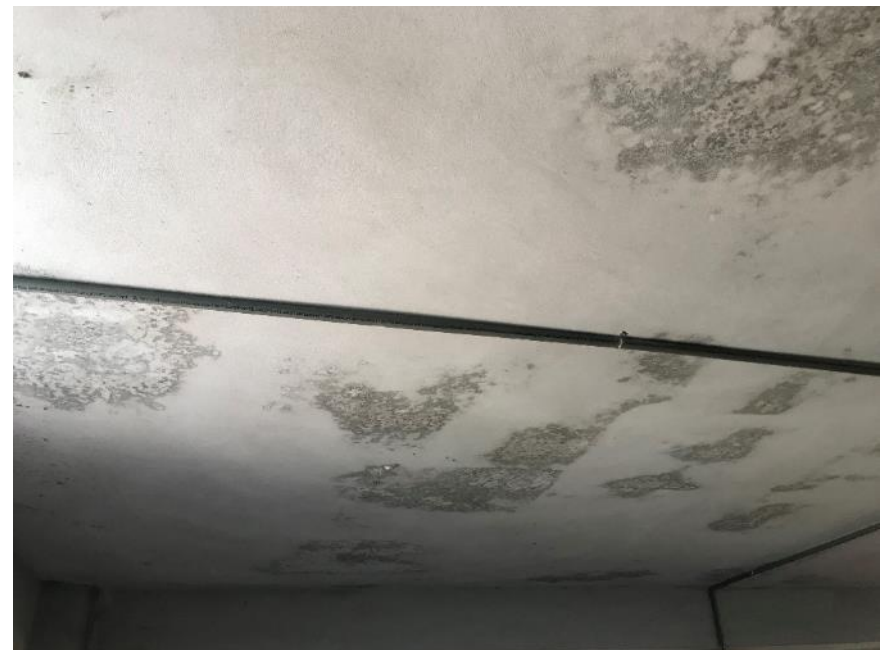
Dampness at Slab Soffit

| Item No. | Observation | Recommended Action Plan | Recommended Timeline |
|---|---|---|---|
| 13 | Water ponding & dampness on slab soffit. (Building-6) | Building engineer is required to investigate the damaged area and suggest proper remedial actions. | 6-weeks |

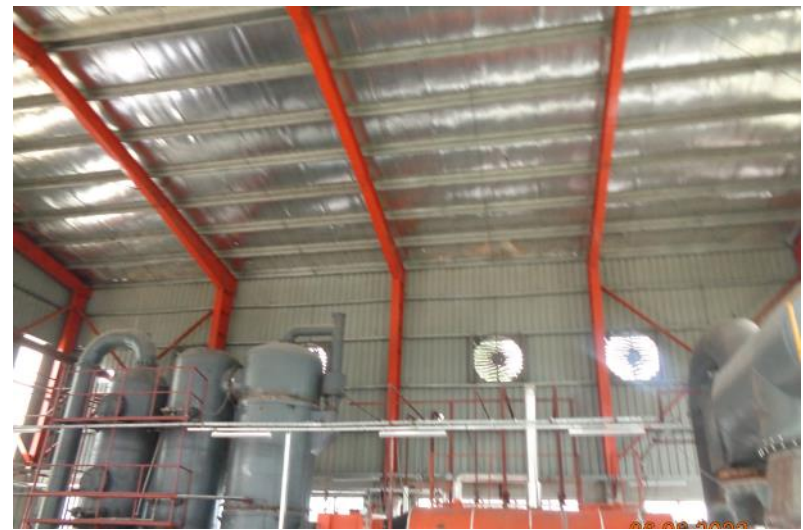
Lateral load transfer media missing at roof level

Lateral load transfer media (compression strut) along the long direction is missing. Building engineer to check the lateral stability of the structure.

| Item No. | Observation | Recommended Action Plan | Recommended Timeline |
|---|---|---|---|
| 15 | Lack of lateral stability system. (Building-7) | Building engineer is required to check the lateral stability of the shed. | 6-weeks |

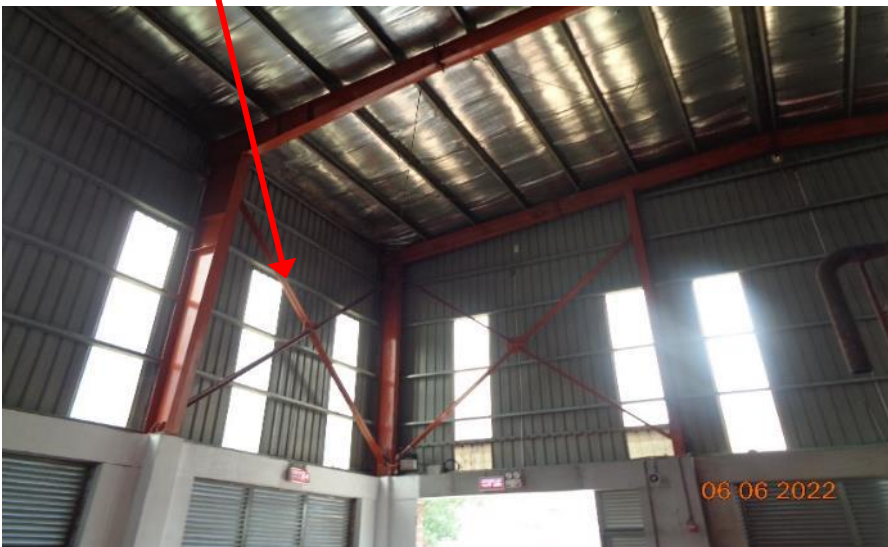
Tension/Angle bracing without compression strut

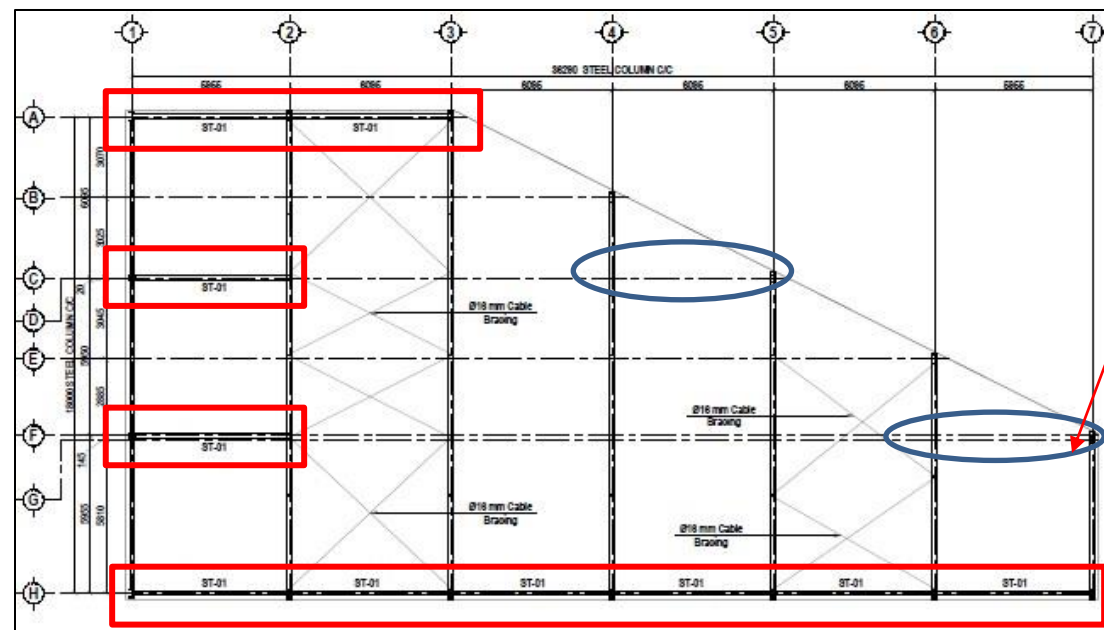
Roof Bracing and compression strut (marked location) Layout plan

Lack of lateral load transfer media (compression strut) marked in blue along the long direction. Building engineer to check the lateral stability of the structure.

| Item No. | Observation | Recommended Action Plan | Recommended Timeline |
|---|---|---|---|
| 17 | Lack of lateral stability system (Building-8). | Building engineer is required to check the lateral stability of the shed. | 6-weeks |

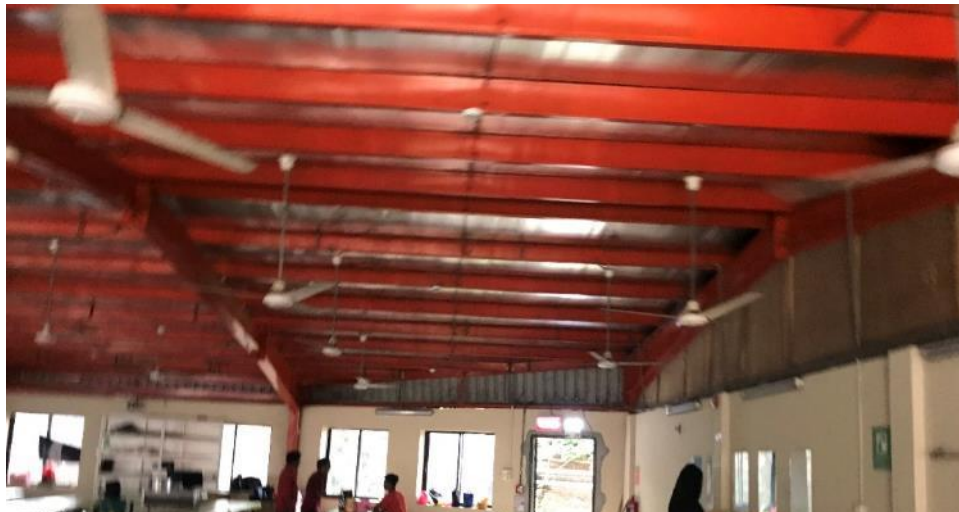
Compression strut missing

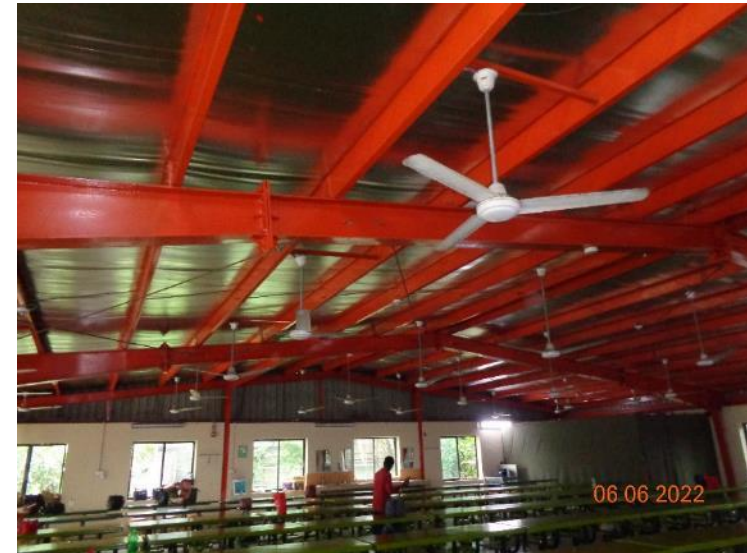
Lateral load transfer media missing at roof level
