# Standard Stitches Ltd. (Unit-2) (Extension)

10/4, Karnapara, Genda, Savar, Dhaka.

05 June 2022

# Observations

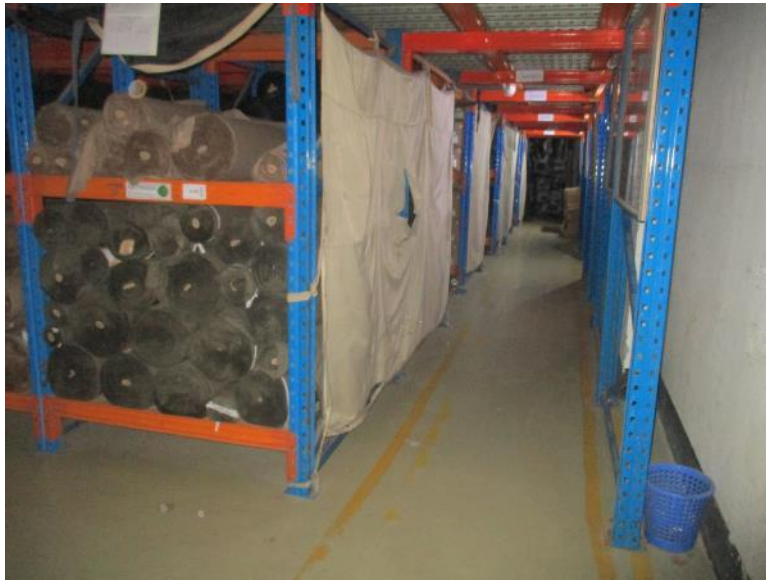
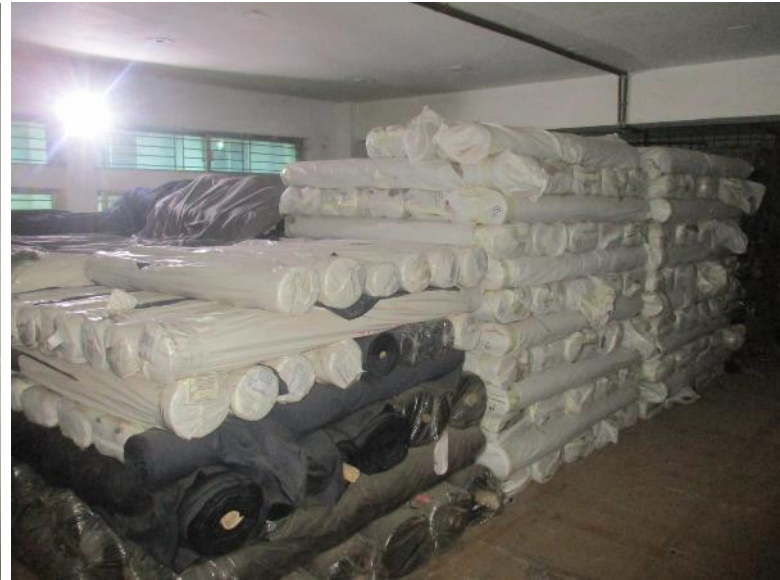
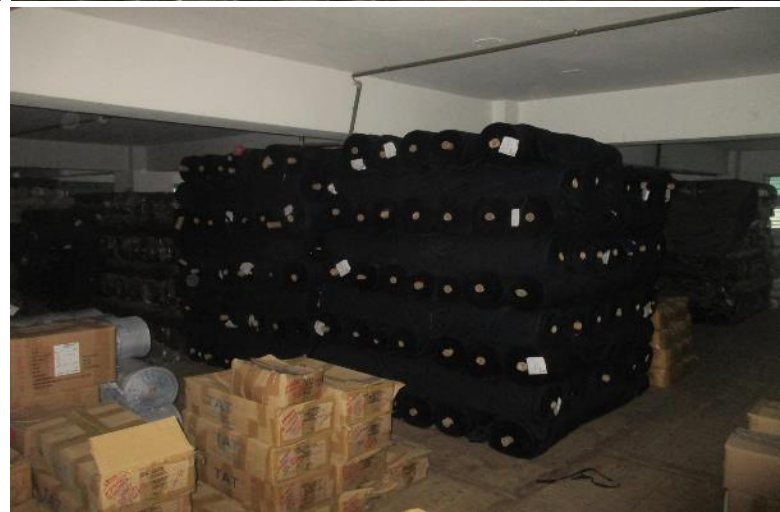
Steel storage rack

Heavy loading observed on the steel racks. There is no floor load plan for the steel racks. The building engineer is required to prepare allowable floor loading plan for the steel racks.

More than 4 kN/m<sup>2</sup> loading on steel racks

| Item No. | Observation | Recommended Action Plan | Recommended Timeline |
|---|---|---|---|
| 01 | Lack of floor load plan for steel storage racks. (Main Production Building-Extension Part) | The building engineer is required to survey the steel racks & prepare as-built drawings with structural details. | 6-weeks |
| 02 | Lack of floor load plan for steel storage racks. (Main Production Building-Extension Part) | Prepare allowable floor loading plan for the steel racks. | 6-weeks |
| 03 | Lack of floor load plan for steel storage racks. (Main Production Building-Extension Part) | Continue to implement floor loading plan. | 6-months |

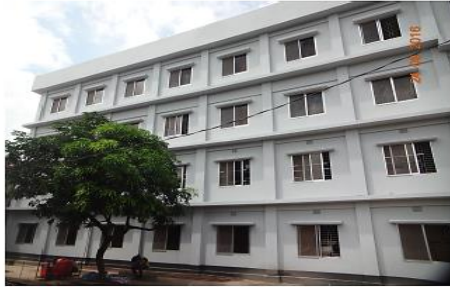
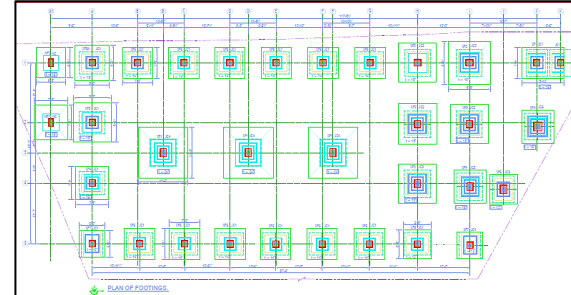
The provided DEA report found incomplete. Almost all columns, footings and beams were retrofitted which has not mentioned in the DEA report. IMRF ( $R=8$ ) framing system is considered without proper justifications. Retrofitting material strength/test report was not available. All BNBC-2006 load combinations were not mentioned in the report. The building engineer is required to complete the DEA report and submit to RSC for review.

| Item No. | Observation | Recommended Action Plan | Recommended Timeline |
|---|---|---|---|
| 04 | Incomplete DEA report. (Office Building) | The building engineer is required to revise the DEA report based on the observations and submit to RSC for review. | 6-weeks |
| 05 | Incomplete DEA report. (Office Building) | Produce and actively manage floor loading plan based on capacity of floor, column and foundation. | 6-weeks |

| Item No. | Observation | Recommended Action Plan | Recommended Timeline |
|---|---|---|---|
| 06 | Incomplete DEA report. (Office Building) | Carry out required remedial actions as per revised DEA. | 6-months |

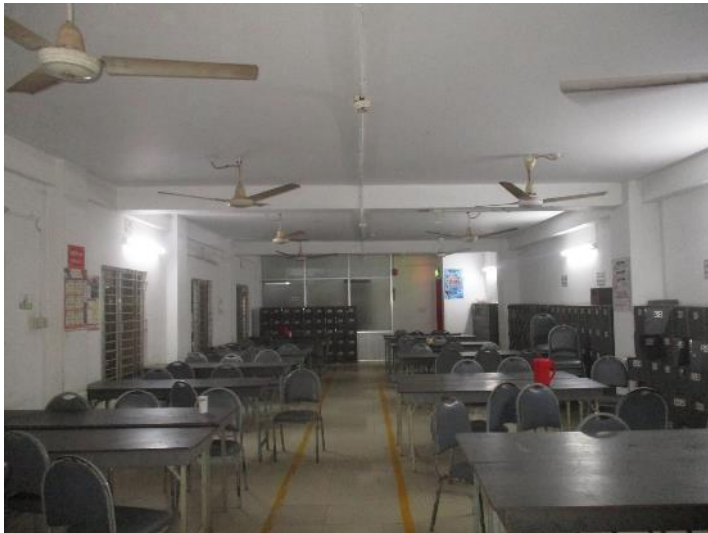
Ground floor- dining

The floor use of the building did not match with the floor layout plan. The ground floor was being used for dining instead of cutting & finish good store, 1st floor used for hanger storage instead sewing and 2nd floor used for office instead of finish good store. Also, there was a steel water tank on the roof which has not mentioned the drawings.

| Item No. | Observation | Recommended Action Plan | Recommended Timeline |
|---|---|---|---|
| 08 | Discrepancy in floor occupancies. (Office Building) | The building engineer is required to check the floor occupancies and prepare a set of architectural layout and floor live loading plan for the building. | 6-weeks |

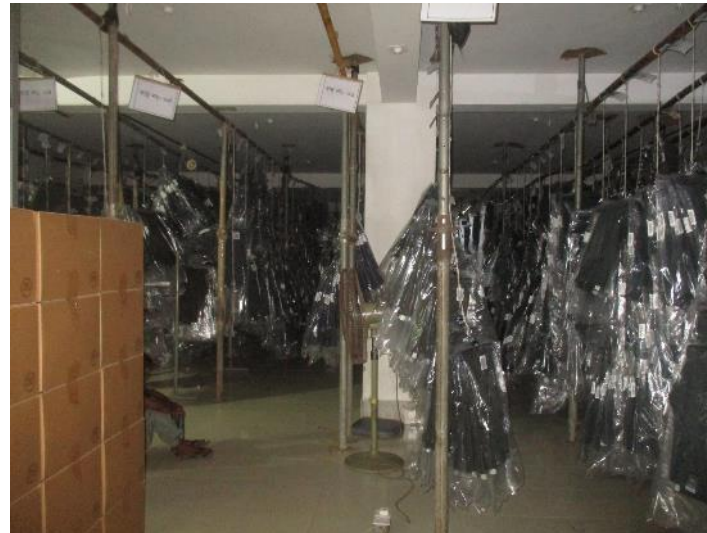
1st floor- hanger storage

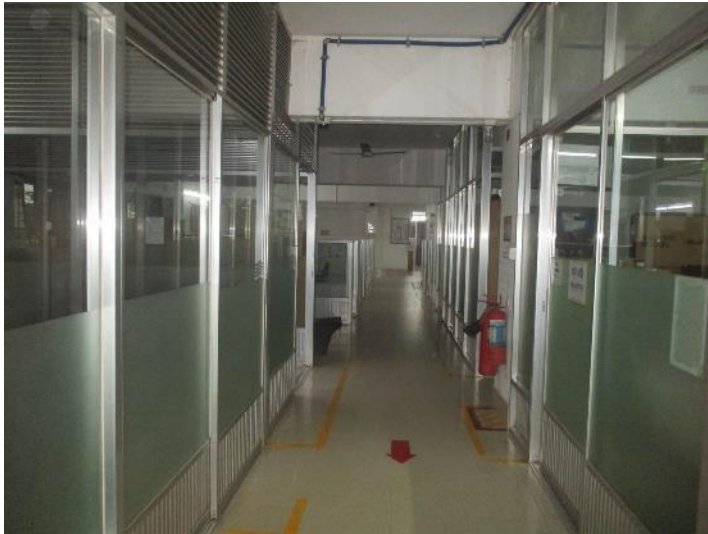
2nd floor- office

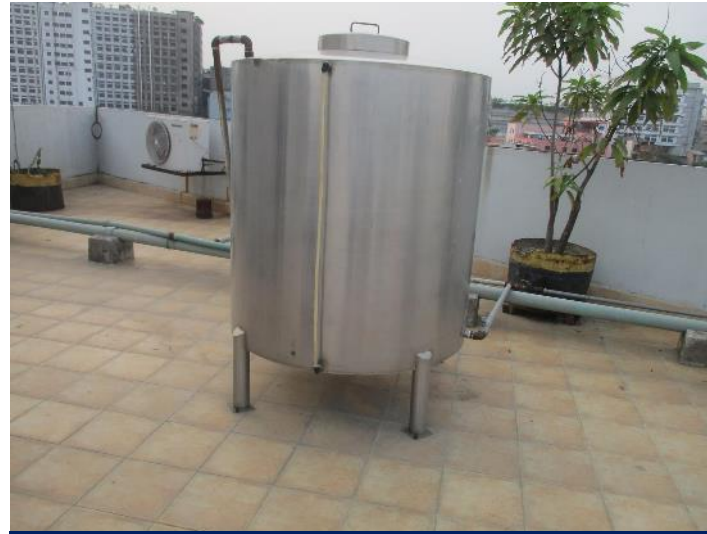
Roof- steel water tank (2000 L)

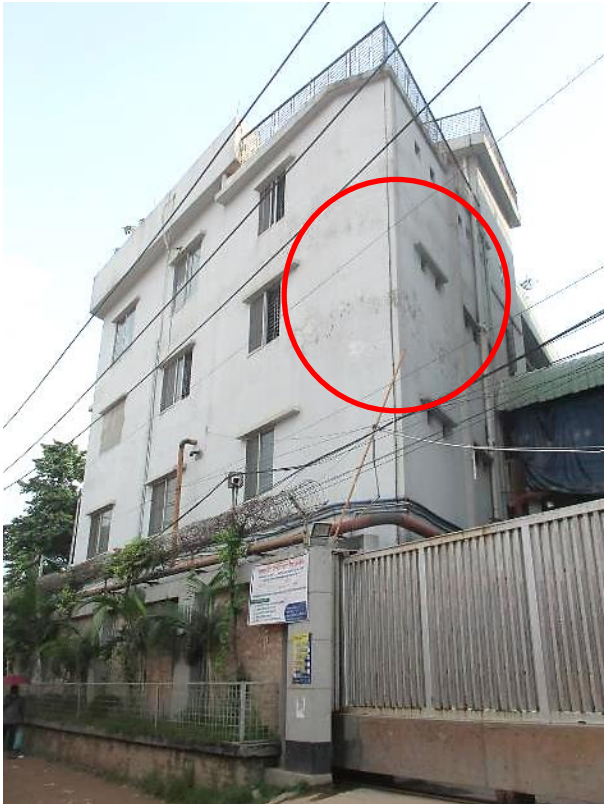
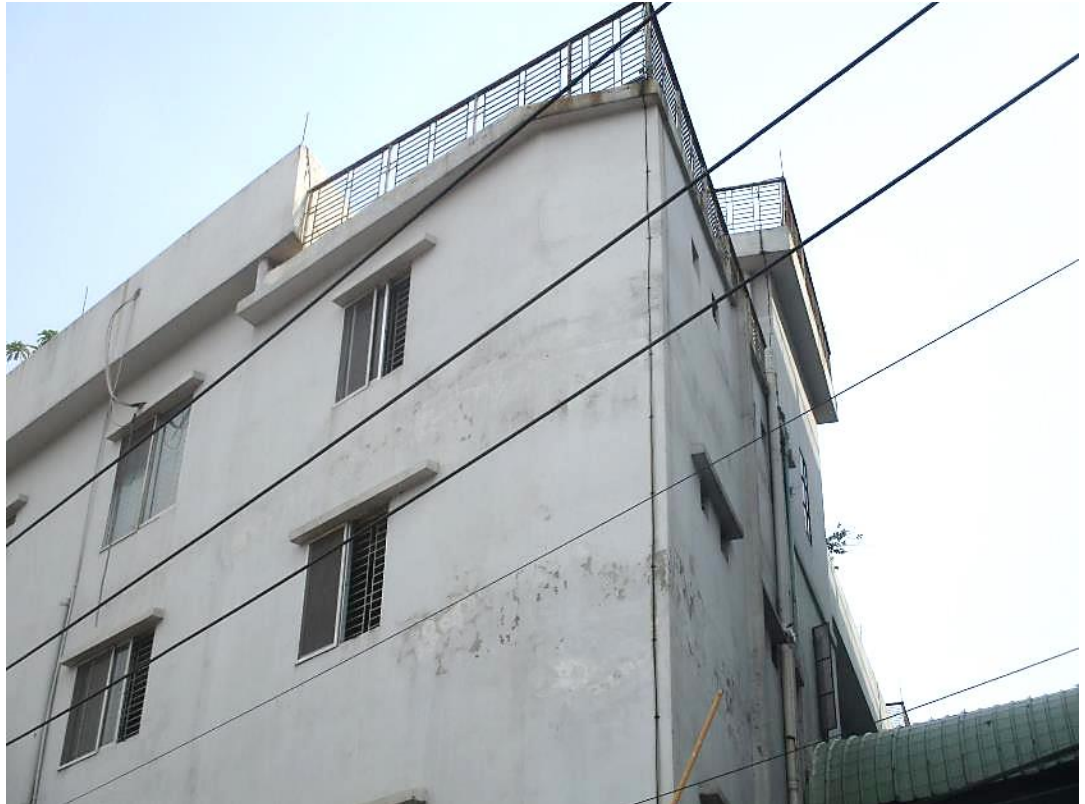
Dampness on exterior façade

Water dampness observed on the exterior facade of the building. The factory is required to repair the damp areas with suitable method.

| Item No. | Observation | Recommended Action Plan | Recommended Timeline |
|---|---|---|---|
| 10 | Dampness on exterior façade. (Office Building) | The factory is required to repair the damp areas with suitable method. | 6-weeks |

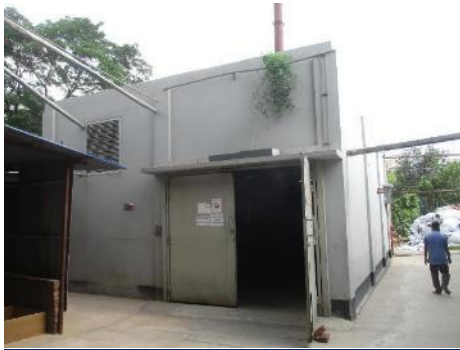
6. Boiler Shed

There are 8 ancillary structures in the factory premises which have no as-built documents. The factory is required to prepare as-built drawings for two Guard Rooms & RMS Room. And prepare as-built drawing along with design report for the Boiler, Compressor, Childcare, Sub-station and Fire Pump Room.

| Item No. | Observation | Recommended Action Plan | Recommended Timeline |
|---|---|---|---|
| 11 | Lack of as-built documents. (Boiler Shed) | The building engineer is required to survey the structures and prepare as-built drawings. | 6-weeks |
| 12 | Lack of as-built documents. (Boiler Shed) | Carry out Engineering Assessment (EA) to verify the stability of the structure for lateral and uplift forces. | 6-weeks |
| 13 | Lack of as-built documents. (Boiler Shed) | Carry out required remedial works as per EA. | 6-months |

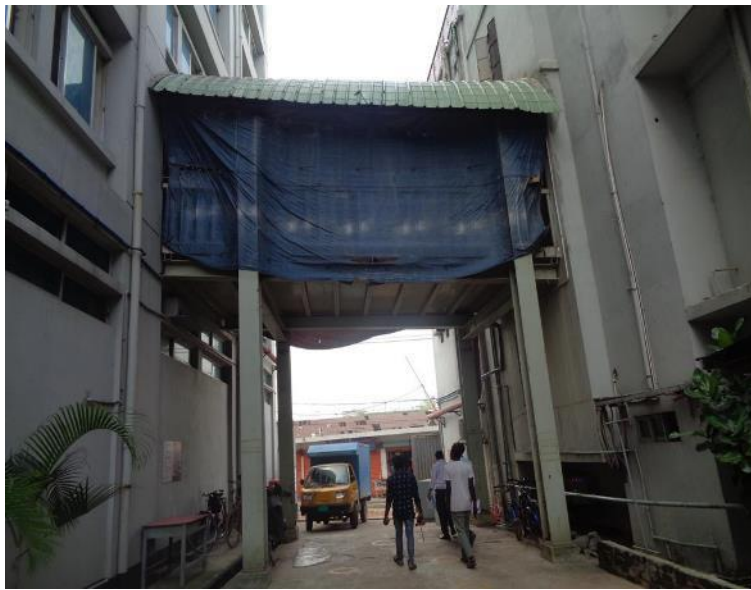
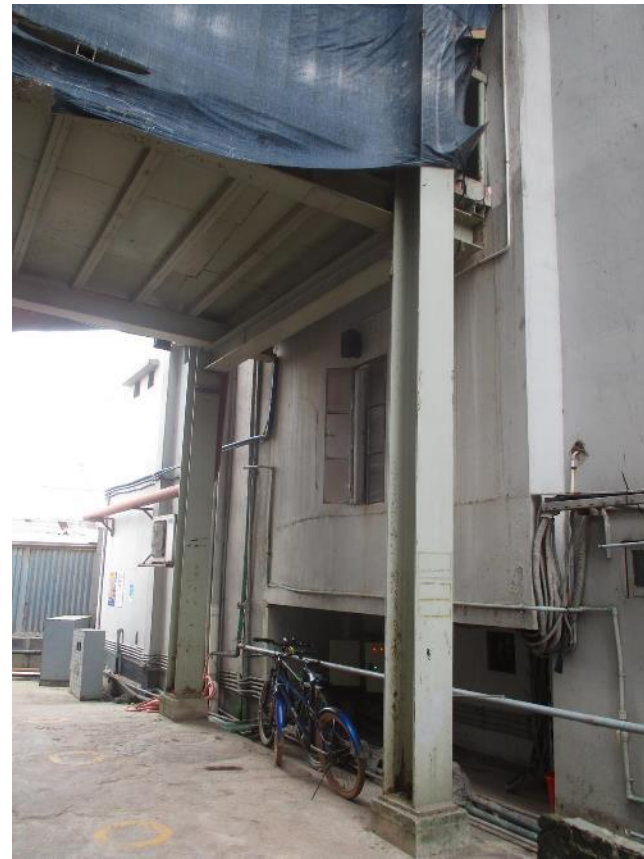
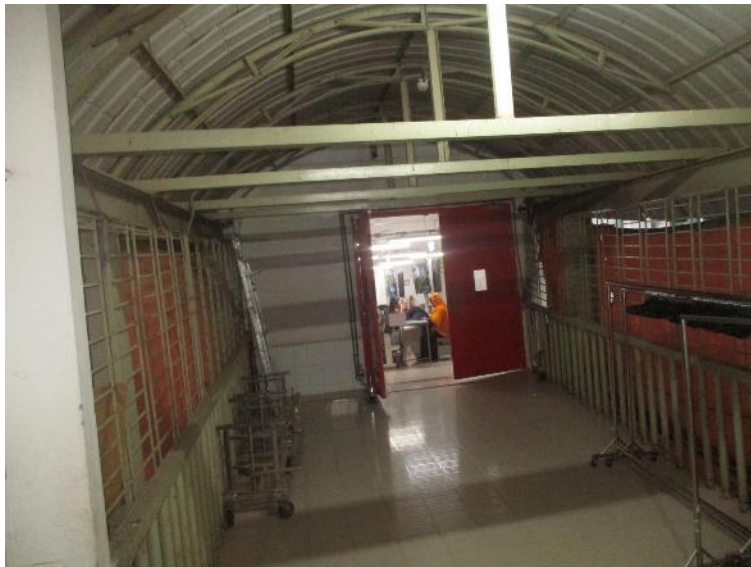
Steel Connecting Bridge

There is a steel connection bridge between Main Building (Extension Part) and Office Building at 1st floor level which have design documents. The factory is required to prepare as-built drawings along with design report for the structure.

| Item No. | Observation | Recommended Action Plan | Recommended Timeline |
|---|---|---|---|
| 27 | Lack of as-built documents. (Steel Connecting Bridge) | The building engineer is required to survey the structures and prepare as-built drawings. | 6-weeks |
| 28 | Lack of as-built documents. (Steel Connecting Bridge) | Carry out Engineering Assessment (EA) to verify the stability of the structure for lateral and uplift forces. | 6-weeks |
| 29 | Lack of as-built documents. (Steel Connecting Bridge) | Carry out required remedial works as per EA. | 6-months |

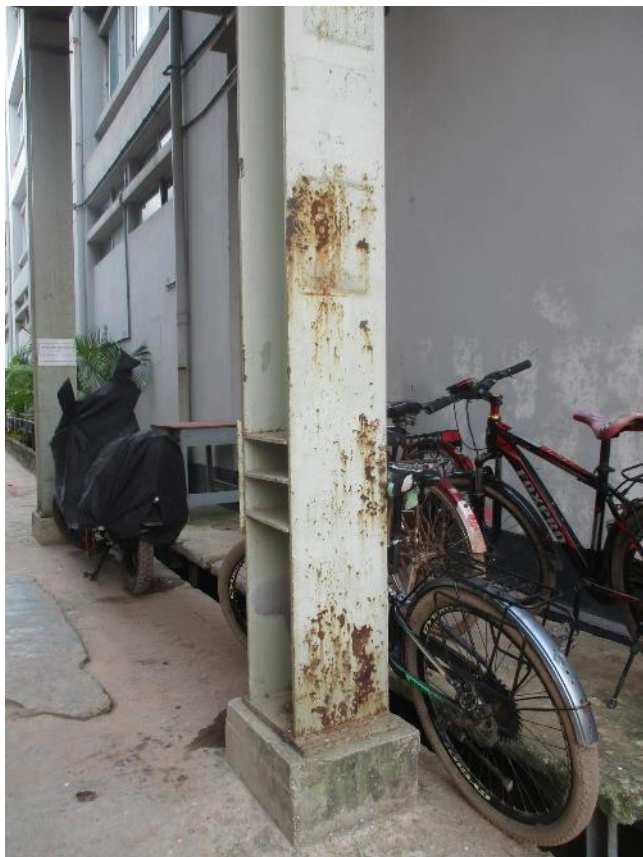
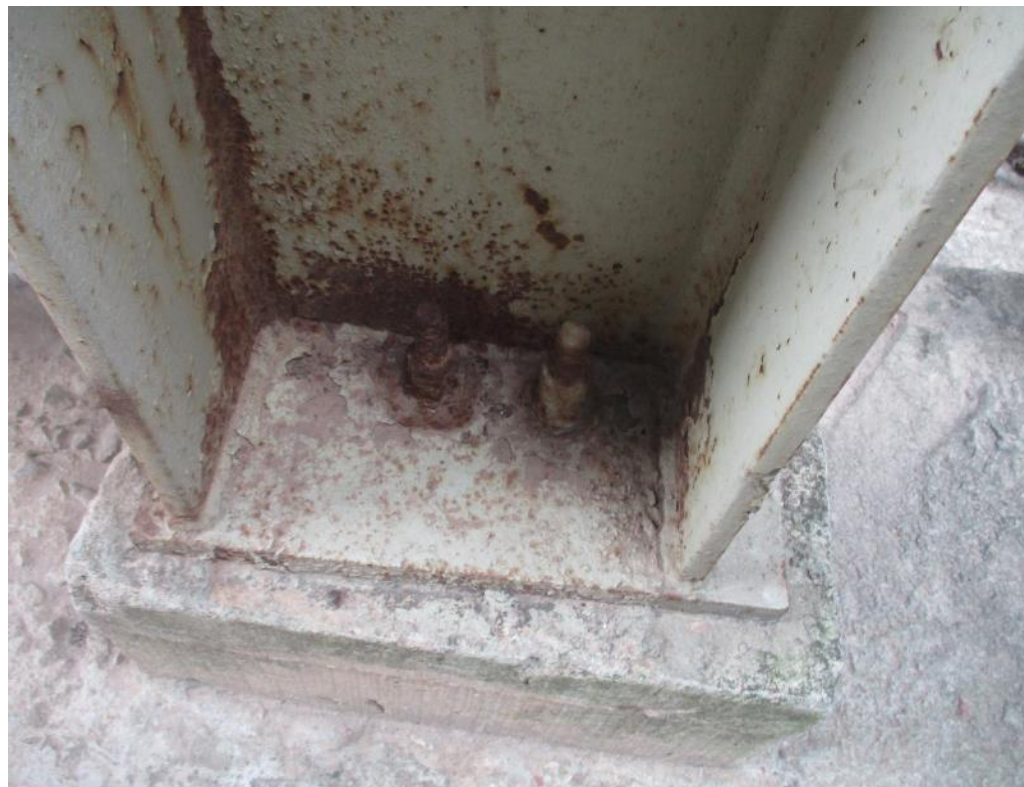
Corrosion on steel members

Corrosion found on the column of steel connecting bridge. The factory is required to remove the corrosion and apply corrosion resistance coating to the steel member.

| Item No. | Observation | Recommended Action Plan | Recommended Timeline |
|---|---|---|---|
| 30 | Corrosion on steel members. (Steel Connecting Bridge) | The factory is required to remove the corrosion and apply corrosion resistance coating to the steel members. | 6-weeks |
