## FIRE SAFETY INSPECTION REPORT

# ARABI Fashion Ltd (Extension)

RSC ID: 24432

Date: 16-June-2022

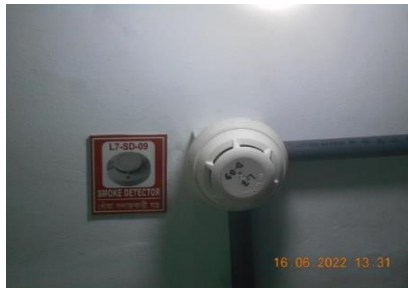
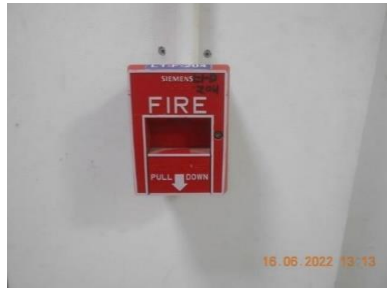
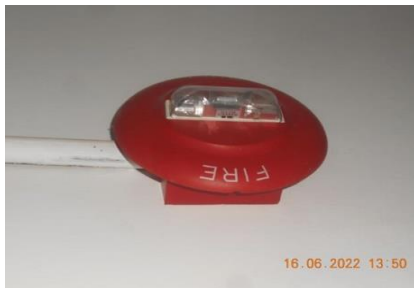
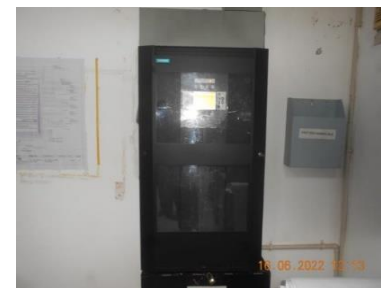
SI No.	Category	Findings	Required Action	Remediation Time Frame
F-07	Egress Lighting ITM	Inspection, testing, and maintenance for the emergency lighting system were not in accordance with The RSC Technical Guidelines (Standard).	Inspect, test and maintain the emergency lighting system in the accordance with The RSC Technical Guidelines (Standard). Keep written records on-site.	Within 3 months
F-08	Fire Alarm & Detection system	Automatic fire alarm and detection system installation complete which requires detailed review to confirm compliance with NFPA 72 and RSC Technical Guidelines (Standard).	Submit the fire alarm system design to RSC for review. Once the design is reviewed, install and modify the fire detection and alarm system throughout the buildings in accordance with review comment, RSC Technical Guidelines (Standard) and NFPA 72. After installation the owner shall conduct internal testing and commissioning and then contact the RSC for witness of final acceptance testing. Also inspect, test and maintain the fire alarm system, and keep written records on-site, in accordance with Table-14.3.1 of NFPA 72.	Design Review within 2 months and installation within 6 months

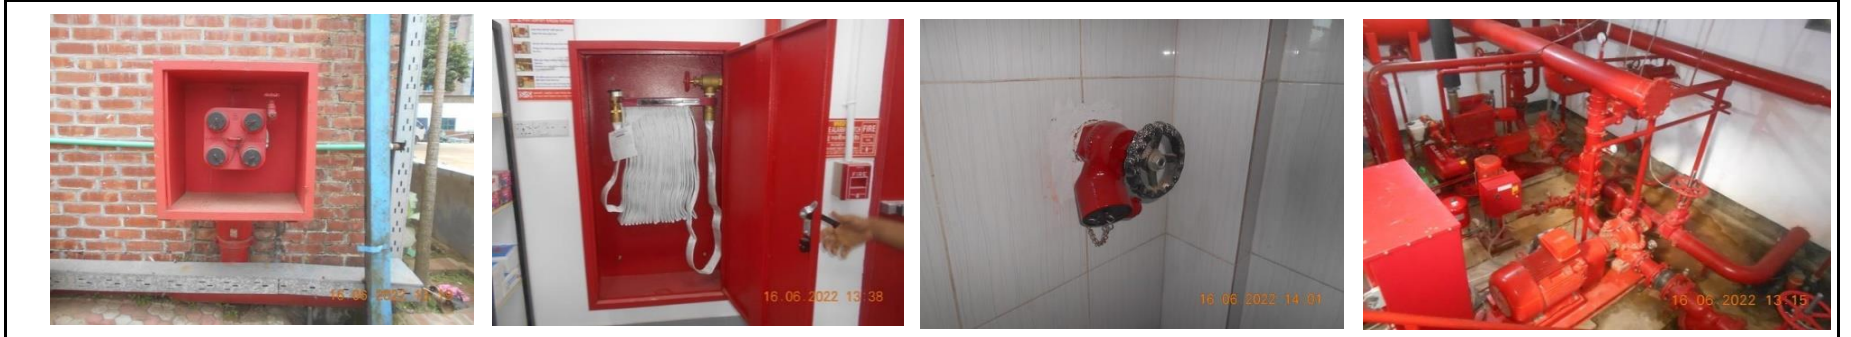
SI No.	Category	Findings	Required Action	Remediation Time Frame
F-09	ITM of Fire Alarm & Detection system	Inspection, testing and maintenance for the fire alarm system is not in accordance with NFPA 72.	Inspect, test and maintain the fire alarm system and keep written records on-site, in accordance with NFPA 72 and RSC Technical Guidelines (Standard).	Within 1 month (after installation)
F-10	Fire Protection System	Standpipe installation requires detailed review to confirm compliance with NFPA 14, 20, 22 and RSC Technical Guideline (Standard). Location: Dining Building.	Submit the standpipe system drawing to RSC for review. Once reviewed, install or modify the standpipe system throughout the building in accordance with RSC Technical Guideline (Standard) and NFPA 14, 20,22 and 24. After installation the owner shall contact the RSC for witness of conducting the final acceptance testing of the standpipe system.	Design Review within 2 months and installation within 4 months.
