# Arabi Fashion Ltd (Extension)

Bokran, Monipur, Gazipur Sadar, Gazipur  
(24.126219, 90.394475)

16<sup>th</sup> June 2022

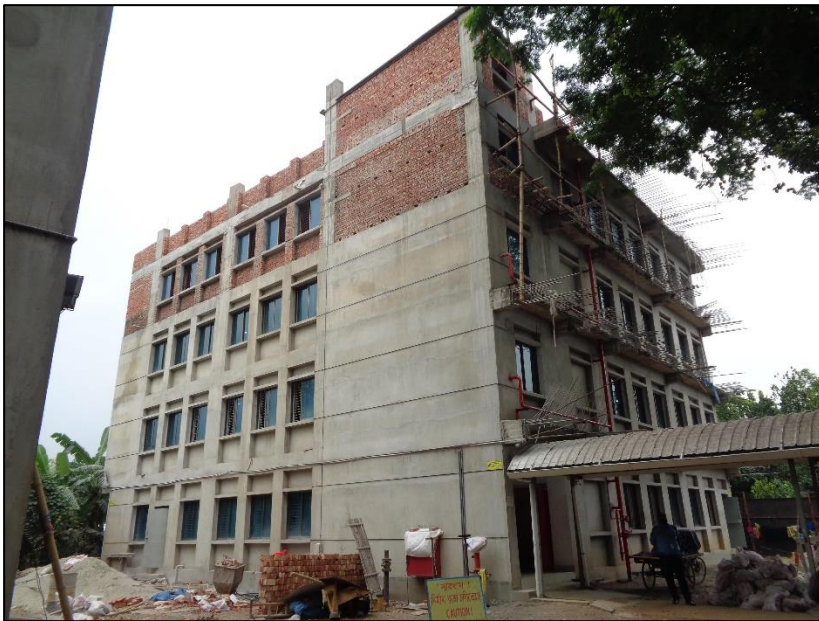
Existing 4 storied building

The building permit layout is for 6 storied structure. However, the building was constructed up-to four stories till the date of this inspection. Moreover, rebars of beams and slabs are extended horizontally in south direction. The building may be extended both vertically and horizontally in future. Prior to any sort of extension/expansion, factory engineer is required to produce Detailed Engineering Assessment (DEA) for the structure according to BNBC and submit to RSC for review.

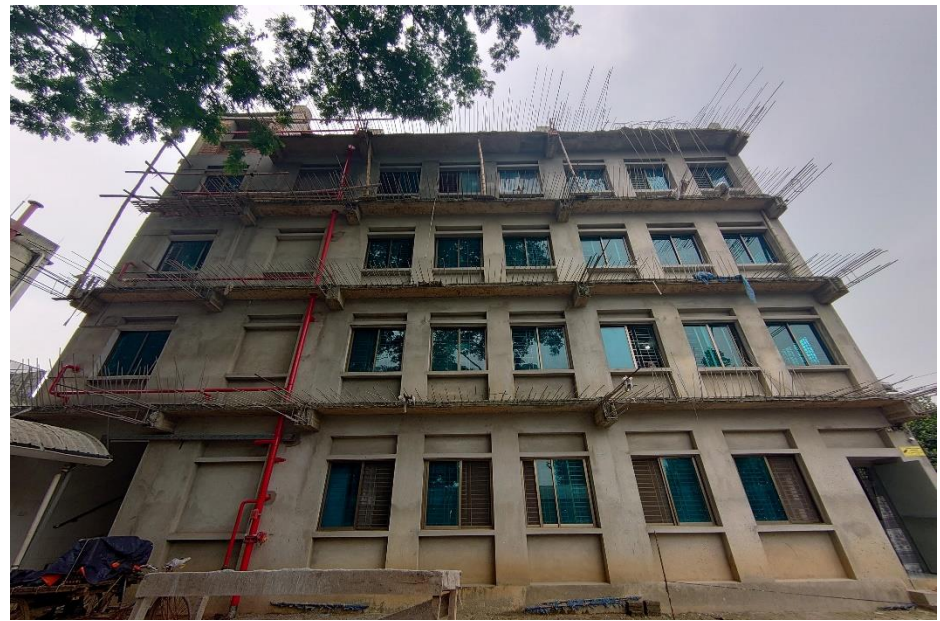
Exposed rebar of beam and slabs (south direction)

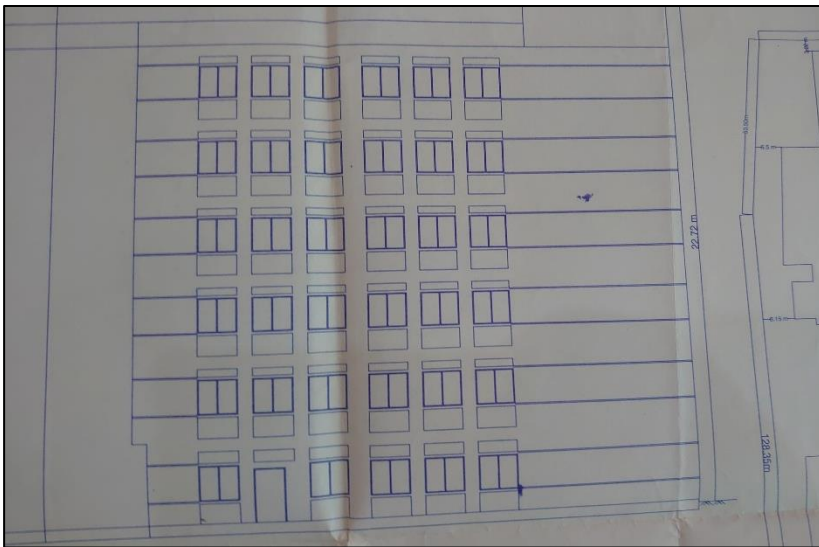
Permit layout for 6 storied building

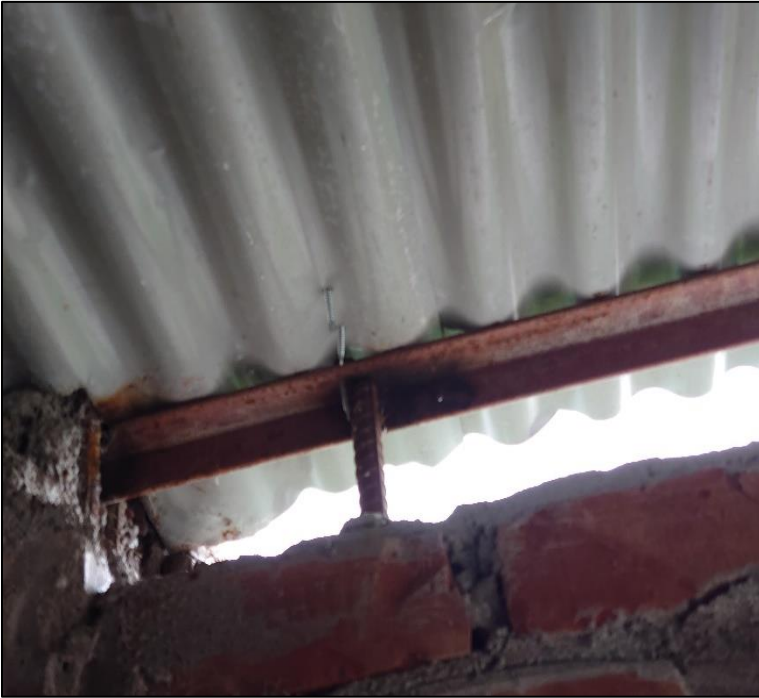
Poor connection details

The steel roof shed is made of angle sections and supported by brick wall over the staircase. Apparently inadequate structural member, poor connection details found. Building engineer is required to check the adequacy of the steel members & connections for gravity and lateral forces and suggest necessary alternatives.

Item No.	Observation	Recommended Action Plan	Recommended Timeline
01	Prepared DEA report needs to be revised (Dining Building)	Building engineer to update the DEA documents including a DEA report, based on verifying in-situ concrete strength in compliance with BNBC-2006.	6-weeks
02	Prepared DEA report needs to be revised (Dining Building)	Complete implementation of any remedial works deemed necessary by the Design Report.	6-months
03	Possible future extension (Dining Building)	Prior to any type of extensions/expansion or modifications of the existing building, a Detail Engineering Assessment (DEA) by a structural Engineer needs to be carryout in compliance with the BNBC.	6-months
04	Possible future extension (Dining Building)	Carry out remedial works from outcome of DEA where necessary before commencement of further construction.	6-months
05	Non-engineered roof shed over staircase (Dining Building)	Building engineer is required to check the adequacy of the roof shed for gravity and lateral forces or replace with the engineered sheds.	6-weeks

Item No.	Observation	Recommended Action Plan	Recommended Timeline
06	Non-engineered roof shed over staircase (Dining Building)	Carry out necessary remedial works arise from the EA report where required.	6-months
07	Apparently non-engineered shed (Sewing Thread Storage Shed)	Building engineer is required to prepare full set of as-built drawings for this structure.	6-weeks
08	Apparently non-engineered shed (Sewing Thread Storage Shed)	As part of Engineering Assessment (EA), building engineer is required to check the adequacy of the roof shed for gravity and lateral forces and suggest proper remedial actions.	6-weeks
09	Apparently non-engineered shed (Sewing Thread Storage Shed)	Carry out necessary remedial works arise from the EA.	6-months

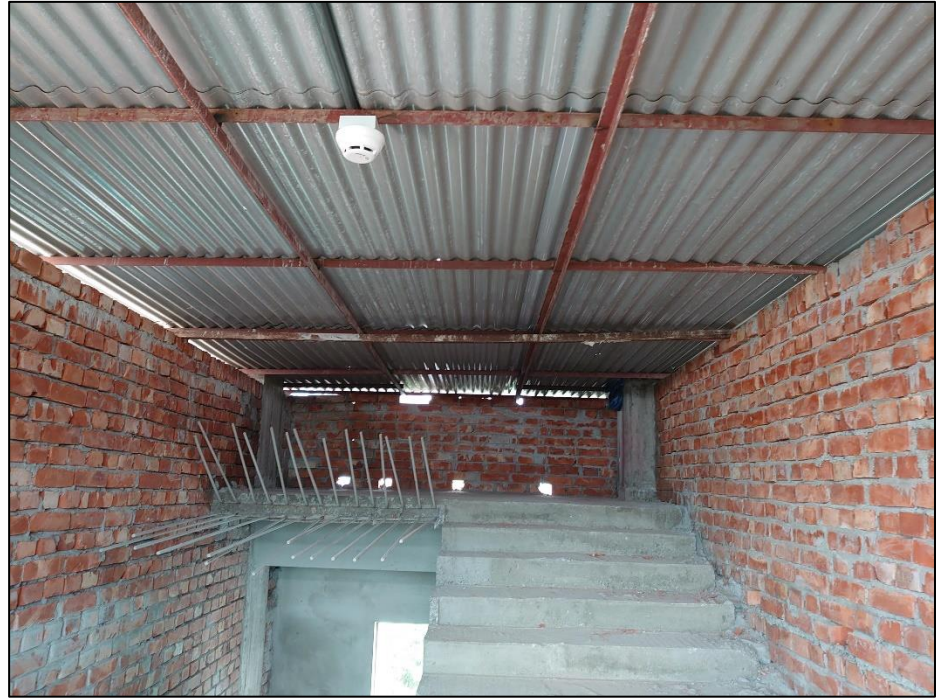
Apparently inadequate structural members

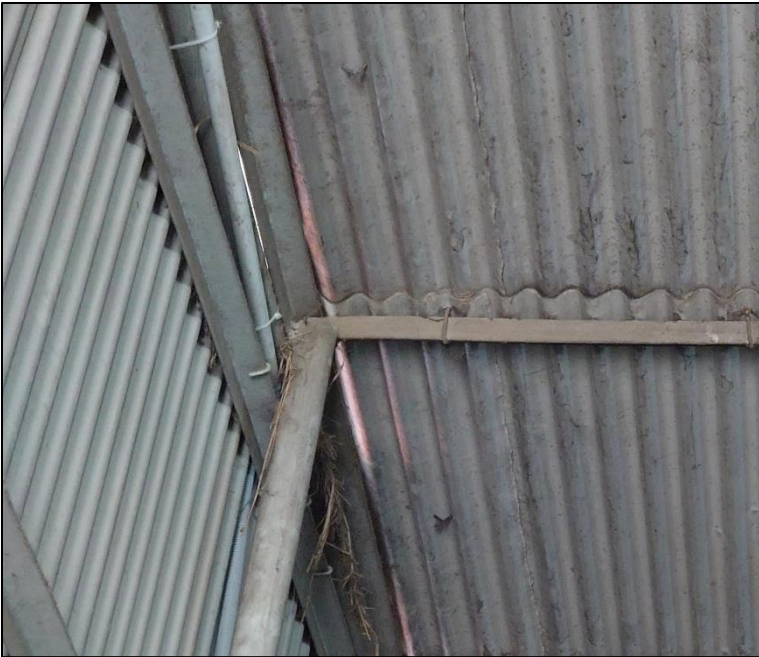
Poor connection details

No as-built drawing was provided for the utility shed. Factory engineer is required to prepare full set of as-built drawings for this structure.

Apparently Inadequate structural member, poor connection details found. Building engineer is required to check the adequacy of the steel members & connection for uplift and lateral forces and suggest proper remedial actions.

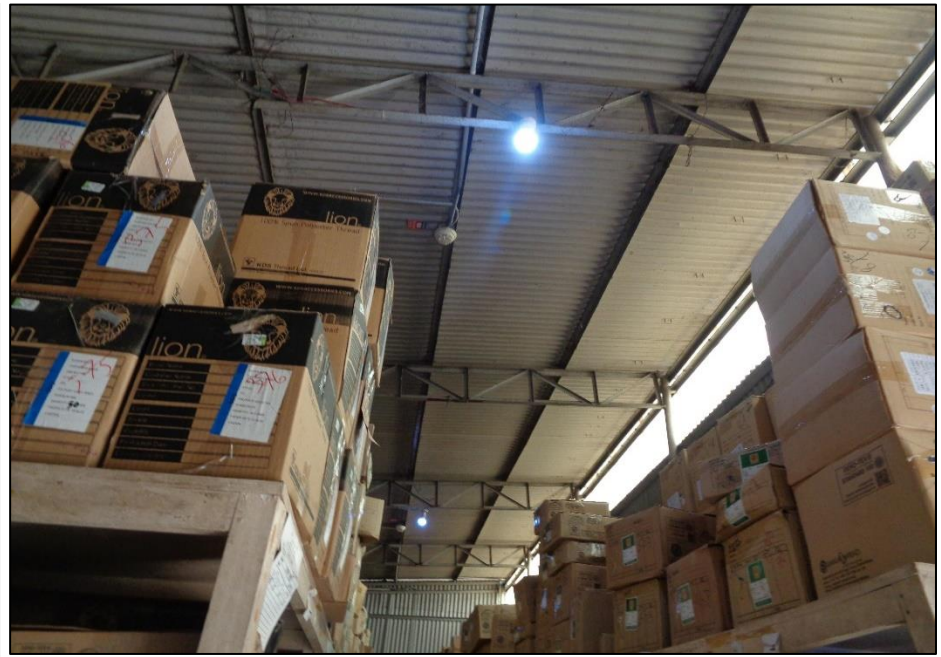
Apparently inadequate structural members
