# Mehnaz Styles & Craft Ltd. (New)

Industry Sl. No.: 56, Ward No: 06, Tongabari, Ashulia, Savar, Dhaka  
(23.898356, 90.323207)

14<sup>th</sup> June 2022

# Observations

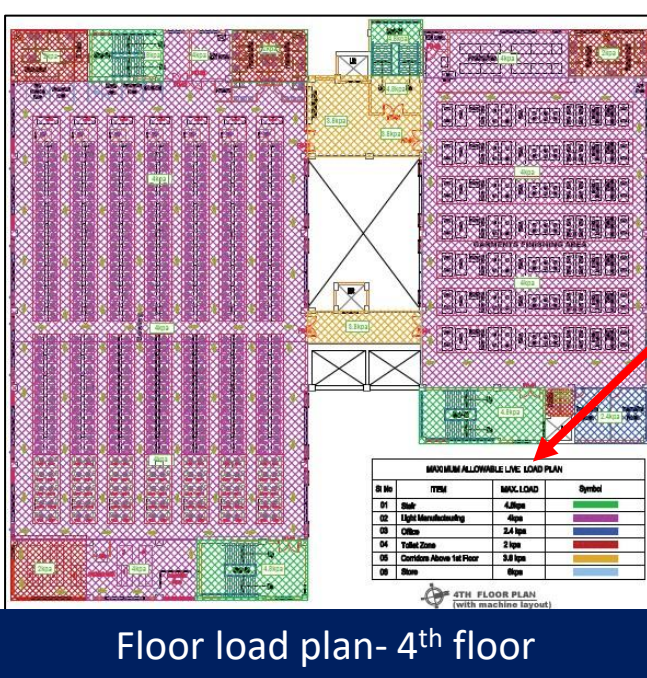
Floor load plan- 4<sup>th</sup> floor

Load For part-B: 5 kPa floor live load has been considered in the design report for 2<sup>nd</sup> to 6<sup>th</sup> floor. But in load plan, 6 kPa has been considered in all the storage area of 1<sup>st</sup> to 3<sup>rd</sup> floor and 5<sup>th</sup> floor. Again at 4<sup>th</sup> floor, 4 kPa live load has been considered in load plan for sewing section. But storage was found in 4<sup>th</sup> floor level. Factory engineer is required to update the floor loading plan and design report following BNBC loading requirements.

| Item No. | Observation | Recommended Action Plan | Recommended Timeline |
|---|---|---|---|
| 01 | Mismatch between design report and floor loading plan. (Building-1) | Building engineer to check the floor occupancies, update the floor loading plan based on BNBC requirements and capacity of floors, columns and foundations of the building. | 6-weeks |

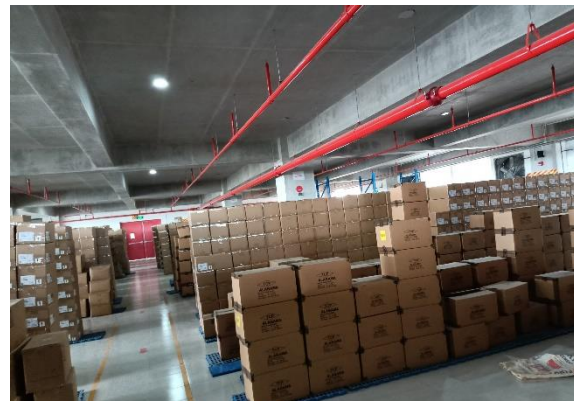
Storage at 4<sup>th</sup> floor

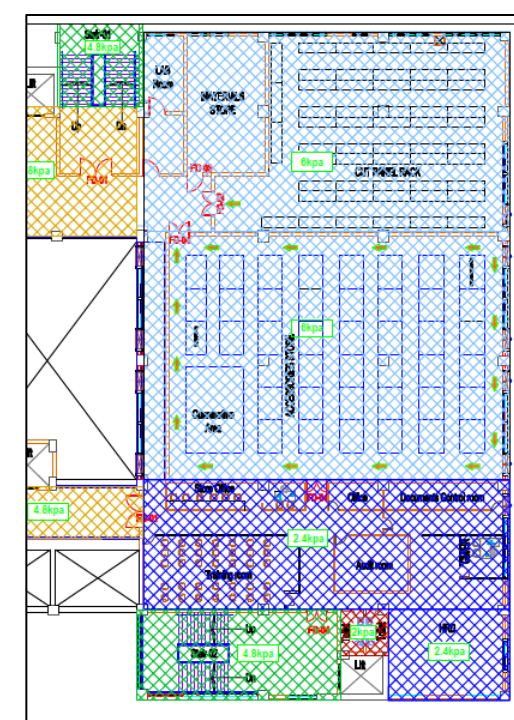
6 kPa live load shown in the load plan of 1<sup>st</sup> floor of part-B

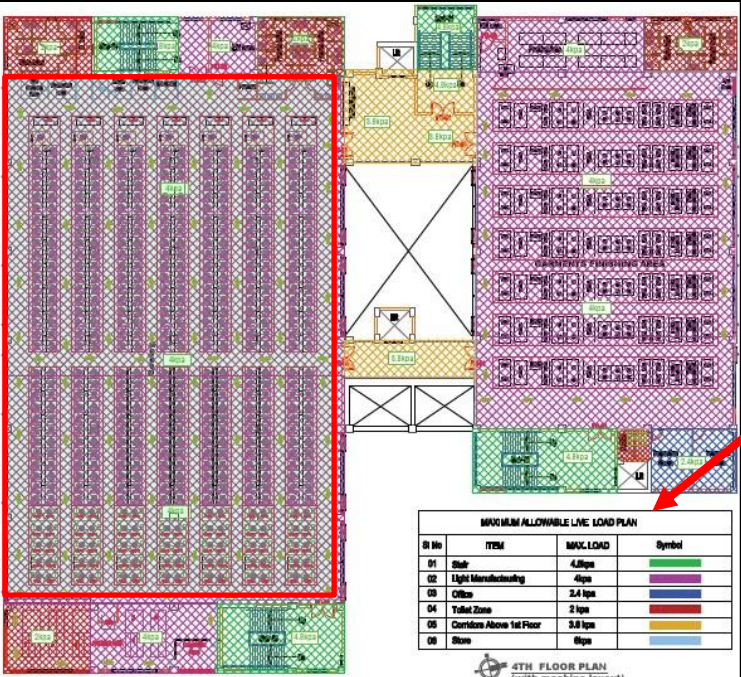
Floor load plan

4 kPa has been considered in software-based analysis model for Part- A

For part-A: The live load of light manufacturing has been considered 4 kPa in the software analysis model and live load plan for all floor levels where in the design report, 6 kPa live load has been considered at 1st floor and 5 kPa considered for upper floors. Factory engineer is required to update the floor loading plan, software-based analysis model and design report following BNBC loading requirements.

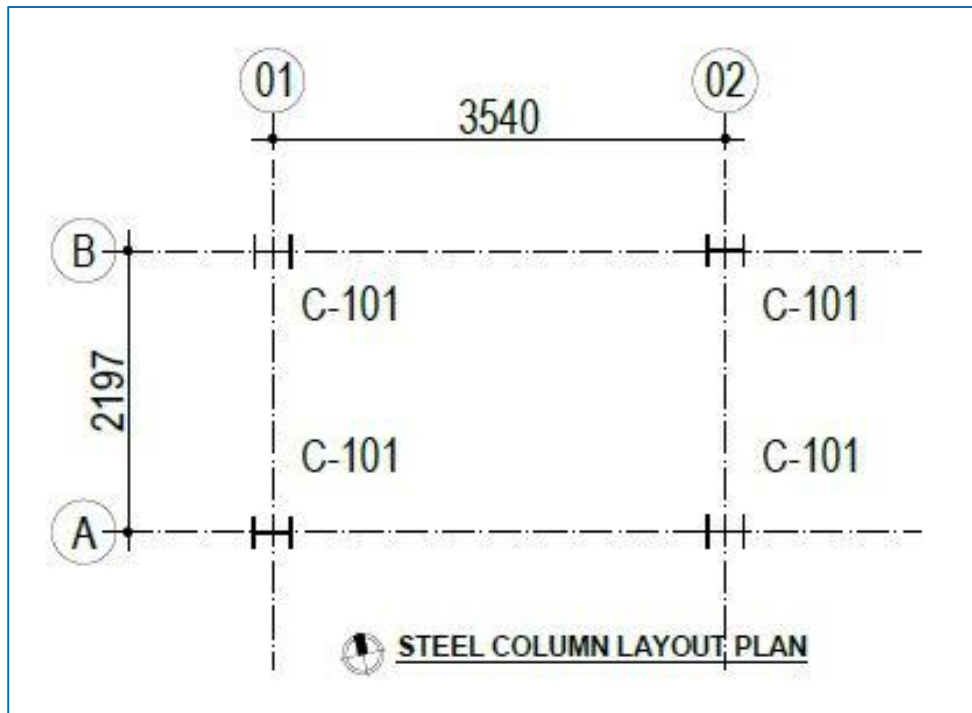
The flange width of stair steel column was found 200mm. Whereas as built drawing shows 250 mm. Building engineer is required revised the as-built drawing as per on site condition.

| Item No. | Observation | Recommended Action Plan | Recommended Timeline |
|---|---|---|---|
| 03 | Mismatch in drawing (Steel Stair) | Building engineer is required revised the as-built drawing as per on site condition. | 6-weeks |

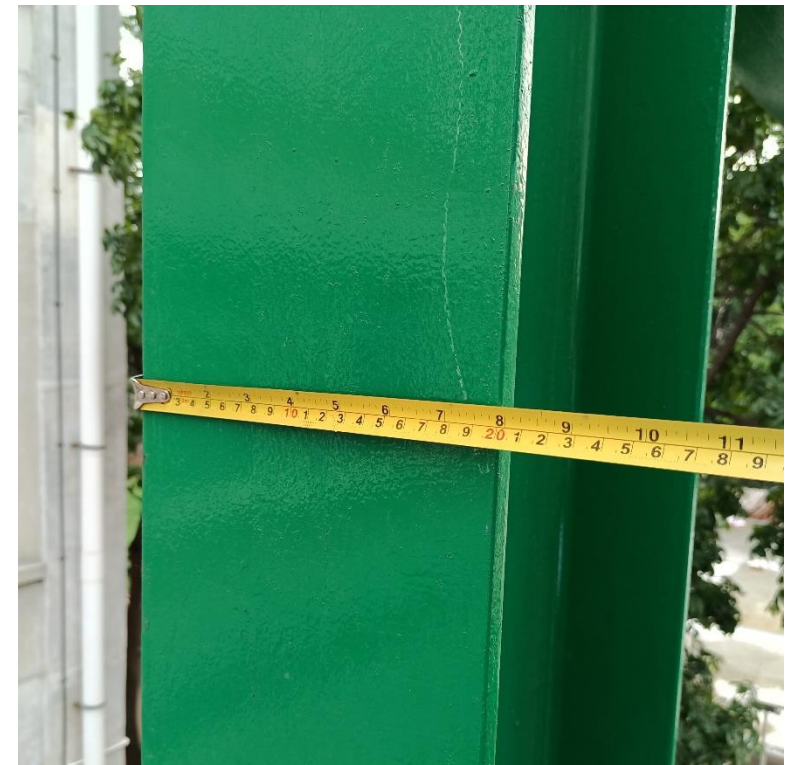
Flange width of steel column 200 mm
