# MU Fashion Ltd.

09 June 2022

# Buildings Information

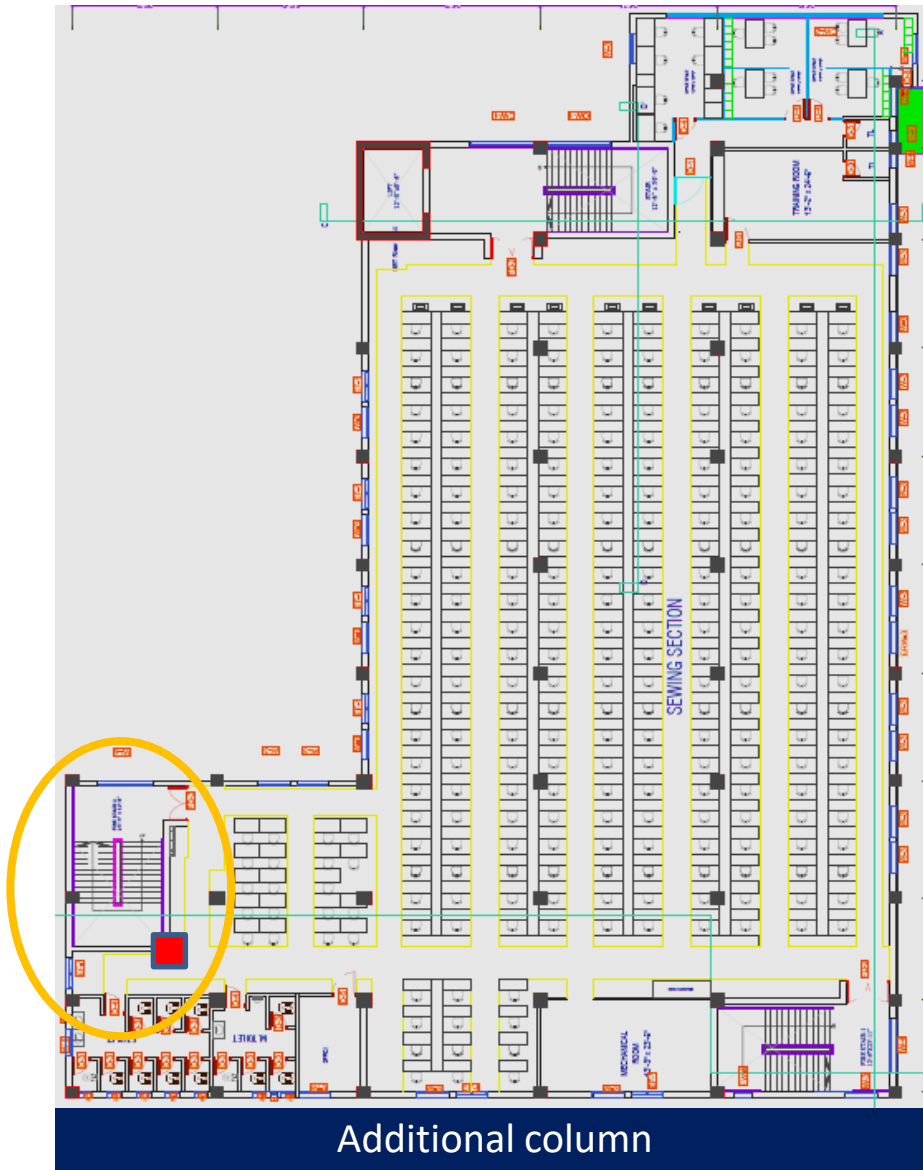
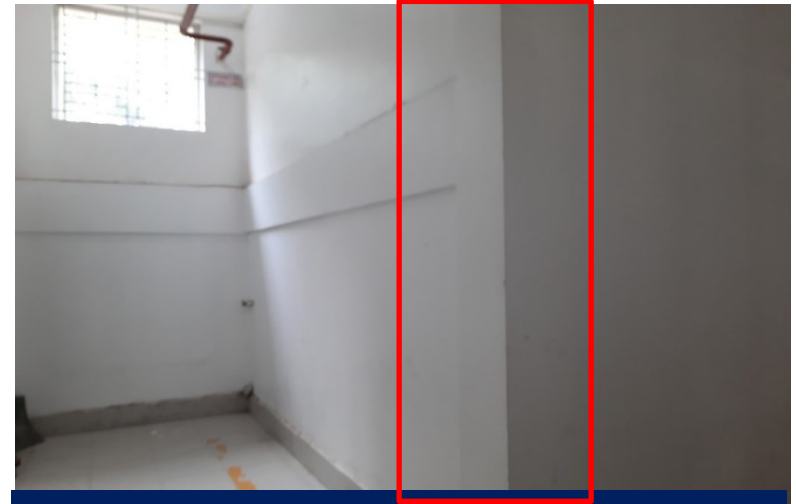
A load bearing RC column found in the marked staircase. No foundation system and load path observed of the column. Building engineer is required to check the vertical load path of the column.

RC column in stair-2 (250 mm X 250 mm)

| Item No. | Observation | Recommended Action Plan | Recommended Timeline |
|---|---|---|---|
| 01 | Vertical load path of the additional column (Production Building) | Building engineer is required to check the adequacy and vertical load path of the column. | 6-weeks |
| 02 | Vertical load path of the additional column (Production Building) | Verify the foundation system of the additional column. | 6-weeks |
| 03 | Vertical load path of the additional column (Production Building) | Carry out remedial works if required. | 6-months |

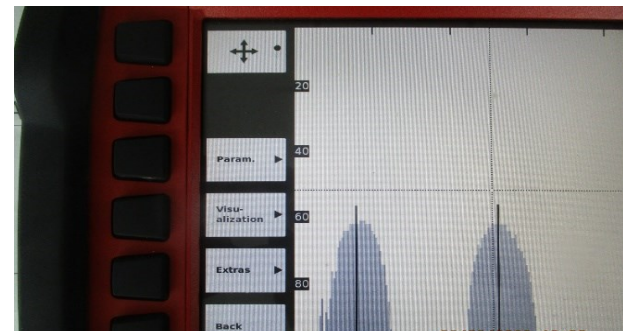
2 no's re-bar found in each side

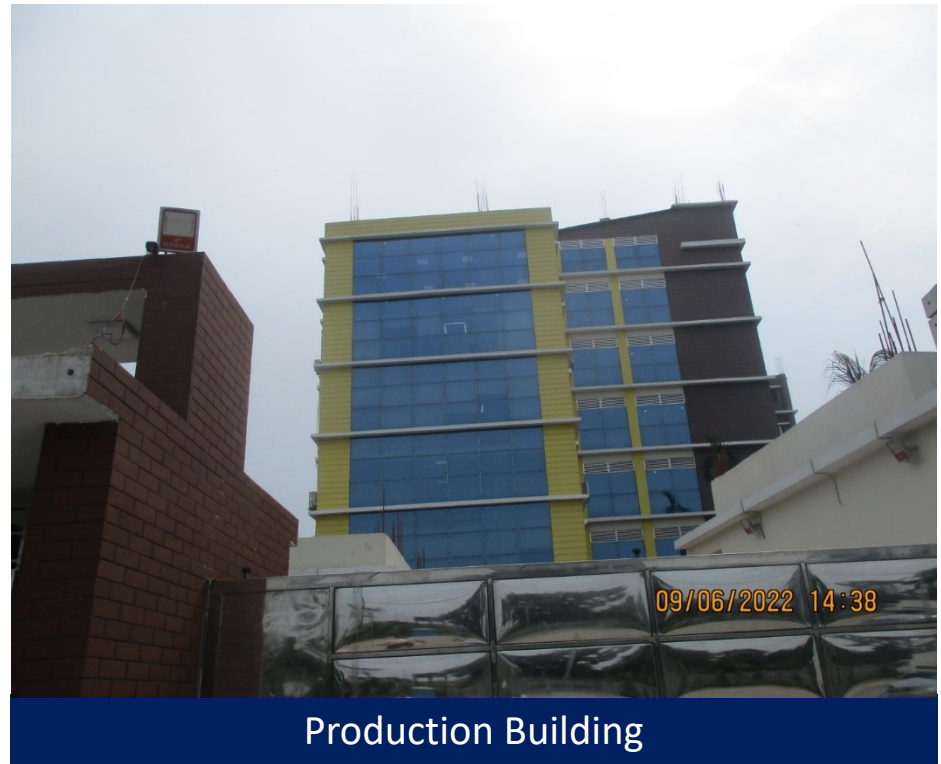
Production Building

As per BNBC every building or structure designed shall have its design documents prepared in accordance with the provision of Section 1.9.1. The design document shall include a design report, and a set of structural drawings, which shall be prepared in compliance with section 1.9.1.1 and section 1.9.1.2 as per BNBC.

| Item No. | Observation | Recommended Action Plan | Recommended Timeline |
|---|---|---|---|
| 04 | Information missing in the design report (Production Building) | Building engineer is required to prepare the design documents including a design report, and a set of structural drawings in compliance with section 1.9.1.1 and section 1.9.1.2 as per BNBC part 6 and submit to RSC for review. | 6-weeks |
| 05 | Information missing in the design report (Production Building) | Carry out remedial works ( if any ) after reviewed by RSC. | 6-months |

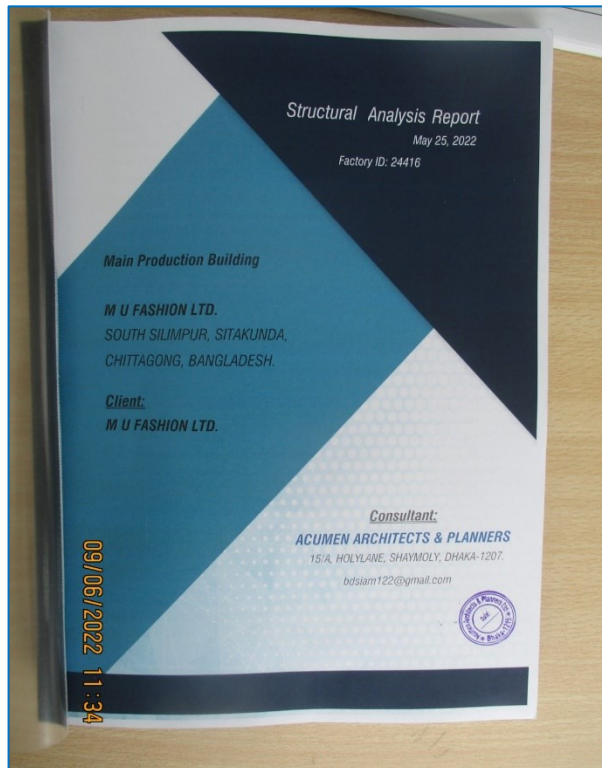
Design report

A Design Report was provided for the production Building at the time of inspection which was prepared based on software analysis. But no software analysis (FEA) model was provided to review the Design report. Moreover, capacity calculation of pre-cast pile as per BNBC were not provided in the design report.

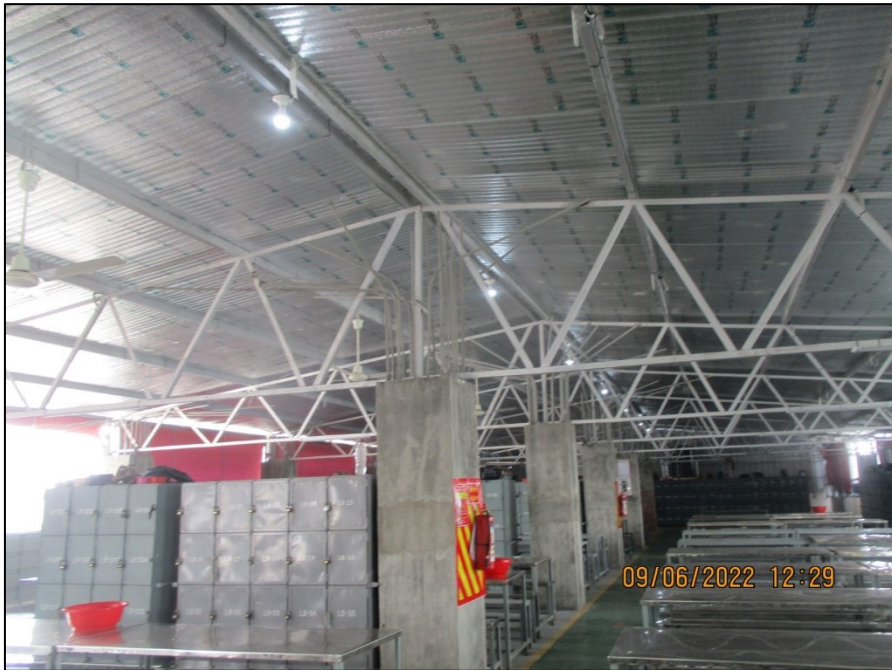
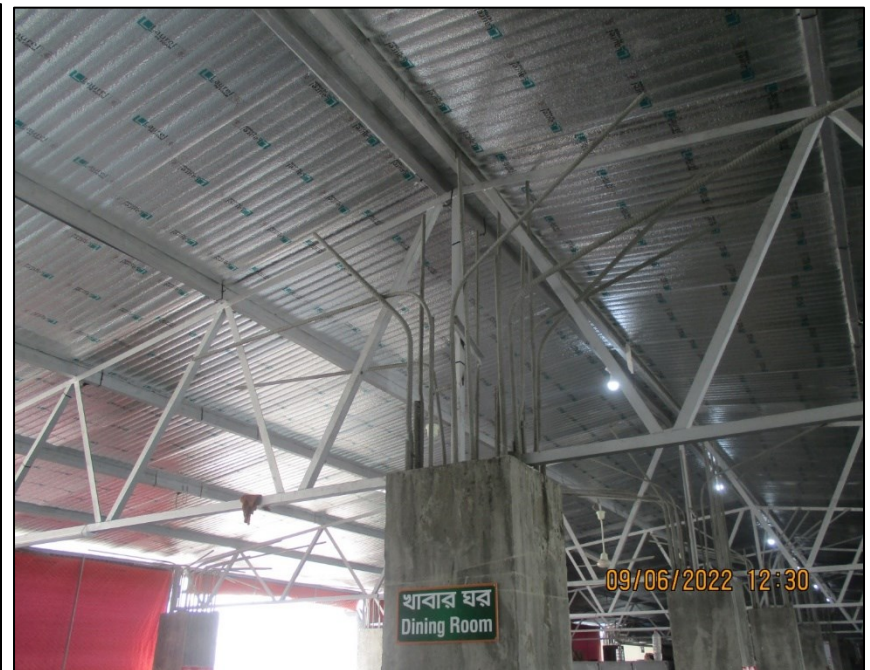
Poor connection details observed, truss welded with column re-bar. Apparently inadequate truss member and lack of lateral stability system (no bracing and compression strut). Building engineer to check the connection & member adequacy and stability of the lightweight roof structure against lateral loading.

| Item No. | Observation | Recommended Action Plan | Recommended Timeline |
|---|---|---|---|
| 06 | Apparently non-engineered shed. (Production Building) | Building engineer is required to check the connection adequacy, member adequacy and lateral stability of the roof shed. Or replace the shed with an engineered structure. | 6-weeks |
| 07 | Apparently non-engineered shed. (Production Building) | Carry out remedial works where necessary. | 6-months |

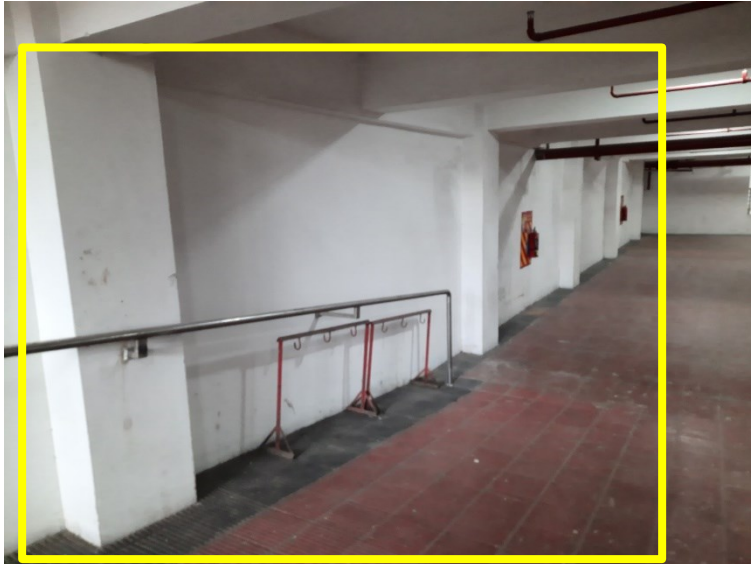
Columns at ramp area (semi-basement) are susceptible to impact loading from vehicles.

| Item No. | Observation | Recommended Action Plan | Recommended Timeline |
|---|---|---|---|
| 08 | Columns susceptible to impact loading (Production Building) | Building engineer is required to provide vehicle impact protection to the susceptible columns. | 6-weeks |

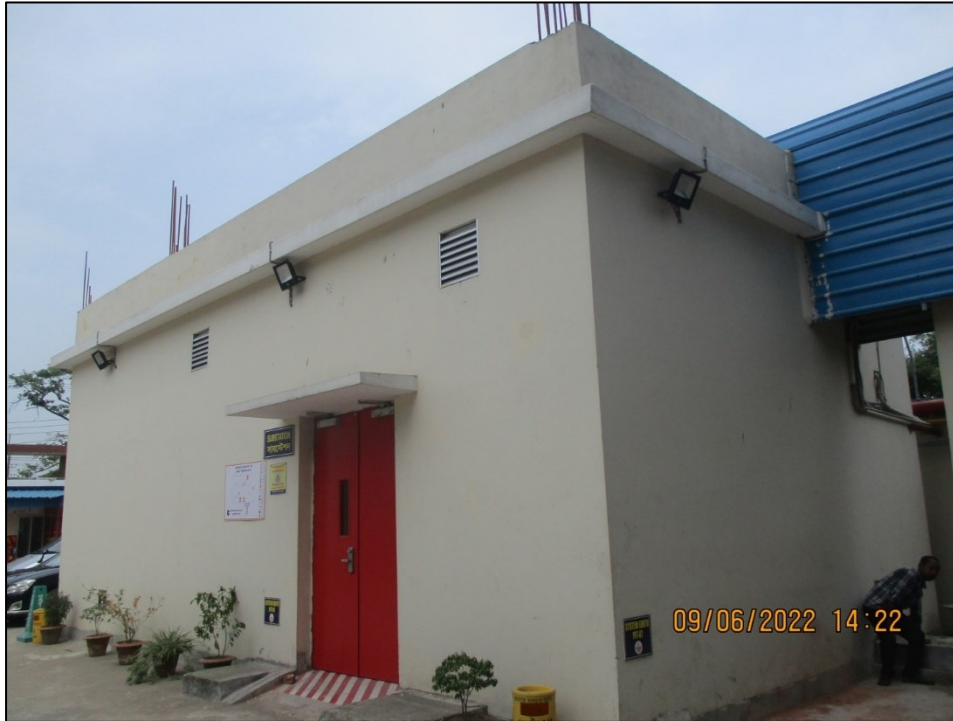
Sub-Station Building and Generator Building are single storied RCC building. Slab layout & details were missing in as built structural drawing. Factory is required to prepare accurate as built structural drawings.

| Item No. | Observation | Recommended Action Plan | Recommended Timeline |
|---|---|---|---|
| 09 | Lack of information in as-built drawings (Sub-Station Building & Generator Building ) | Building engineer is survey the whole structure and prepare accurate as-built drawings. | 6-weeks |
