# KARIM TEXTILES LTD (9297)

Noorbag, Kaliakoir, Gazipur  
(+23.817032N, 90.365189E)

31.MARCH.2014

# Identified Priority 1 Concerns

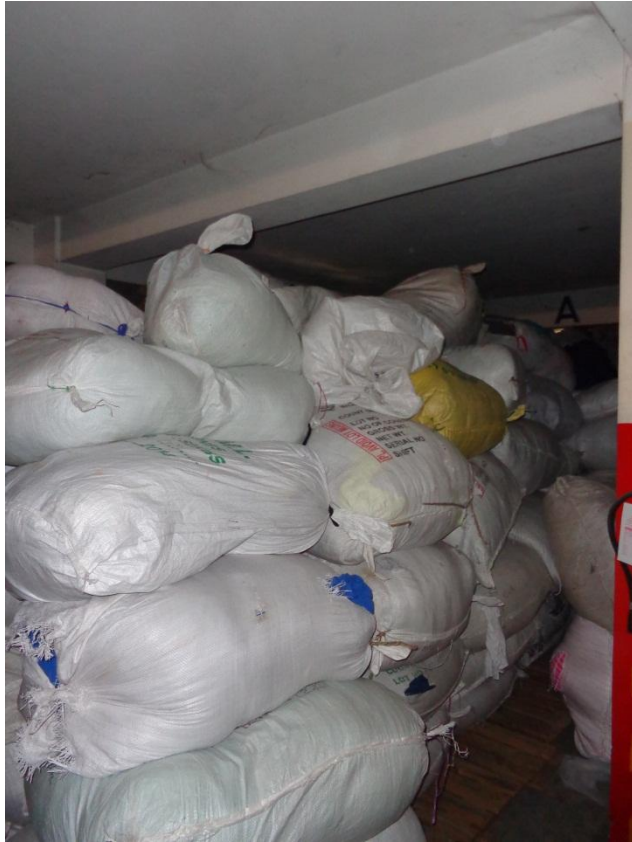
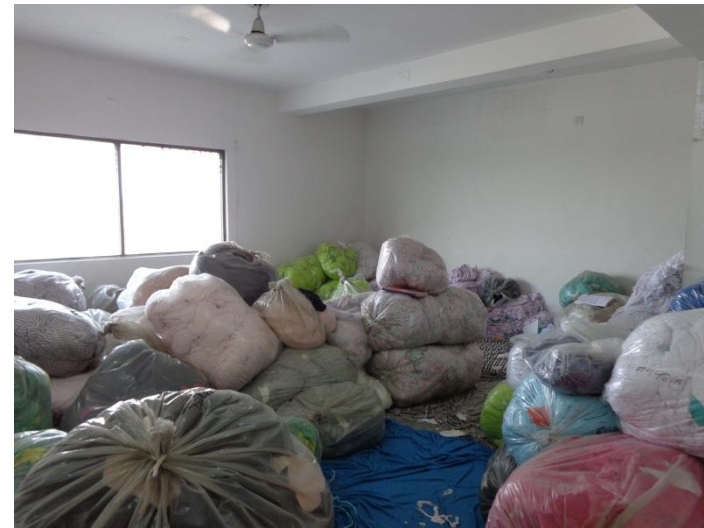
Excessive storage of boxes and fabric on levels 5 and 6.

Excessive Storage on levels 5 and 6

High storage and equipment loads on floors 5 and 6.

- Immediately reduce stacking height of boxes and fabric to ensure total load does not exceed 3.0kPa.

- Mark the maximum allowable height of fabric and box stacking to ensure full compliance with specified design loads.

- Produce and actively manage a loading plan, ensuring maximum height of storage is adhered to in the long-term.

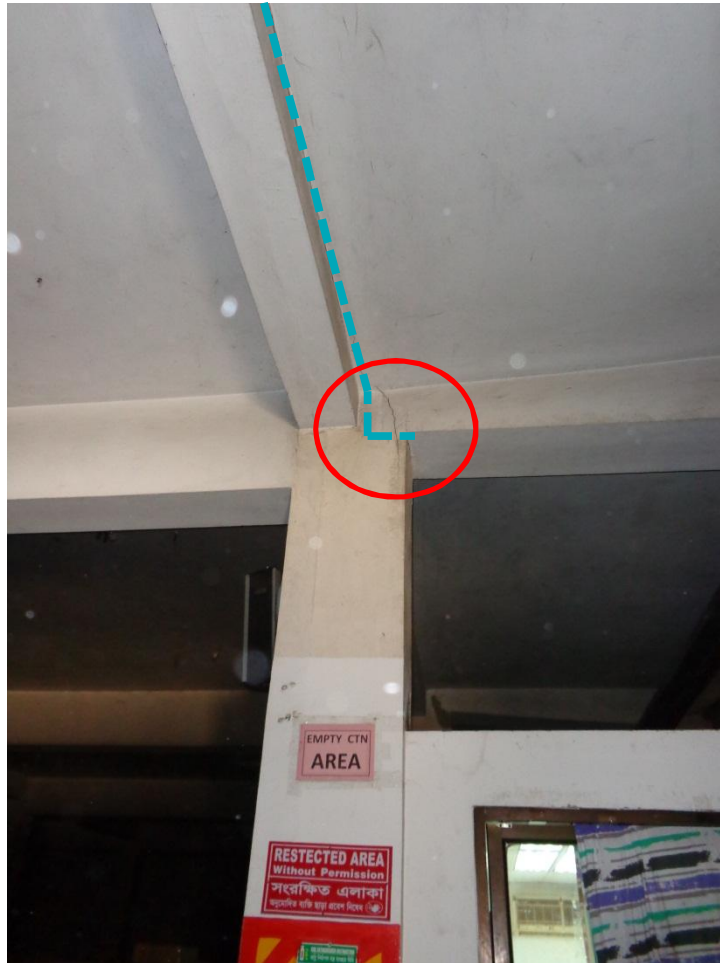
Due to the placement of the movement joint on the 1<sup>st</sup> floor slab, columns on the ground floor have been damaged.

The movement joint on the 1<sup>st</sup> floor has caused damages to the columns on the ground floor

- Repair the damage to the columns
- Install compressible material between the column and the overhanging slab to prevent future damage.

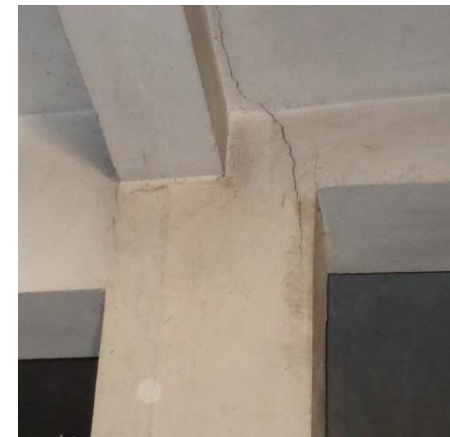
Column Stress

Based on the load run-down analysis following the agreed minimum design live load assignment, the columns' factor of safety falls between 1.5 and 1.86, giving a YELLOW warning. The building was constructed in year 2002, with brick aggregate, with total of 12 storeys (including roof and basement).

Preliminary load take-down calculations indicates that the columns factor of safety is between 1.5 and 1.86.

- Factory Engineer to review design, loads and columns stresses.
- Verify insitu concrete stresses by 100mm dia. cores from 4 typical internal columns.

- Produce and actively manage a loading plan for all floor plates within the factory giving consideration to floor capacity and column capacity.

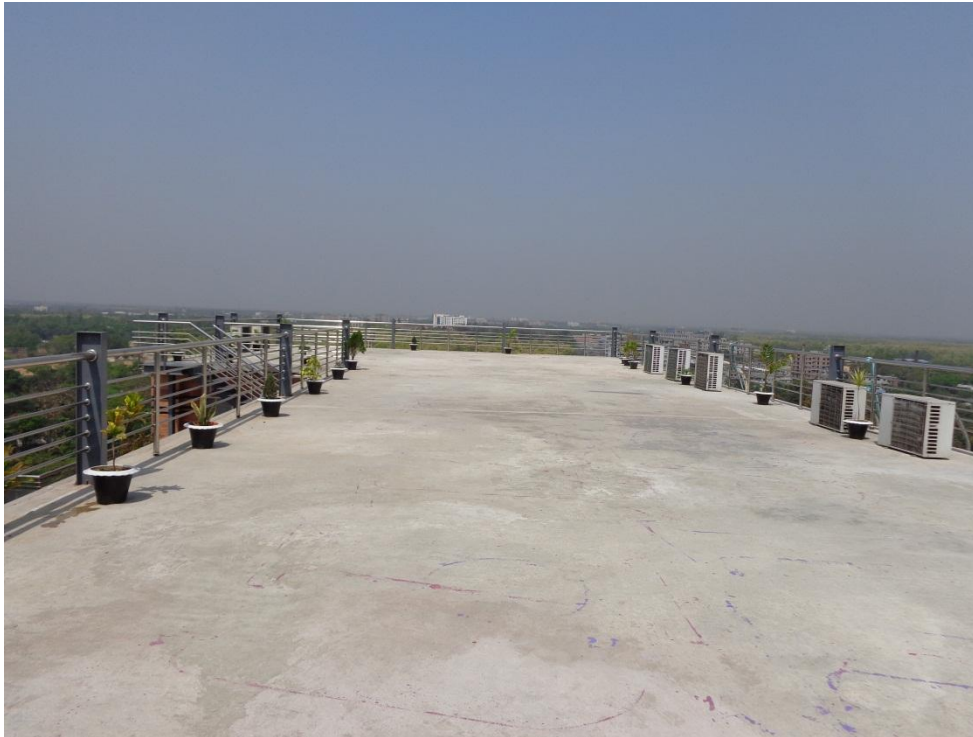
No waterproofing membrane was visible on the roof of the building. This means that any cracks in the surface finishes on the roof will allow water to seep into the concrete slab beneath the finishes, and cause long-term soaking of the slab.

**Roof Floor does not appear to have any waterproof membrane to protect lower floor from water damage**

Roof appears not to have any waterproofing system applied.

- Consider applying a new waterproofing membrane.
