# Islam Garments Ltd. (Knitwear Division)

Block-F, Holding # 119/1, Jarun, Konabari, Gazipur-1346, Bangladesh  
(23.996118N, 90.324504E)

20 June 2022

**Building-7:** Partially seven storied (G+M+6) reinforced concrete (RC) building.

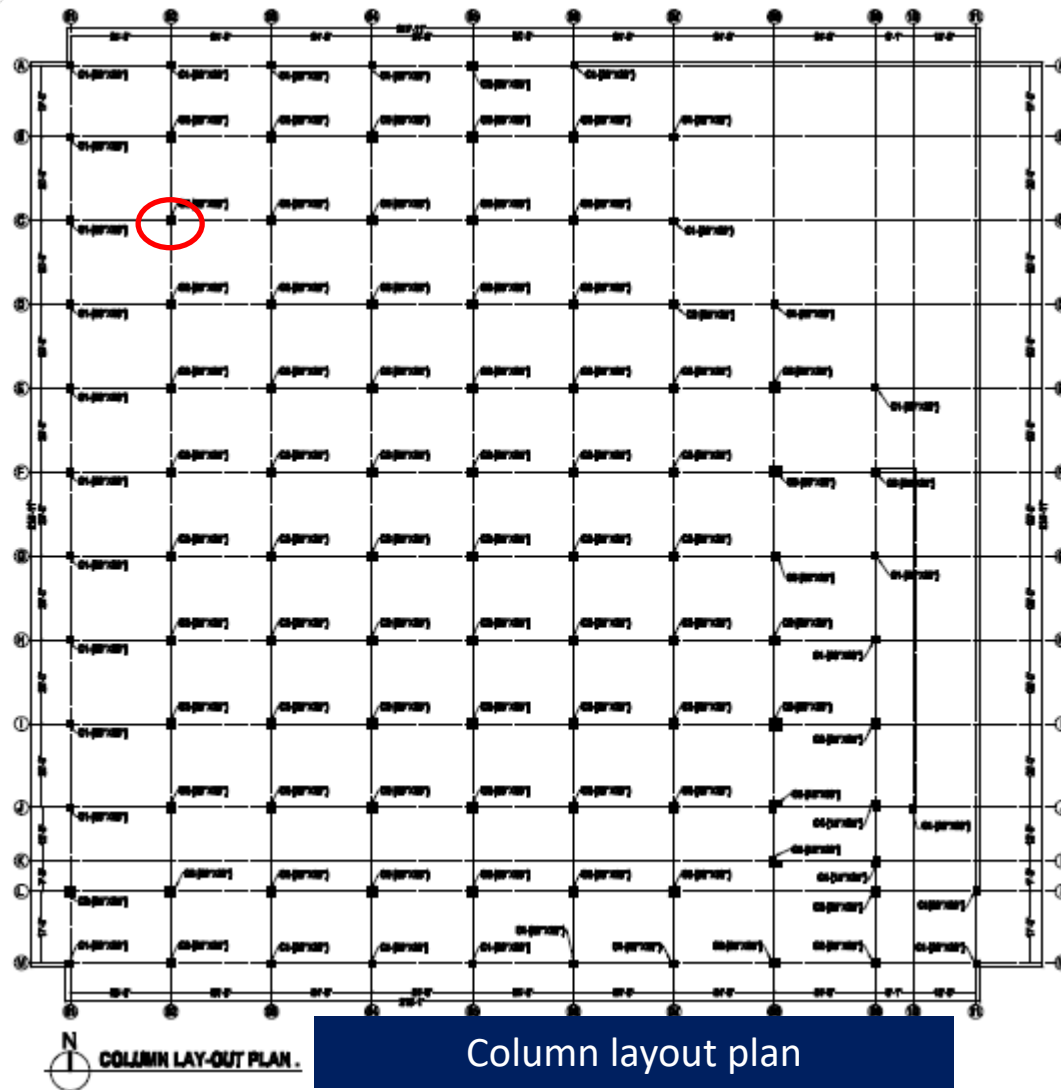
Column layout plan

**Column stress exceeds normal design limit**

Cursory calculation indicates that factor of safety (FoS) of column at north-west staircase is below the allowable limit considering the floor live load 3 kPa for typical floor, 4 kPa for stair area, 1.5 kPa for roof and super imposed load from brick walls and overhead water tank. Building engineer is required to review the design, loads and column stresses and suggest a proper remediation scheme.

| Item No. | Observation | Recommended Action Plan | Recommended Timeline |
|---|---|---|---|
| 01 | Column stress exceeds normal design limit. (Building-7) | As part of Engineering Assessment (EA) the building engineer is required to review the design, loads and column stresses and suggest a proper remediation scheme. | 6-weeks |
| 02 | Column stress exceeds normal design limit. (Building-7) | Verify in-situ material strength from column (by taking minimum 4 number of concrete cores). | 6-weeks |
| 03 | Column stress exceeds normal design limit. (Building-7) | Update the floor loading plan based on floor, column and foundation capacity of the structure. | 6-weeks |
| 04 | Column stress exceeds normal design limit. (Building-7) | Carry out suggested remedial actions where required. | 6-months |

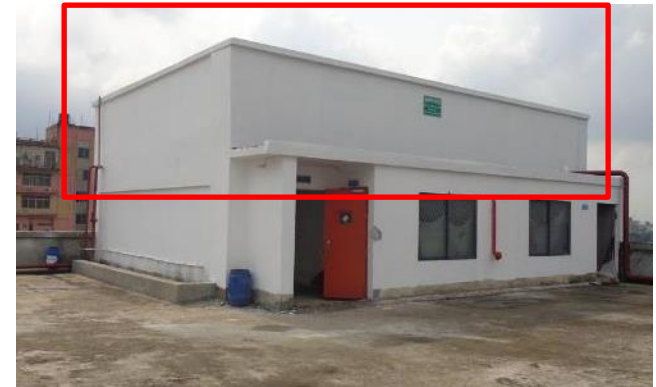
Load comes from the OHWT

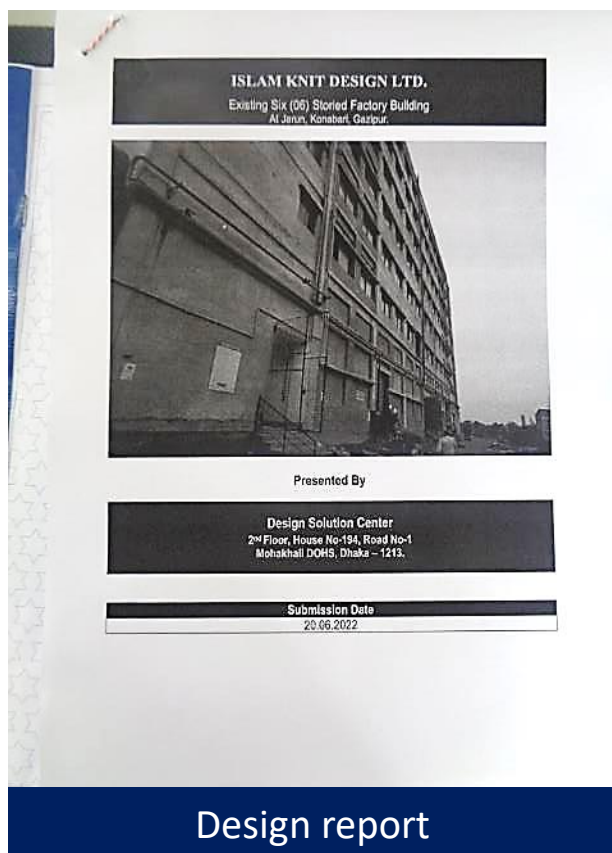
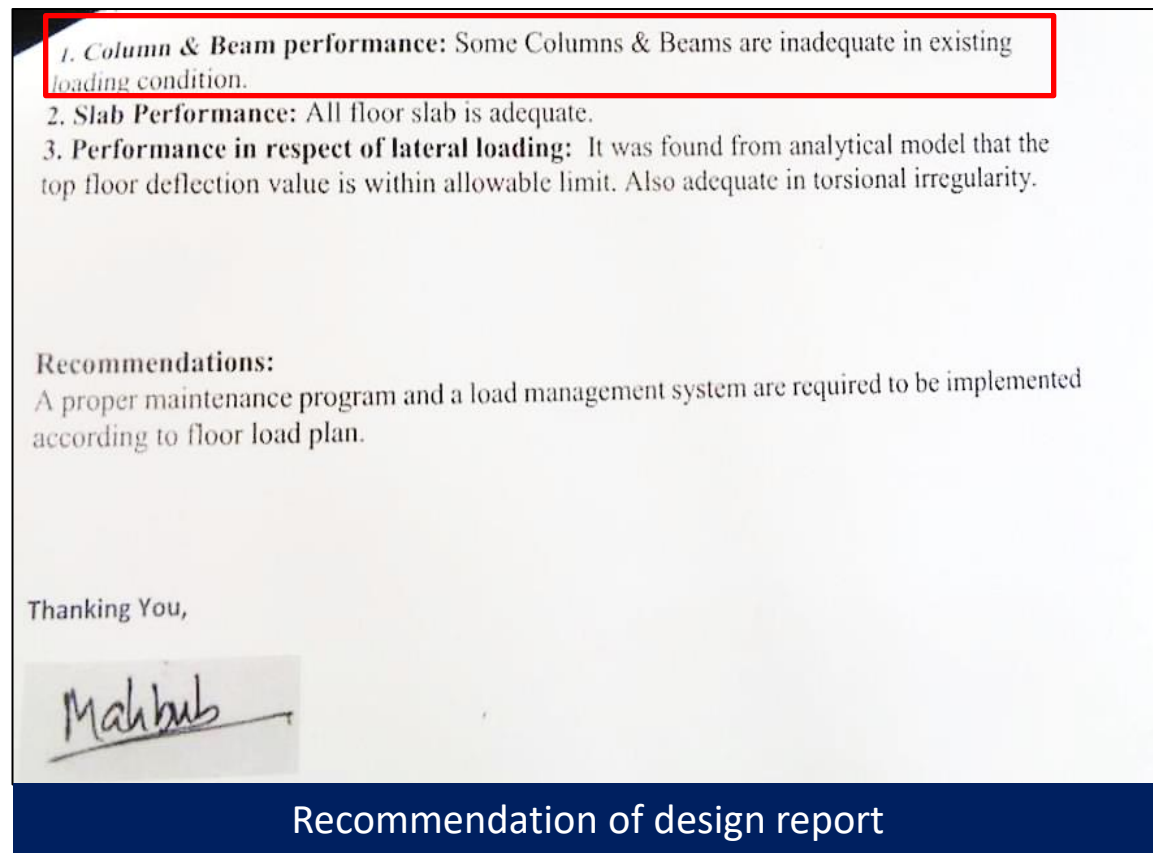
A copy of design report was found on-site. According to the observation of the report, some columns and beams are inadequate for existing loading condition. Building engineer is required to carry out Engineering Assessment (EA) of the structure to verify the columns actual stresses based in-situ material strength.

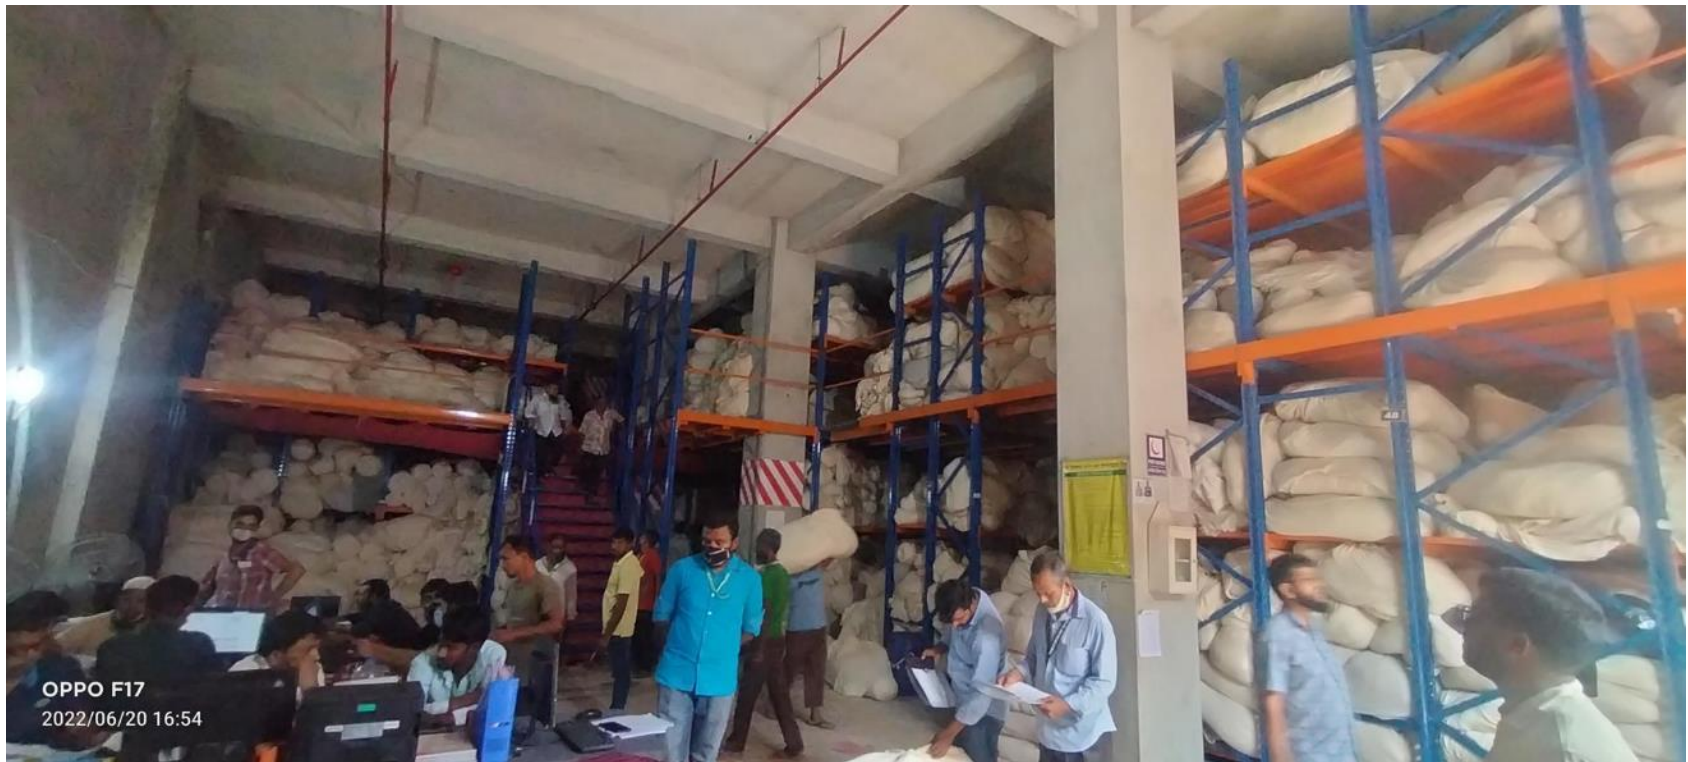
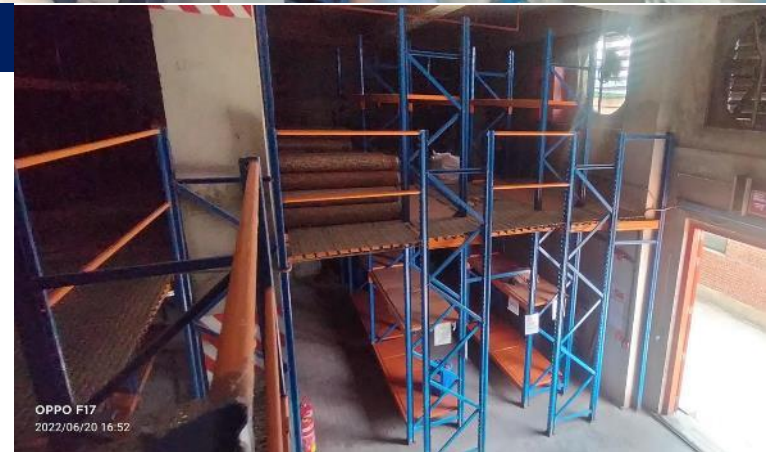
Steel storage rack and floor loading

No load plan was available for the steel racks, Building engineer is required to prepare floor loading plan for the steel racks based on its member and ground floor slab capacity.

| Item No. | Observation | Recommended Action Plan | Recommended Timeline |
|---|---|---|---|
| 06 | Lack of load plan for steel storage rack. (Building-7) | As part of Engineering Assessment (EA) the building engineer is required to prepare a floor loading plan based on members and foundation capacity of the steel rack. | 6-weeks |
| 07 | Lack of load plan for steel storage rack. (Building-7) | Continue to implement floor loading plan. | 6-months |

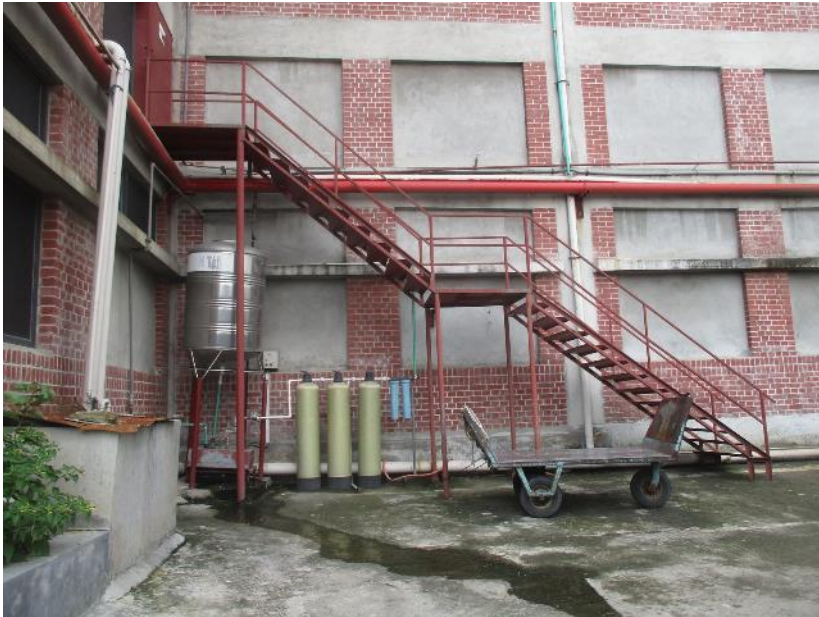
External steel stair adjacent to the Building-7

The external steel stair has no lateral stability system and the member & connections are apparently inadequate. The building engineer to check the stability system of the steel stair and suggest proper remedial actions.

| Item No. | Observation | Recommended Action Plan | Recommended Timeline |
|---|---|---|---|
| 07 | Lack of lateral stability of external steel stair. (Building-7) | As part of Engineering Assessment (EA) the building engineer is required to check the stability system of the structure and suggest remediation actions accordingly. | 6-weeks |
| 08 | Lack of lateral stability of external steel stair. (Building-7) | Carry out suggested remedial actions. | 6-months |

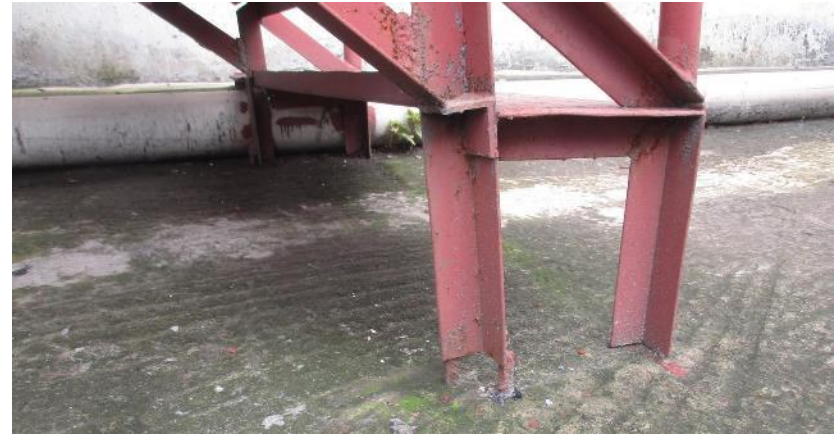
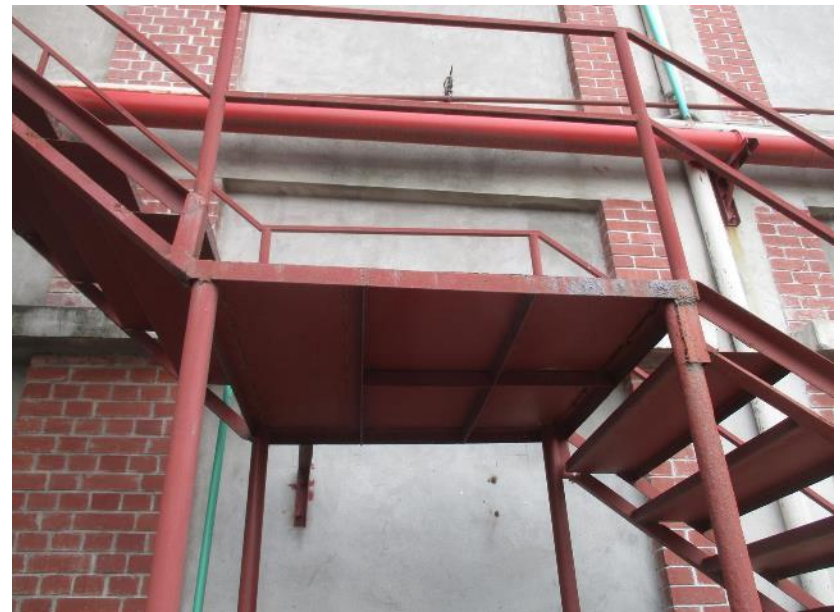
Poor connection of the external steel stair

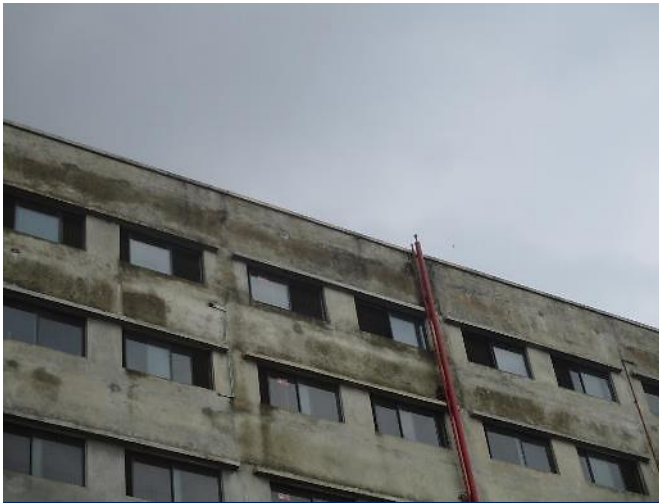
Dampness on exterior façade

Factory is required to repair the damped area with suitable method.

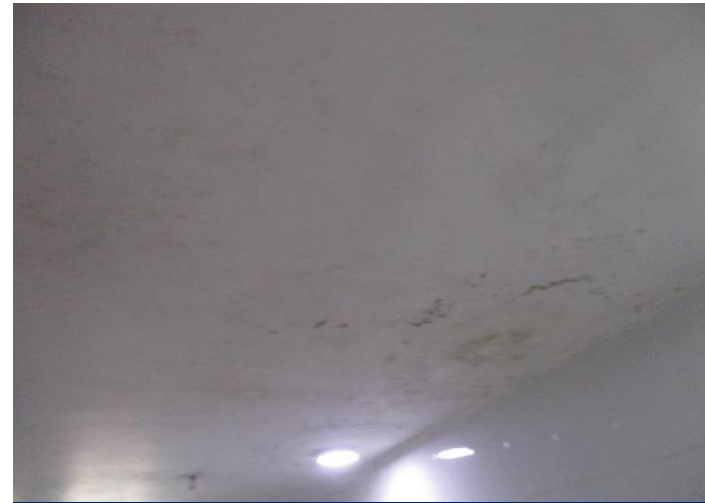
Dampness on soffit of toilet false slab

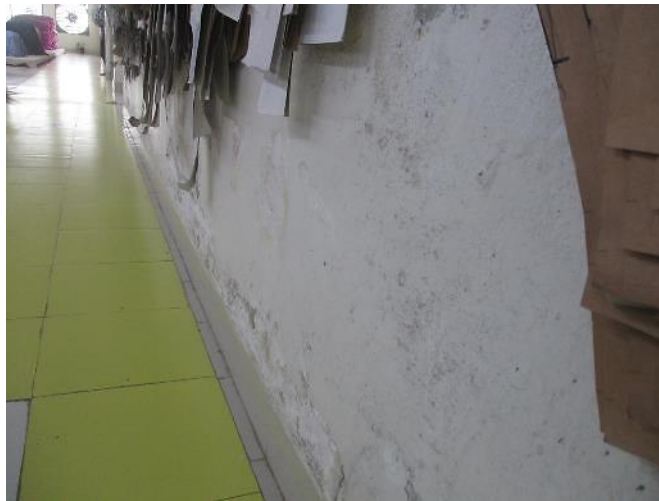
Dampness on wall of toilet zone

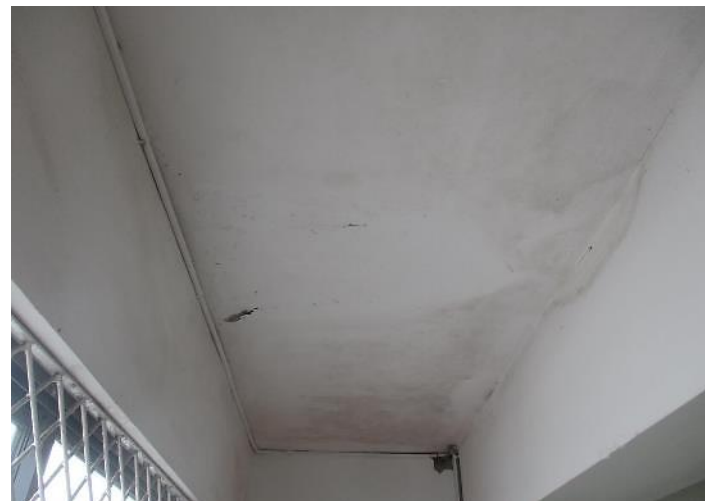
Dampness on soffit of stair roof slab

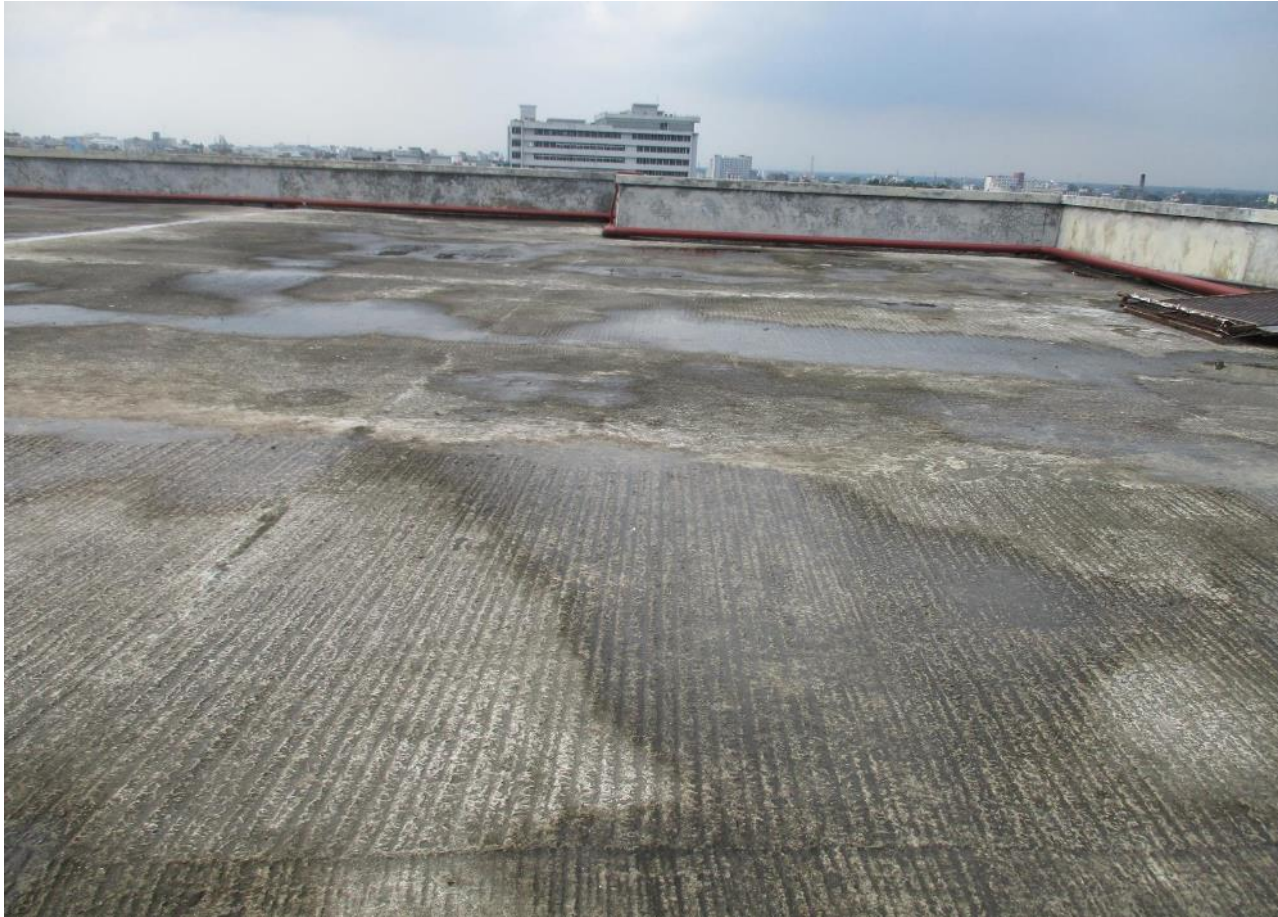
Stagnant water on the roof

Stagnant water on the roof was observed. The factory is required to develop proper drainage system on the roof with adequate slopping.

| Item No. | Observation | Recommended Action Plan | Recommended Timeline |
|---|---|---|---|
| 10 | Roof drainage system to be improved. (Building-7) | The factory is required to develop proper drainage system on the roof with adequate slopping. | 6-months |

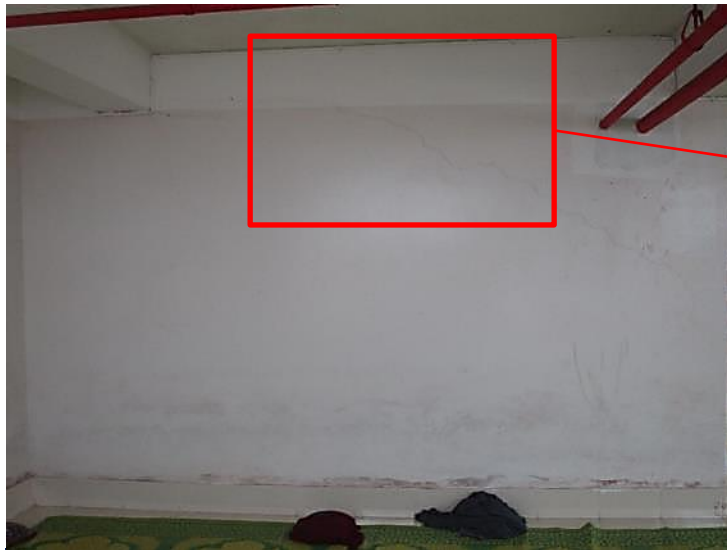
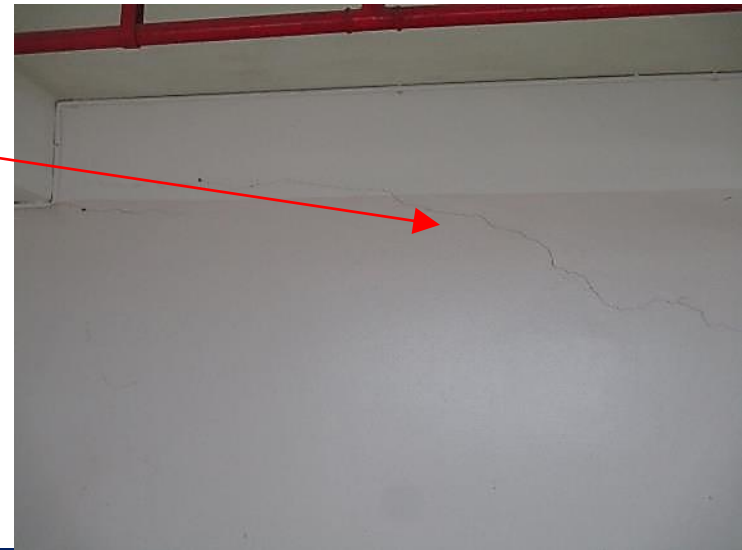
Crack on top floor brick walls of north-west stair

Crack on brick walls in two locations (north-west and north-east stair) . The factory is required to repair the cracks as per the suggestion of the building engineer.

| Item No. | Observation | Recommended Action Plan | Recommended Timeline |
|---|---|---|---|
| 11 | Crack on brick walls. (Building-7) | The factory is required to repair the cracks as per the suggestion of the building engineer. | 6-weeks |

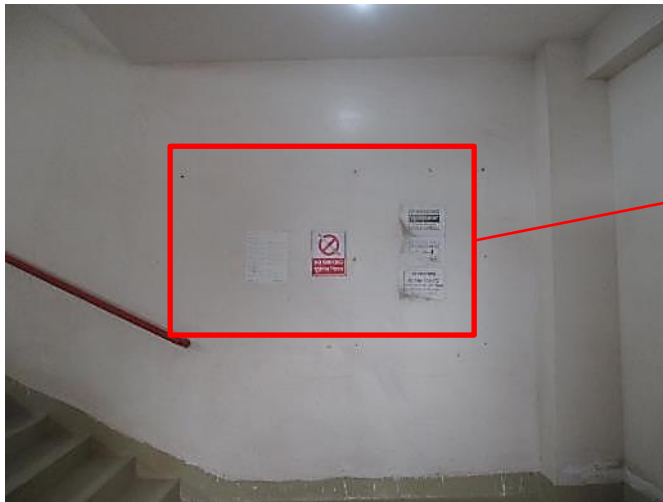
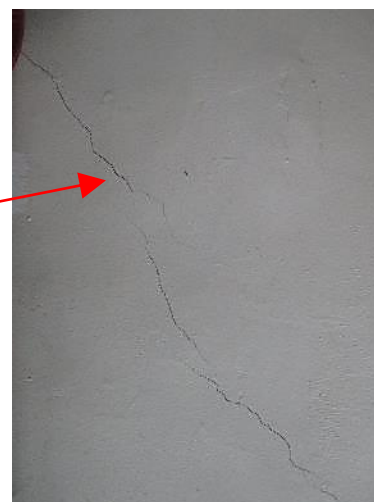
Crack on ground floor brick walls of north-east stair

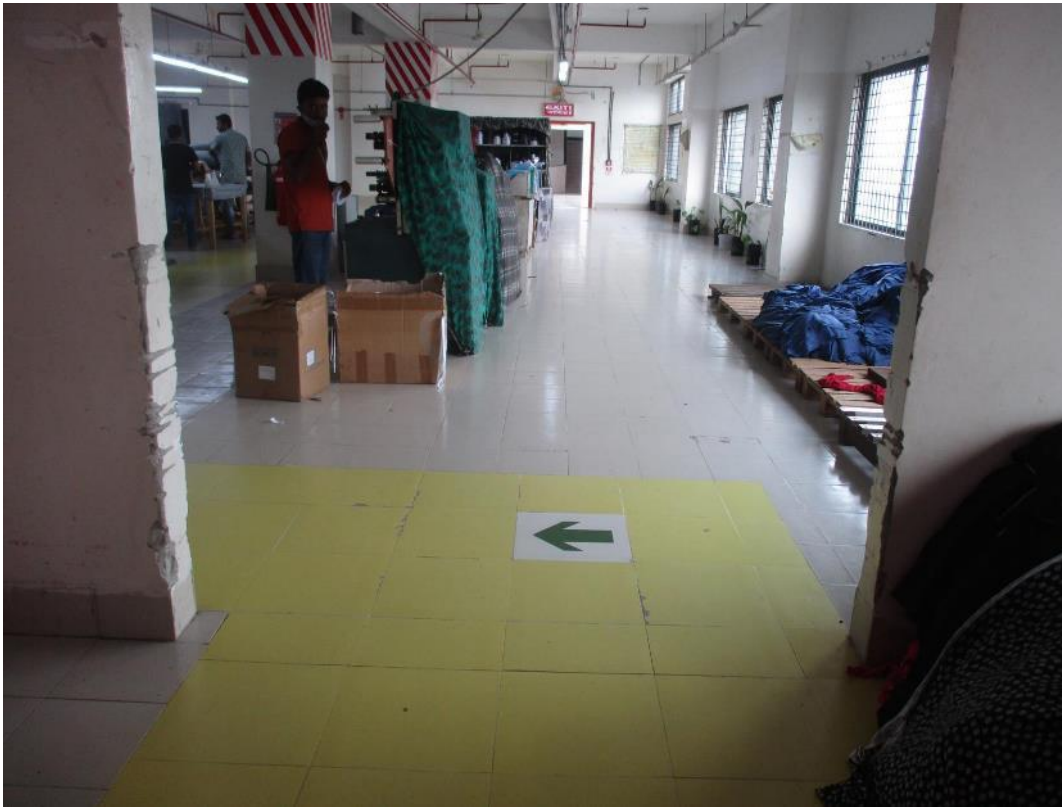
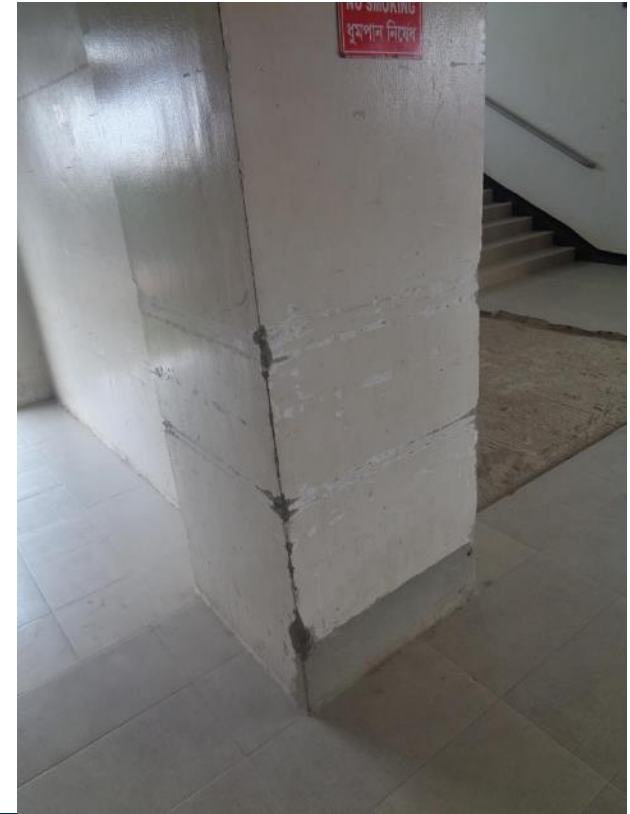
Damage of wall & column surface due to trolley impact

Factory is required to provide safety barrier to avoid trolley impact on the columns and walls.

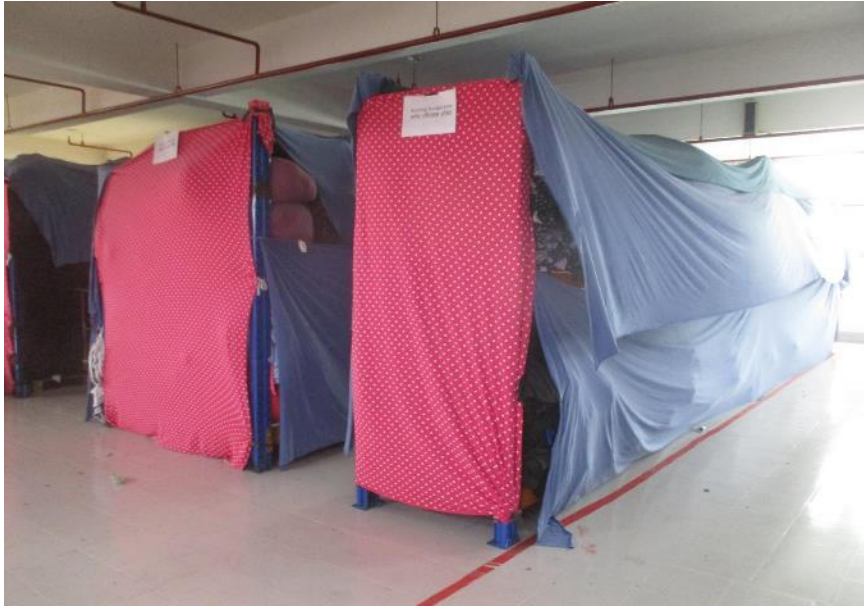
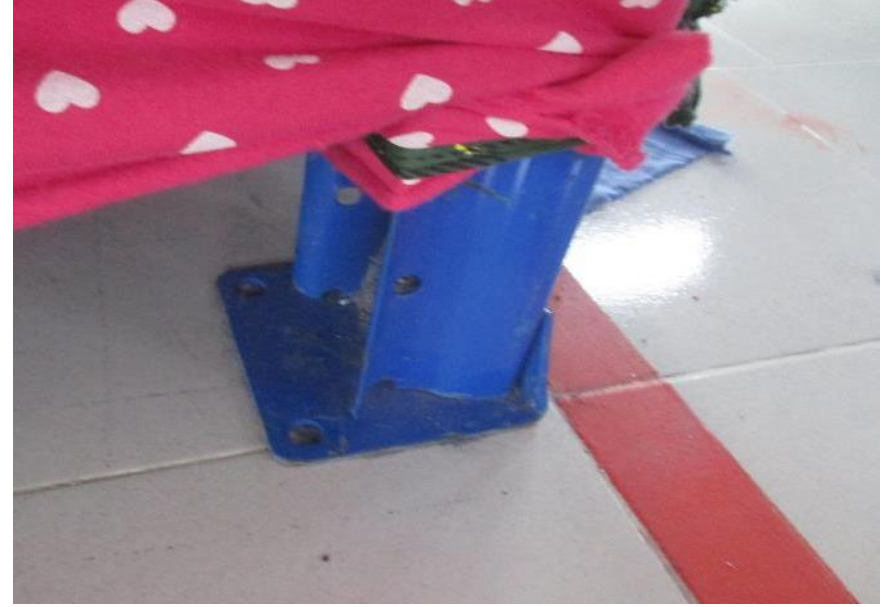
Storage racks on the typical floors are not adequately anchored or braced to resist earthquake forces.

Factory is required to anchored or braced properly all kinds of non-structural elements.

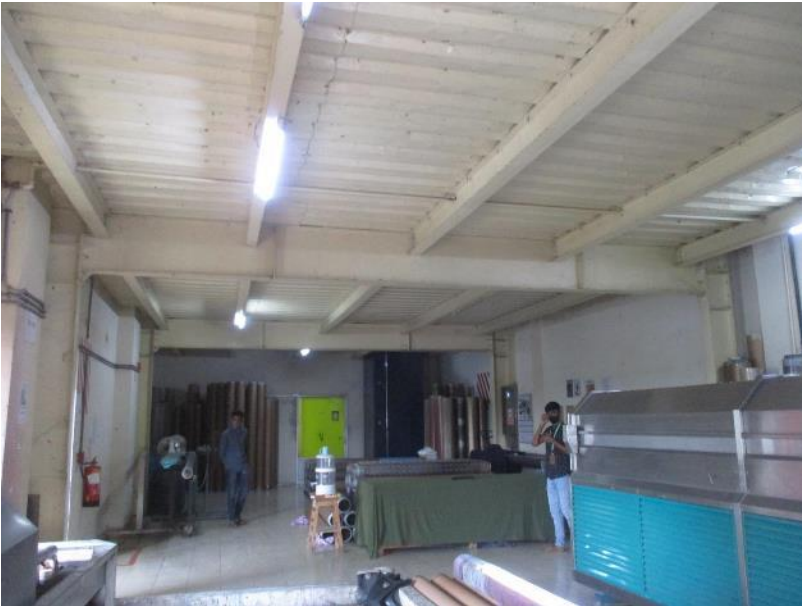
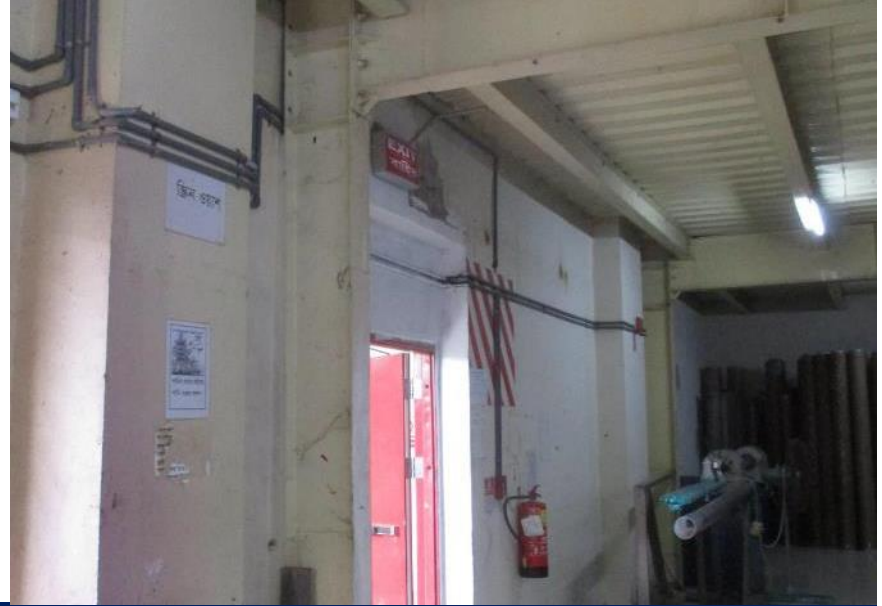
**Steel mezzanine floor- have no obvious lateral stability system**

Portal frame without lateral bracing along long direction.

Building engineer is required to check the stability system of the structure and suggest proper remedial actions accordingly.

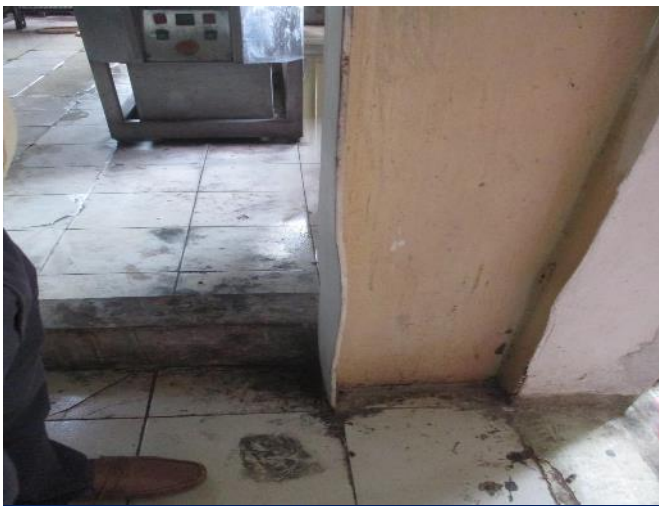
Distorted column

| Item No. | Observation | Recommended Action Plan | Recommended Timeline |
|---|---|---|---|
| 16 | Steel mezzanine floor- Distorted column, connection gap between joint plates, missing bolts and corrosion on steel columns. (Building-7) | Repair the distorted column as per the engineer's suggestion. | 6-weeks |

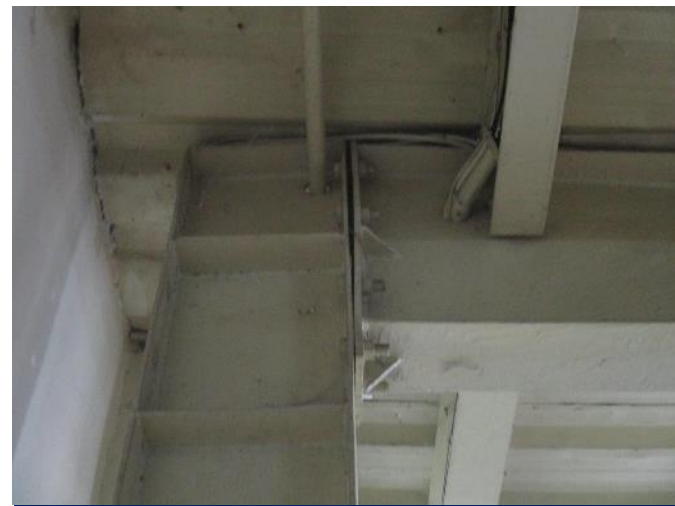
Connection gap

| Item No. | Observation | Recommended Action Plan | Recommended Timeline |
|---|---|---|---|
| 17 | Steel mezzanine floor- Distorted column, connection gap between joint plates, missing bolts and corrosion on steel columns. (Building-7) | Fill the connection gaps and install the missing bolts. | 6-weeks |

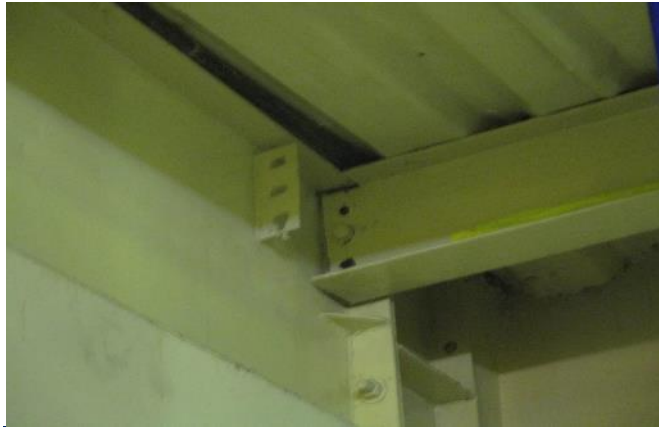
missing bolts

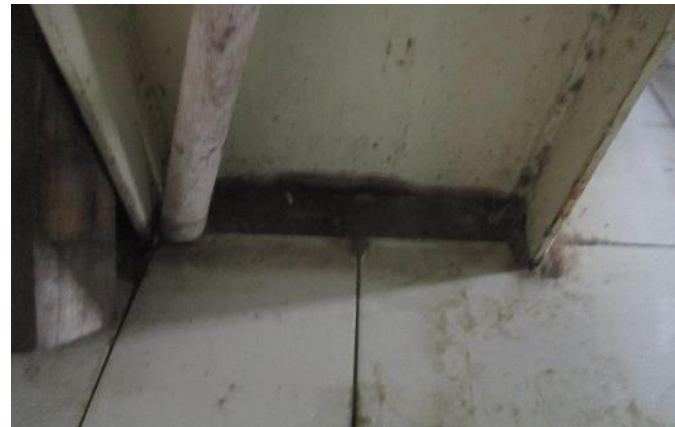
Corrosion on steel column

| Item No. | Observation | Recommended Action Plan | Recommended Timeline |
|---|---|---|---|
| 18 | Steel mezzanine floor- Distorted column, connection gap between joint plates, missing bolts and corrosion on steel columns. (Building-7) | Remove the corrosion & apply suitable corrosion resistance coating on the steel members. | 6-weeks |
