# Salman Adnan Ltd. Azim & Son Ltd.

35-B/1, Indira Road, Dhaka-1215  
(23.757772N, 90.385554E)

21<sup>st</sup> March 2015

# **Buildings 1A, 1B and 1C**

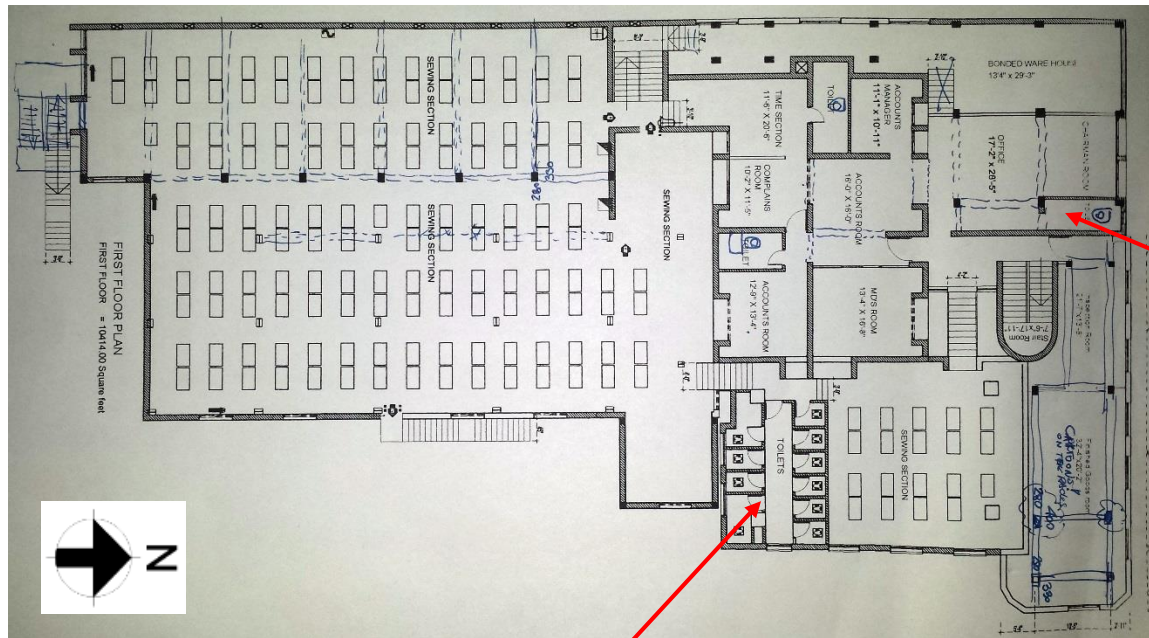
## **Heavy loads on floors**

| Item No. | Observation | Recommended Action Plan | Recommended Timeline |
|---|---|---|---|
| 1 | Buildings 1A, 1B and 1C - Heavy loads on floors | Building Engineer to review design, loads and slab stresses in all buildings. | 6-weeks |
| 2 | Buildings 1A, 1B and 1C - Heavy loads on floors | Produce and actively manage a loading plan for all floor plates within the factory, giving consideration to floor capacity and column capacity. | 6-months |

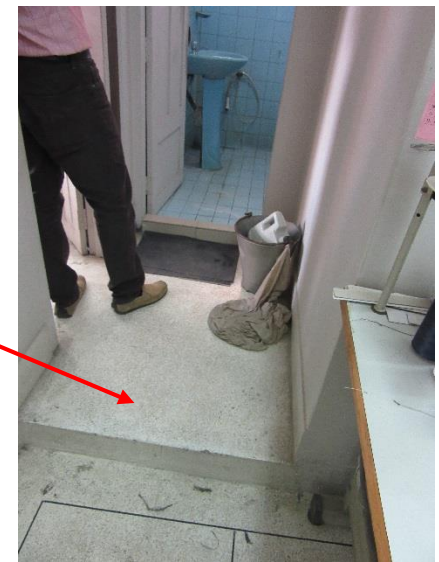
Build-up sin the toilet  
on 1<sup>st</sup> floor (90mm)

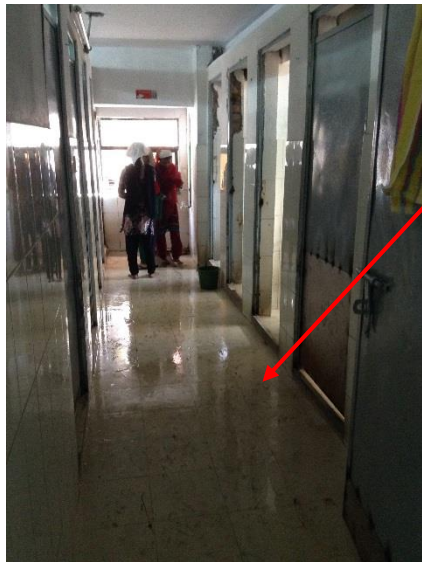
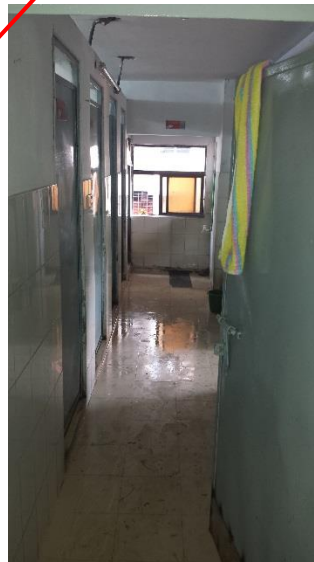
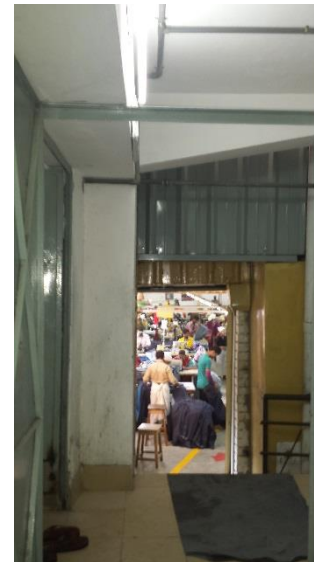
Build-ups in the toilets zones on 1<sup>st</sup> floor (70mm)

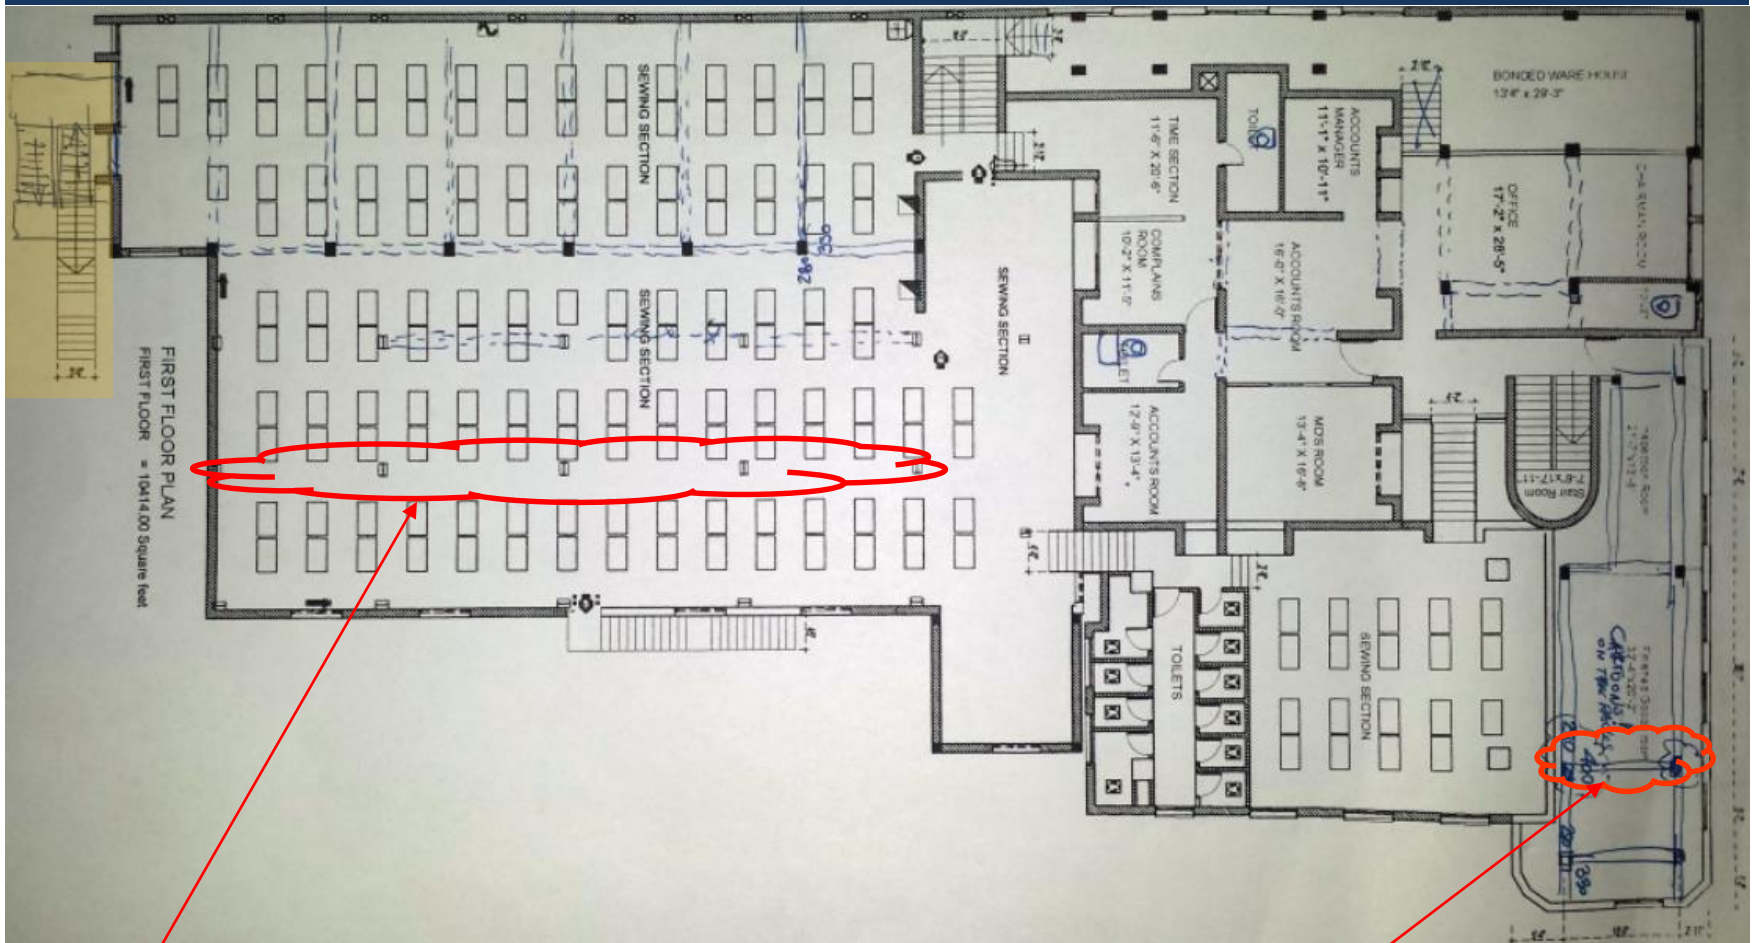
## Staircase

Columns not present on site

Missing columns on the plans

Differences between architectural “as-built” drawings and on site observation.

| Item No. | Observation | Recommended Action Plan | Recommended Timeline |
|---|---|---|---|
| 3 | All buildings - discrepancies on Permit drawings | Building Engineer to survey all buildings for correct structural layout and dimensions. | 6-weeks |
| 4 | All buildings - discrepancies on Permit drawings | Building Engineer to produce accurate as-built drawings for all buildings. | 6-months |
