# Masco Printing and Embroidery Ltd.

30<sup>th</sup> May 2022

# Building Information

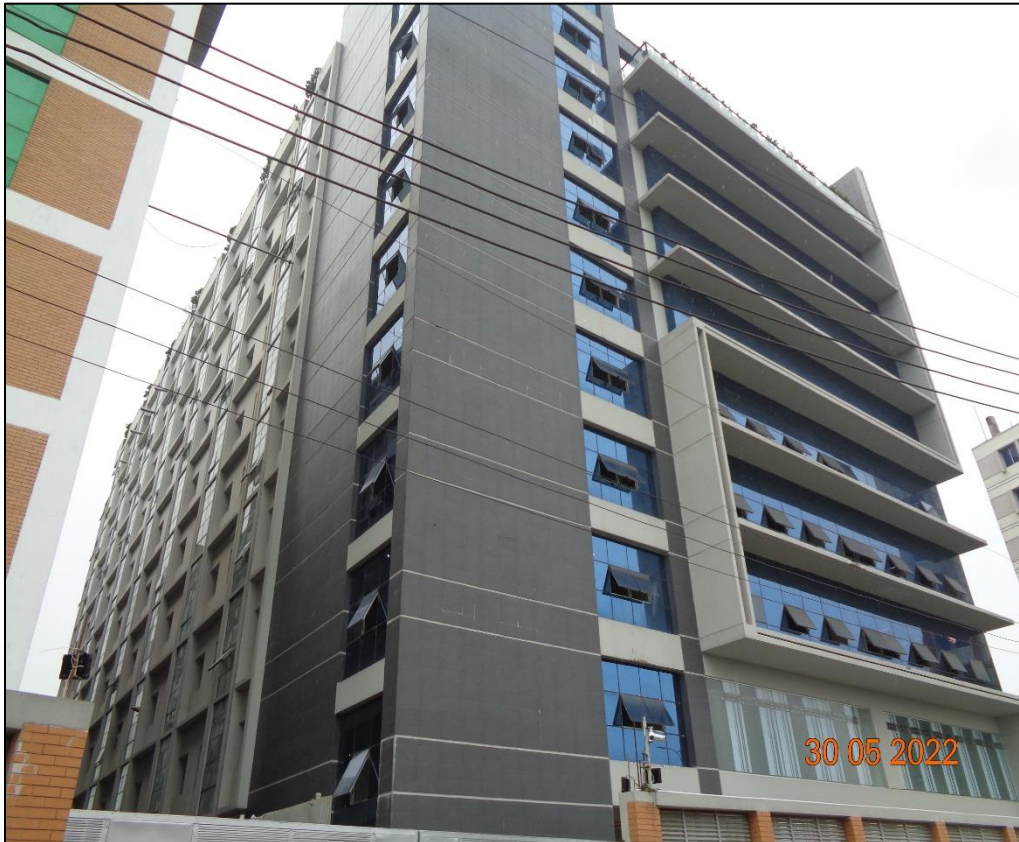
West and South elevation

**Design Report needs to be prepared**

As per BNBC, every building or structure designed shall have its design documents prepared in accordance with the provision of Section 1.9.1. The design document shall include a design report, and a set of structural drawings, which shall be prepared in compliance with section 1.9.1.1 and section 1.9.1.2 as per BNBC. At the time of inspection, only as-built drawing was available, but no design report was available which is required to be prepared in compliance with section 1.9.1.1 (part-6, BNBC).

| Item No. | Observation | Recommended Action Plan | Recommended Timeline |
|---|---|---|---|
| 01 | Design report needs to be prepared (Building-1) | Building engineer is required to prepare the design report in compliance with section 1.9.1.1 (part-6, BNBC). | 6-weeks |

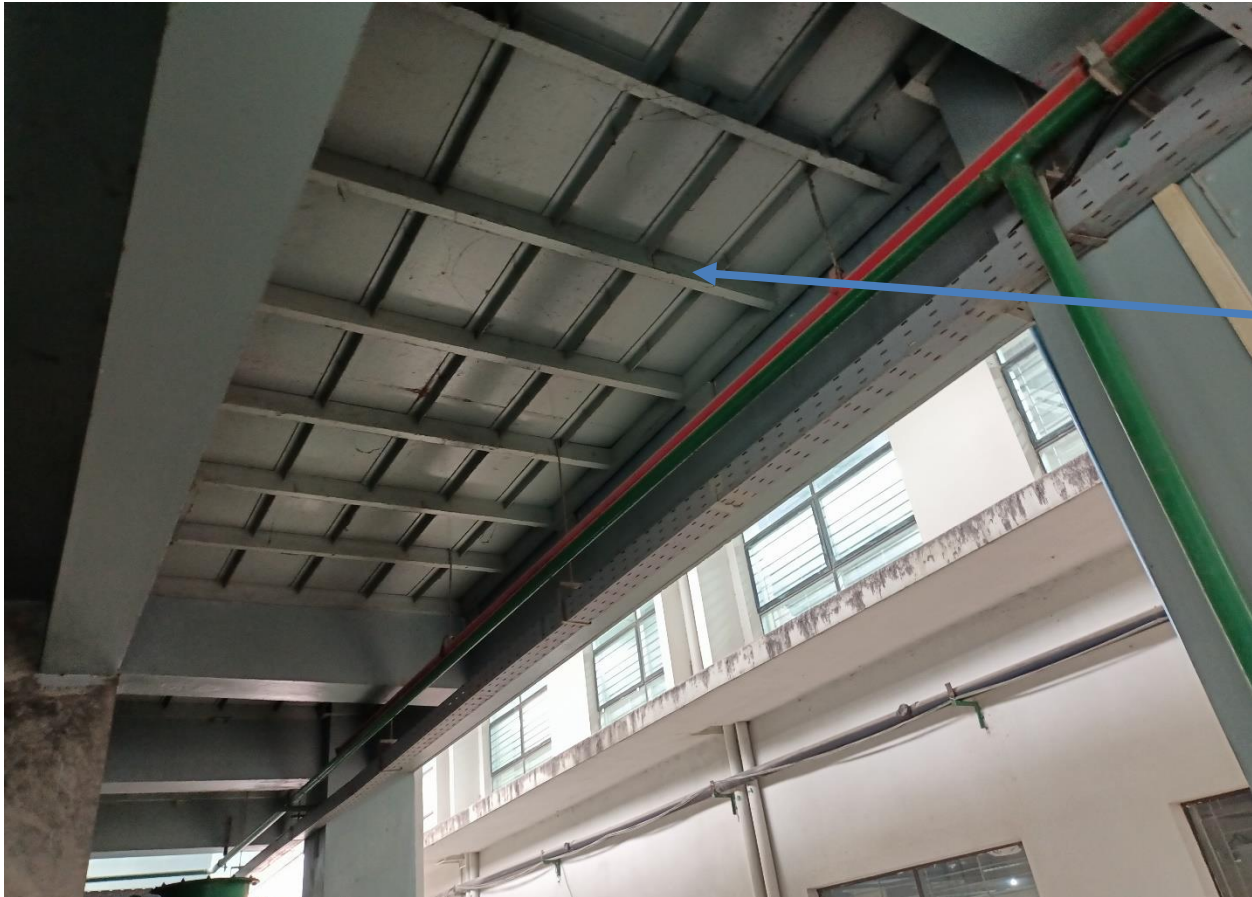
An undocumented steel deck slab was found on 1<sup>st</sup> floor of Building-1 at ETP portion (Single bay) . The building engineer to survey the structure and prepare as-built structural drawings with clear connection details.

Undocumented Deck slab

| Item No. | Observation | Recommended Action Plan | Recommended Timeline |
|---|---|---|---|
| 04 | Lack of information in as-built drawing (Building-1) | The building engineer to survey the structure and prepare as-built structural drawings with clear connection details. | 6-weeks |

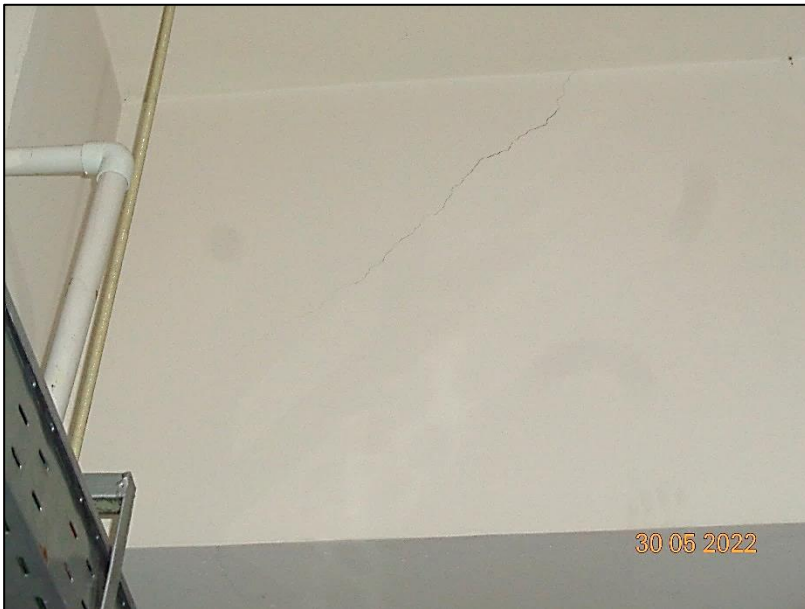
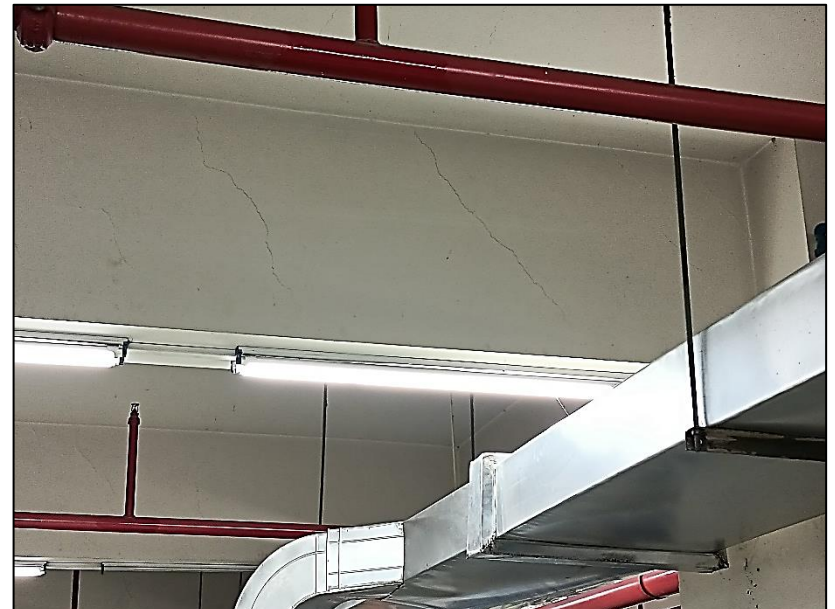
Cracks in several beam on 4<sup>th</sup> floor

Hairline cracks were found in several beam on 4<sup>th</sup> floor. Factory engineer is required to investigate the cracks, produce investigation report showing extent of cracks and repair methodology. Factory is required to repair the cracks as per crack investigation report.

| Item No. | Observation | Recommended Action Plan | Recommended Timeline |
|---|---|---|---|
| 05 | Hairline cracks on 4th floor beam (Building-1) | Factory engineer is required to investigate the cracks, produce investigation report showing extent of cracks and repair methodology. | 6-weeks |

| Item No. | Observation | Recommended Action Plan | Recommended Timeline |
|---|---|---|---|
| 06 | Hairline cracks on 4th floor beam (Building-1) | Factory is required to repair the cracks as per crack investigation report. | 6-weeks |

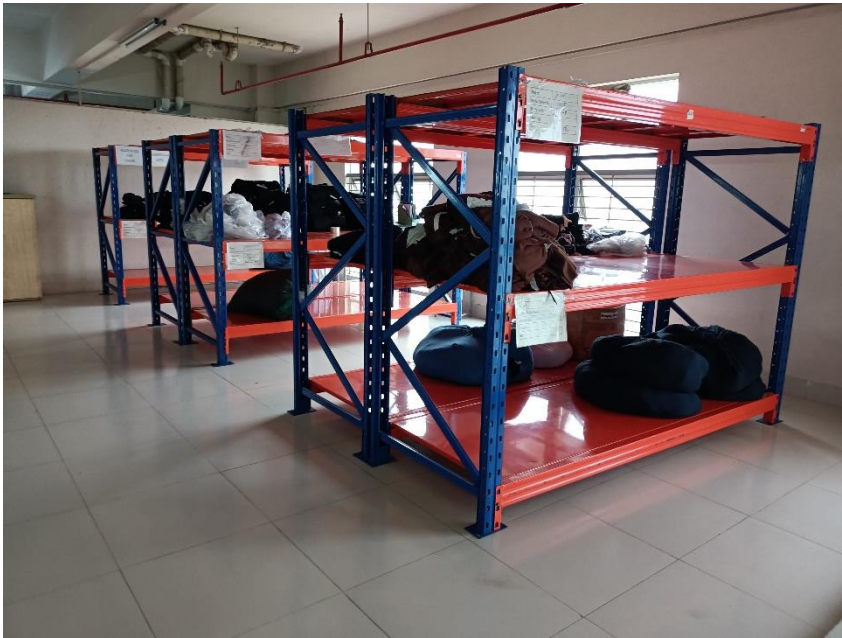
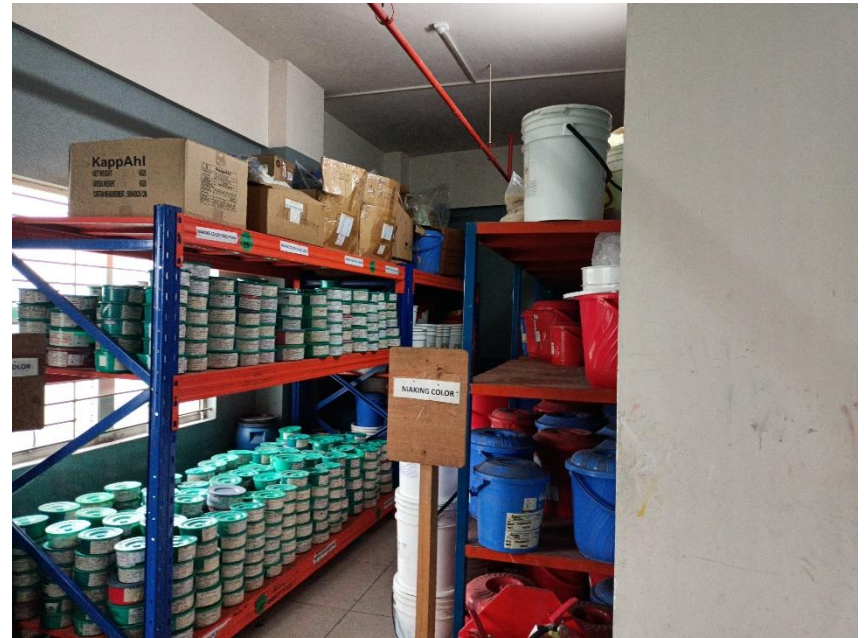
Racks on different floors are not adequately anchored or braced to resist earthquake forces. The factory engineer is required to anchor and brace all nonstructural elements of the building.

| Item No. | Observation | Recommended Action Plan | Recommended Timeline |
|---|---|---|---|
| 07 | Non-structural element not braced/anchored. (Building-1) | Adequately anchor and brace all non-structural elements of the building to resist earthquake forces. | 6-weeks |

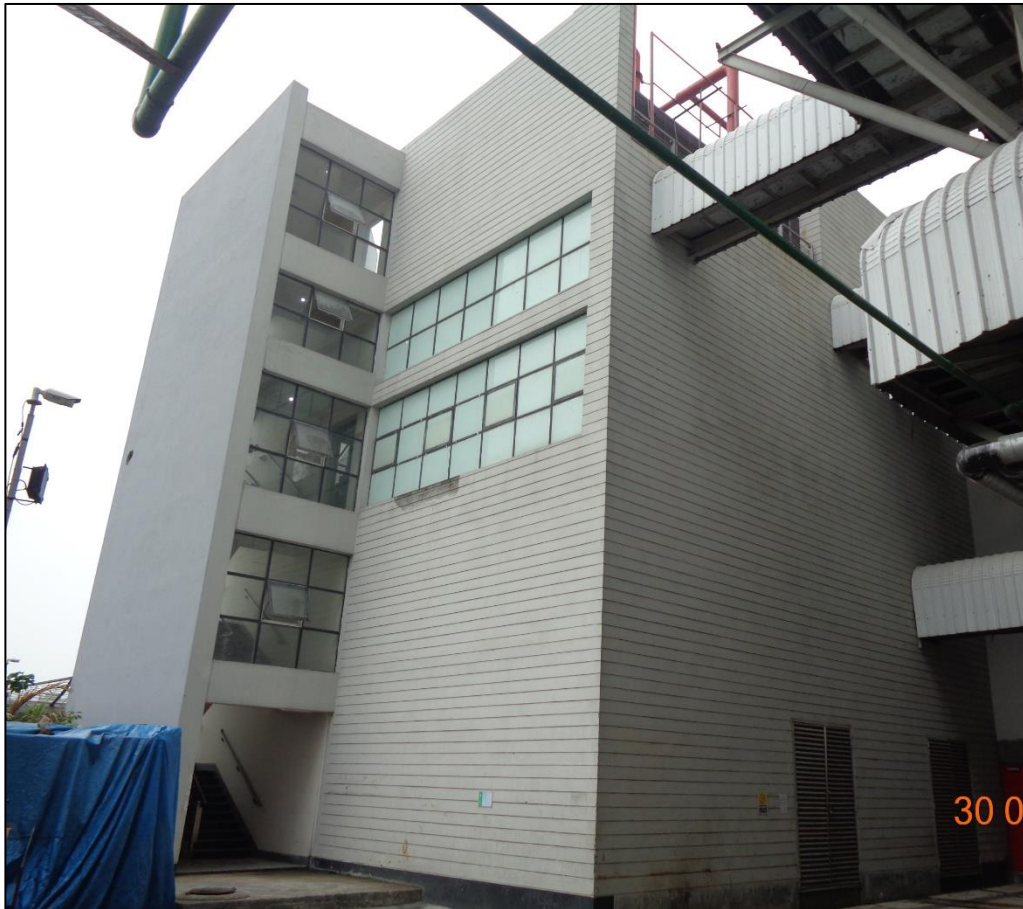
West and South elevation

**Design Report needs to be prepared**

As per BNBC, every building or structure designed shall have its design documents prepared in accordance with the provision of Section 1.9.1. The design document shall include a design report, and a set of structural drawings, which shall be prepared in compliance with section 1.9.1.1 and section 1.9.1.2 as per BNBC. At the time of inspection, only as-built drawing was available, but no design report was available which is required to be prepared in compliance with section 1.9.1.1 (part-6, BNBC).

| Item No. | Observation | Recommended Action Plan | Recommended Timeline |
|---|---|---|---|
| 08 | Design report needs to be prepared (Building-2) | Building engineer is required to prepare the design report in compliance with section 1.9.1.1 (part-6, BNBC). | 6-weeks |

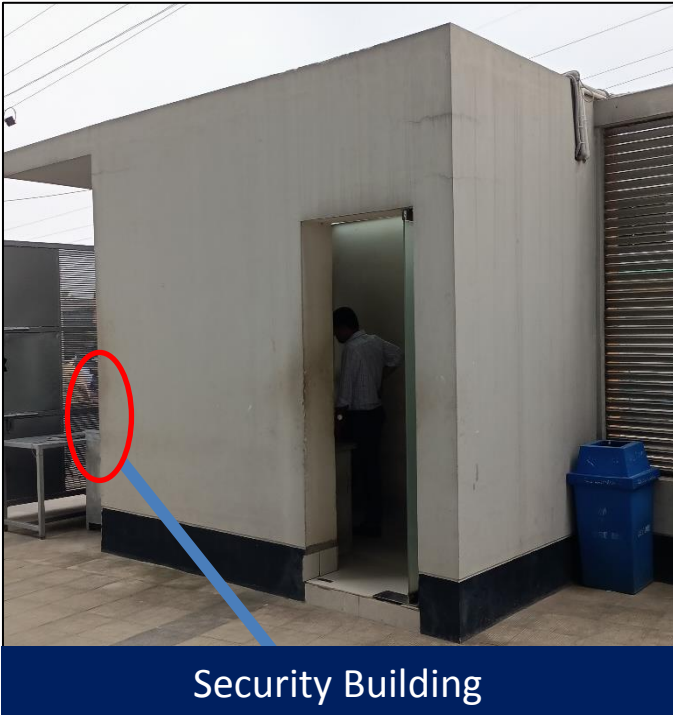
As per structural drawing, the Security Building is made of RC column but during on-site verification RC column was not found. The building is made of masonry brick wall. The building engineer to survey the structure and prepare as-built structural drawings.

Masonry  
Brick Pier  
observed  
on-site.

| Item No. | Observation | Recommended Action Plan | Recommended Timeline |
|---|---|---|---|
| 11 | Mismatch in as-built drawing (Building-4) | The building engineer to survey the structure and prepare as-built structural drawings. | 6-weeks |
