# Modele De Capital Ind. Ltd.(Unit-2)

2 No, Hajiganj, Narayanganj, Dhaka, Bangladesh.

27 June 2022

# Observations

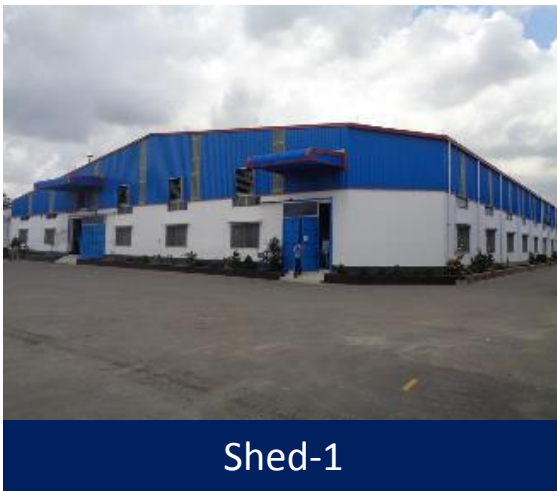
Shed-1

No design report is available for the structures (Shed-1, Shed-2, Shed-3, Shed-4 & Boiler room).

As per BNBC, every building or structure designed shall have its design documents prepared in accordance with the provision of Section 1.9.1. The design document shall include a design report, and a set of structural drawings, which shall be prepared in compliance with section 1.9.1.1 and section 1.9.1.2 of part-6, BNBC. However, design report was not available during inspection. The building engineer is required to prepare a design report in compliance with BNBC for all structures.

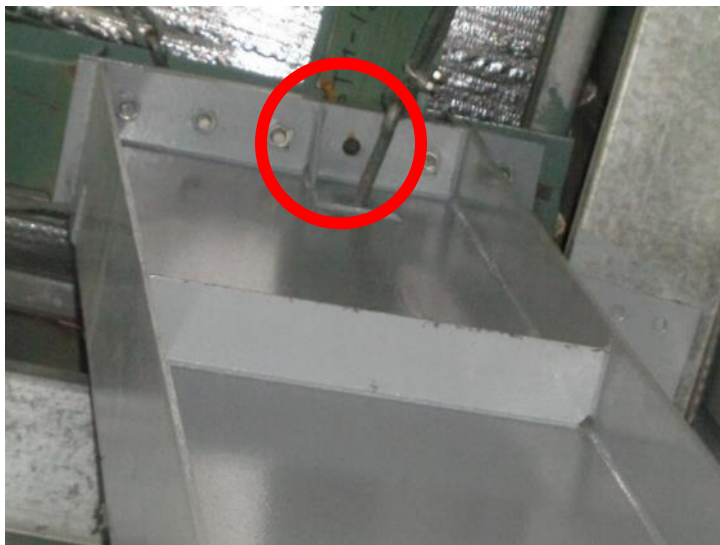
Missing bolts

Missing bolt, connection gap & rusty member were observed in the shed-1. Building engineer is required to install the missing bolts as per specification, fill the connection gaps by suitable repair method and apply anticorrosive coating on the steel members as per the suggestion of building engineer.

| Item No. | Observation | Recommended Action Plan | Recommended Timeline |
|---|---|---|---|
| 03 | Connection gap between joint plates, missing bolts and corrosion on steel columns. (Shed-1) | Install the missing bolts as per specification. | 6-weeks |

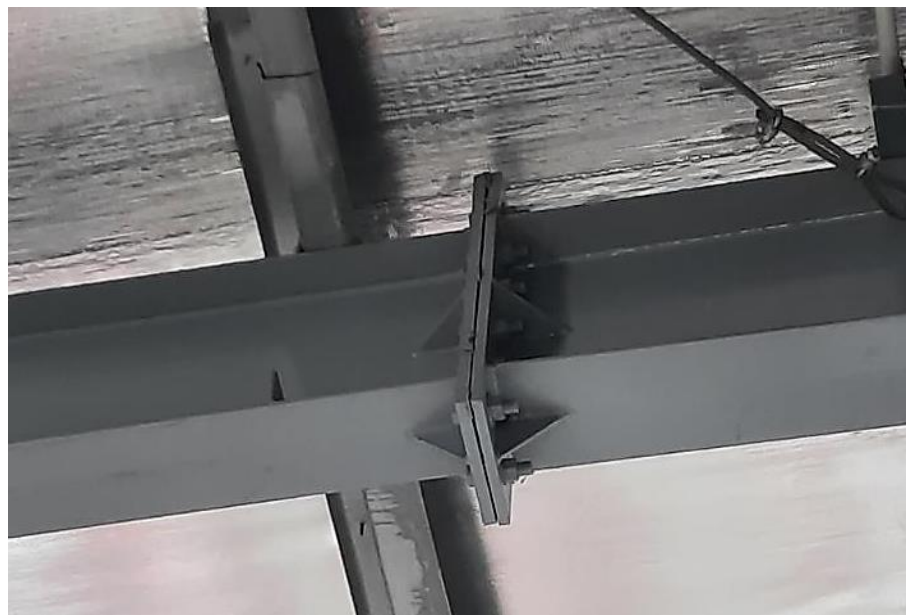
Connection Gap

| Item No. | Observation | Recommended Action Plan | Recommended Timeline |
|---|---|---|---|
| 04 | Connection gap between joint plates, missing bolts and corrosion on steel columns. (Shed-1) | Fill the connection gaps with suitable repair method. | 6-weeks |

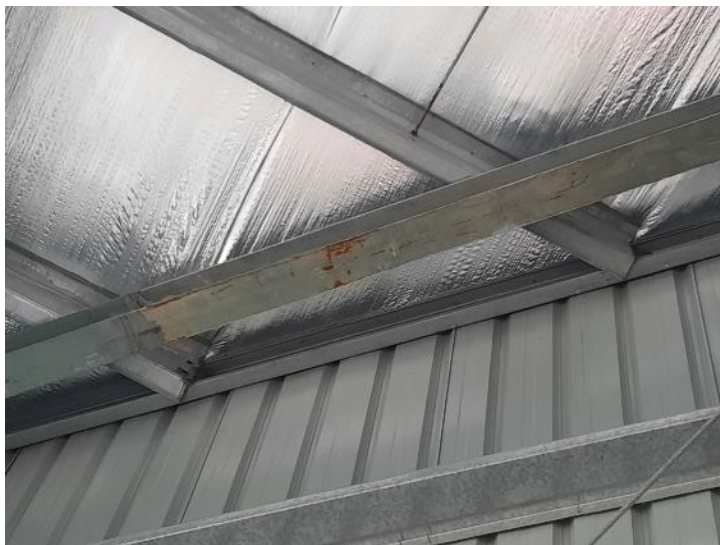
Corrosion on steel column

| Item No. | Observation | Recommended Action Plan | Recommended Timeline |
|---|---|---|---|
| 05 | Connection gap between joint plates, missing bolts and corrosion on steel columns. (Shed-1) | Remove the corrosion & apply suitable corrosion resistance coating on the steel members. | 6-weeks |

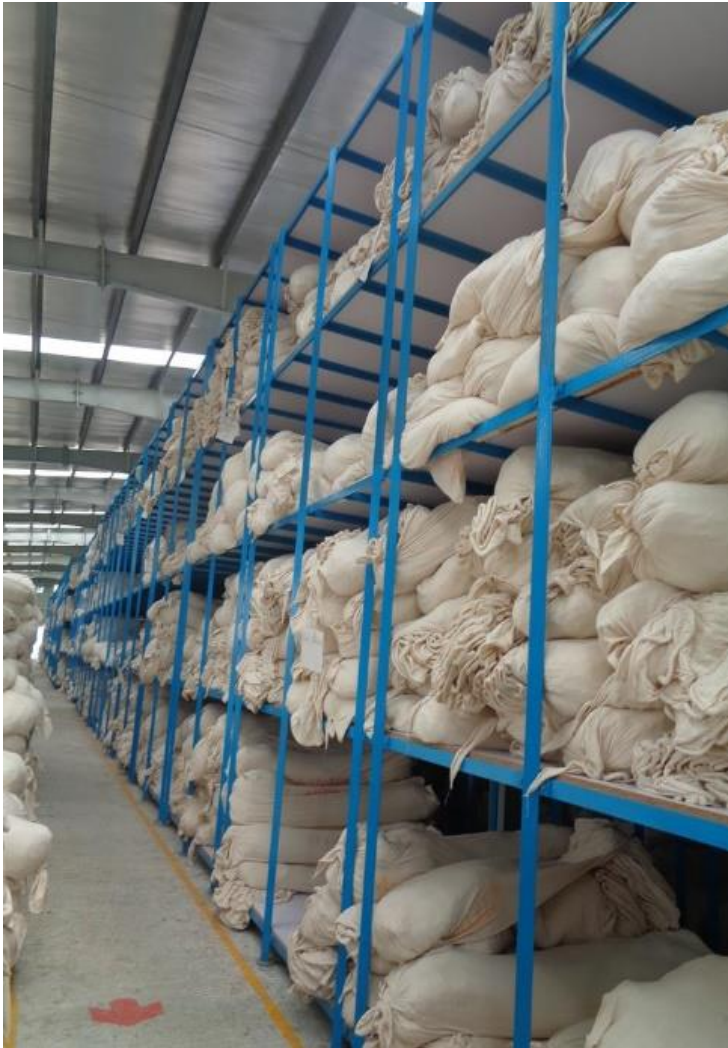
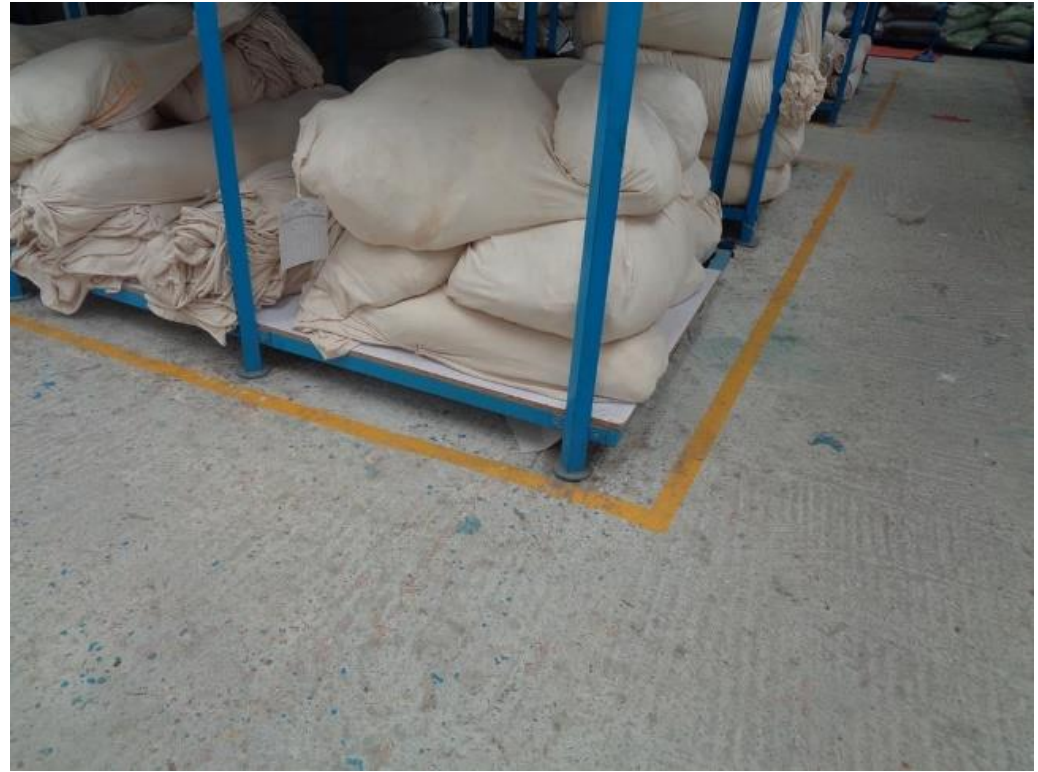
Storage rack at Shed-2

Storage racks were not anchored or braced to resist earthquake forces

Building engineer is required to anchor or brace properly all kinds of non-structural elements.

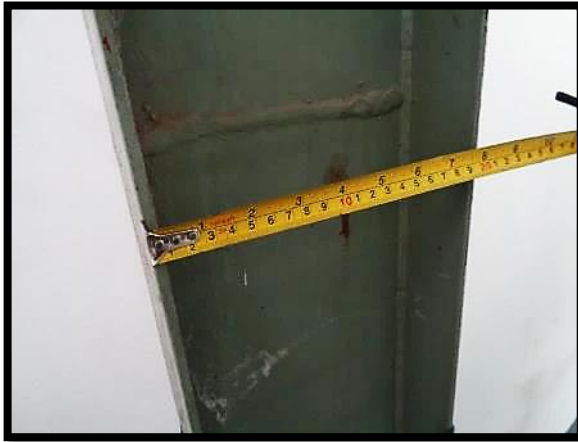
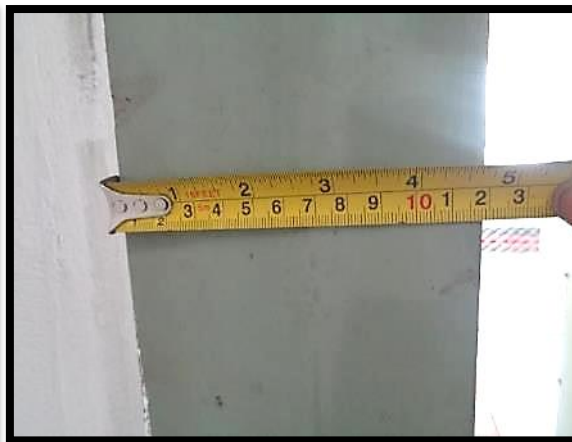
Steel column (SC-3) measured (F-120X8; W-195X8) instead of (F-135X8; W-210X8)

Discrepancy found between the as-built drawing and on-site condition. Building engineer is required to prepare accurate as-built drawing.

| Item No. | Observation | Recommended Action Plan | Recommended Timeline |
|---|---|---|---|
| 07 | Discrepancy between as-build drawing and on-site condition. (Shed-3) | Building engineer is required to survey the structure & prepare accurate as- built drawings with structural details. | 6-weeks |

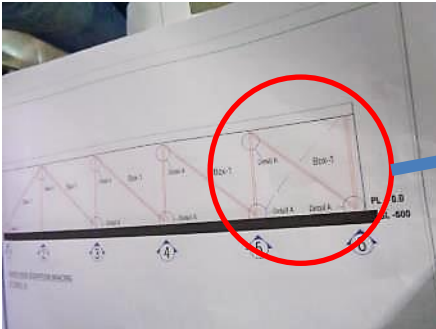
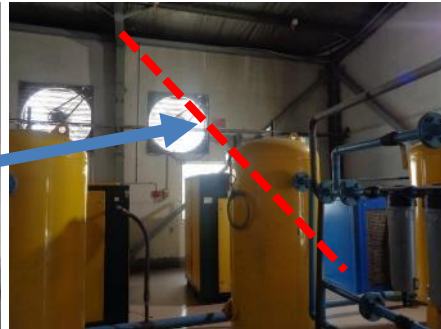
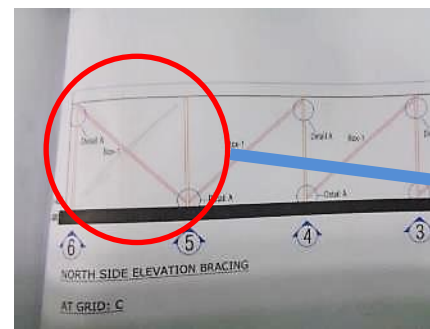
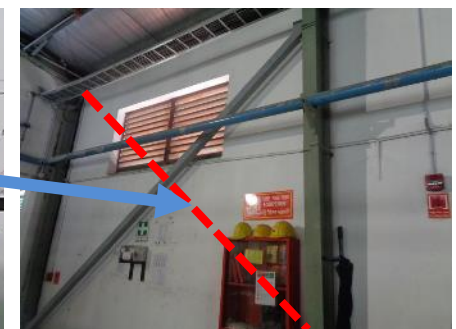
Mismatch observed in wall bracing arrangement

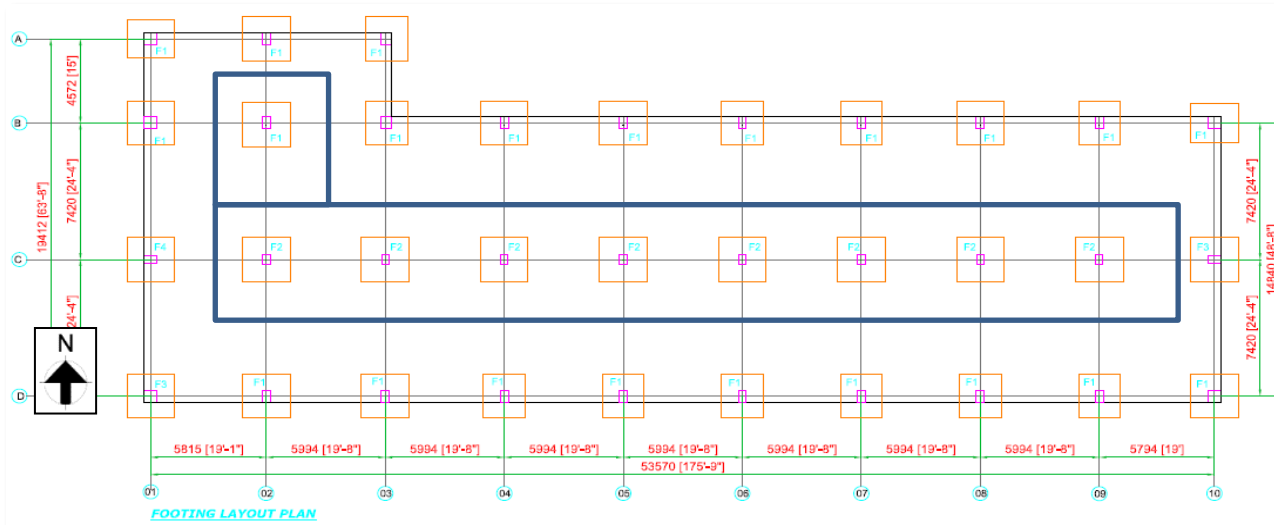
## Foundation layout plan Shed- 4

Cursory calculation indicates that the foundation stress exceeds the normal design limit for the internal footings. Considering prepared live load plan of 6 kPa and bearing capacity of foundation as per soil test report. The building engineer is required to review the design load and foundation stress.

| Item No. | Observation | Recommended Action Plan | Recommended Timeline |
|---|---|---|---|
| 08 | Bearing capacity of isolated footing below the normal design limit. (Shed-4) | Building engineer is required to review the design, load and foundation stress. | 6-weeks |
| 09 | Bearing capacity of isolated footing below the normal design limit. (Shed-4) | Verify and confirm the bearing capacity of the soil. | 6-weeks |
| 10 | Bearing capacity of isolated footing below the normal design limit. (Shed-4) | Carry out remedial works where necessary. | 6-Months |

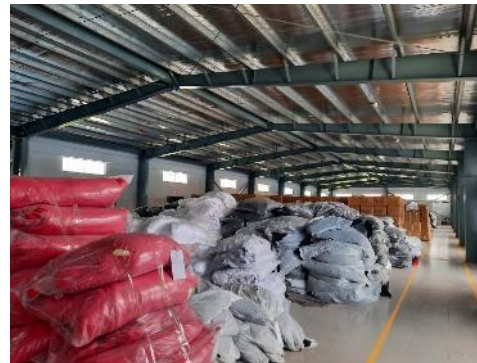
Typical storage loading on first floor

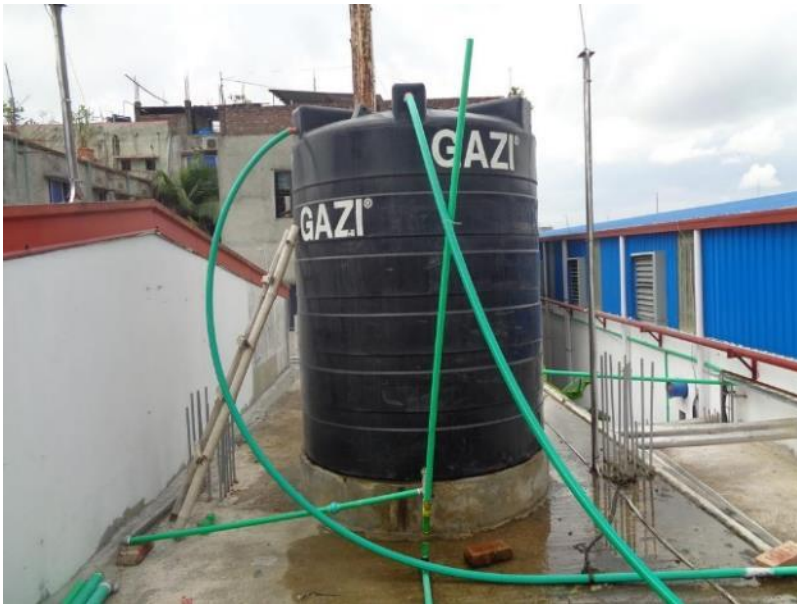
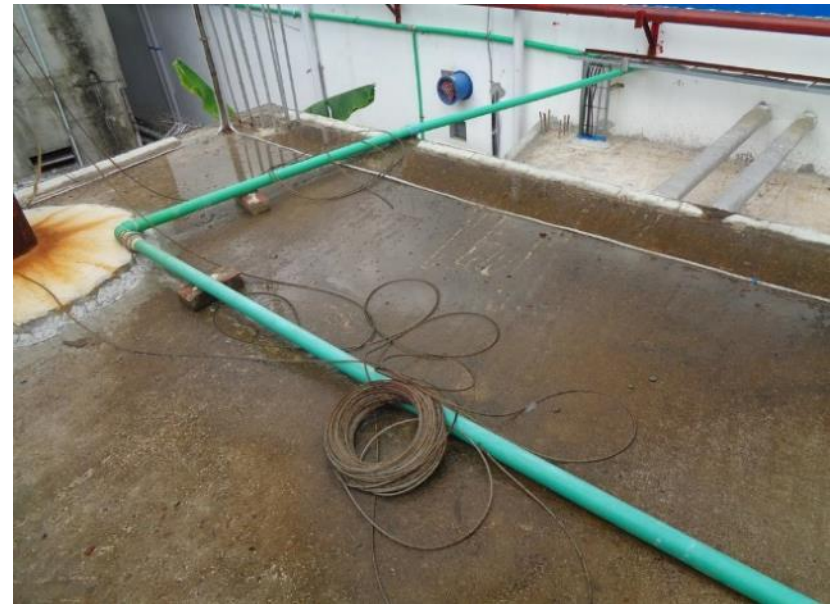
Standing water on the roof

Standing water on roof observed due to improper drainage system. Building engineer is required to provide adequate slope to drain out the water from roof slab

| Item No. | Observation | Recommended Action Plan | Recommended Timeline |
|---|---|---|---|
| 11 | Standing water on the roof (Boiler room) | Building engineer is required to provide adequate slope to drain out the storm water. | 6-weeks |
