# JK Knit Composite Limited (Textile & Utility Buildings)

03 July 2022

# Observations

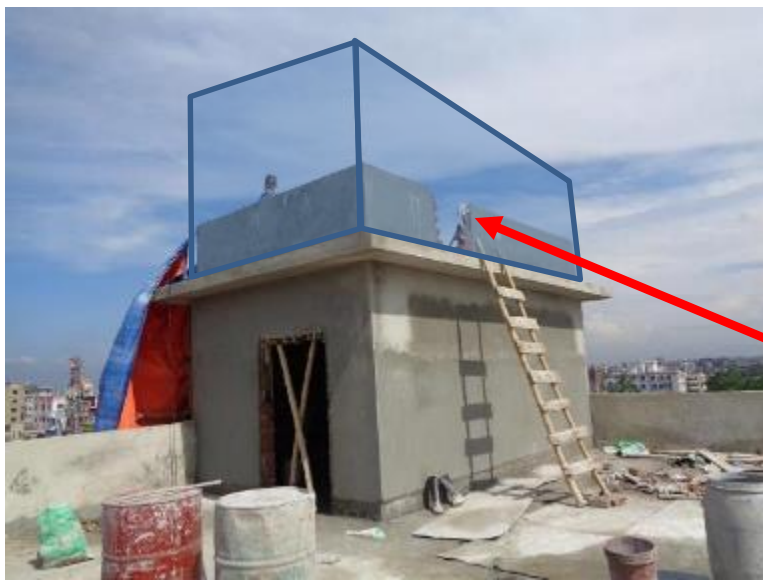
South East Staircase (OHWT not constructed)

Discrepancy observed in the provided drawing. Factory Engineer is required to prepare as-built drawing.

| Item No. | Observation | Recommended Action Plan | Recommended Timeline |
|---|---|---|---|
| 01 | Discrepancy between drawing and on-site condition. (Building-09). | <ul style="list-style-type: none"> <li>Building engineer is required to survey the structure &amp; prepare accurate as-built drawings.</li> </ul> | 6-weeks |

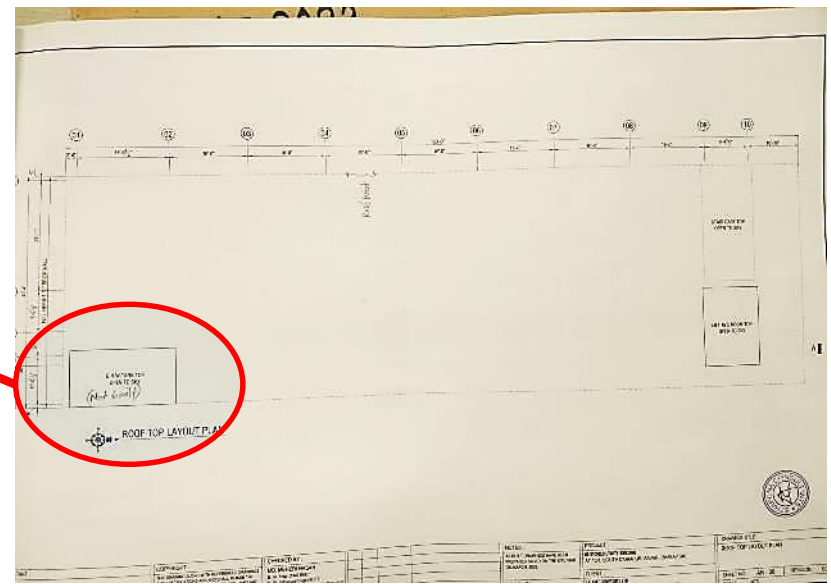
OHWT shown in the As-built drawing

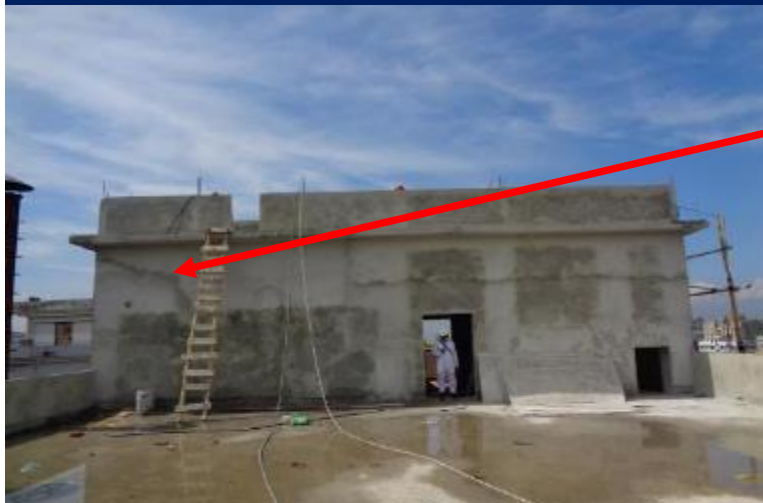
OHWT constructed over South East Staircase

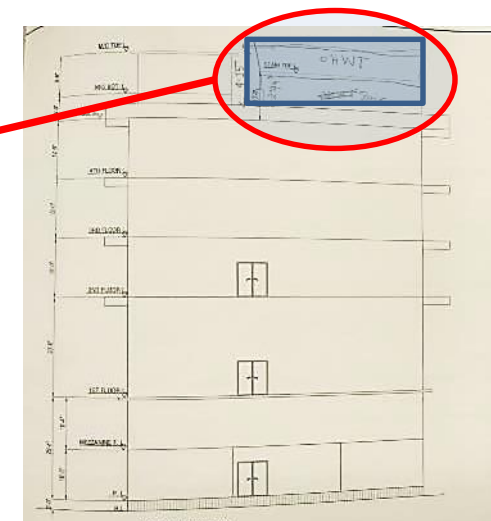
No OHWT shown in the As-built drawing

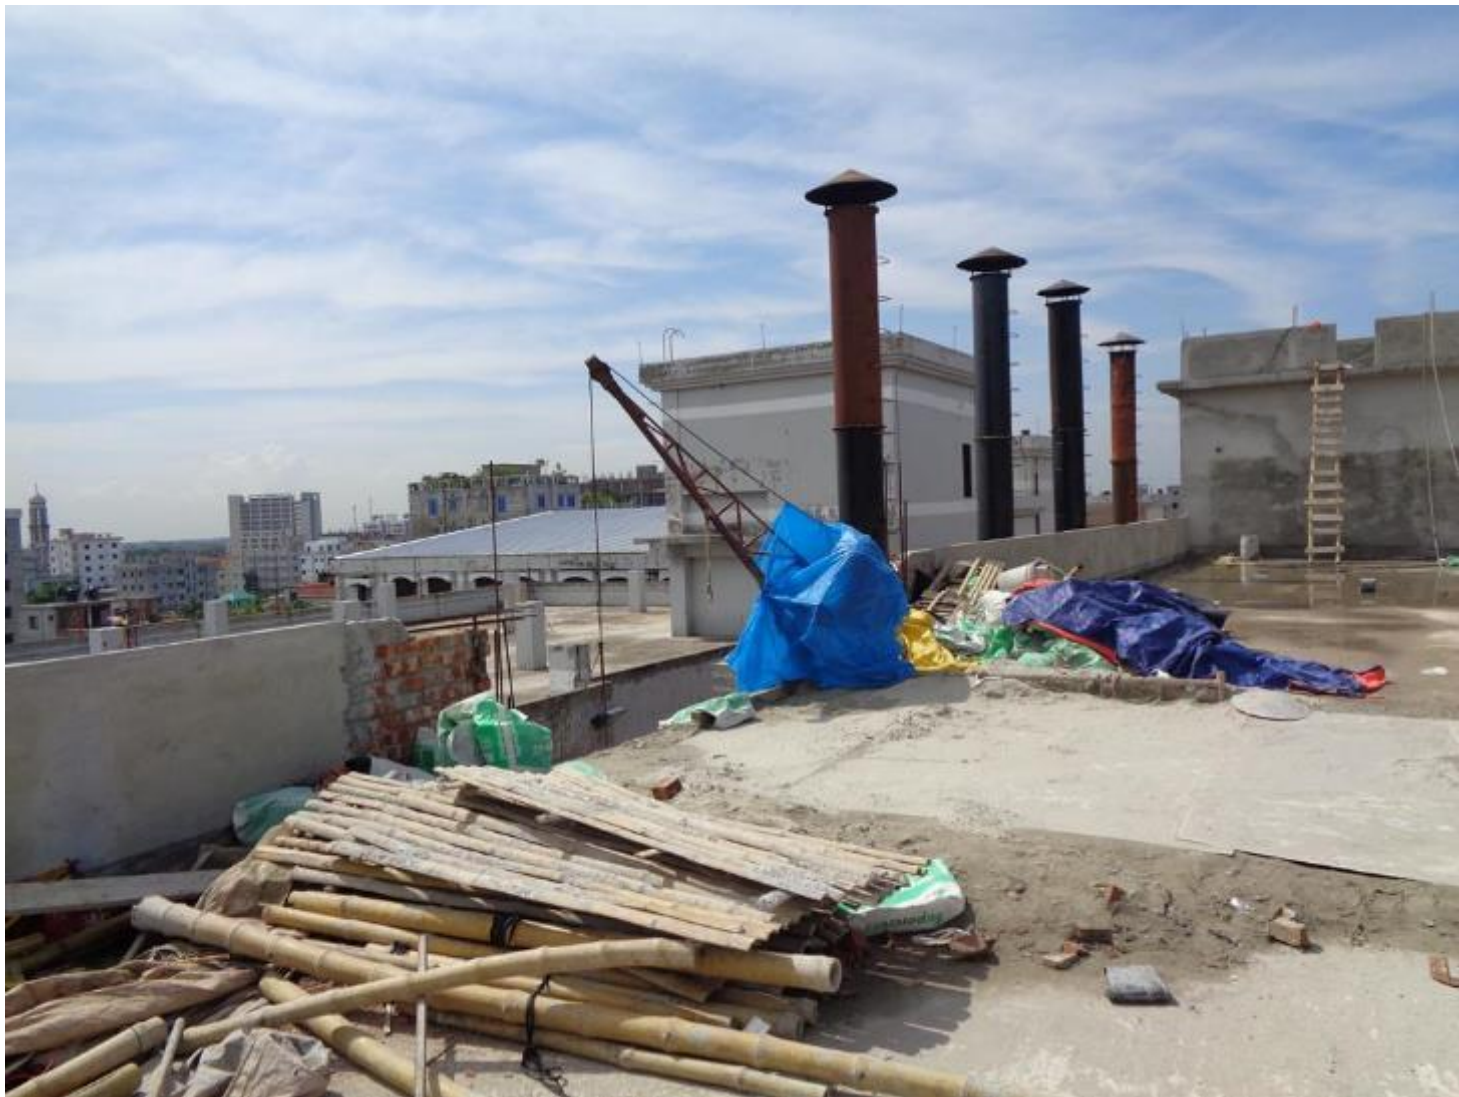
Parapet wall not constructed due to the placing of roof hoist west side of the roof. Factory is required to complete the construction of parapet wall to avoid possible falling hazard.

| Item No. | Observation | Recommended Action Plan | Recommended Timeline |
|---|---|---|---|
| 02 | Incomplete parapet wall. (Building-09). | <ul style="list-style-type: none"> <li>Factory is required to complete the construction of parapet wall to avoid potential of falling hazard.</li> </ul> | 6-weeks |

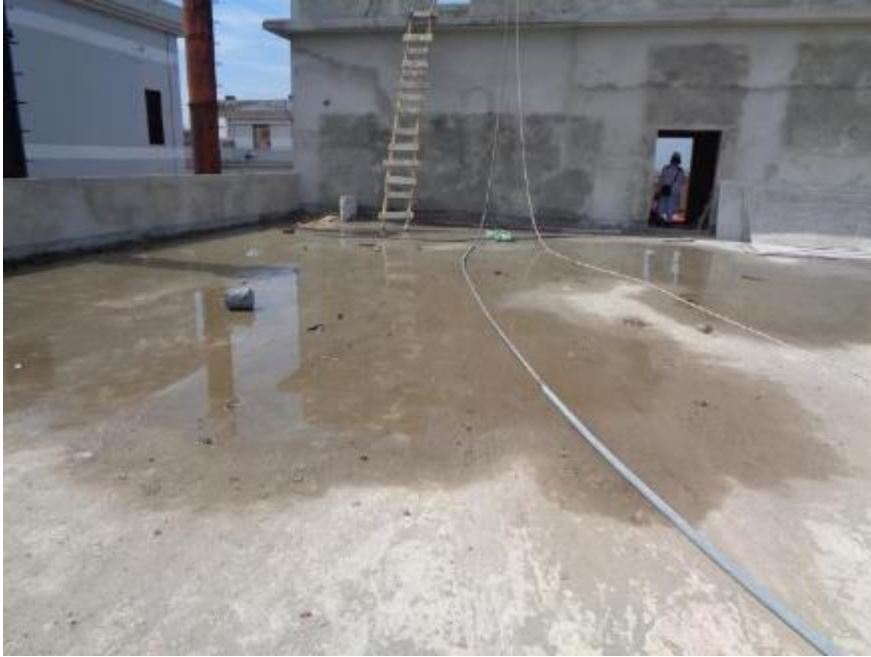
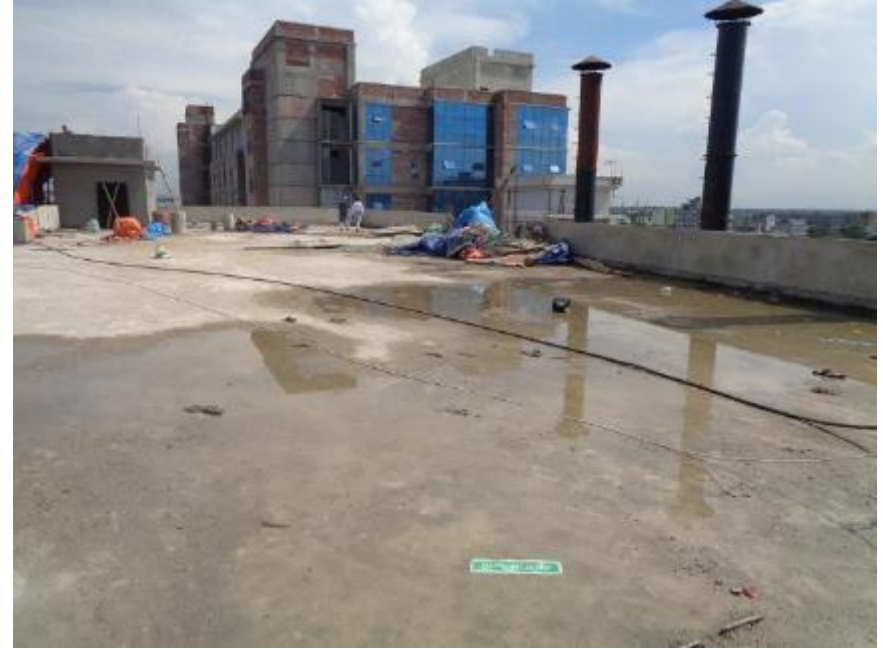
Stagnant water on the roof was observed. The factory is required to develop proper drainage system on the roof with adequate slopping.

| Item No. | Observation | Recommended Action Plan | Recommended Timeline |
|---|---|---|---|
| 03 | Water stagnant on the roof. (Building-09 (Utility Building-2)). | <ul style="list-style-type: none"> <li>Factory is required to develop proper drainage system on the roof with adequate slope.</li> </ul> | 6-weeks |

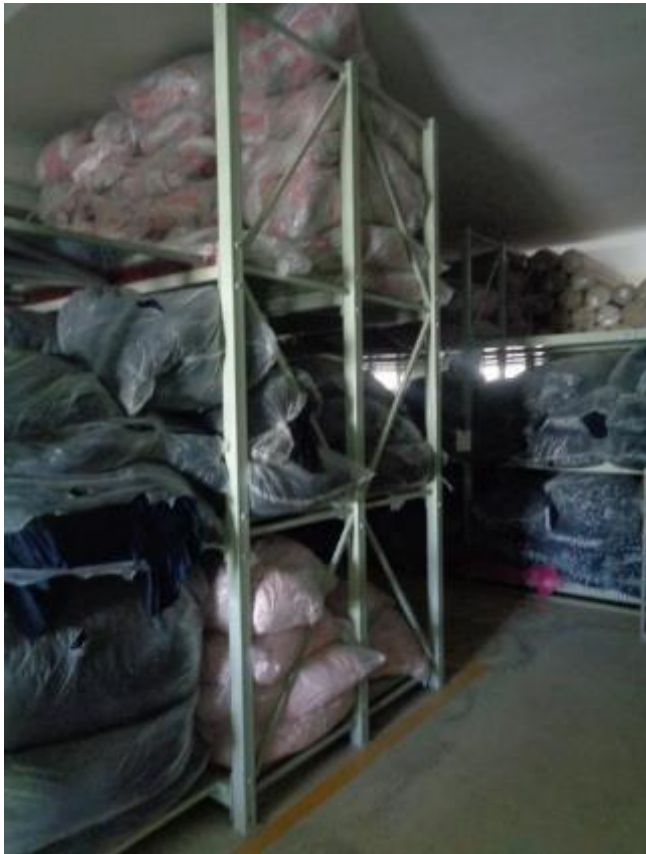
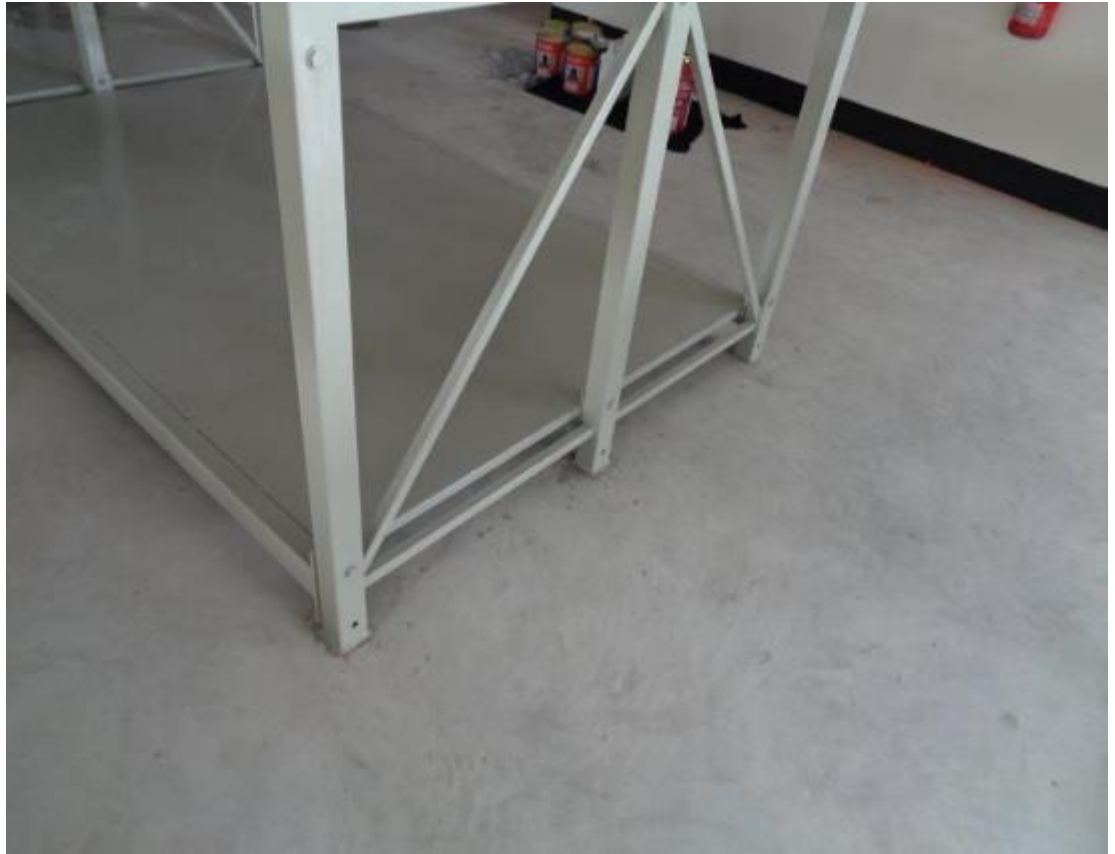
Storage racks on the floors are not adequately anchored or braced to resist earthquake forces.

Factory is required to anchored or braced properly all kinds of non-structural elements.

| Item No. | Observation | Recommended Action Plan | Recommended Timeline |
|---|---|---|---|
| 04 | Storage racks without anchorage/bracing. (Building-09 (Utility Building-2)). | <ul style="list-style-type: none"> <li>Factory is required to anchored or braced properly all kinds of non-structural elements.</li> </ul> | 6-weeks |

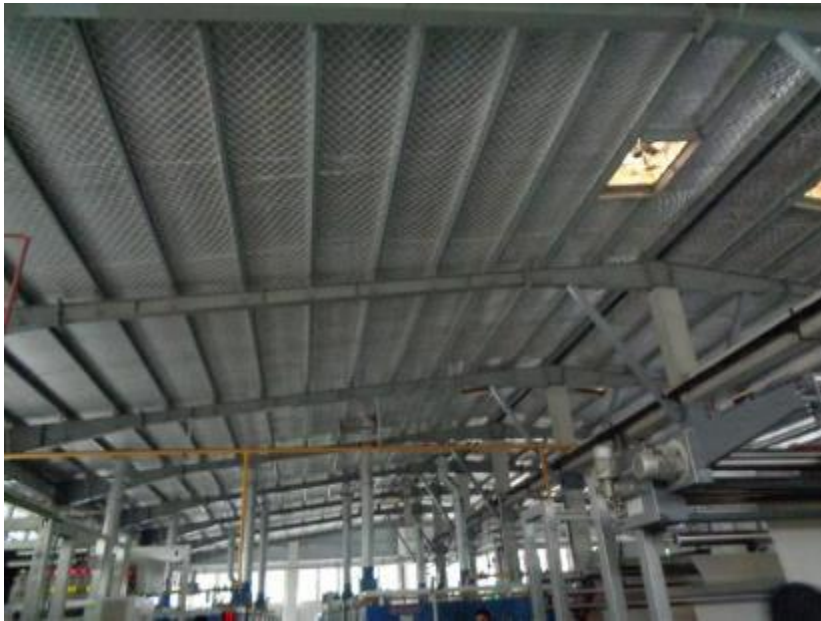
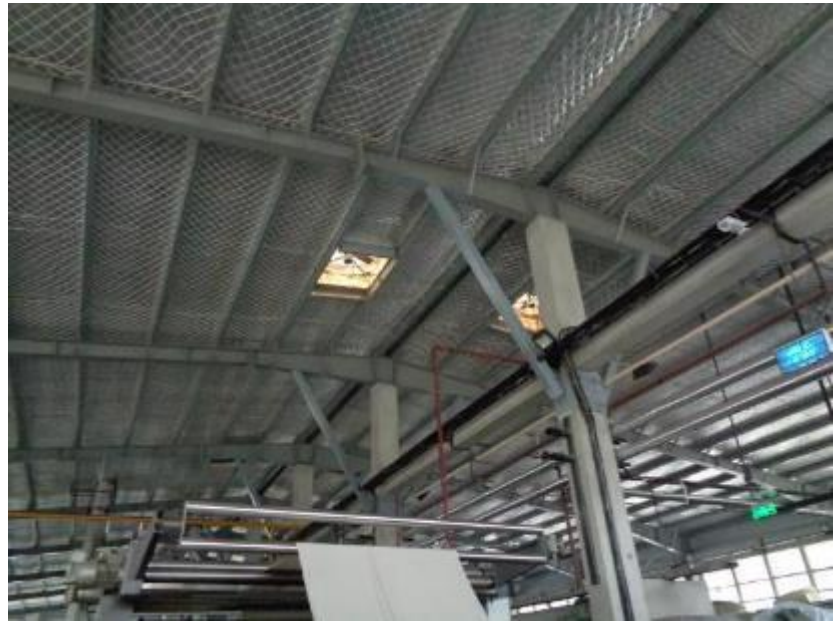
Lack of bracing at roof

The building engineer is required to check the requirement of roof bracing.

| Item No. | Observation | Recommended Action Plan | Recommended Timeline |
|---|---|---|---|
| 05 | Lack of bracing at steel roof. (Finishing Shed). | <ul style="list-style-type: none"> <li>The building engineer is required to check the requirement of roof bracing and suggest remedial action accordingly.</li> </ul> | 6-weeks |
| 06 | Lack of bracing at steel roof. (Finishing Shed). | <ul style="list-style-type: none"> <li>Carry out suggested remedial works (if required).</li> </ul> | 6-months |

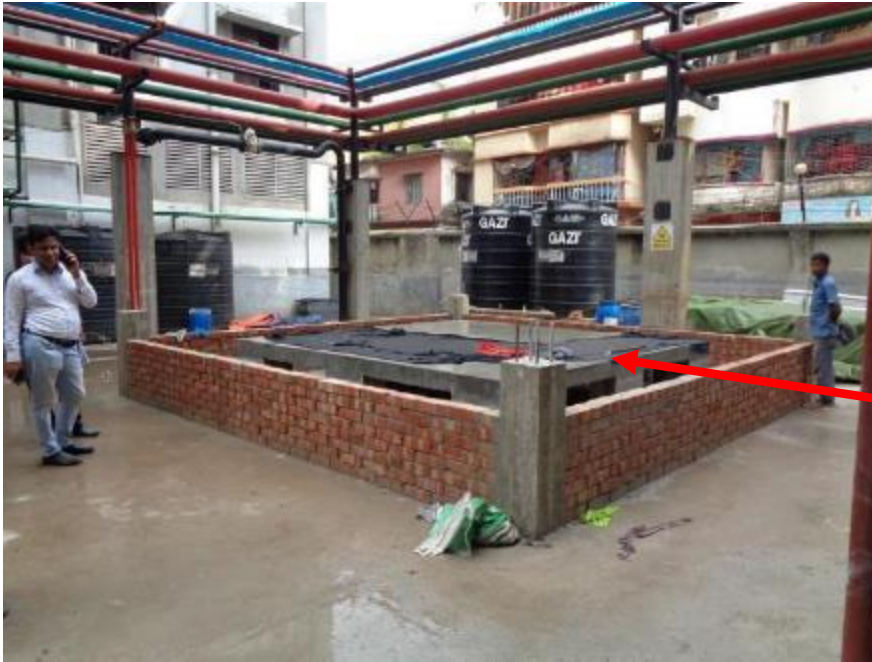
Undocumented rooftop slab and column on site

The building engineer is required to update the as-built drawing and check the capacity of top slab.

| Item No. | Observation | Recommended Action Plan | Recommended Timeline |
|---|---|---|---|
| 07 | Undocumented platform on the top slab of OHWT. (Fire Pump Room). | <ul style="list-style-type: none"> <li>Building engineer is required to survey the structure &amp; prepare accurate as-built drawings with structural details.</li> <li>Check the adequacy of top slab of UGWR.</li> </ul> | 6-weeks |

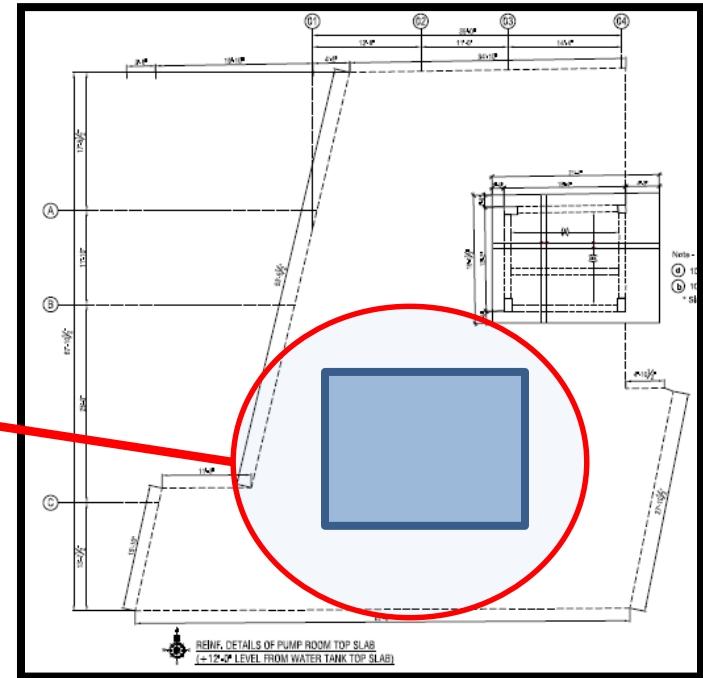
Rooftop slab over UGWT not shown in Drawing

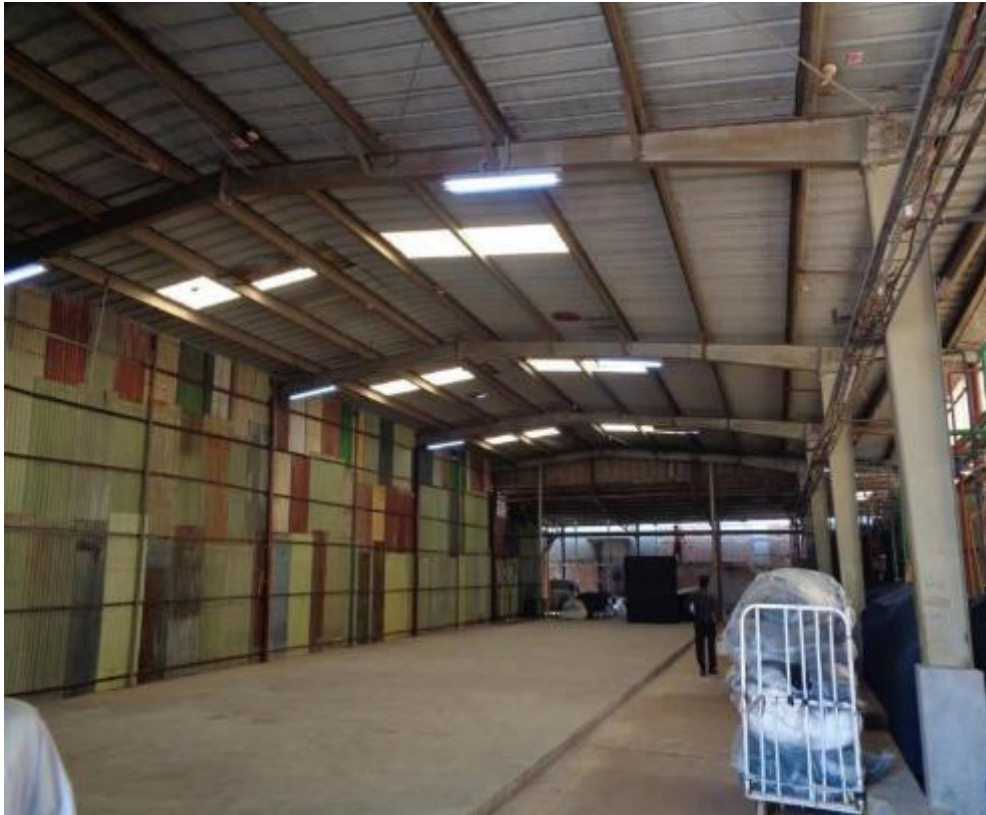
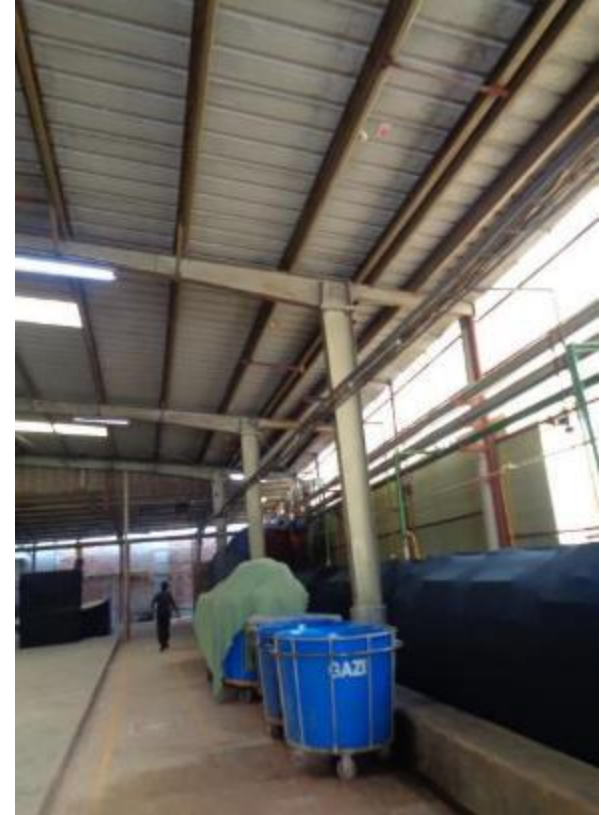
Lack of compression member along long direction of the shed

The building engineer is required to prepare the as-built drawing and check the lateral stability system of the steel shed.

| Item No. | Observation | Recommended Action Plan | Recommended Timeline |
|---|---|---|---|
| 08 | Lack of lateral stability system. (Temporary steel shed). | <ul style="list-style-type: none"> <li>The building engineer is required to prepare the as-built drawing, check the lateral stability system and suggest proper remedial actions accordingly.</li> </ul> | 6-weeks |
| 09 | Lack of lateral stability system. (Temporary steel shed). | <ul style="list-style-type: none"> <li>Carry out suggested remedial works.</li> </ul> | 6-months |
