Pretty Composite Textiles Ltd (extension of S.Suhi Industrial Park Ltd) Oxford Colours Ltd.

Holding # Hazi Liakot Mir Road, Zamgora, Ashulia, Savar, Dhaka-1349 (Beside Fantasy kingdom).

26 June 2022

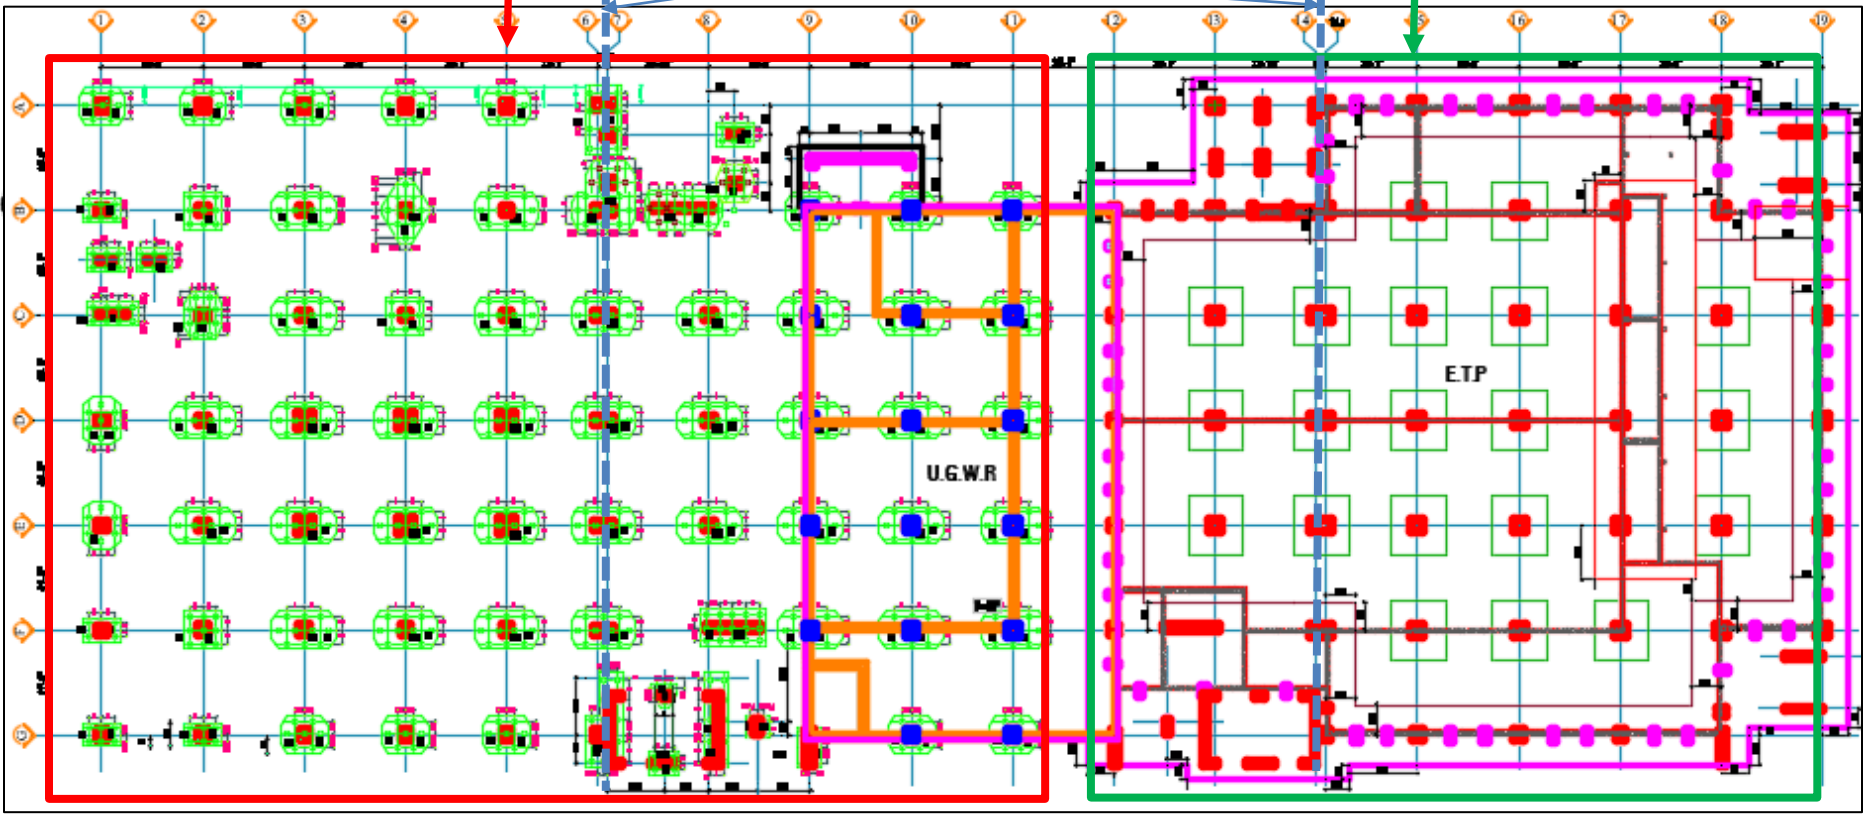
Foundation Layout Plan

Settlement check for different foundation system

Shallow and Deep foundations are constructed and connected with the beams. Building engineer is required to check the differential settlement issue for the deep and shallow foundation.

Item No.	Observation	Recommended Action Plan	Recommended Timeline
01	Settlement check for different foundation system (Building-1: Production Building)	Building engineer is required to check the differential settlement issue for the deep and shallow foundation.	6-weeks
02	Settlement check for different foundation system (Building-1: Production Building)	Implement remediation work if required.	6-months
03	Live load consideration at storage areas (Building-1: Production Building)	Factory engineer is required to revise the load plan as per BNBC requirement and review the design accordingly.	6-weeks
04	Live load consideration at storage areas (Building-1: Production Building)	Implement remediation work if required from design review.	6-months
05	Ongoing vertical extension work (Building-1: Production Building)	Ongoing vertical extension work (Building-1: Production Building)	6-weeks

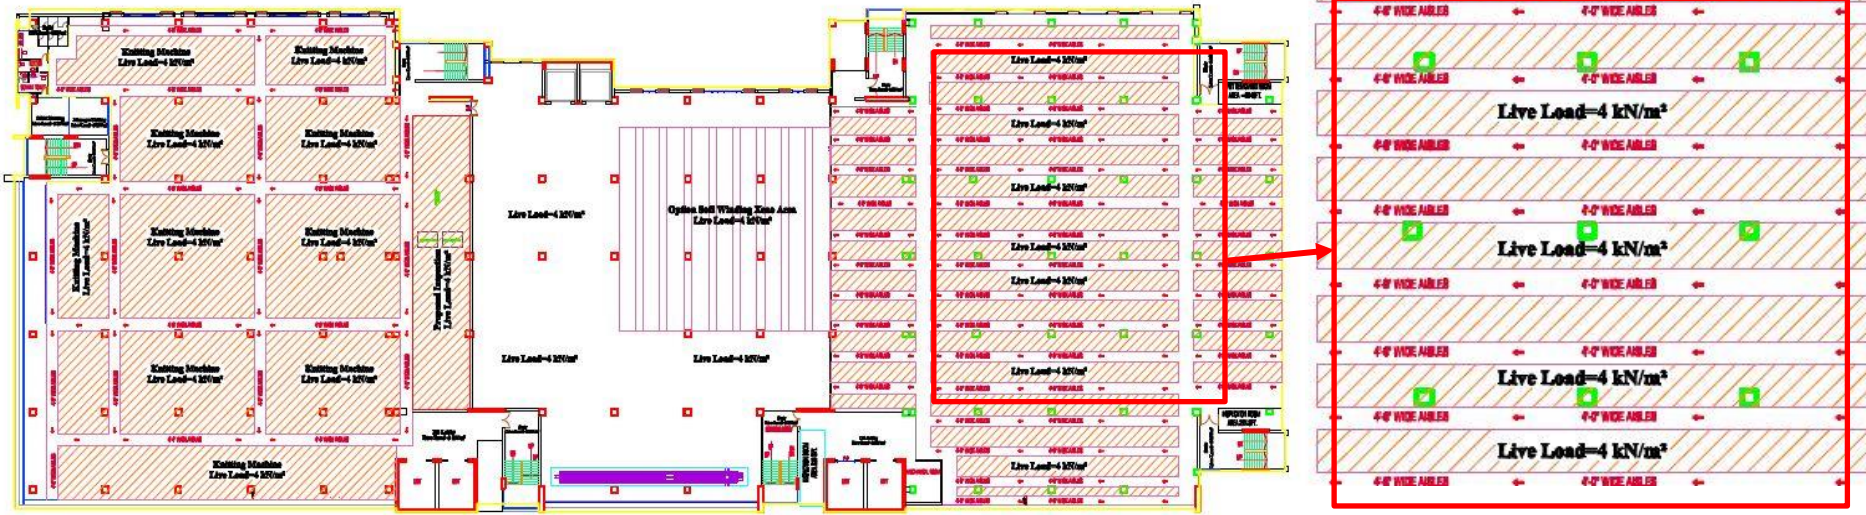
Live load plan- 3rd floor (live load considered as 4 kPa and no occupancy type is mentioned)

Live load consideration at storage areas

Live load on 3rd floor is considered as 4 kPa in prepared load plan (occupancy type not mentioned). Storage was found on 3rd floor. As per BNBC live load for light storage areas is required to be considered minimum 6 kPa. However, the factory engineer is required to revise the load plan as per BNBC requirement and review the design accordingly.

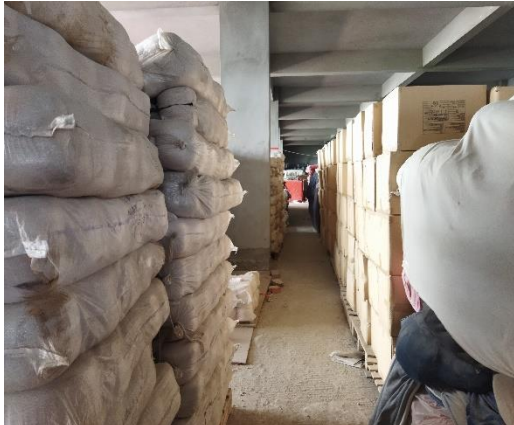
Storage on 3rd floor

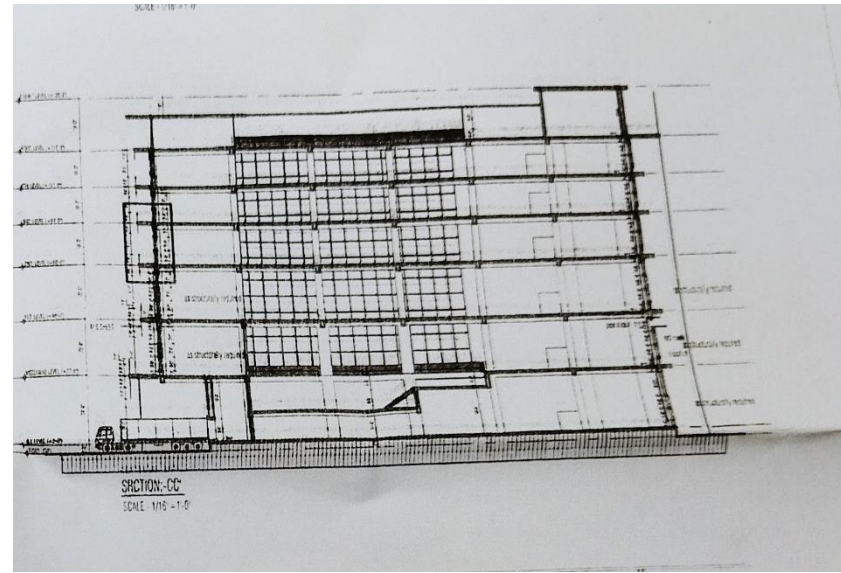
Building is permitted for 6 storied from local authority

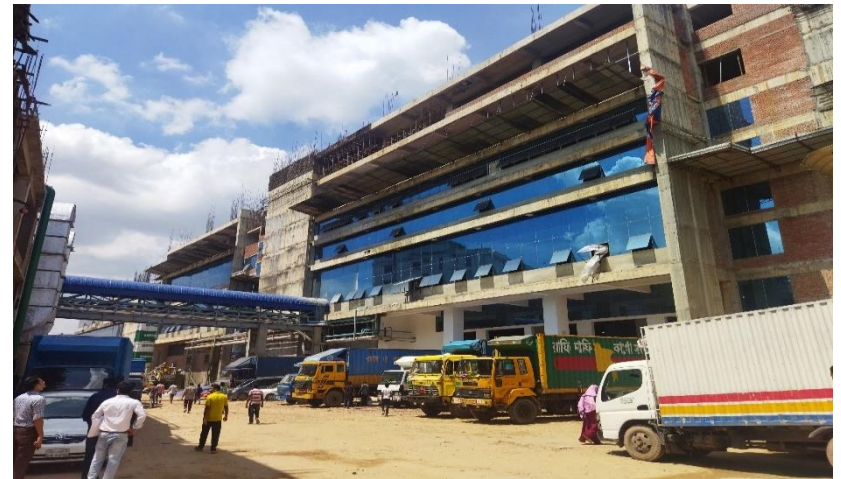
Building is currently partially 5 storied

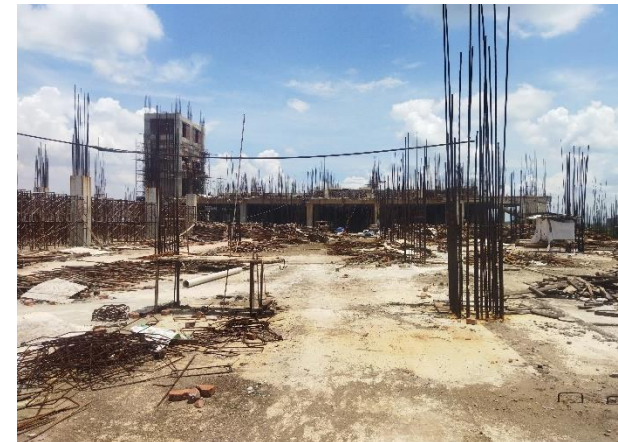
Ongoing extension work

The building has permit drawing for 6 storied and factory is conducting vertical extension at all tree parts. Factory is required to seek approval from local authority before conducting extension above 6 storied. Also, a Detail Engineer Assessment (DEA) is required to completed before the construction above 6-storied.

Item No.	Observation	Recommended Action Plan	Recommended Timeline
06	Ongoing vertical extension work (Building-1: Production Building)	Also, a Detail Engineer Assessment (DEA) is required to completed before the construction above 6-storied.	6-weeks
07	Ongoing vertical extension work (Building-1: Production Building)	Implement remediation work from the DEA.	6-months
08	Expansion joint filled with rigid material (Building-1: Production Building)	Factory is required to fill the gap with any flexible material suggested by the engineer.	6-weeks
09	Possible vehicle impact for column (Building-1: Production Building)	Factory is required to provide barrier for all exposed column at ground floor to prevent from possible vehicle impact.	6-weeks
10	Absence of design documents (Building-2:Utility Building-2)	Factory engineer is required to prepare a design report in compliance with section 1.9.1 (BNBC).	6-weeks

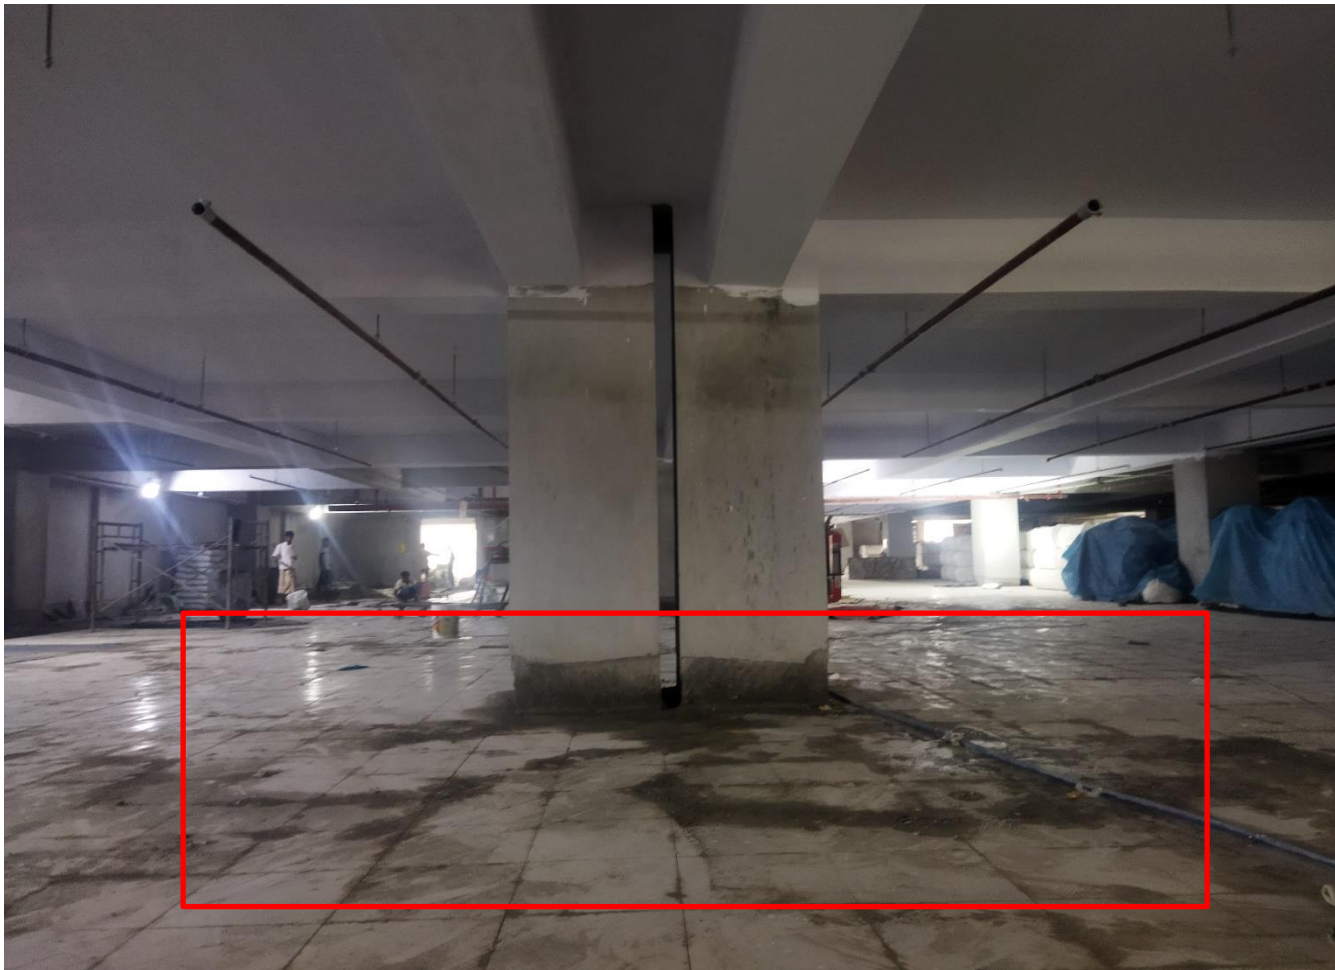
Expansion joint filled with rigid material at every floor

Expansion joint was found filled with rigid material which may disturb lateral movement during the earthquake. Factory is required to fill the gap with any flexible material suggested by the engineer.

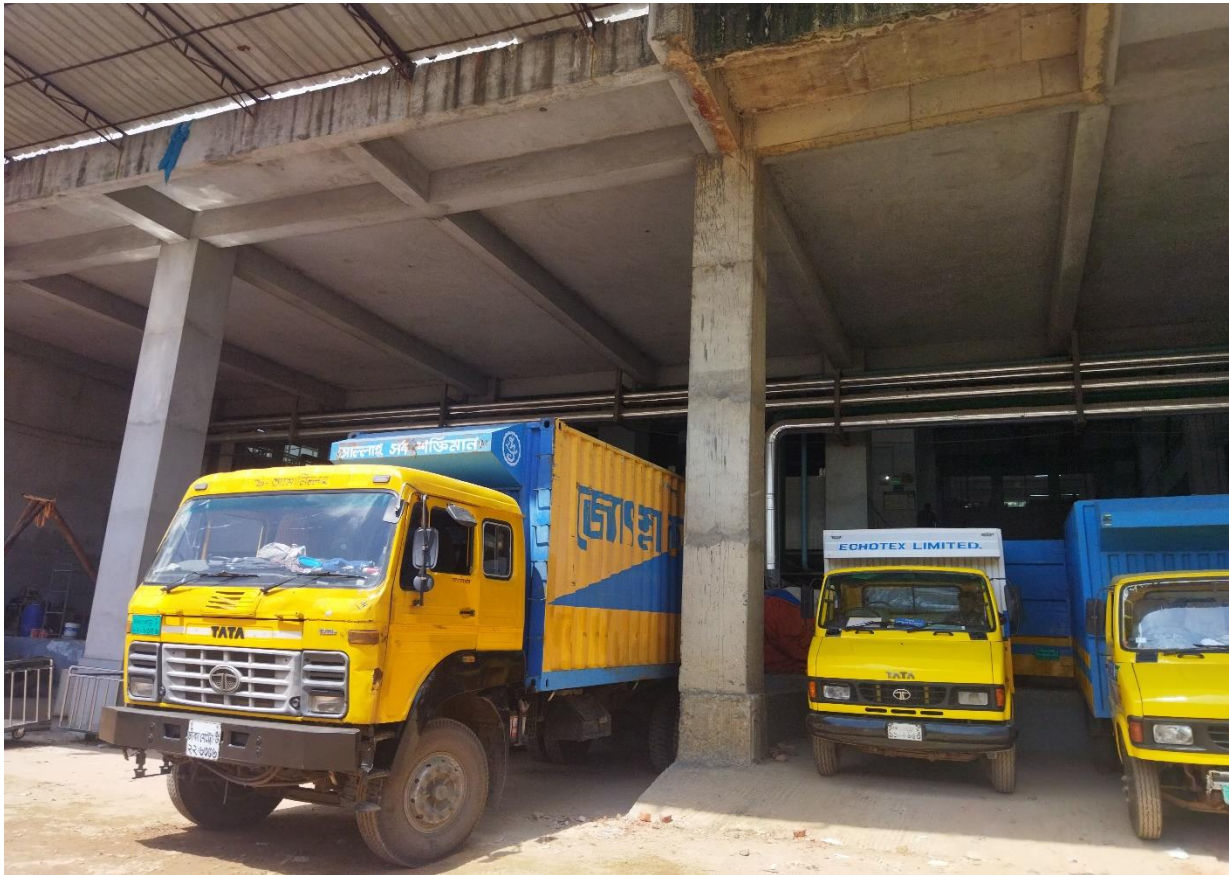
No barrier provided for the exposed columns at ground floor

Columns at ground floor are prone to possible vehicle impact. Factory is required to provide barrier for all exposed column at ground floor to prevent from possible vehicle impact.

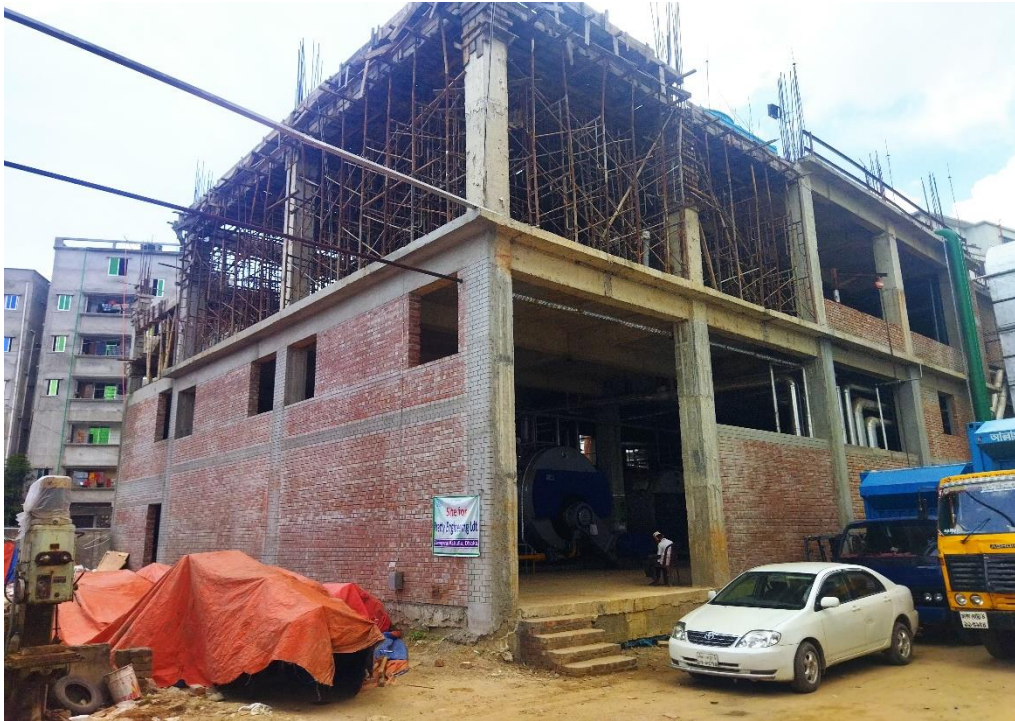
Building-2 (Utility Building-2)

Absence of design documents

As per BNBC, every building or structure designed shall have its design documents prepared in accordance with the provision of Section 1.9.1. The design document shall include a design report, and a set of structural drawings, which shall be prepared in compliance with section 1.9.1.1 and section 1.9.1.2 as per BNBC. At the time of inspection, design report was not available which is required to be prepared in compliance with section 1.9.1 (BNBC).

11	Absence of design documents (Building-2:Utility Building-2)	Implement remediation work if required.	6-months
