# Joy Auto Garments Ltd.

B/274/1, Enayet Nagar Purbopara, Godnail, Siddirgonj, Narayanganj  
(23.645665, 90.512449)

19<sup>th</sup> July 2022

# Observations

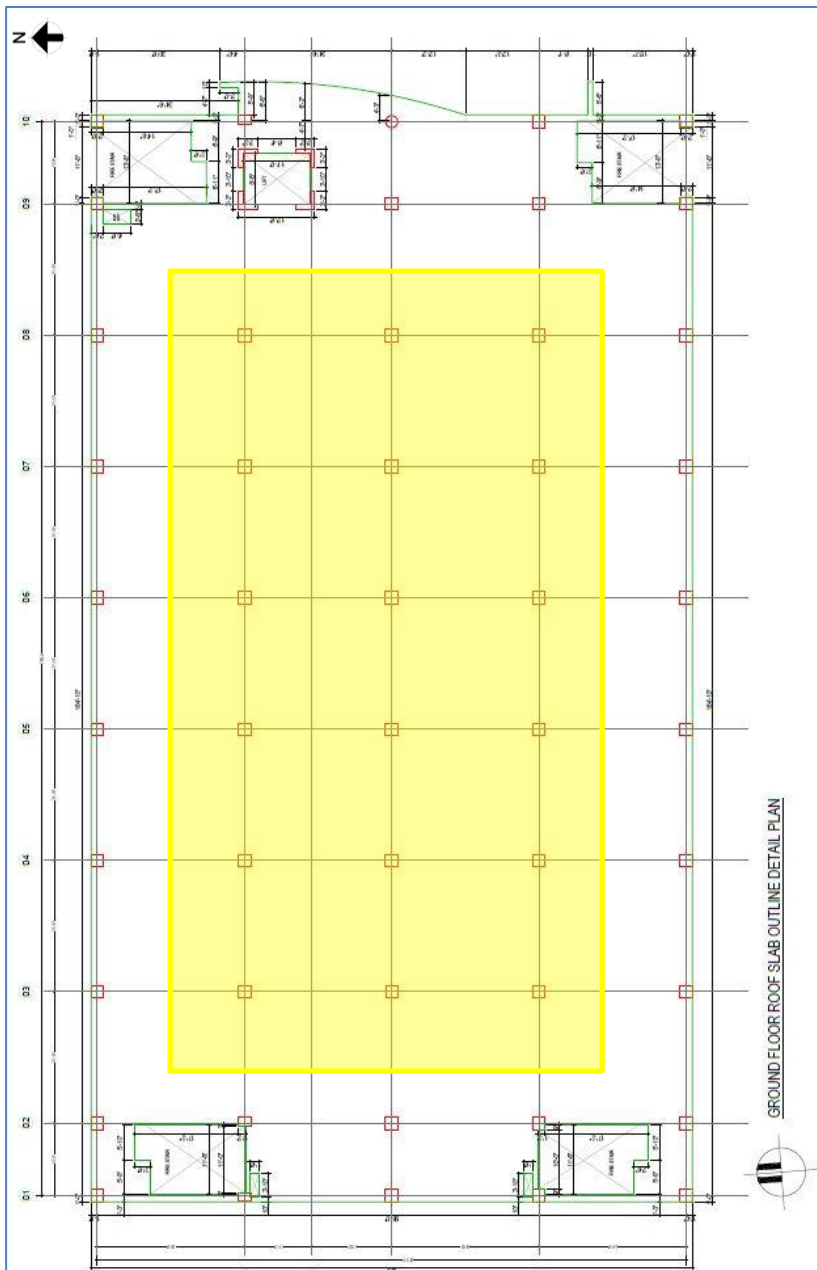
**Stress in column exceeds normal design limit**

Stressed columns in layout (yellow marked)

The cursory calculation indicates that some column's stress exceeds the normal design limit considering a typical floor live load 5kPa, roof live load of 1.5 kPa, and minimum concrete strength of 16.31 MPa. The building engineer is required to review the design, loads, and column stresses for the marked columns based on in-situ material strength.

Verify in-situ concrete stresses by 100 mm diameter cores from a minimum of 4 columns. Produce and actively manage a loading plan for all floors considering floor and column capacity.

| Item No. | Observation | Recommended Action Plan | Recommended Timeline |
|---|---|---|---|
| 01 | Stress in column exceeds normal design limit (Building-1) | Factory Engineer to review design, loads and columns stresses in area identified above. | 6-weeks |
| 02 | Stress in column exceeds normal design limit (Building-1) | Verify in-situ concrete stresses by 100mm dia. cores from minimum of 4 columns. | 6-weeks |
| 03 | Stress in column exceeds normal design limit (Building-1) | Produce and actively manage a loading plan for all floor plates considering floor and column capacity. | 6-weeks |

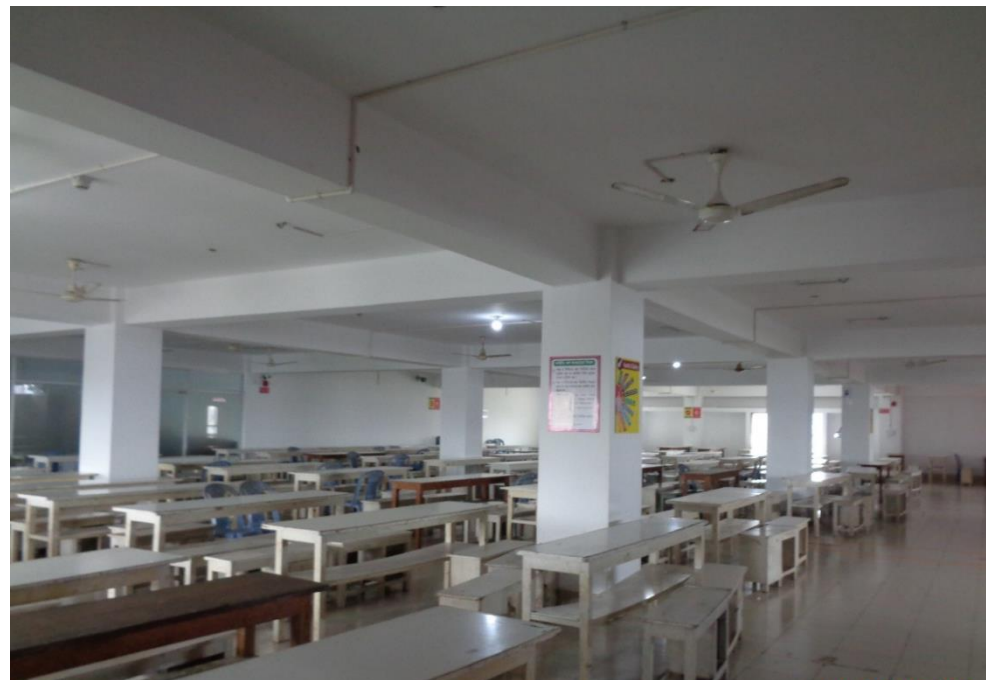
Typical stressed columns

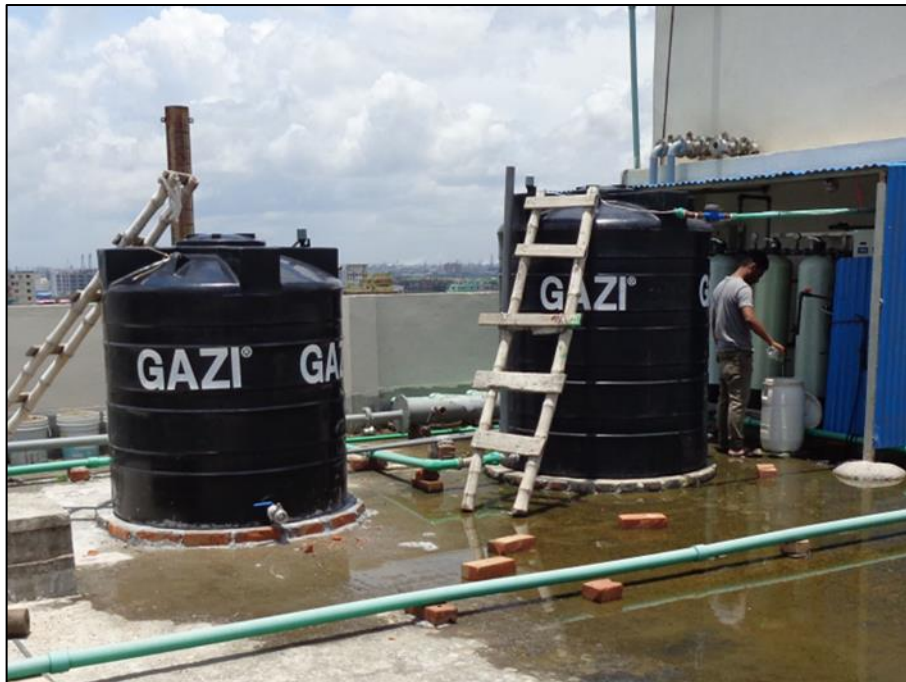
Some plastic tanks resting on the rooftop and racks on different floors are not adequately anchored or braced to resist lateral (earthquake) forces.

Plastic water tank on roof

Adequately anchor and brace all non-structural elements (all buildings) to resist earthquake forces to comply with the BNBC.

| Item No. | Observation | Recommended Action Plan | Recommended Timeline |
|---|---|---|---|
| 06 | Non-structural elements not anchored or braced (Building-1) | Adequately anchor and brace all non-structural elements to resist earthquake forces to comply with the BNBC. | 6-weeks |

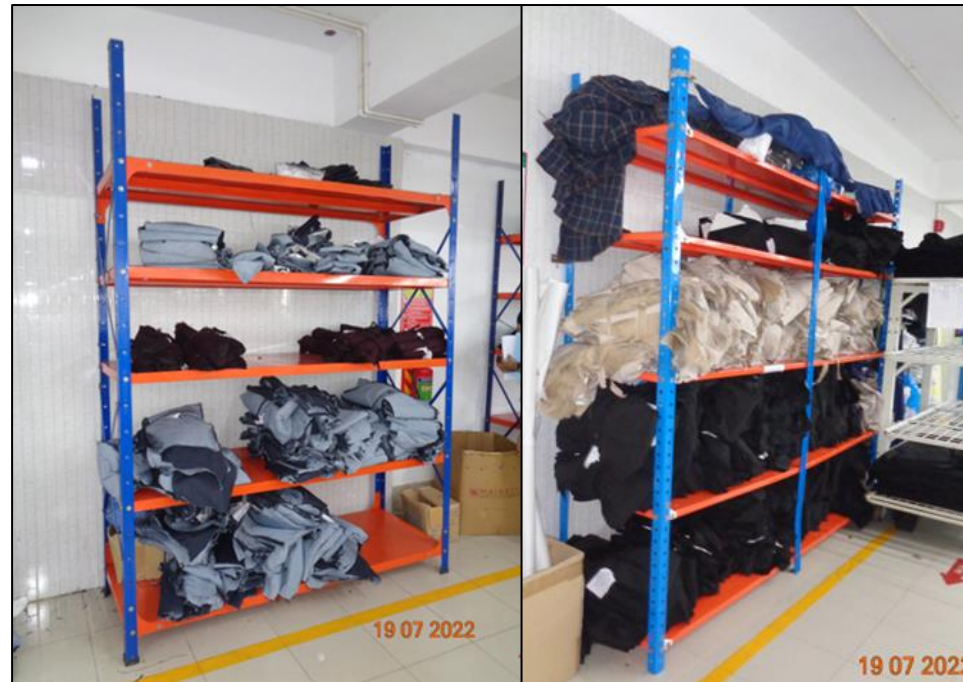
Rack on floor level

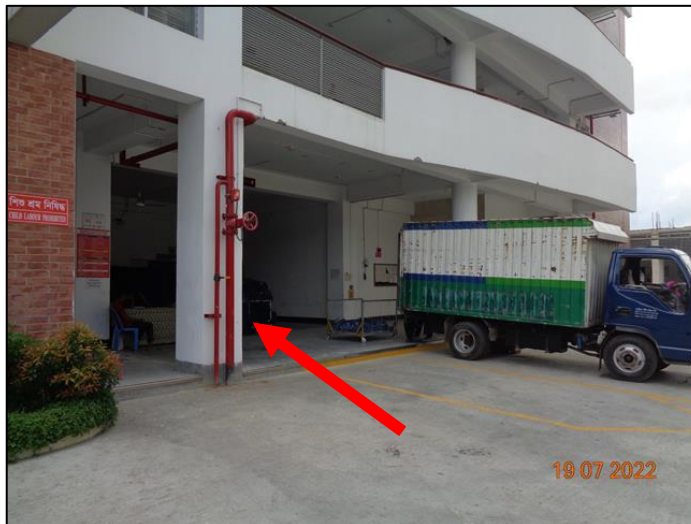
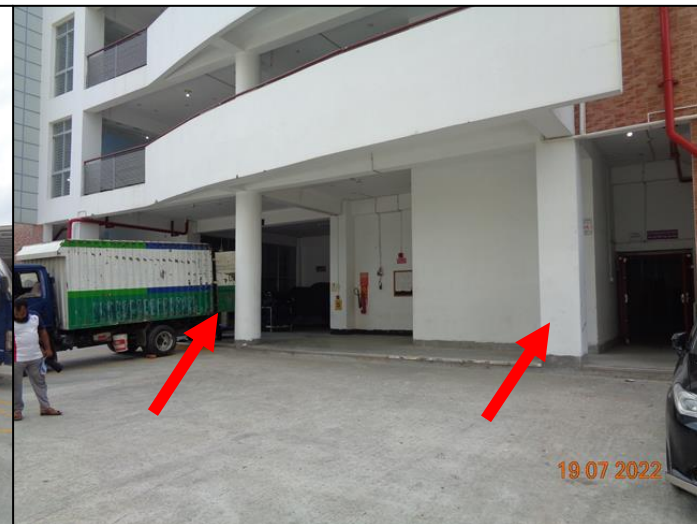
Columns having no barrier/protection at ground floor

Ground floor columns and 1<sup>st</sup> floor beams of the loading un-loading area are susceptible to vehicle impact. The factory engineer is required to take necessary measures (by providing the barrier around the columns) to avoid possible vehicle impact.

| Item No. | Observation | Recommended Action Plan | Recommended Timeline |
|---|---|---|---|
| 07 | Column susceptible to vehicle impact (Building- 1) | The factory engineer is required to take necessary measures to prevent the vehicle impact by providing barrier for column & beam. | 6-months |

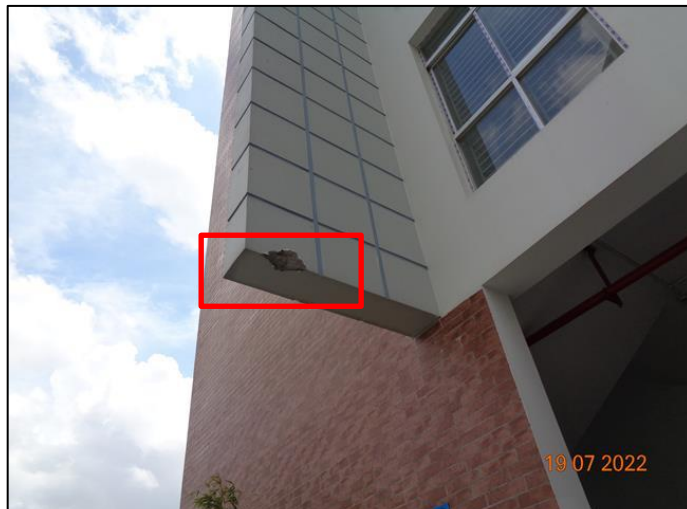
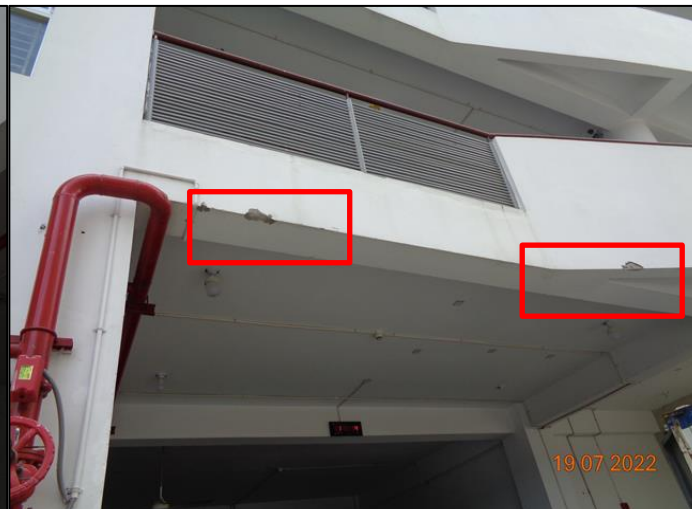
Beams are affected by the impact of vehicle

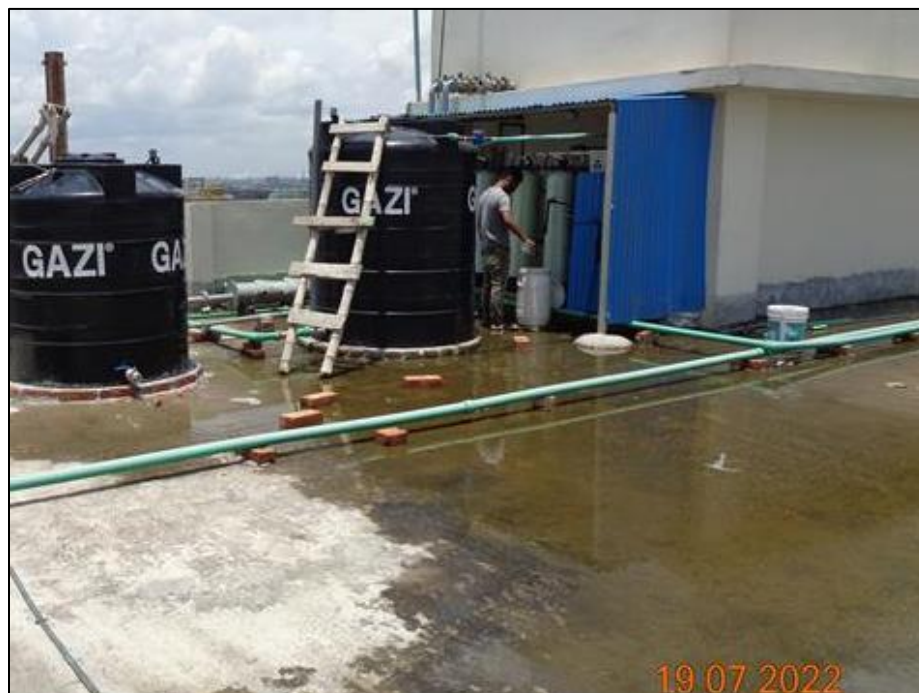
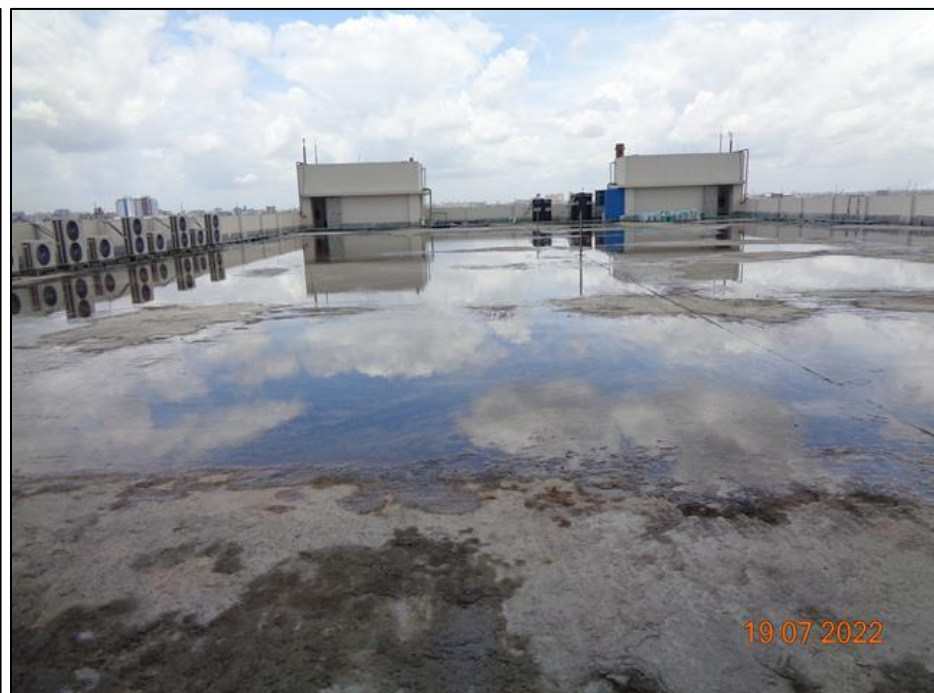
Water ponding at Roof

Water ponding was found on the roof slab due to inadequate slope. The factory is required to develop proper drainage system with adequate slope and water outlet on the roof.

| Item No. | Observation | Recommended Action Plan | Recommended Timeline |
|---|---|---|---|
| 08 | Water ponding. (Building- 1) | The factory engineer to develop proper drainage system with adequate slope to resist water ponding on the roof. | 6-months |

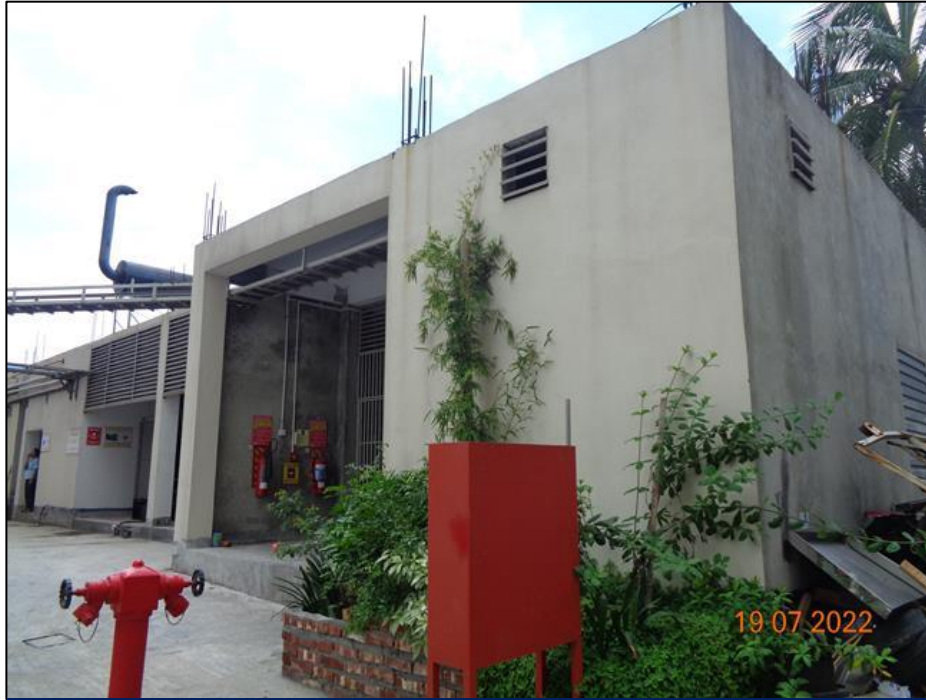
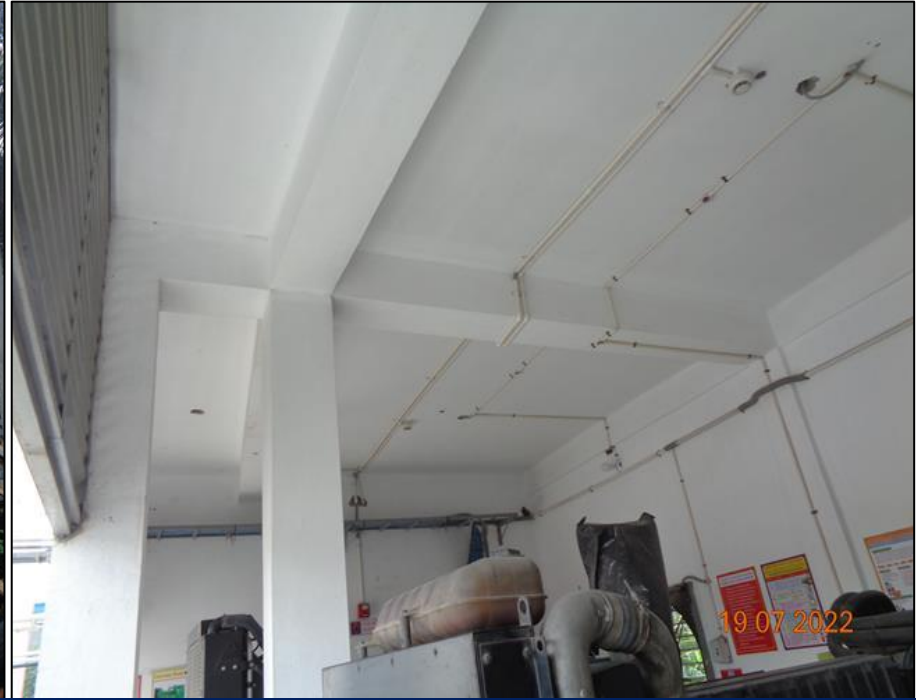
Utility Building

**Design report needs to be prepared**

The utility building do not have any design document except structural drawing. As per BNBC, every building or structure designed shall have its design documents prepared in accordance with the provision of Section 1.9.1. The design document shall include a design report, and a set of structural drawings, which shall be prepared in compliance with section 1.9.1.1 and section 1.9.1.2 as per BNBC. Factory engineer is required prepare the design documents including architectural drawing and design report based on FEA model in compliance with section 1.9.1 (part-6, BNBC).

| Item No. | Observation | Recommended Action Plan | Recommended Timeline |
|---|---|---|---|
| 09 | Design report needs to be prepared (Building- 2) | Building engineer to prepare the design document including a design report, and a set of structural drawings in compliance with section 1.9.1.1 and section 1.9.1.2 as per BNBC. | 6-weeks |
| 10 | Design report needs to be prepared (Building- 2) | Complete any remedial works arising from design report after reviewed by the RSC. | 6-months |

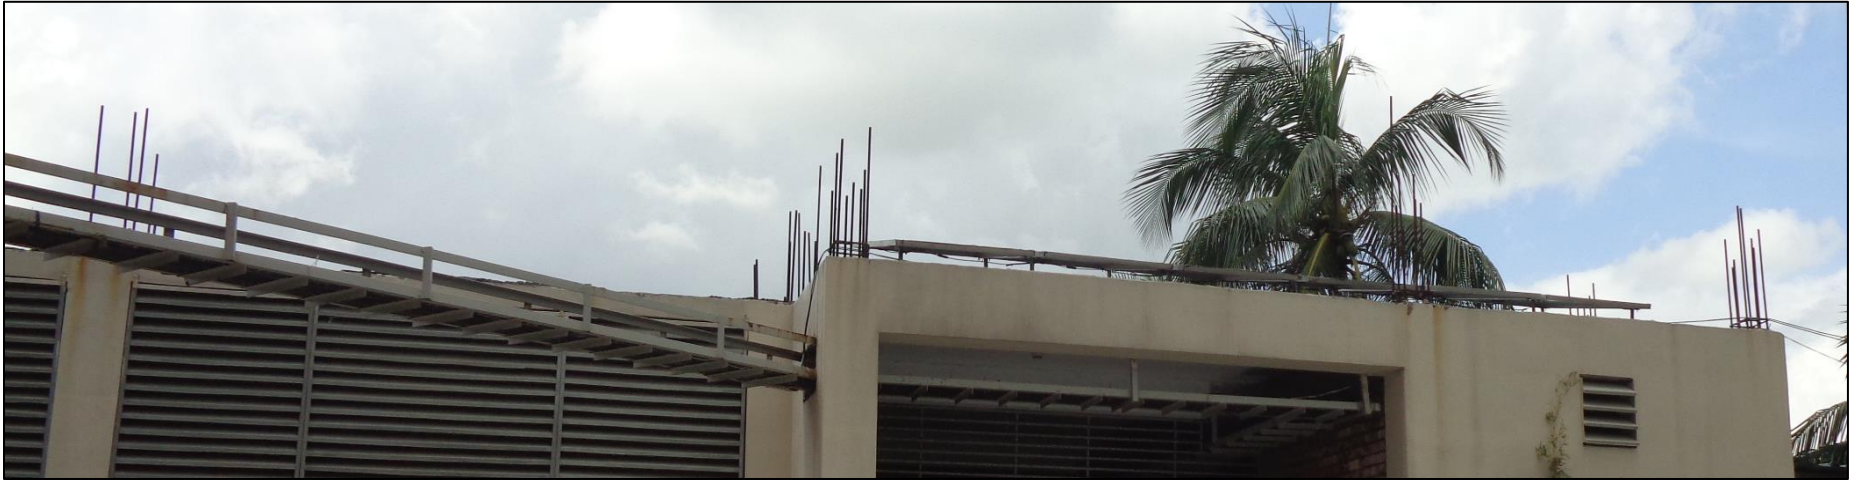
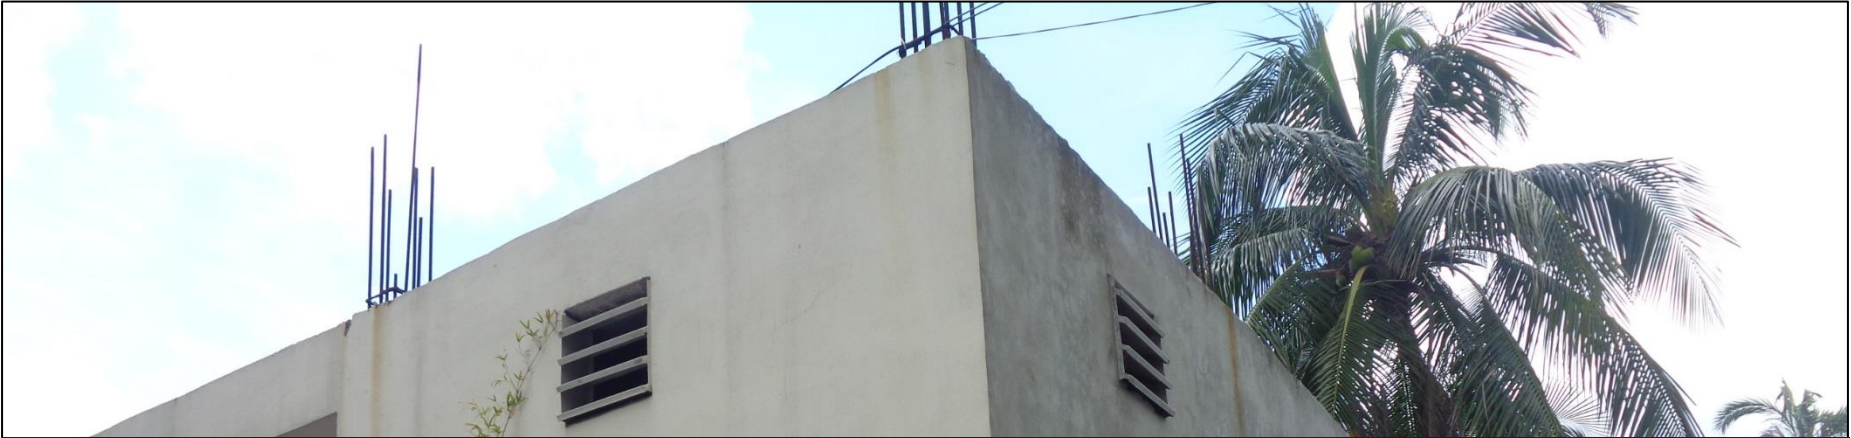
Exposed rebar of Column

Exposed reinforcement was found on roof top columns. Factory engineer is required to take necessary measures to prevent the corrosion of exposed rebar.

| Item No. | Observation | Recommended Action Plan | Recommended Timeline |
|---|---|---|---|
| 11 | Corroded and exposed rebar at roof. (Building- 2) | All exposed reinforcement is to be protected from corrosion which may cause degradation of the concrete. | 6-weeks |

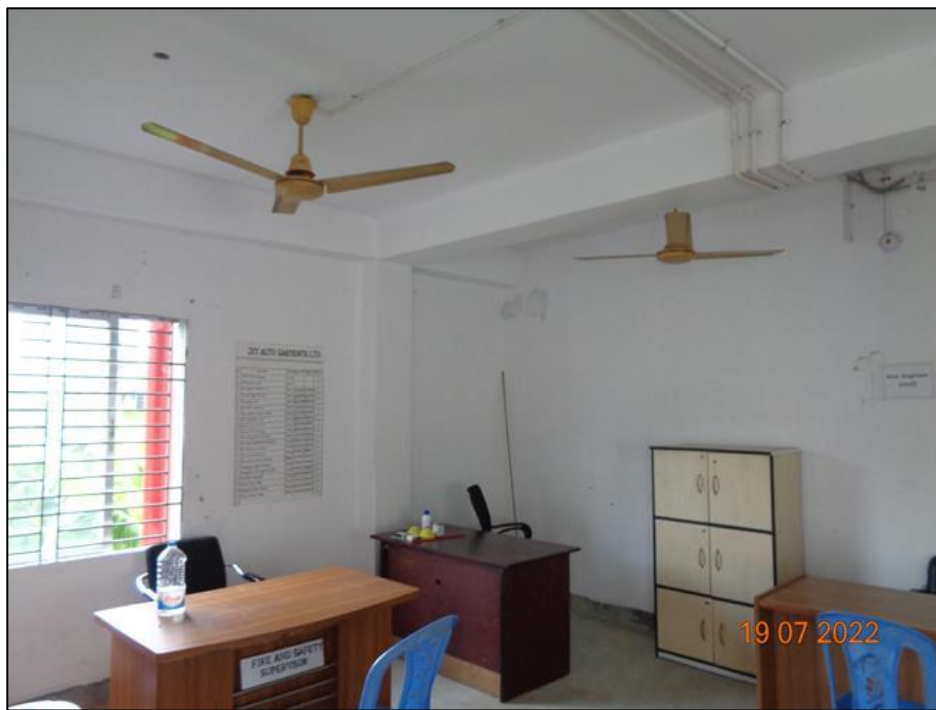
Fire Pump Room

**Design report needs to be prepared**

The utility building do not have any design document except structural drawing. As per BNBC, every building or structure designed shall have its design documents prepared in accordance with the provision of Section 1.9.1. The design document shall include a design report, and a set of structural drawings, which shall be prepared in compliance with section 1.9.1.1 and section 1.9.1.2 as per BNBC. Factory engineer is required prepare the design documents including architectural drawing and design report based on FEA model in compliance with section 1.9.1 (part-6, BNBC).

| Item No. | Observation | Recommended Action Plan | Recommended Timeline |
|---|---|---|---|
| 12 | Design report needs to be prepared (Building- 3) | Building engineer to prepare the design document including a design report, and a set of structural drawings in compliance with section 1.9.1.1 and section 1.9.1.2 as per BNBC. | 6-weeks |
| 13 | Design report needs to be prepared (Building- 3) | Complete any remedial works arising from design report after reviewed by the RSC. | 6-months |

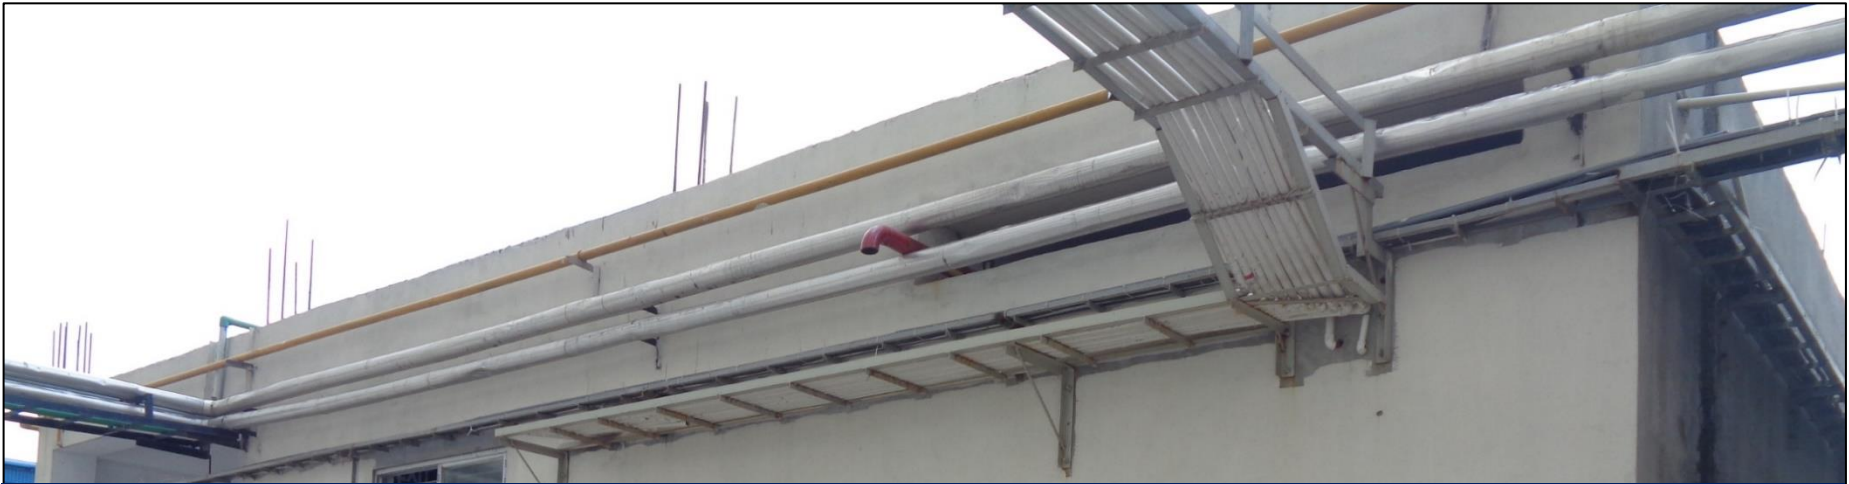
Exposed rebar of column

Exposed reinforcement was found on roof top columns. Factory engineer is required to take necessary measures to prevent the corrosion of exposed rebar.

| Item No. | Observation | Recommended Action Plan | Recommended Timeline |
|---|---|---|---|
| 14 | Corroded and exposed rebar at roof. (Building- 3) | All exposed reinforcement is to be protected from corrosion which may cause degradation of the concrete. | 6-weeks |

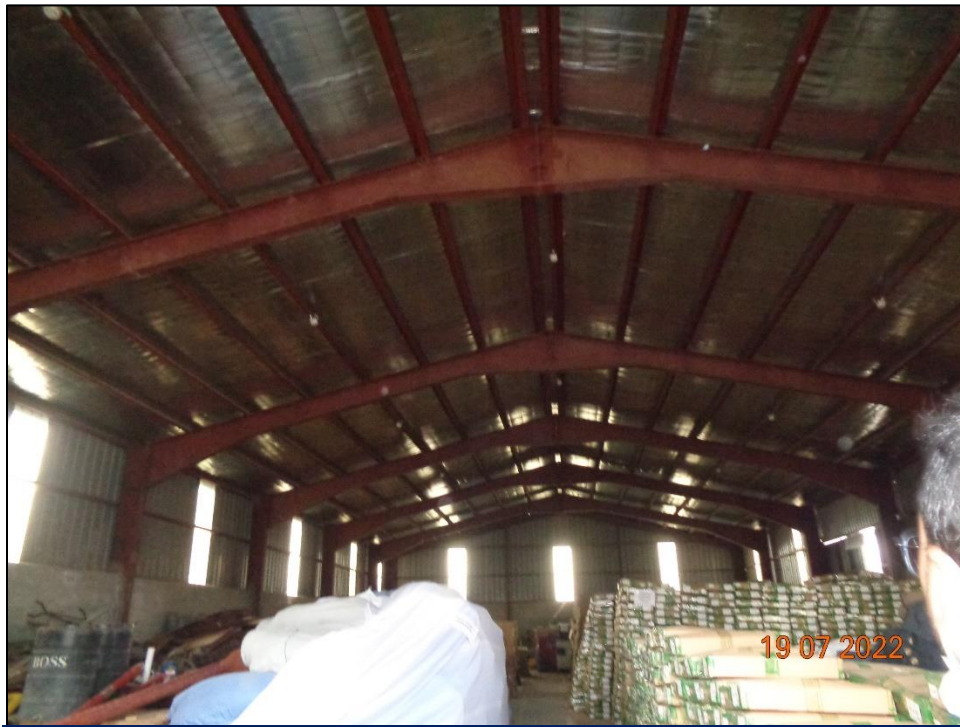
Steel portal frame

The steel roof portal frame is supported by steel column. There is no apparent load path to transfer the lateral loading along the long direction. The vertical & horizontal bracing was missing. Building Engineer is required to check the lateral stability system of the steel shed.

As per BNBC, every building or structure designed shall have its design documents prepared in accordance with the provision of Section 1.9.1. The design document shall include a design report, and a set of structural drawings, which shall be prepared in compliance with section 1.9.1.1 and section 1.9.1.2 as per BNBC. During the inspection, the as built drawings & design report was not found. Now, the building engineer is required to prepare Engineering Assessment (EA) report for the structure in compliance with section 1.9.1 of part-6, BNBC.

| Item No. | Observation | Recommended Action Plan | Recommended Timeline |
|---|---|---|---|
| 15 | Lack of lateral stability (Building-4) | Building engineer to conduct Engineering Assessment (EA) to check the lateral stability of the structure and prepare design documents (report & drawings) in compliance with section 1.9.1, part-6 of BNBC. | 6-weeks |
| 16 | Lack of lateral stability (Building-4) | Carryout suggested remedial works as per EA. | 6-months |

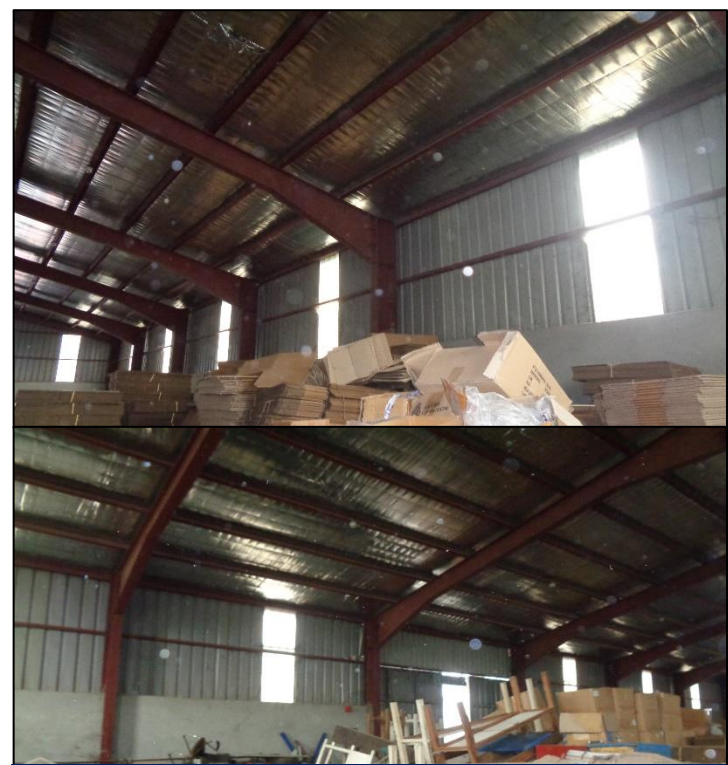
No load transfer media and bracing
