# Deshbandhu Textile Mills Ltd

MSSFB # 1&2, Uttara Export Processing Zone, Shongalshi, Saidpur, Nilphamari.

23 June 2022

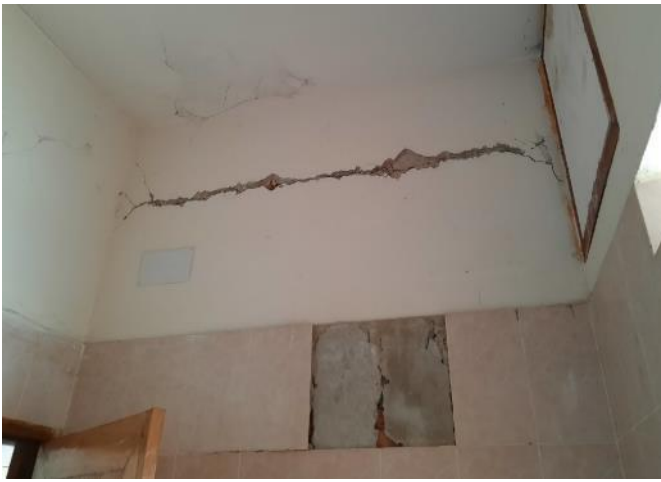
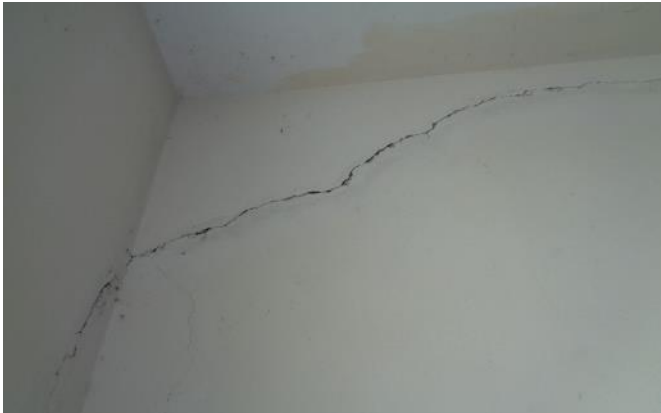
Crack in brick walls

Severe crack was found in brick wall at 3<sup>rd</sup> floor toilet zone area. Also, cracks were found at the façade walls. These cracks may have been generated due to the torsional irregularity of the structure or/and deflection of slab.

Factory engineer is required to investigate the cause of crack and repair the crack as per recommendation from investigation report.

| Item No. | Observation | Recommended Action Plan | Recommended Timeline |
|---|---|---|---|
| 01 | Cracks in brick wall (Building-1) | Factory engineer is required to investigate the cause of crack and repair the crack as per recommendation from investigation report. | 6-weeks |

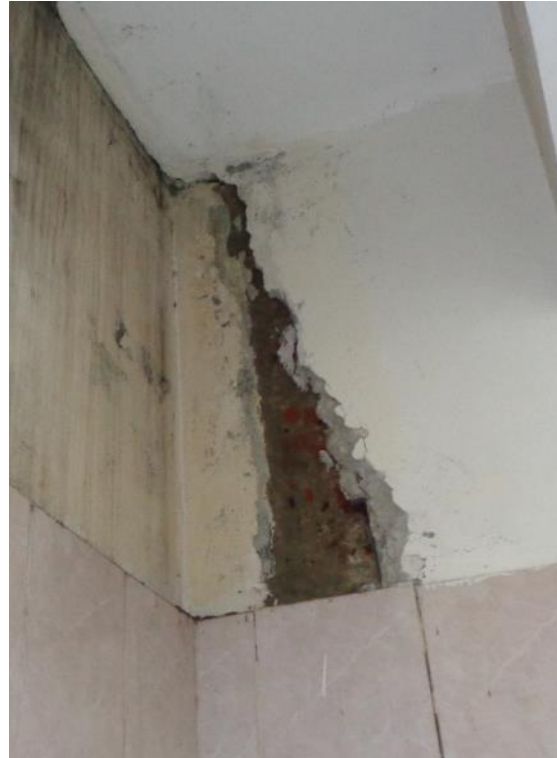
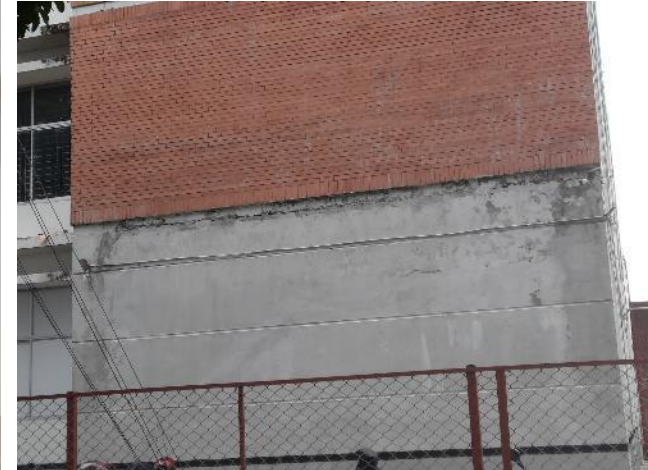
Crack in the façade wall

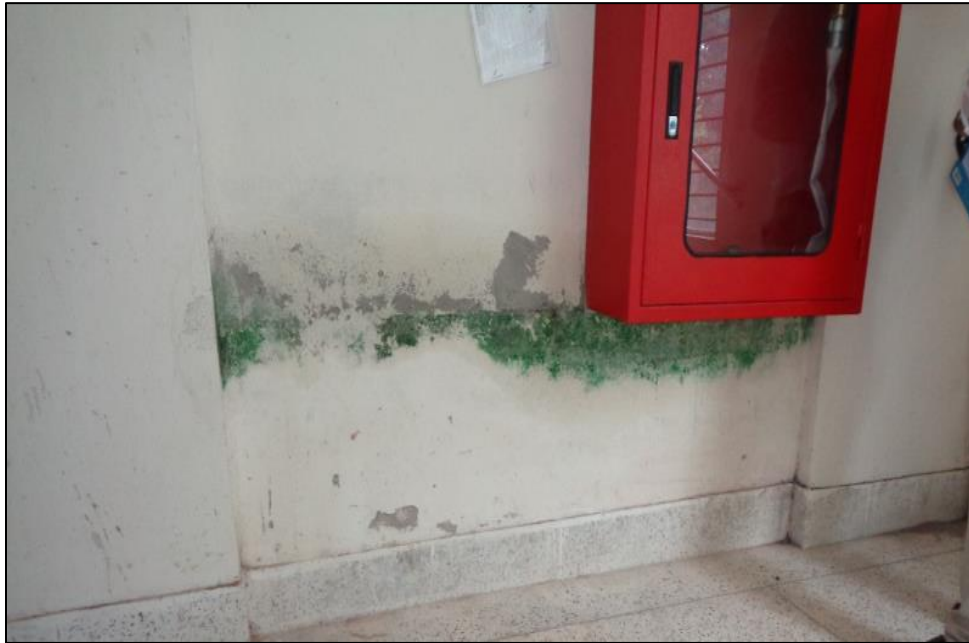
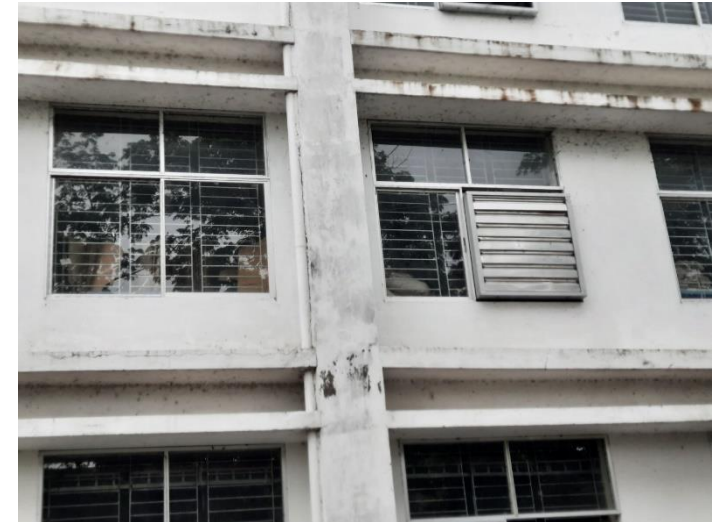
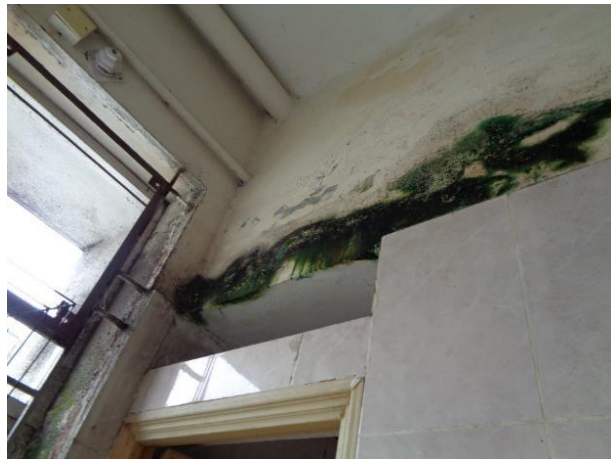
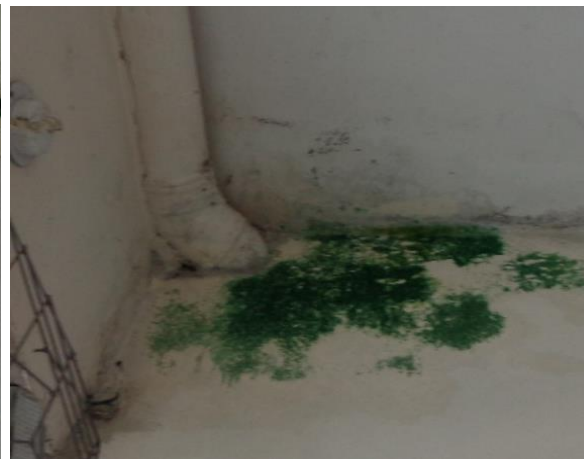
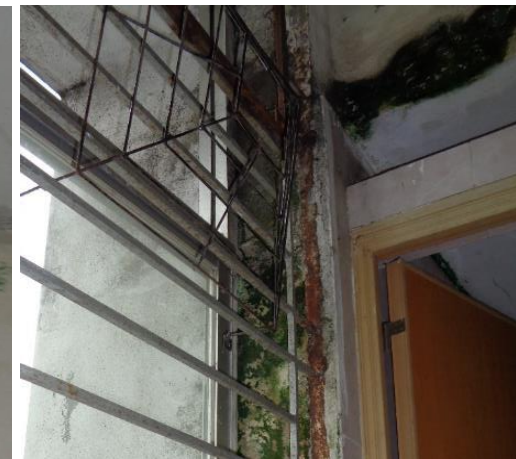
Severe dampness was found several locations of the structure (e.g façade, brick wall, column & beam). Factory engineer is required to investigate the source of dampness and take necessary measures to prevent the dampness.

| Item No. | Observation | Recommended Action Plan | Recommended Timeline |
|---|---|---|---|
| 02 | Dampness at several locations (Building-1) | Factory engineer is required to investigate the cause of the dampness and repair the damp areas as per the investigation report. | 6-weeks |

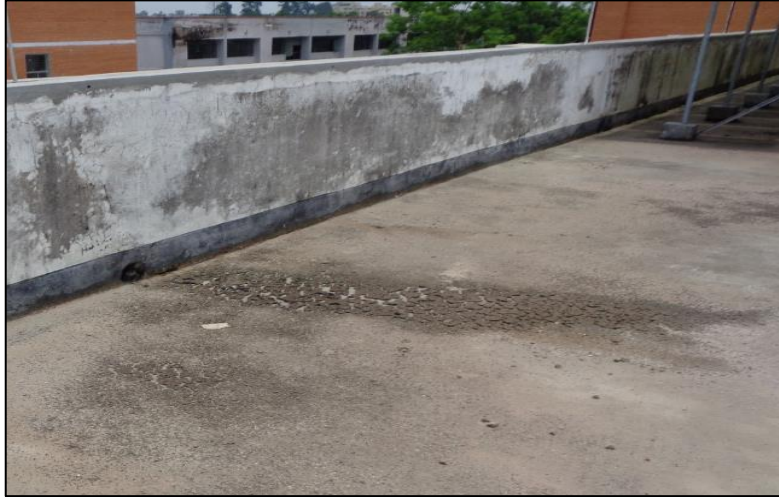
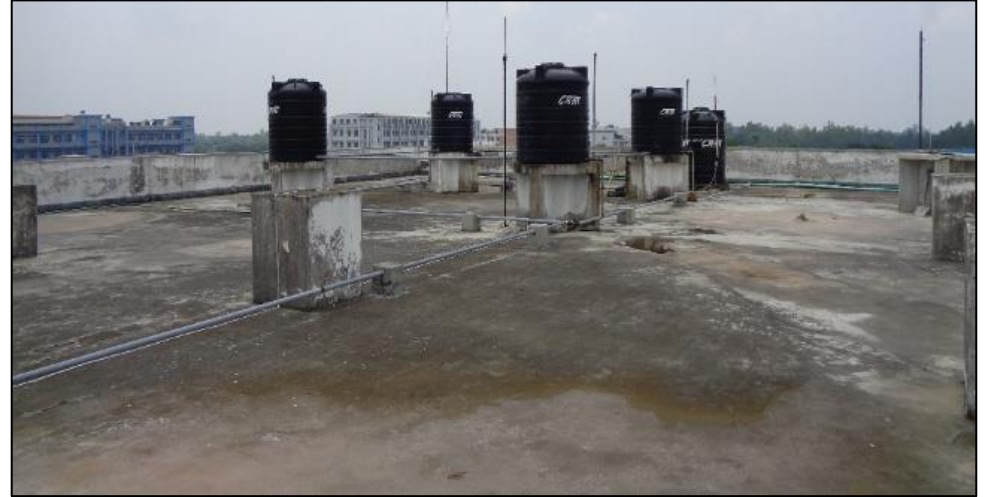
Signage of water ponding

Signage of water ponding found at roof. Factory engineer is required to take necessary measures improve the drainage system with adequate slope to prevent the water ponding at roof.

| Item No. | Observation | Recommended Action Plan | Recommended Timeline |
|---|---|---|---|
| 04 | Signage of water ponding at roof (Building- 1) | Improve the roof drainage system with adequate slope. | 6-weeks |

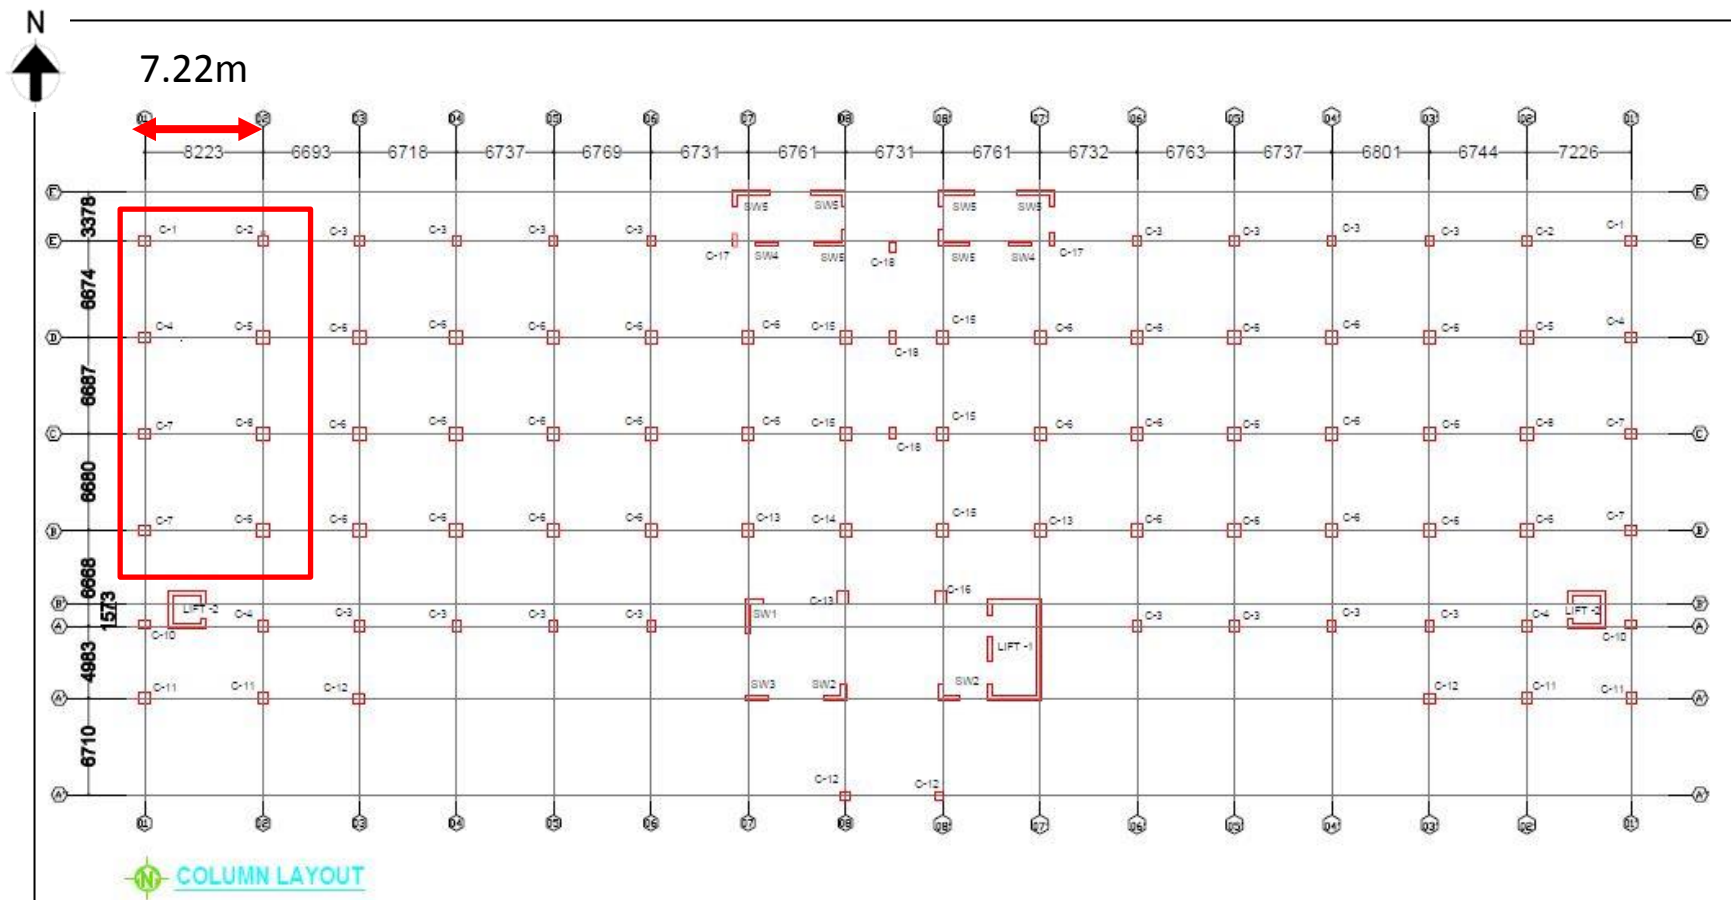
Grid dimension was measured 7.22m instead of 8.22m (marked)

Factory engineer is required to survey the whole structure and update as-built drawing accordingly.

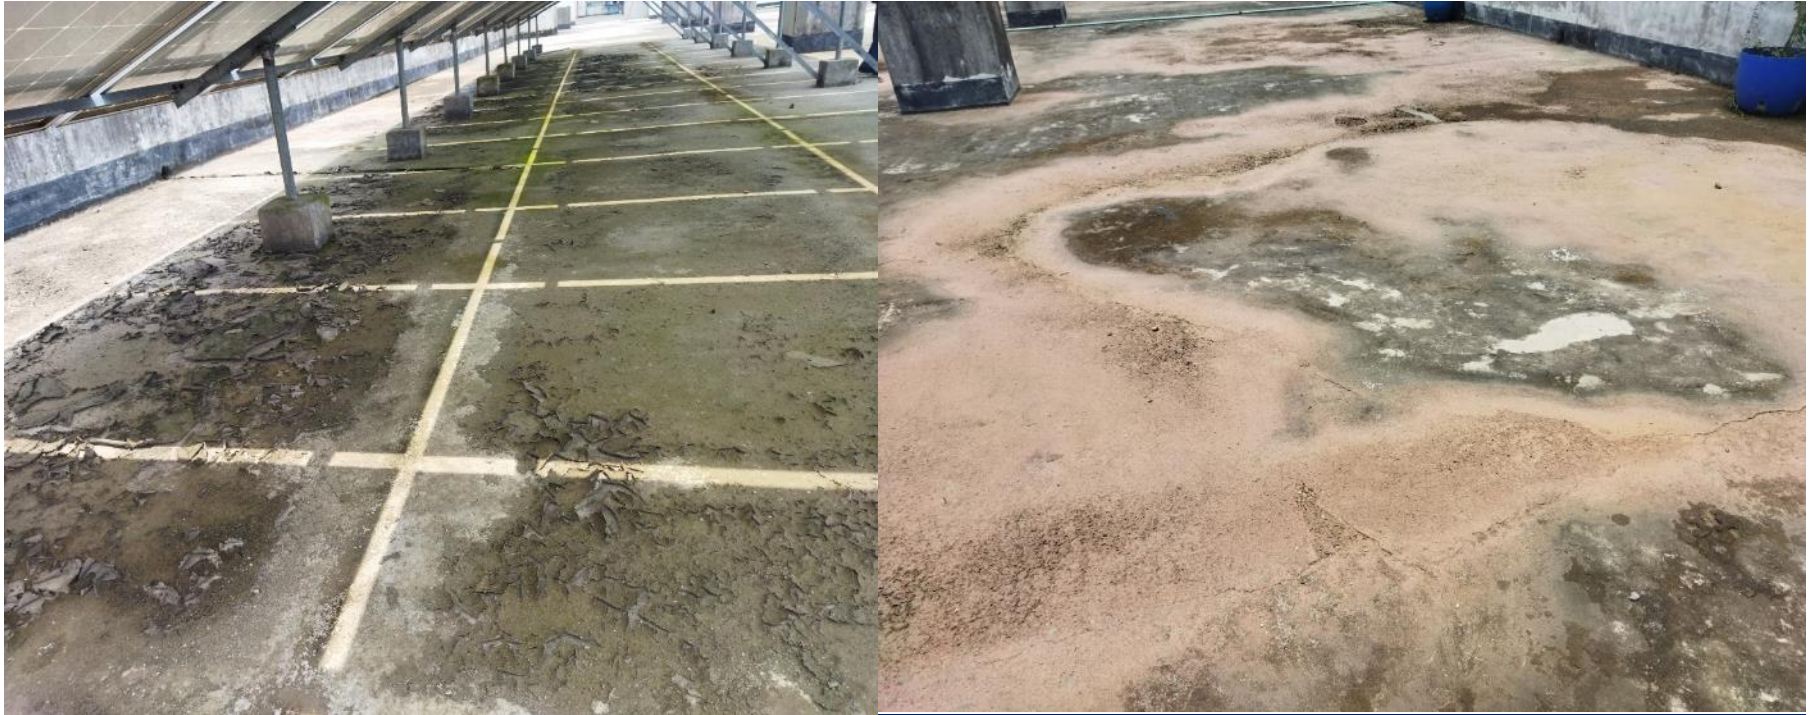
Signage of water ponding on roof slab

Signage of water ponding on roof slab due to poor drainage system. Factory is required to improve drainage system with proper slope to prevent the water ponding on the roof slab.

| Item No. | Observation | Recommended Action Plan | Recommended Timeline |
|---|---|---|---|
| 06 | Signage water ponding on the roof (Building-2). | Factory is required to improve drainage system with proper slope to prevent the water ponding on the roof slab. | 6-weeks |

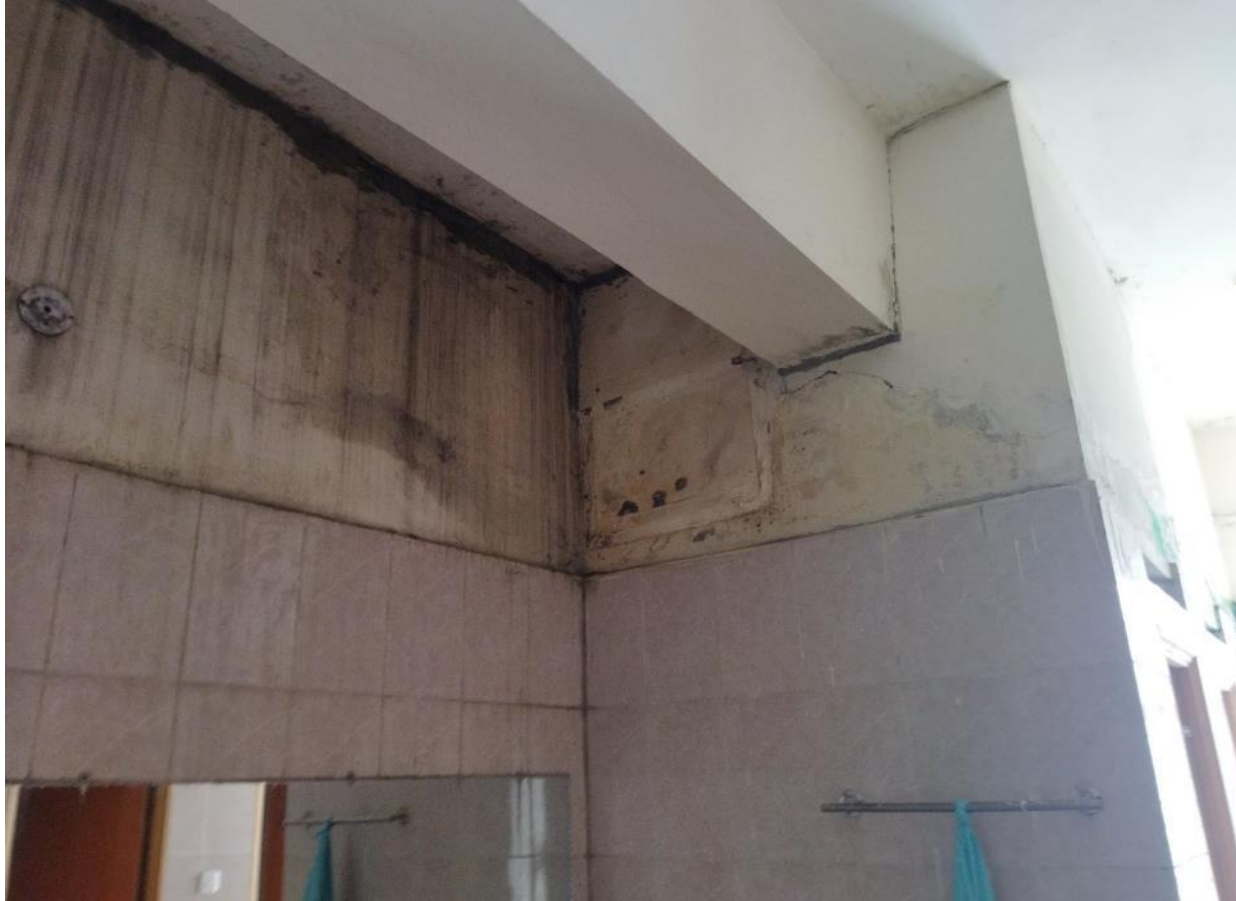
Dampness was found on brick wall at toilet areas (east side). Factory engineer is required to investigate the cause of the dampness and repair as per investigation report.

| Item No. | Observation | Recommended Action Plan | Recommended Timeline |
|---|---|---|---|
| 07 | Dampness in toilet areas (Building-2). | Factory engineer is required to investigate the cause of the dampness and repair the damp areas as per the investigation report. | 6-weeks |

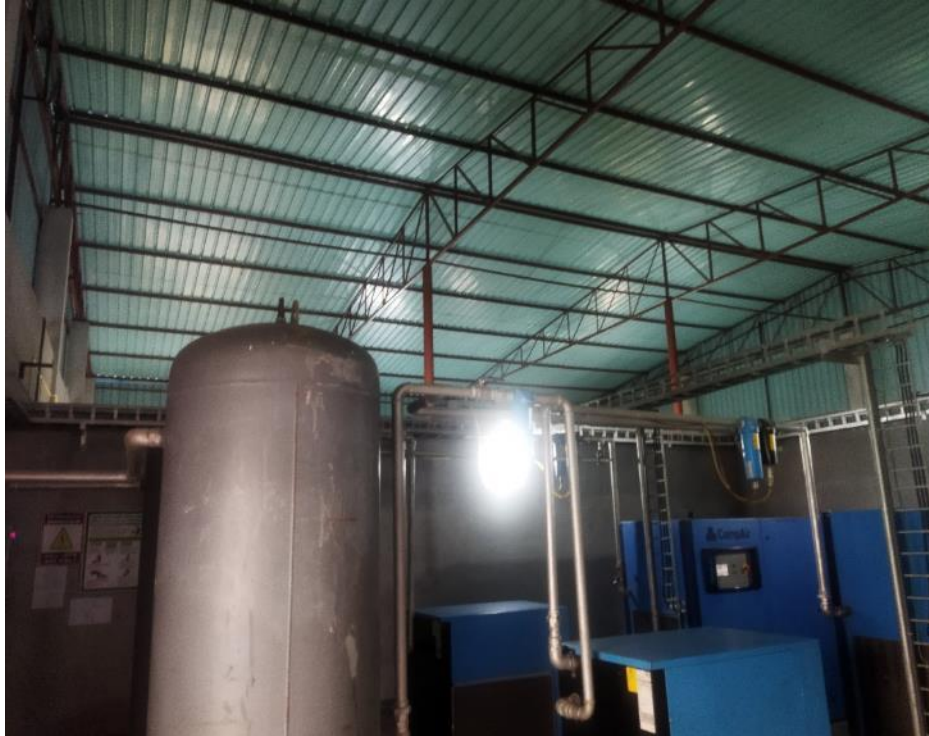
No bracing system/load transfer media provided

No load transfer media provided from frame to frame along long direction. Besides, no roof bracing system is provided therefore there is no obvious lateral stability for this shed. In addition, poor connection was found at truss to column connection. Factory engineer is required to check the stability of the shed against the lateral forces. Also, check the connection adequacy for all connections against uplift forces.

| Item No. | Observation | Recommended Action Plan | Recommended Timeline |
|---|---|---|---|
| 08 | Apparently lack of lateral stability (Building-3) | As part of Engineering Assessment (EA), factory engineer is required to check the lateral stability of the structure and suggested necessary remedial actions. | 6-weeks |
| 09 | Apparently lack of lateral stability (Building-3) | Also, check the connection adequacy against uplift forces. | 6-weeks |
| 10 | Apparently lack of lateral stability (Building-3) | Carry out suggested remediation works as per EA. | 6-Months |

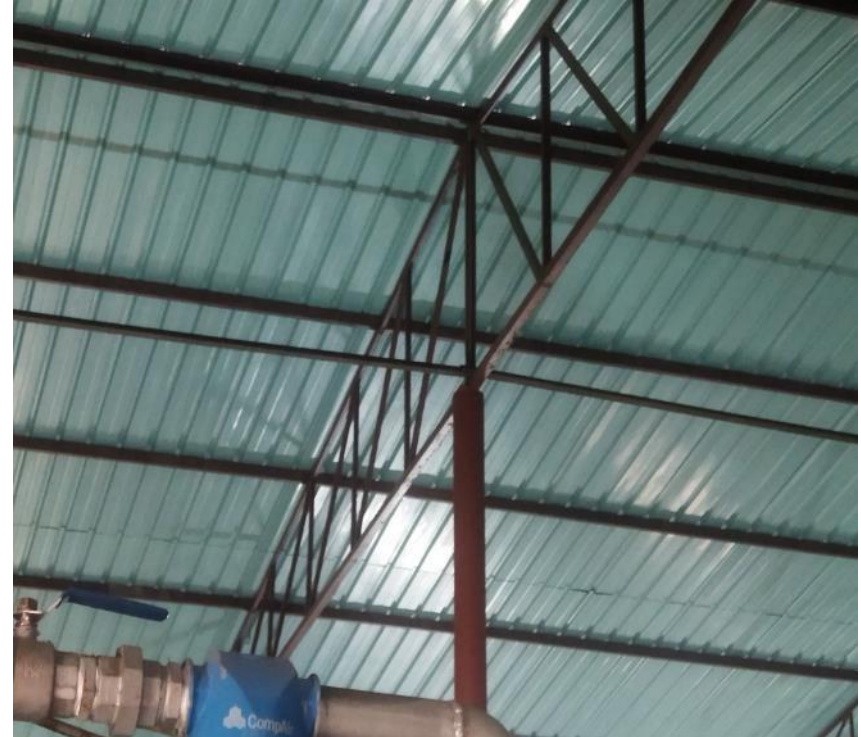
Poor connection at truss to column

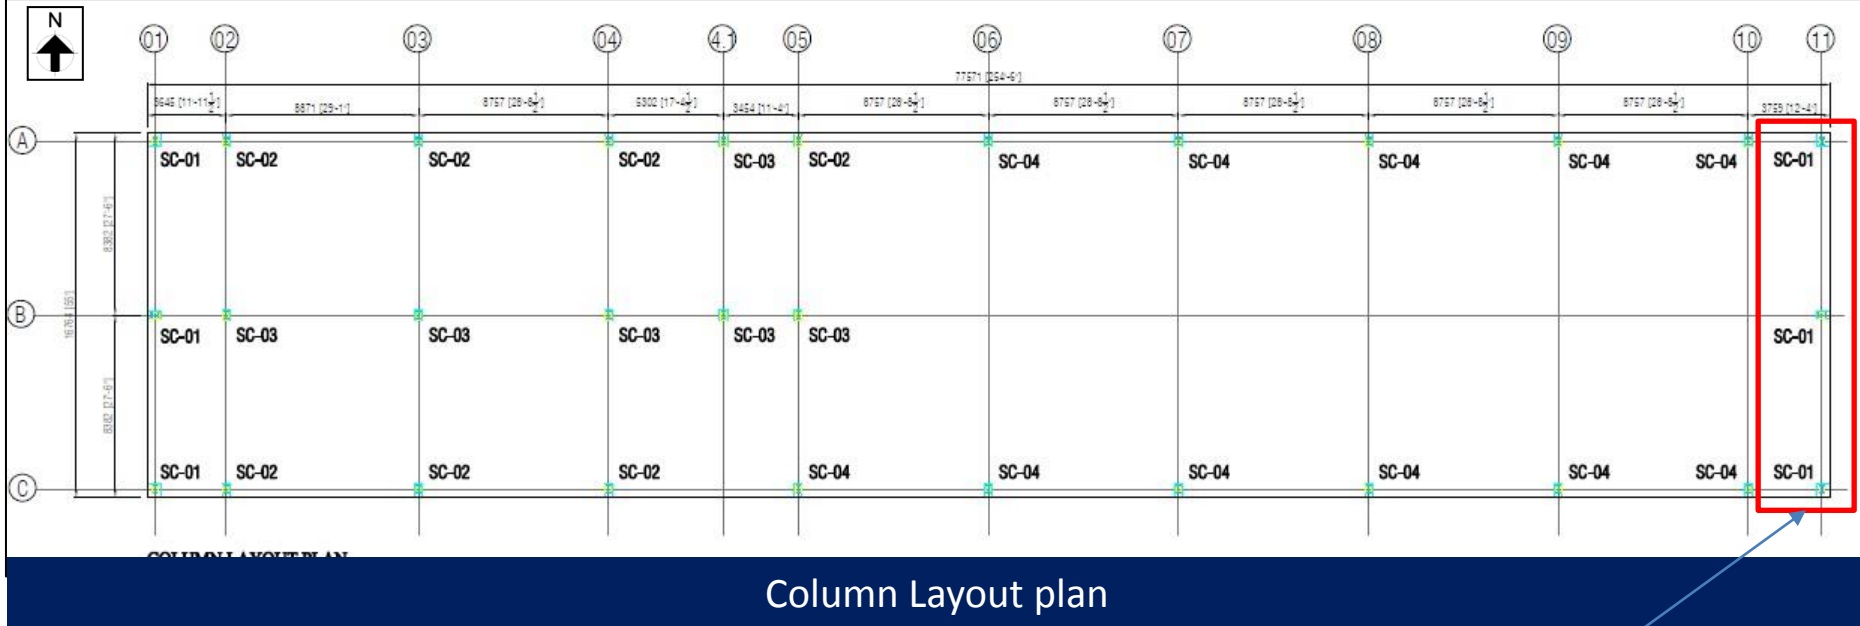
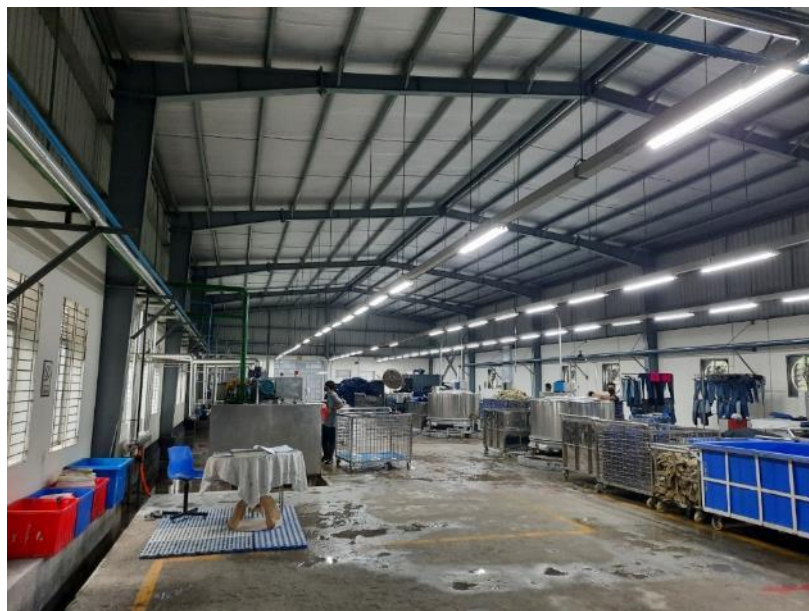
The marked columns at gable end were not found onsite but shown in the drawing.

Factory engineer is required to survey the structures and prepare accurate as-built drawings that follow section 1.9.1.2 of BNBC.

| Item No. | Observation | Recommended Action Plan | Recommended Timeline |
|---|---|---|---|
| 11 | Discrepancies in as-built drawings (Building- 8) | Factory engineer to survey the structure and prepare accurate as-built drawings and design documents as per present condition of the structure following the section 1.9.1 of BNBC. | 6-weeks |

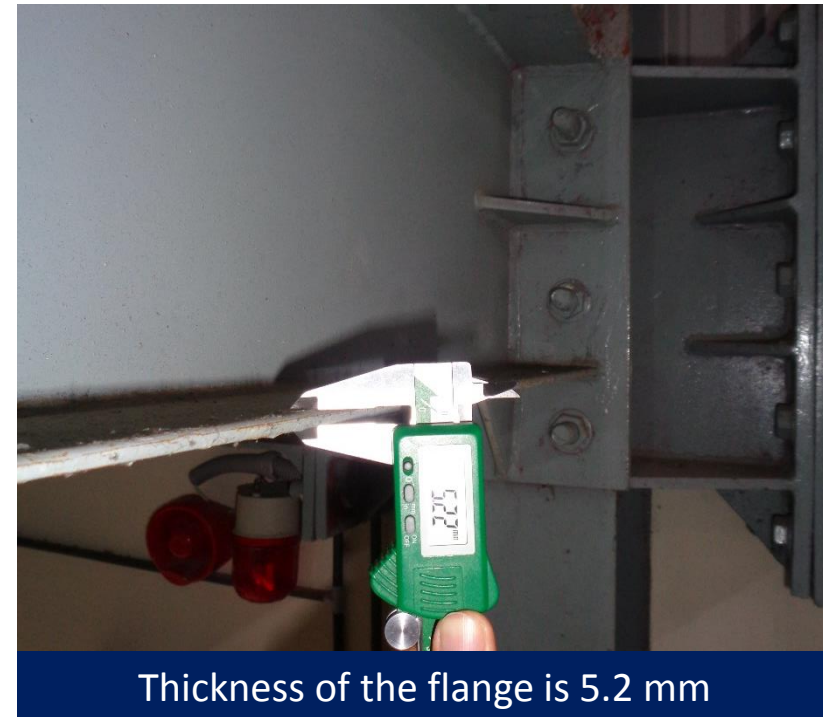
The thickness of the SMB-02 has been shown 6.0 mm in as built drawing. But thickness of the flange was found 5mm on site.

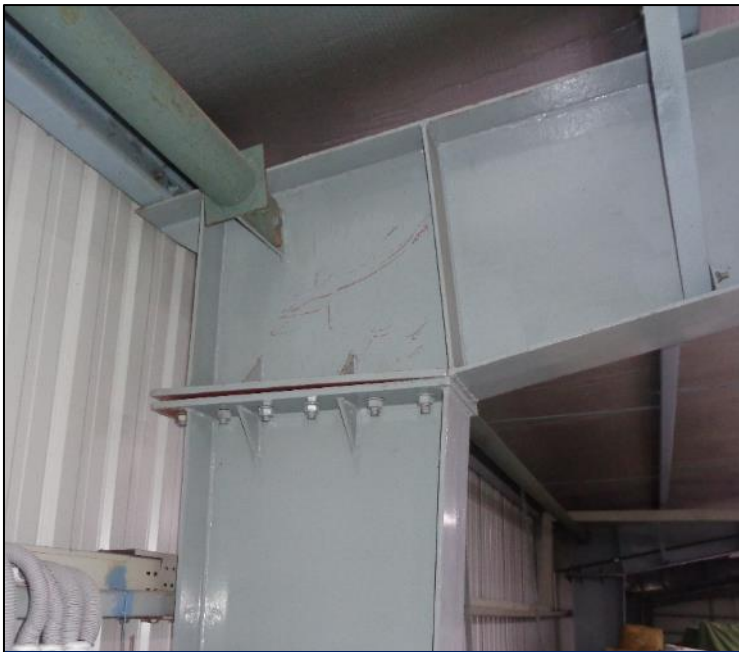
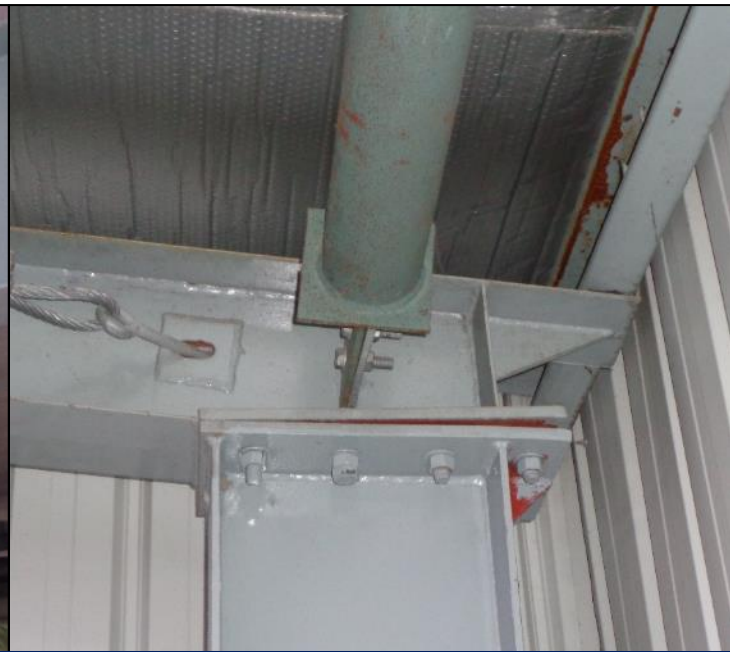
Connection Gap was found at several locations

Significant connection gap and missing bolts observed at column rafter joint at several locations. Factory engineer is required to carry out suitable remedial works.

| Item No. | Observation | Recommended Action Plan | Recommended Timeline |
|---|---|---|---|
| 11 | Significant connection gap and bolt missing at several locations.(Building-8) | Identify the locations and carryout suitable repair works where necessary. | 6-weeks |

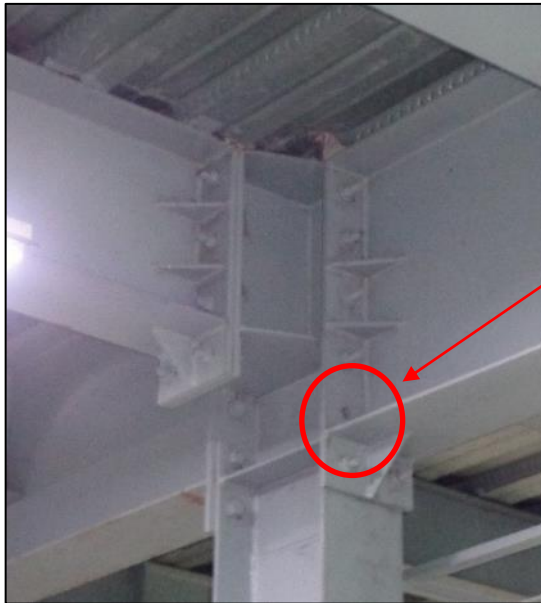
Bolt was missing

| Item No. | Observation | Recommended Action Plan | Recommended Timeline |
|---|---|---|---|
| 12 | Significant connection gap and bolt missing at several locations.(Building-8) | Install the missing bolts as per specification. | 6-weeks |

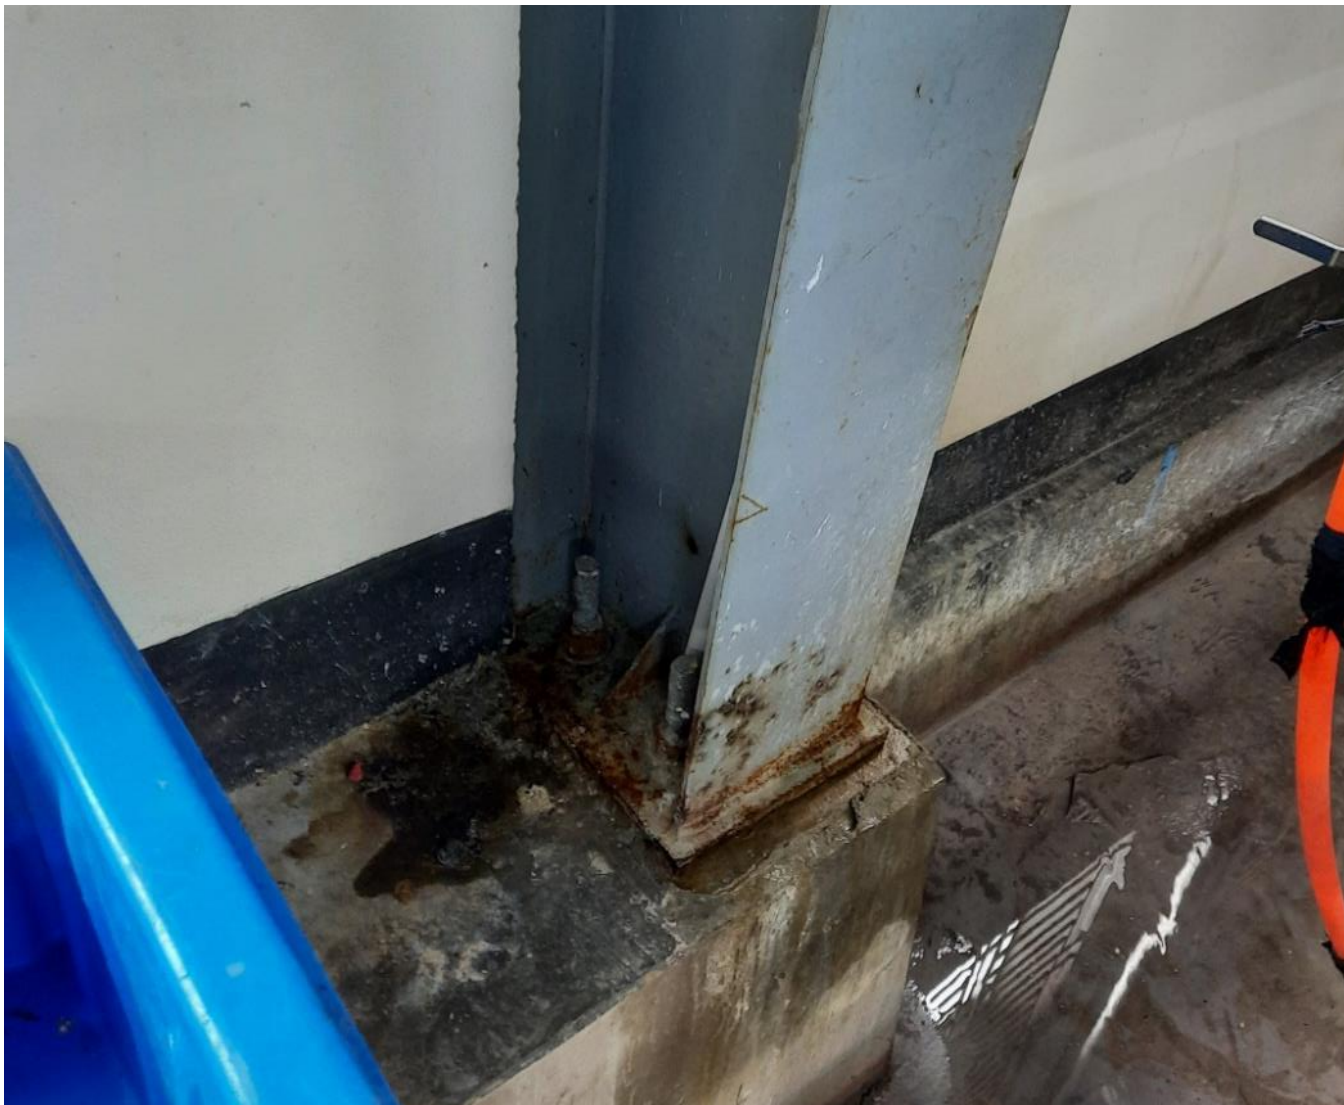
Corrosion in steel column

Corrosion was found in the steel column base. Factory is required to remove the corrosion and apply rust proofing coating on the corroded areas to protect the steel members from corrosion.

| Item No. | Observation | Recommended Action Plan | Recommended Timeline |
|---|---|---|---|
| 12 | Corrosion in steel column (Building-8) | Factory is required to remove the corrosion and apply rust proof coating to the corroded steel members. | 6-weeks |

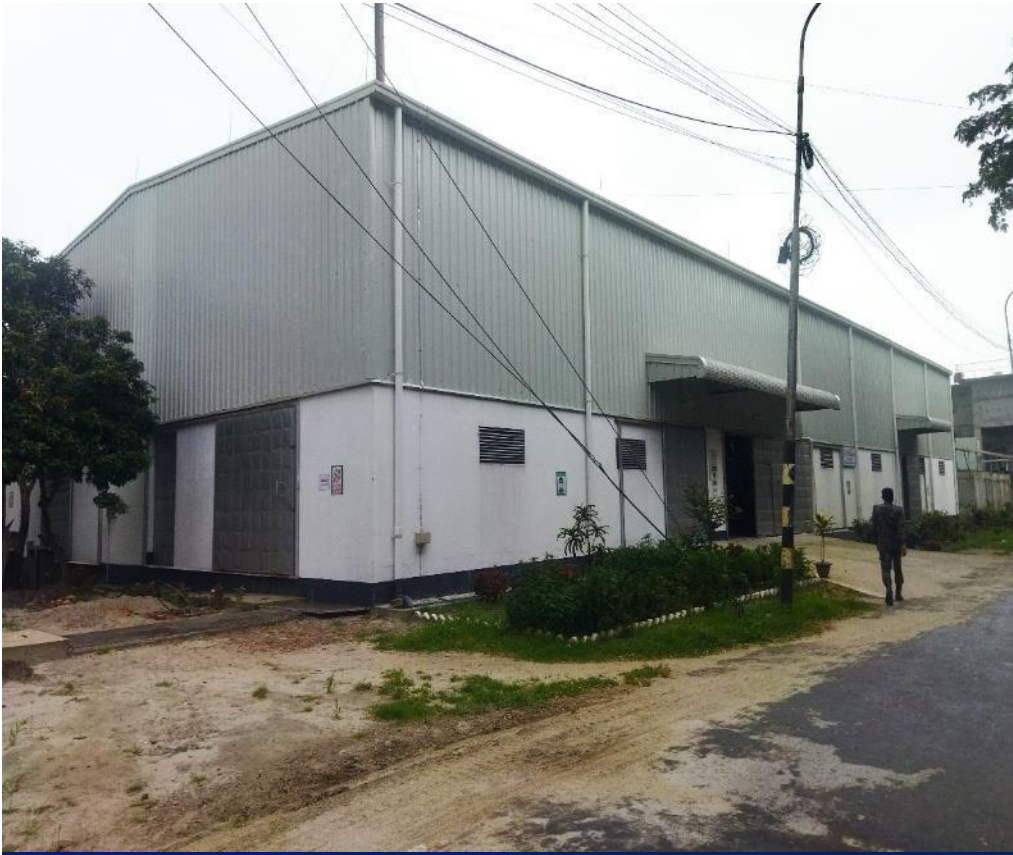
Building-9 (Utility Shed-2)

As per BNBC, every building or structure designed shall have its design documents prepared in accordance with the provision of Section 1.9.1. The design document shall include a design report, and a set of structural drawings, which shall be prepared in compliance with section 1.9.1.1 and section 1.9.1.2 as per BNBC. At the time of inspection, design report was not available. Factory engineer is required to prepared a design report in compliance with section 1.9.1.1 (BNBC).

| Item No. | Observation | Recommended Action Plan | Recommended Timeline |
|---|---|---|---|
| 14 | Absence of design documents (Building-9) | Factory engineer is required to prepared a design report in compliance with section 1.9.1.1 (BNBC). | 6-weeks |
| 15 | Absence of design documents (Building-9) | Implement remediation work if required from design report. | 6-weeks |

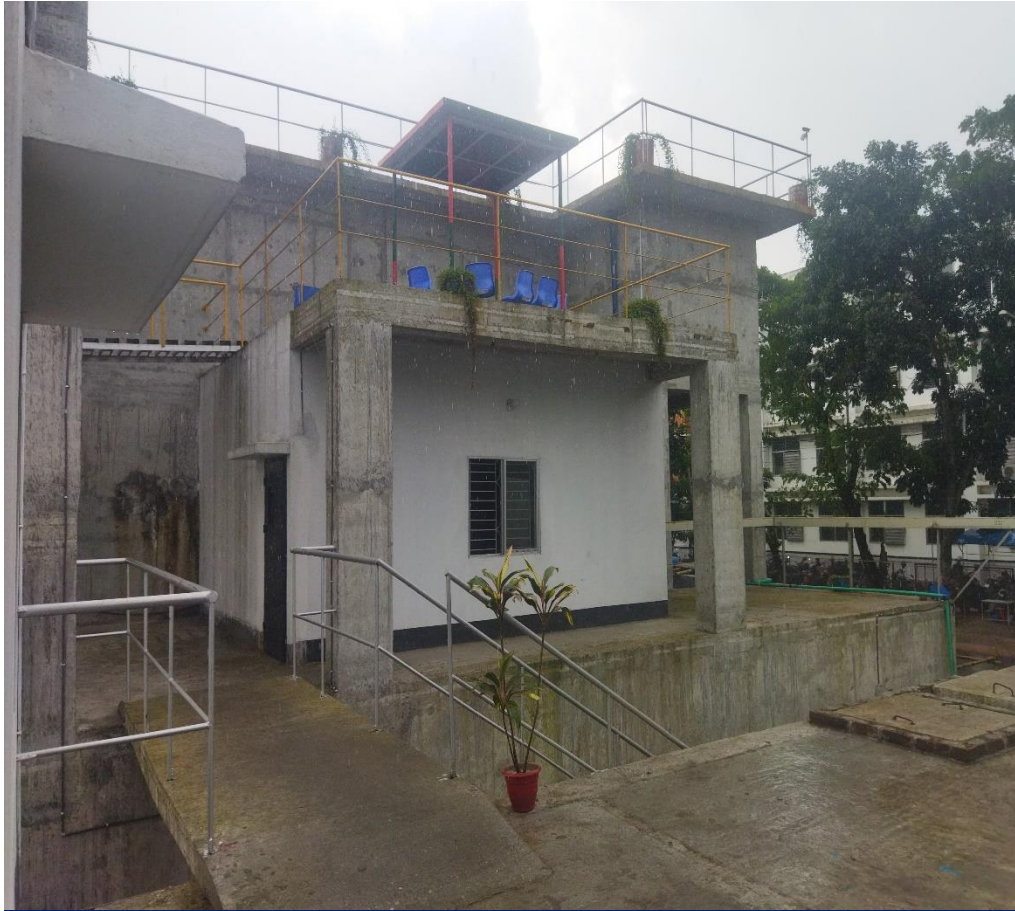
Building-10 (ETP & WTP)

As per BNBC, every building or structure designed shall have its design documents prepared in accordance with the provision of Section 1.9.1. The design document shall include a design report, and a set of structural drawings, which shall be prepared in compliance with section 1.9.1.1 and section 1.9.1.2 as per BNBC. At the time of inspection, design report was not available. Factory engineer is required to prepared a design report in compliance with section 1.9.1.1 (BNBC).

| Item No. | Observation | Recommended Action Plan | Recommended Timeline |
|---|---|---|---|
| 16 | Absence of design documents (Building-10) | Factory engineer is required to prepared a design report in compliance with section 1.9.1.1 (BNBC). | 6-weeks |
| 17 | Absence of design documents (Building-10) | Implement remediation work if required from design report. | 6-weeks |
