# KDS Apparels Ltd. (Extension)

251-252, Nasirabad I/A, Baizid Bostami Road, Chattogram, Bangladesh  
(22.392195, 91.819786)

21 July 2022

**Block-C Building:** Partially 6 storied (G+5) building.

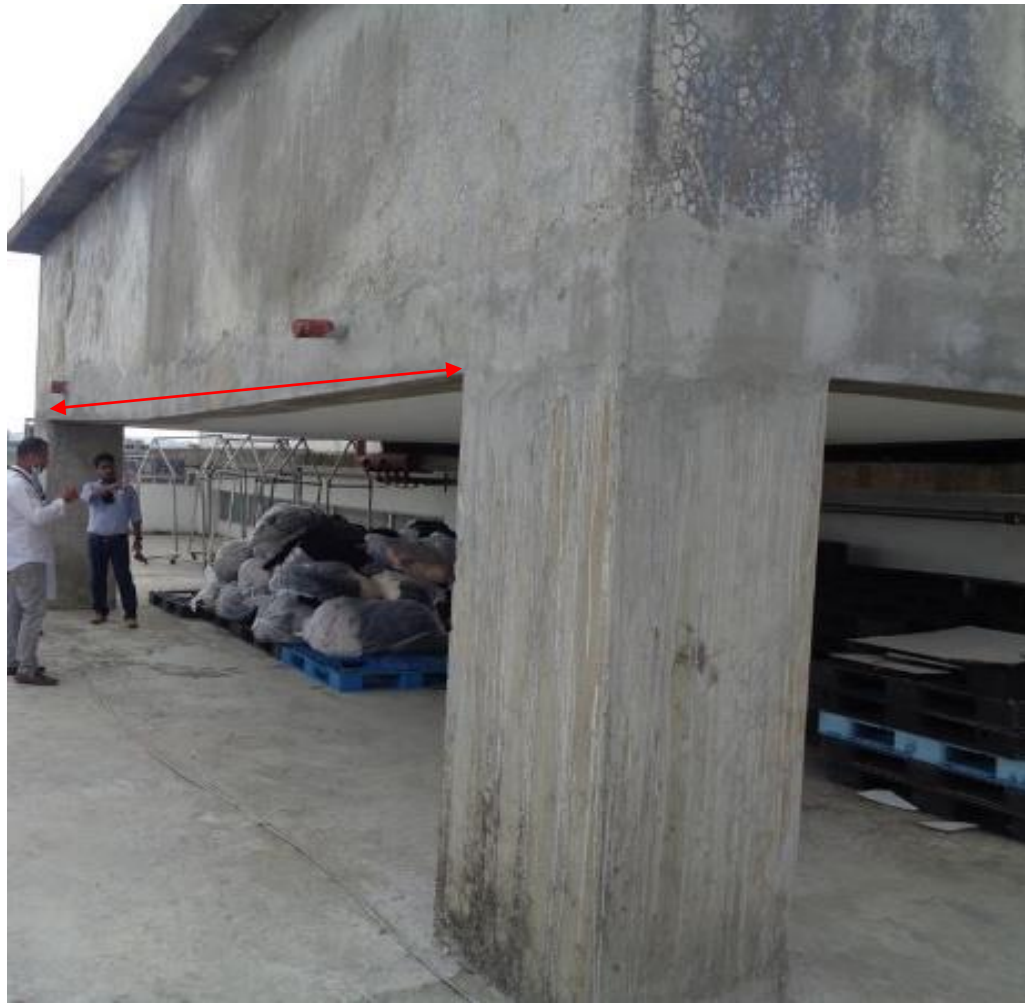
Deflection at Inverted beam of OHWT

Deflection at Inverted slab of OHWT was observed. Building engineer is required to check whether the deflection cross the normal design limit or not and take necessary action as per engineer's guideline.

| Item No. | Observation | Recommended Action Plan | Recommended Timeline |
|---|---|---|---|
| 01 | Deflected of slab under the overhead water tank. [Block-C (RC part)] | Building engineer is required to check the adequacy of OHWT slab to confirm deflection is within the allowable limit. | 6-weeks |
| 02 | Deflected of slab under the overhead water tank. [Block-C (RC part)] | Produce and actively manage a loading plan for the OHWT and maintain accordingly. | 6-weeks |
| 03 | Deflected of slab under the overhead water tank. [Block-C (RC part)] | Carry out remedial works if required. | 6-months |

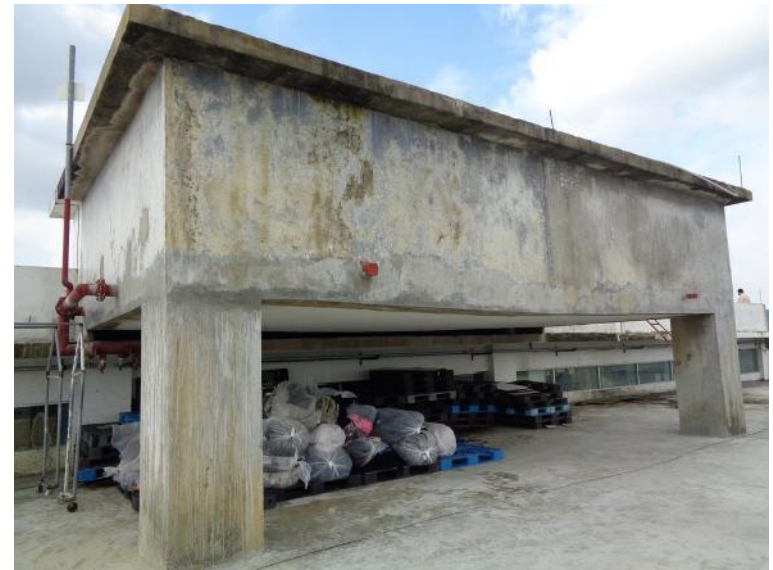
Deflection at slab

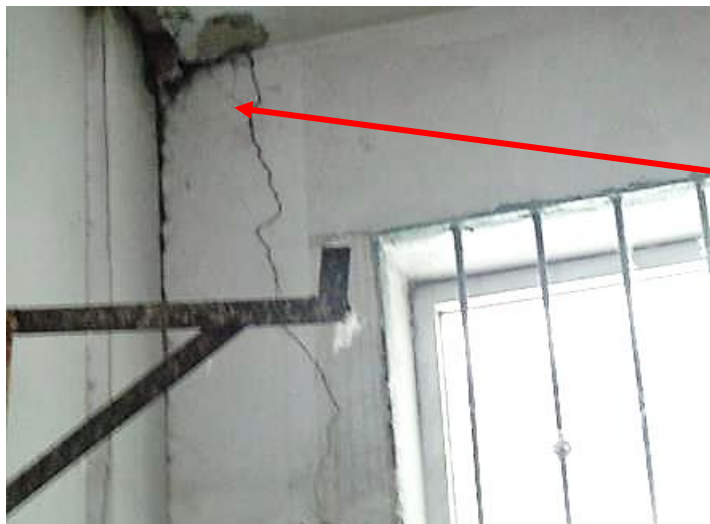
Zoom view of crack

Crack was observed at brick wall. Building engineer is required to check the intensity of crack and suggest proper repair methodology.

| Item No. | Observation | Recommended Action Plan | Recommended Timeline |
|---|---|---|---|
| 05 | Crack on brick wall. [Block-C (RC part)] | Building engineer is required to check the extent of crack and suggest proper repair methodology. | 6-weeks |
| 06 | Crack on brick wall. [Block-C (RC part)] | Carry out remedial works. | 6-months |

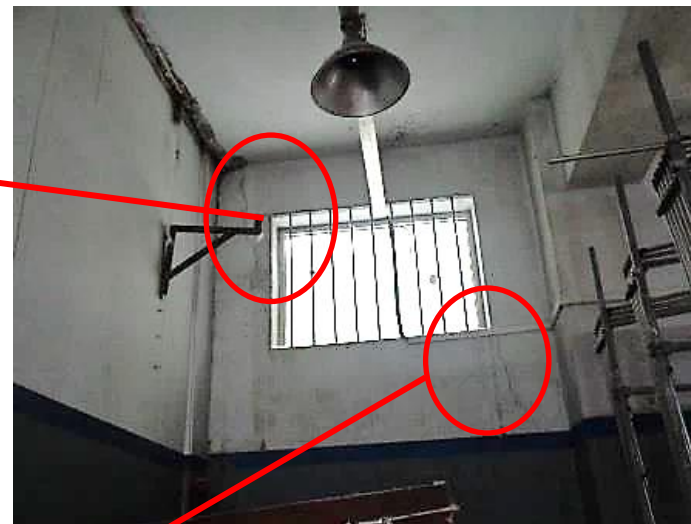
Cracks on wall

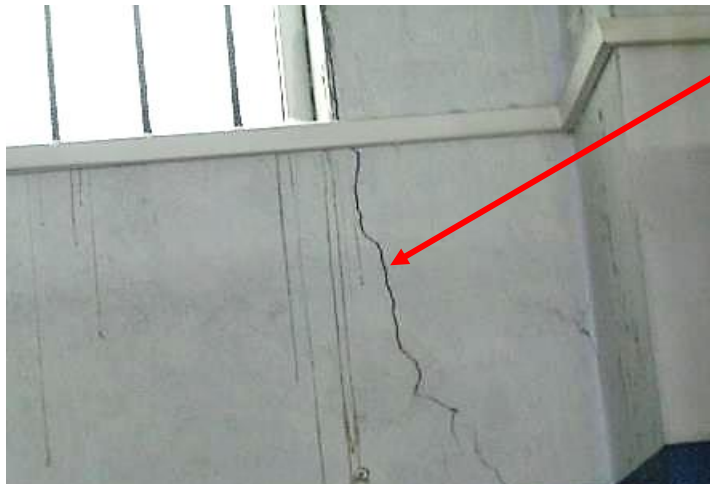
Zoom view of crack

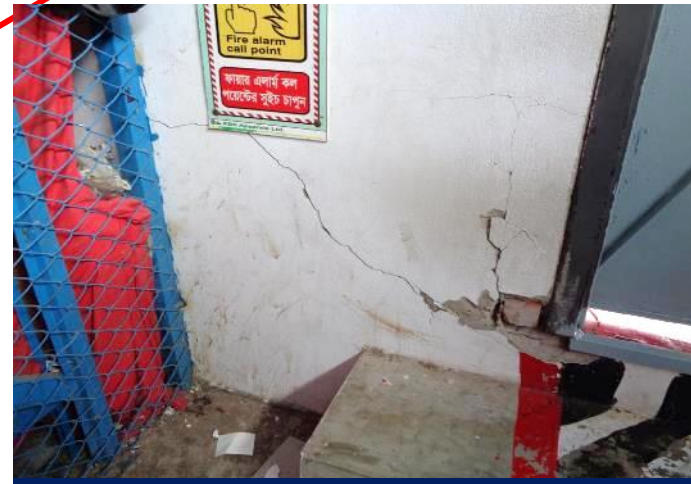
Cracks on wall

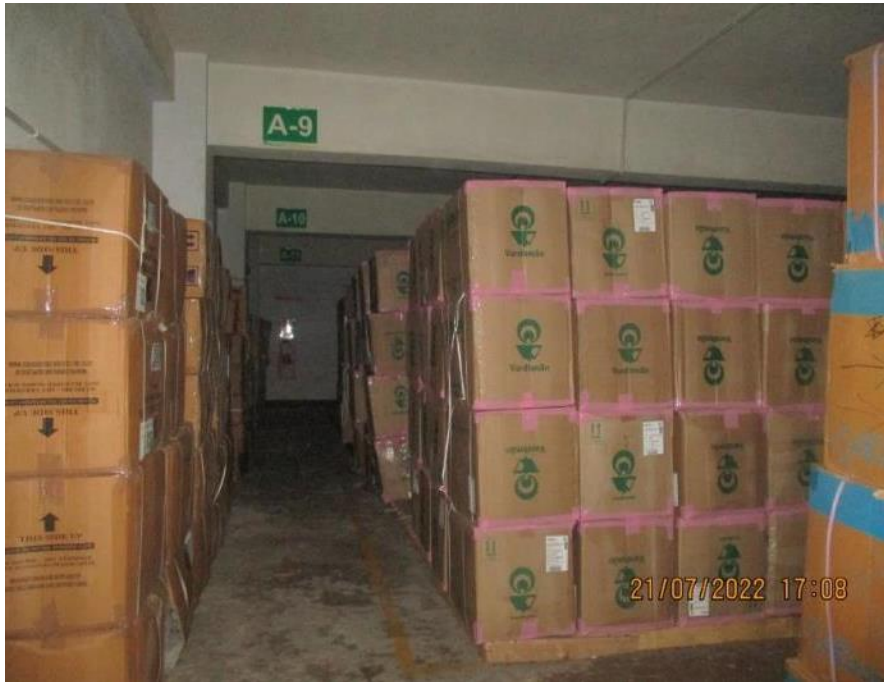
Yarn store (2<sup>nd</sup> Floor), RC part

As per prepared load plan, allowable live load limit of 2<sup>nd</sup> floor (Yarn store) is 7.5 kPa. But, at the time of inspection calculated localize loading was found more than 7.5 kPa.

| Item No. | Observation | Recommended Action Plan | Recommended Timeline |
|---|---|---|---|
| 07 | Localized high loading on 2nd floor.<br>[Block-C] | Factory engineer to investigate the floor loading arising from storage and advise on any necessary alterations taking account of floor capacity and column capacity. | 6-weeks |
| 10 | Localized high loading on 2nd floor.<br>[Block-C] | Make any structural alterations as advised by factory engineer. | 6-months |

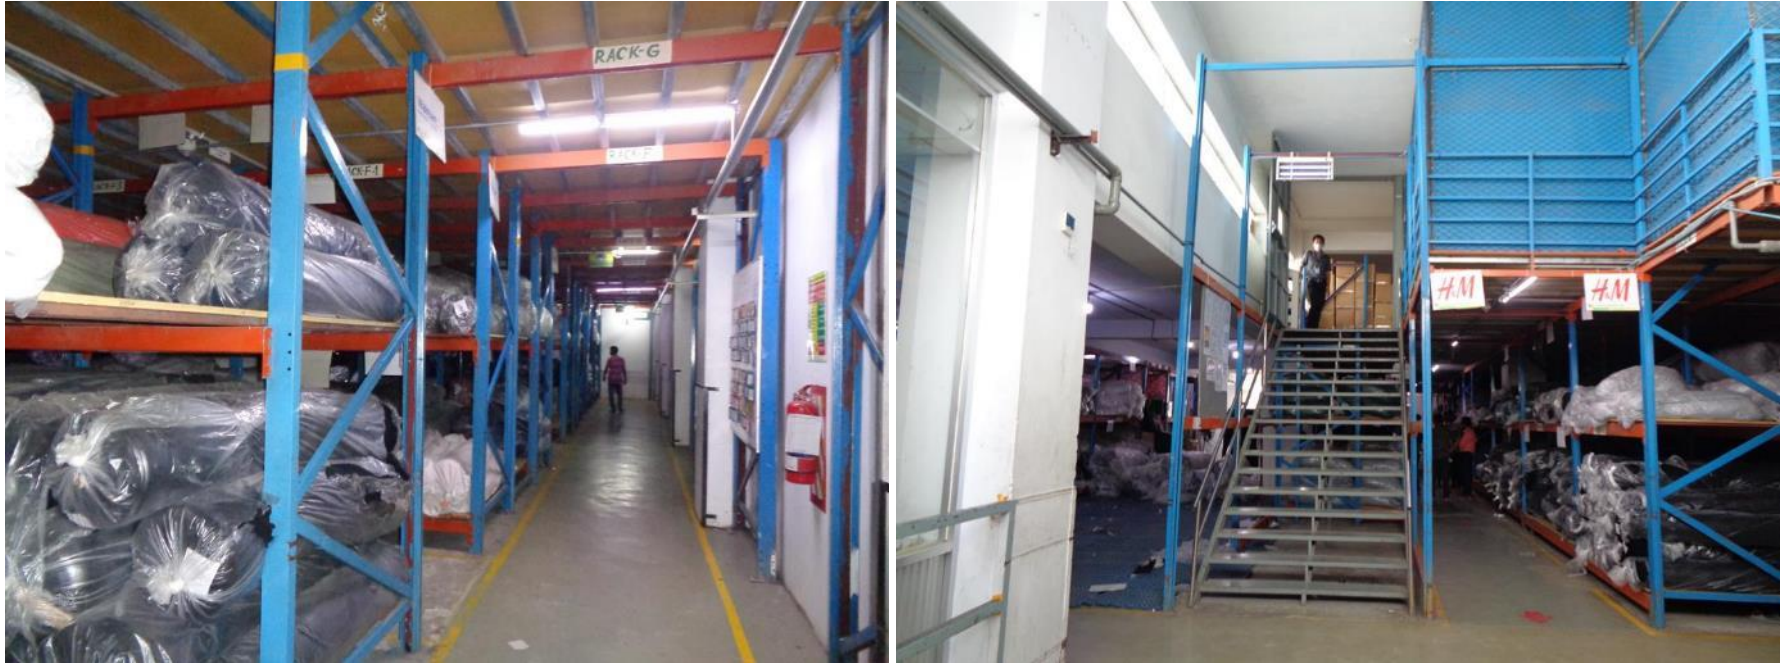
Storage rack (5<sup>th</sup> Floor), RC part

Storage rack has no allowable loading limit. Also, the rack has no adequate anchorage.

| Item No. | Observation | Recommended Action Plan | Recommended Timeline |
|---|---|---|---|
| 08 | Localized high loading on 2nd floor.<br>[Block-C] | Check the adequacy of steel storage rack. | 6-weeks |
| 09 | Localized high loading on 2nd floor.<br>[Block-C] | Adequately anchor and brace all non-structural elements to resist earthquake forces to comply with the BNBC. | 6-weeks |

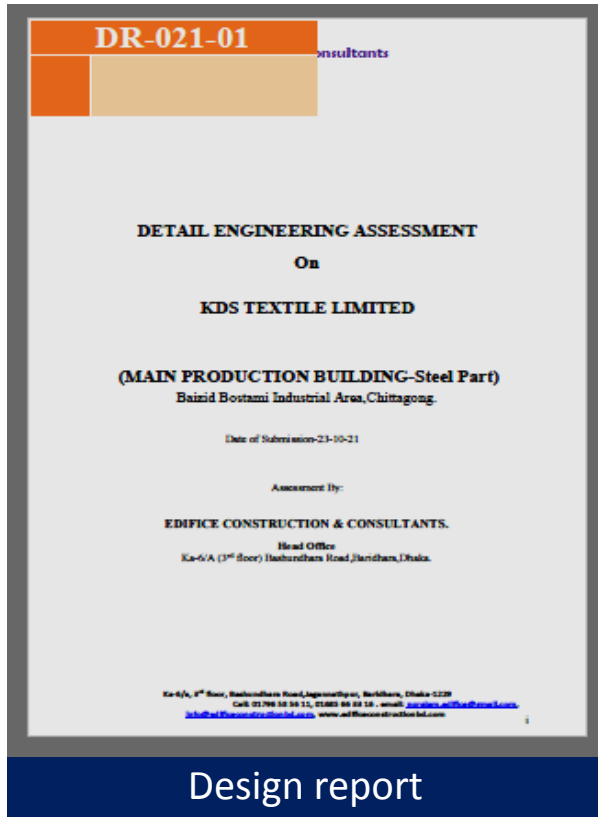
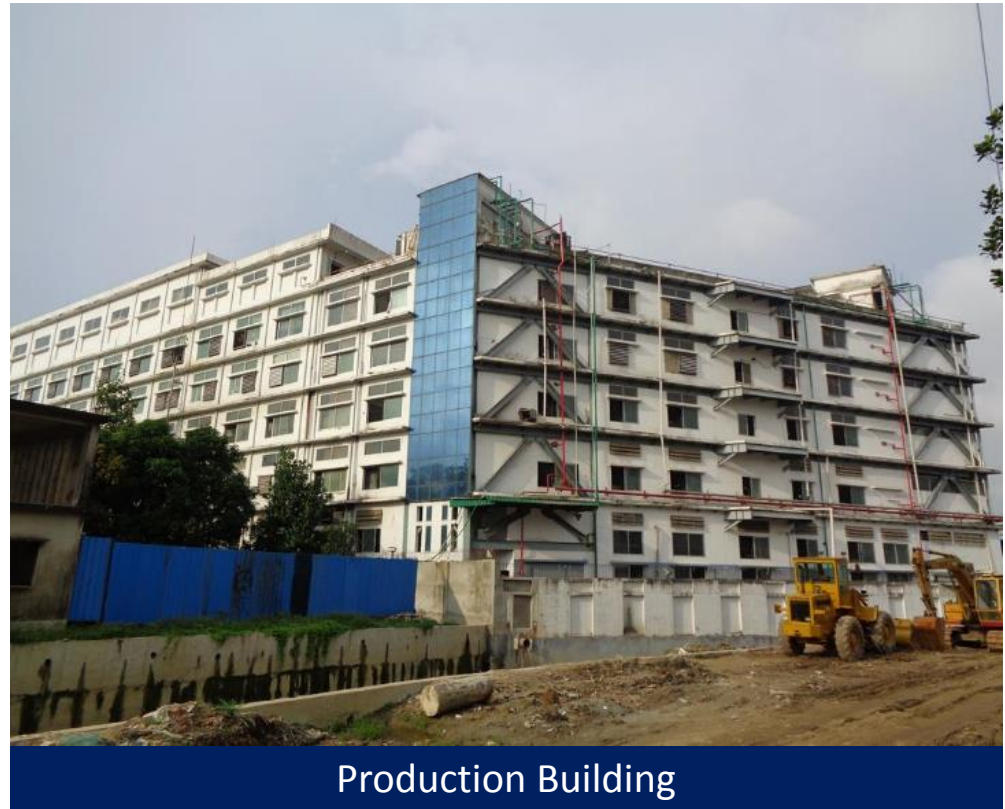
A Detail Engineering Assessment (DEA) report was provided for the Block-C (Steel Part) at the time of inspection which was prepared based on software analysis. Adequacy of sub beams, vertical bracings (I-section) and serviceability checks as per BNBC were not incorporated in the DEA report.  
Factory is required incorporate all type of adequacy check in the DEA report.

| Item No. | Observation | Recommended Action Plan | Recommended Timeline |
|---|---|---|---|
| 12 | Information missing in the DEA report.<br>[Block-C (Steel part)] | Factory is required incorporate all type of adequacy check in the DEA report and the report should be in compliance with section 1.9.1 of BNBC (part 6). | 6-weeks |
| 13 | Information missing in the DEA report.<br>[Block-C (Steel part)] | Carry out remedial works (if any) after reviewed by the RSC. | 6-months |

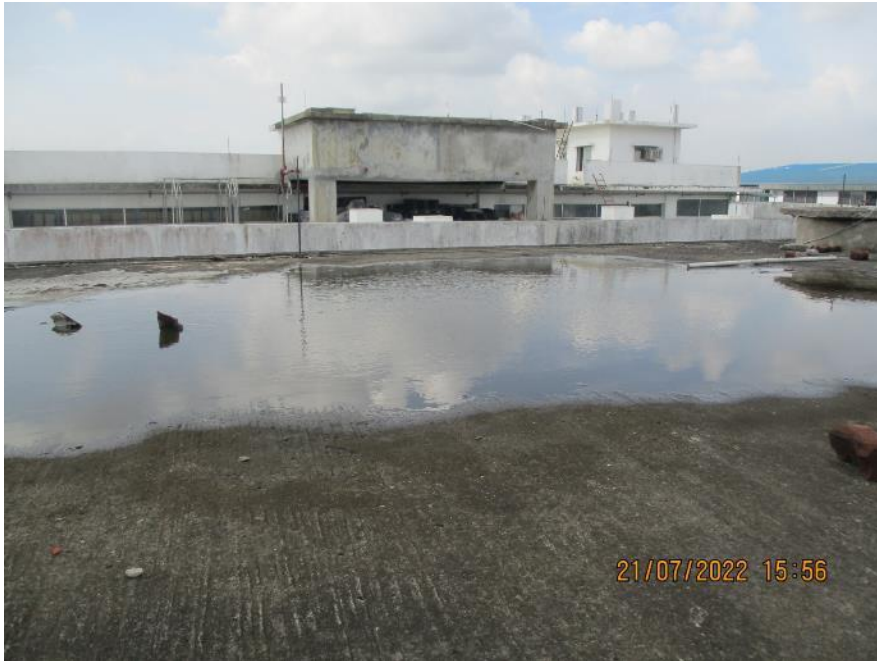
Standing water on the roof of RO plant

Standing water & growth of algae/ vegetation on roof floor due to improper drainage system. Factory engineer is required to provide adequate slope to wash out the water.

| Item No. | Observation | Recommended Action Plan | Recommended Timeline |
|---|---|---|---|
| 14 | Standing water on the roof and floor of RO plant. [Block-C (Steel part)] | Factory engineer is required to develop roof drainage system with adequate slope and outlets. | 6-weeks |

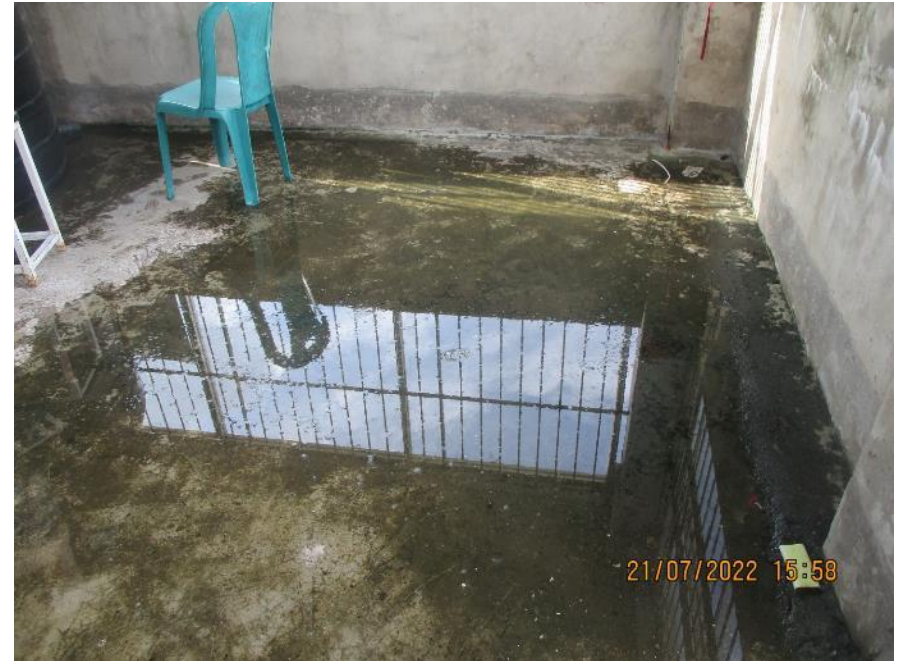
Standing water on the floor of RO plant

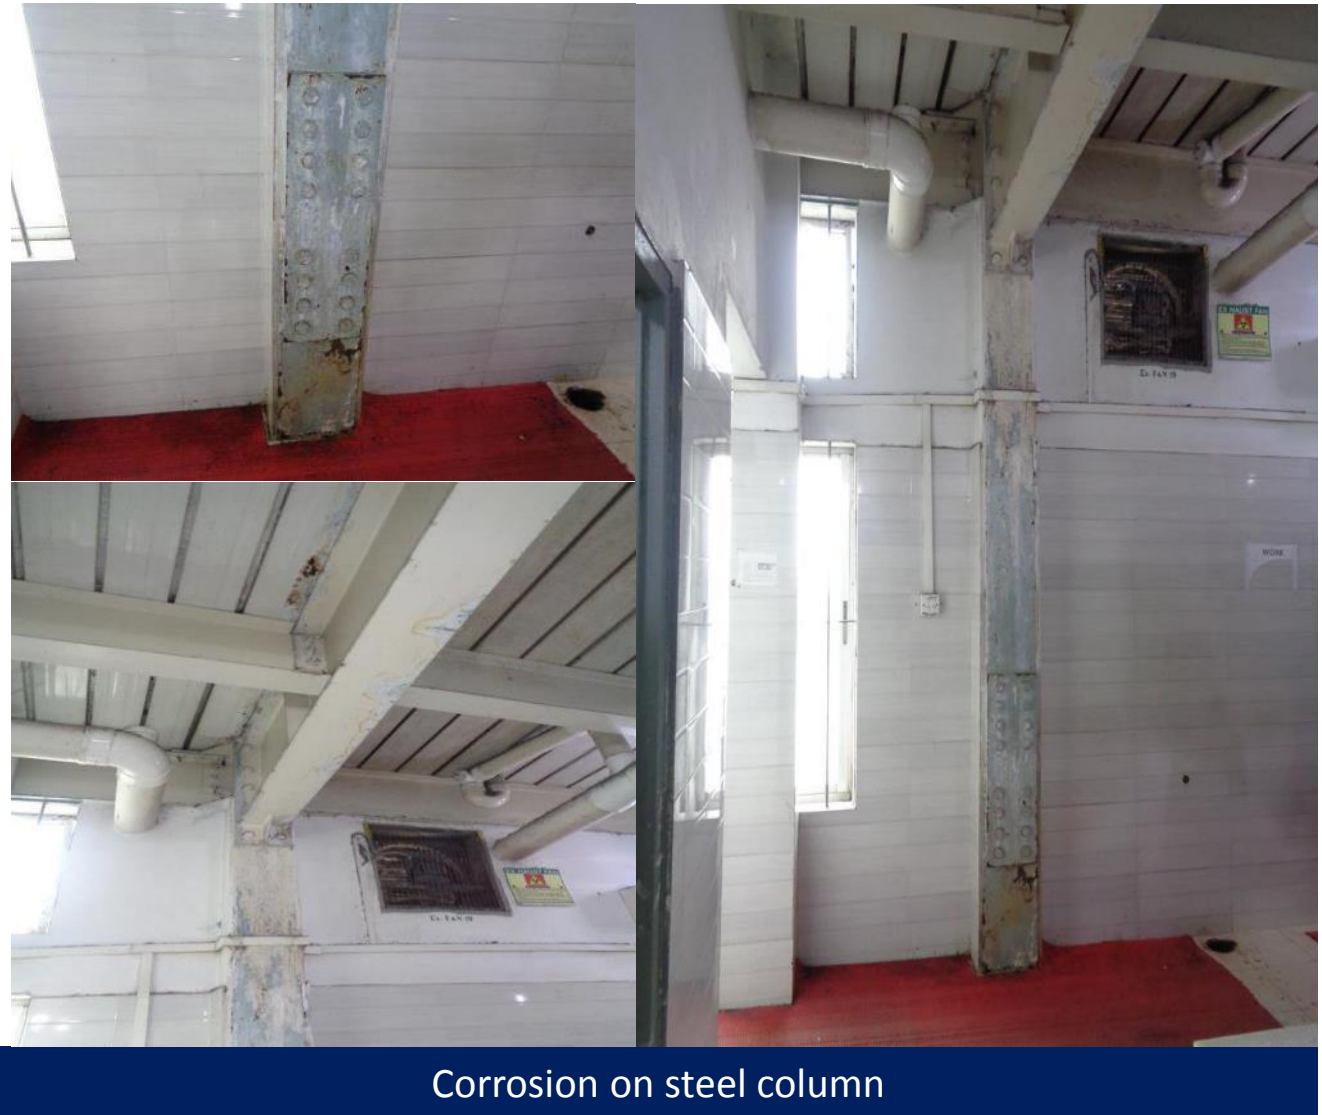
Corrosion was found on steel column at toilet zone. The building engineer to investigate the reason of corrosion and suggest proper remedial measure accordingly.

Corrosion on steel column

| Item No. | Observation | Recommended Action Plan | Recommended Timeline |
|---|---|---|---|
| 15 | Corrosion on steel column at toilet zone. [Block-C (Steel part)] | The building engineer to investigate the reason of corrosion and suggest proper remedial measure accordingly. | 6-weeks |
| 16 | Corrosion on steel column at toilet zone. [Block-C (Steel part)] | Remove rust from affected steel member and apply corrosion resistance coating to the steel member. | 6-weeks |

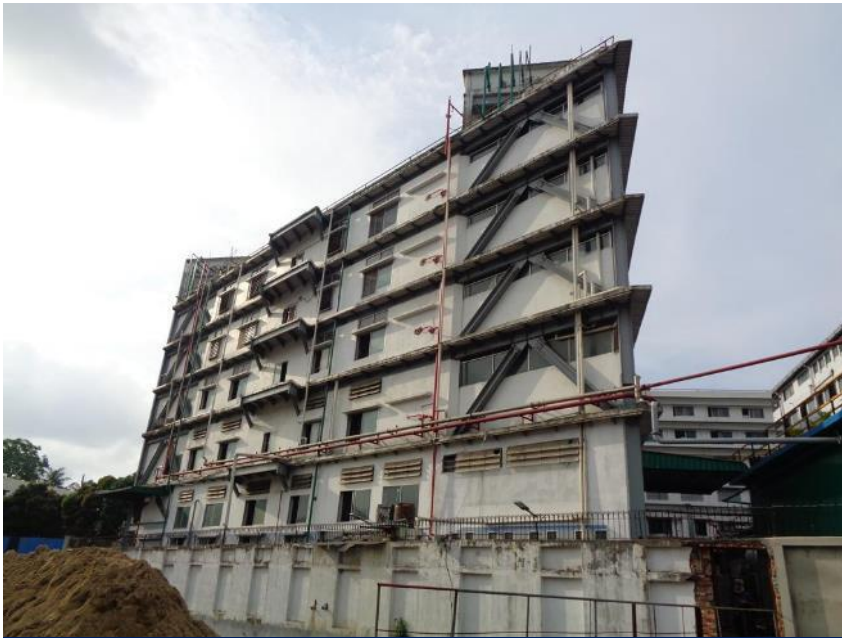
Vertical bracing (I-section)

No information related to vertical bracing details in the as built drawing of Block-C (Steel Part).

| Item No. | Observation | Recommended Action Plan | Recommended Timeline |
|---|---|---|---|
| 17 | Lack of information in as-built drawing. [Block-C (Steel part)] | Building engineer is survey the whole structure and prepare accurate as-built drawings with structural details. | 6-weeks |

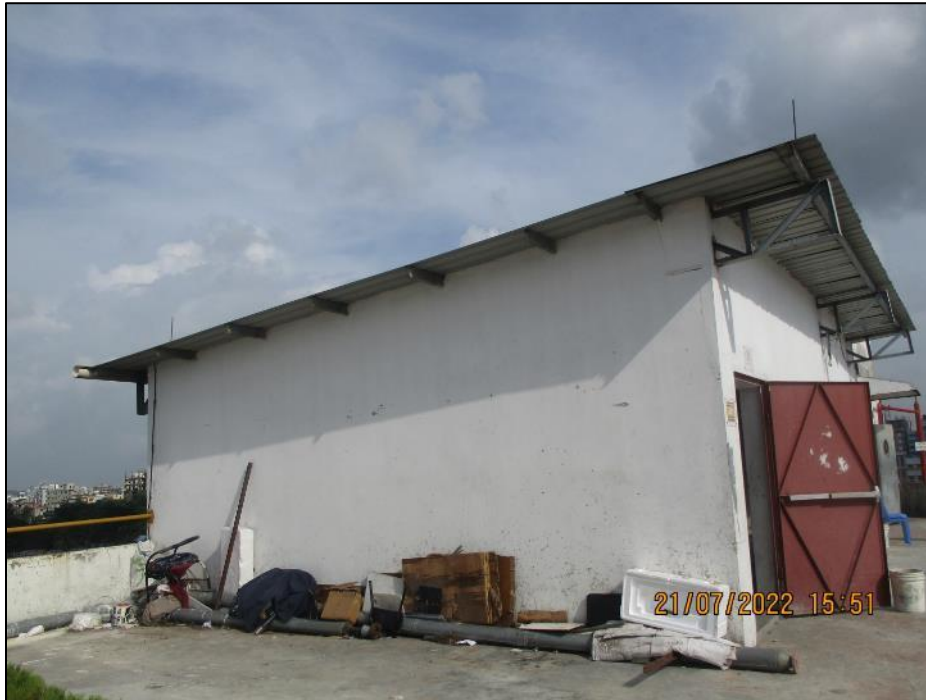
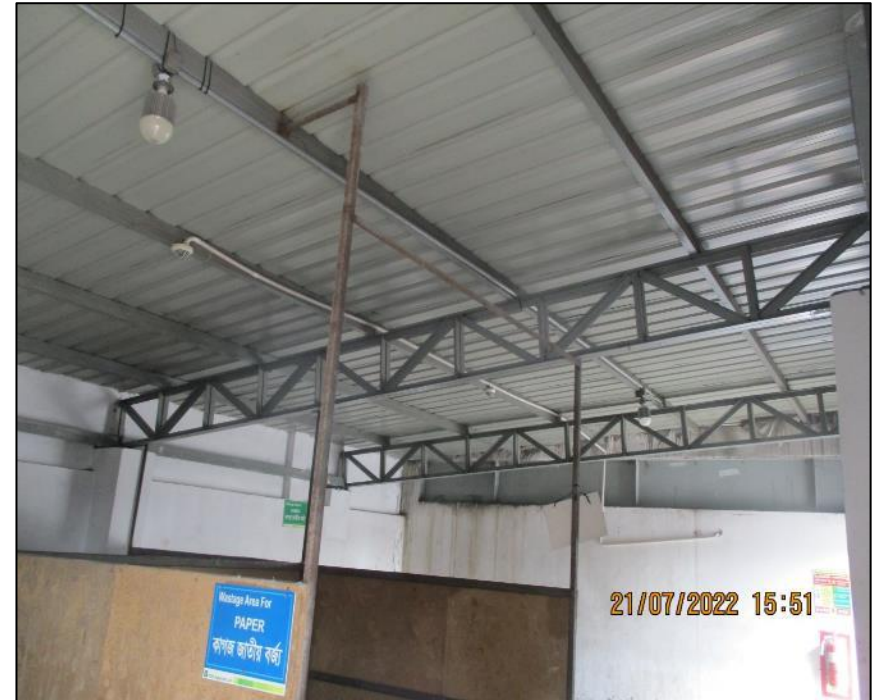
Wastage storage area

No information related to wastage storage area in the as built drawing of Block-C (Steel Part). Factory engineer is required to survey the whole structure and to prepare accurate as-built drawing. Also, check the connection adequacy for uplift forces.

| Item No. | Observation | Recommended Action Plan | Recommended Timeline |
|---|---|---|---|
| 18 | Lack of information in as-built drawing. [Block-C (Steel part)] | Check for the connection adequacy of truss support for uplift forces and suggest proper remedial actions accordingly. | 6-weeks |
