# A.T.S. Apparels Ltd

414, Kouchakuri, Telirchala, Mouchak, Kaliakoir, Gazipur - 1751  
(24.01690N, 90.30266E)

25 March 2014

# Observations

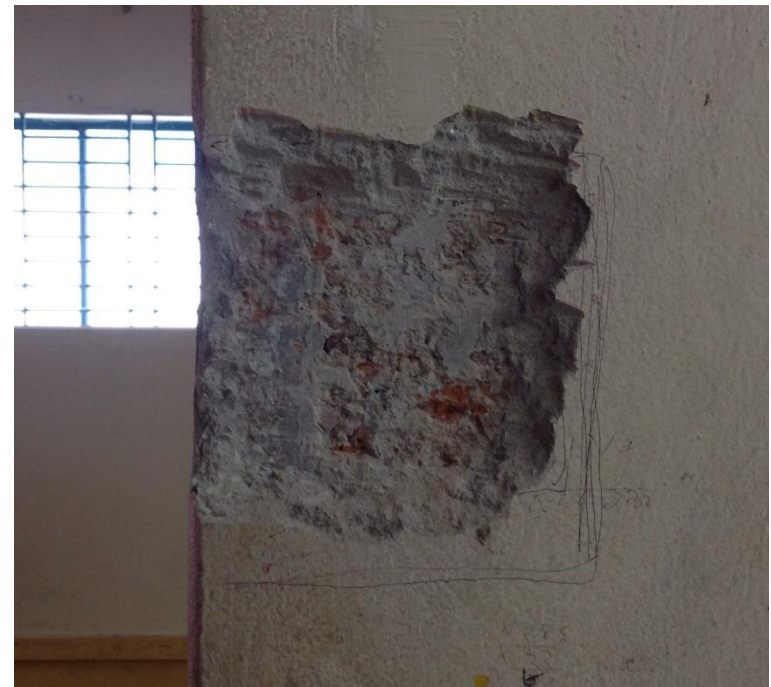
**Columns appear to be stressed in excess of normal design limits – Building Engineer to verify concrete stresses and in-situ concrete strength**

Tested Ground Floor Column C2 (2007) Brick Aggregate Noted.

Cursory calculations indicate that the working stress of columns at Ground Floor level are at a high level.

Building Engineer to check that columns have been designed to accommodate loads.

| Item No. | Observation | Recommended Action Plan | Priority |
|---|---|---|---|
| 1 | Columns appear to be stressed in excess of normal design limits – Building Engineer to verify concrete stresses and in-situ concrete strength. | Factory Engineer to review design, loads and columns stresses. | 6-weeks |
| 2 | Columns appear to be stressed in excess of normal design limits – Building Engineer to verify concrete stresses and in-situ concrete strength. | Verify in-situ concrete stresses either by 100mm diameter cores or existing cylinder strength data for cores from 4 columns. | 6-weeks |

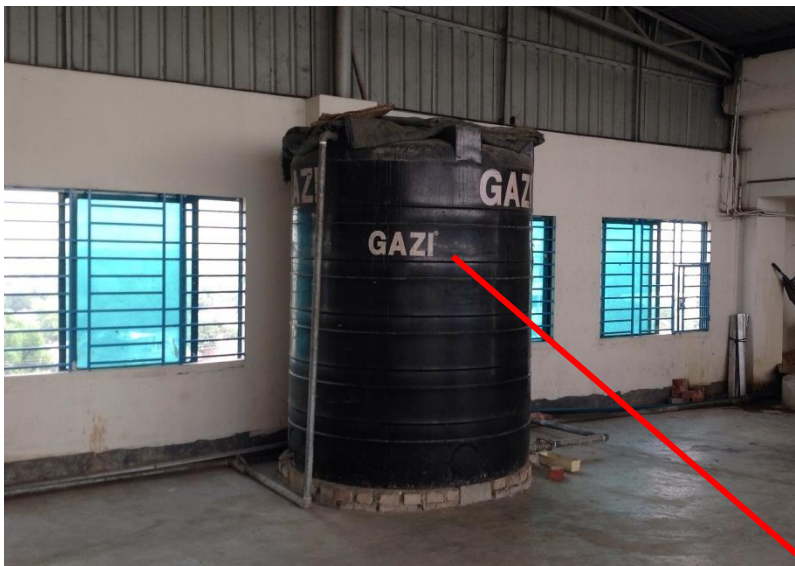
Roof – Plastic Water Tank

2 no. 5000L water tanks, mounted on 100mm brickwork are loading the roof slab structure.

Building Engineer to check that the beams and slabs have been designed to accommodate the loads.

| Item No. | Observation | Recommended Action Plan | Priority |
|---|---|---|---|
| 4 | Design Check required for the loading from the plastic water tanks at roof level and for the location of the fusing machine at 3rd Floor Level. | Locations of loading noted to be surveyed and capacity of floor structure to be assessed by the Building Engineer to confirm that the floor slab is designed to carry these loads. | 6-months |

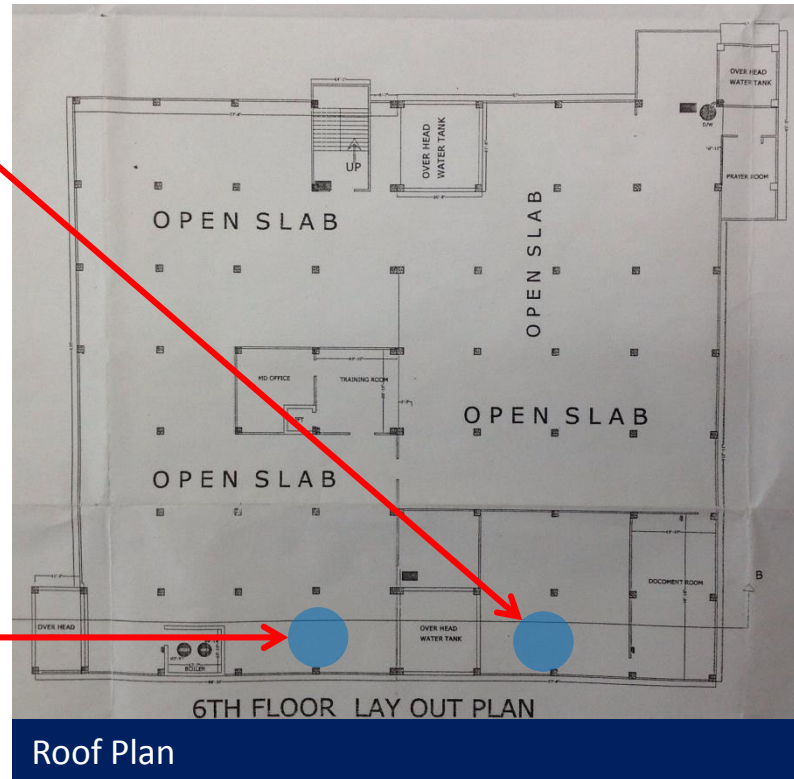
Roof Plan

Location of Water Tanks

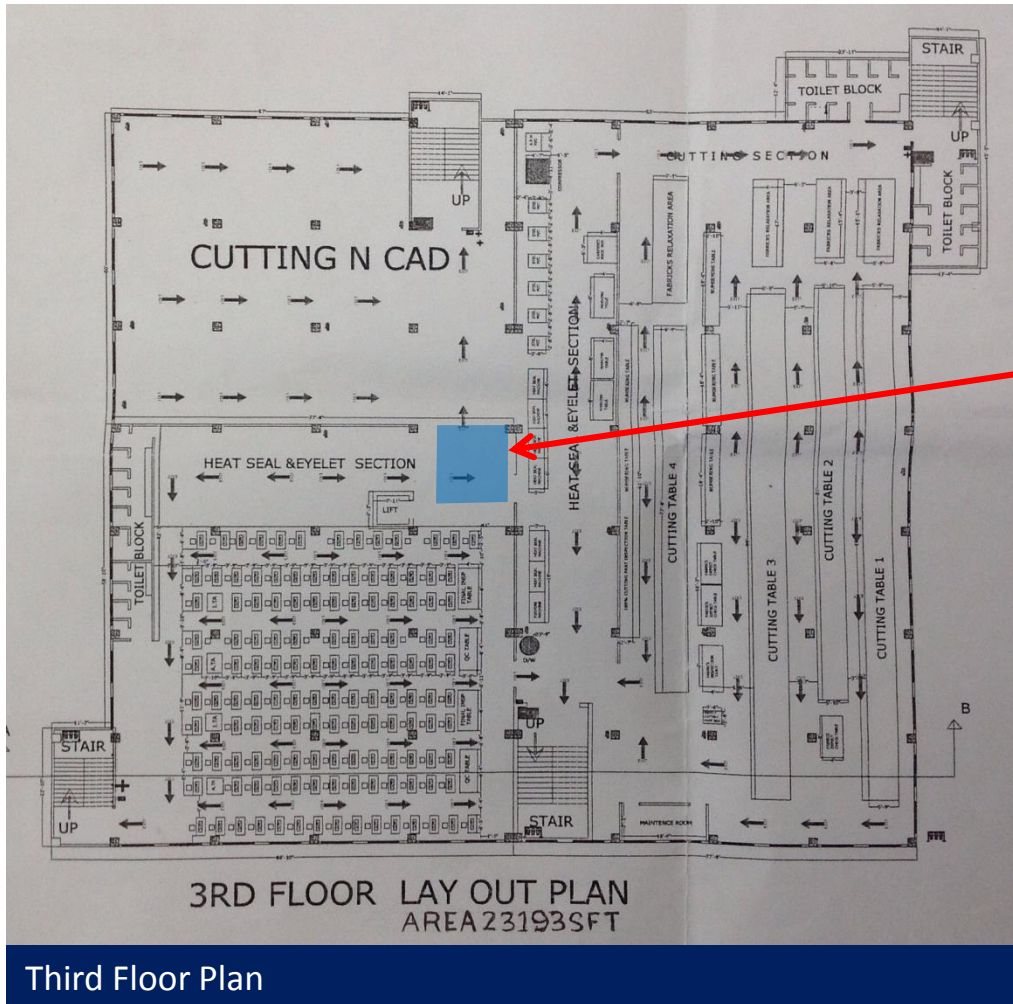
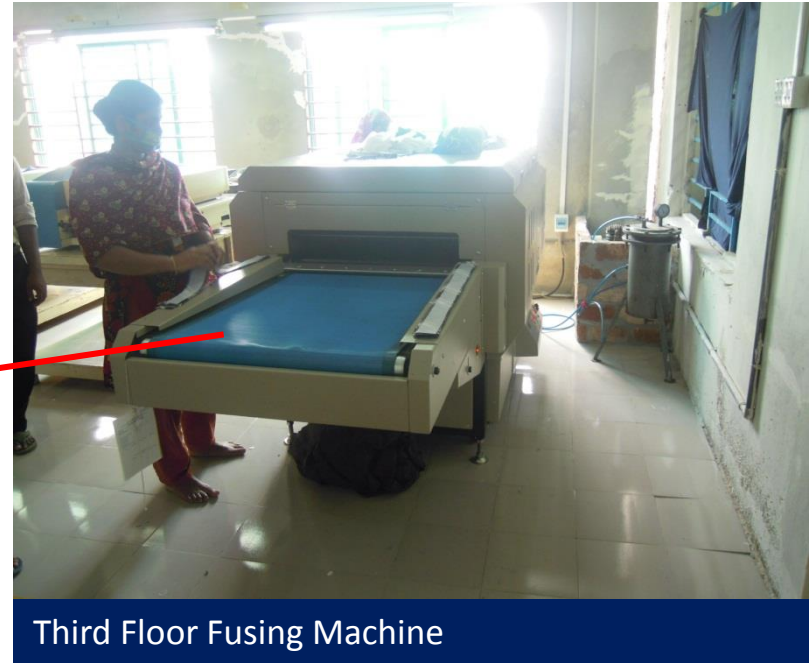
Fusing Machine Area

There is a Fusing Machine at Third Floor level adjacent to the movement joint.

Building Engineer to check that the beams and slabs have been adequately designed to carry the associated loading.

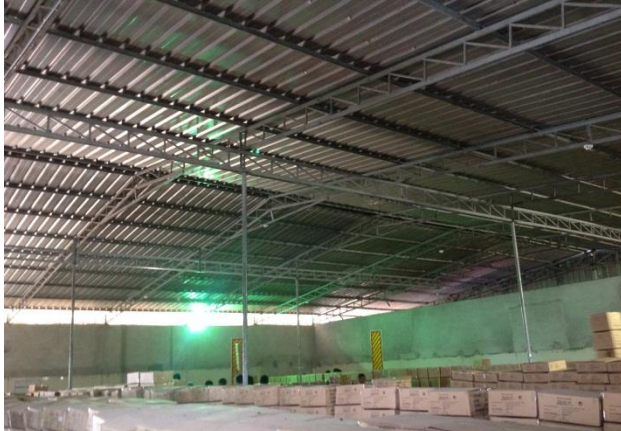
Finished Goods Store

Capacity of lightweight roof structures for Ancillary buildings to resist uplift loading due to wind to be checked, with particular emphasis on connections and lateral stability.

| Item No. | Observation | Recommended Action Plan | Priority |
|---|---|---|---|
| 6 | Design check required for the single storey buildings to confirm there adequacy to support wind loading (pressure/ suction and uplift.) | Building Engineer to provide detailed calculations for the single storey structures and the associated light steel roofs. These should confirm their ability to withstand all wind loading pressure, suctions and uplift forces. | 6-months |

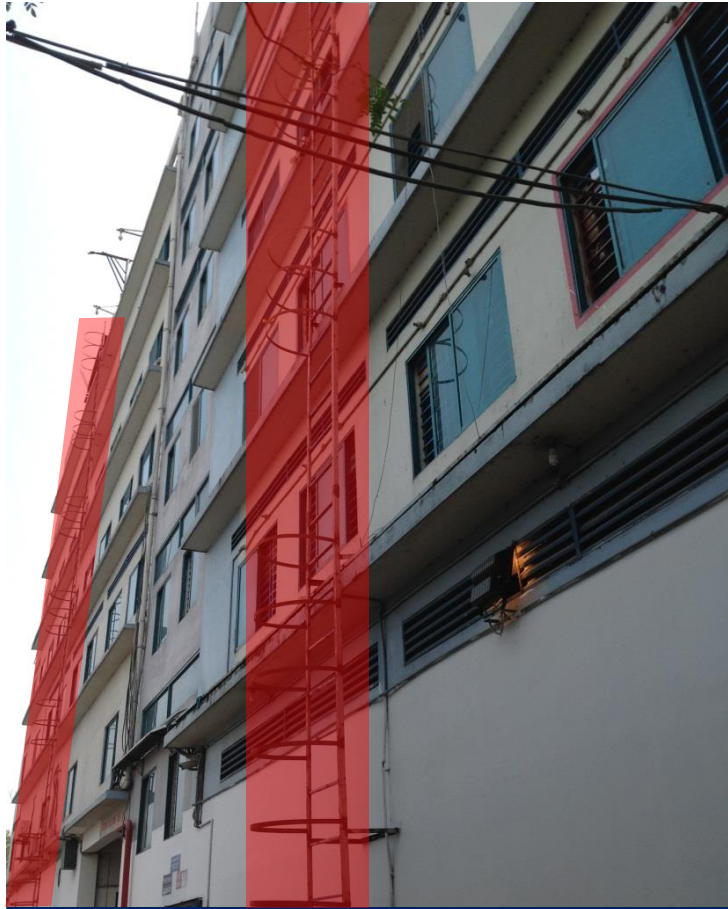
Fire escape ladders to North elevation

The vertical fire escape ladders to the building elevations were observed to be under construction at time of survey.

Building engineer to check the design and detailing of the fire escape ladders.

| Item No. | Observation | Recommended Action Plan | Priority |
|---|---|---|---|
| 7 | Design check required for the vertical escape ladders on the façades. | Building Engineer to provide calculations for the design of these ladders to confirm that their load carrying capacity is adequate. Connections to the building and overall detailing also needs to be reviewed. | 6-months |

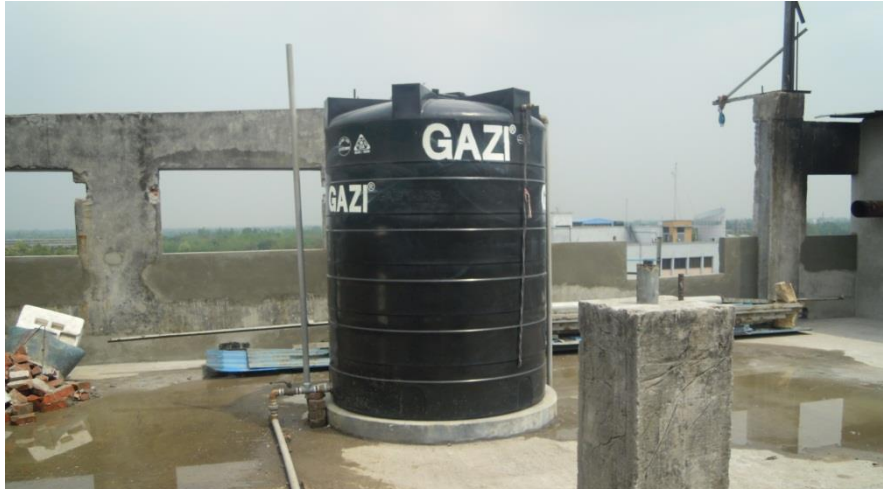
Ponding to Roof

**Roof drainage to be assessed to remove  
water ponding**

# Building Engineer to assess Roof drainage to remove water ponding.

| Item No. | Observation | Recommended Action Plan | Priority |
|---|---|---|---|
| 8 | Roof drainage to be assessed to remove water ponding. | Building Engineer to review the roof drainage and implement an appropriate drainage system that will prevent water ponding on the roof. | 6-months |

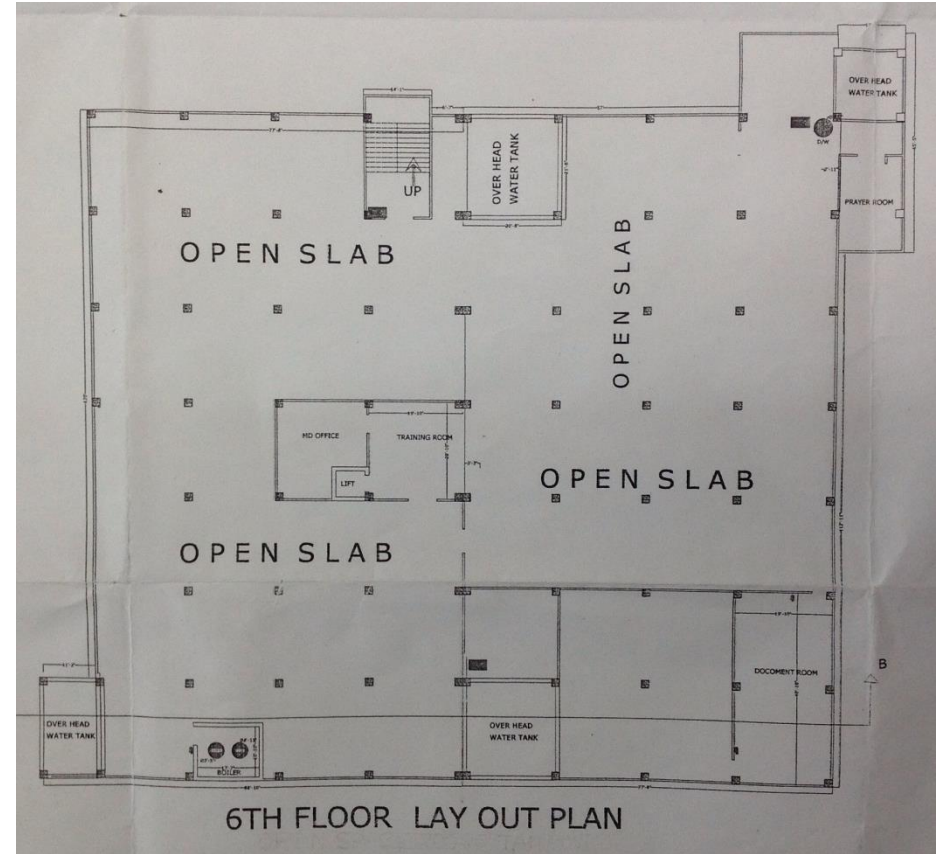
Roof Plan

**Ponding to Roof**

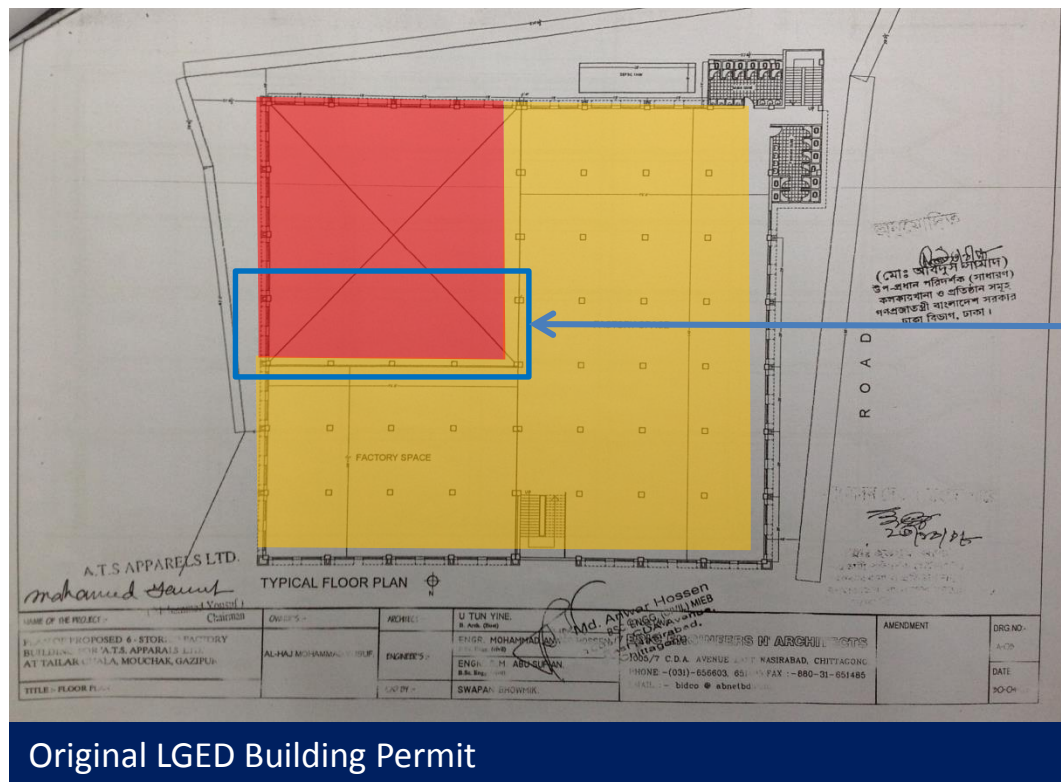
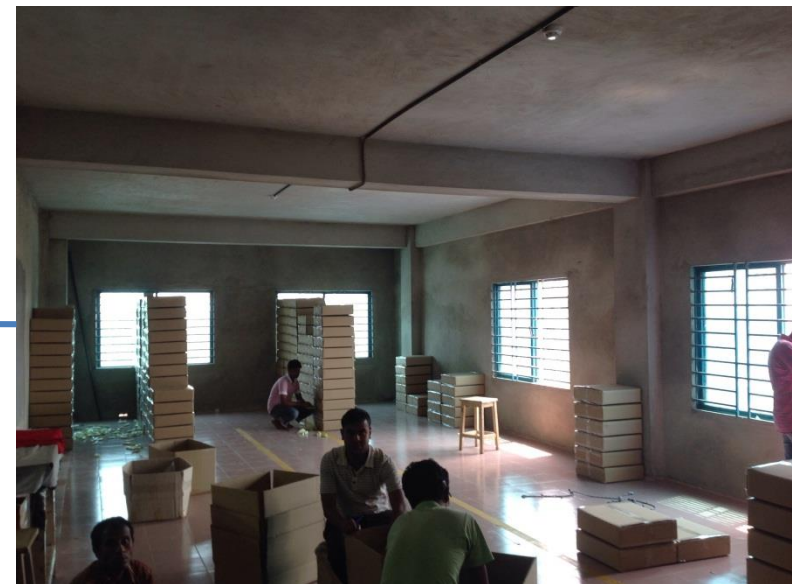
A 6-storey addition to the structure is planned to the South-East corner of the building, with construction currently underway, for which only an industrial permit (2014) was provided. The original LGED-approved building permit (2006) calls up an L-shaped Factory with a Ground Floor warehouse, as indicated.

Additional bay completed in 2013

Any proposed additions to the existing building structure should be reviewed by the Building Engineer.

| Item No. | Observation | Recommended Action Plan | Priority |
|---|---|---|---|
| 9 | It is noted that an addition to the structure is planned at the south east corner. | If any additions to the building structure are proposed, the Building Engineer shall provide calculations showing the structural adequacy of all columns taking into account any additions to the existing structure, the loading plans and as built structure, including insitu concrete strength testing. | 6-months |

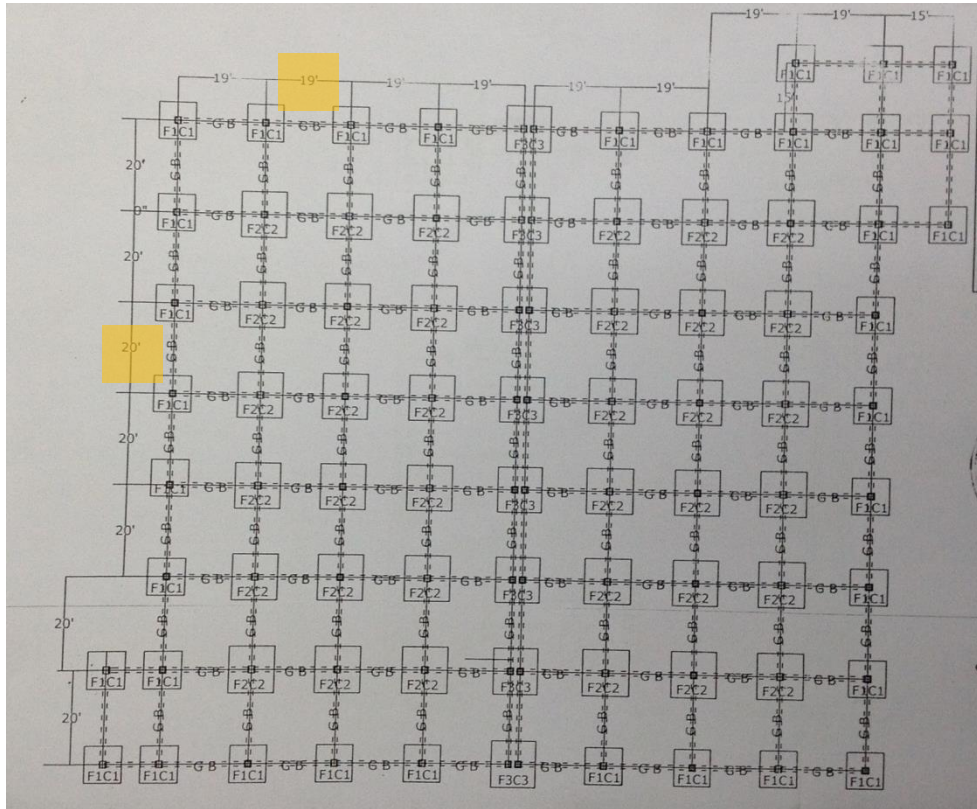
Inconsistency in column layout:

Drawings call up 5.8m x 6.1m (19ft x 20ft), whereas observed grid is 5.3m x 5.6m.

Building engineer to check, collect information and produce accurate and complete as-built documentation.

| Item No. | Observation | Recommended Action Plan | Priority |
|---|---|---|---|
| 10 | Inconsistencies between the drawings and the constructed building. | Building engineer to check, collect information and produce accurate and fully complete as-built documentation. | 6-months |

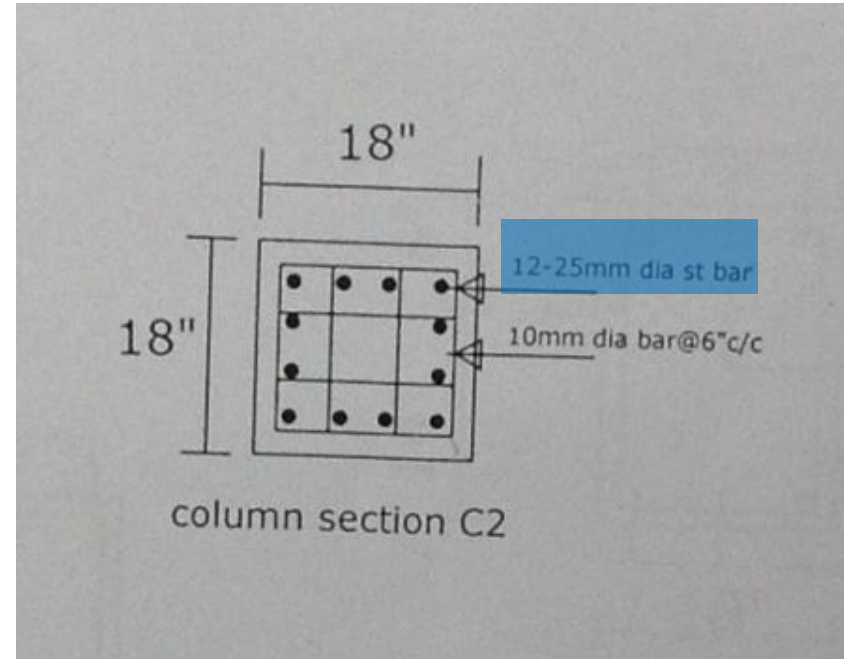
Inconsistency in column rebar:

Drawings call up 12 no.  $\varnothing 25\text{mm}$  bars in C2 columns, whereas observed columns have only 10 no. bars (Ferros scanner).
