Texpro Eco Apparel Ltd

89/13, Ward-1, Block-C, Birulia Savar Road, Kaliakoir, Savar, Dhaka
(23.8516, 90.2918)
27 July 2022

Buildings Information

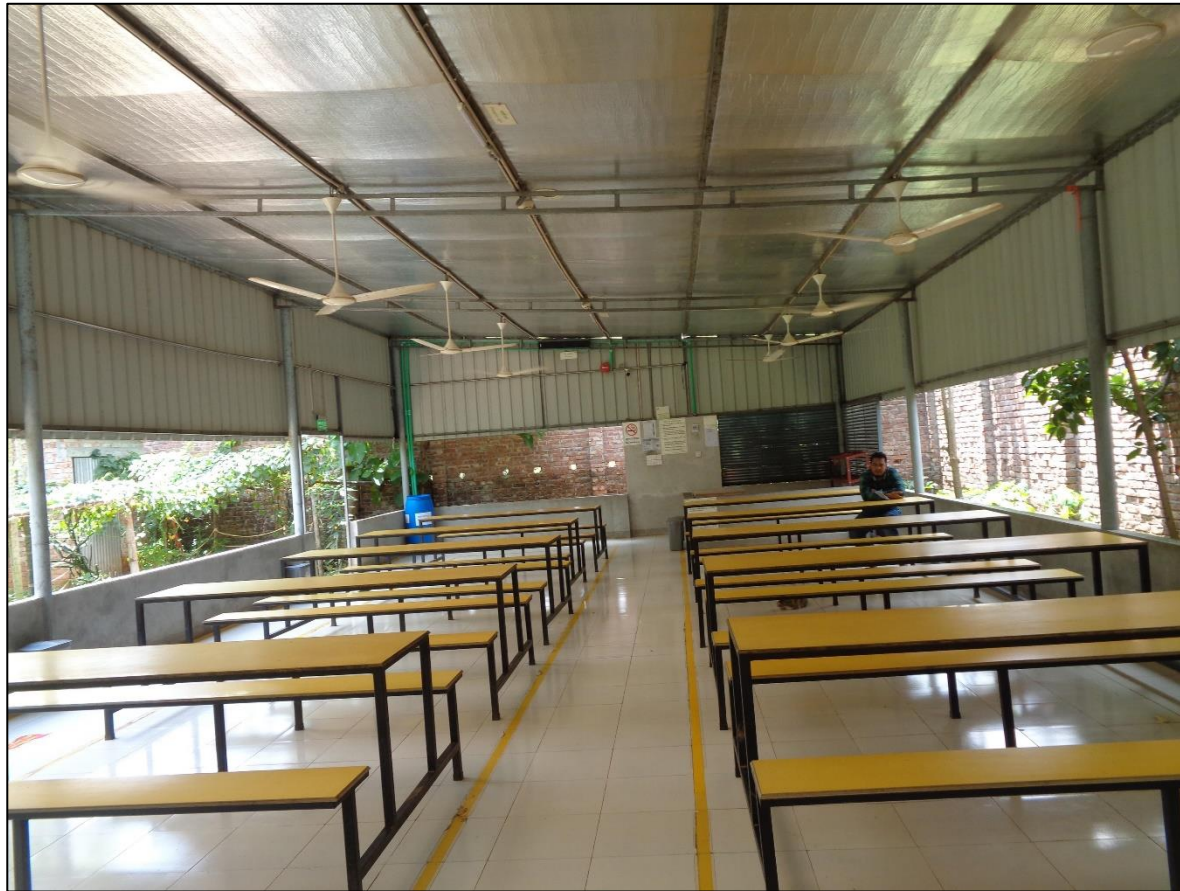
Lack of lateral stability system

No bracing system/load transfer media provided

No load transfer media provided along long direction. In addition, no roof bracing system is provided. Building engineer is required to check the lateral stability system of the shed against the lateral loadings and suggest necessary alternatives.

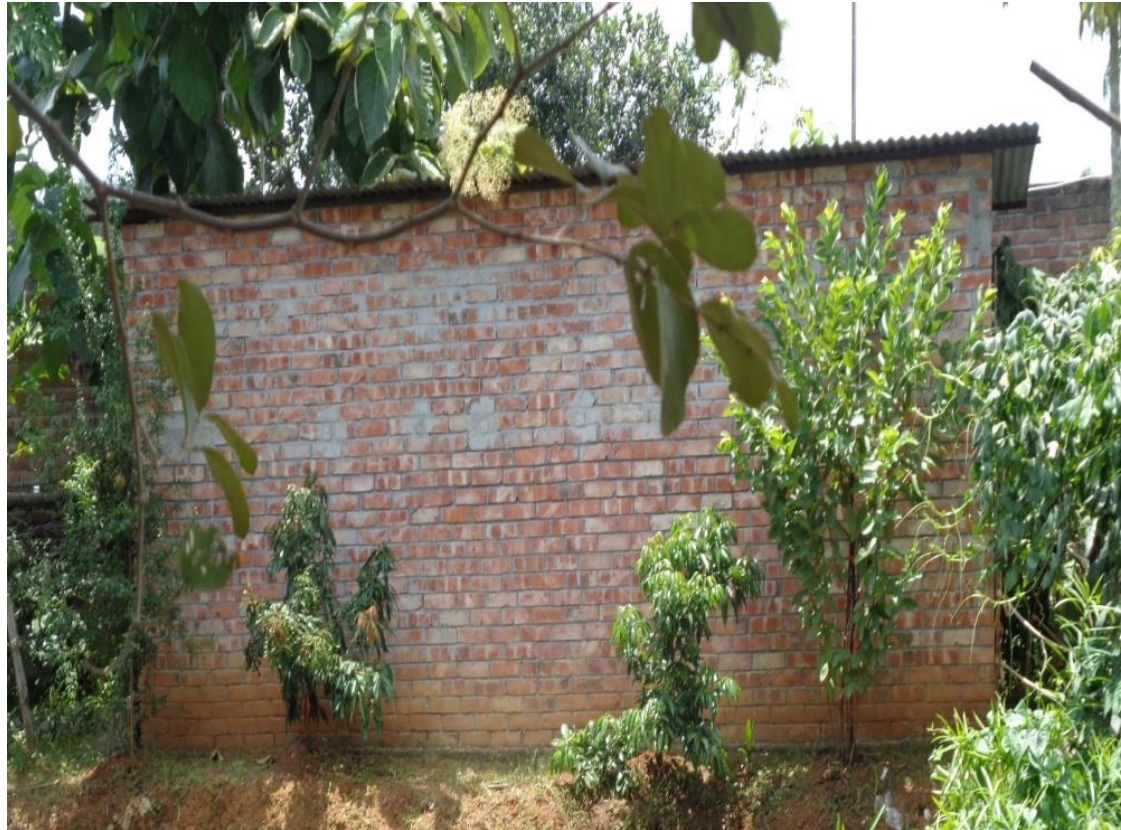
Building 6: Wastage Room

Lack of as-built drawings

As-built drawings was not available for the structure. Building engineer is required to produce as-built drawing.

- Factory engineer is required to prepare full set of as-built drawings as per BNBC (part-6, section 1.9.1.2).
