# Northern Fashions Ltd. (9202)

Plot 16-18 Dakkin Panishail, EPZ Kaliakoir Road, Kashimpur, Gazipur, Dhaka  
(+23.991154, +90.257172)

## Client Summary Report

**ACCORD**  
on Fire and Building Safety in Bangladesh

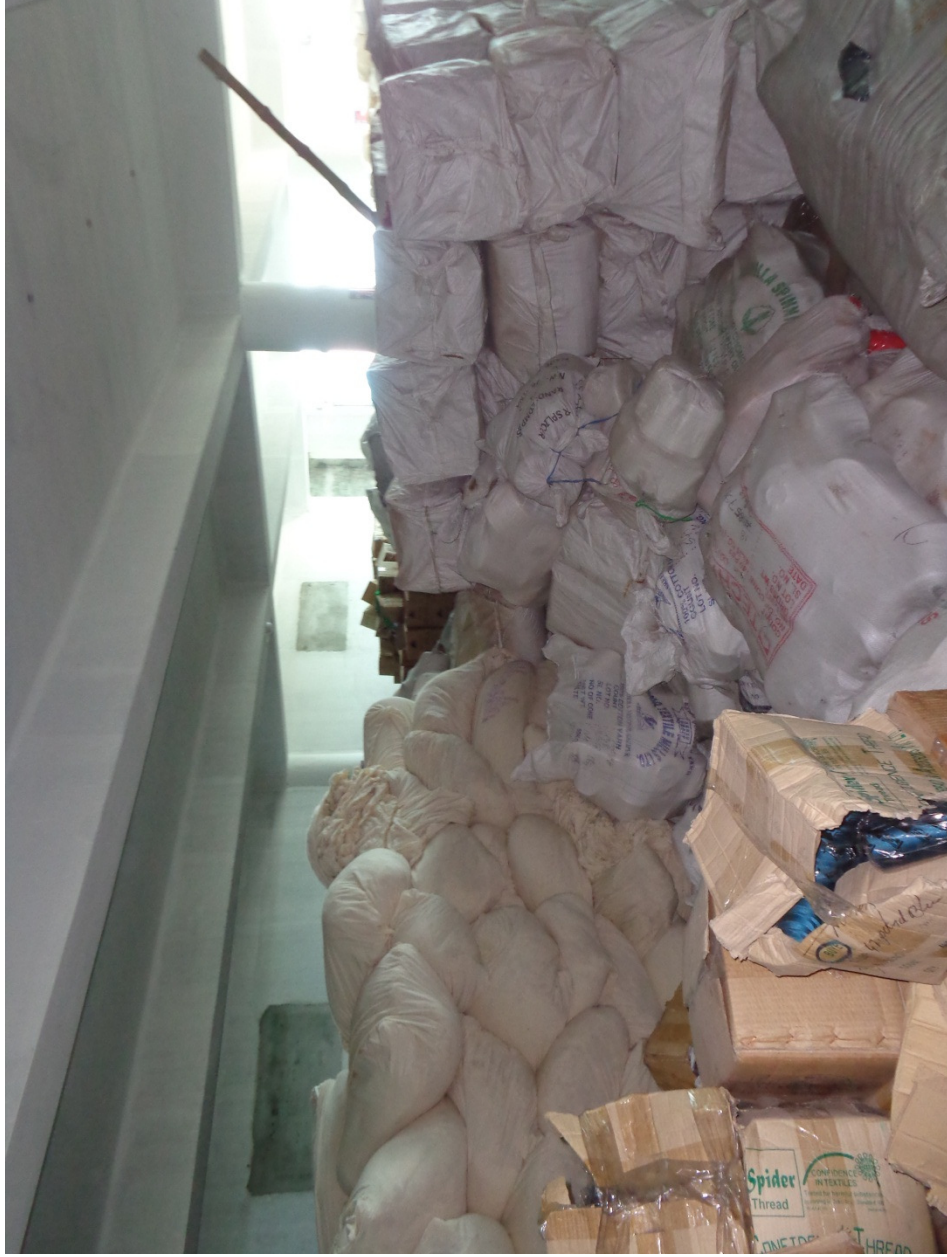
No formal loading plan was available at the time of inspection, very localized areas of higher than desirable storage were observed. However for the most part storage loads were very low.

### Lack of Floor Loading Plan

**ITEM 1: (Priority 3)** No floor loading plan was available at the time of inspection. Floors were for the most part reasonably loaded. However, localized areas of high storage were observed.

- Develop a loading plan for all floor plates within the factory complex giving consideration to slab, beam and column capacity.

- Actively manage the existing loading plan for all floor plates within the factory complex.
