# INITIAL FIRE ASSESSMENT REPORT (FAR)

Factory Name: **Zyta Apparels Ltd**

Assessor: **CCRD**

Date: **21 Apr 2013**

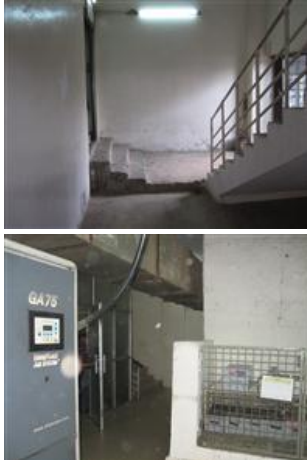
| Description: | The stair widths are inconsistent from the top to the bottom. The Main stair is 46 in. wide from the roof and 69 in. wide from Floor 9 to Floor 1. The Emergency stair is 46 in. wide from the roof, 60 in. wide and 46 in. from the Ground Floor to the grade discharge. This last stair to grade creates a reduction in the overall available width of the stair. Based on the BNBC requirement of 8 mm/person for stairs, the maximum permitted occupant load per floor is 365. There is an additional exterior stair from Floor 1; however, this stair discharges back to the Main stair at the Ground Floor effectively maintaining the overall exit capacity. |
| Source of Findings: | Photograph: Reduced Emergency Stair width, Visual Assessment: Measured stair widths |

| Description: | The path of egress is reduced at the Ground Floor for the Emergency Stair. The stair widths are inconsistent from the top to the bottom. The Emergency stair has a further restriction/trip hazard at the Ground Floor where the stair from the Ground Floor laundry runs into the stairwell discharge. The available clearance between the two stairs is 36 in. The Main exit stair requires people to walk around an air compressor and battery storage to access the stair | |
| Source of Findings: | Photograph: (1) Emergency Stair at Ground Floor (2) Obstruction to Main Stair (Basement) | |

| Suggested Plan of Action: | Limit the number of occupants on the Roof level canteen to 292 based on the available width of the stairs. Alternatively, widen the stairs from Floor 9 to the Roof to handle the additional load. Replace the Emergency exit discharge stair (from the Ground Floor to grade) with a 60 in. wide stair to facilitate the capacity that is available from the rest of the 60 in. wide stair above the Ground Floor level. Limit the number of occupants on the sewing floors to 365 until the Emergency exit discharge stair can be widened or automatic sprinkler protection is provided throughout the building. | |
